Report No. FHWA-WY-16/07F

INVESTIGATION OF SILICA FUME
CONCRETE BRIDGE DECK OVERLAY FAILURES

by
Kim Basham, PhD. PE, FACI
KB Engineering, LLC
1716 Capitol Avenue
Cheyenne, WY 82001
kbashamatKBEngLLC.com

February 23, 2016

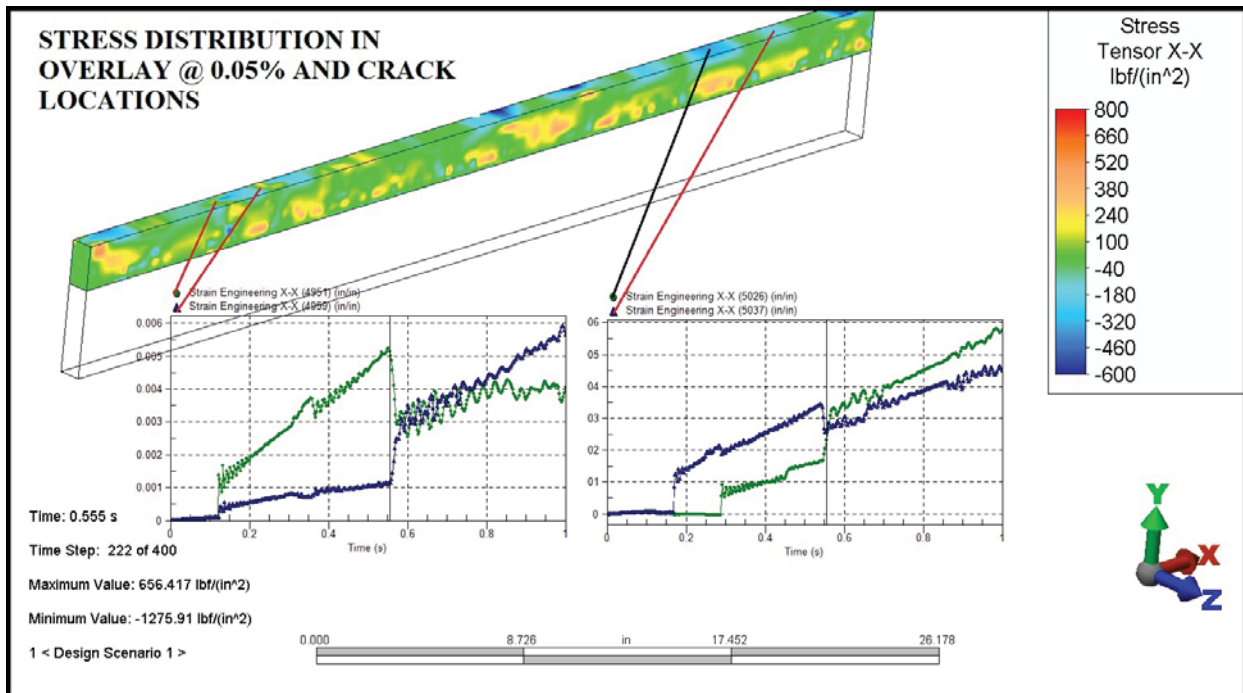
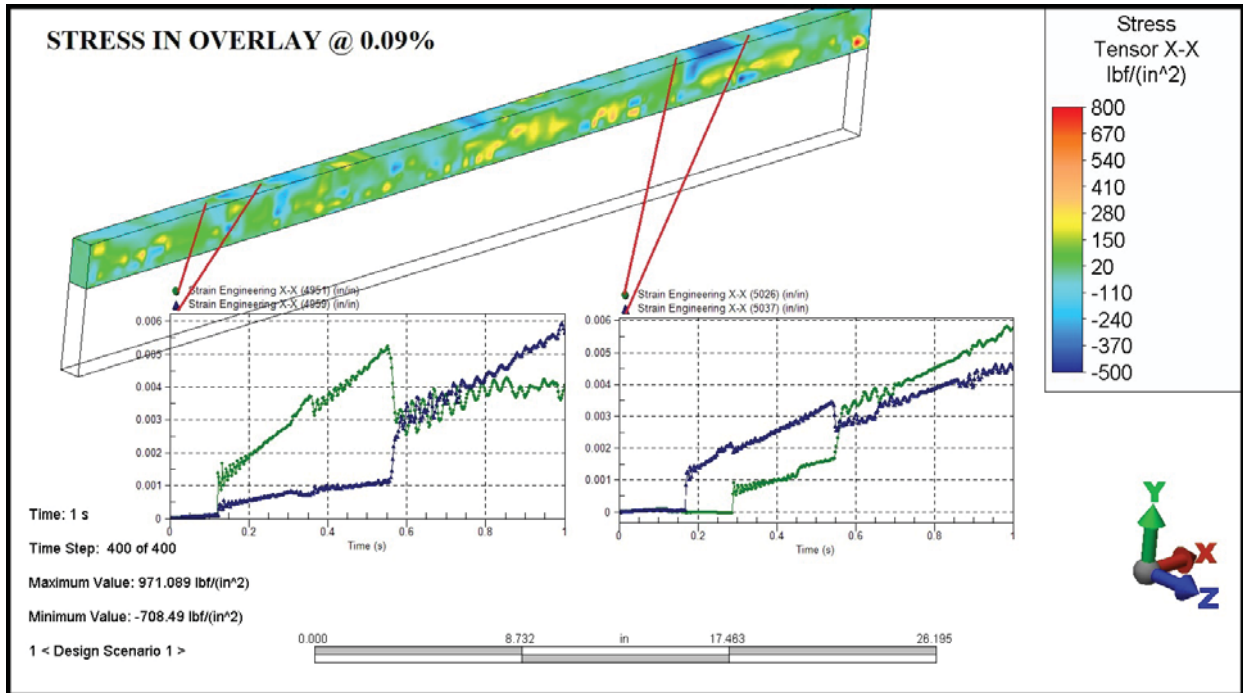
Figure 5.31. Stress tensor X-X at bond interface for at 0.09% shrinkage condition and crack opening history plots.

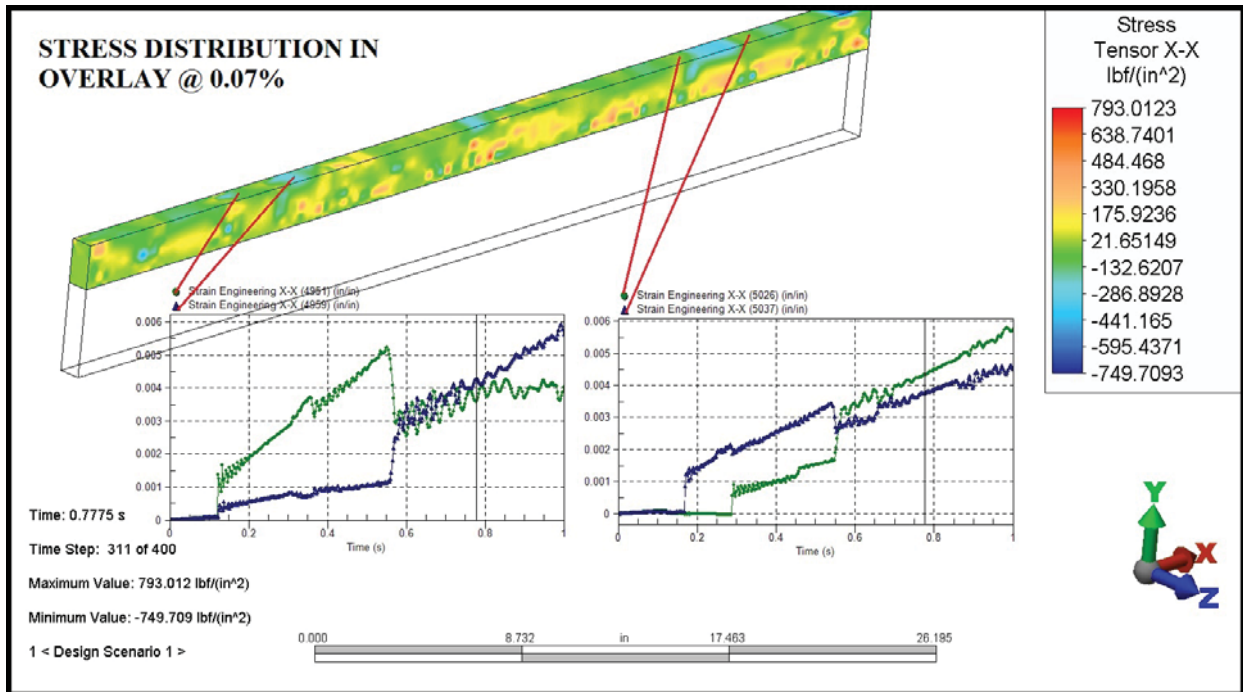
Figure 5.32. Stress distribution in overlay at 0.09% shrinkage and relation to locations of existing and developing cracks with crack opening history plots.

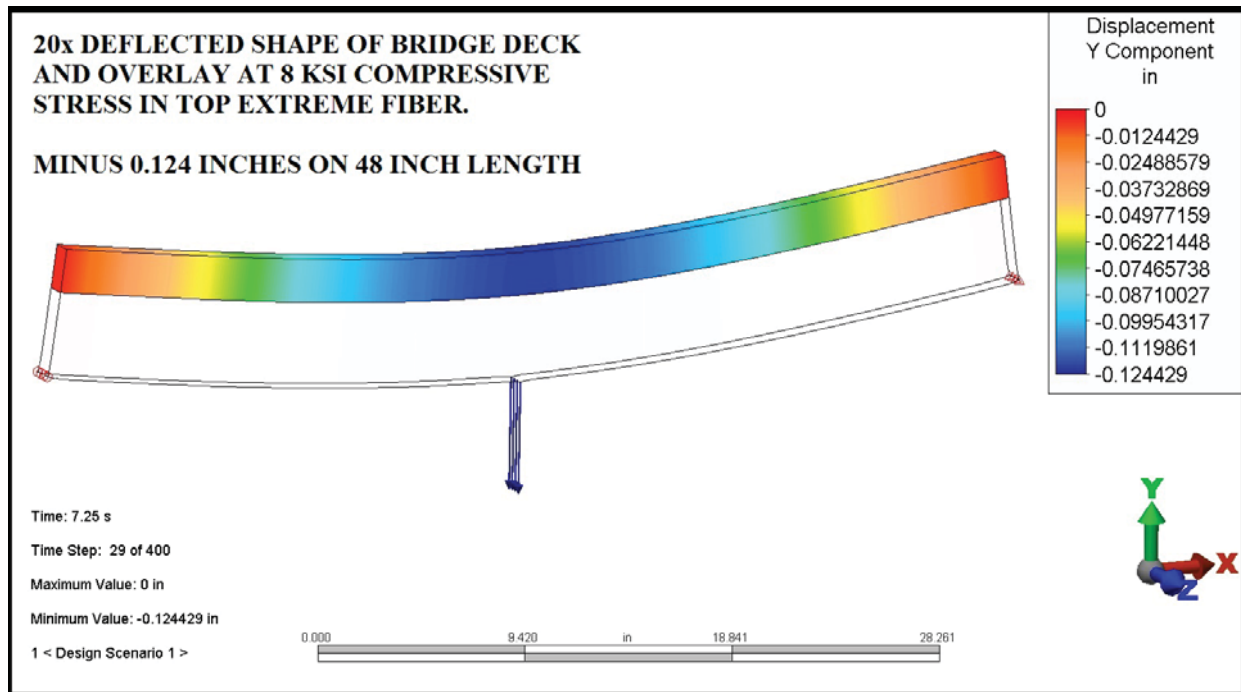
Figure 5.33. Deflected shape of bridge deck and overlay due to the positive bending moment .

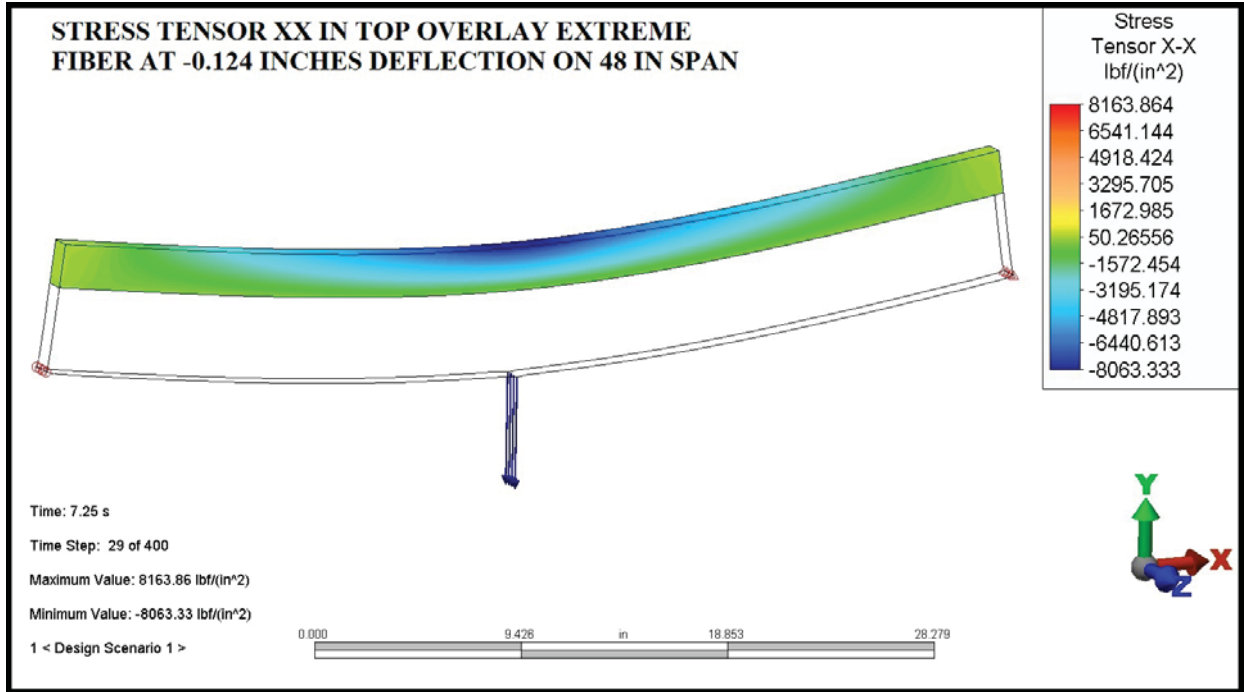
Figure 5.34. Stress tensor X-X at extreme fiber in top of overlay at -0.124 inch deflection.

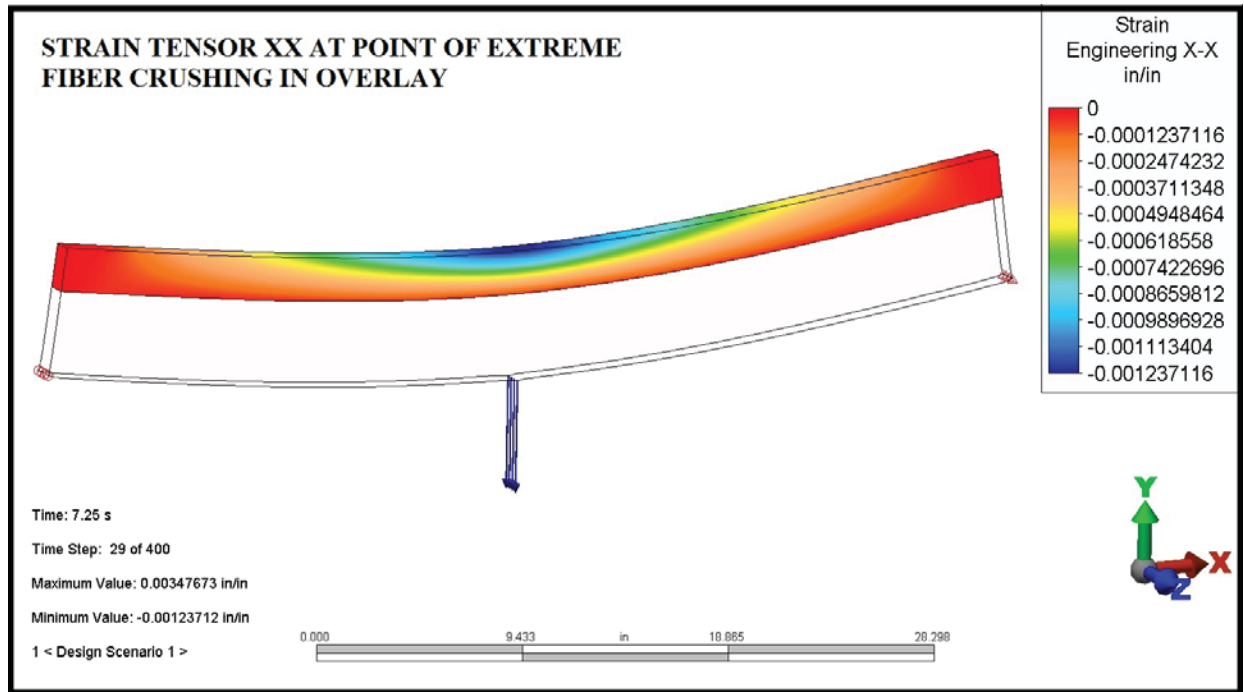
Figure 5.35. Stress tensor X-X at extreme fiber in top of overlay at extreme fiber crushing.

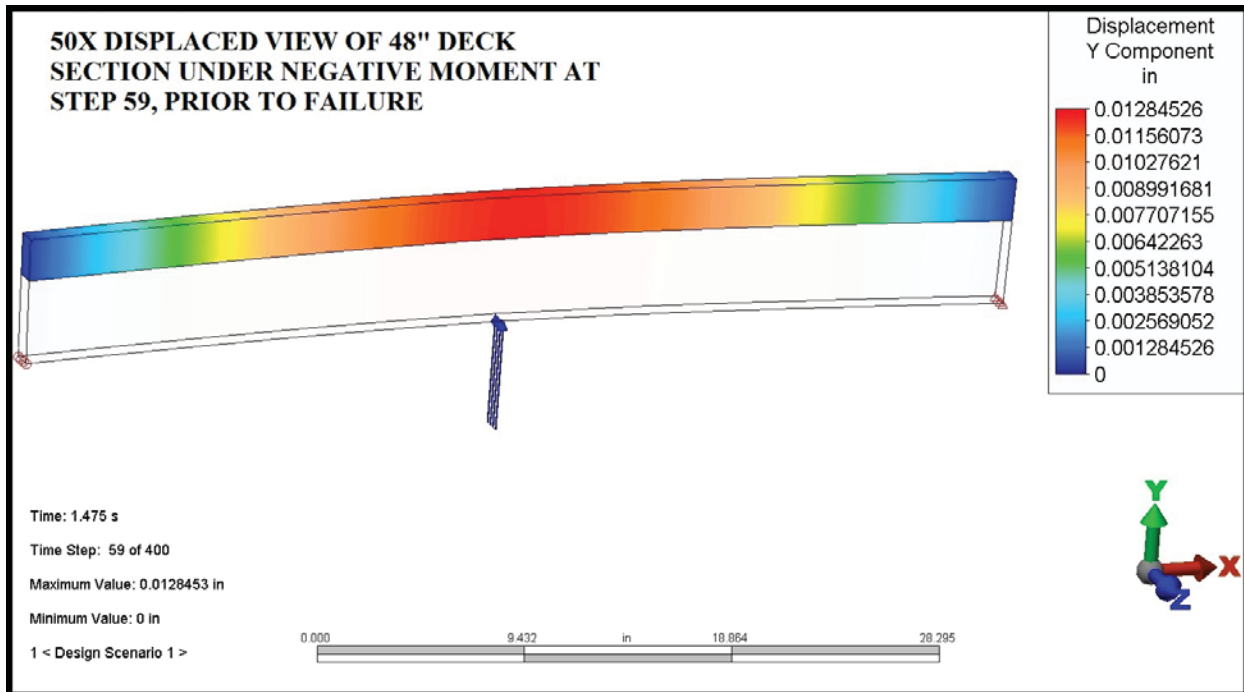
Negative moment due to an overlay section located directly above a bridge main or secondary structural member would tend to create a tensile stress in the overlay. Since cracks would form at the upper extreme fiber of the section, this cracking mechanism due to the negative moment was considered to be a likely cause of overlay damage as shown in Figures 5.36 – 5.42.

Figure 5.36. Deflected shape of bridge deck and overlay due to the negative bending moment prior to tensile failure.

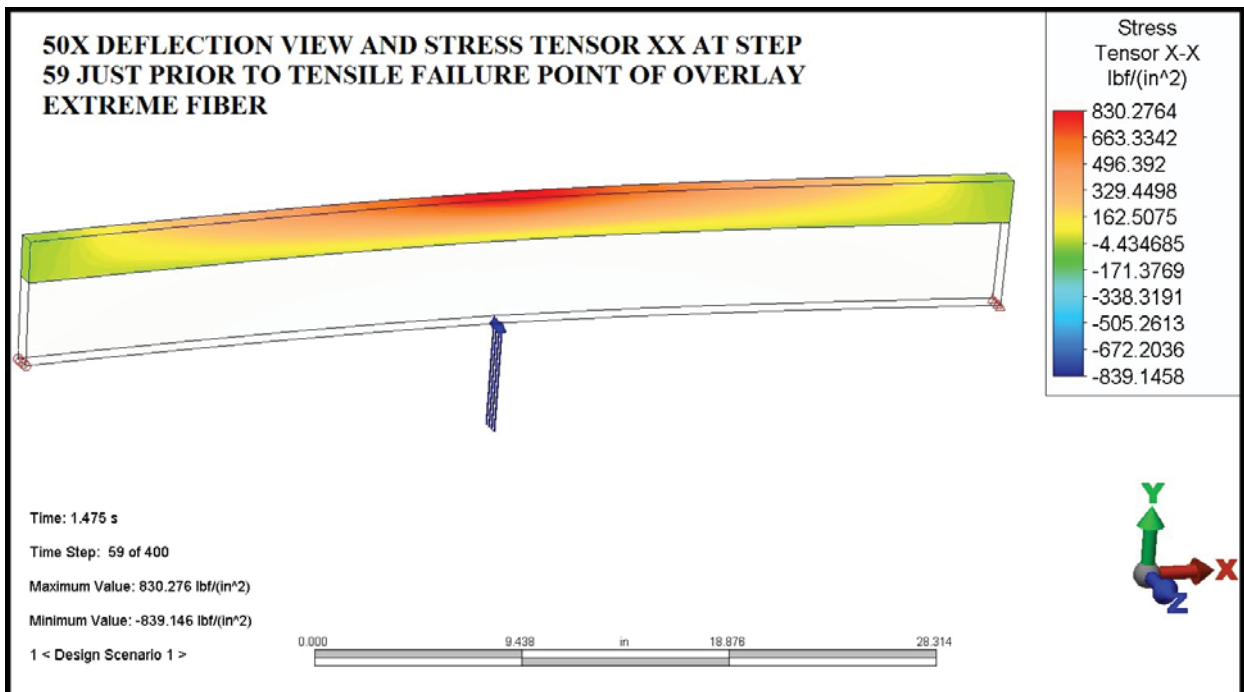
Figure 5.38. Deflected shape of bridge deck and overlay due to negative moment after tensile failure of overlay.

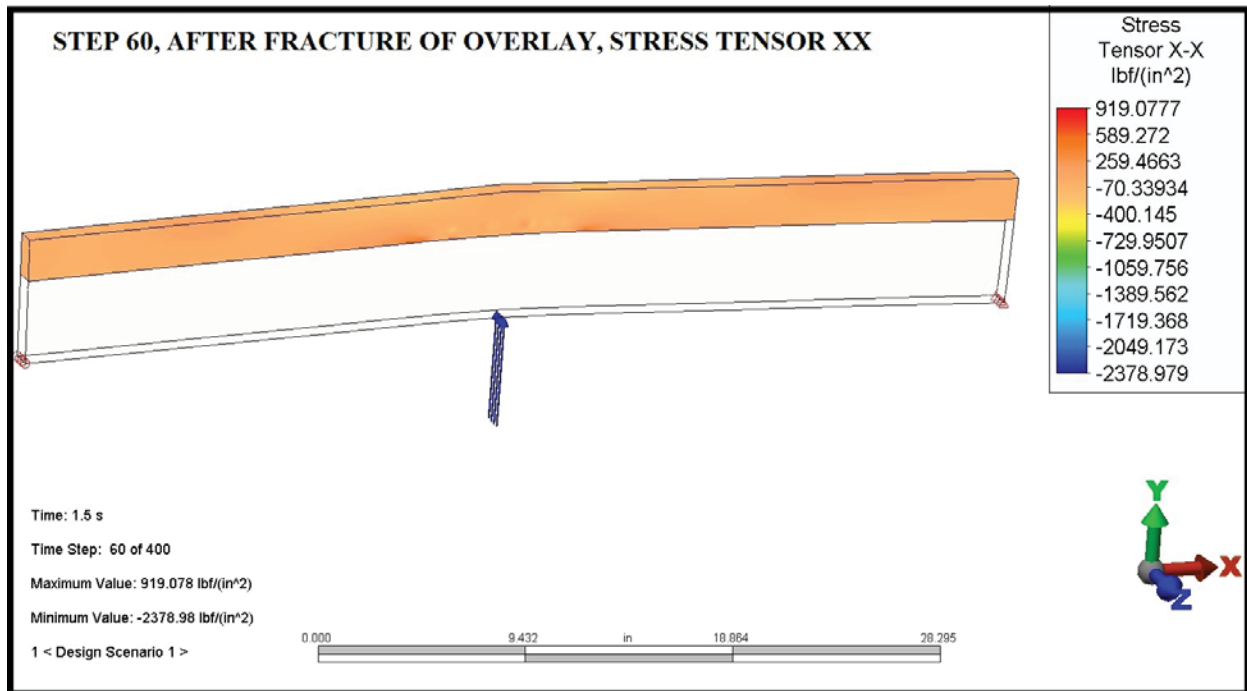
Figure 5.39. Stress tensor X-X at extreme top fiber of overlay after fracture.

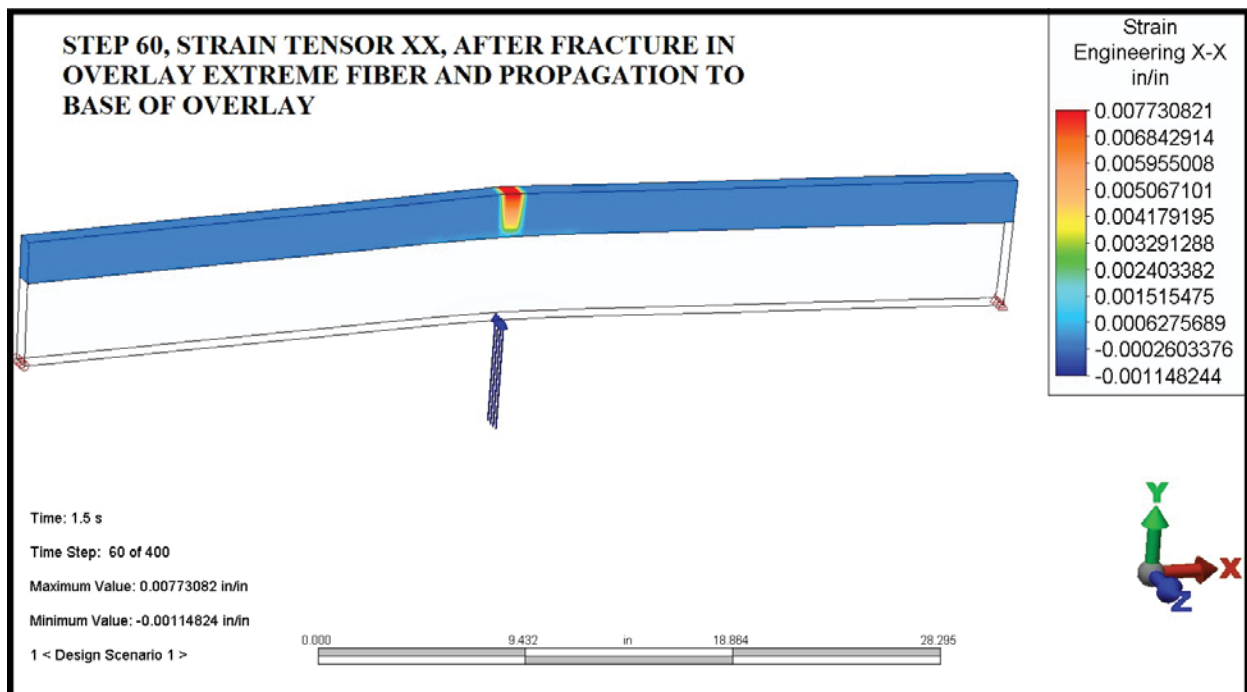
Figure 5.40. Stress tensor X-X at extreme top fiber of overlay after fracture and crack propagation to base of overlay.

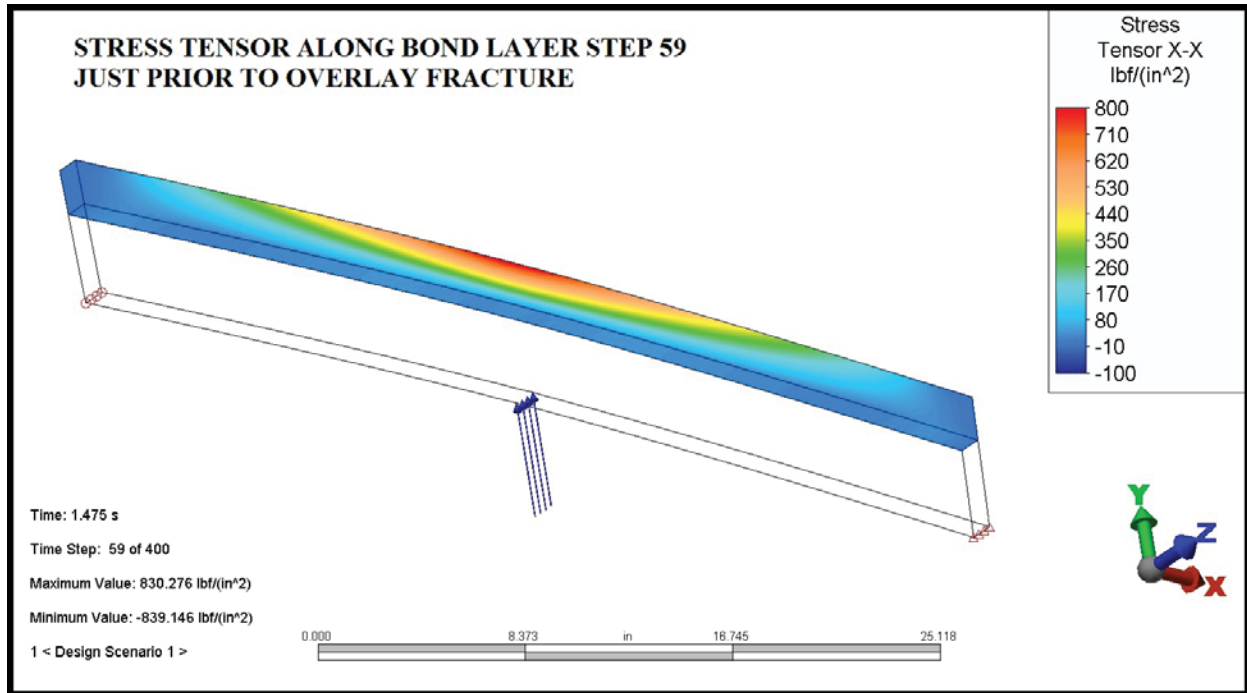
Figure 5.41. Stress tensor X-X along bond layer prior to overlay tensile fracture.

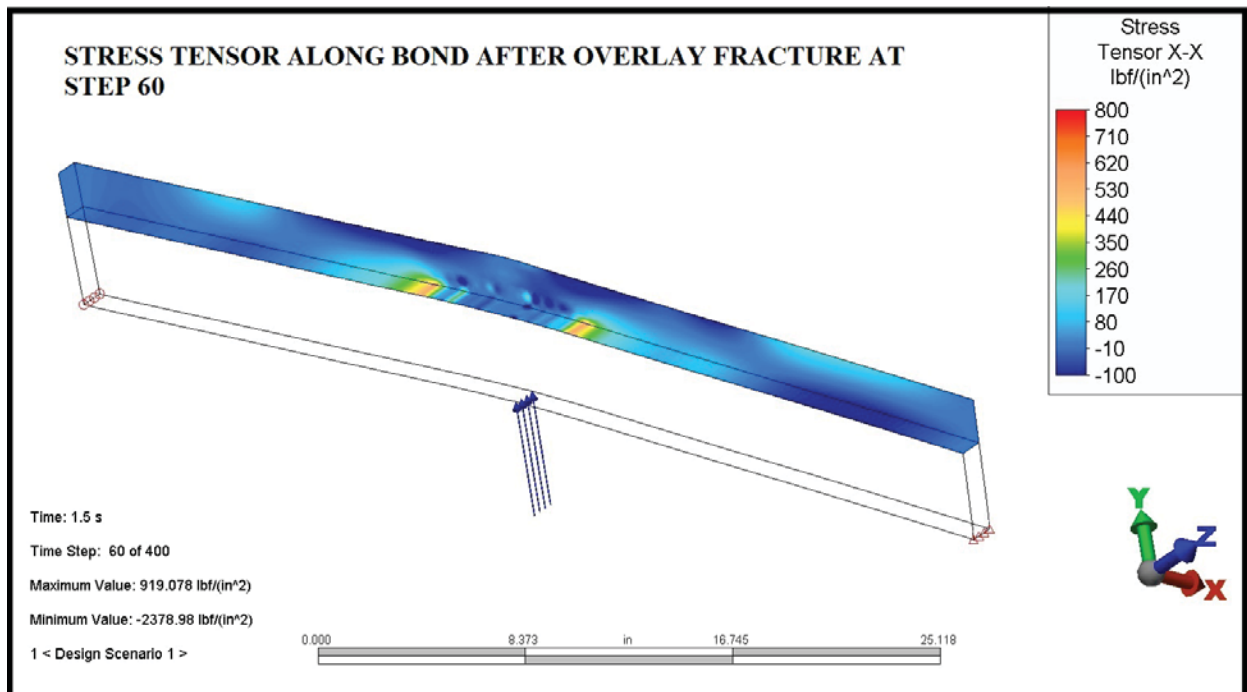
Figure 5.42. Stress tensor X-X along bond layer after overlay tensile fracture.
