CIVIL AERONAUTICS BOARD

AIRCRAFT ACCIDENT REPORT

BOEING AIRPLANE COMPANY, BOEING 707-227, N 7071,
NEAR ARLINGTON, WASHINGTON, OCTOBER 19, 1959

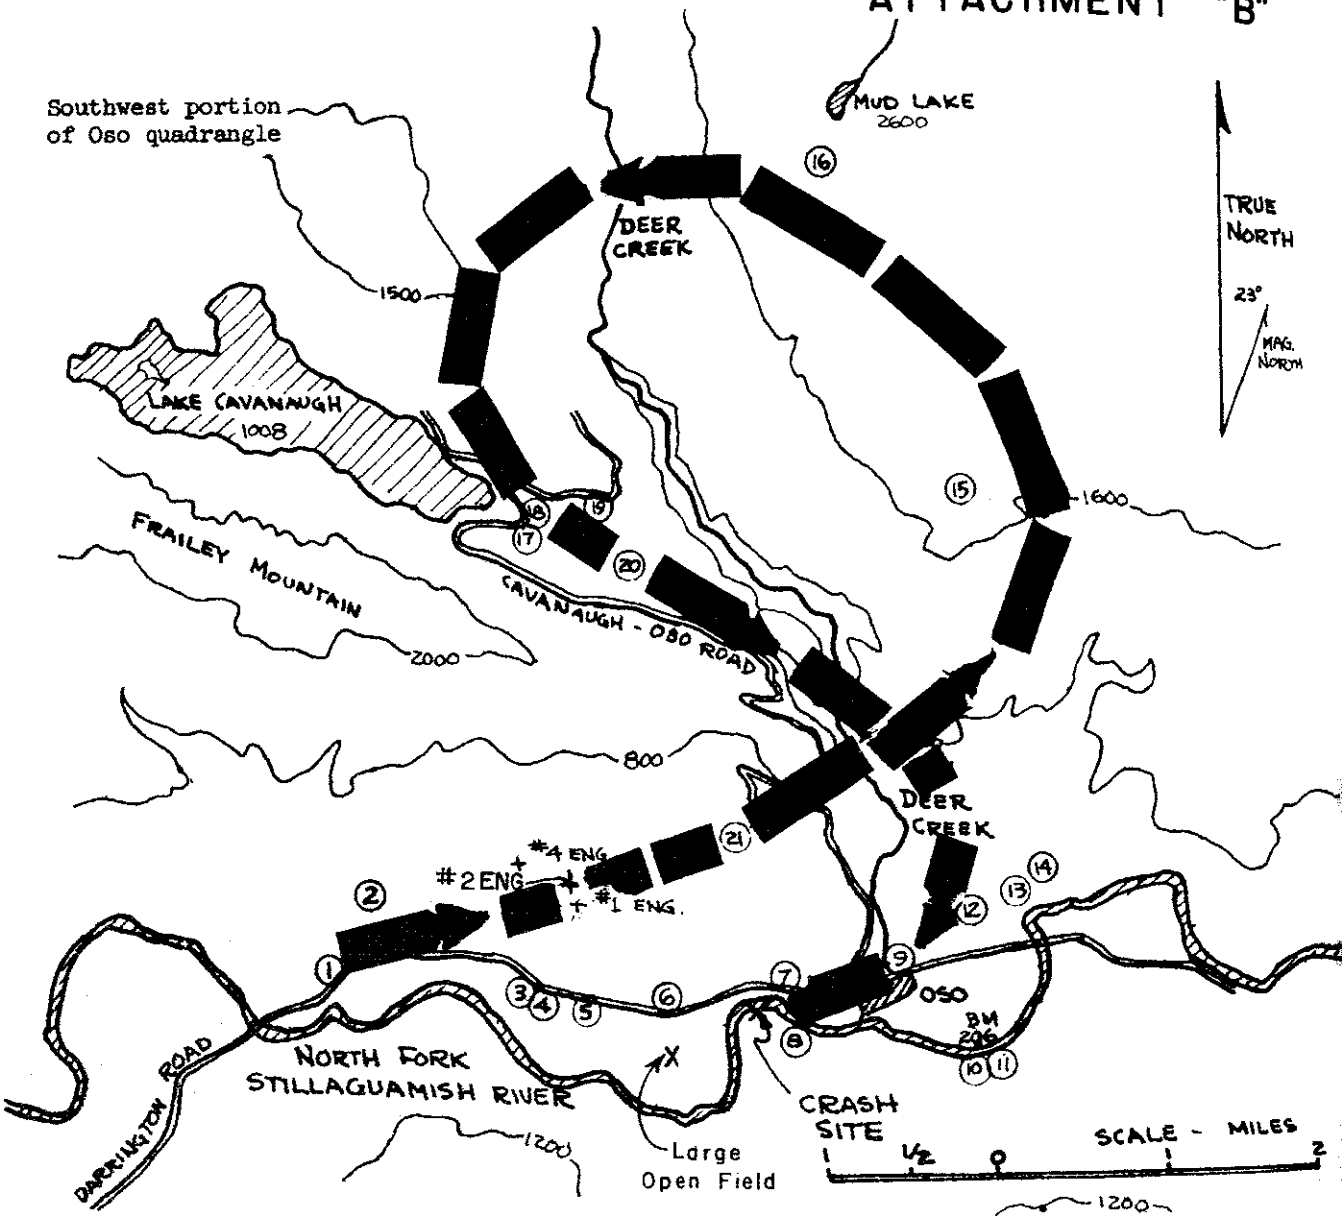
ATTACHMENT "B"

Weather was not a factor in this accident although a thin broken to overcast cloud coverage existed over the entire area with ceilings reported as about 4,000 feet. A number of ground witnesses saw the aircraft after it had emerged from this overcast in its descent The probable flight path of N 7071, depicted in Attachment "B" to this report, is based on evaluation of the sightings of these witnesses.

CIRCLED NUMBERS INDICATE LOCATION OF EYE WITNESSES.

Accident involving Aircraft N 7071 occurred one mile west of Oso, Washington, on October 19, 1959
