Final Report

Concrete Pipe – Electrochemical Cell, Phase II
BDV27-977-03

Submitted to
Florida Department of Transportation Research Center
605 Suwannee Street
Tallahassee, Florida 32399

August 2016

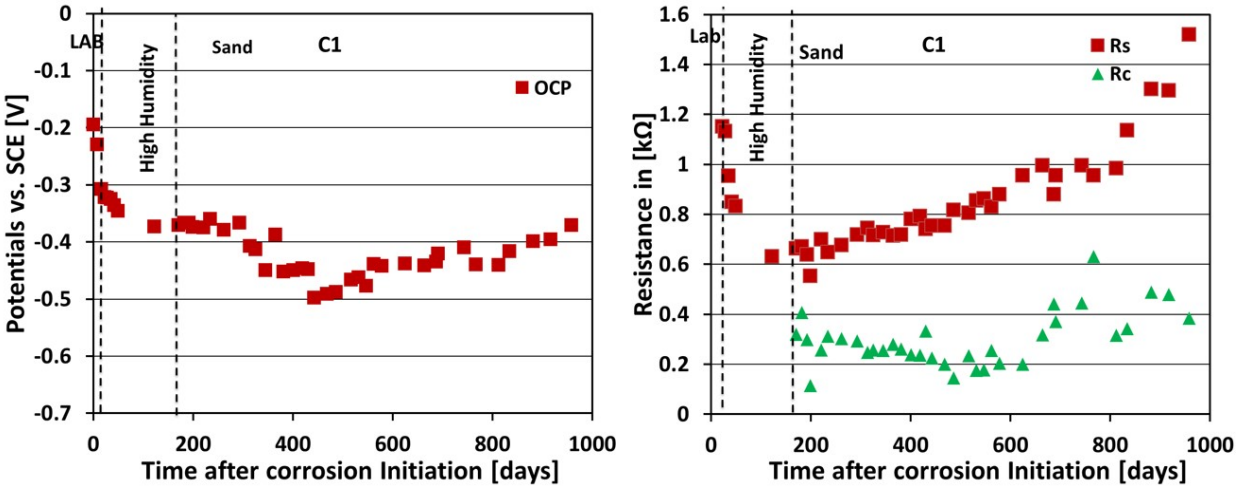
Figure 42 – Potential, Rs, and Rc values measured on C1 specimen.

Figure 42 shows on the left a plot of the reinforcement potential evolution and, on the right, the Rs and Rc values measured on specimen C1. The potential, once corrosion initiated, was close to -0.2 V; while exposed in lab conditions, it drifted to -0.23 V. Upon placing it in high moisture, the potential shifted to more negative values and reached a value of -0.38 V. The specimen was then placed in a container covered with saturated sand; the reinforcement potential then drifted further to more negative potential values and reached a potential value of -0.5 V by day 400. The reinforcement potential values then started to drift toward more positive values, but plateaued for some time (200 days) at a potential value of -0.43 V and, after day 600, slowly drifted to more positive values. The potential was -0.38 Vsce before terminating this specimen. Regarding the Rs evolution with time, it went from a value of 0.6 kΩ to a value of 1.6 kΩ by day 950. Most Rc values were between 0.2 and 0.4 kΩ. The Rc values initially decreased and then, after day 600, showed an slight increase in magnitude, suggesting that a modest reduction in the corrosion rate might have taken place.

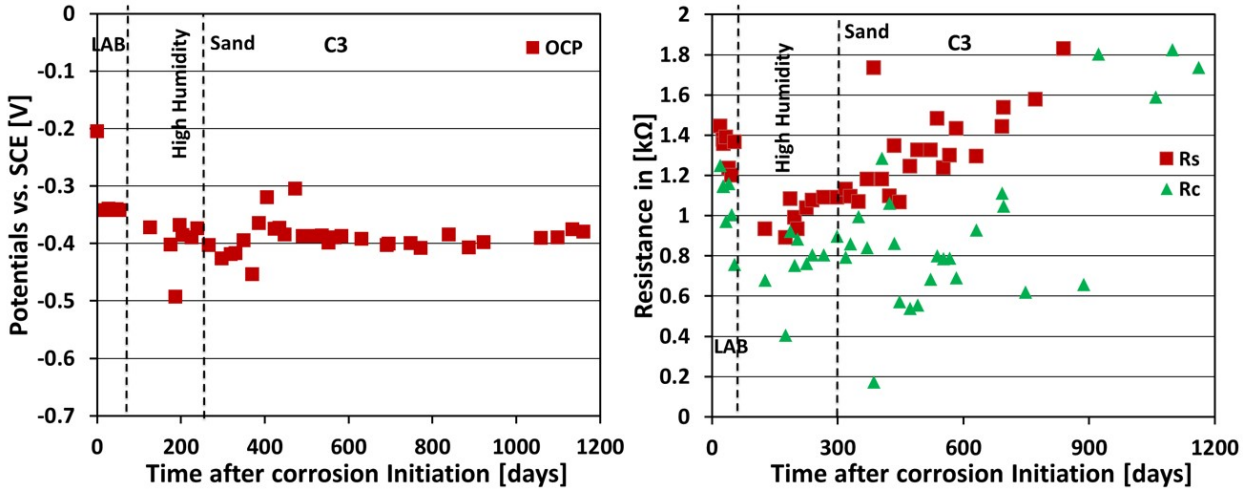
Figure 43 shows on the left a plot of the potential evolution measured during three different exposures for the reinforcing steel of specimen C3. The potentiostatic method was used to accelerate the chloride transport in specimen C3. Corrosion initiation was declared after 30 days, in this case, when the reinforcement potential had reached a value of -205 mVsce. The specimen was then exposed to the laboratory environment for 29 days and then transferred to the high humidity exposure for 147 days; the specimen was then covered with saturated sand. The potential of the reinforcement during the laboratory exposure quickly shifted to a more negative value of -342 mV and remained close to this value during the lab humidity exposure. Once the specimen was transferred to the high humidity exposure, the potential of the reinforcement decreased from -342 mV to -402 mV by day 176. Then the specimen was transferred to an exposure that fully covered the specimen with saturated sand. The potential of the reinforcements showed a gradual and moderate decrease in value to -426 mV by day 298 of exposure. After day 320, the reinforcement potential gradually increased, and by day 406 of exposure, the potential of the reinforcing steel had reached a value of -320 mVsce. Afterward,

the potential oscillated, and by day 495, it had returned to -400 mVsce. The potential remained around -400 mVsce till day 1200, and slowly increased to -380 mVsce by day 1500.

Figure 43 – C3 specimen: a) potential vs. time b) Rc and Rs vs. time.

The plot on the right of Figure 43 shows that the Rc values decreased from 1.25 kΩ to 0.97 kΩ by day 33 under lab RH exposure. Then the Rc value decreased further to 0.41 kΩ by day 176, while exposed to high humidity. When the specimen was exposed covered with saturated sand, the Rc value ranged between 0.5 and 1.2 kΩ (till day 900). Toward the end of the reported period, it increased to a value of 2 kΩ, with the last reading being a little over 3 kΩ. The Rs on this specimen experienced a monotonic increase from day 176 to day 1500, from 1 kΩ to 2.6 kΩ.

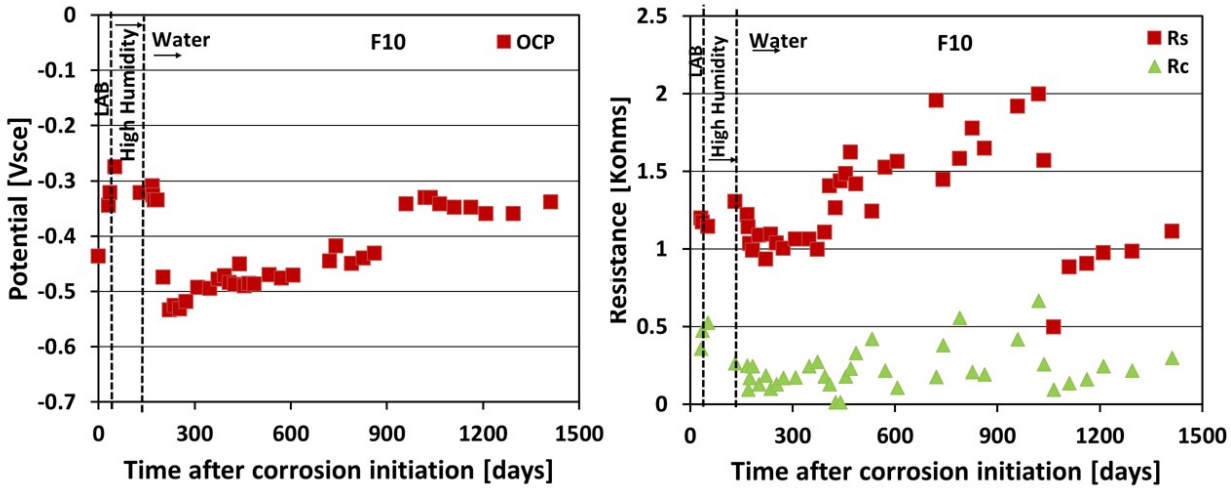
Figure 44 presents on the left a plot of the potential evolution measured during three different exposures for the reinforcing steel of specimen F10. After corrosion had initiated, this specimen was exposed to the laboratory environment for 32 days and then transferred to a high humidity environment for 136 days; it was then immersed in water. Figure 9a shows that the potentials of the reinforcement, during the laboratory exposure condition, gradually increased from -435 mV to -345 mV by day 32. While in the high humidity exposure, the reinforcement potential momentarily increased from -345 mV to -280 mVsce and shifted to -309 mV by day 168. In the immersed water condition, the reinforcement potential decreased to -534 mV by day 222 and remained around this value for 30 days. This was followed by a modest increase in potential to a value of -493 mV by day 309, and remained at this level subsequently till day 600. The steel potential then drifted toward more positive values and eventually reached a value of -0.35 by day 1400. Figure 44 – plot on the right – presents the observed trend for Rs and Rc on specimen F10. It shows that the Rc measured value (while exposed to high humidity conditions) decreased from 0.435 kΩ to 0.225 kΩ by day 168. The specimen was then immersed in water and the Rc value slowly decreased to a value of 0.099 kΩ by day 236, followed by a gradual modest increase to 0.4 kΩ by day 490. The Rc value then oscillated between 0.05 kΩ and 0.6 kΩ, with the last Rc values being 0.3 kΩ.

Figure 44 – F10 specimen: a) potential vs. time b) Rc and Rs vs. time.

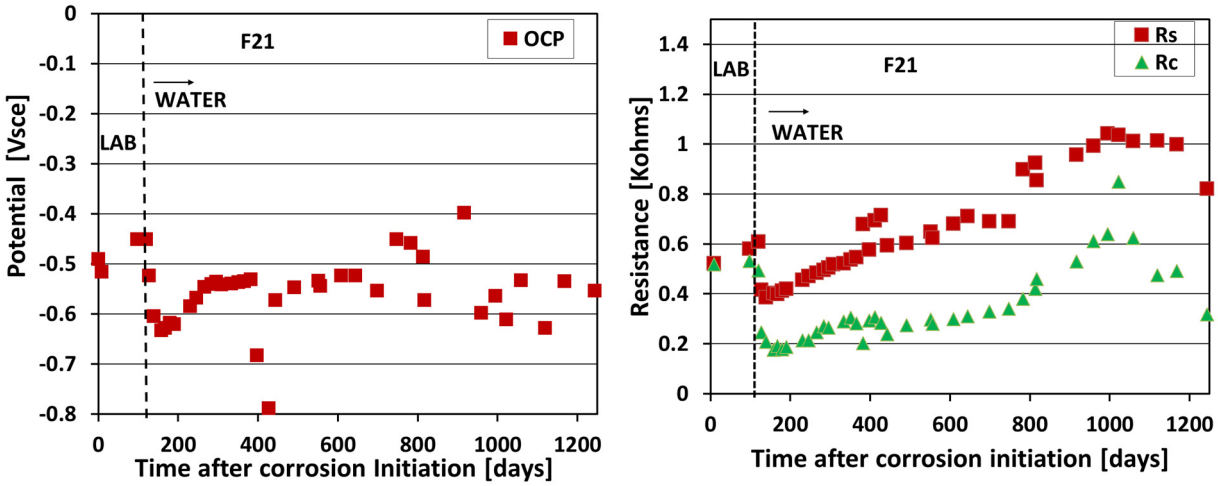
The plot on the left in Figure 45 presents the potential evolution measured during three different exposures for the reinforcing steel of specimen F21. Specimen F21 was subjected to the galvanostatic method for accelerated chloride transportation. The reinforcement potential, upon corrosion initiation, was -491 mV. After corrosion initiated, the specimen was exposed to laboratory conditions for 120 days and then immersed in water for more than 100 days. During the laboratory exposure, the potential values showed a moderate increase to -461 mV, but while immersed in water, the potential values decreased to a more negative value of -633 mV by day 168, and then was followed by a gradual increase in potential to a value of-546 mV by day 266 of exposure, and remained there until day 390. The plot on the right in Figure 45 shows that the Rc value remains almost unchanged while exposed to laboratory atmosphere. While immersed in water, the Rc value initially decreased from 0.493 kΩ to 0.245 kΩ by day 127 and gradually reached a lower value of 0.177 kΩ by day 168. Then the Rc value showed a modest gradual increase and reached a value of 0.24 kΩ by day 400. While immersed in water, the average Rc value was 0.2 kΩ.

Figure 45 – F21 specimen: a) potential vs. time b) Rc and Rs vs. time.

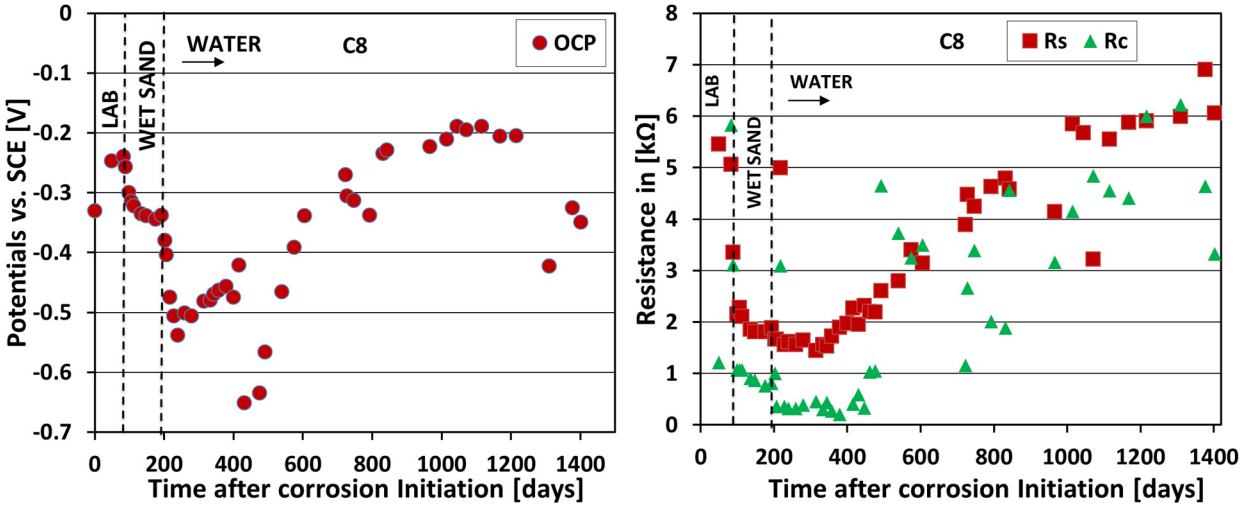
The potential evolution measured during three different exposures for the reinforcing steel of specimen C8 is shown in Figure 46 (plot on the left). C8 was subjected to the galvanostatic method for accelerated chloride transportation. The specimen started corroding after 163 days, and the corresponding potential was -330 mV. After corrosion had initiated, the specimen was exposed to laboratory conditions for 83 days and then it was placed in the fully buried sand condition for 110 days. C8 was then immersed in water. The potential gradually increase to -240 mV by day 83 while in laboratory conditions. Then, while covered with sand, the potential decreased gradually and reached a similar value (-338 mV) to the potential value measured upon corrosion initiation by day 193. While fully immersed in water, the potential values decreased further: to -538 mV by day 239. This was followed by a gradual shift to nobler values reaching a potential value of -481 mV by day 315.

Figure 46 – C8 specimen: a) potential vs. time b) Rc and Rs vs. time.

The evolution of the Rs and Rc values in the C8 specimen against time in days is shown in Figure 46 (plot on the right). The plot shows that the Rc value increased from1.2 kΩ to 3.063 kΩ by day

83 of laboratory exposure. While covered with saturated sand exposure, the Rc value decreased from 3.063 kΩ to 0.762 kΩ by day 99. When immersed in water, it gradually decreased to an even lower value from 0.762 kΩ to 0.2 kΩ by day 400. The average Rc value, while immersed in water condition was 0.3 kΩ.

water he observed a gradual potential increase, the values observed ranged from -.62 Vsce to -.4 up to a year. The observed range of potential values reported in here agrees with Hussain's even if the cathode to anode areas are different. The potential shift was even larger on some cases e.g., C8 (See Figure 46).

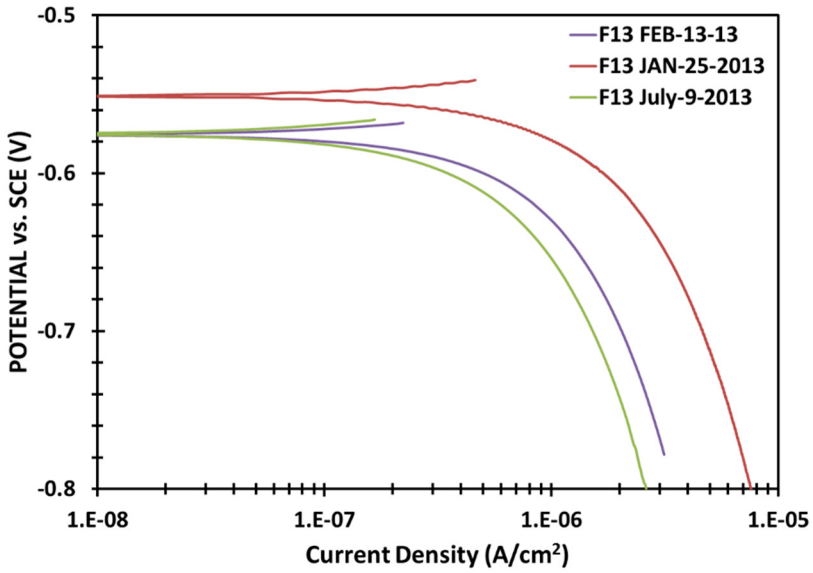
Figure 47 shows three potentiostatic scans performed on three different days on specimen F13 while exposed to saturated sand environment (corrosion propagation experiments). The right most curve was the earliest cathodic polarization scan performed on the F13 specimen; the open circuit potential of the steel was -550mV, and the current density, measured at -800m Vsce, was 7.35×10^{-6} A/cm^2. During the second potentiostatic scan (middle cure) it was observed that the potential of the specimen was now -580mVsce. There was a small reduction in the current density (6.0×10^{-6}A/cm^2) observed at a potential of -800 mV. In the latest scan performed after a long exposure, there was no change in the open circuit potential; only a small reduction in the current density measured was observed (i.e., at -800 mV the current density was 5.0×10^{-6} A/cm^2). The three polarization scans suggest that at open circuit potential the cathodic reaction was under mix control, i.e., both activation potentials and mass transfer control. The recorded current density measured at -600 mV had gradually decreased by an order of magnitude from January to July. Hence, although the cathodic reaction was not under mass transport only, it significantly influences the cathodic output per unit area. It was possible that the area where the cathodic reaction that took place increases with time, partially due to larger throwing power, and also, as corrosion progresses, it increases the surface area. This change was not reflected in the curves shown below; thus, the corresponding current densities for latter scans might be smaller than that reported in here.

Figure 47 – Cathodic potentiodynamic scans performed on F13.

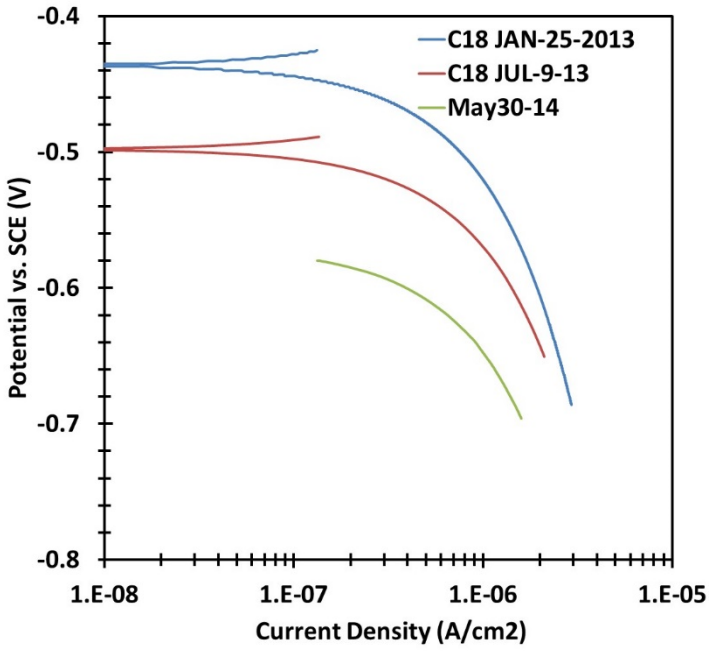
Figure 48 presents the three potentiodynamic scans performed on specimen C18 after immersed in water. The scan performed in January suggests that the open circuit potenial was-440 mV and the current density was 5.7×10^{-6} A/cm^{2}for -700 mVsce. From the cathodic polarization scan performed after a long exposure, it can be observed that the open circuit potential decreased to -520mV. At a potential of -800 mV, the current density was 8×10^{-6} A/cm^2. This current density was an indication of the limiting current density, as indicated above. It could be possible that the area correction was off and the limiting current density could be lower. When comparing the current density from both curves at a potential of -660 mV, there was a modest reduction (log scale) in the measured current density to about 1/3rd.

Figure 48 – Cathodic potentiodynamic scans performed on C18.

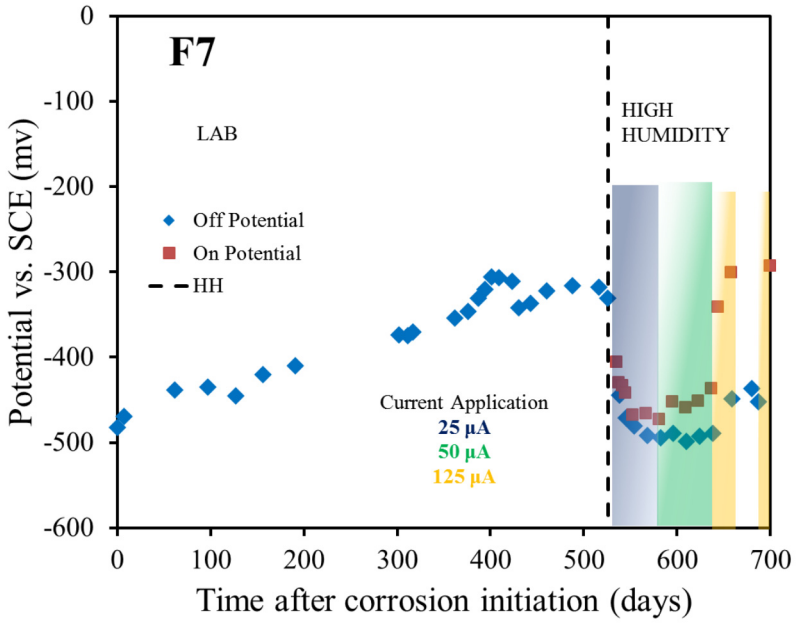
Figure 49 displays the on- and off-potential evolution versus time of the reinforcement for specimen F7. Note that for the time period between 659-689 days, the current was not applied. The specimen was repolarized for 2 weeks before being terminated. Initially, the off-potential was ~-500 mV_{sce} after corrosion initiated. The off-potential increased over time and was in the range of ~-305 mV_{sce} to ~-320 mV_{sce} before applying the current. After exposure in the high humidity container and the initial application of 25 µA cycle, the off-potential of the reinforcement became more negative to ~-480 mV_{sce}; whereas, the steel on-potential was slightly more positive, ranging between ~-405 mV_{sce} to ~-440 mV_{sce}. After a few cycles (49 days of current application), the current was increased to 50 µA where the off-potentials decreased to around ~-500 mV_{sce}. The on-potentials initially were ~-480 mV_{sce} 7 days after increasing the current to 50 µA, and then increased slightly to ~-450 mV_{sce} by day 91 of the current application. After 105 days, the current application was increased to 125 µA. The off-potentials increased to values between -436 mV_{sce} to -449 $mV_{sce,}$ whereas, the on-potentials increased significantly to ~-300 mV_{sce}. Although the current was suspended for ~30 days after 130 days of current being applied (between day 659-689), the off-potentials remained the same. When the applied current was increased, the potential separation between the on- and off-potential steel

values increased. Specimen F7 was terminated on day 701 after corrosion initiated with the last 175 days under current application.

Figure 49 – On- and off-potential vs. time for specimen F7.

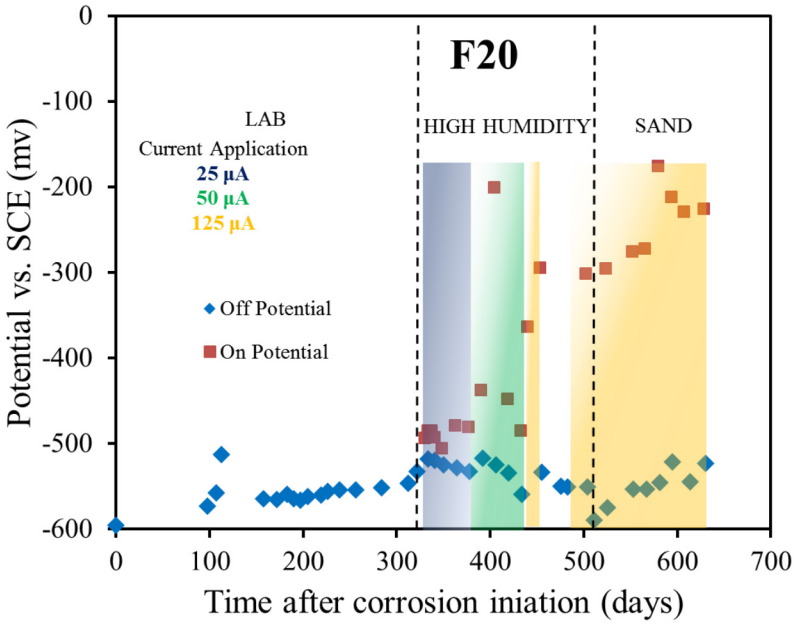
Figure 50 – On- and off-potential vs. time for specimen F20.

Figure 50 displays the on- and off-potential evolution versus time of the reinforcement for specimen F20. Note that for the time period between 455-483 days, the current was not applied. After corrosion initiated, the potential was ~-600 mV_{sce} and had increased to ~-540 mV_{sce} before being placed in high humidity and polarized. After the sample was in the high

humidity container and the initial current application of 25 µA for two weeks, the off-potential of reinforcement was ~-545 $mV_{sce,}$ whereas, the on-potential saw a slight increase to -484 mV_{sce}. After 56 days of current application, the current was increased to 50 µA. During this time, the off-potentials slowly decreased to ~-575 mV_{sce} and the on-potentials increased to ~-450 mV_{sce}. After 112 days, the current was increased to 125 µA and the off-potential measured was comparable to values after the first two weeks with a current application of 25 µA. The on-potentials measured drastically increased to values between -365 mV_{sce} to ~-294 mV_{sce}. The specimen was disconnected for four weeks where the off-potentials remained stable. Shortly after repolarizing the reinforcement on day 450, the sample was covered with saturated sand where it remained under 125 µA current application. While covered with saturated sand, the off-potential ranged between -600 and -530 mV_{sce}. The on-potentials gradually increased to values that ranged between -175 mV_{sce} to -228 mV_{sce}. Similar to what was observed for specimen F7, when the current application was increased, the potential separation between the on- and off-potentials increased. Specimen F20 was terminated on day 642 with the last 321 days under current application.

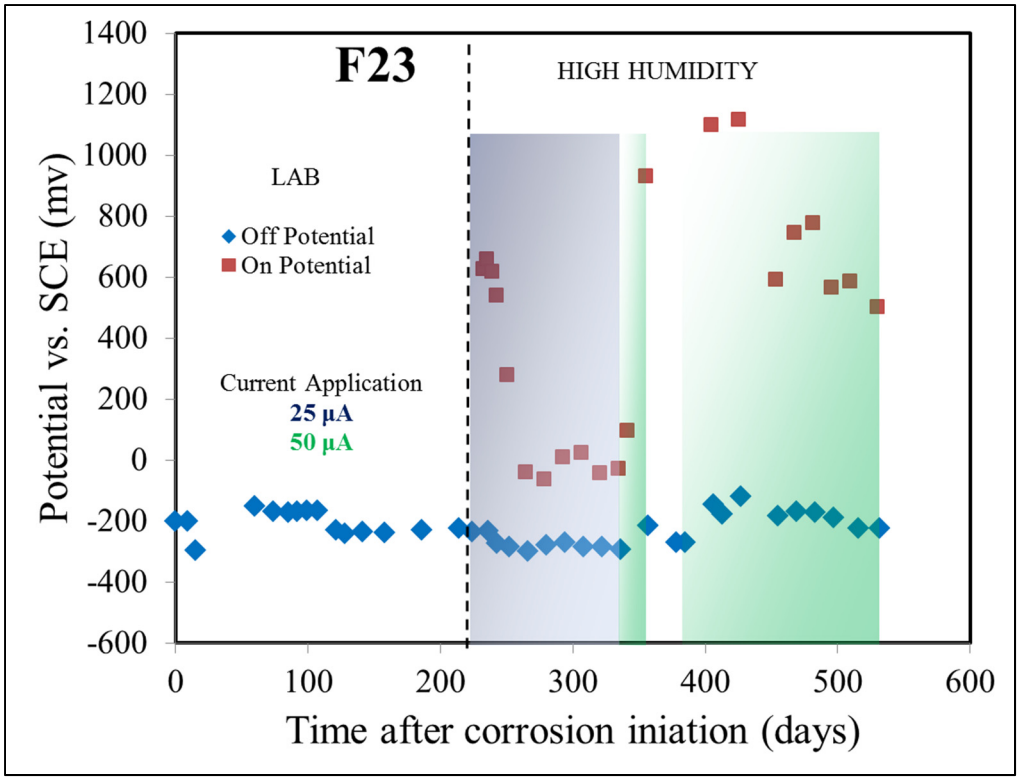
Figure 51 displays the on- and off-potential evolution versus time of the reinforcement for specimen F23. Note that for the time period between 357-385 days, the current was not applied. After corrosion initiated, the potential measured was -201 mVsce and decreased to -233 mVsce before applying the galvanostatic pulse. After spraying water on the sample in the high humidity container and the initial electric field application of 25 µA for two weeks, the off-potential of the reinforcement became more negative to -283 mVsce before the current was increased. The on-potential increased dramatically to values between -38 mVsce to +659 mVsce and then decreased to values that ranged between -60 mVsce to +98 mVsce. Upon increasing the applied current to 50 µA, the on-potential increased dramatically to +934 mVsce and off-potential slightly increased to -214 mVsce. The off-potential initially increased to -178 mVsce, then gradually decreased to -222 mVsce before being terminated. The specimen was terminated after 544 days after corrosion initiated with the last 327 days under accelerated corrosion. The separation between the on- and off-potentials increased when the current was increased similar to what was observed on specimens F7 and F20; however, the separation was much larger. The off-potentials were also more positive than specimens F7 and F20, indicating that corrosion may be taking place at a lower rate (and possibly over a smaller area).

Figure 51 – On and off-potential vs. time for specimen F23.

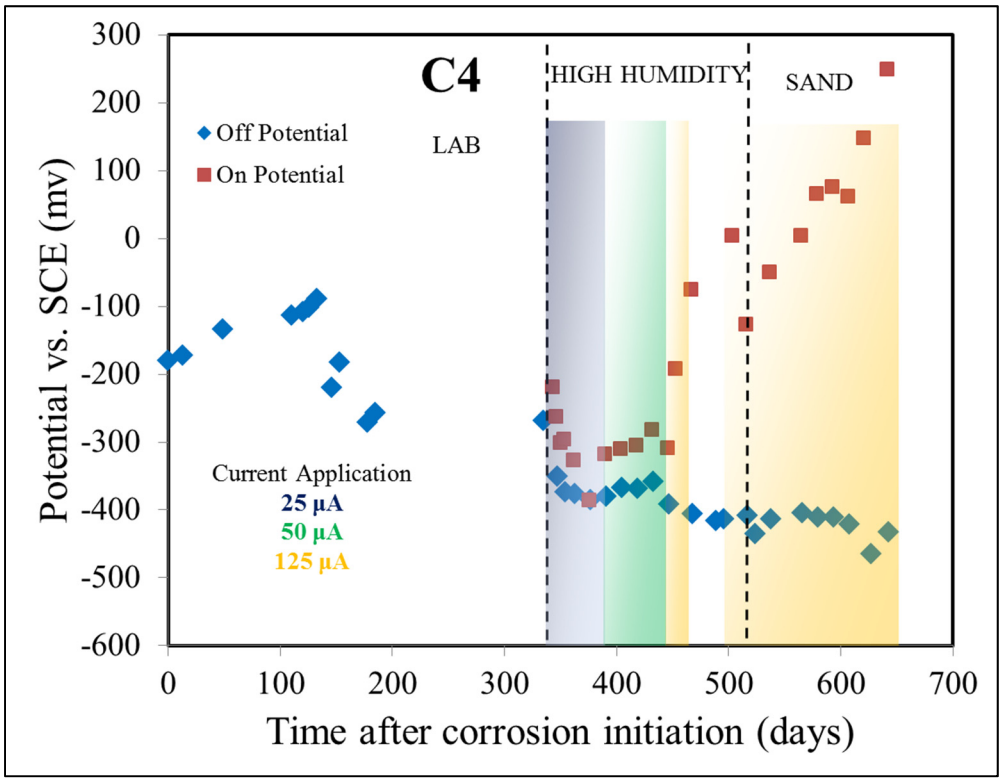
Figure 52 displays the on- and off-potential evolution versus time of the reinforcement for specimen C4. Note that for the time period between 468-496 days, the current was not applied. After corrosion initiated, the potential measured -180 mVsce. The potential increased to -89 mVsce after 133 days of natural corrosion propagation and then decreased to -269 mVsce before applying the electric field. After spraying water on the sample in the high humidity container and the initial current application of 25 µA for two weeks, the off-potential of the reinforcement became more negative measuring -374 mVsce and slightly decreased to -379 mVsce before increasing the magnitude of the applied current. The on-potential measured -219 mVsce and became more negative to -317 mVsce before increasing the current. After 56 days of current application, the current was increased to 50 µA. During this time, the off-potentials slowly decreased to -391 mVsce, and the on-potentials increased to -308 mVsce before increasing the current further. After 112 days, the current was increased to 125 µA. The off-potentials decreased to -409 mVsce before the specimen was covered with saturated sand. The on-potentials measured drastically increased to values between -191 mVsce to +5 mVsce. The specimen was disconnected for four weeks while the off-potentials remained stable, whereas the on-potential, upon polarization, recovered to -126 mVsce. Shortly after covering the specimen with saturated sand, the sample's reinforcement was repolarized via the 125 µA current application. While covered with saturated sand, the off-potentials remained stable for the next ~80 days around -415 mVsce and then finally decreased to a potential of -433 mVsce before forensic analysis took place. The on-potentials gradually increased to values from -49 mVsce to +250 mVsce before being terminated from day 510 to day 655. Similar to the F specimens, when the current application was increased, the potential separation between the

on- and off-potentials increased. Specimen C4 was terminated on day 655 with the last 320 days under current application.

Figure 52 – On- and off-potential vs. time for specimen C4.

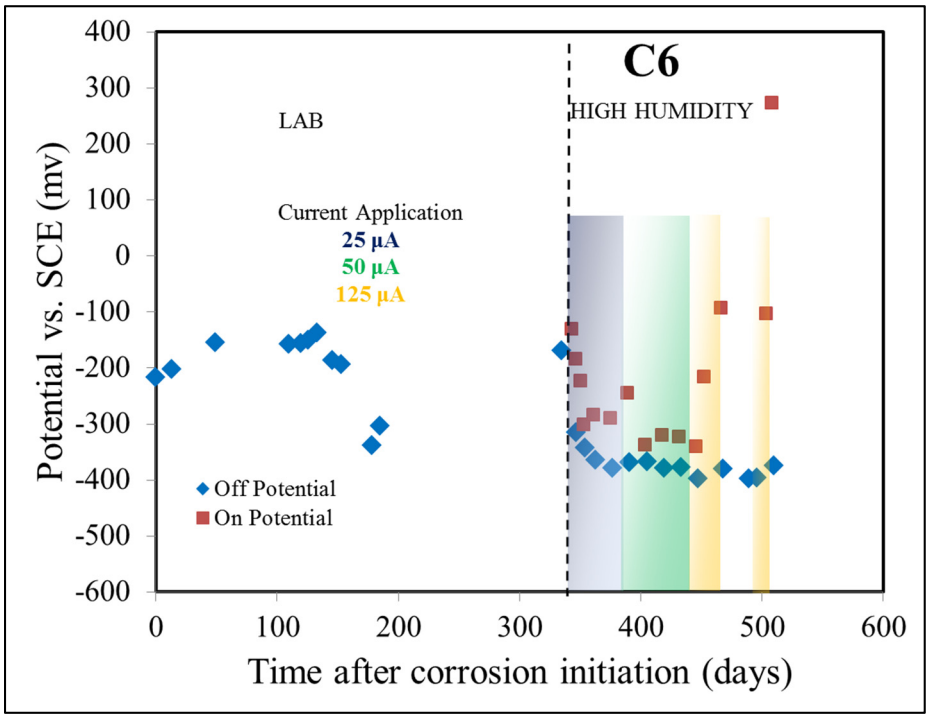
Figure 53 displays the on- and off-potential evolution versus time of the reinforcement for specimen C6. Note that for the time period between 468-496 days, the current was not applied. The specimen was repolarized the final 2 weeks before being terminated. Similar to what was observed on specimen F7, the potentials - shortly after corrosion initiation for C6 - initially increased over time to values between -220 mVsce to -150 mVsce. After ~200 days following corrosion initiation, the off-potential drastically decreased to -300 mVsce, then recovered to a value (-200 mVsce) comparable ~100 days after corrosion initiation before applying the electric field. After spraying water on the sample in the high humidity container and the initial electric field application of 25 µA for two weeks, the off-potential of the reinforcement became more negative, to -343 mVsce, whereas, the on-potential was slightly more positive - around -223 mVsce to -300 mVsce. After 56 days of current application, the current was increased to 50 µA, where the off-potentials measured were comparable to values measured at 25 µA. The on-potentials decreased slightly after the current was increased from 25 µA to 50 µA to values between -320 mVsce to -340 mVsce. After 105 days, the current was increased to 125 µA. The off-potentials slightly decreased to -400 mVsce and remained there until the specimen was terminated. The on-potentials drastically increased to around -100 mVsce and measured +274 mVsce before being terminated the following week. Similar to specimen F7, when the current application was increased to 125 µA, the potential separation

between the on- and off-potentials increased. The on-potential moved to more noble values. Specimen C6 was terminated on day 510 with the last 176 days under current application.

Figure 53 – Potential vs. time after corrosion initiation for specimen C6.

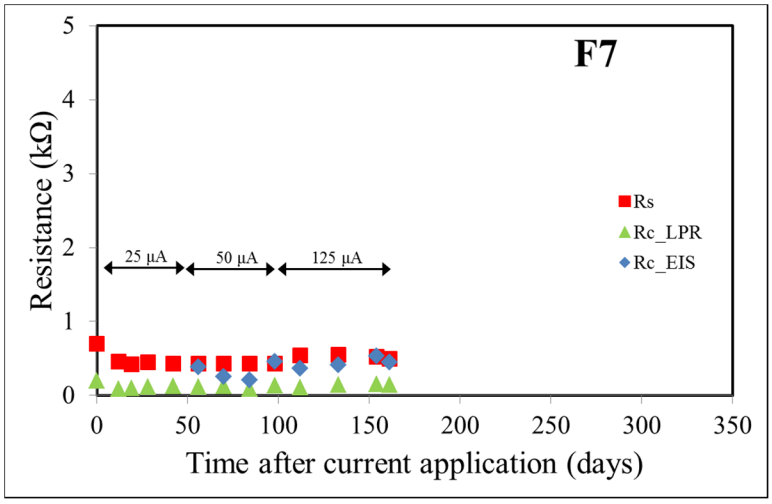
The Rs, Rc_LPR and Rc_EIS values can be seen in Figure 54 for specimen F7. After being placed in high humidity and polarized but measured while disconnected, the LPR Rc (Rc_LPR) values of specimen F7 decreased slightly and remained constant around ~0.10 kΩ after 56 days of current application. The Rs also decreased slightly after the first two measurements before stabilizing around ~0.40 kΩ. After 56 days of galvanostatic pulse, the current was increased to 50 µA, where the Rc_LPR values remained between 0.10 kΩ - 0.12 kΩ. After the current was increased to 50 µA, the frequency for the EIS test ranged from 300 Hz - 0.001 Hz. The Rc values obtained from impedance (Rc_EIS) after the current was increased to 50 µA were larger than that of LPR on the order of 0.25 kΩ - 0.45 kΩ using a CPE model. The Rs values were comparable during the 25 µA current application at ~0.40 kΩ. After 112 days of current application, the current was increased to 125 µA. The Rc_LPR values increased slightly to ~0.15

kΩ before being terminated. The Rs values increased slightly to ~0.50 kΩ before being terminated. The Rc_EIS values remained stable around ~0.4 kΩ - 0.5 kΩ before the specimen was terminated. A final Rc_LPR and Rc_EIS value of ~0.15 kΩ and ~0.5 kΩ suggests that the steel was actively corroding. Looking at the Nyquist plot of specimen F7 in Figure 55, a shift in Rs as time passed (applied current magnitude increased also) suggesting that corrosion products may have formed, accumulated and entered the concrete's pore structure. Also, the Nyquist results do not completely represent a CPE response (perfect depressed semi-circle); it was beyond the scope of this project to identify a more adequate equivalent circuit. The F7 specimen was terminated 510 days after corrosion initiation.

Figure 54 – Plot of Rc_LPR, Rc_EIS, and Rs vs. time for specimen F7.

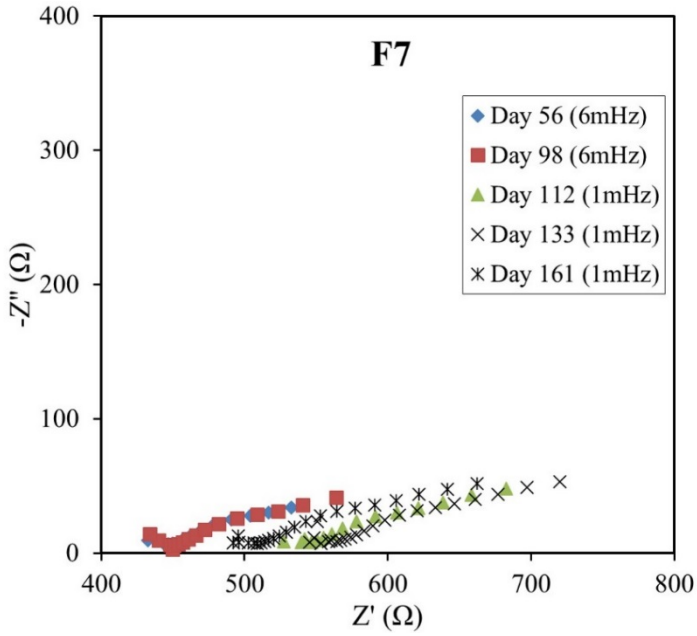
Figure 55 – Nyquist plot of specimen F7.

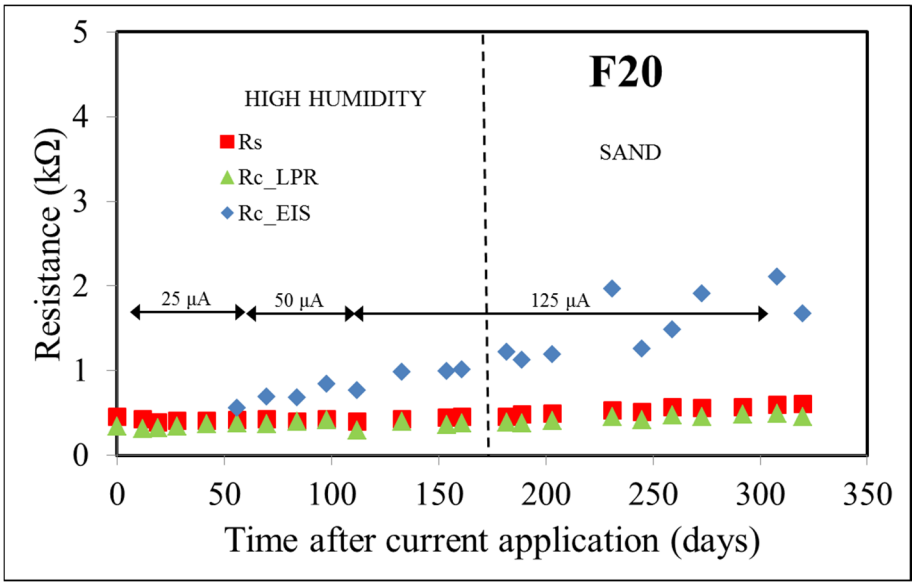
The Rs, Rc_LPR and Rc_EIS values can be seen in Figure 56 for specimen F20. After being placed in high humidity and polarized but measured while disconnected, the LPR Rc (Rc_LPR) values of specimen F20 ranged from 0.31 kΩ to 0.37 kΩ after 56 days, whereas the Rs values initially measured 0.27 kΩ and then increased slightly to 0.41 kΩ before increasing the current to 50 µA. After 56 days, the current was increased to 50 µA where the Rc_LPR values were constantly ~0.37 kΩ, but decreased to 0.29 kΩ before increasing the current to 125 µA. After the current was increased to 50 µA, the frequency for the EIS test ranged from 300 Hz - 0.001 Hz. The Rc values obtained from impedance (Rc_EIS) after the current was increased to 50 µA were larger than that of LPR. The Rc_EIS values initially measured 0.56 kΩ and then increased to 0.76 kΩ. The Rc_EIS values were obtained using a CPE model. The Rs values were comparable during the 25 µA current application around ~0.40 kΩ before increasing the current to 125 µA. After 112 days, the applied current was increased to 125 µA. The Rc_LPR values increased slowly from 0.29 kΩ to 0.45 kΩ before terminating the specimen. The Rs values increased similar to the Rc_LPR values from ~0.40 kΩ to 0.60 kΩ before terminating the specimen. The Rc_EIS values significantly increased from 0.76 kΩ to 1.67 kΩ before terminating the specimen. These Rc values indicate that the steel was actively corroding. The large increase in Rc_EIS values was believed to have been due to a bad fit using a CPE model. Similar to specimen F7 as the time and current increased, the shape of the Nyquist plots at lower frequencies tended to display an even more depressed semicircle and might require additional elements in the equivalent circuit model for a better fit. (This was also beyond the scope of this project.) A possible component to be added is a transmission line, sometimes used to simulate corrosion products that have filled into the concrete pores. The Nyquist plot can be seen in Figure 57. Also notice the shift in the Rs to the right (higher values) indicating that the Rs now include the resistance of the corrosion products that may have entered the concrete's pore structure. Specimen F20 was terminated 642 days after corrosion initiation.

Figure 56 – Plot of Rc_LPR, Rc_EIS, and Rs vs. time for specimen F20.

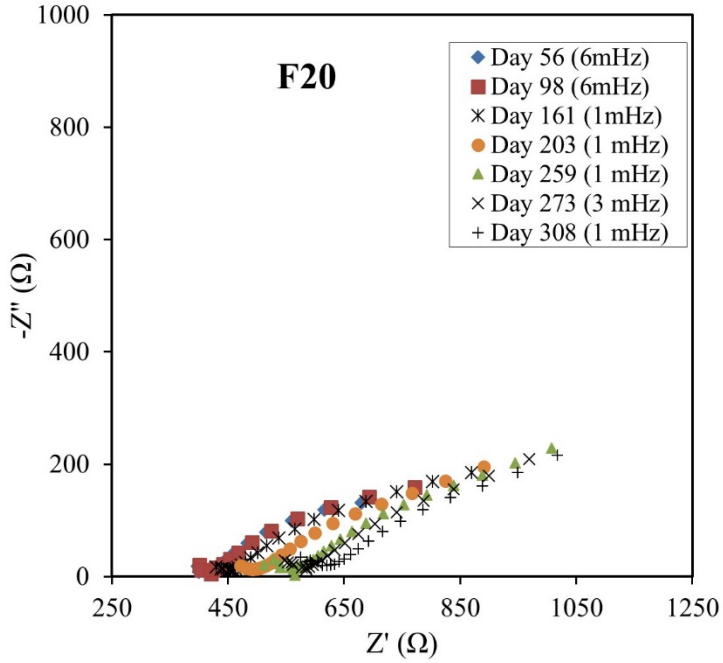
Figure 57 – Nyquist plot of specimen F20.

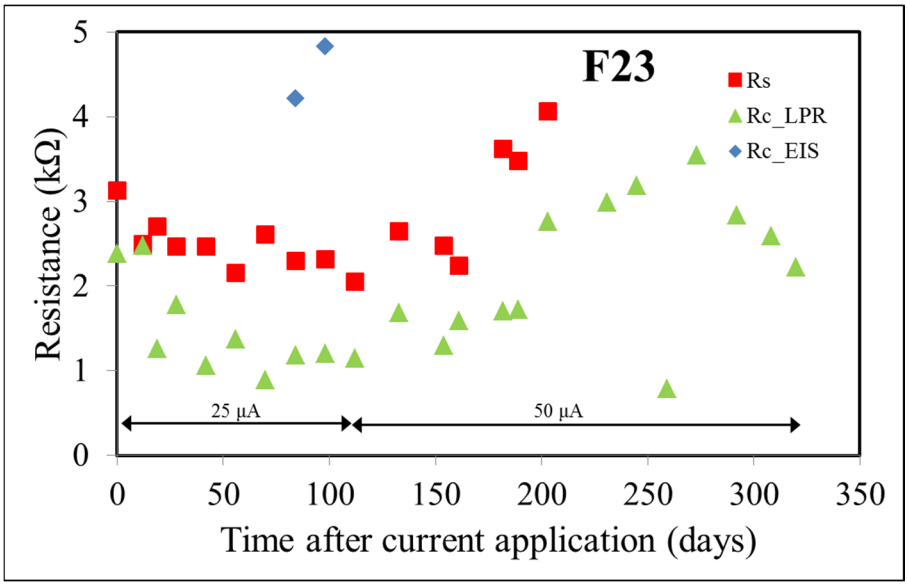
The Rs, Rc_LPR and Rc_EIS values can be seen in Figure 58 for specimen F23. After being placed in high humidity and polarized but measured while disconnected, the LPR Rc (Rc_LPR) values of specimen F23 initially decreased from 2.38 kΩ to 2.05 kΩ after 112 days before increasing the current to 50 µA. Initially, the Rs values measured 3.13 kΩ and decreased to 2.05 kΩ after 112 days with an applied current of 25 µA. After 56 days, the frequency range for the EIS test ranged from 300 Hz - 0.01 Hz. The CPE model did not provide a good fit for the impedance data past day 161 of current application. The Nyquist plot shown in Figure 59 shows that the impedance measured does not appear to be a depressed semi-circle. After 112 days, the current was increased to 50 µA. The Rc_EIS values were greater than 4 kΩ, especially after the current was increased to 50 µA. Surprisingly, the Rc_LPR values increased from 2.05 kΩ to 3.19 kΩ after 245 days of current application, then decreased to 2.22 kΩ before being terminated. The Rs values increased significantly on days 203, 273, and 308 after the current was increased to 50 µA from 2.05 kΩ to more than 5 kΩ before being terminated. The increase in Rc_LPR and Rs values after the current was increased to 50 µA indicate that the corrosion products might have penetrated the pore structure adding an additional resistance. It is possible that as the current was increased to 50 µA, a small actively corroding area became saturated with current and then displaced the extra applied current to the larger non-corroding area, thus causing part of those areas to activate. This can be verified by the corrosion potentials that were measured being ~-200 mVsce and the autopsy in the forensic analysis chapter. The specimen was terminated 544 days after corrosion initiation.

Figure 58 – Plot of Rc_LPR, Rc_EIS, and Rs vs. time for specimen F23.

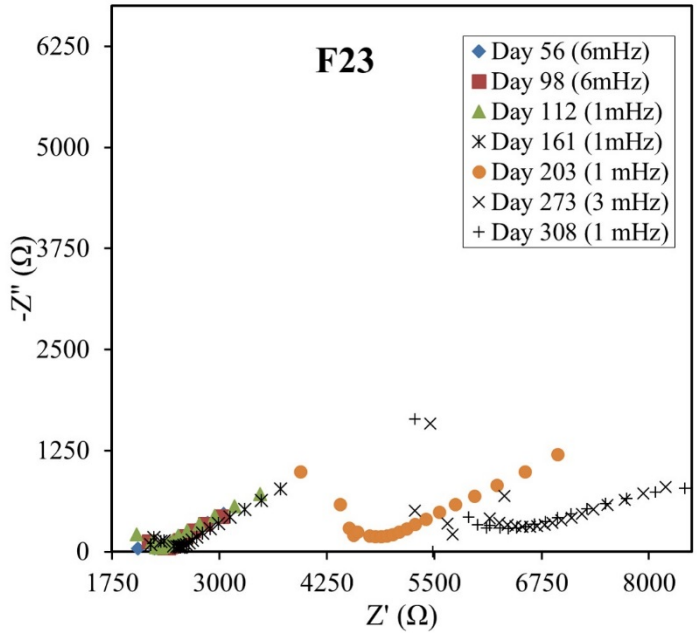
Figure 59 – Nyquist plot of specimen F23.

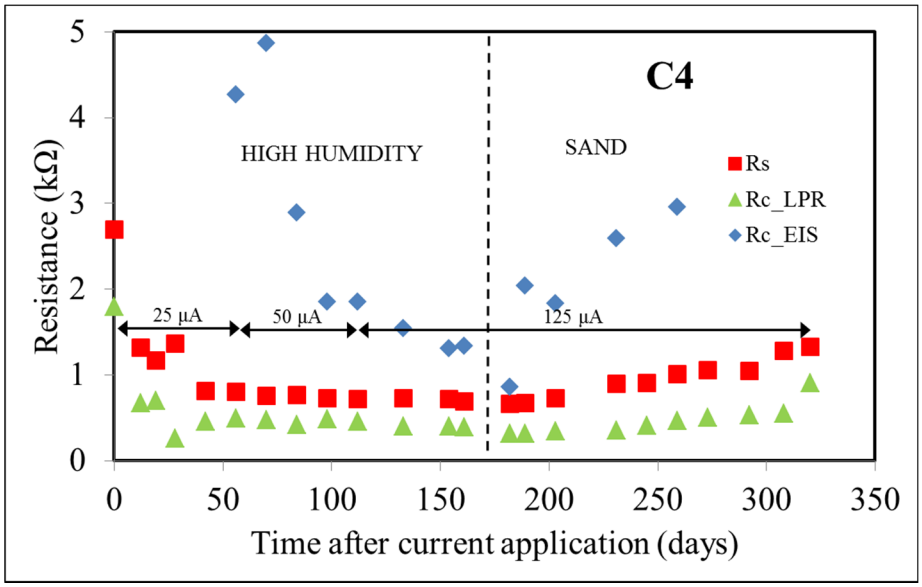
The Rs, Rc_LPR and Rc_EIS values can be seen in Figure 60 for specimen C4. After being placed in high humidity and polarized, but measured while disconnected, the LPR Rc (Rc_LPR) values of specimen C4 initially were ~1.80 kΩ and decreased to 0.48 kΩ after 56 days of 25 µA current application. Initially, the Rs was 2.70 kΩ and decreased to 0.75 kΩ before increasing the current. After 56 days of current application, the current was increased to 50 µA. The Rc_LPR values remained constant during this time between 0.48 kΩ and 0.42 kΩ. The Rs values also remained constant between 0.76 kΩ to 0.72 kΩ. After 56 days of current application, the frequency measured for the EIS test ranged from 300 Hz - 0.01 Hz. A simple CPE model did not provide a good fit for the impedance data. The Nyquist plot shown in Figure 61 shows a high

frequency tail (left side of data) that made it difficult to accurately fit. The Rc_EIS values initially were as high as 4.9 kΩ and significantly decreased to ~1.80 kΩ before increasing the current to 125 µA. After 112 days of current application, the current was increased to 125 µA. The Rc_LPR and Rs values remained constant for the next ~40 days before covering the specimen with saturated sand. The Rc_LPR values ranged from 0.45 kΩ to 0.39 kΩ. The impedance data fit to a CPE model slightly better when the current was increased to 125 µA, but still did not completely represent a CPE situation. The values decreased from ~1.50 kΩ to ~1.20 kΩ over the ~40 days span. After 165 days of current application, the specimen was covered with saturated sand and repolarized to 125 µA. The Rc_LPR and Rs values initially remained constant around ~0.32 kΩ and ~0.66 kΩ and then linearly increased to final values of 0.91 kΩ for the Rc_LPR and 1.33 kΩ for the Rs, before being terminated 655 days after corrosion initiation. The Rc_EIS values were not valid. As you can see in Figure 61, there existed a high frequency tail that made it difficult to model to a CPE. The Rc_LPR, Rc_EIS, and Rs values were all larger for C4 compared to the type F specimens except for specimen F23.

Figure 60 – Plot of Rc_LPR, Rc_EIS, and Rs vs. time for specimen C4.

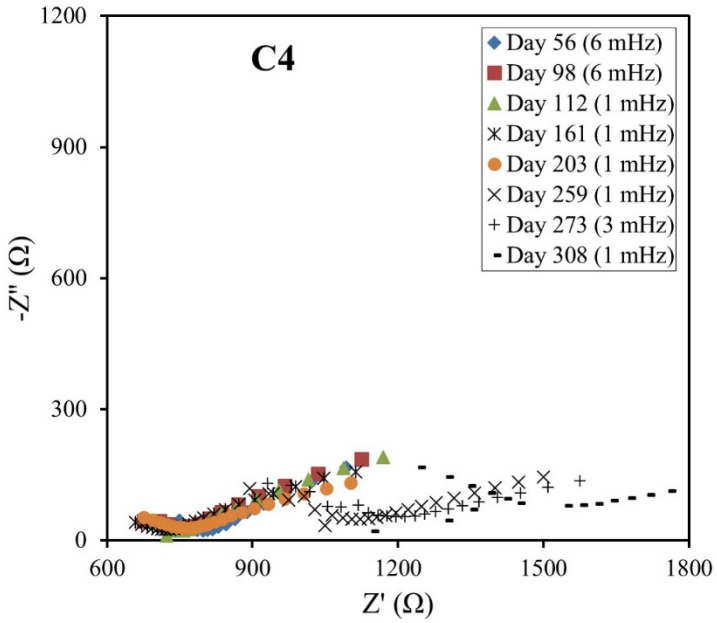
Figure 61 – Nyquist plot for specimen C4.

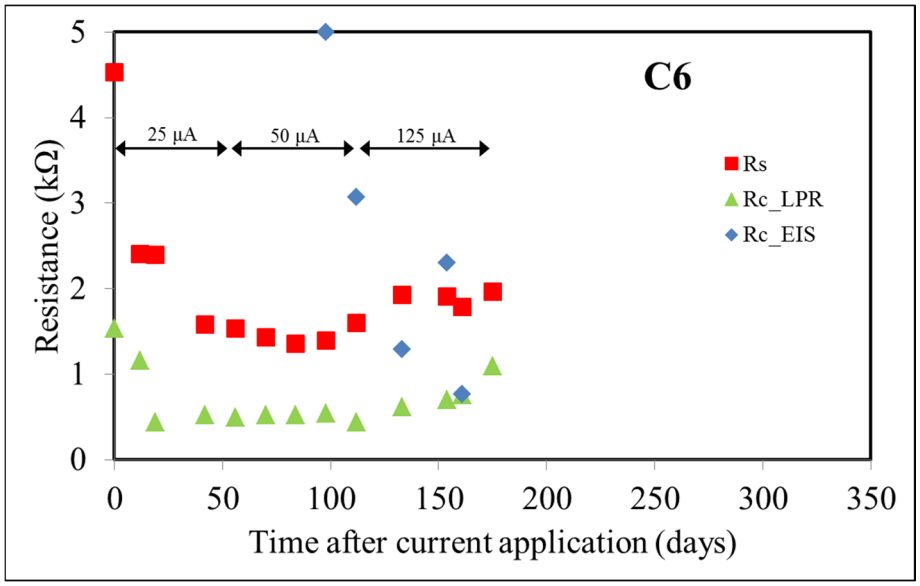
The Rs, Rc_LPR and Rc_EIS values can be seen in Figure 62 and the Nyquist plot in Figure 63 for specimen C6. After being placed in high humidity and polarized, but measured while disconnected, the LPR Rc (Rc_LPR) values of specimen C6 decreased from 1.50 kΩ to 0.50 kΩ after 56 days of applying a 25 µA current. The Rs values initially measured 4.54 kΩ, then significantly reduced to 1.43 kΩ after 56 days of applying a 25 µA current. After 56 days, the current was increased to 50 µA. The Rc_LPR values remained almost constant around 0.48 kΩ and reduced to 0.45 kΩ before increasing the current to 125 µA. The Rs values remained almost constant around 1.43 kΩ after 14 days of applying a 50 µA current and then recovered to 1.60 kΩ before increasing the current to 125 µA. After the current was increased to 50 µA, the frequency for the EIS test ranged from 300 Hz - 0.01 Hz. Similar to specimen C4, the Rc values obtained from impedance (Rc_EIS) after the current was increased to 50 µA did not provide a good fit to a simple EC with a CPE model. The Rc_EIS values for a CPE model initially measured 16.85 kΩ, decreasing to 3.07 kΩ before increasing the current. After 112 days of current application, the current was increased to 125 µA. The Rc_LPR values increased steadily from 0.45 kΩ to 1.10 kΩ before terminating the specimen. Similarly, the Rs values increased from 1.60 kΩ to 1.97 kΩ before terminating the specimen. Again the impedance data did not provide a good fit to a CPE model to acquire a Rc_EIS value. The Rc_EIS values for a CPE model decreased from 3.07 kΩ to 0.77 kΩ before being terminated. Similar to all of the type F specimens, the Rs values tended to increase as the current increased, but with a greater magnitude. The Rc_LPR values were larger than the type F specimens except for specimen F23. The specimen was terminated 510 days after corrosion initiation.

Figure 62 – Plot of Rc_LPR, Rc_EIS, and Rs vs. time for specimen C6.

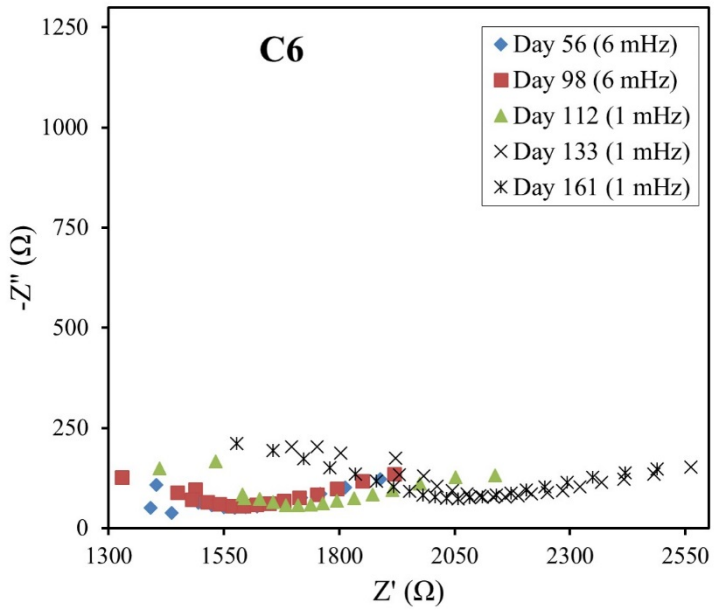
Figure 63 – Nyquist plot of specimen C6.

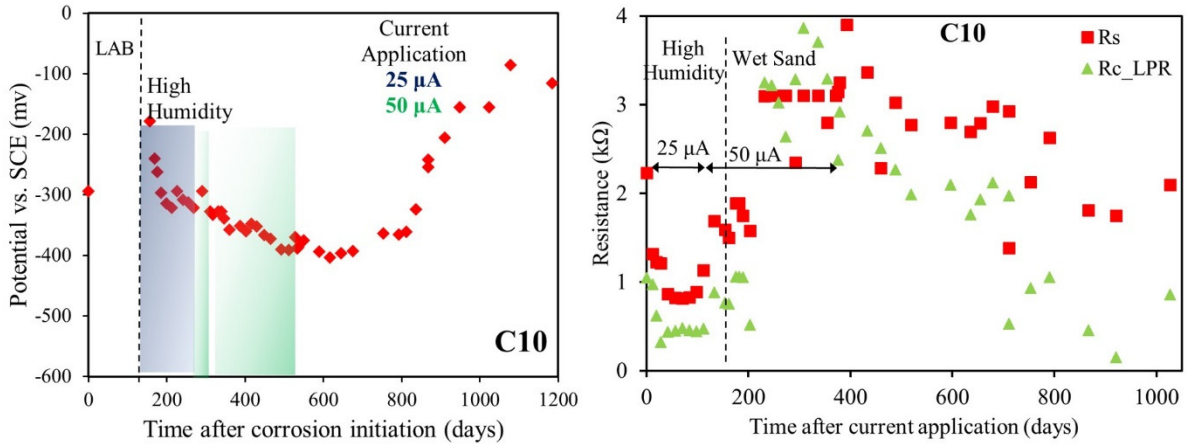
One specimen remained for this group of samples (C10), and specimens F16, F17 (July 2016), and F18 (summer 2015) were forensically analyzed recently. Updated plots for C10, F16, F17 and F18 specimens are shown below. On these plots only the off-potential is shown, and no color to the right of the shaded areas indicates that current was no longer applied. Figure 64 shows the potential, Rc (from LPR tests Rp_app minus Rs), and Rs evolution corresponding to specimen C10. The moisture content was not maintained as high past day 900; the potential and Rc values were affected by this moisture change. Figure 65 shows the potential, Rc, and Rs evolution measured on specimen F16. Specimen F16 was place in the same container as specimen C10, and was also affected by the lower moisture past day 900, but to a lesser

Figure 64 – Potential, Rs, and Rc values measured on specimen C10.

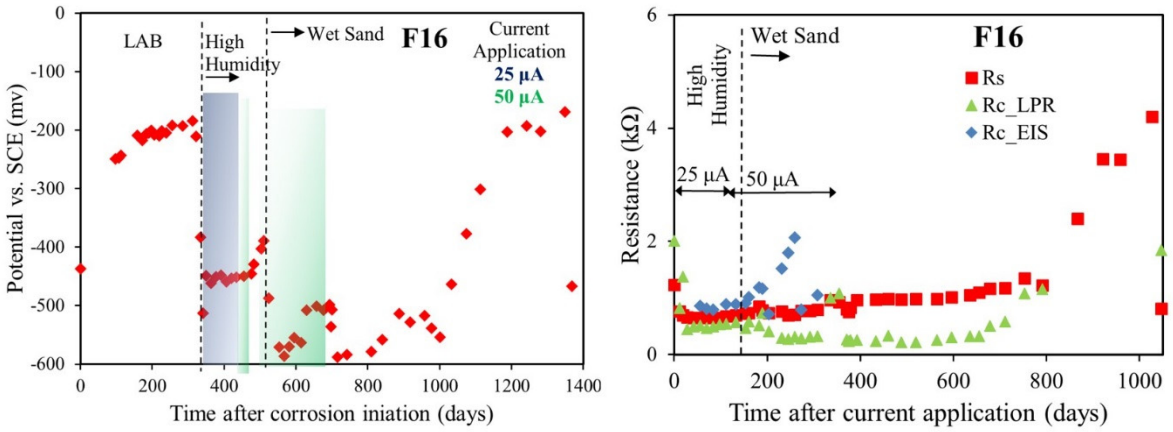
Figure 65 – Potential, Rs, and Rc values measured on specimen F16.
