Final Report

Concrete Pipe – Electrochemical Cell, Phase II
BDV27-977-03

Submitted to
Florida Department of Transportation Research Center
605 Suwannee Street
Tallahassee, Florida 32399

August 2016

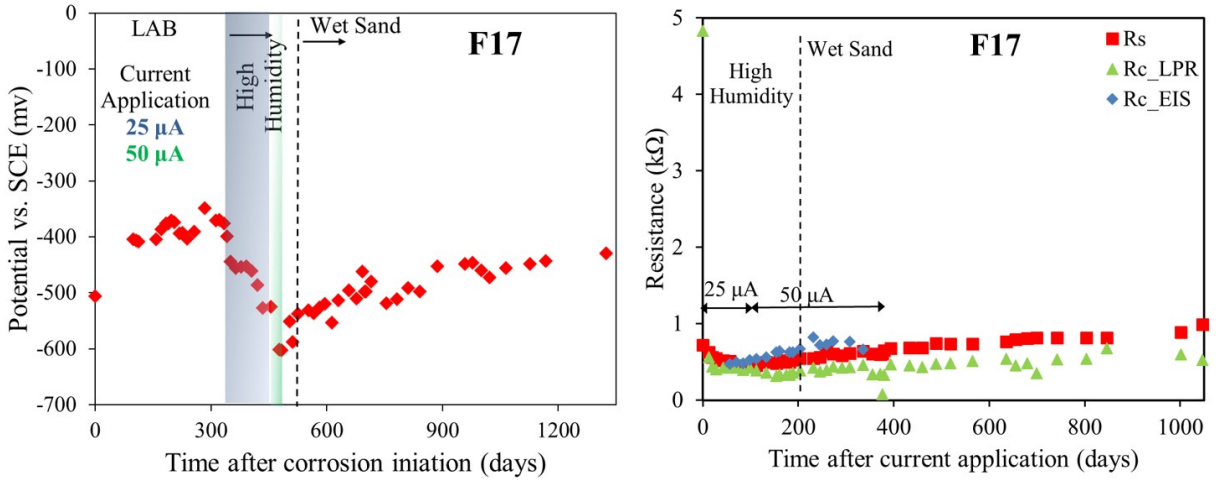
degree. Figure 66 and Figure 67 show similar plots for specimen F17 and specimen F18, respectively. The potential values in Figures 64, 65, 66 and 67 are given in mV. The color-shaded areas indicate the amount and duration of current applied on the potential plots shown on the left (potential vs. time). The Rc and Rs vs. time plots shown here start when the specimens were transferred to a high humidity environment for current application. The potential values measured on specimen F17 were somewhat more negative than those recorded for specimen F18. The steel potential on specimen F16 increased to values as positive as -200 mVsce past day 950, and the Rs increased from one kΩ to four kΩ. However, upon increasing the moisture content, the steel potential on F16 shifted to -500 mVsce, and the Rs and Rc shifter to values smaller than one kΩ and two kΩ, respectively.

Figure 66 – Potential, Rs, and Rc values measured on specimen F17.

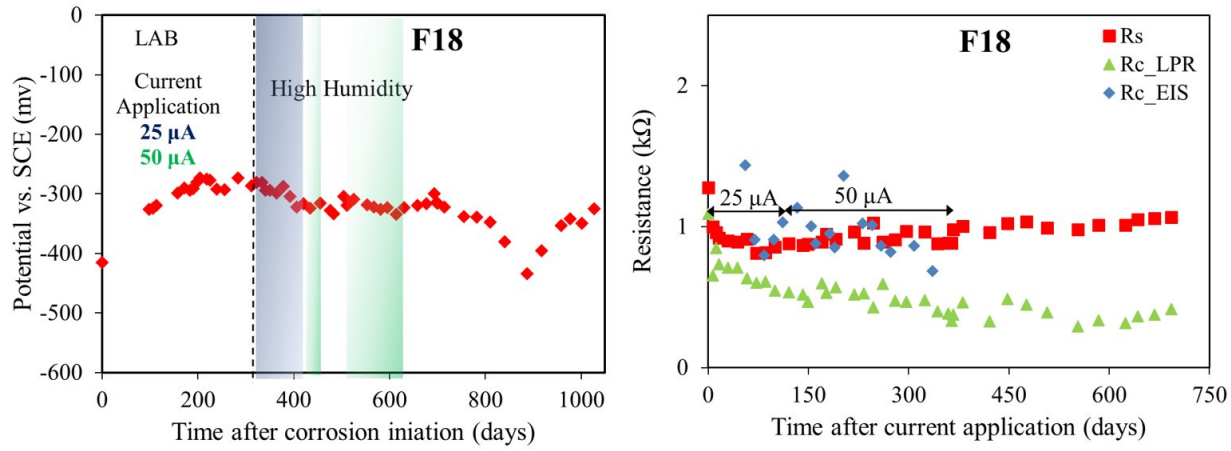
Figure 67 – Potential, Rs, and Rc values measured on specimen F18.

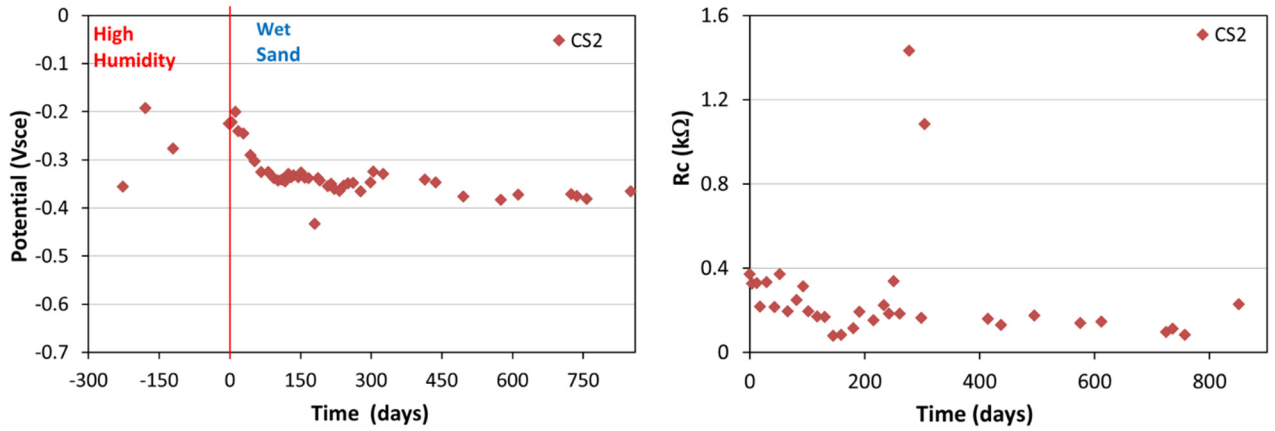
Figure 68 shows two plots: on the left, the corrosion potential, and on the right, the measured Rc values on specimen CS2. Similarly, Figure 69 and Figure 70 show potential and Rc values measured on Specimen FS2 and Specimen FS3, respectively. These three specimens have been covered with wet sand for the duration of the high moisture exposure. The potential evolution on both follow a similar trend. The most recent potential values measured on Specimen CS2 were approx. -0.38 V. From day 200 to about day 700, the average potential value ranged between -0.38 and -0.42 V on both FS2 and FS3 specimens. Then, these two specimens were

brought to the lab and subjected to an accelerated chloride transport, followed by a modest galvanostatic pulse so as to accelerate the corrosion of the steel wire mesh. The last set of potential values ranged between -0.65 and -0.7 V. The Rc values ranged between 0.4 and 0.1 kΩ on specimen CS2. The Rc values measured on specimens FS2 and FS3 (prior to additional chloride transport) ranged between 0.8 to 0.2 kΩ (the latter) and 0.2 and 0.05 kΩ (the former). After the additional chloride transport and two weeks of applied current the Rc shifted to ~0.01 kΩ.

Figure 68 – Potential and Rc values for specimen CS2.

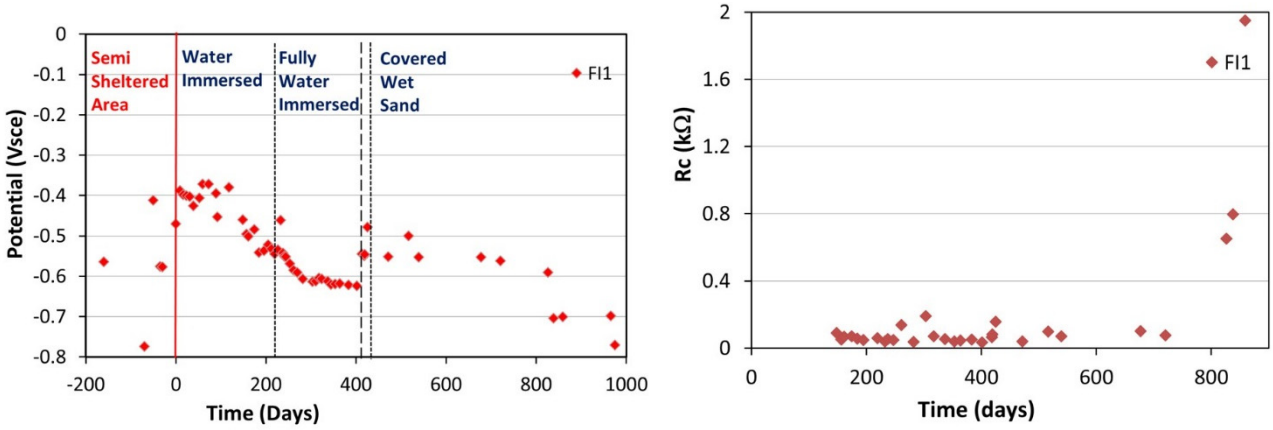
Figure 71 – Potential and Rc values for specimen FI1.

The Potential and Rc vs. time for specimens FI1 and CI2 are shown in Figure 71 and Figure 72, respectively. These specimens were immersed in water for approximately 400 days, removed from the water for about a week, and then moved to the exposure covered with saturated sand for close to 500 days. The reinforcement potential while the specimens were fully immersed was as negative as -0.6 V on specimen FI1 and -0.5 V on specimen CI2. While covered with wet sand, the potential drifted toward more positive values, with the shift being more pronounced on specimens CI2. The Rc values measured on both specimens were less than 0.2 kΩ while immersed in water. The Rc measured on FI1 remained the same over the next 300 days while covered with wet sand, and just recently increased, and with the last reading, approached 2 kΩ with a corresponding potential of -0.7 V (moisture was not kept as high for day 800 to day 950). Upon increasing the moisture content, the Rc shifted back to -0.6 kΩ, whereas for specimen CI2, the Rc increased when moved to the exposure covered with wet sand to values as large as 1 kΩ (day 700); however, the last two measurements were 0.5 kΩ.

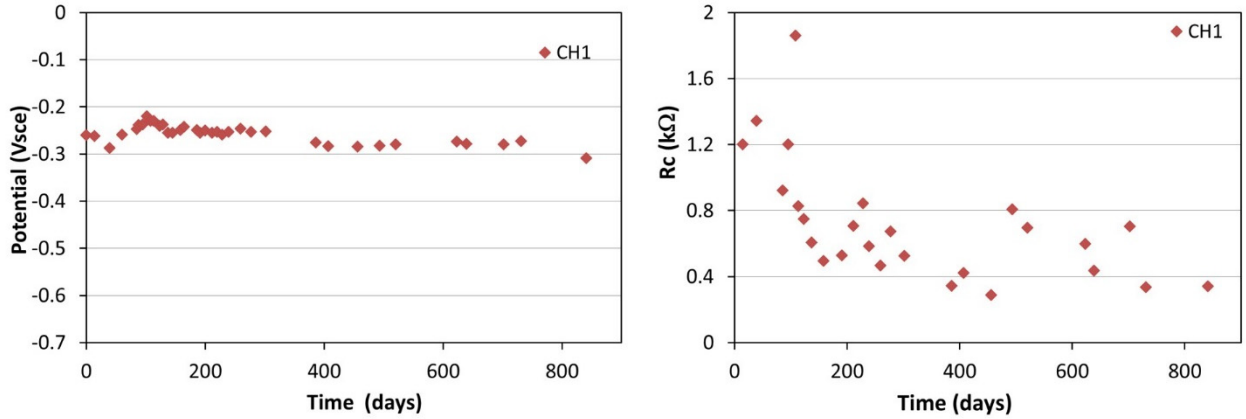
Figure 73 – Potential and Rc values for specimen CH1.

Figure 73 shows the potential evolution for the ring specimen that is being exposed indoors inside a high humidity chamber. The reinforcement potential has been around -0.3 Vsce since corrosion initiated (with a drift to more positive values for a short period of time). The Rc values ranged between 1.8 and 0.3 kΩ, with most values being less than 0.8 kΩ.

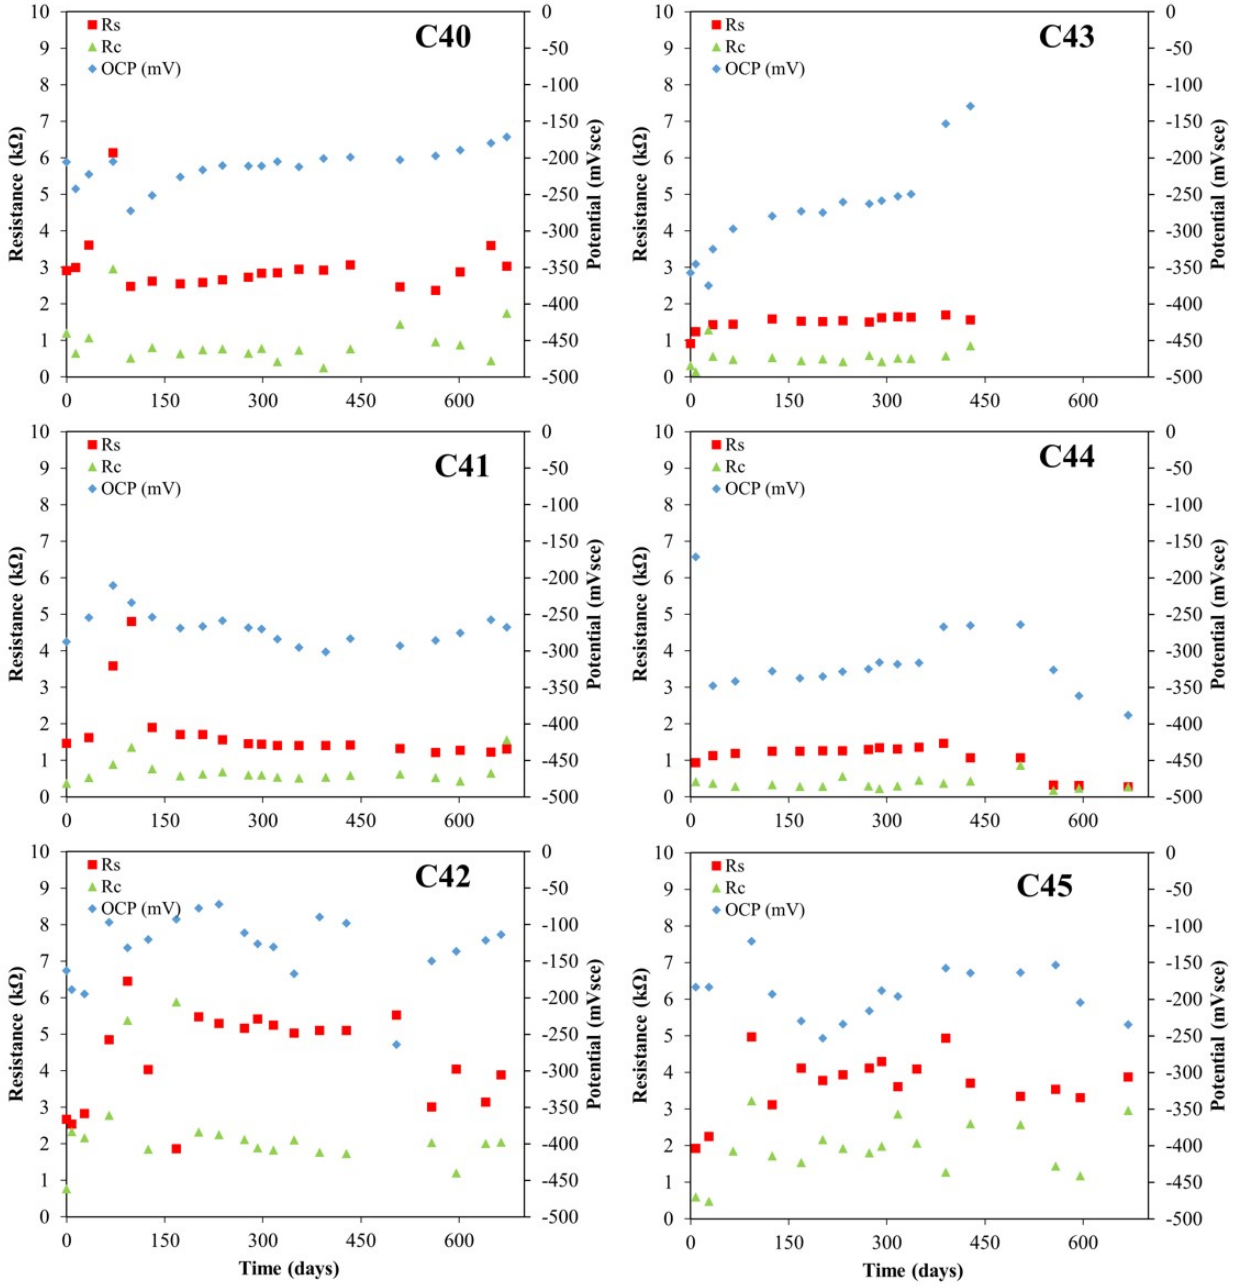
Figure 74 – Potential, Rs, and Rc values for specimens C40 and C45.

Figure 74 shows steel potential, Rs and Rc vs. time for specimens of type C that were obtained from terminated ring samples. For example, the reinforcement potential for specimen C42 was significantly more positive (approx. -0.13 V) than that observed on specimen C44 (approx. -0.32 V). The steel potential value measured on specimen C44 suggests that the reinforcement might be corroding. The Rc values measured on specimen C44 tend to confirm this by the smaller Rc values observed for C44 reinforcement as compared to those measured on specimen C42. The Rc value is about 5 times larger on specimen C42 (2 kΩ) than on specimen C44 (0.4 kΩ). Specimen C43 was selected for forensic examination.

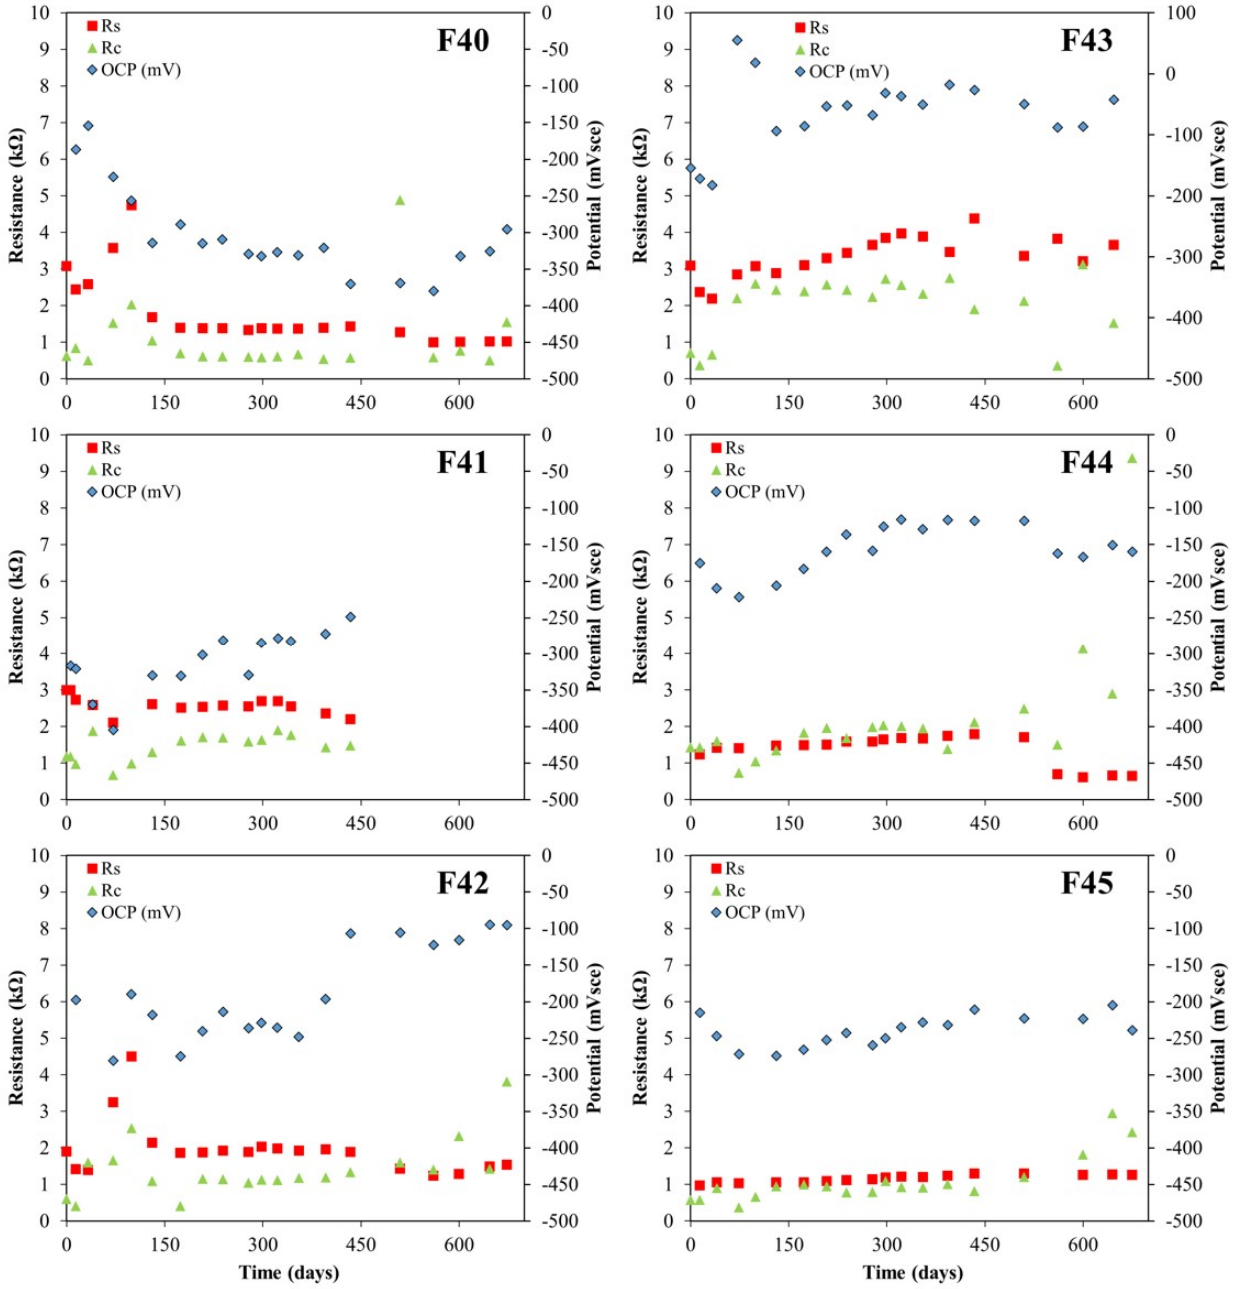
Figure 75 – Potential, Rs, and Rc values for specimens F40 and F45.

Figure 75 shows steel potential, Rs and Rc vs. time for specimens of type F. The reinforcement potential values for specimen F45 was somewhat more positive (currently -0.235 V) than that observed on specimen F40 (currently approx. -0.32 V). These potential values suggest that the reinforcement of both specimens might be corroding. The Rc values measured on specimen F45 and F40 are comparable currently: Rc is 0.8 and 0.6 kΩ, respectively. Specimen F41 was selected for forensic examination. The steel potential of specimen F43 (between 0 and -100 mVsce) was the most positive of the F type specimens and also showed the largest Rc values.

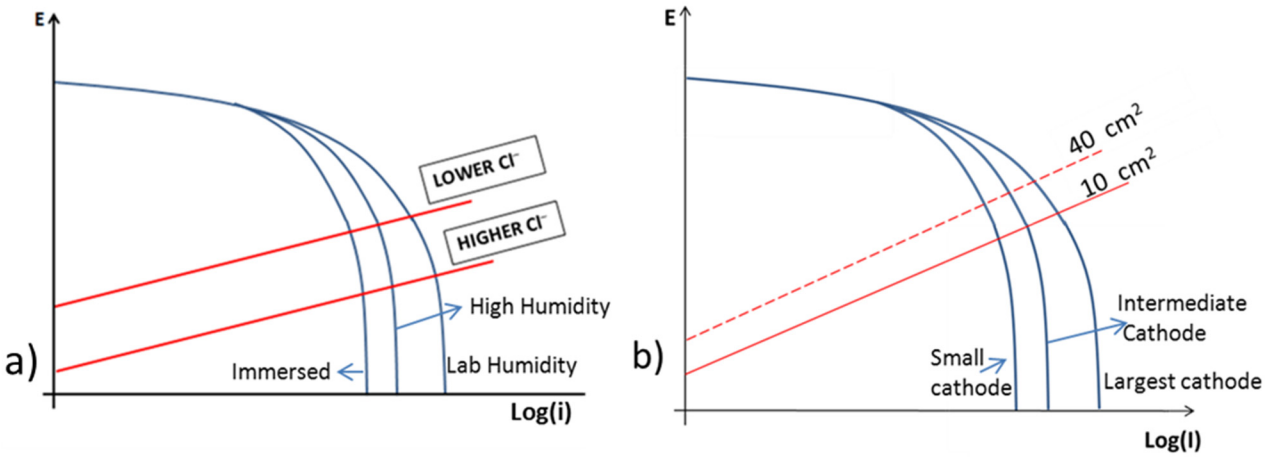
Figure 76 – Evans diagram: (a) change in Cl^- concentration and/or O_2, (b) change in areas.

Let's consider a case in which the cathode and anode areas are the same and that there was no change in the sizes of the anode area or the cathode area. Figure 76a shows an Evans[40] diagram with two anodic polarization curves that represent two different chloride concentrations at the anode for two different specimens[41]. Let us consider that the cathodic polarization curve farther to the right represents a situation with mix-control, but with higher O_2 concentration (e.g., lab humidity). The specimen with the lower chloride concentration at the anode would have the more positive mix potential and somewhat lower corrosion current density than another specimen with the higher chloride concentration at the steel surface. When the specimens are transferred to a high moisture environment (e.g., covered with wet sand or very high humidity), then the cathodic polarization curve in the middle might better represent the cathodic reaction. For both specimens, the new steel mix potential would be more negative, and the corrosion current density would be somewhat smaller.

Upon further O_2 reduction, the cathodic polarization curve on the left would represent full concrete saturation (e.g., covered with saturated sand) or immersed in water exposure. The mix potential would decrease to even more negative values, and the corrosion current density would be even smaller. The reduction in potential was observed in many cases upon exposure to high humidity or covered in saturated sand and even more negative potential values were observed when the specimen was immersed in water. However, the corrosion current density decay was not observed as per the Rc measured values. It is possible that because of the similarity in Rs and Rc magnitudes, there is some error in the calculated value; still, the activity appears to proceed at the same rate. The anode-to-cathode area ratios on most specimens tested are likely not the same (or don't remain the same with time) as it was assumed above. Moreover, on a given specimen, if the chloride concentration at the steel surface increases, then the polarization curve would shift from the low chloride anodic curve to the high chloride anodic curve, and the potential would shift toward more negative potential values. When this occurs, there is little or no change in the corrosion current density. Hussain[6] experiment used reinforcement segments embedded in high chloride concentration and when immersed in

Since the specimens during the propagation stage were exposed to high moisture conditions, the specimens are expected to eventually reach full saturation condition. This increase in moisture content likely reduce the concrete resistivity and hence allowed for a more favorable macrocell, which eventually might resulted in larger available cathode area which in turn would accelerate the corrosion and potentially increase the anode area. The diagram in Figure 76b shows an Evans diagram with an exaggerated increase in the anode area (not to scale), a four-fold increase in area would shift the anodic polarization curve from the solid red line to the dotted red line. For this scenario, the mix potential value would shift to a more positive potential value; provided that cathode area remains the same. This type of potential trend was reported by Hussain et al.[6], but not attributed to this explanation. Note that in this diagram (Figure 76b) the x-axis indicate current (not current density).

Assuming there is no change in anode area (Figure 76b). Due to the increase in moisture content in the specimens, the resistivity of the concrete would be lower and the anode would be able to interrogate a larger remote cathode. As indicated above the moisture content increase likely shifts the cathodic polarization curve to the left. However, better connectivity allows for a larger cathode which might compensate and still provide/match the required anodic current, resulting in very little change on the mix potential and measured corrosion current. Based on the experimental observations it is likely that this macro cell situation is taking place. Hence, the corrosion rates that are being observed. It is possible that upon additional exposure time the oxygen at the cathode might be consumed and not readily replenished, which would reduce the cathodic capacity (i.e., intermediate or smallest cathode shown in Figure 12b) and hence lower the corrosion rate. The high porosity of the concrete might explain why it is taking longer to reach this state compared to what others have found[7,10,11].

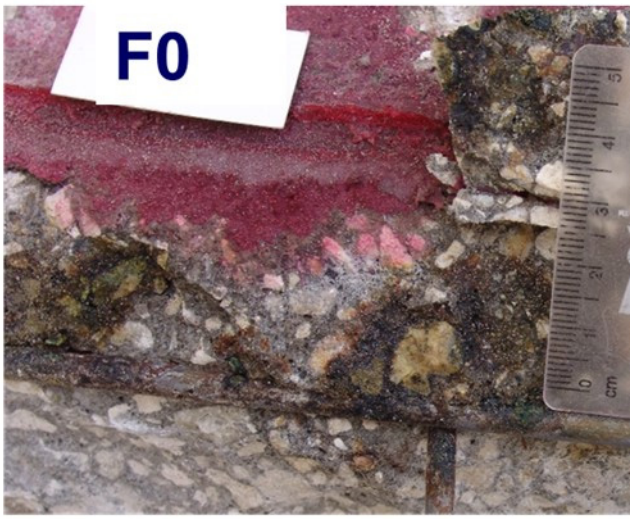
Figure 77 show pictures taken for Specimen F0 before removing the reservoir and for selected locations as the reinforcement was being removed. The pictures in the center show that a thin crack was present (before (top) and after applying a dye-penetrant (bottom picture)). The two pictures on the right show a portion of the reinforcement as the concrete was being removed; the corrosion spots appear to be localized in specimen F0. Figure 78 shows how much the corrosion penetrated into the concrete on specimens F0. The corrosion products penetrated close to 20 mm at various locations as can be observed from the picture. The corrosion sites

were 5 to 10 mm long and there were several of these spots (see picture shown below after cleaning).

Figure 78 – Corrosion penetration into the concrete for specimen F0.

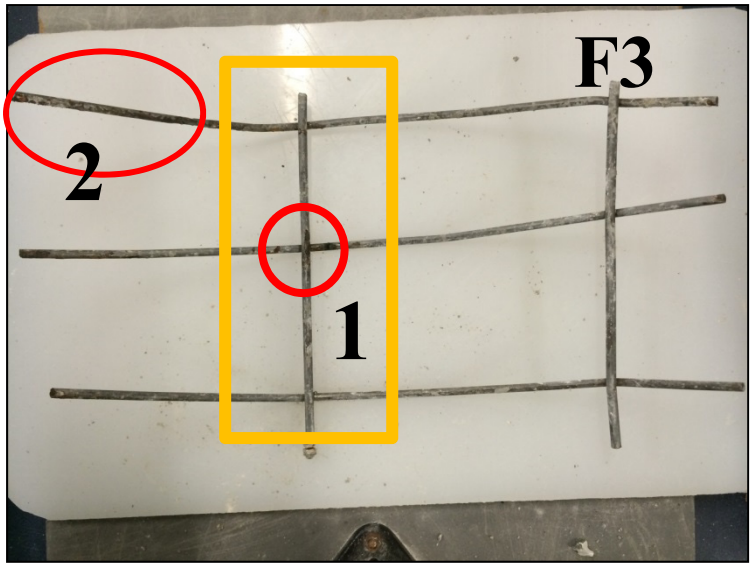
Upon removing some of the concrete on specimen F3, the steel reinforcement's corrosion under the ponding at the reinforcement junction was a mix of red and green/black rust. Corrosion occurred in this region as can be seen in Figure 82. Figure 83 shows black/green rust observed outside of the ponding along of the transverse steel wires. The steel reinforcement of specimen F3 can be seen in Figure 84 displaying the locations where corrosion occurred. As seen in Figure 85, specimen F3 experienced mild corrosion at location 1 under the ponding at the reinforcement junction. Severe cross-section loss can be seen at location 2 along the side of the transverse steel wire (spiral). Corrosion did occur outside the ponding.

Figure 84 – Autopsy result of specimen F3 – full steel wire mesh.

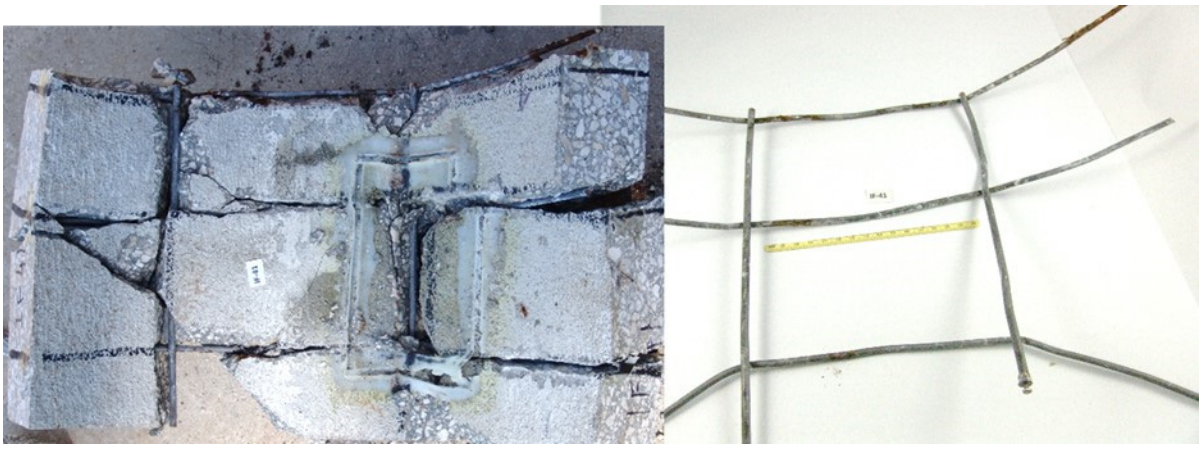
Specimen F41 was obtained from one of the ring specimens. Modest amount of corrosion was found at various locations outside of the solution reservoir. Figure 91 shows a picture on the left while the concrete was being removed and on the right after removing the concrete. Several of the rust spots were outside of the area below the solution reservoir, as can be observed on the transverse steel wires to the right of the longitudinal on the left.

Figure 91 – Specimens F41 prior to and after concrete removal.

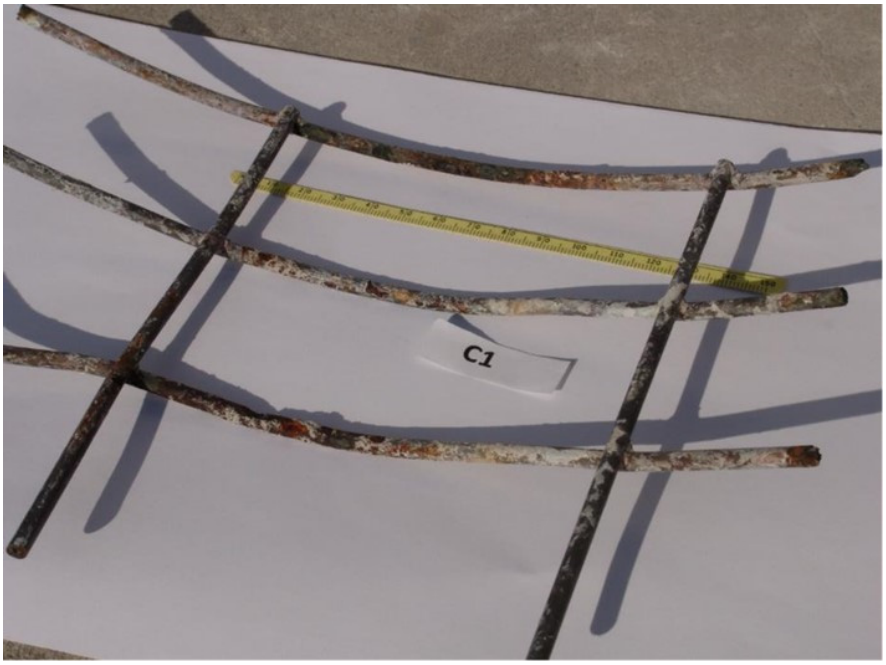
wire obtained after removing the concrete on specimen C1. It is evident that significant corrosion took place at two of the transverse (circumferential) steel wires.

Figure 94 – Steel wire mesh removed from specimen C1.

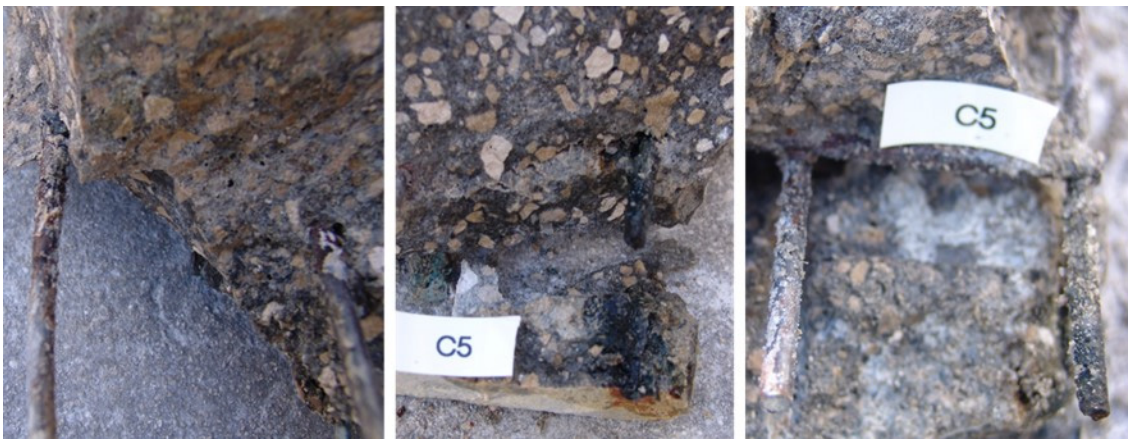
The corrosion extent observed at selected locations of the steel wire embedded on specimen C5 is shown in Figure 95. The center top picture shows corrosion products on the exposed steel and the concrete, a deep dark green (almost black) spot was found for this specimen. This specimen was exposed immersed in water. Figure 96 shows the surface condition upon removing all concrete, a spot with significant corrosion was outside the solution reservoir. Under the solution reservoir, the steel showed some red rust spots and appear to be superficial corrosion. The white products were more dispersed on this reinforcement.

Figure 95 – Steel wire while concrete is removed on specimen C5.

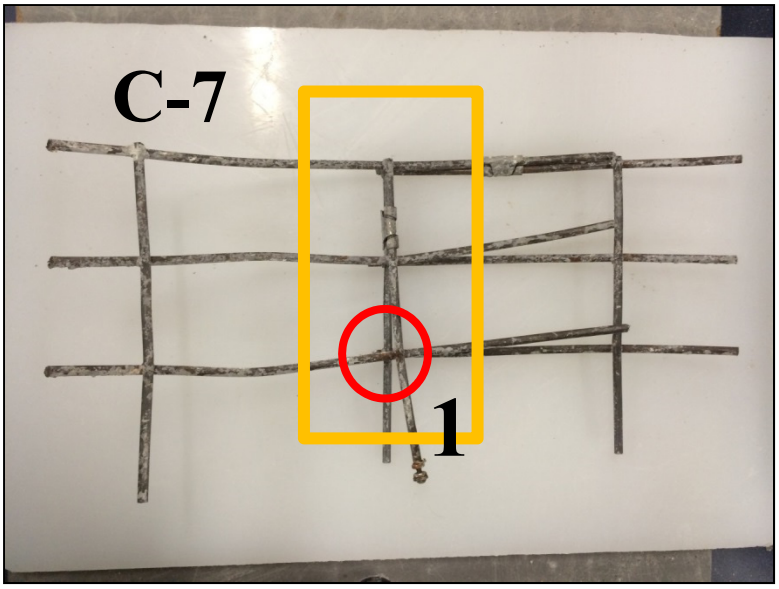
Before opening specimen C7, two dark black/green rust stains were observed on the bottom of the specimen. This can be seen in Figure 97. Upon opening the specimen, the steel reinforcement's corrosion spots observed were above where the black/green rust stains were located. The corroding area can be seen in Figure 98. Specimen C7's steel reinforcement can be seen in Figure 99 displaying the locations where corrosion occurred. Specimen C7 experienced mild to no corrosion. Under the ponding there was mild corrosion at the junction and along the longitudinal reinforcement shown at location 1 in Figure 100. A small amount of corrosion occurred outside the ponding.

Figure 99 – Autopsy result for specimen C7 – whole steel wire mesh.

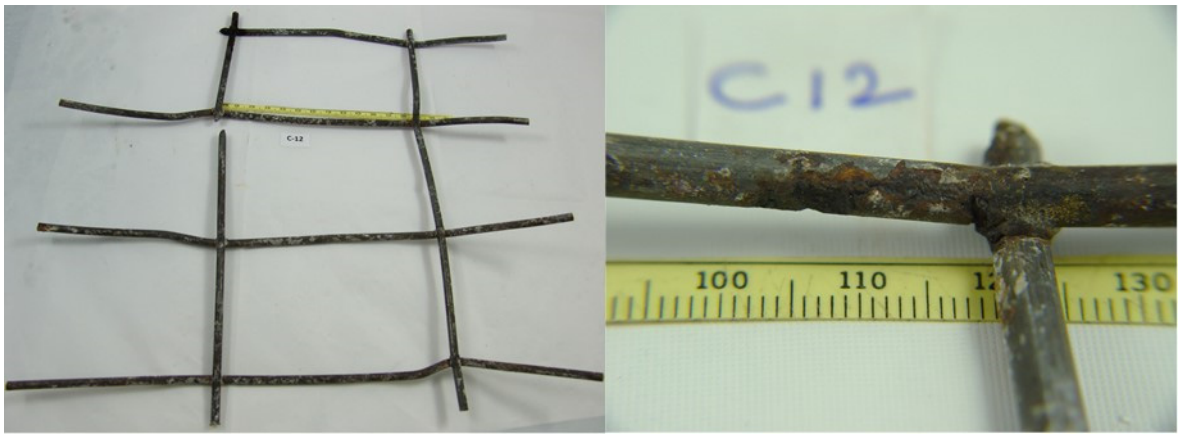
Specimens C12 and C22 were vertically oriented and partially covered with wet sand (1/3rd) and exposed in high humidity. Figure 102 and Figure 103 show the corrosion extent on steel wires removed from Specimens C12 and C22, respectively. Modest corrosion was observed on the steel wire on both specimens. It is interesting to note that corrosion took place on the steel wire some distance above the solution reservoir.

Figure 102 – Steel wire mesh for specimen C12.

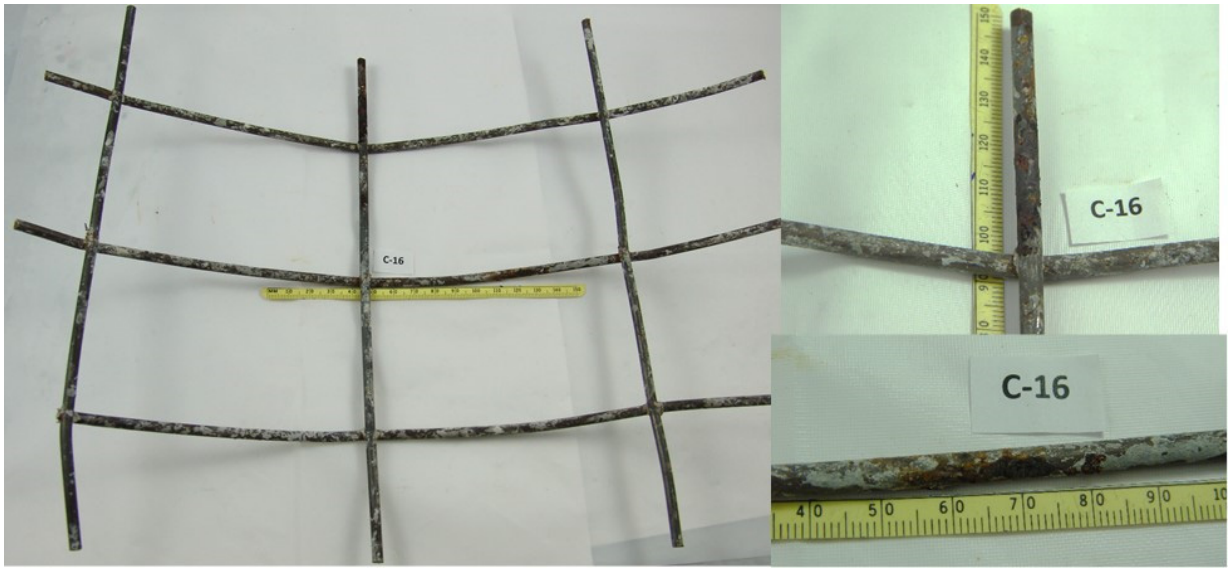
Specimen C16 was exposed while oriented vertically and covered with wet sand during the corrosion propagation stage. Figure 105 shows the extent of corrosion on the steel wire as the concrete was being removed. Figure 106 shows the steel wire after all concrete was removed and a close-up of the two sections with the most corrosion. More corrosion was observed on this specimen than what was observed on specimen C24.

Figure 106 – Steel wire removed from specimen C16.

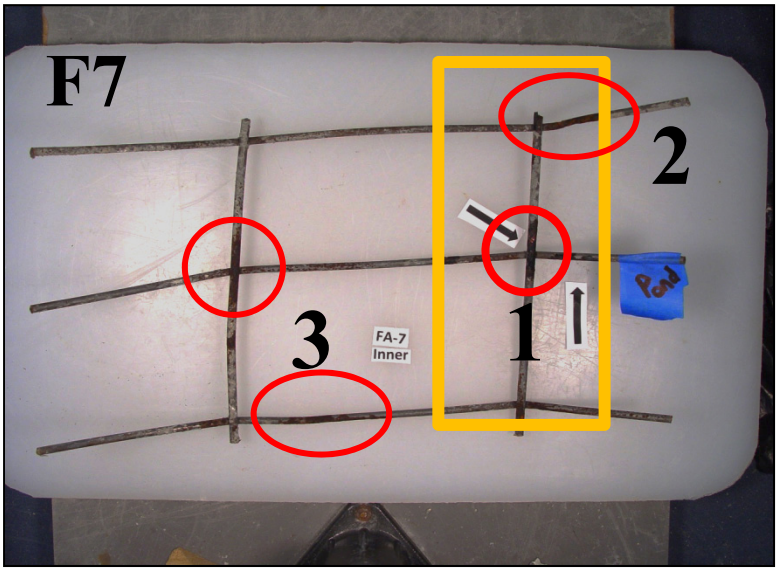
Before cracking the specimen open, two red/orange rust stains were seen located under the ponding and ~0.5 inch from the ponding. The rust stains can be seen in Figure 108. Upon breaking the specimen open, the steel wire's corrosion appeared greenish/black in color. The "green" or "black" color of the corrosion products can be seen in Figure 109 and Figure 110. The steel reinforcement of specimen F7 can be seen in Figure 111 displaying the locations where corrosion occurred the most severe. Specimen F7's applied current was increased to 125 µA before termination. As can be seen in Figure 112, location 1 experienced significant corrosion and occurred under the ponding at the reinforcement junction. Severe cross-section loss can be seen along the transverse reinforcement at location 2 in Figure 108. However, on F7 corrosion did occur outside the ponding as seen at location 3 (Figure 111).

Figure 111 – Autopsy result of specimen F7 – whole steel wire mesh.

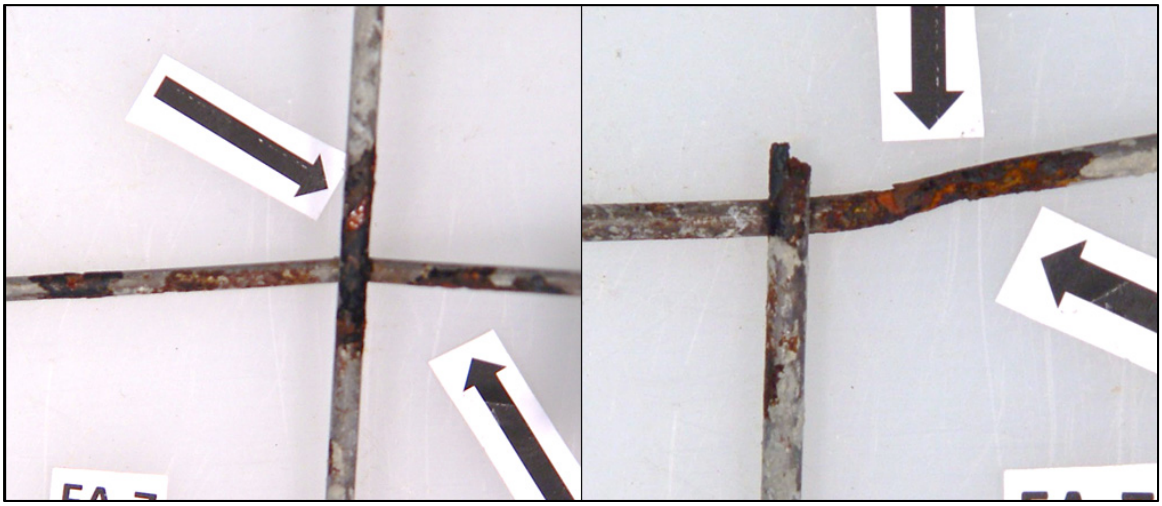
Figure 112 – Autopsy result of specimen F7. Left: location 1. Right: location 2.

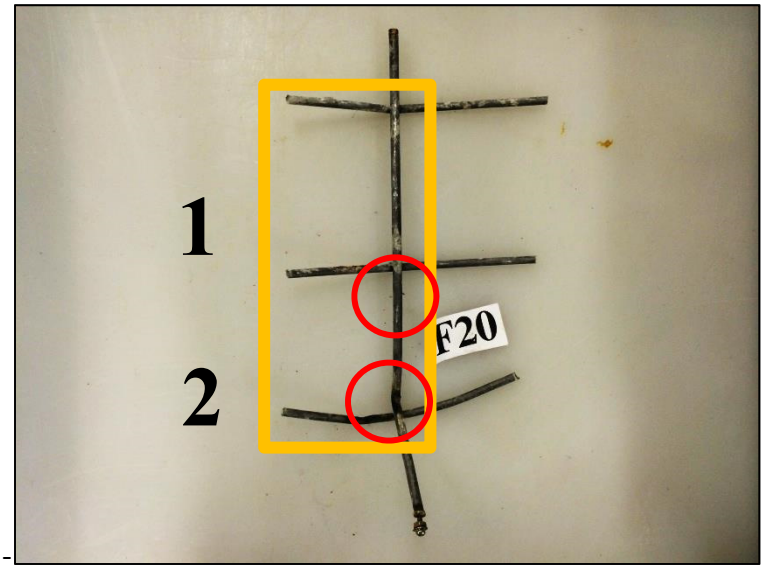
location. The steel reinforcement of specimen F20 can be seen in Figure 116 displaying the location where corrosion occurred. Specimen F20's applied current was increased to 125 µA before termination and also the specimen was covered with saturated sand during latter part of the exposure period. As seen in Figure 117, location 1 experienced significant corrosion occurred under the ponding at the reinforcement junction. Upon exposure the corrosion products were blackish green suggesting that moisture was present. Mild corrosion can be seen along the transverse reinforcement at location 2 in Figure 117. Corrosion did not occur outside the ponding.

Figure 116 – Autopsy result of specimen F20.

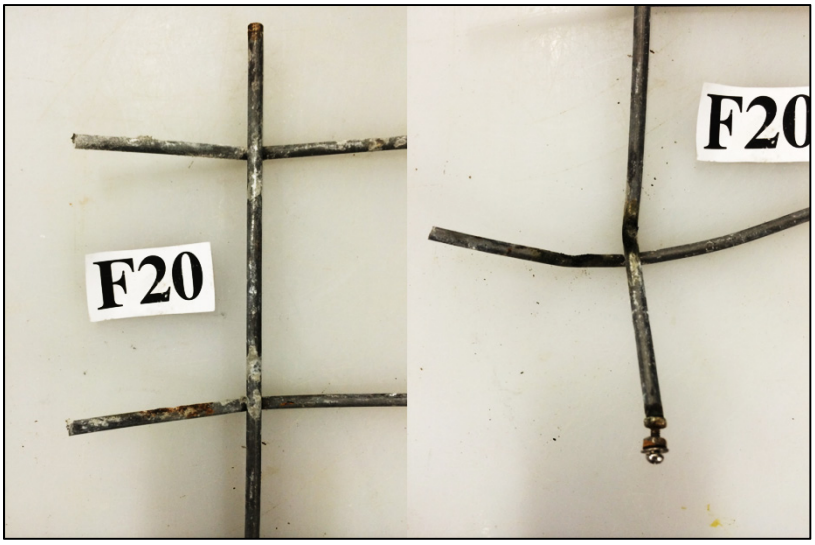
Figure 117 – Autopsy result of specimen F20. Left: location 1. Right: location 2.

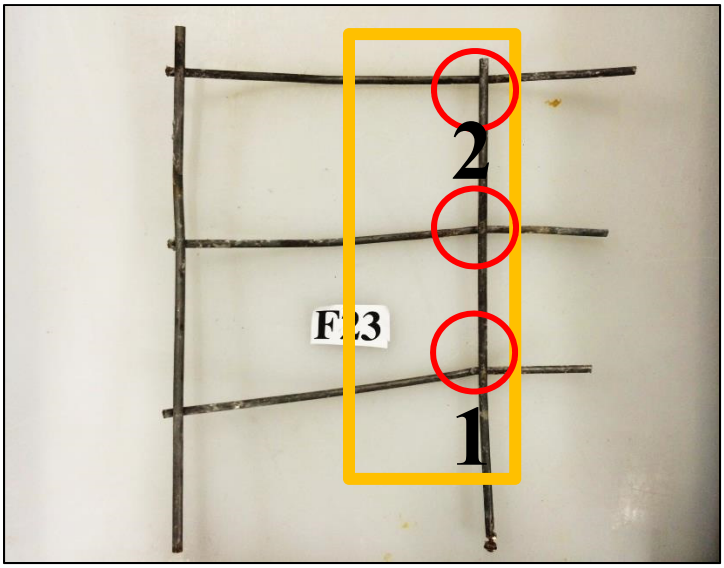
Upon breaking the specimen open, the steel reinforcement's corrosion products were red rust. It is likely that there was plenty of oxygen available at the steel's depth. This can be seen in Figure 118. The steel reinforcement of specimen F23 can be seen in Figure 119 displaying the locations where a small amount of corrosion occurred. In both location 1 and 2 a small amount of corrosion occurred at the steel junction and also extended 1" from the junction along the transverse steel which can be seen in Figure 120. A larger area of the steel reinforcement did not show corrosion which may be due to a smaller chloride concentration at the corroding sites. Corrosion did occur outside the ponding.

Figure 119 – Autopsy result of specimen F23.

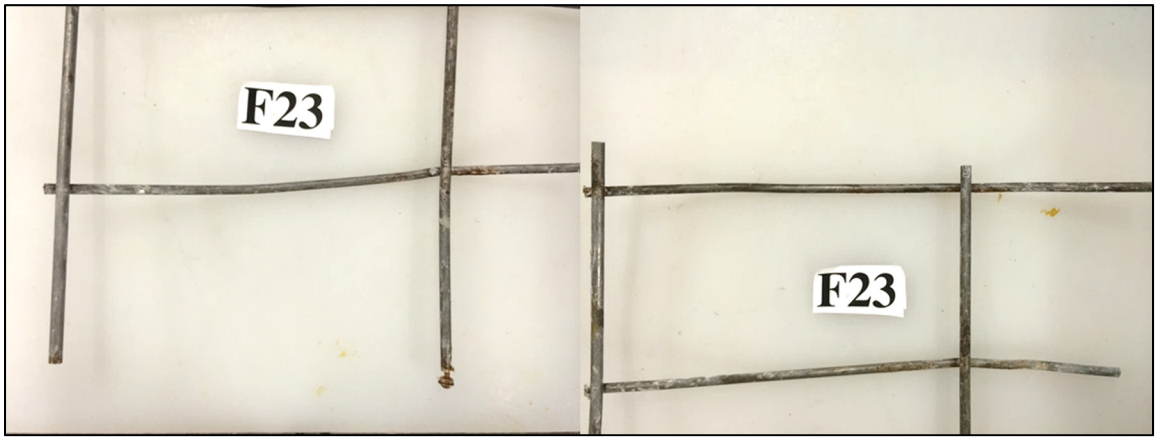
Figure 120 – Autopsy result of specimen F23. Left: location 1. Right: location 2.

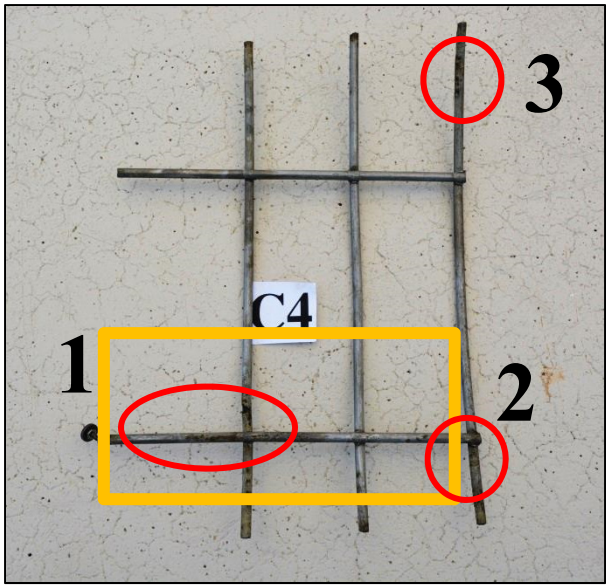
Before cracking the specimen open, the exposed ends of the steel reinforcement were observed to be corroding as seen in Figure 121. Upon breaking the specimen open, the steel reinforcement's corrosion observed was red in some areas and "black" (or " dark green) in other areas as seen in Figure 122. The steel reinforcement of specimen C4 can be seen in Figure 123 displaying the locations where corrosion occurred. Specimen C4's applied current was increased to 125 µA before termination and also the specimen was covered with saturated sand. As seen in Figure 124 corrosion occurred at the steel junction at locations 1 and 2, and also along the transverse and longitudinal wires between the junction. Upon exposure the corrosion products were blackish green suggesting that there was significant moisture at the steel depth. Corrosion did occur outside the ponding at location 3.

Figure 123 – Autopsy result of specimen C4.

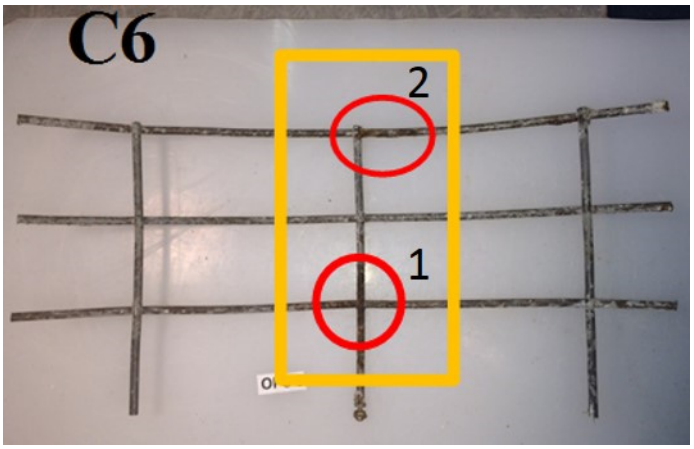
Upon breaking the specimen open, the steel reinforcement's corrosion observed was red rust in some areas as seen in Figure 125. The corrosion products color was "black" (or "dark green") at other locations as seen in Figure 126. The steel reinforcement of specimen C6 can be seen in Figure 127 displaying the locations where corrosion occurred. Specimen C6's applied current was also increased to 125 µA before termination. As seen in Figure 128, location 1 experienced mild corrosion under the ponding at the reinforcement junction. Also, mild corrosion can be seen at the junction along the transverse steel shown in Figure 128. Corrosion did not occur outside the ponding. Specimen C6 experienced more corrosion than C4 which may be attributed to the higher current applied and the fact that specimen C4 was covered with saturated sand for the last 140 days before being terminated whereas specimen C6 was exposed in high humidity.

Figure 127 – Autopsy results of specimen C6 – whole steel wire mesh.

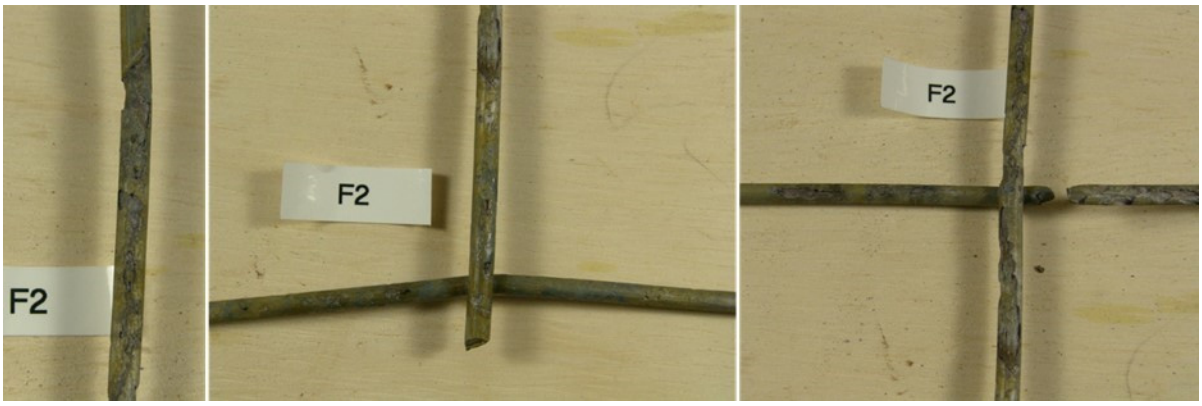
Figure 131 – Close-up of corroding sites for specimen F2.

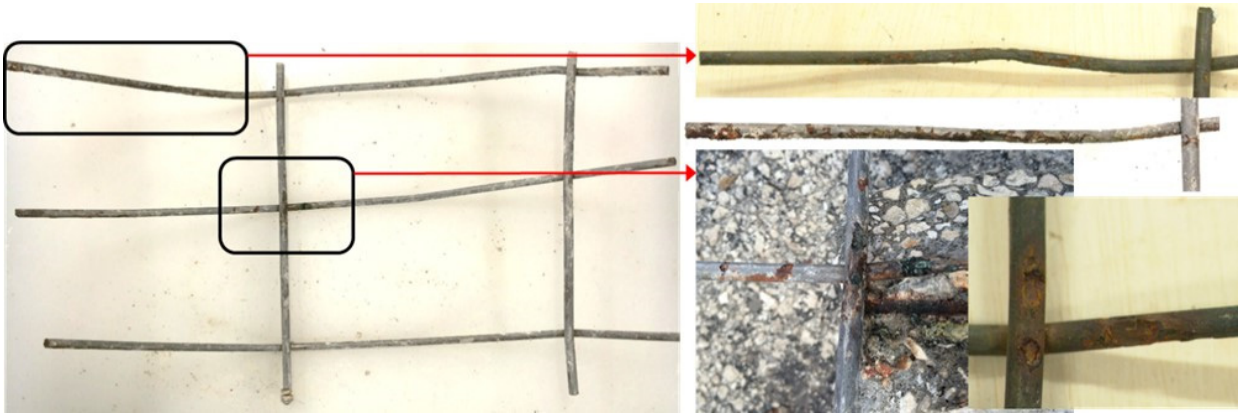
Figure 132 – Autopsy result of specimen F3. Left: after opening. Right: close-ups.

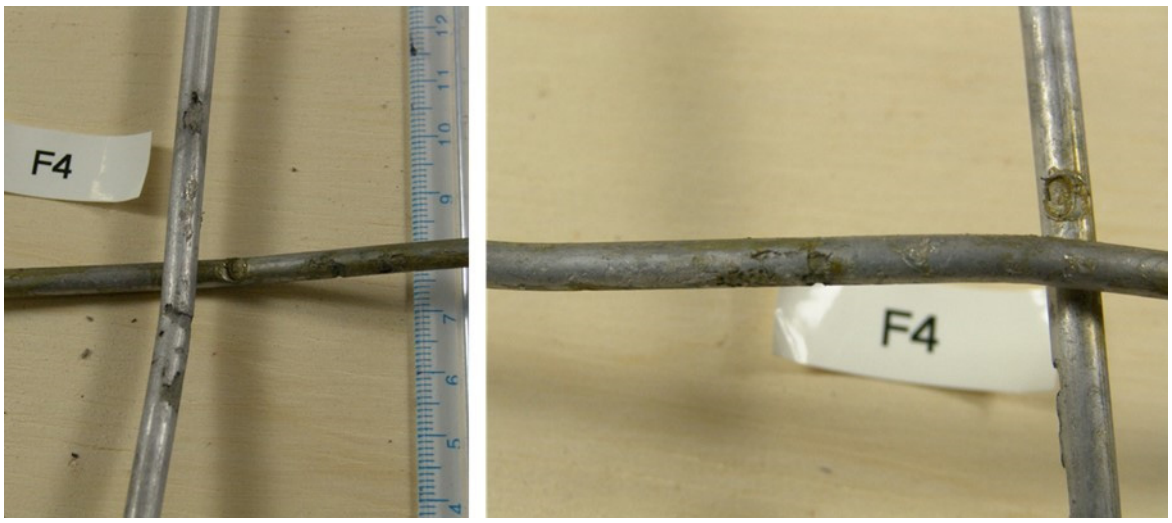
Figure 133 shows the front and back of the section that presented the more corrosion. Corrosion took place on the top side of the steel, as well as on the side and on the back side of one of the spiral wires.

Figure 133 – Steel wire mesh after cleaning for specimen F4.

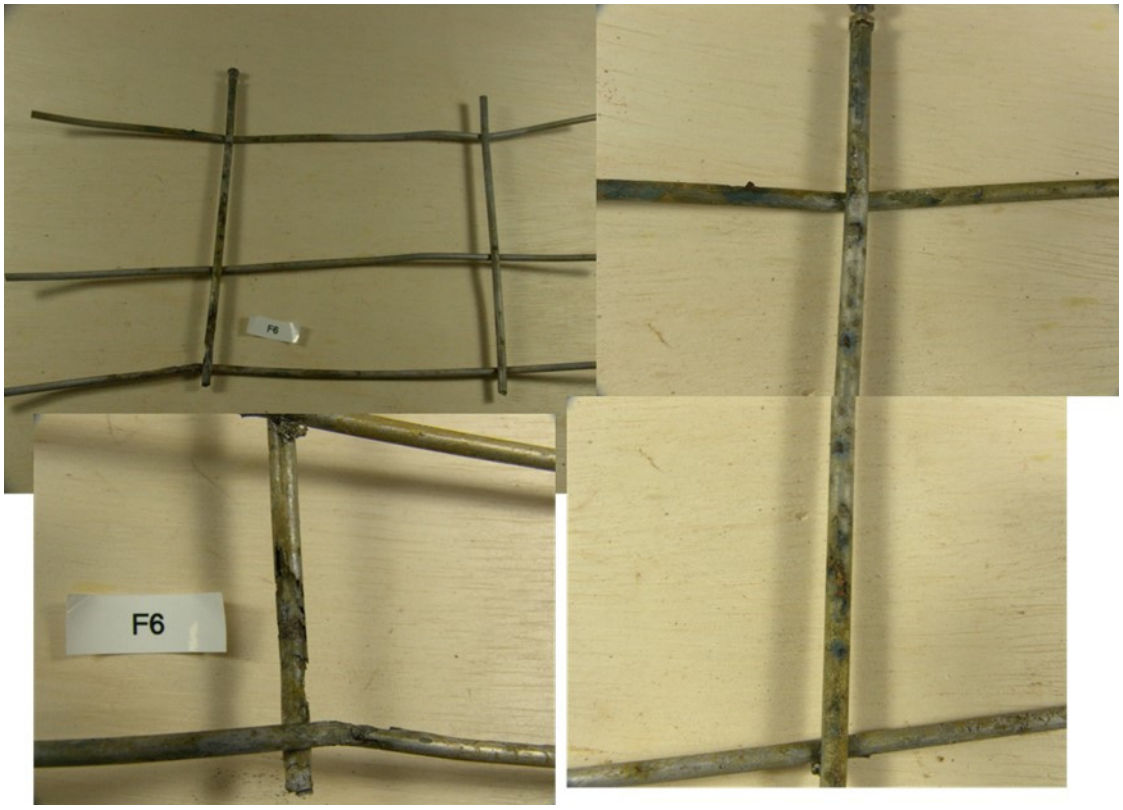
Figure 134 shows pictures of the cleaned steel wire mesh for Specimen F6. The longitudinal wire show significant amount of corrosion for the portion of the longitudinal steel wire that was under the solution reservoir.

Figure 134 – Steel wire mesh for specimen F6 after cleaning.
