Final Report

Concrete Pipe – Electrochemical Cell, Phase II
BDV27-977-03

Submitted to
Florida Department of Transportation Research Center
605 Suwannee Street
Tallahassee, Florida 32399

August 2016

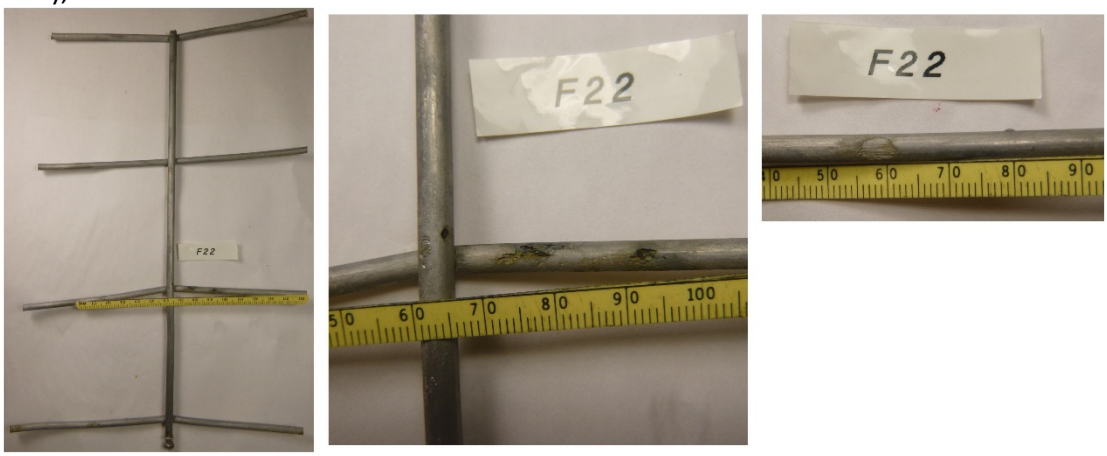
Figure 138 shows the steel wire removed from specimen F22 after cleaning. The close-up picture in the center shows that there were two spots with significant cross-section loss (spiral) and a small corrosion spot ~2 mm diameter (longitudinal) that looked like a deep pit. The inset on the right show that at a location away from the reservoir: corrosion also took place (about 5 mm wide), but the cross-section loss was modest.

Figure 138 – Steel wire mesh specimen F22 after cleaning.

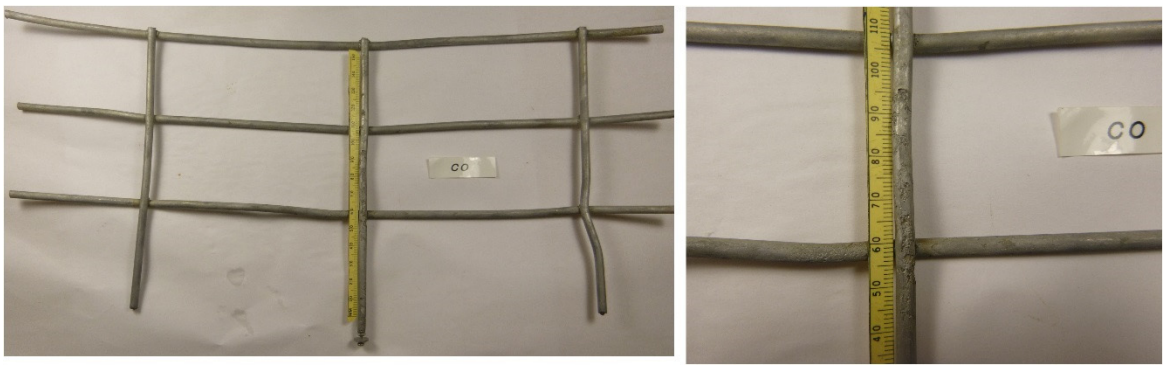
Figure 139 shows on the left the wire mesh from Specimen C0 after chemical cleaning. The picture on the right shows a close up of the region that suffered significant cross-section loss. Several spots 10 mm long (or more) are easy to identify.

Figure 139 – Steel wire mesh specimen C0 after cleaning.

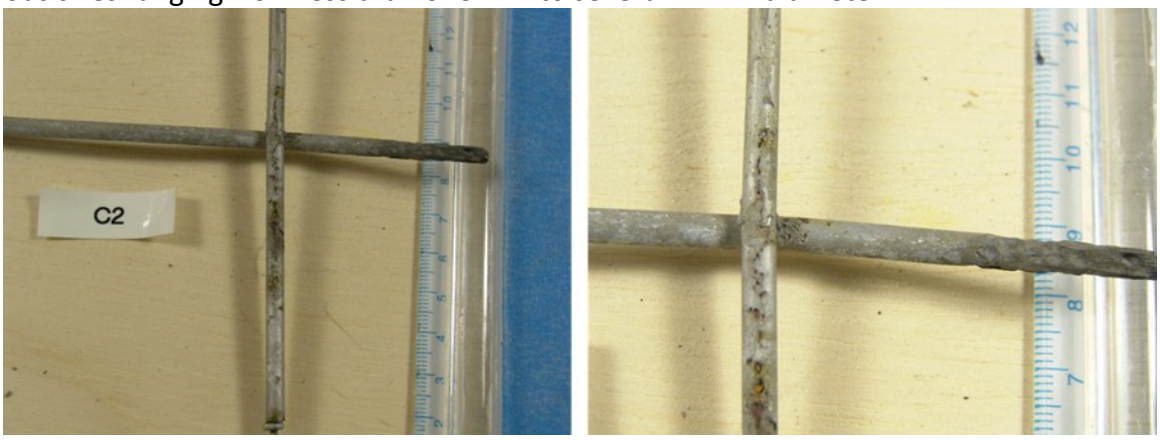
Significant corrosion took place along one of the longitudinal steel wires on Specimen C2 as can be seen on the pictures on Figure 140. The picture on the left shows that corrosion took place also on one of the transverse steel wires a certain distance from where the multiple corrosion spots were present on the longitudinal steel wire. The corrosion spots are pit like shape of various sizes ranging from less than one mm to several mm in diameter.

Figure 140 – Steel wire mesh specimen C2 after cleaning.

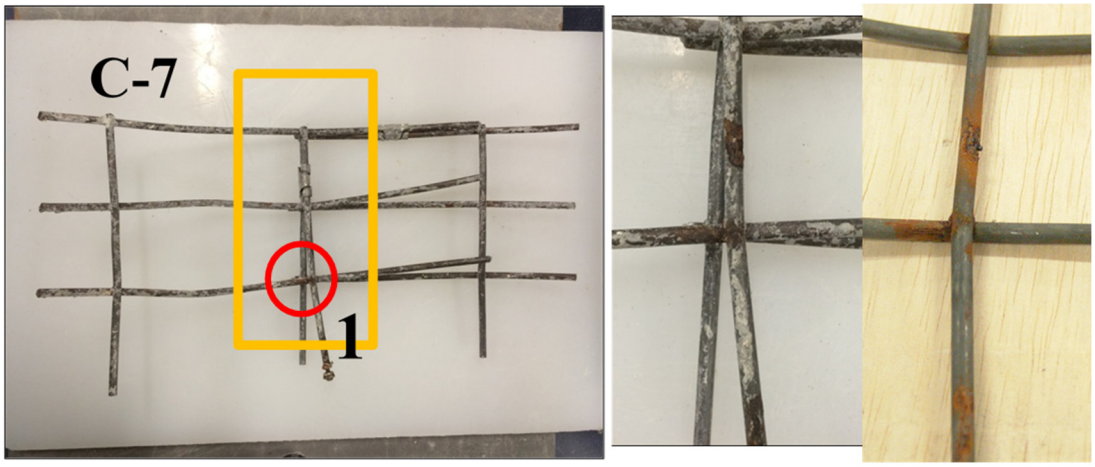
Figure 141 – Autopsy result for specimen C7 – Left: full wire mesh. Right: close-up.

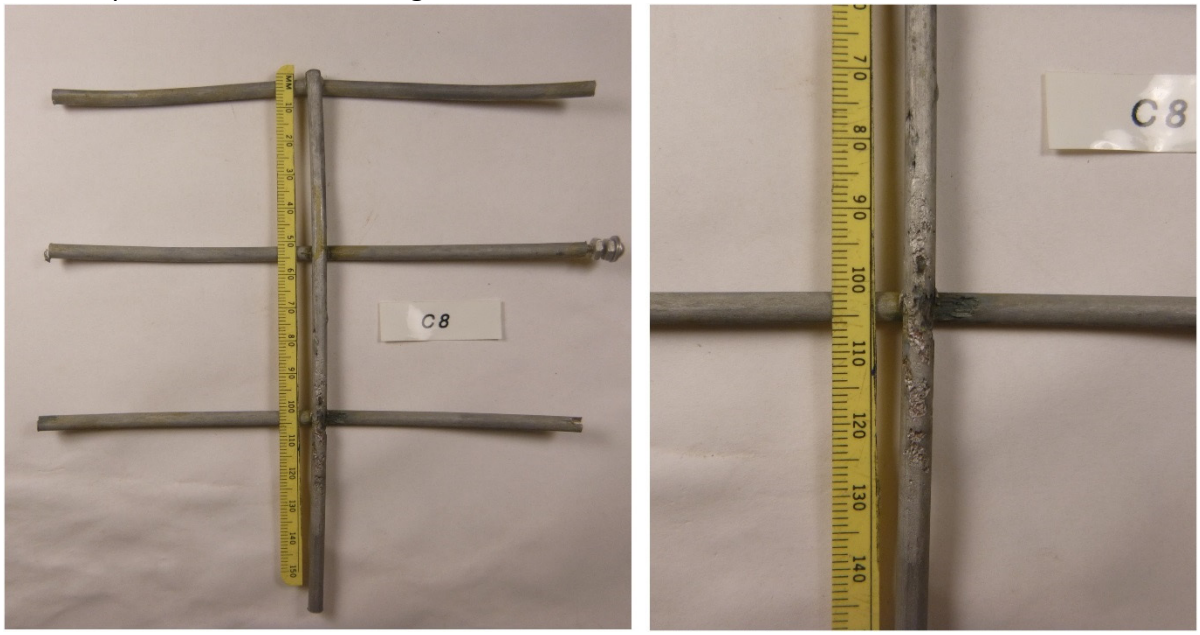
Figure 142 shows on the left the steel wire mesh from Specimen C8 after chemical cleaning. The picture on the right shows a close up of the region that suffered significant cross-section loss. The corroding region was below the solution reservoir. Several spots 10 mm long (or more) are easy to identify. Both, longitudinal and transverse wires showed corrosion, although corrosion was more pronounced on the longitudinal steel wire.

Figure 142 – Steel wire mesh after cleaning for specimen C8.

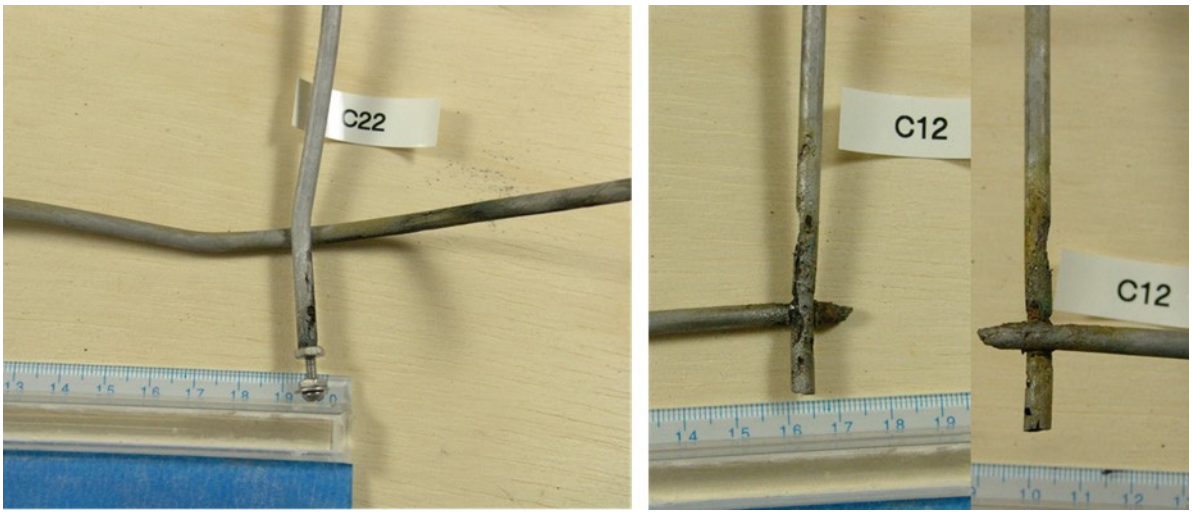
Figure 145 shows close-ups for the steel wire meshes removed from specimens C12 and C22. It is evident that the cross-section loss was significant on both cases. The location of the corrosion sites was above the solution reservoir. Both of these specimens were exposed in the vertical

direction. The steel wire for specimen C12 showed corrosion on both sides of the wire (the two pictures on the right show front and back surface).

Figure 145 – Steel wires after cleaning for specimen C22 and specimen C12.

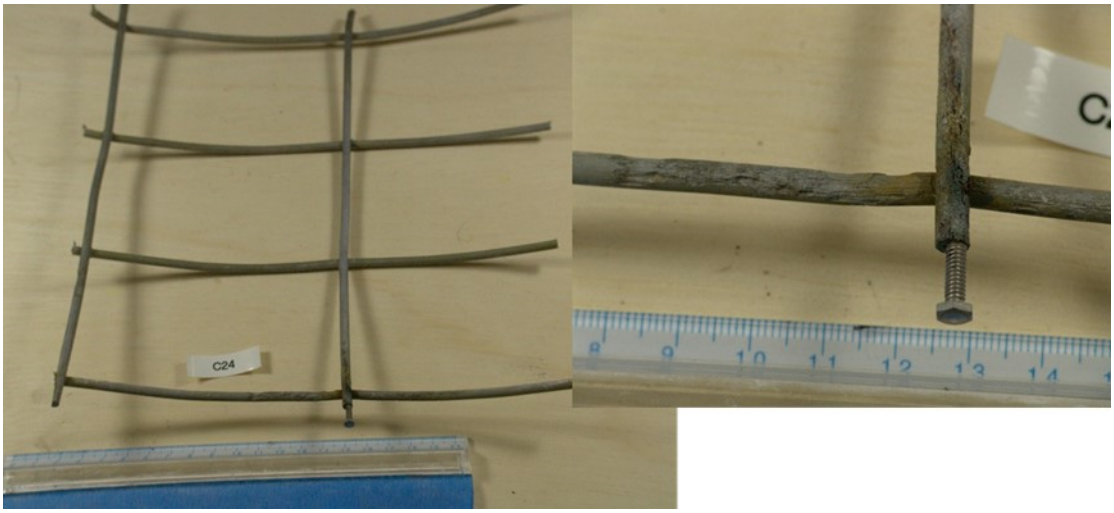
Figure 146 – Close-up after cleaning steel wire for specimen C24.

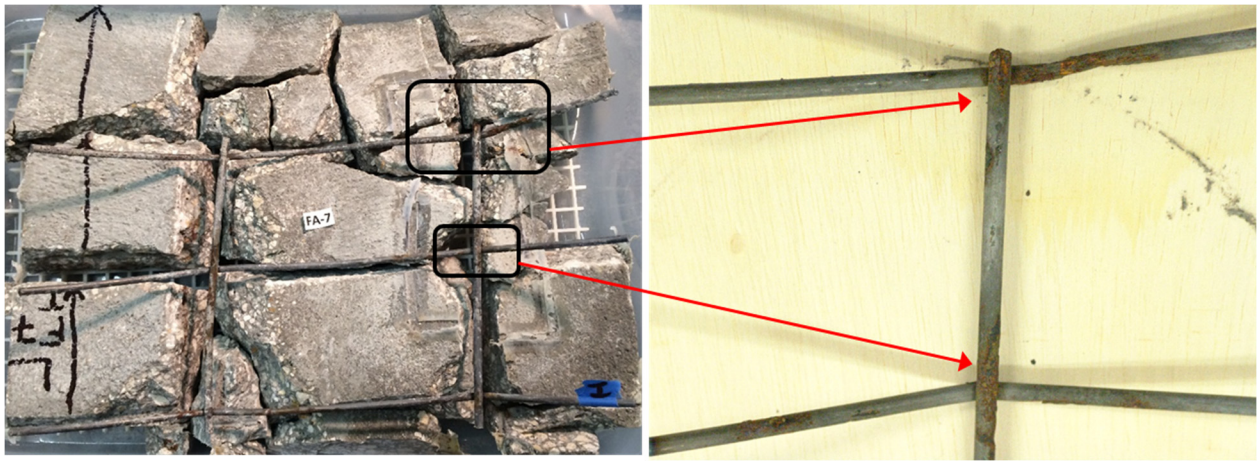
Figure 147 – Specimen F7: Left: shortly after opening. Right: locations under the ponding.

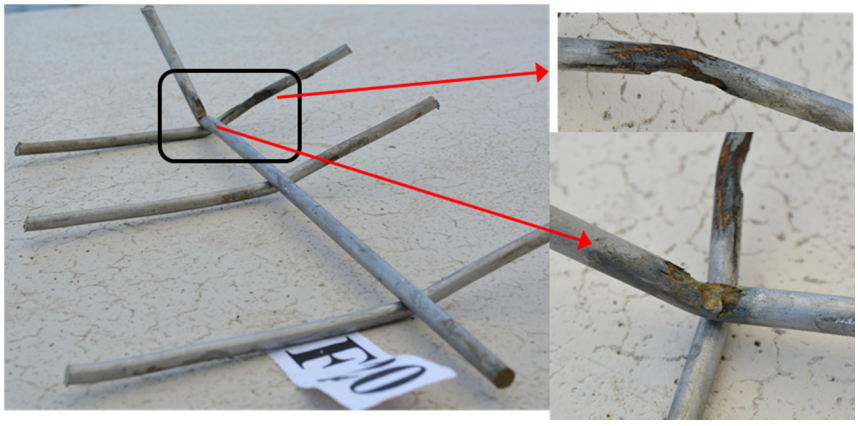
The steel reinforcement of specimen F20 can be seen in Figure 148 displaying the location where corrosion occurred (pictures taken after cleaning). Specimen F20's applied current was increased to 125 µA before termination and also the specimen was covered with saturated sand. As seen in the Figure 148 picture on the right, the steel experienced significant corrosion occurred under the ponding at the reinforcement junction. Upon exposure the corrosion products were blackish green suggesting that there was very little oxygen at the steel depth (not shown). Corrosion did not occur outside the ponding. Figure 149 shows pictures of the reinforcement in Specimen F19. Corrosion occurred under the ponding, but the cross-section loss was not as significant.

Figure 148 – Autopsy result of specimen F20. Left: all reinforcement 1. Right: corroding sites.

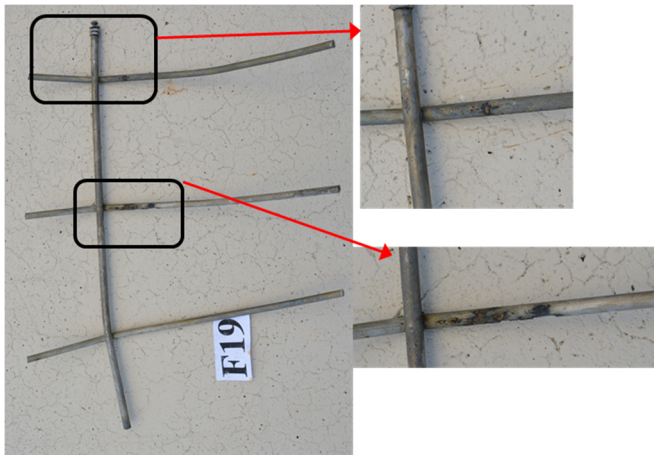
Figure 149 – Autopsy result of Specimen F19: Left: all reinforcement, Right: corroding sites.

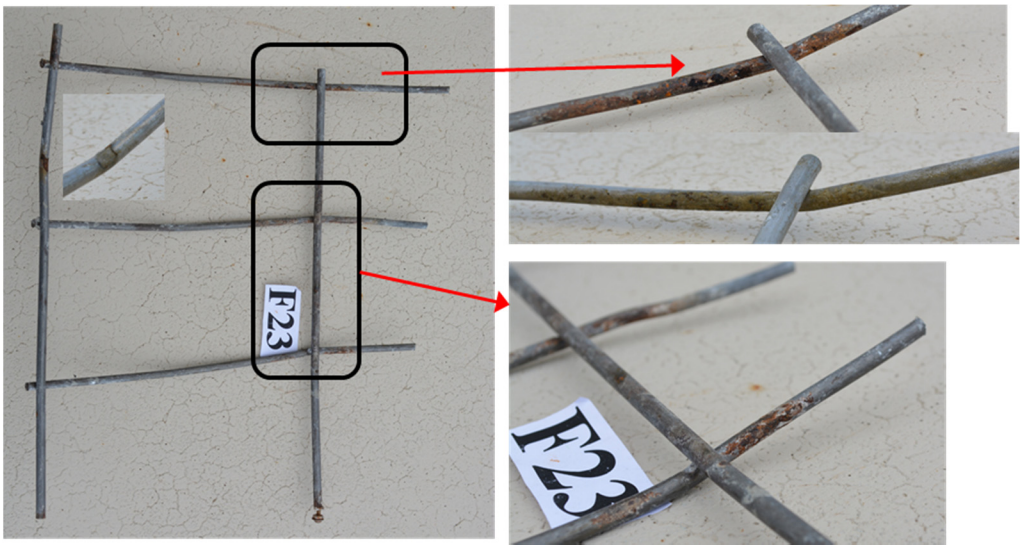
Figure 150 – Autopsy result of specimen F23. Left: all steel wire. Right: corroding sites.

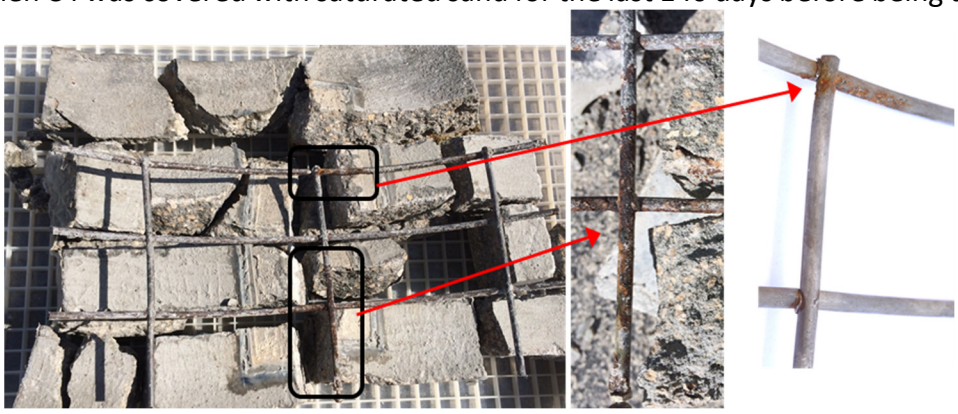
Figure 152 – Autopsy result of specimen C6. Left: after opening. Right: close-ups of corroding sites.

The steel reinforcement of specimen C6 can be seen in Figure 152 displaying the locations where corrosion occurred. Specimen C6's applied current was also increased to 125 µA before termination. As seen in the Figure 152 pictures on the right, the reinforcement experienced corrosion under the ponding at the reinforcement junctions. Also, mild corrosion can be seen at the middle junction along the transverse steel shown. Corrosion did not occur outside the ponding. Specimen C6 experienced more corrosion than C4 which may be attributed to the fact that specimen C4 was covered with saturated sand for the last 140 days before being terminated.

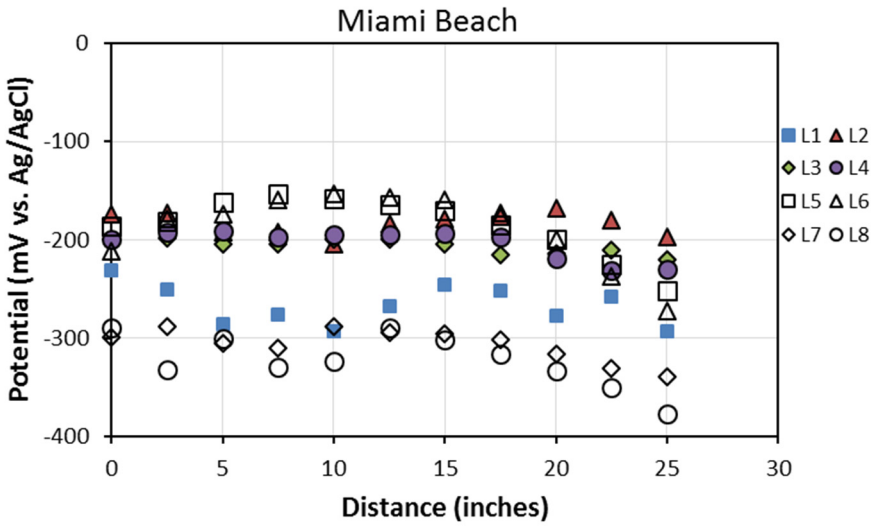
Figure 155 – Potential profile along longitudinal.

Figure 154 shows the 12 inch inside diameter pipe segment obtained during the site visit to Alton Road in Miami Beach. Figure 155 shows the potential profiles measured along each of the longitudinal steel wires. The potential values (measured against an Ag/AgCl electrode) measured along three of the longitudinal steel wires (L1, L7 and L8) suggest that corrosion was taking place. After additional exposure to the lab humidity the potential on all longitudinal steel wires shifted toward more positive values.

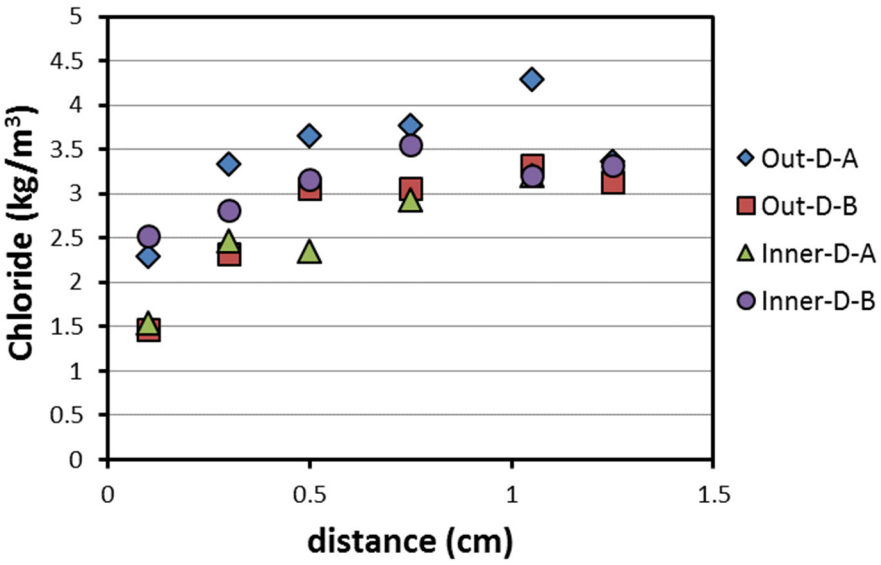
Figure 156 – Chloride profile for Miami Beach specimen.

Figure 156 shows the chloride concentrations measured from both sides on two concrete pieces that were milled. The chloride concentration at 1.25 cm from the surface ranged between 3 and 3.5 kg/m^3.

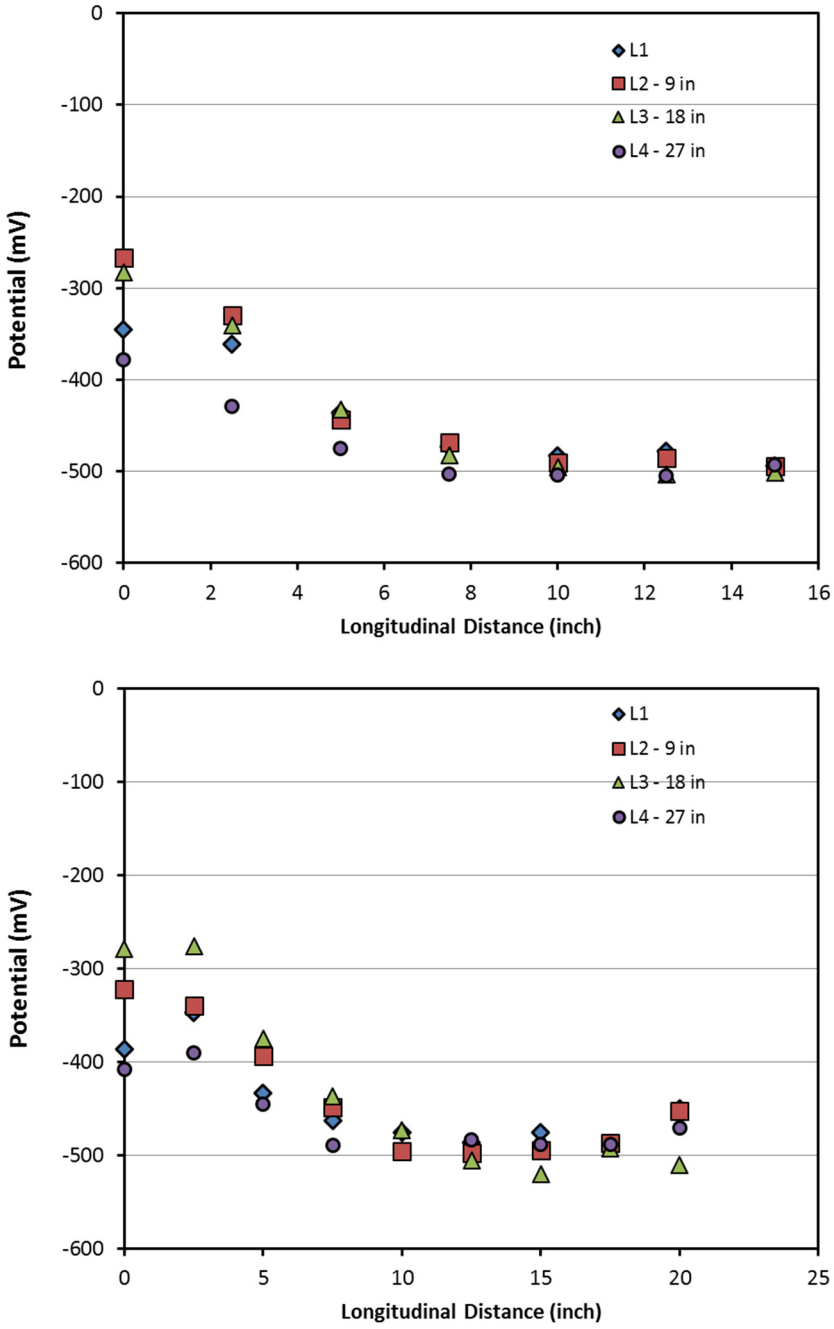
Figure 157 – Potential profiles measured along longitudinal wires (Dania Beach Marina).

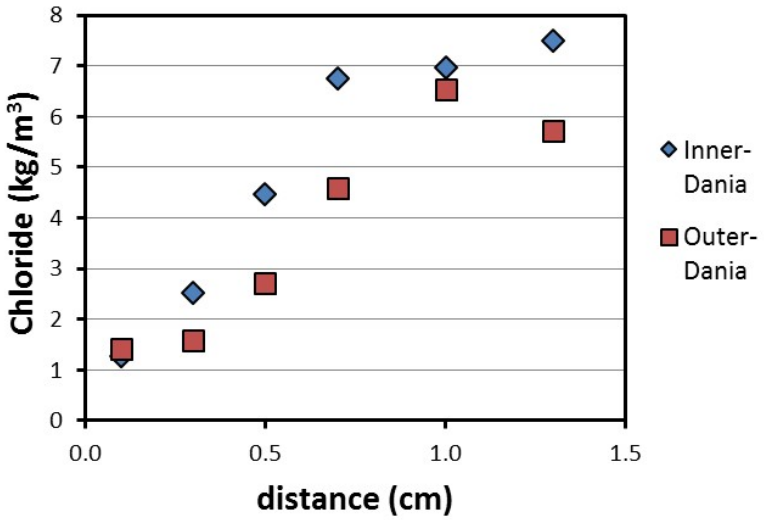
Figure 158 – Chloride profile from RCP at Dania Beach Marina.

exposed steel wires were used to check continuity and as electrical connections. Figure 157 shows the potential profiles measured along the longitudinal reinforcements. Several small pieces were brought into the lab for forensic examination. Concrete was milled from the surface of both the inner and outer side of a pipe concrete piece. Chlorides were measured from the pulverized concrete. Figure 158 shows the chloride profiles obtained. At a depth of 1.4 cm the chloride concentration ranged between 6 and 7.5 kg/m^3.

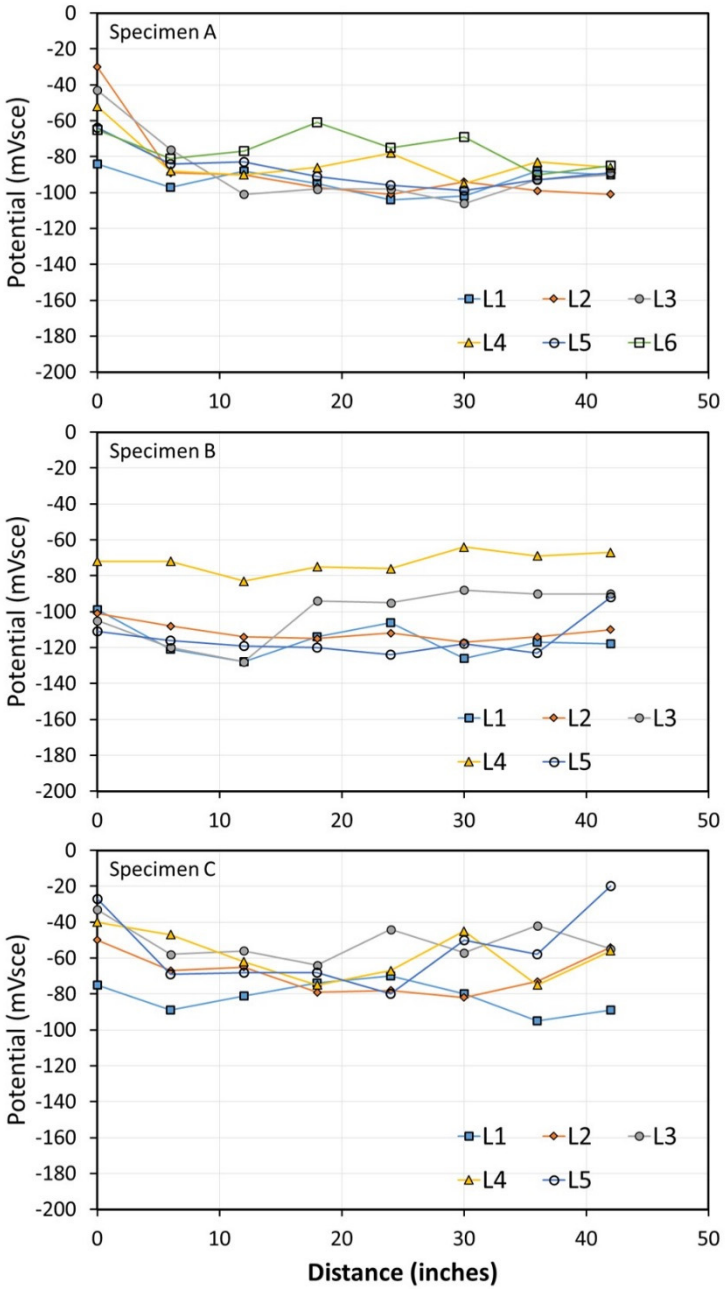
Figure 159 – Potential profiles measured on pipes taken from the Titusville Airport.

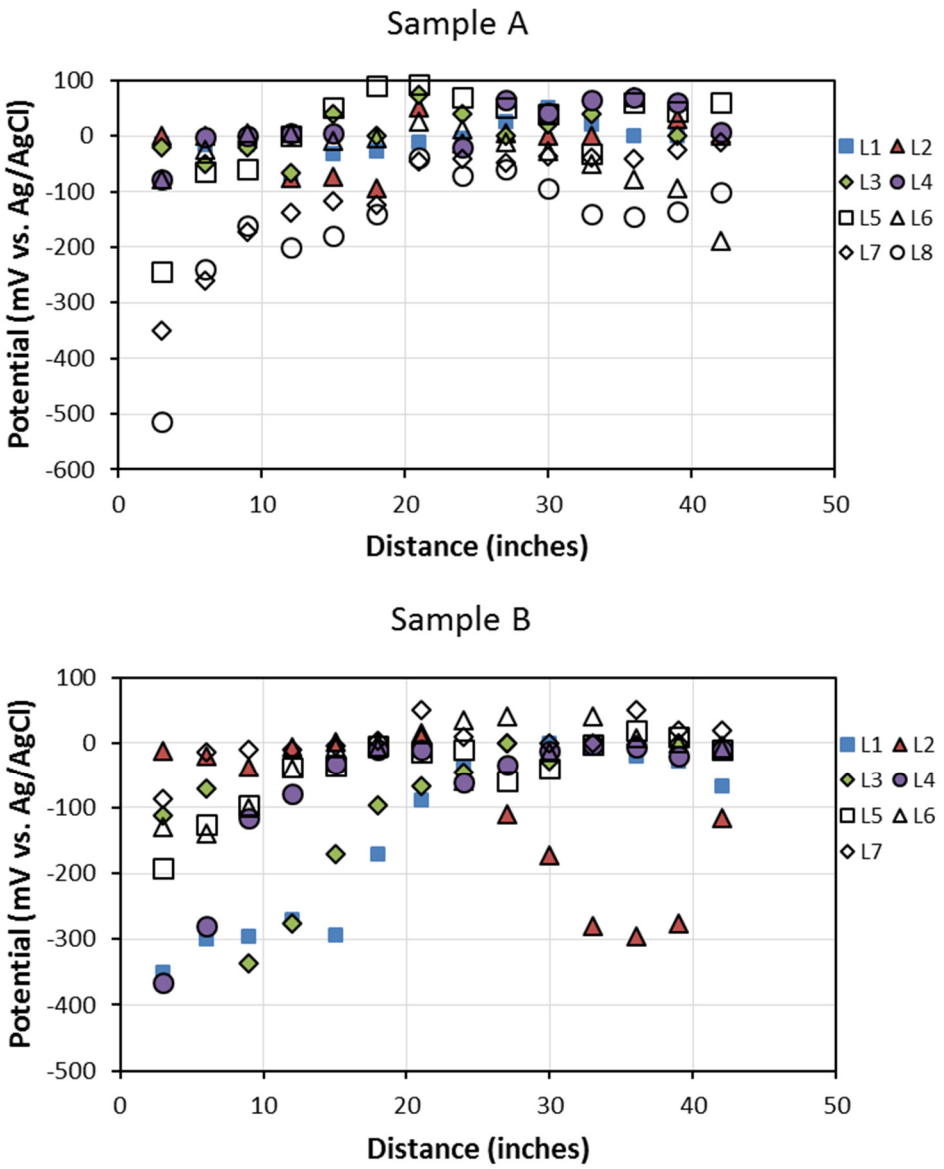
Figure 160 – Potential maps along the longitudinal reinforcements on samples at Indian Rock Beach.

Figure 160 show plots of the potential values measured along selected longitudinal reinforcements on the RCPs at Indian Rock Beach (Largo FL). The reference electrode used during this visit was an Ag/AgCl reference electrode. Based on the measured values two

longitudinal reinforcements (L7 and L8) appear to be active on sample A; whereas on Sample B four longitudinal reinforcements appear to be active (Along L3, L4 and L5 on the left side and L2 on the right side) based on the steel potential. Several concrete pieces were cut-off from the latter pipe (Sample B).

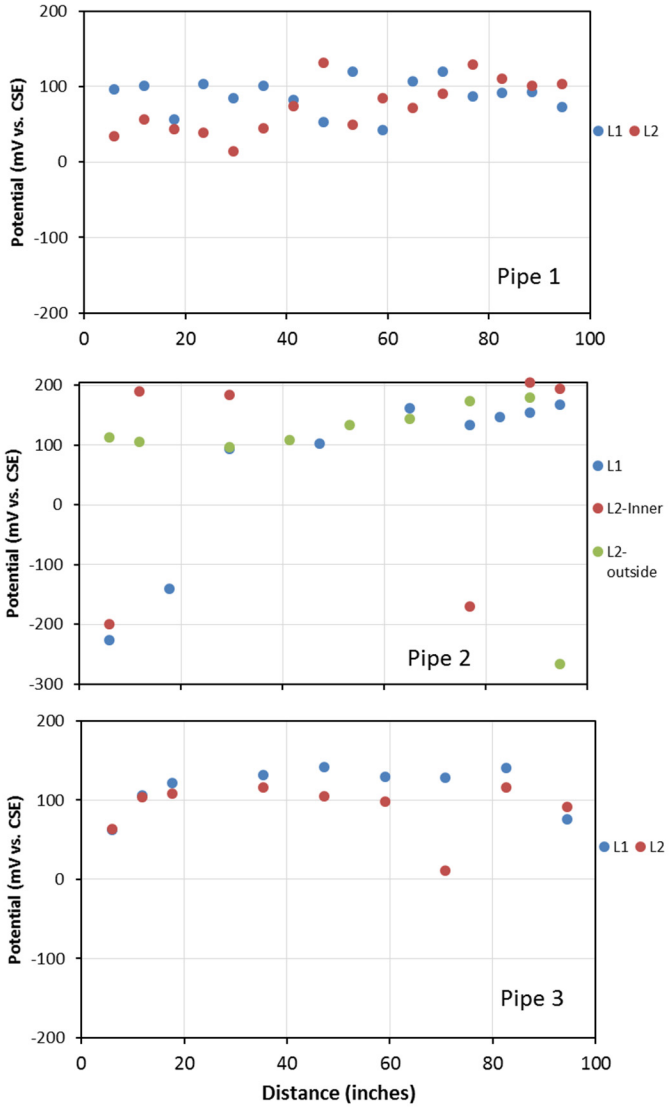
Figure 161 – Potential values along the longitudinal reinforcements on RCP (Tallahassee).

The steel potential values were measured along several longitudinal strands on three different pipes during the visit to the Tallahassee site. The steel potentials were measured against a copper sulfate electrode (CSE). Figure 3 below shows plots of the potential profiles measured

along the selected steel strands. Only pipe 2 appear to have a few active spots. A segment was cut off from pipe 2 for forensic analysis in the laboratory.

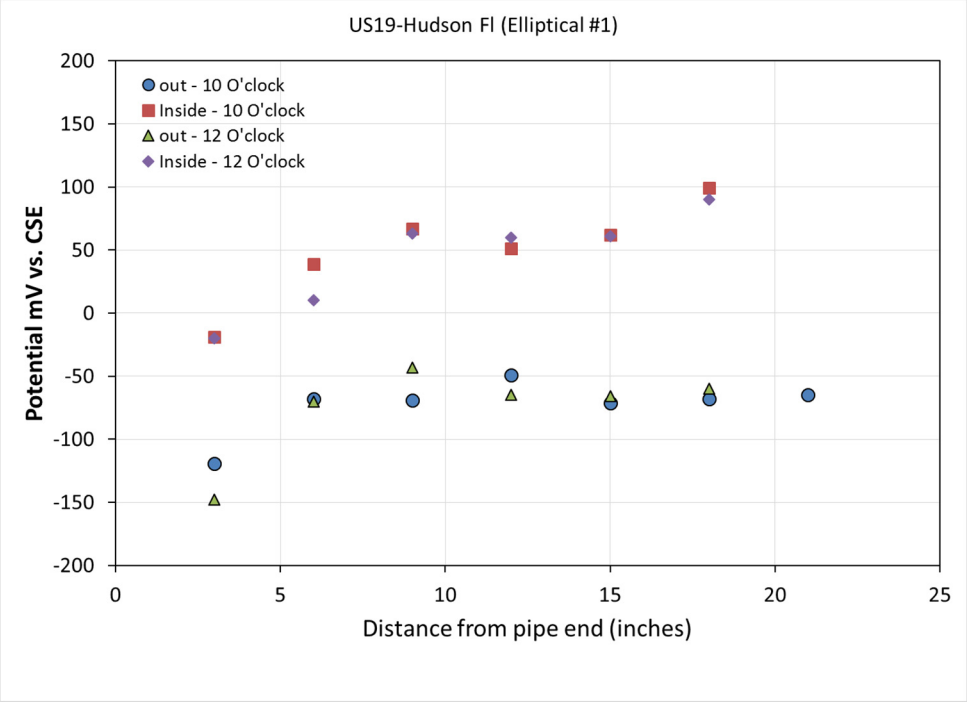
Figure 162 – Reinforcement potential along longitudinal wires (Elliptical 1).

This section describes the reinforcement potential values measured along selected longitudinal wires on pipes found during the visit to Hudson, FL. The potential values shown are vs. CSE in mV. Figure 162 shows a plot with the values measured on one of the elliptical RCPs named elliptical #1. The reinforcement potential values measured on the outside surface were 100 to 150 mV more negative than those measured inside the pipe. The visit took place in July during the rainy season, which might in part explain the potential difference. Figure 163 shows the potential values measured on a pipe labelled elliptical #2, and Figure 164 shows the potential values measured along the longitudinal on a round RCP pipe found a few miles from the two

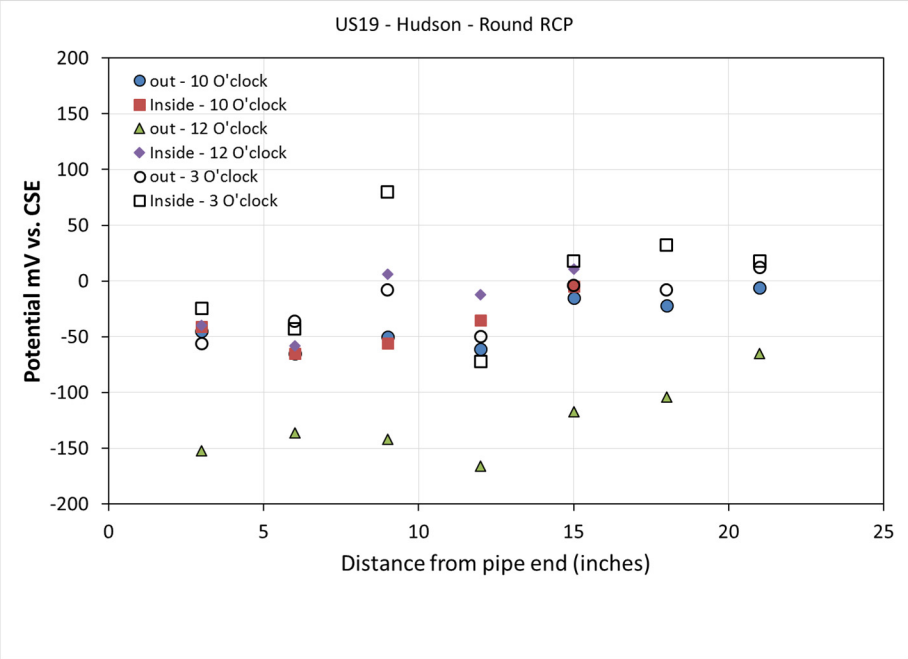
Figure 164 – Reinforcing wire potential along three longitudinal wires, on a round RCP.

elliptical pipes measured. Most potential values measured were more positive than -150 mVcse, which suggest that the reinforcing wire was likely not corroding. Segments were obtained from three pipes and brought to FAU SeaTech for forensic analysis.

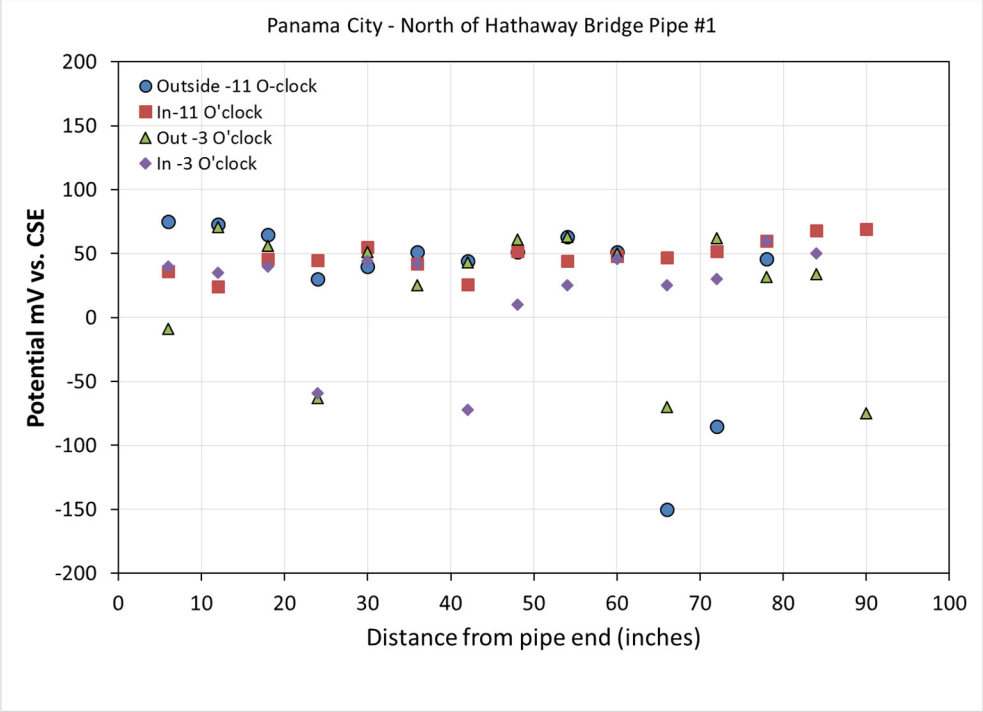
Figure 165 – Potential values along longitudinal wires on pipe #1 north of Hathaway Bridge.

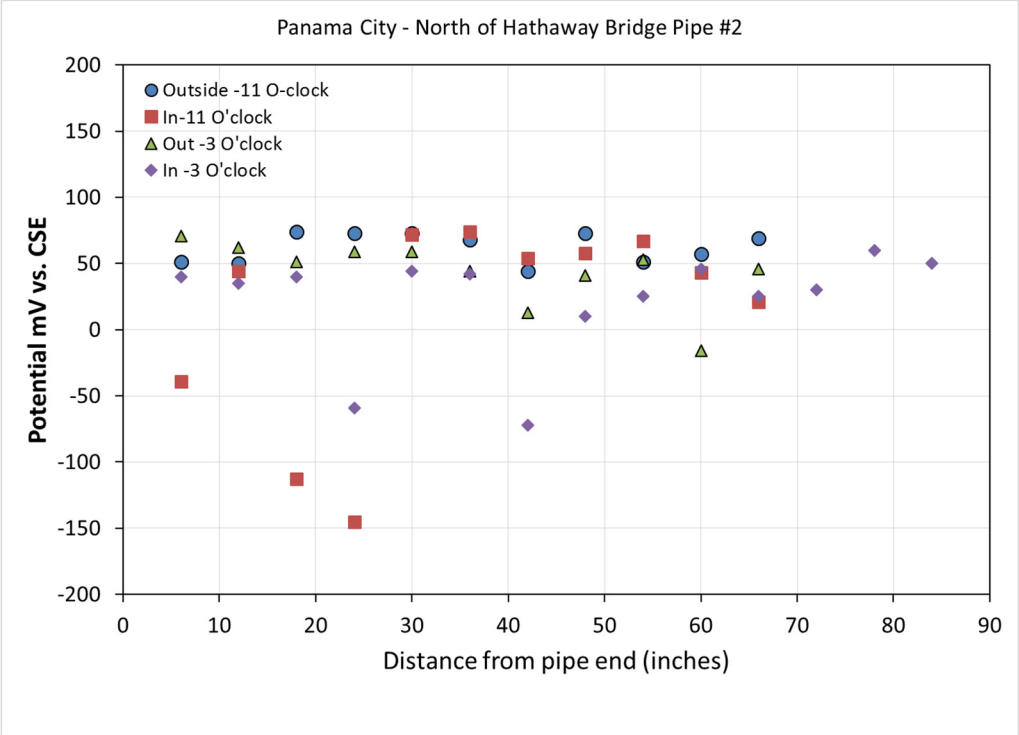
Figure 166 – Potential values along longitudinal wires on pipe #2 north of Hathaway Bridge.

A good number of RCPs were found just before reaching the Hathaway Bridge (from land side). Two of the several pipes already removed were selected to characterize the steel potential along selected longitudinal reinforcements. The pipe inside diameter was 4 ft wide. These pipes have two wire meshes (inner and outer), similar to those found at Zolfo Springs. The potential series marked as in correspond to values measured on inner longitudinal reinforcements and out refers to values measured along a longitudinal reinforcement wire of the outer mesh. Figure 165 and Figure 165 show the potential profiles measured on two different pipes. The magnitude of the potential values suggest that corrosion is not taking place. A CSE reference electrode was used.

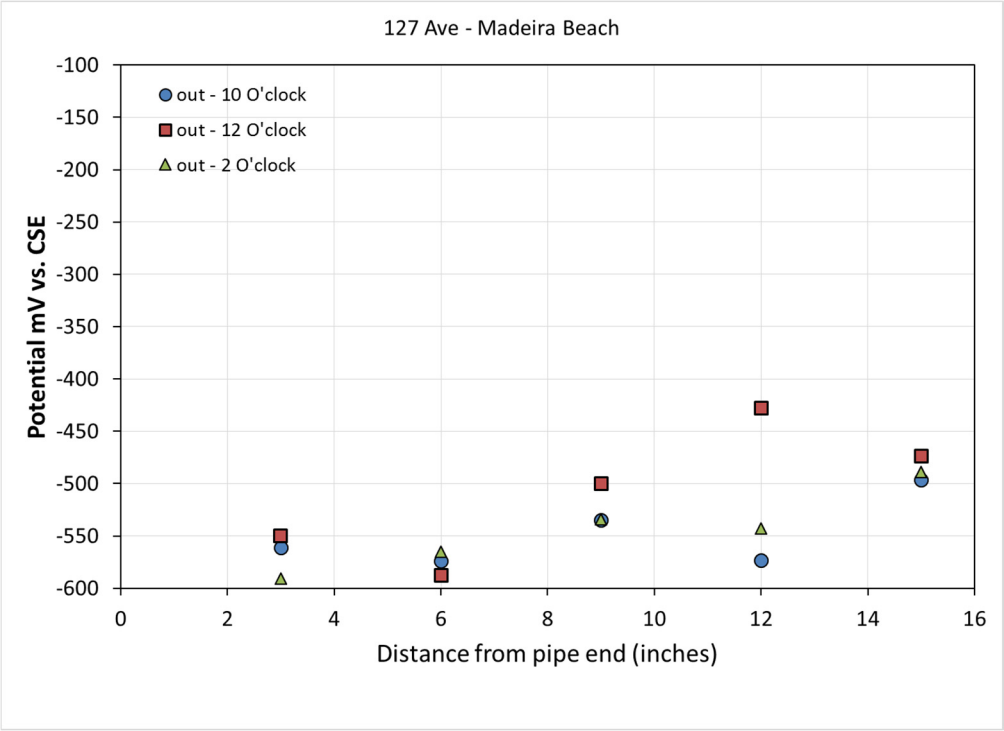
Figure 168 – Potential values along longitudinal wires measured on pipe at 127th Ave. Madeira Beach, FL.

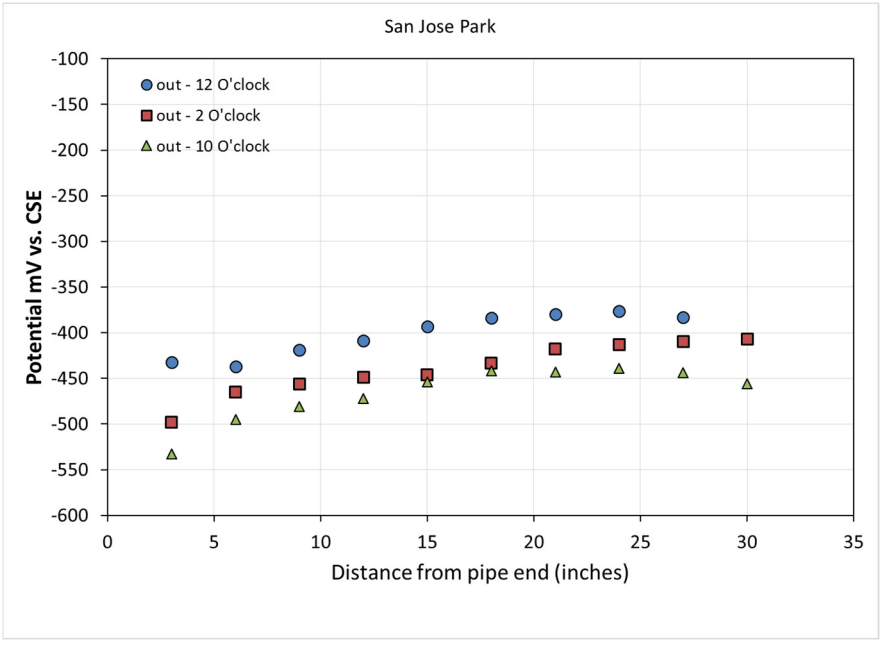
Figure 170 – Potential values along longitudinal wires at St. Jose Park pipe (Dunedin FL).

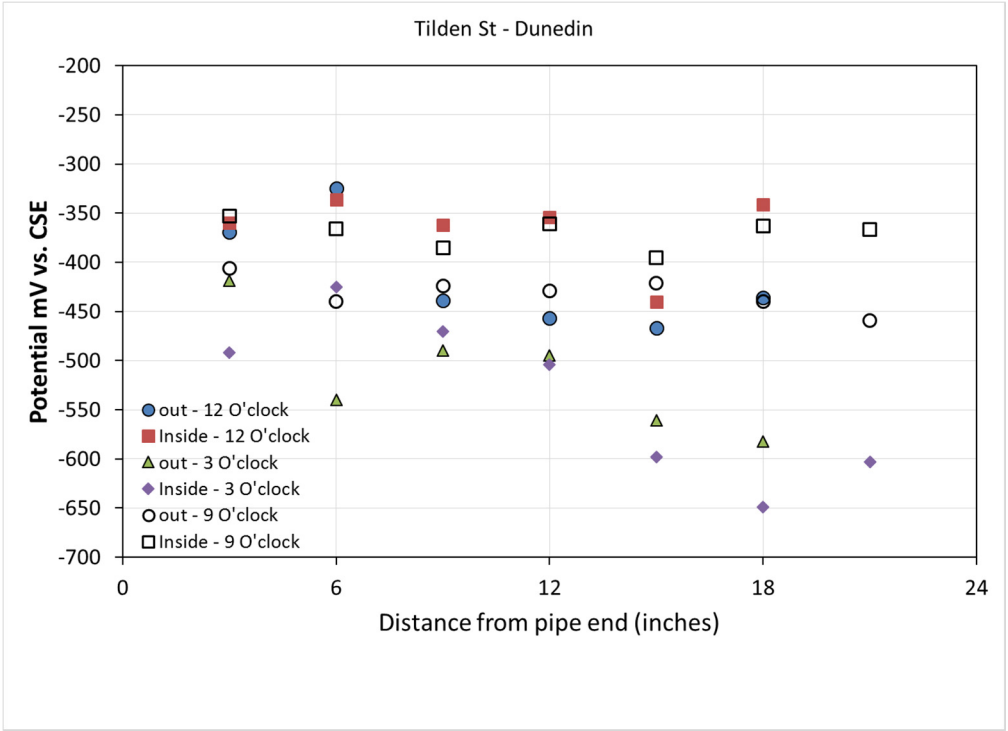
Figure 172 – Potential values along longitudinal wires at Tilden St. pipe (Dunedin, FL).

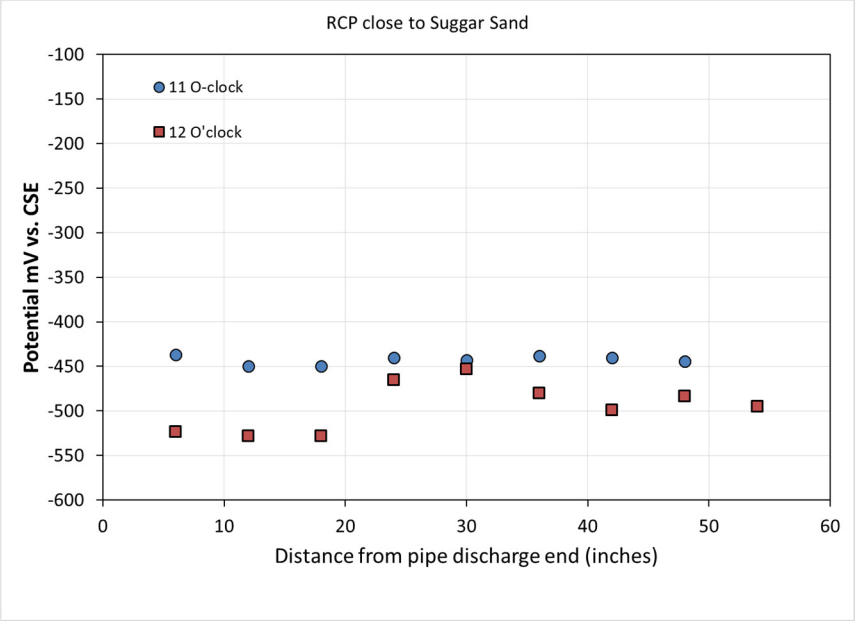
Figure 174 – Potential values measured along longitudinal wires on RCP at Sugar Sand site.

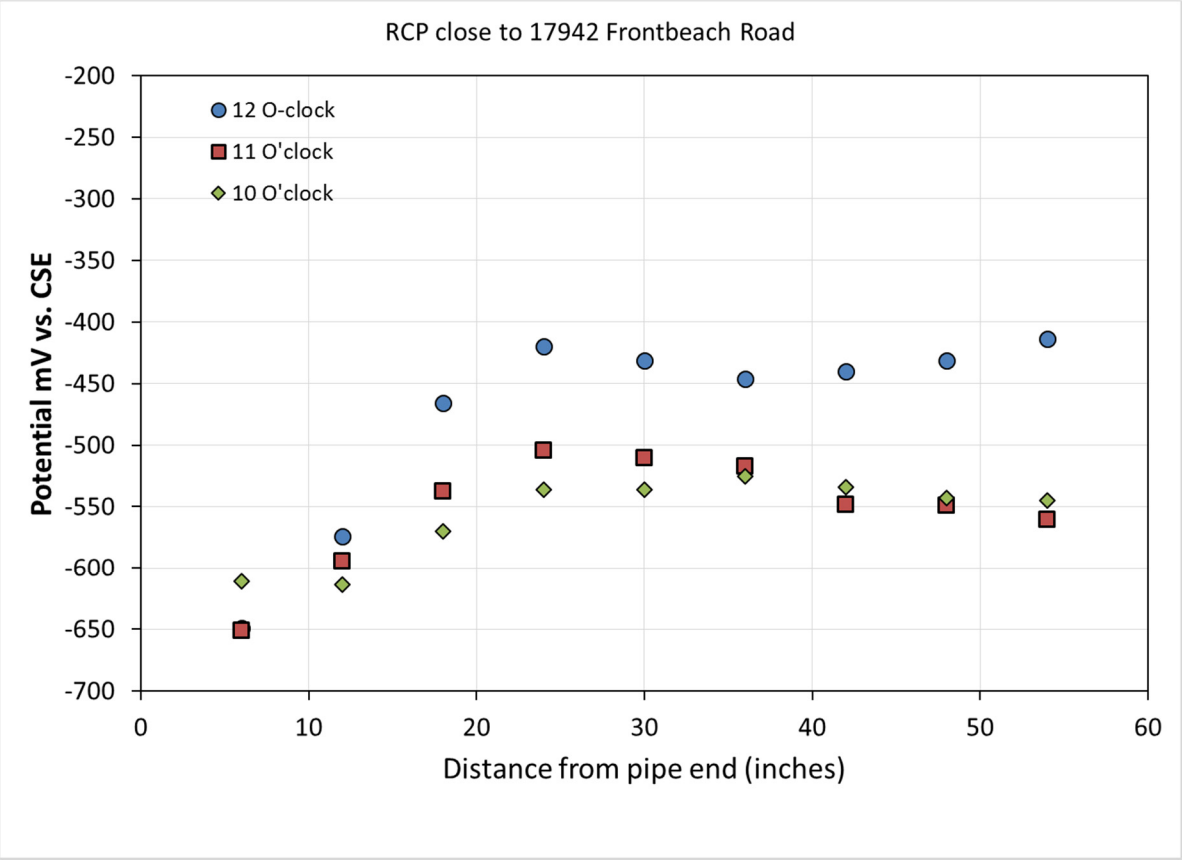
Figure 175 – Potential values measured along longitudinal wires on RCP close to 17942 Front beach Road Site.

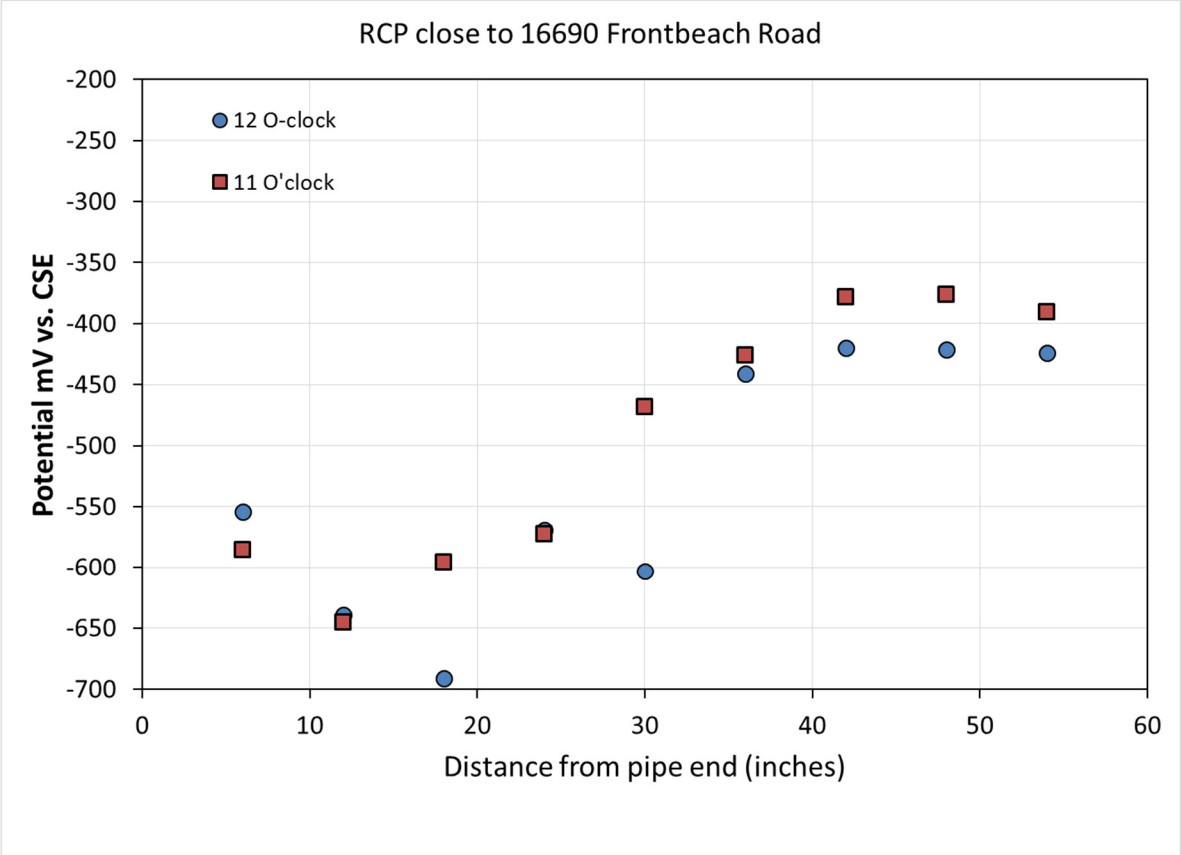
Figure 176 – Potential values measured along longitudinal wires on RCP close to 16690 Front Beach Road Site.

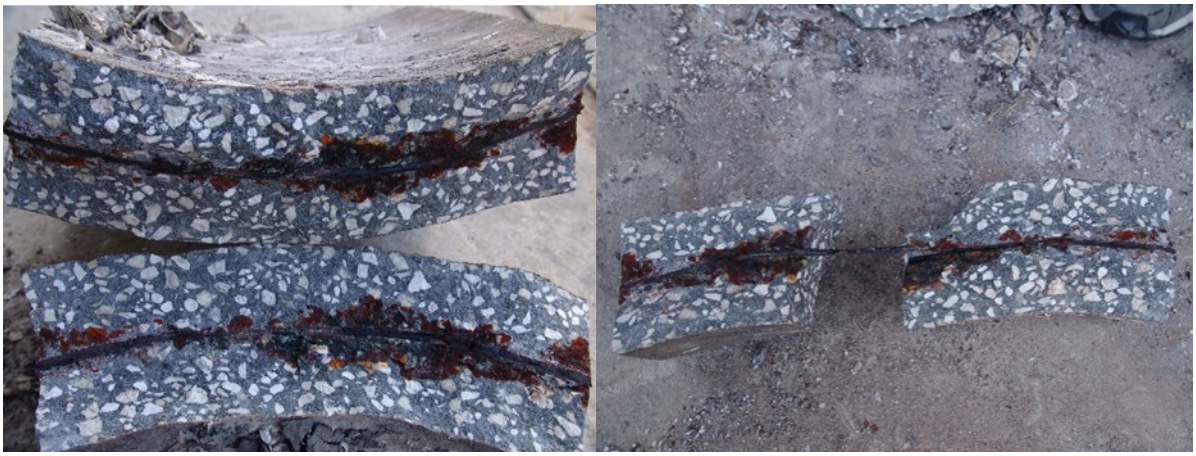
Figure 180 – After breaking the segment in two pieces. Significant cross-section loss observed on wire.
