Final Report

Concrete Pipe – Electrochemical Cell, Phase II
BDV27-977-03

Submitted to
Florida Department of Transportation Research Center
605 Suwannee Street
Tallahassee, Florida 32399

August 2016

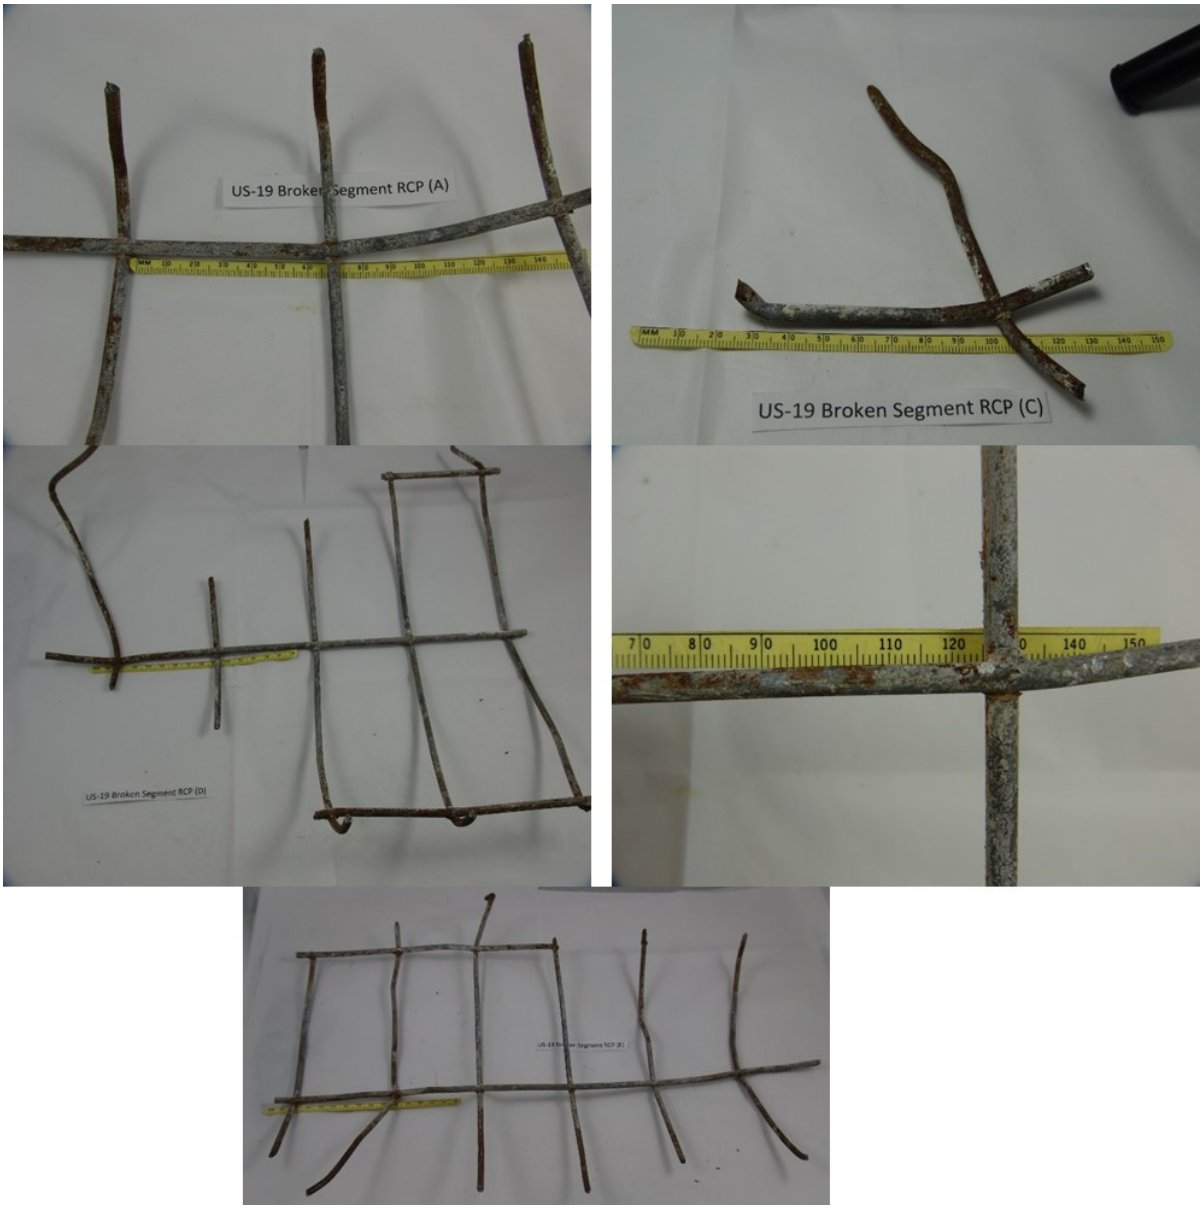
Figure 186 – Wire mesh after removing concrete on several segments.

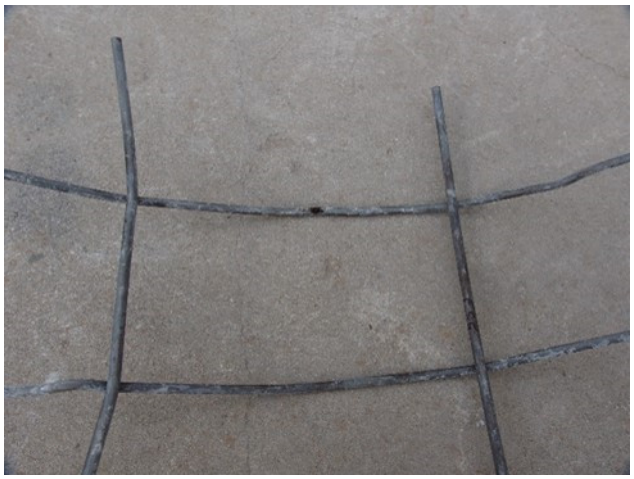
Figure 195 – Steel wire after removing concrete on segment 2 of FI1 specimen.

Specimen FI1 was first exposed for 400 days immersed in water and then exposed outdoors covered with sand. Two segments were selected for forensic analysis from this ring specimen. Figure 194 shows that some corrosion took place on two of the longitudinal wires. Figure 195 shows a small spot where corrosion took place on the second steel wire mesh.

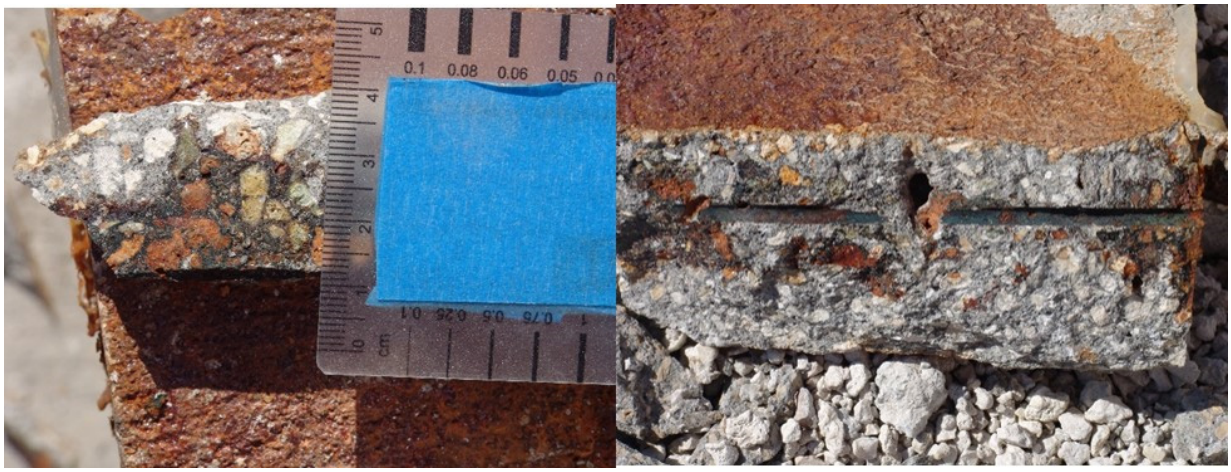
Figure 200 – Penetration into the concrete from the corrosion products (FS2).
