Montana Department of Transportation
Research Program
November 2007

EXPERIMENTAL EVALUATION FINAL REPORT

Emulsified Asphalt Treated Aggregate (EATA)

Location:	Deer Lodge and Silver Bow Counties; Butte District Highway 43: P-46, C000046 Approximate Milepost 51-58; Project is located in the Bighole River Valley, beginning at the Sportsman's Campground east to Dickie Bridge
Project No.:	Sportsman's Campground – East STPP 46-5(2)51; CN 2137
ADT:	2001 ADT=350; 7.3% Trucks 2021 ADT=460
FHWA No.	Experimental Project No.: MT 00-14
Description:	The Sportsman's Campground project is a reconstruct that included grading, gravel, plant mix surfacing, seal/cover, and two bridges. This project was determined a good candidate to incorporate EATA as an 'improved' winter driving surface and enhanced road surface dust suppression.
Dates of Evaluation:	September 2006 through May 2007
Date Constructed:	Fall 2006
Principal Investigator:	Craig Abernathy Experimental Project Manager

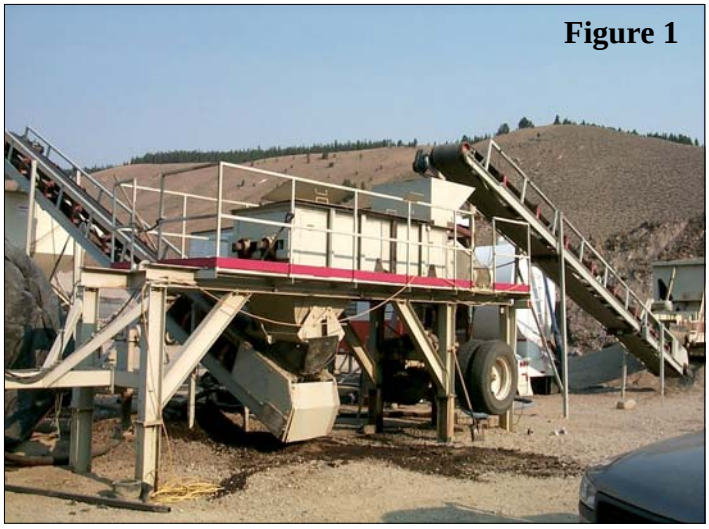
Figure 1

The contractor used a double-screw-type pug mill to incorporate the CSS-1H with the CAC as seen in figure 1. The blended EATA was then sent to a holding bin and subsequently loaded by conveyor belt to waiting trucks. The contractor explained that this method of pug milling allowed the CSS-1H product to coat the aggregate at each stage of the process including the loading of the truck (figure 2).

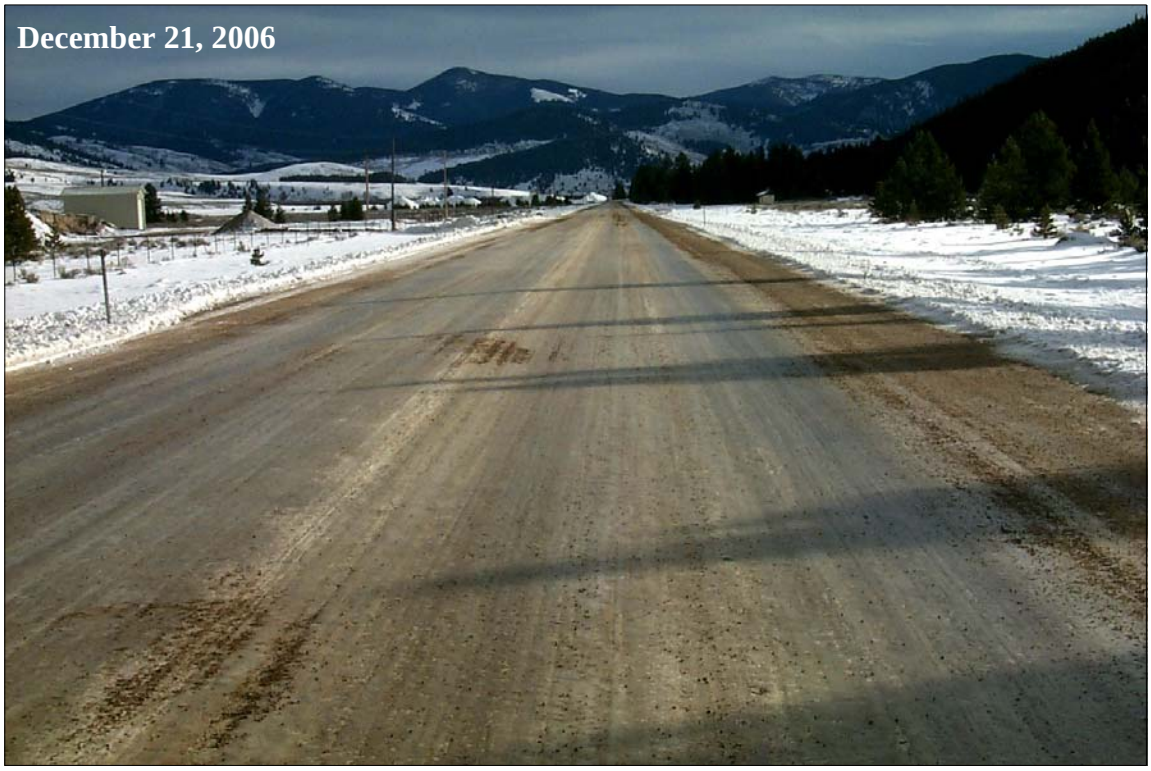
Section 1: 1.5% EATA, 100mm

The 1.5%, 100mm (section 1) displayed the most in raveling and traffic dust during the mild months. Pertaining to section 1, the crushed aggregate course (CAC) used in this project contained a high level of fines which would be difficult for a homogeneous coating of emulsion during the pug milling process. The lower the percentage of emulsion may attribute to more segregation and raveling with the higher percentage level of emulsion (or the higher amount of residual asphalt content after cure) functioning better. The 2.5% treatment (section 4) did achieve performance over the other test sites but it should be noted that the 2.0% sections performed almost as well as the 2.5% site. There was no discernable difference in function over the 100mm and 200mm depths. The gravel control section performed as expected, described as having the poorest ride quality based on severity of potholes, raveling, washboard and dust. The control section required routine surface maintenance due to conditions previously noted.

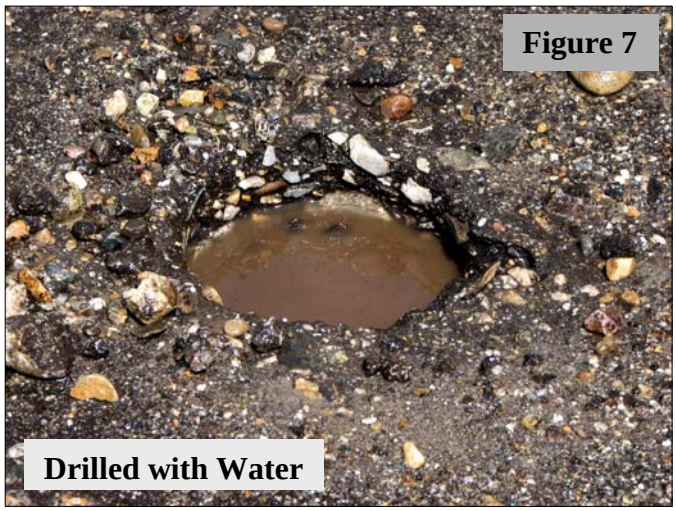
Figure 7 shows partially the interior of the core wall after the core was removed. Figure 8 shows another image of the condition of the core side walls. Notice the evidence of asphalt released during the coring. The side walls of these cores were relatively smooth and hard.

Drilled with Water

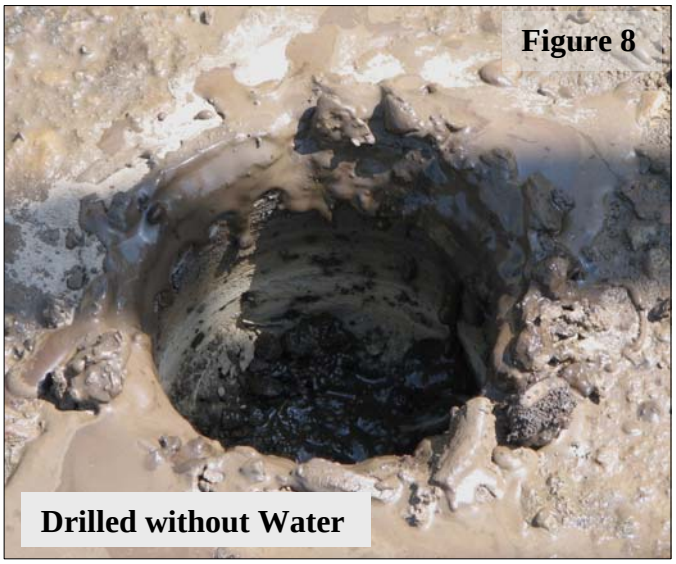
Figure 8

Drilled without Water
