VTRC
Virginia Transportation Research Council

Evaluation of the Terminal Boulevard (SR 406) Concrete Rubblization Project

Final Report VTRC 19-R30

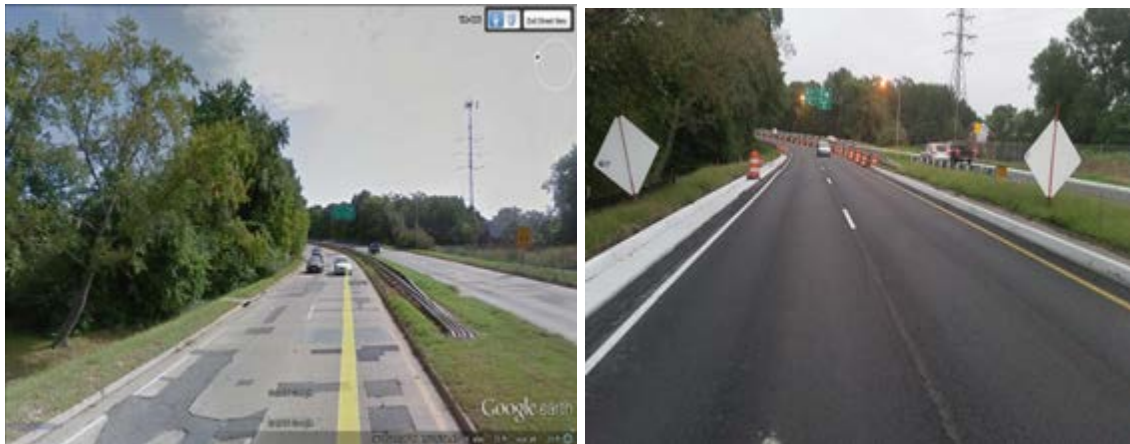
Figure 14. Project Site Before and After Paving

After rubblization, 4 in of IM 19.0E mixture (two 2-in lifts) and 2 in of SM 12.5E mixture were used for paving (Figures 12 and 13). A total of 10,000 tons of IM 19.0E mixture and 5,600 tons of SM 12.5E mixture were used. In areas with full-depth removal, 4 in of base mixture (BM 25.0 D) was placed below the intermediate and surface mixtures. Figure 14 shows a part of the section before and after paving.

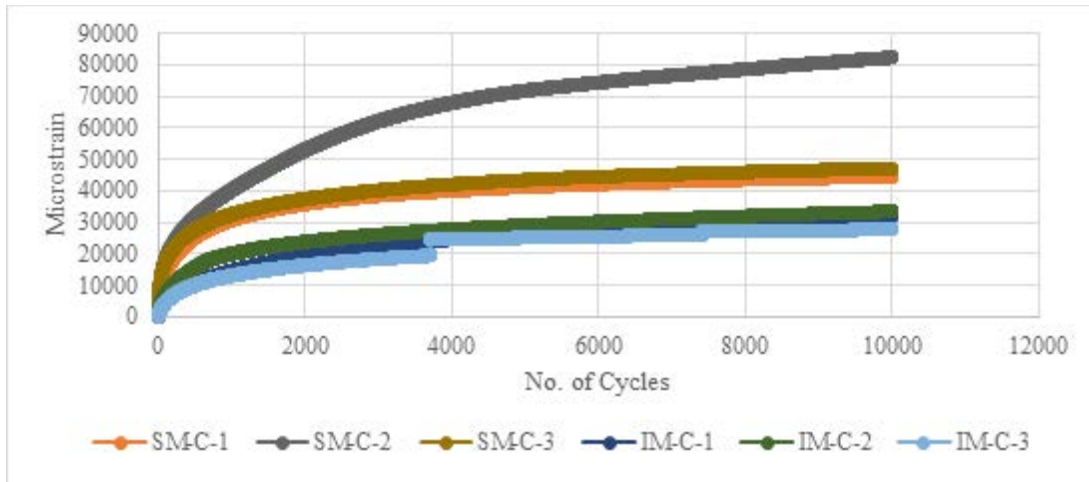
Figure 18. RLPD Results (No. of Cycles vs. Microstrain). RLPD = Repeated load permanent deformation.

The flow number represents the number of cycles required for loaded specimens to begin exhibiting tertiary creep, or flow. This condition is defined as the number of cycles that corresponds to the minimum rate of change in permanent axial strain of the specimen under a repeated load test. The test response for each mixture (three specimens each for the surface and intermediate mixture) is shown in Figure 18. Both mixtures had the maximum flow number value of 10,000, indicating excellent rutting resistance. Polymer modified binders in both mixtures contributed to the potential for increased rutting resistance.

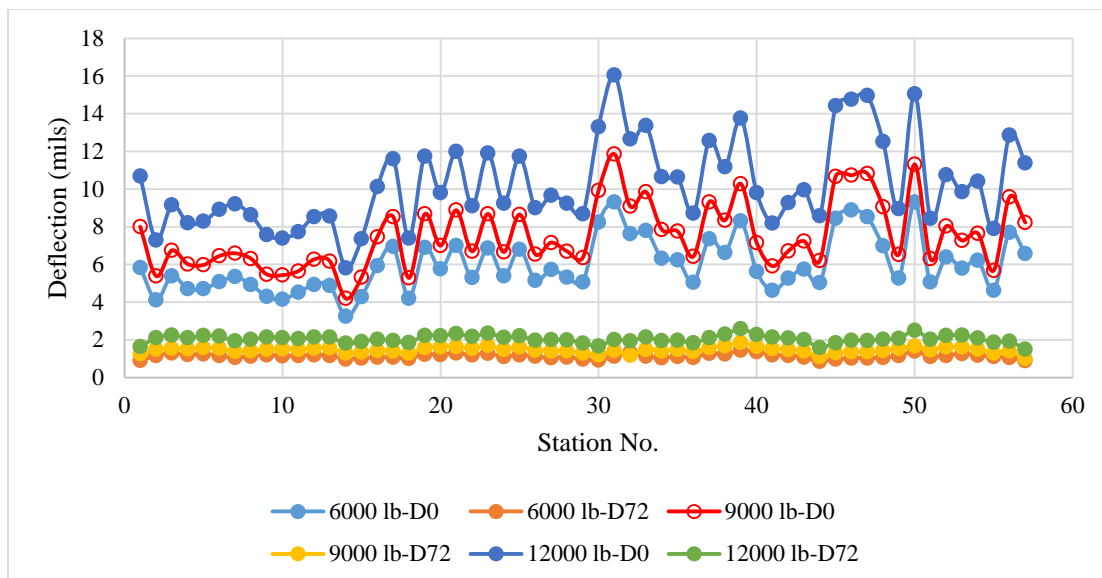
Figure 19. Deflection Results From FWD Testing at Eastbound Lane 1. FWD =falling weight deflectometer; D0 = deflection at loading plate; D72 = deflection at 72 in from loading plate.

Deflection tests were conducted using a Dynatest Series 8000 FWD and were performed by a third party consultant. Figure 19 shows the results of this testing in terms of the deflection at the loading plate (D0) and the deflection at a distance of 72 in from the loading plate (D72). The D0 parameter is an indicator of the overall structural capacity of the pavement system, whereas D72 is an indicator of the quality of the pavement foundation. The results in Figure 19 show the pavement foundation to be stiff and uniform with a deflection of approximately 2 mils. The results in Figure 19 also show the deflection of D0 to be uniform from Station 0 to approximately Station 30, with an average of approximately 7 mils, and a bit higher from approximately Station 30 to Station 58, with an average of approximately 8 mils. Given the variation, the change is not statistically significant.

Table 9 gives the average deflection and standard deviation for each lane tested. It can be seen that all of the lanes had similar deflection values for the three different load levels, indicating the same structure strength in all lanes. Earlier studies showed that these deflection values indicate a strong structural pavement (Diefenderfer et al., 2019; Pierce et al., 2017).

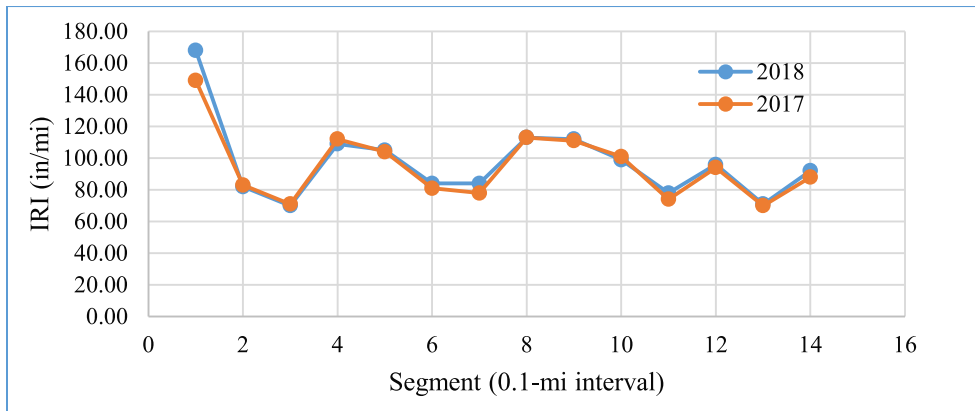
Figure A3. IRI Data for SR 406 (Eastbound). IRI = International Roughness Index.

Early-age distress data were extracted from VDOT's PMS and are shown in Table 14. There was no observed cracking in the pavement. Table 14 shows an increase in roughness and rutting in 2017 and 2018, but the difference is within the random variability encountered with year-to-year testing. More detailed data to include each 0.1-mi segment are shown in the Appendix. Additional years of data are required to determine if a trend is evident.

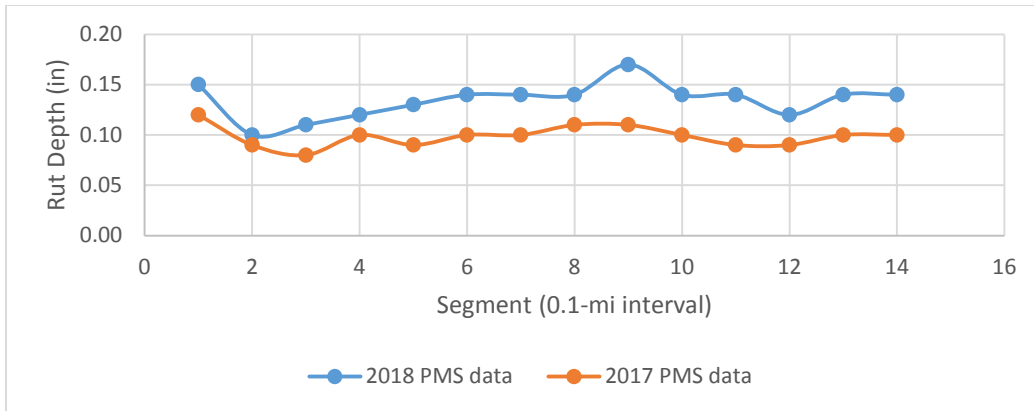
Figure A5. Rut Data for SR 406 (Eastbound). PMS = Pavement Management System.

- Pavement ME analysis showed a design life of 18 to 19 years for the pavement. Analysis also predicted that the rutting distress limit (0.26 in) will be reached in 5 to 6 years, which is sooner than expected since polymer modified binders were used in surface and intermediate mixtures. Initial predicted rutting and observed rutting PMS were similar. However, more data are needed to confirm the trend.
