Ten-Year Review of Monitoring System on I-35W Saint Anthony Falls Bridge

1. Report No. MN 2020-19	2.	3. Recipients Accession No.
4. Title and Subtitle Ten-Year Review of Monitoring System on I-35W Saint Anthony Falls Bridge		5. Report Date June 2020

TEN-YEAR REVIEW OF MONITORING SYSTEM ON I-35W SAINT ANTHONY FALLS BRIDGE

FINAL REPORT

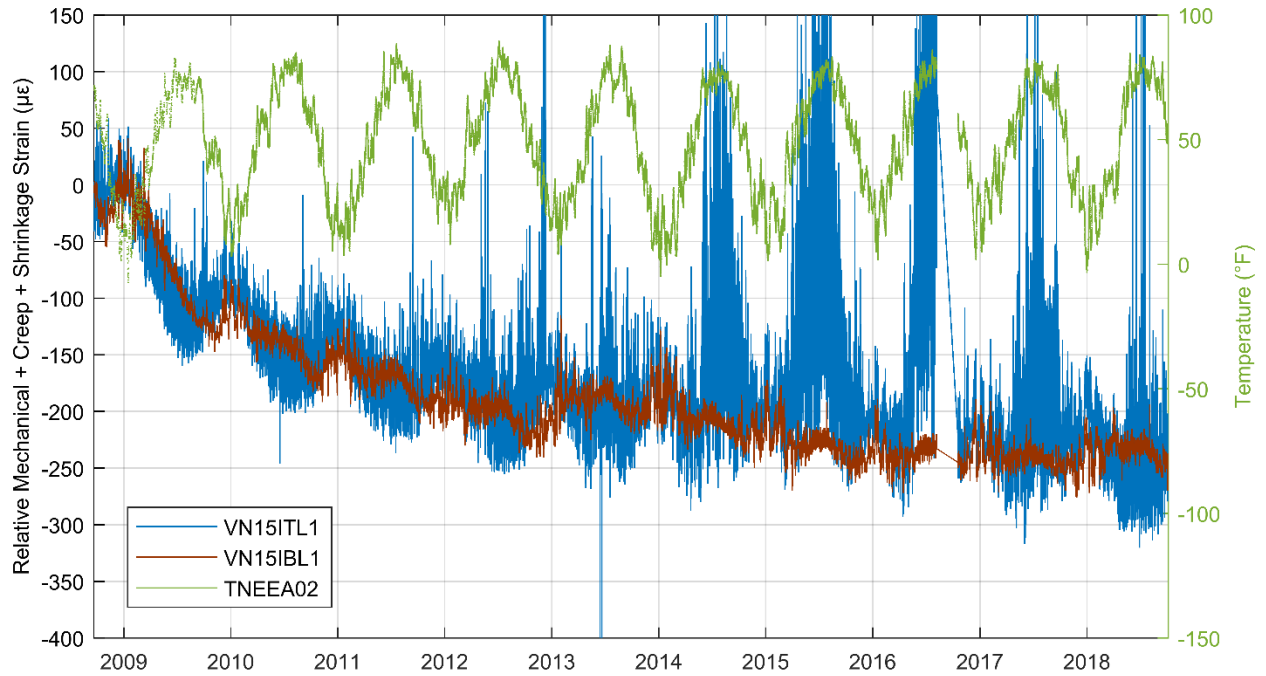
Figure 4.15: Relative mechanical strain plus creep and shrinkage strains for gages VN15ITL1 (blue; longitudinal gage in top flange at northbound Location 15) and VN15IBL1 (red; longitudinal gage in bottom flange at northbound Location 15).

Strain data from sensor VN15ITL1 (Figure 4.15, longitudinal gage in top flange at northbound Location 15) appears to contain erroneous readings from October 2012 to present. Strain readings from sensors VN09ITL1, VS15IBL1, VS07EBL1, and VS03EBT2 also appear to contain previously undocumented erroneous strain readings. None of the superstructure vibrating wire strain gages, including those not plotted in Figures 4.1 through 4.18, showed any clear indications of cracking or other damage.

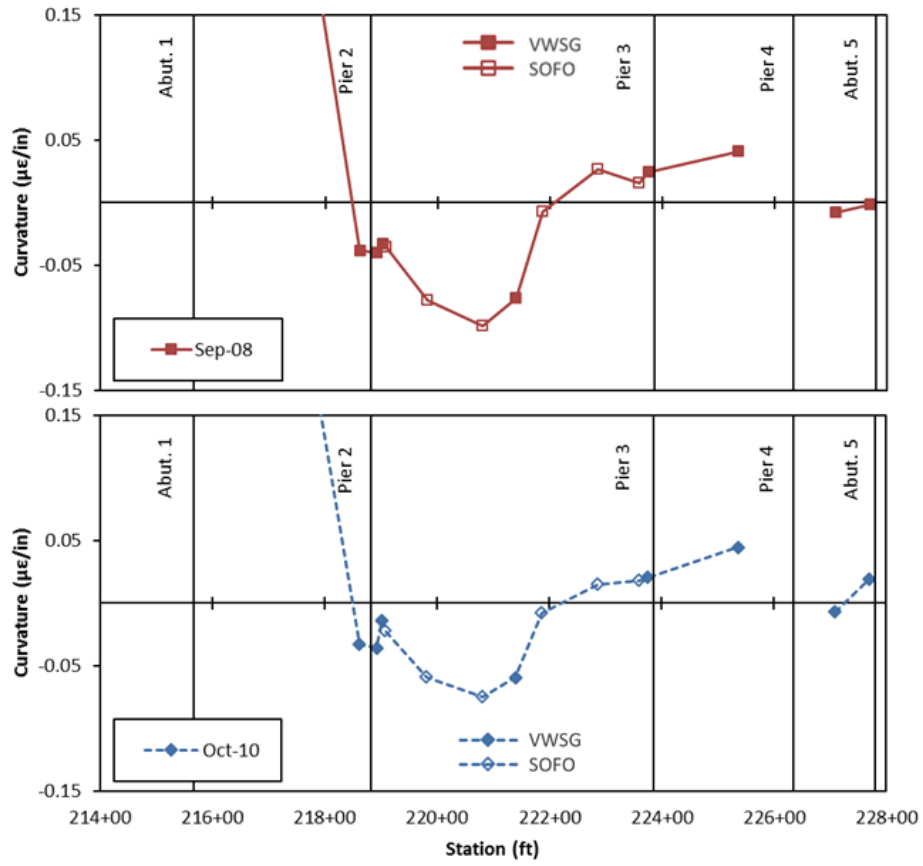
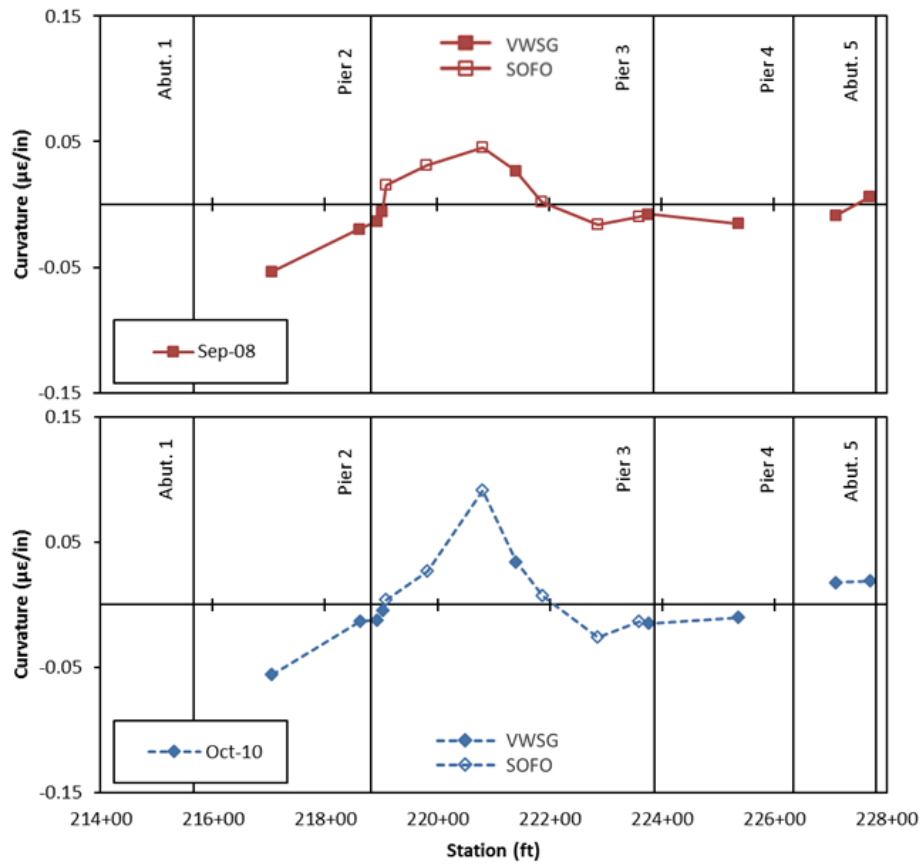
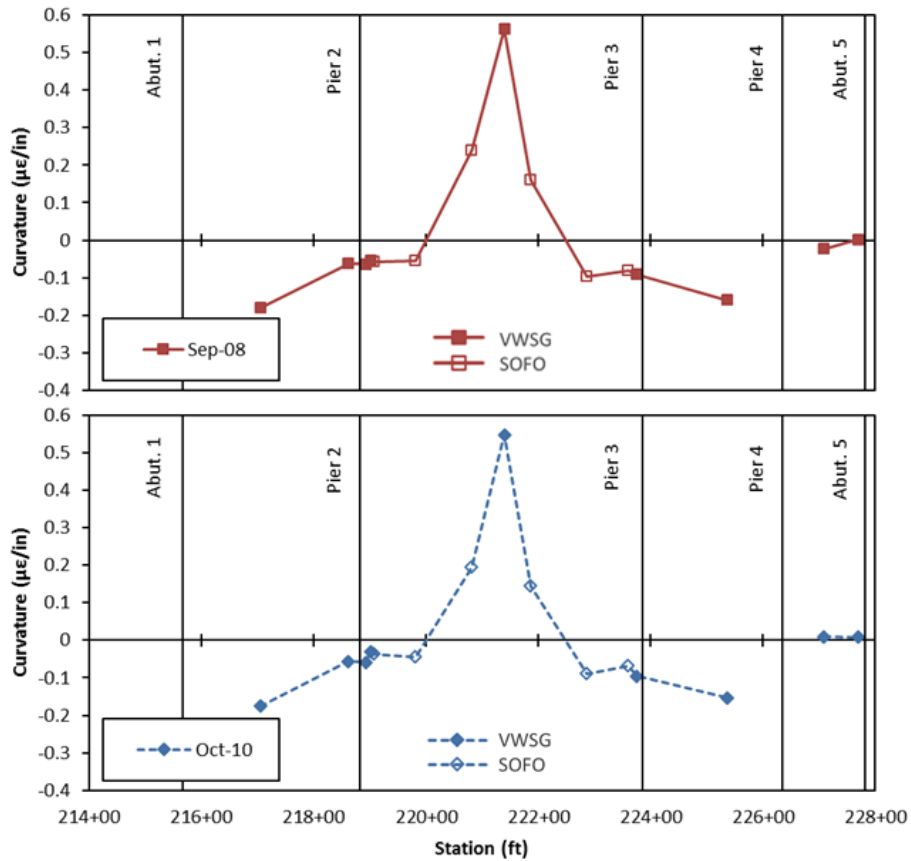
Truck test data was previously analyzed by French et al. (2012). The curvature plots from three truck tests (STI3SB, STI6SB, and STI7SB) are shown in Figures 4.25 through 4.27. Note that the vertical axis scale varies for these figures; the intent is to compare curvatures calculated using vibrating wire strain gages and SOFO fiber optic strain gages. Curvatures measured using the SOFO fiber optic sensors are shown with unfilled symbols, whereas locations with VWSGs are presented as filled symbols. Overall, the southbound curvature plots from the October 2010 tests were found to be nearly identical to those from the September 2008 tests, with the exception of test STI6SB (eight trucks across the width of the bridge at Location 6). The SOFO sensors near the midspan of Span 2 gave much higher strains than anticipated during the October 2010 STI6SB test, though curvature magnitudes recorded during STI6SB

tests were far less than during test STI7SB (eight trucks across the width of the bridge at Location 7, Figure 4.27). No malfunctions were detected in the gages at that time, and none of the three values that were averaged to obtain these results appeared to be anomalous. The measured response of the structure due to thermal gradients both before and after the October 2010 truck tests did not exhibit any notable change in the structural response, so it was believed that the differences noted here were not damage related. As mentioned in the previous report by French et al. (2012), the cause for this discrepancy was uncertain.

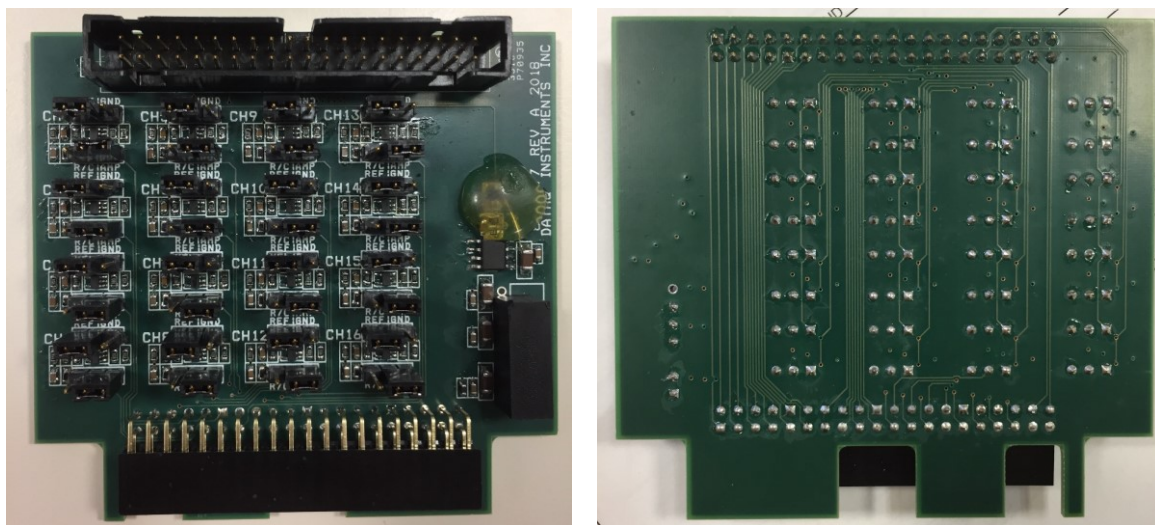
Figure A.1: Prototype filter board installed on acquisition channels 17-32 of dynamic system Node 6.

Because the dynamic data collection nodes are wired in series, if the connection in any one node fails, then all nodes down the chain will also fail. For example, if communication is lost to Node 4, Nodes 5 through 8 will also be down. This made troubleshooting difficult when there was a system failure and was a task that typically required at least two people: one inside the bridge and one on the server (accessed either remotely or at the server shed). Finding the location of the faulty node was most efficiently achieved using two spare functional boards.
