Federal Highway Administration
Every Day Counts
Innovation Initiative

Safety Edge$_{\text{SM}}$
PCC Demonstration Project
County Highway E34
Fairview, Iowa

Field Report
June 10, 2011

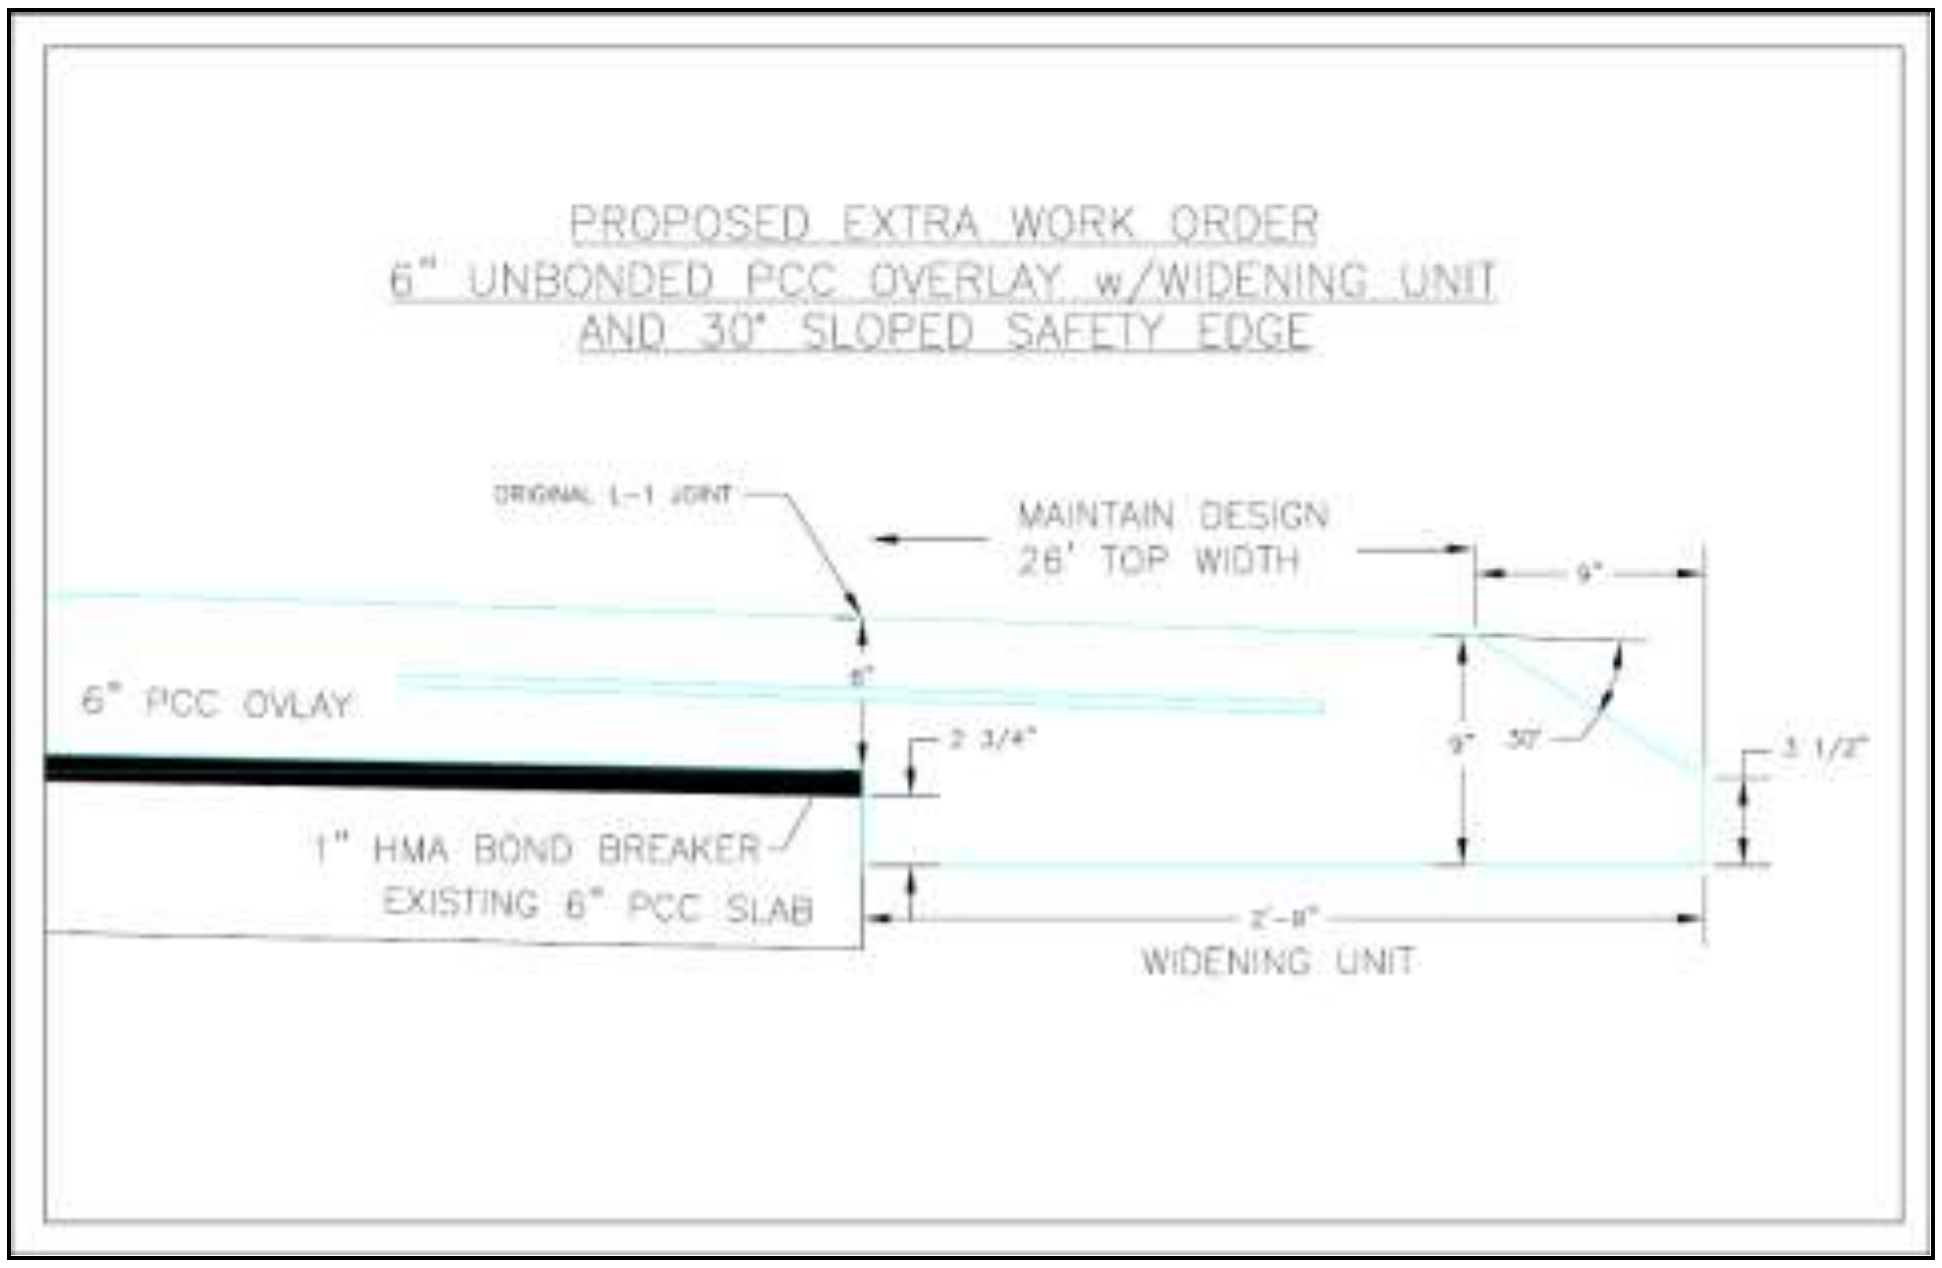
Figure 3. Cross section of concrete pavement overlay.

Figure 2 presents a view of a completed section of the roadway. The construction included a 6 inch overlay of unbonded PCC over an existing 6 inch PCC pavement. The overlay included a tied 9-inch thick shoulder 2.75 ft wide, with a 30° sloped Safety Edge$_{SM}$ in both the westbound and eastbound direction. A schematic of the cross section of the pavement is shown in Figure 3.

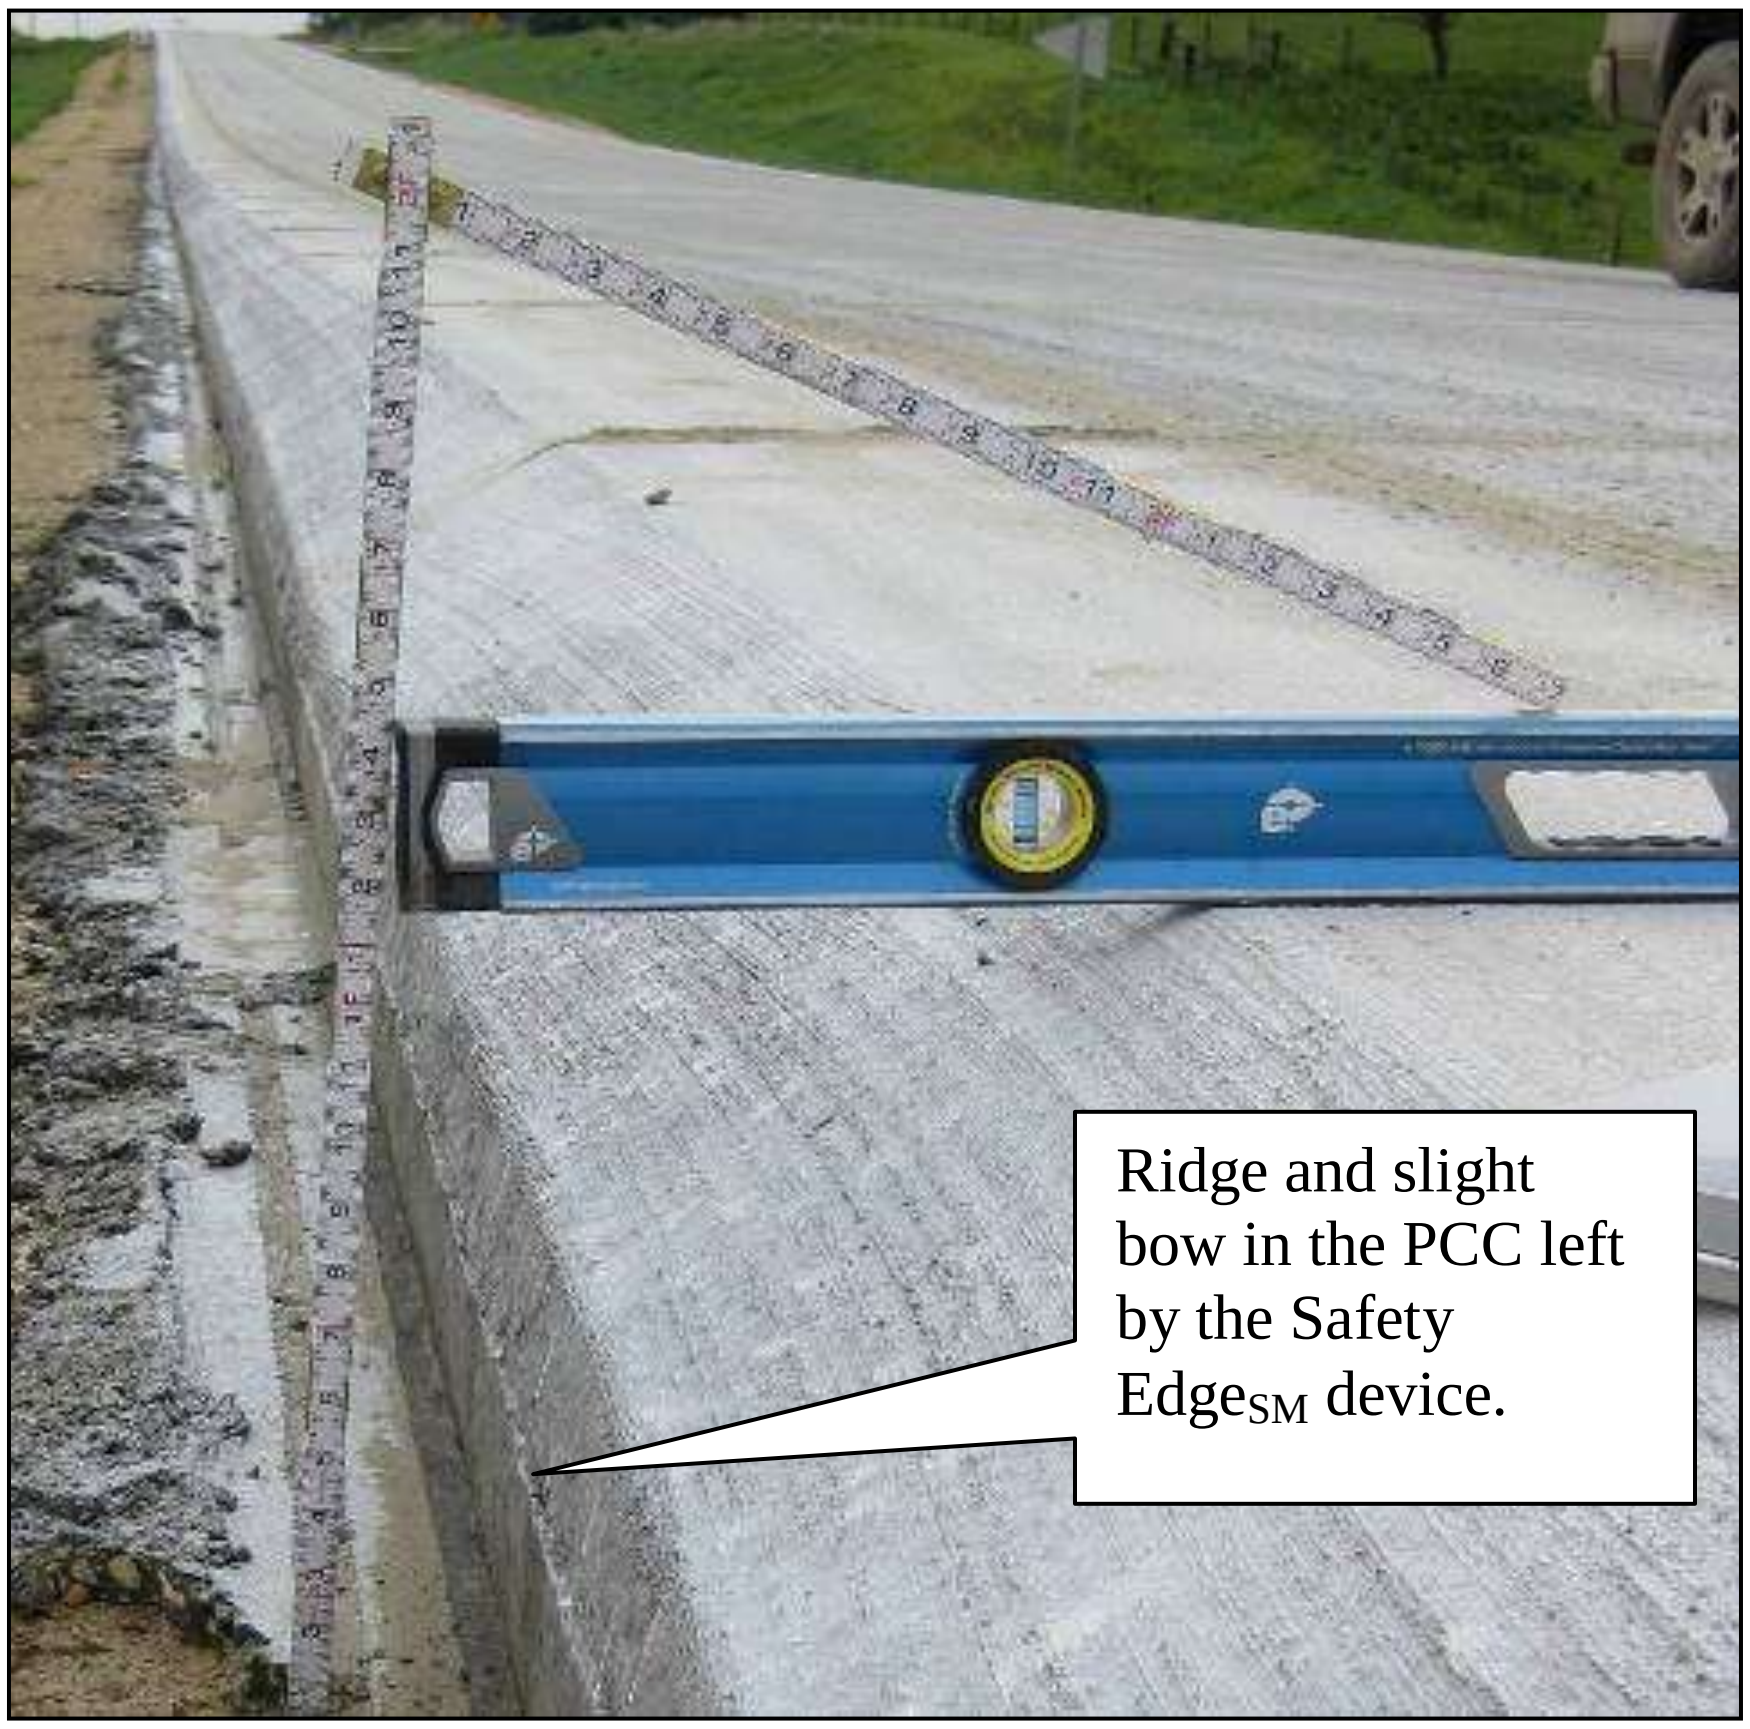
Figure 5. Slope face showing ridge and bow.

Some deviation in the flatness of the slope face was observed. The flatness was measured by placing a straightedge on the face as shown in Figure 4. The face was found to be concave in some cases and convex in other cases. This condition may be caused by either flexing of the device or issues during finishing. The deviation from flat is generally considered minor and is not expected to have a significant impact on the performance of the Safety Edge$_{SM}$.

Similarly, the vertical edge face of the pavement was found to have defects from forming. The Safety Edge$_{SM}$ device did not always seal tightly against the end gate, leaving a ridge in the face. Figure 5, shows an example of this. The vertical face is bowed and the marks created by the end of the device and the end gate can be clearly observed.

Ridge and slight bow in the PCC left by the Safety Edge$_{SM}$ device.

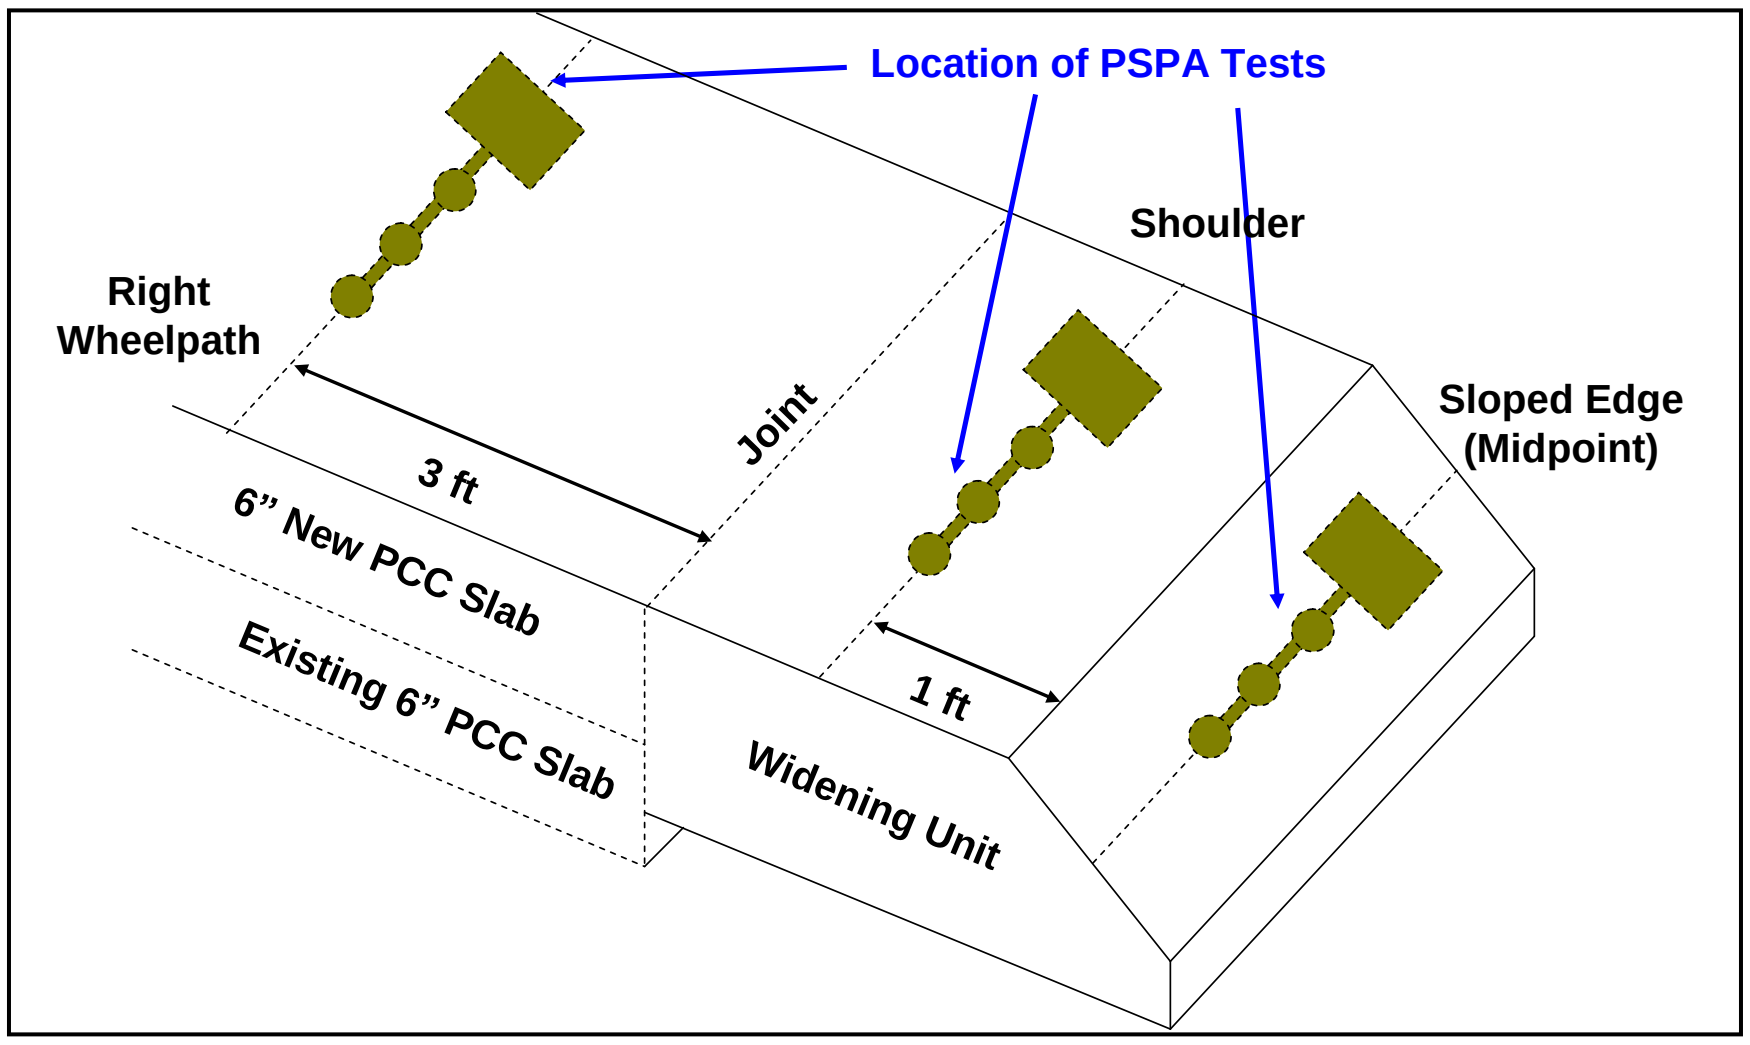
Figure 6. Location of PSPA test points.

The PSPA was utilized to provide a measure of quality by determining the variation in modulus with depth of the concrete in the field. Details of this nondestructive test procedure are explained in Appendix A. PSPA testing was conducted on the sloped edge, at 1 ft from the edge, and on the right wheelpath as illustrated in Figure 6. This was done to compare the quality of the concrete within the edge and at points gradually moving towards the interior of the pavement.

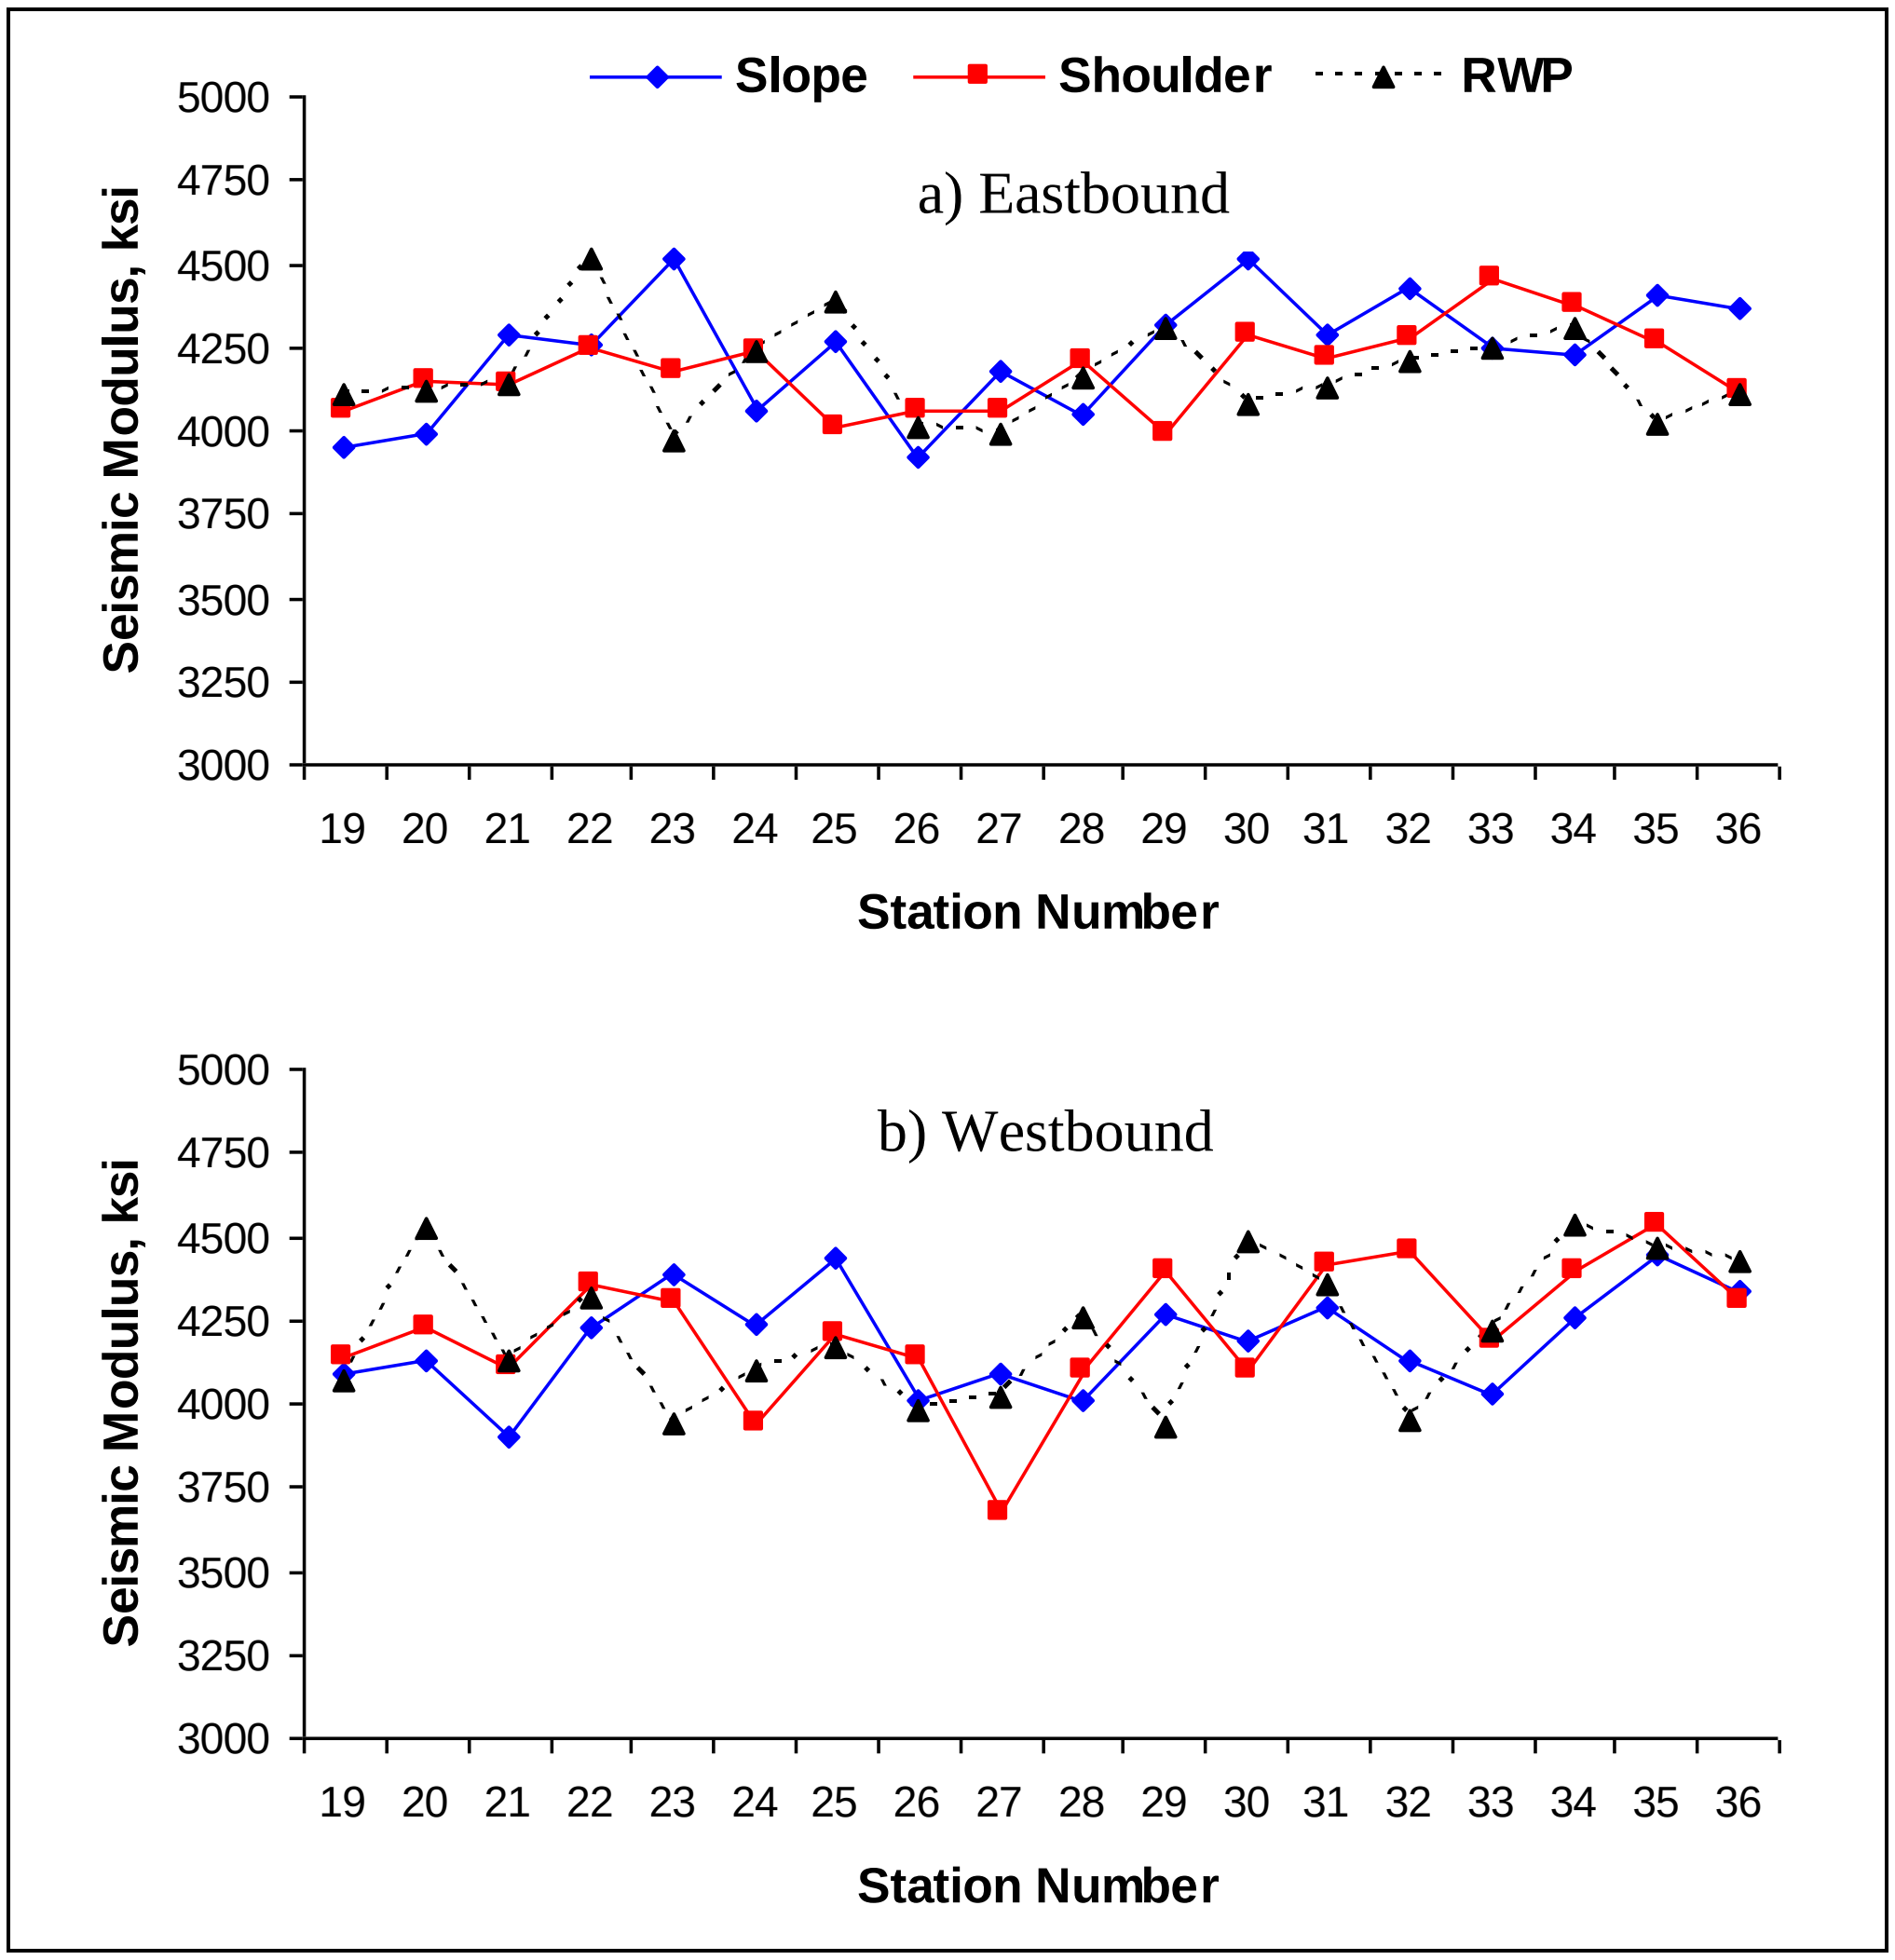
Figure 7. Variations of the moduli for the sections tested on Day 1.

Moduli for the 44 stations investigated in each direction and representative statistics are summarized in Table 1. The full set of data are presented in Appendix A. The section that was paved on Day 1 exhibited an average modulus of 4,200 k/in^2, slightly higher than the section constructed on Day 2 (4,050 ksi). Coefficients of variation (COV) of the modulus for all stations were small and between 3 and 6 percent. Figure 7 and Figure 8 graphically present the variation of moduli at the three lateral points tested along the project.

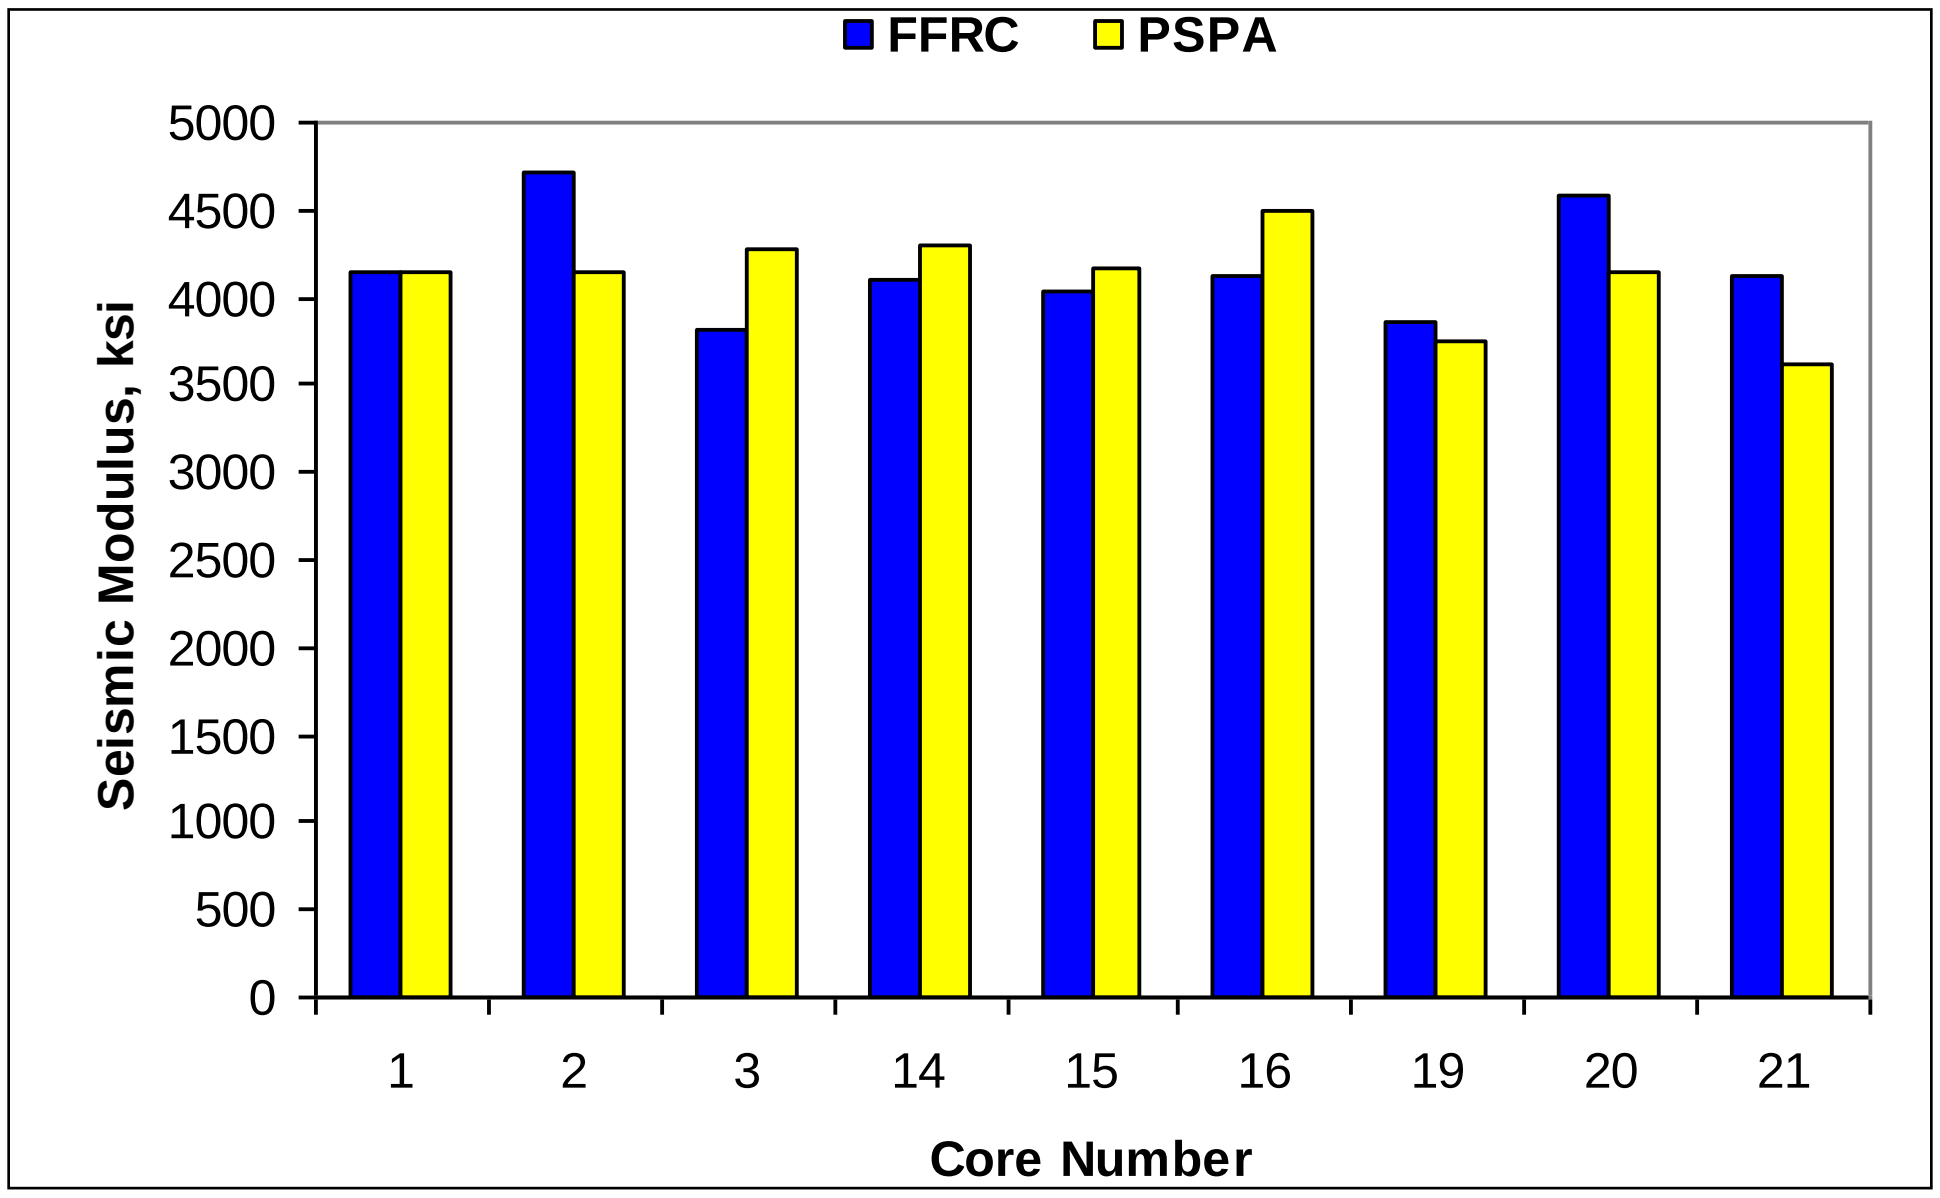
Figure 10. Comparison of the moduli obtained with PSPA and FFRC.

The seismic moduli of the cores were determined by measuring the resonant frequency of vibration (standing waves) according to the FFRC test for comparison with the moduli measured in the field with the PSPA. Details of the FFRC test procedure are included in Appendix A. At the time of FFRC testing, the specimens had cured for approximately seven days. The comparisons of the lab and field moduli for the nine cores are presented in Figure 10. The results of the PSPA and FFRC testing were similar with the average difference of 7 percent and a range of 1 to 13 percent.

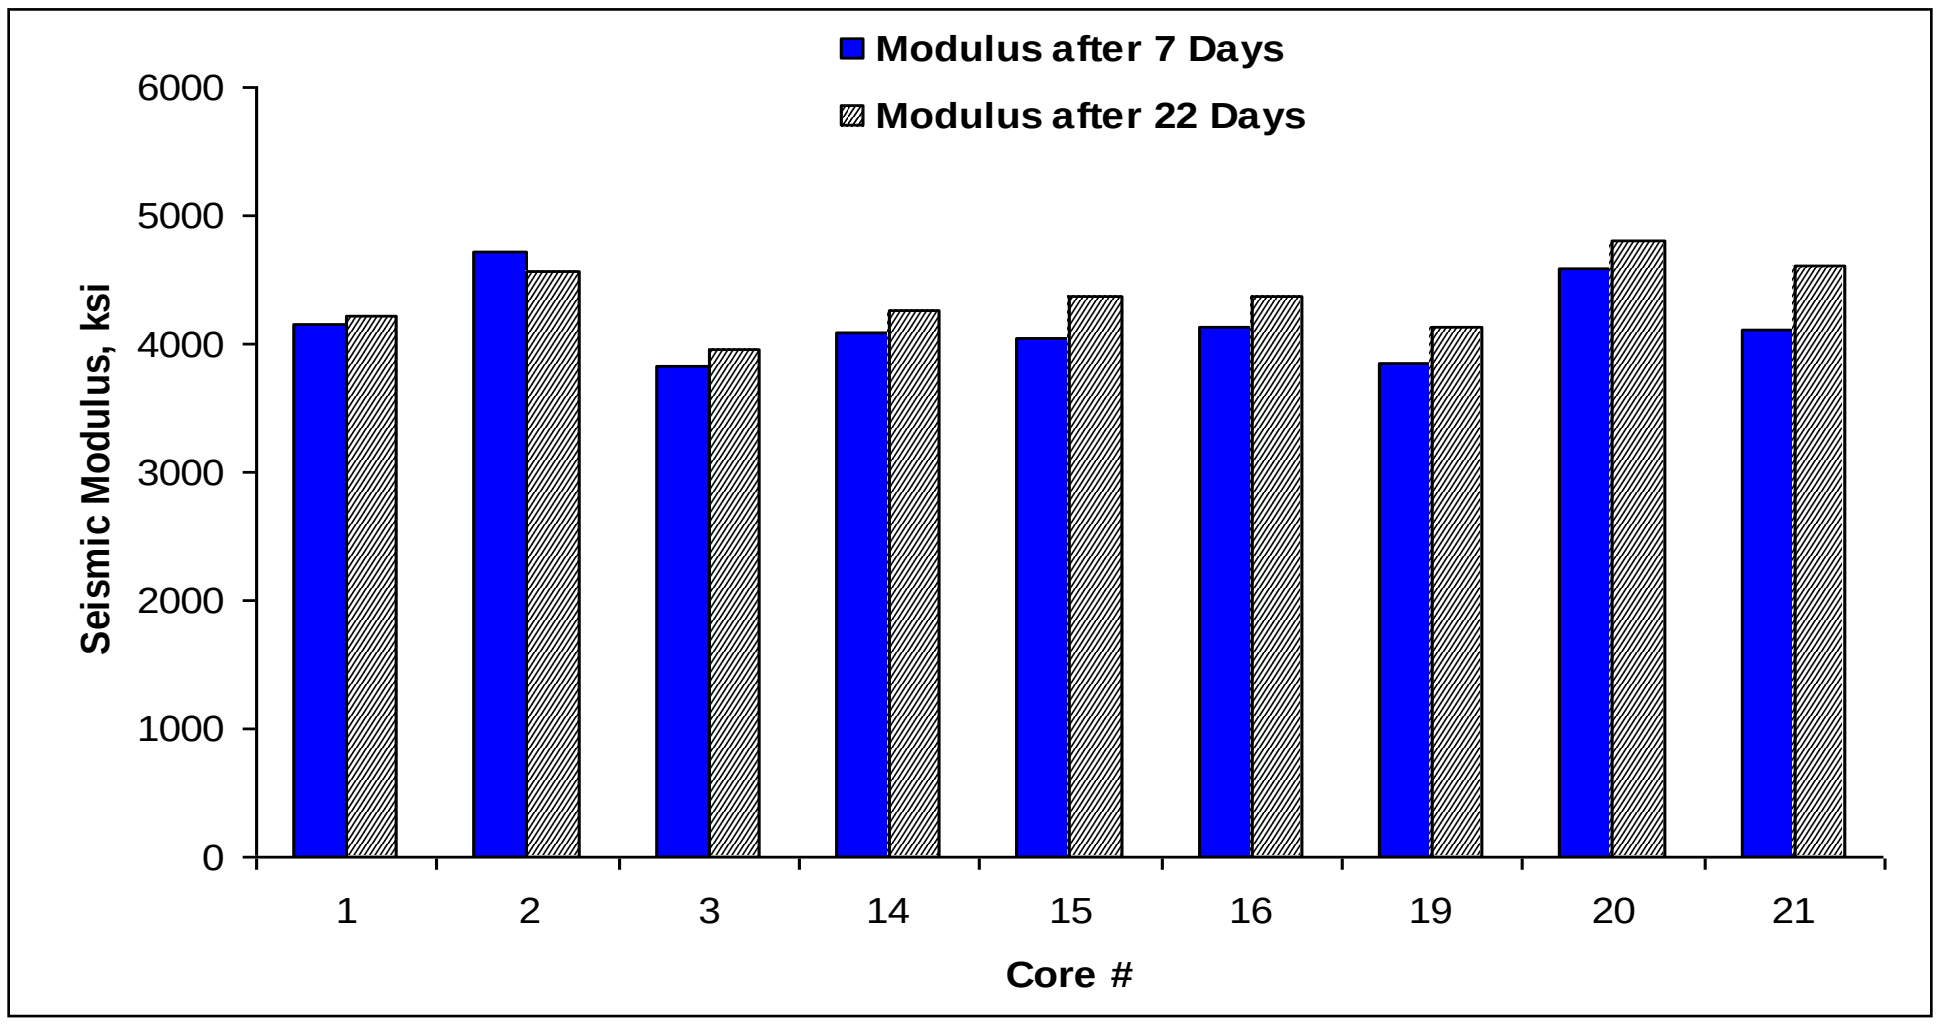
Figure 11. Comparison of the FFRC Moduli.

Before conducting strength tests, the cores longer than 8 inches were further trimmed to 8 inches and all cores were tested again with the FFRC. The comparisons of the FFRC moduli at ages of 7 and 22 days are shown in Figure 11. On average, the moduli increased by 5 percent in that time frame.

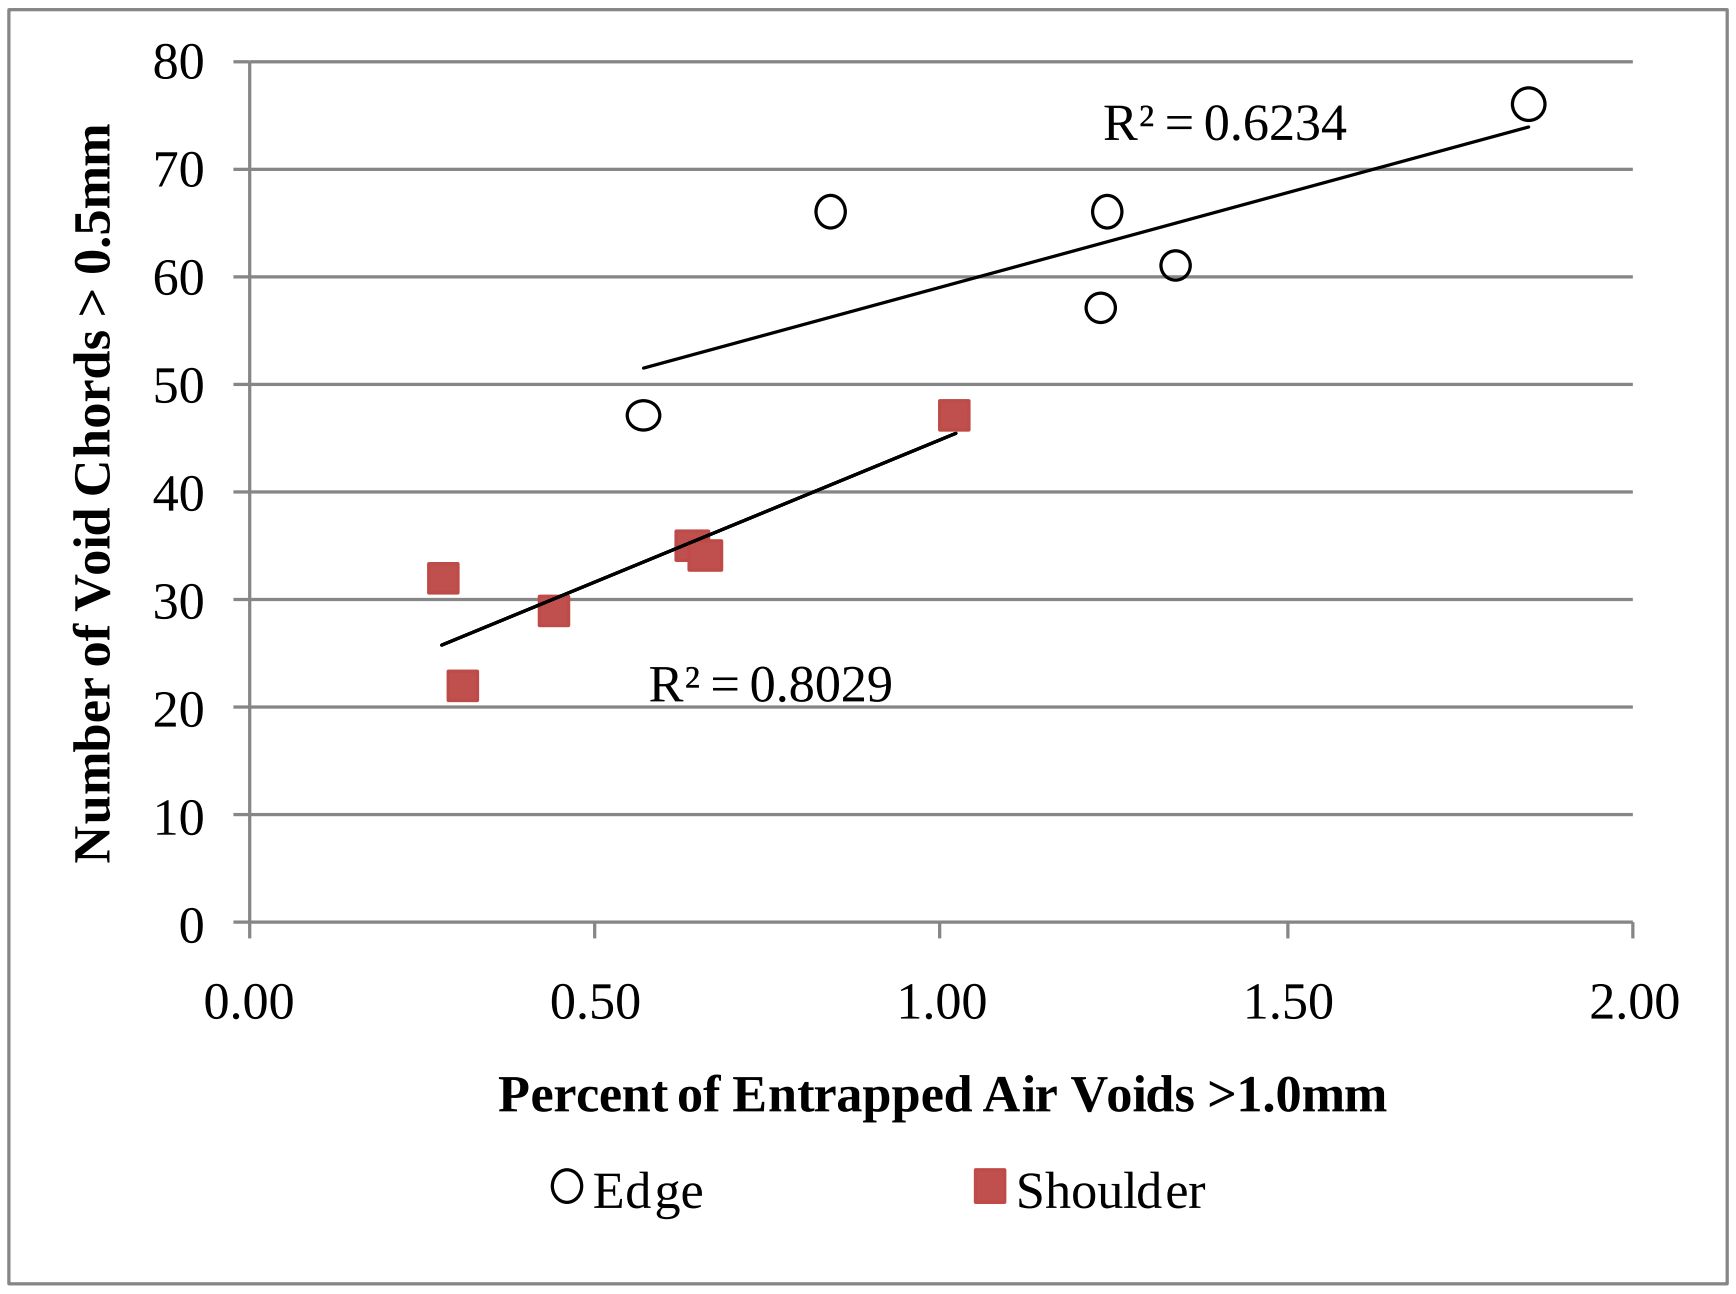
Figure 12. Comparison of the percentage of entrapped air and the number of void chords greater than 0.5mm.

Generally, laboratory testing revealed that the air void systems in the edge cores had both a greater percentage of entrapped air voids greater than 1.0 mm and more air void chords greater than 0.5mm in comparison to the shoulder cores (Figure 12).

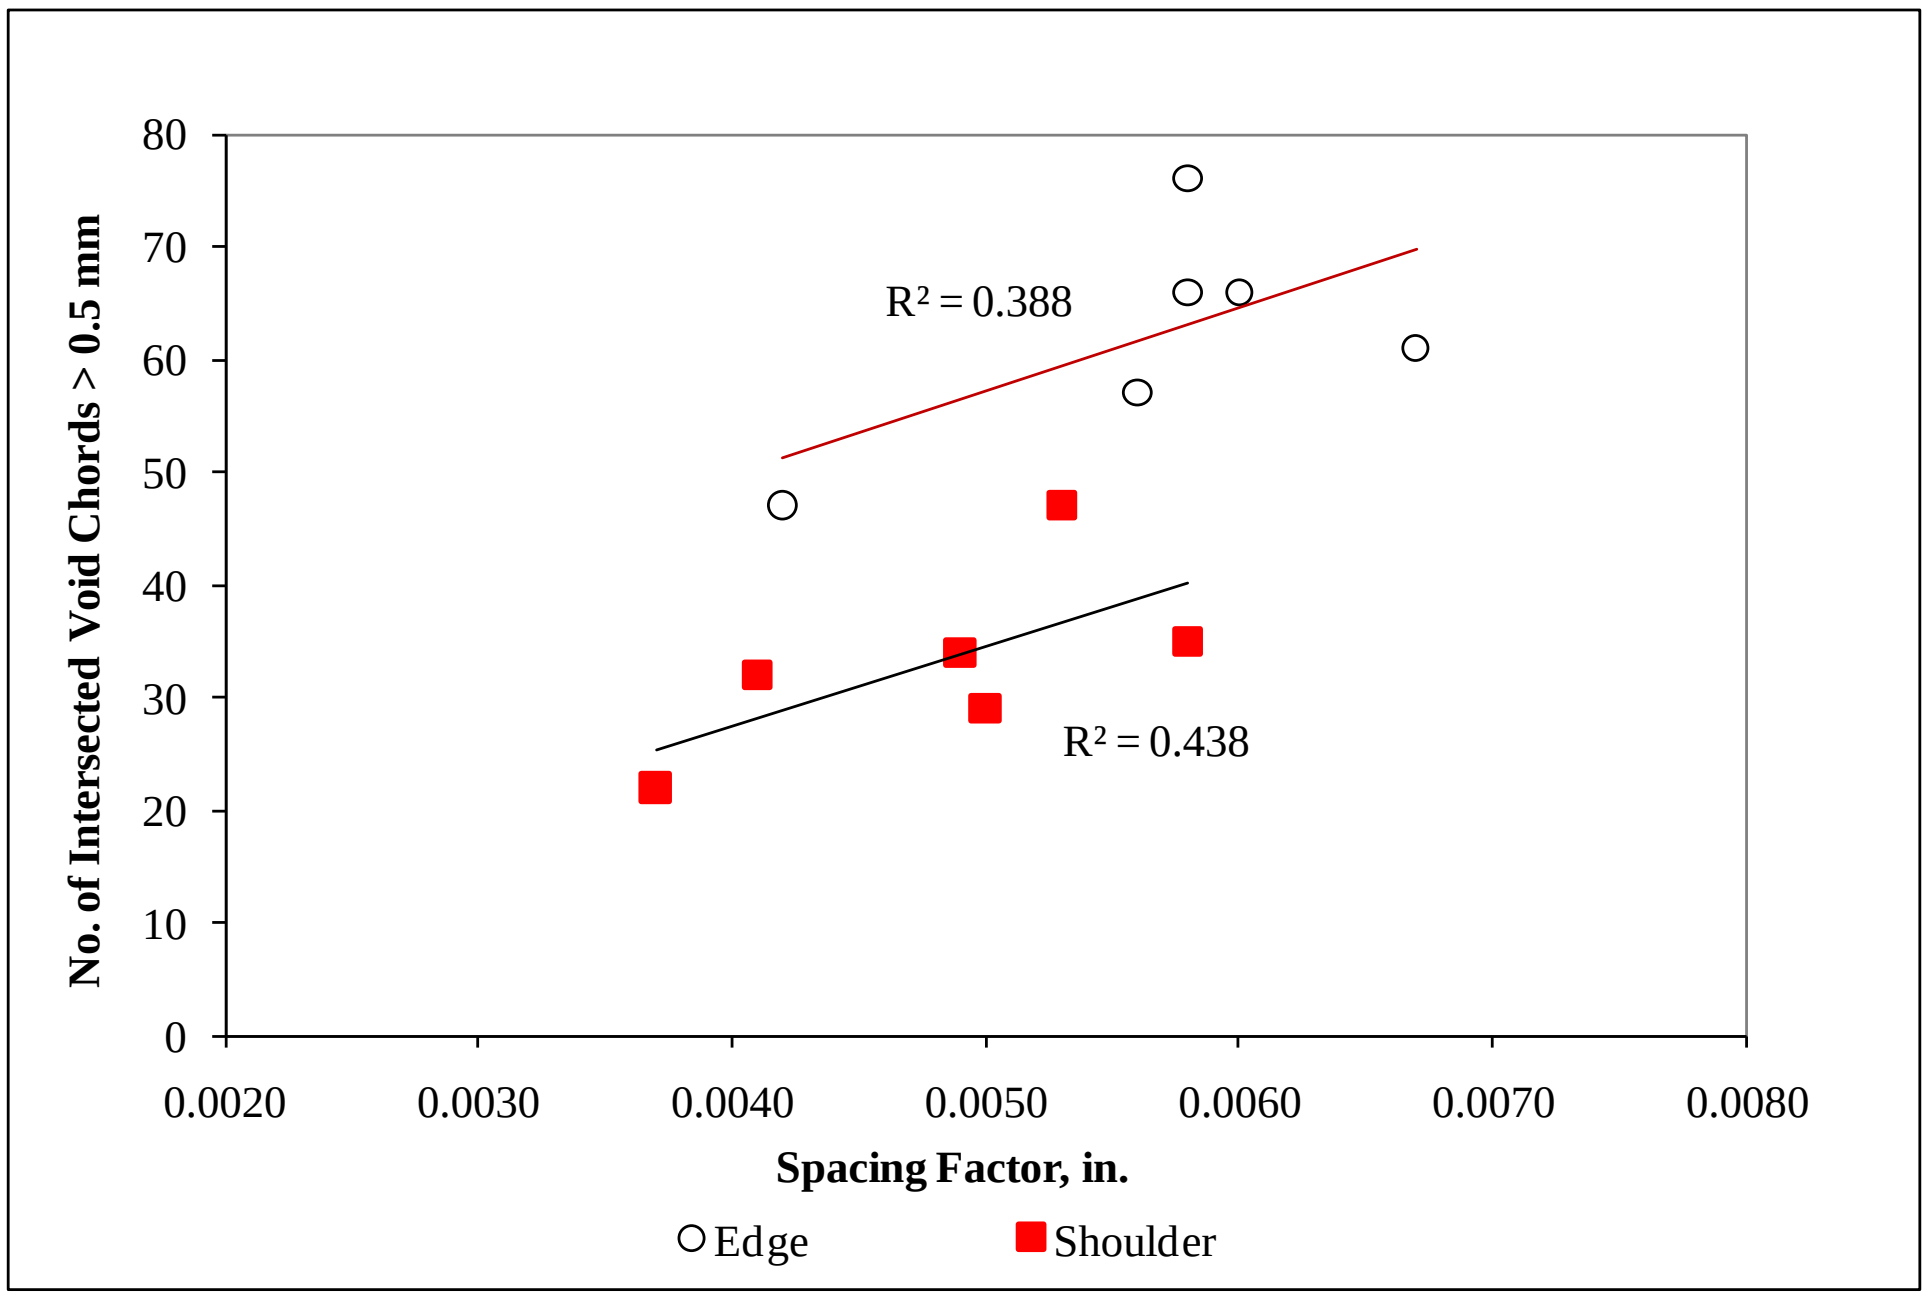
Figure 13. Comparison of the number of large air voids (> 0.5 mm) and the spacing factors.

The only consistent difference found in the pairs of cores is that the Safety Edge$_{SM}$ cores had a somewhat greater amount of entrapped air voids in regards to the spacing factors as compared to the shoulder cores (Figure 13). This observation appears in both the amount of entrapped air voids as determined by both the linear traverse method (where the length of all traverse chord across air voids was observed) and the point count method.

On average, the edge cores had a lower unit weight, a higher air content, a slightly higher spacing factor, and more air voids over 0.5mm. Despite the differences, however, the spacing factors and other parameters were reasonable and the concrete at the edge as well as from the shoulder appears to be durable. Table 6 summarizes these results.
