Federal Highway Administration
Every Day Counts
Innovation Initiative

Safety Edge$_{\text{SM}}$
PCC Demonstration Project
County Highway E34
Fairview, Iowa

Field Report
June 10, 2011

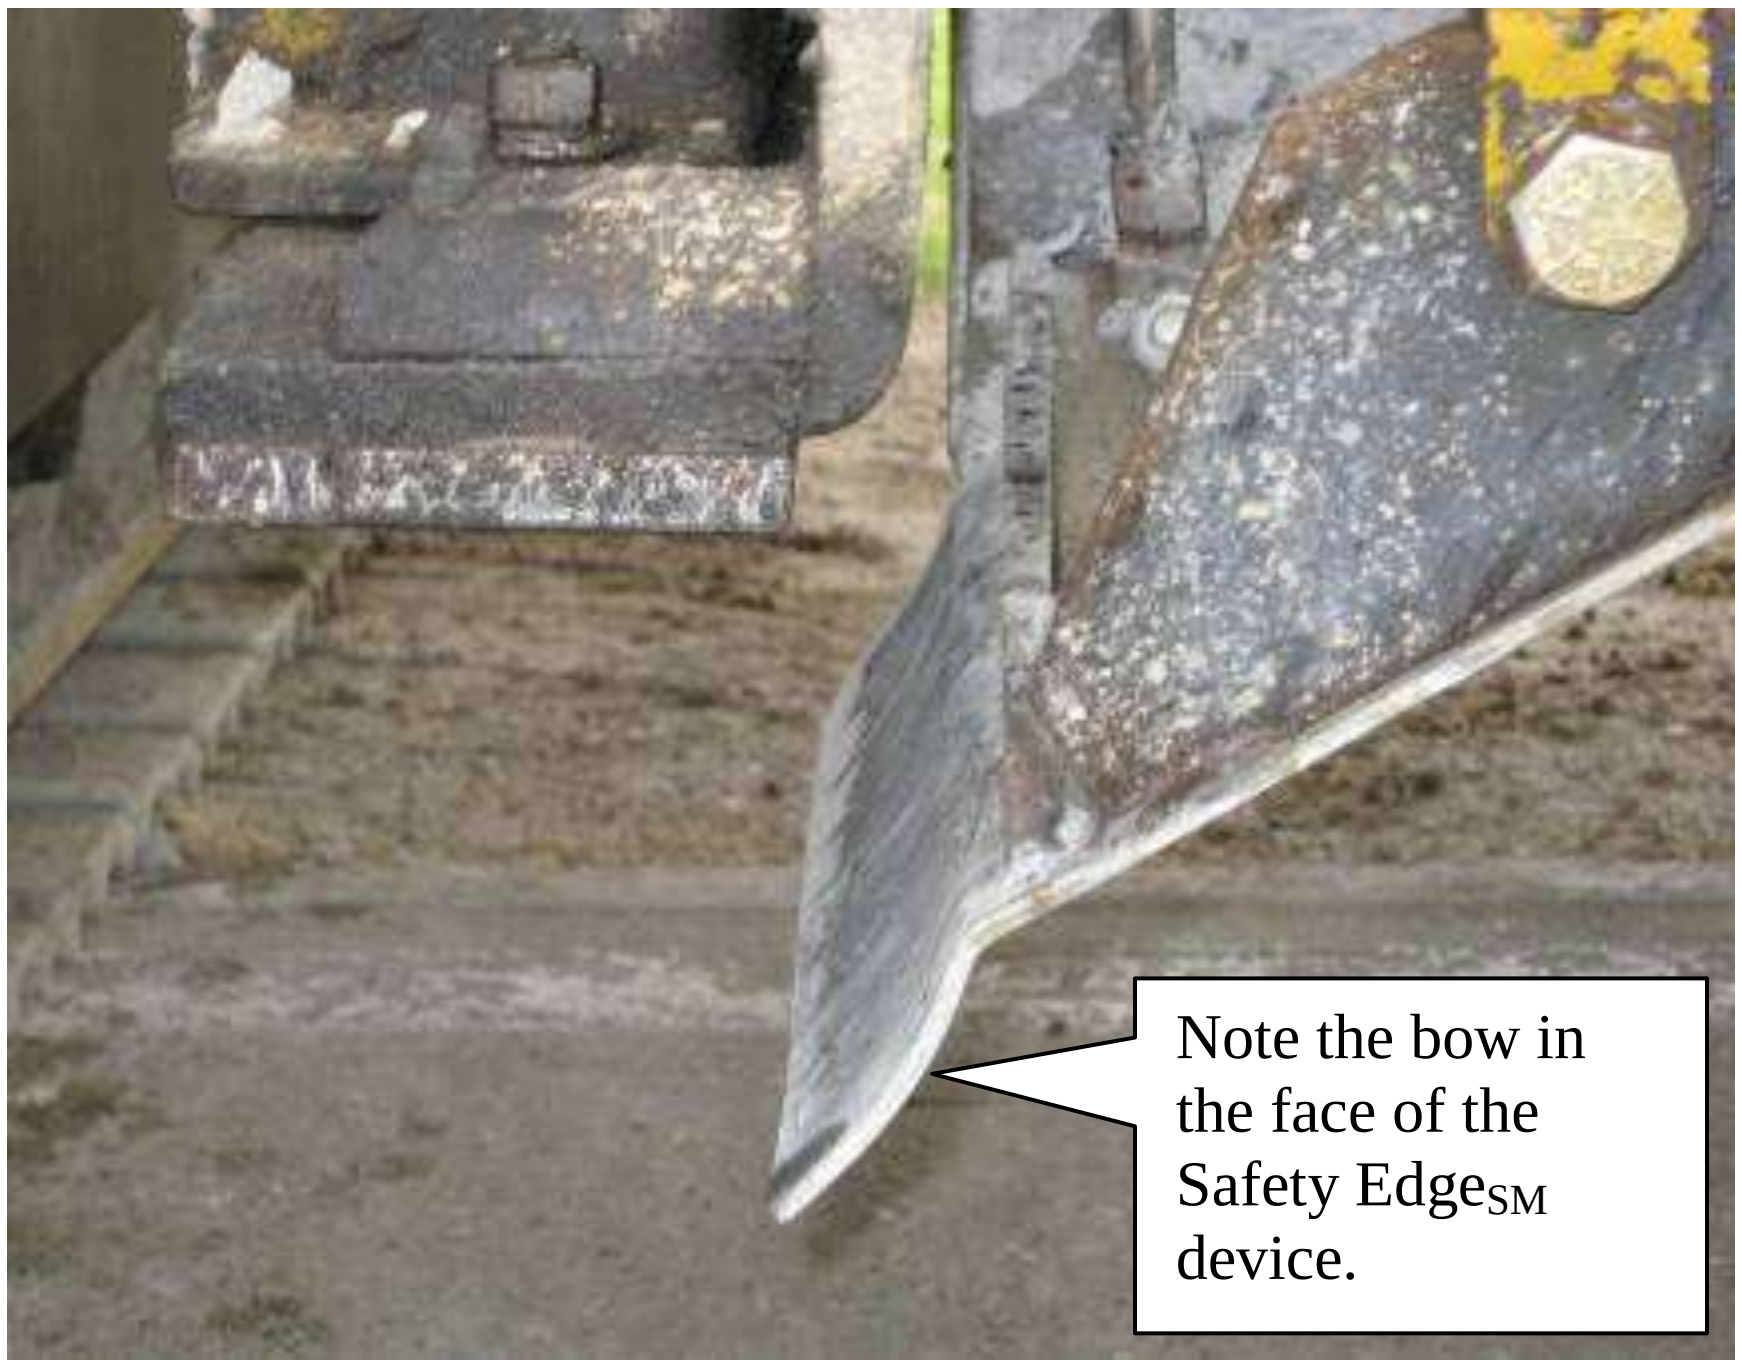
Figure 15. Viewed from the rear of paver showing the bend in the Safety Edge$_{SM}$ device.

The Safety Edge$_{SM}$ device can be seen in Figure 14. The device in Figure 15 is shown welded to the back of the pan and sits closely to the end gate. It is evident that the device has been bent. The contractor indicated the device was bent during transport operations. This bend in the device can be seen in the pavement as a bow in the exposed vertical face of the pavement edge.
