LONG-TERM PERFORMANCE EVALUATION OF NUDECK IN KEARNEY EAST BYPASS

Nebraska Department of Transportation (NDOT)

Project No. SPR-P1(15) M026

FINAL REPORT

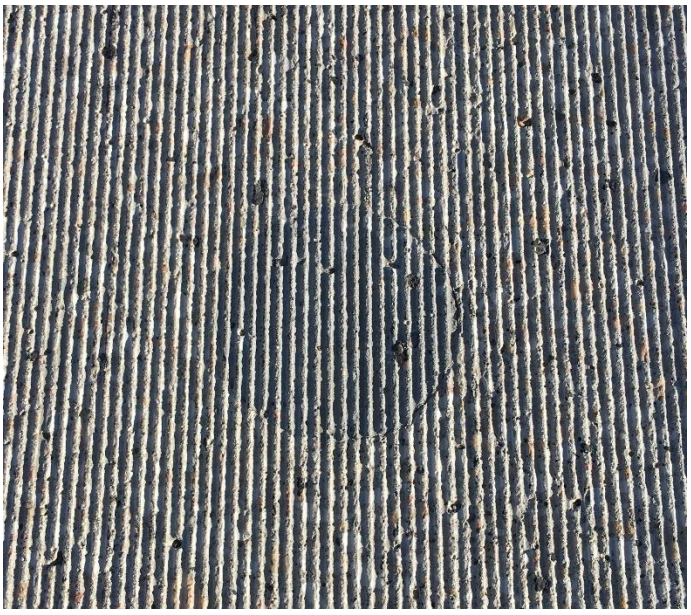
FIGURE 2.8 Grouting hole with fine pour line at its circumference

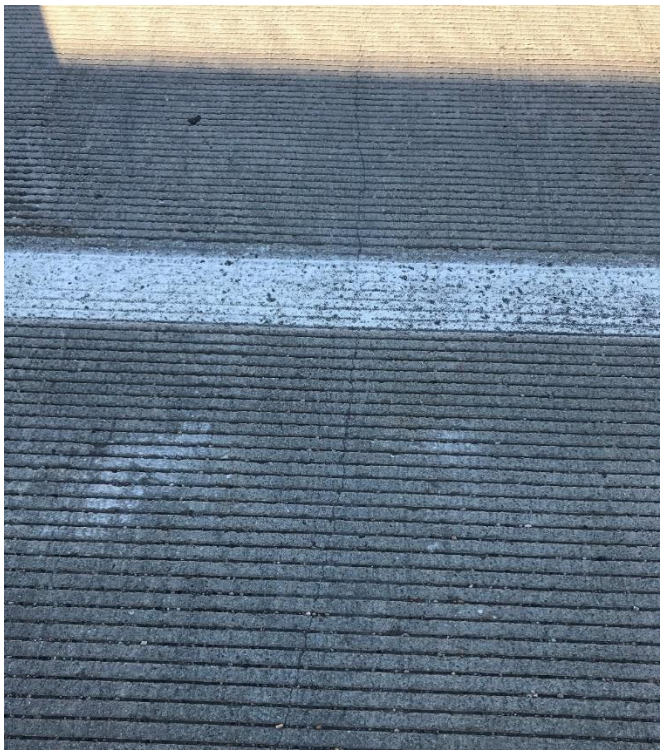
This visit was conducted almost two years after the bridge was opened to traffic (more than three years after construction). Figures 2.20, and 2.21 show the cast-in-place deck cracking at the negative moment region, which is more noticeable than those in the previous visual inspection. Figures 2.22 shows the pier section transverse joint, which is in the same condition observed in earlier inspections. This means there is no increase in the width of the pour line or any signs of progressive deterioration. Figure 2.23 shows the PT anchorage blocks on the south and north ends of the precast deck with signs of progressive deterioration at the wedge-like corner of the blocks, while Figure 2.24 shows similar type of distress at one of the grouting holes. These isolated incidents could be attributed to the effect of freeze-thaw cycles on such unreinforced portions of concrete. It could also be aggravated during the snow removal operations.

FIGURE 2.21 One of the transverse cracks extending the full width of CIP deck

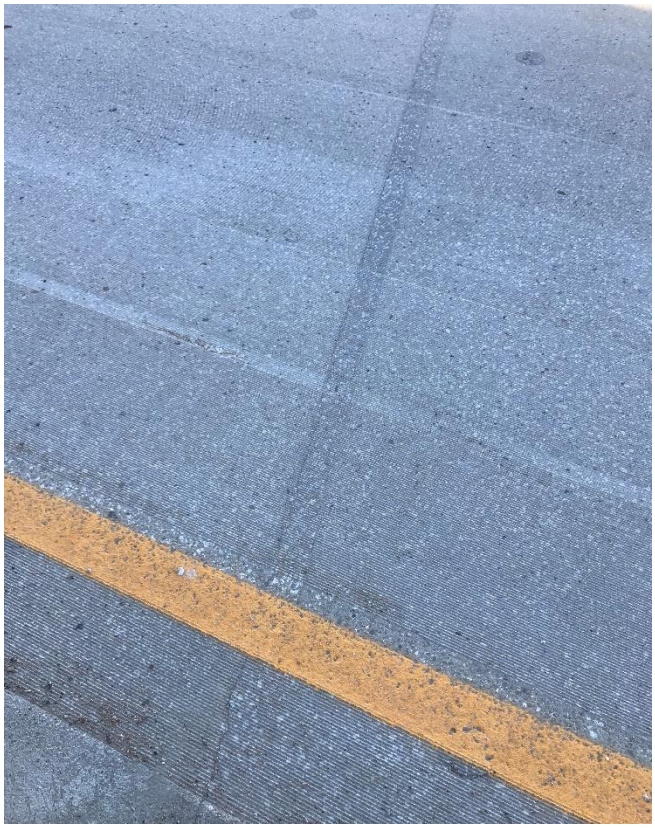
FIGURE 2.22 Pier section transverse joint in precast deck

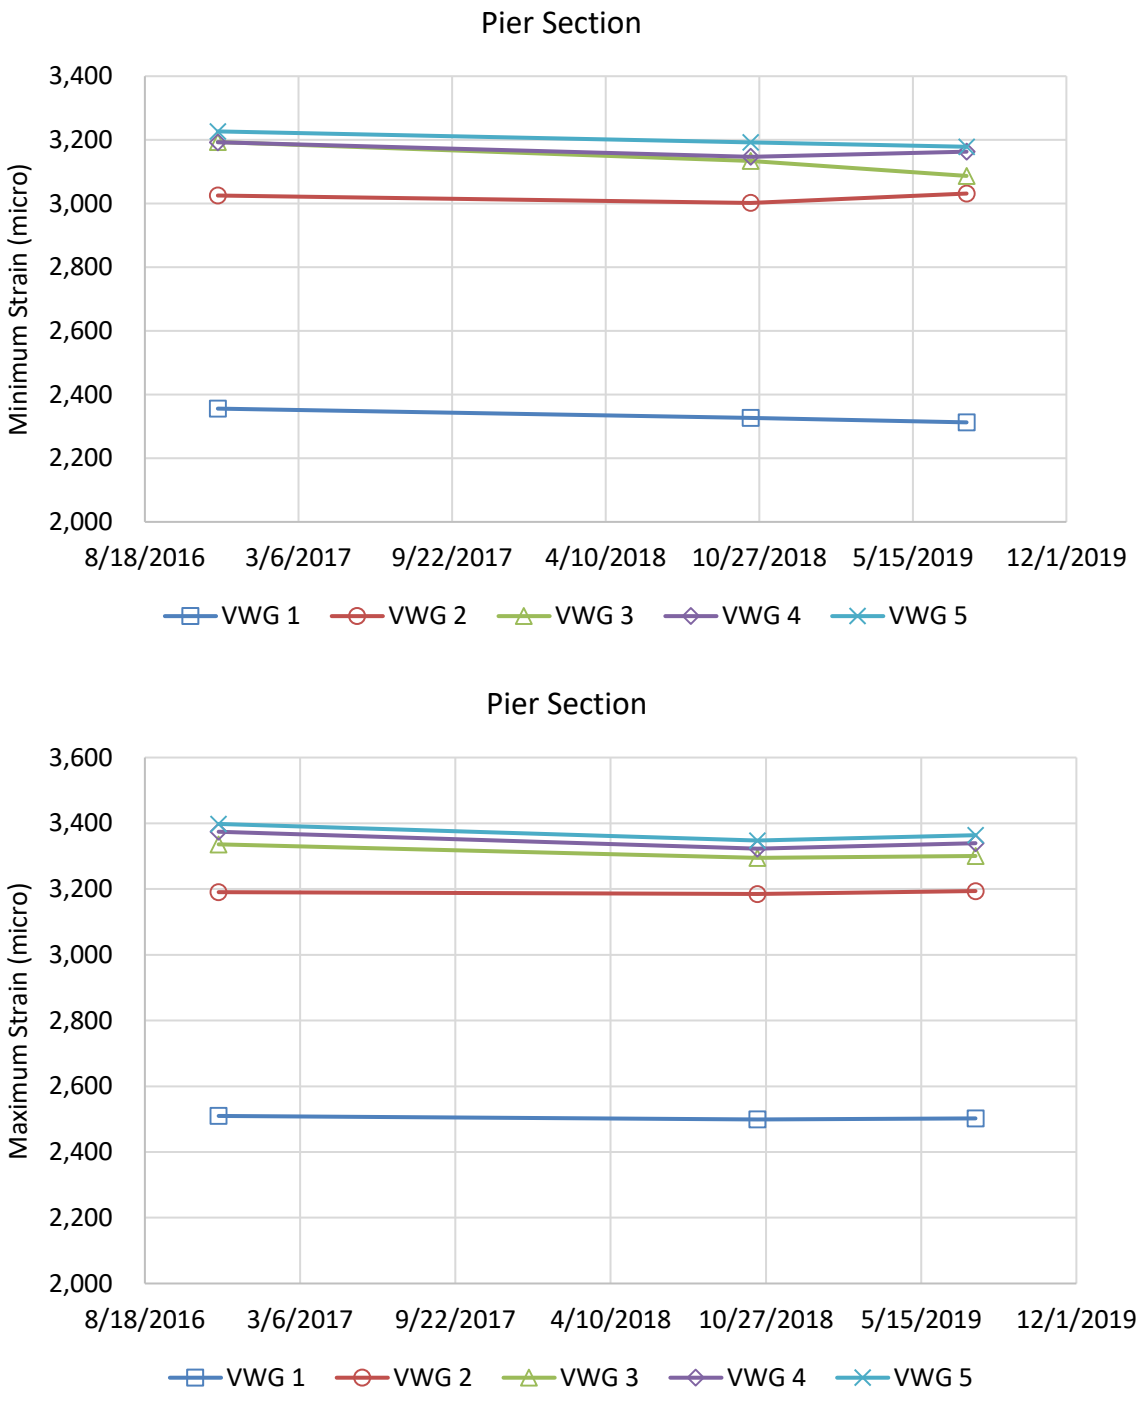
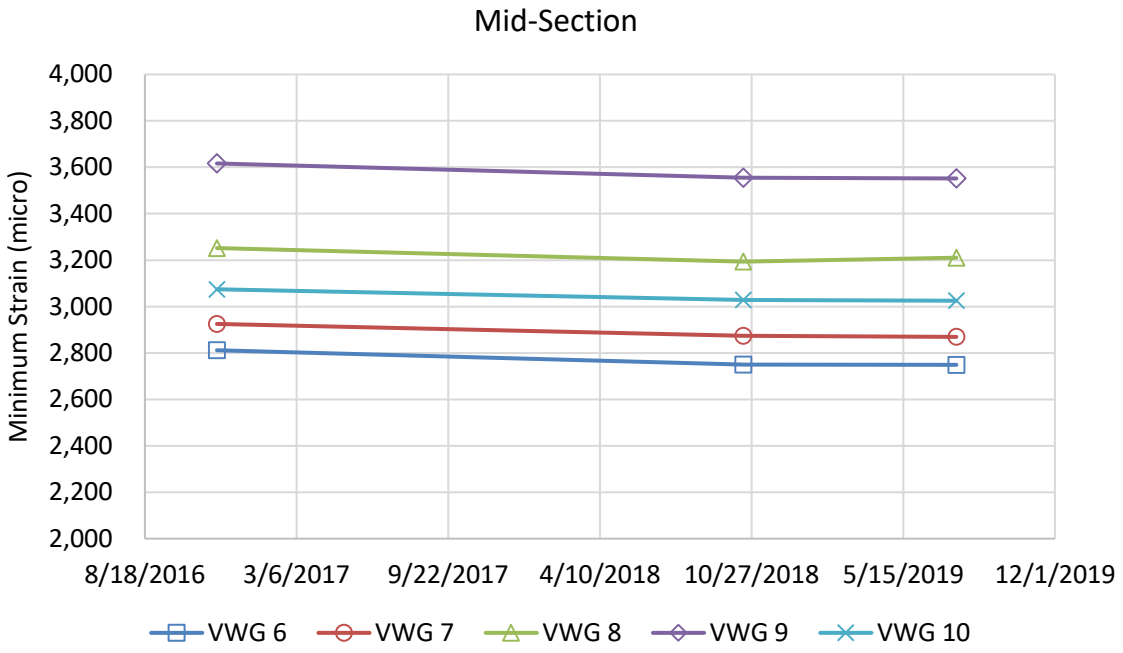
In order to make conclusions based on the measured strain values over the three-year period, the minimum and maximum strain values in each of the three periods were plotted versus time for both pier and mid sections. Figure 4.14 plots the changes in minimum and maximum strain values obtained from the five gauges at the pier section, while Figure 4.15 plots the changes in minimum and maximum strain values obtained from the five gauges at the mid section. Table 4.2

lists these values as well as the corresponding temperatures. These plots and table indicate that the largest change in bottom flange strain at the pier section is 48 micro-strain and at the mid-section is 65 micro-strain. These values correspond to a prestress loss of 1.4 ksi and 1.9 ksi respectively, which are considered reasonable for shrinkage and creep after deck placement.

FIGURE 4.14 Changes in minimum and maximum strain readings at the pier section

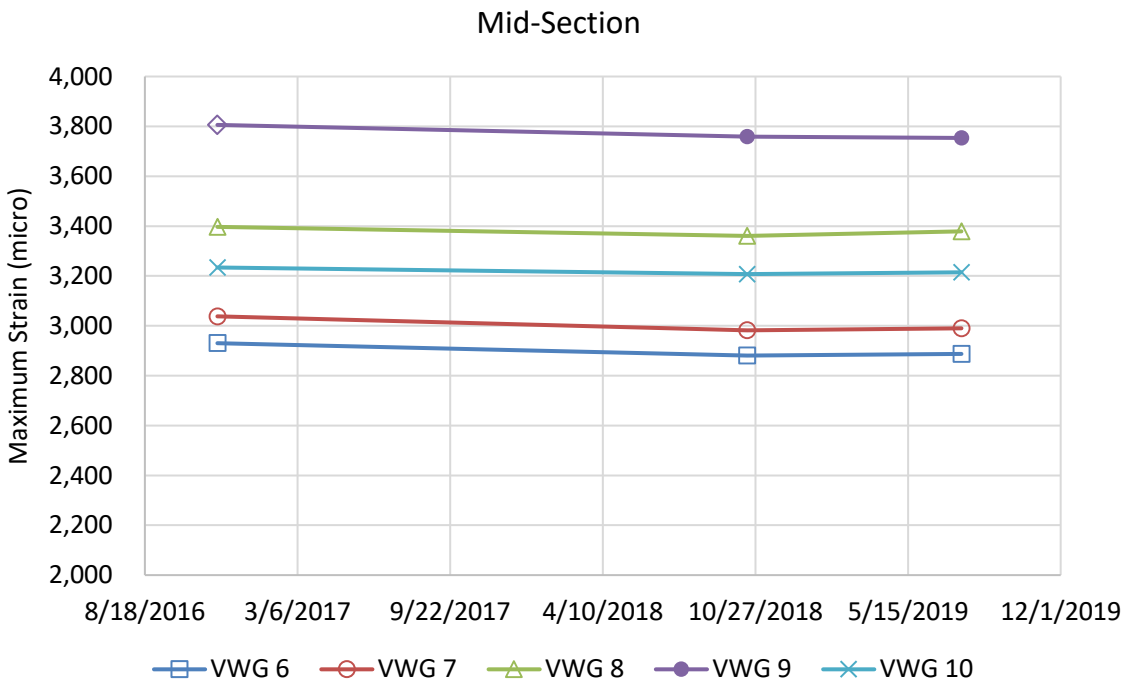
FIGURE 4.15 Changes in minimum and maximum strain readings at the mid-section

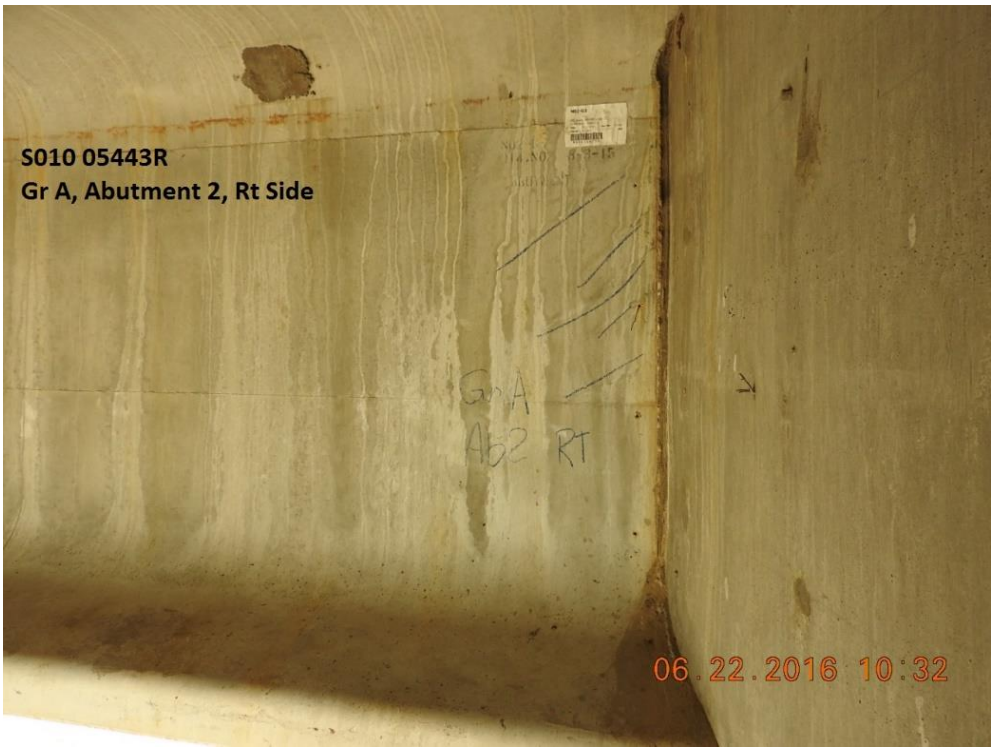
Initial Inspection Date: 6/22/2016
Rails have vertical shrinkage cracks at 4 to 8 feet intervals. Every joint between the precast panels are cracked even after post tensioning. South paving section has 20 sq feet of crack and North paving section has 10 square feet of cracks. A few girders have diagonal cracks at the girder ends. These cracks are not in the direction of shear cracks. Cracks are too fine for epoxy injections. They should be monitored for growth.
Deck rating = 9
Superstructure rating = 9
Substructure rating = 9

S010 05443R
Gr A, Abutment 2, Rt Side
GrA
Ab2 RT
06.22.2016 10:32
