Alaska Department of Transportation & Public Facilities

Minnesota Drive Ramps Microsurfacing Experimental Feature

Post-Construction Report

October 2020

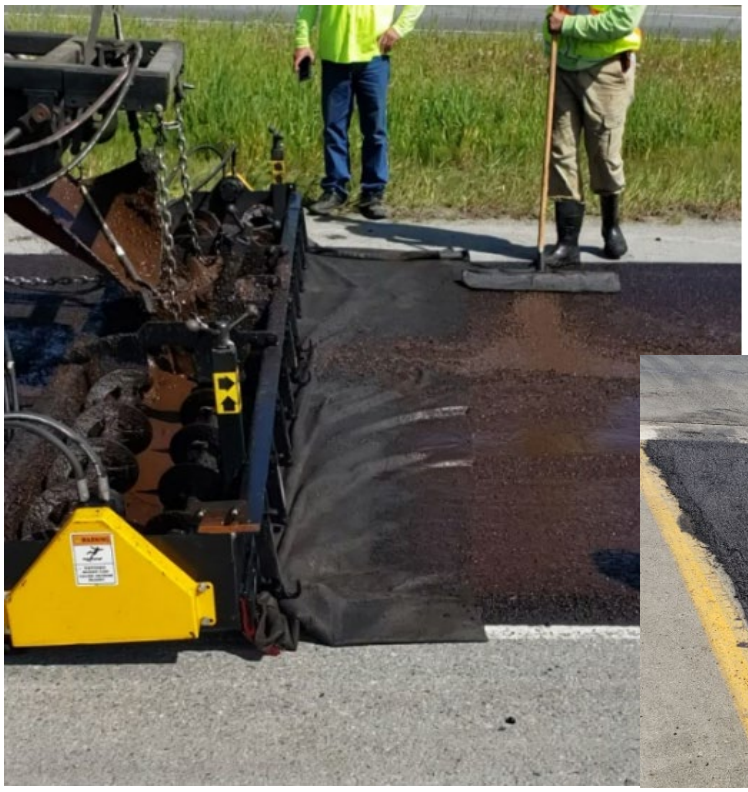
Photo 10 - Secondary Strike Off and Hand Working

The sack on the end of the spreader box (see photo below) is used for secondary strike-off to provide surface texture on the final microsurfacing overlay and remove surface defects.

It takes approximately 90 seconds for the materials to be mixed, travel through the Macropaver unit and enter the spreader box through the diverter. The crew will hand work the microsurfacing using a squeegee at locations it is hard for the equipment to access, as well as remove drag marks and other surface imperfections (shown in the picture to the left.) The photo on the right is an example of an area that was hand worked at the intersection of Ramp 6 and International Airport Road.

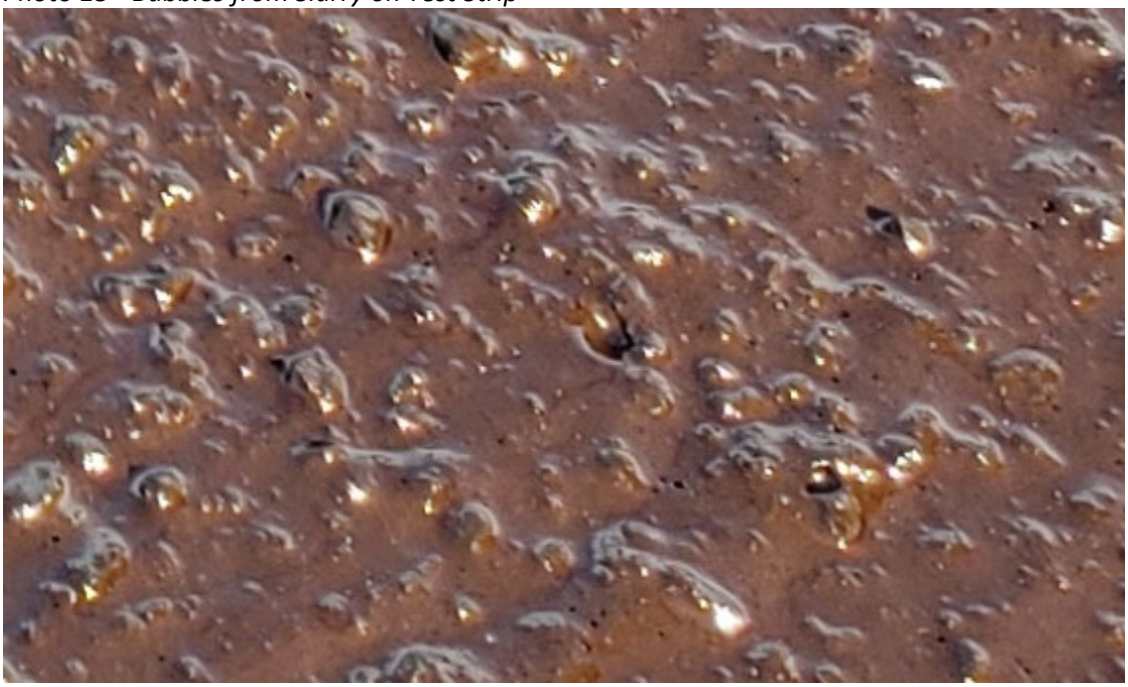
Photo 13 - Bubbles from Slurry on Test Strip

After the microsurfacing was placed on the test strip, small holes/bubbles were observed on the surface which were not seen with the previous formulation using lime. This indicates water is escaping the system as it sets and, while difficult to see, can be observed in the photo below.
