MASH TEST 4-12 OF SHALLOW ANCHORAGE SINGLE SLOPE TRAFFIC RAIL (SSTR)

Test Report 0-6968-R10

TEXAS A&M TRANSPORTATION INSTITUTE
COLLEGE STATION, TEXAS

TEXAS DEPARTMENT OF TRANSPORTATION

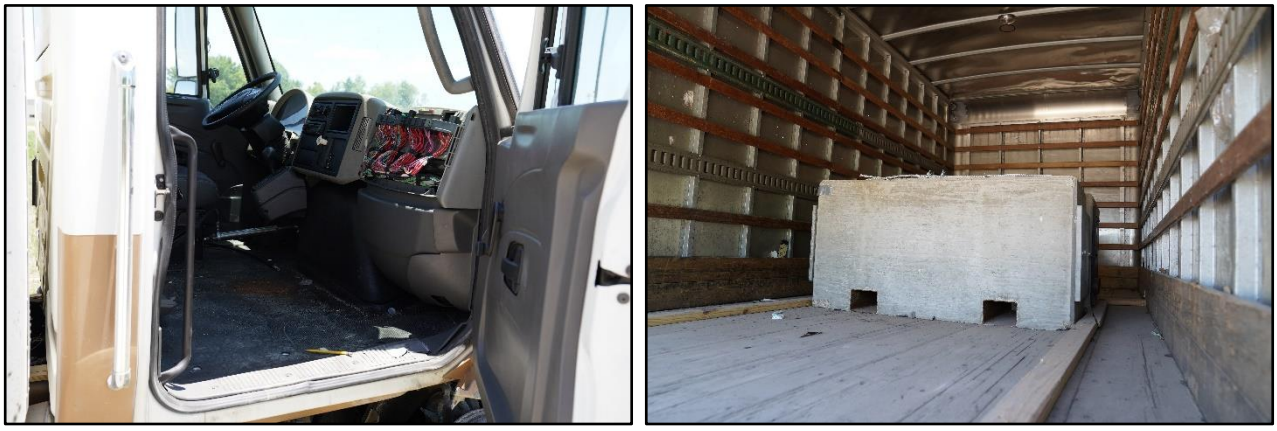
Figure 5.5. Interior of Test Vehicle after Test No. 469680-02-1.

Figure 5.4 shows the damage sustained by the vehicle. The front bumper, hood, right front tire and rim, right front spring assembly and U-bolts, right fuel tank and side steps, right door, right floor pan, right lower edge of box, right rear outer tire and rim, and right rear U-bolts were damaged. Maximum exterior crush to the vehicle was 18.0 inches in the front plane at the right front corner at bumper height. Maximum occupant compartment deformation was 2.5 inches in the right front floor pan/firewall. Figure 5.5 shows the interior of the vehicle.

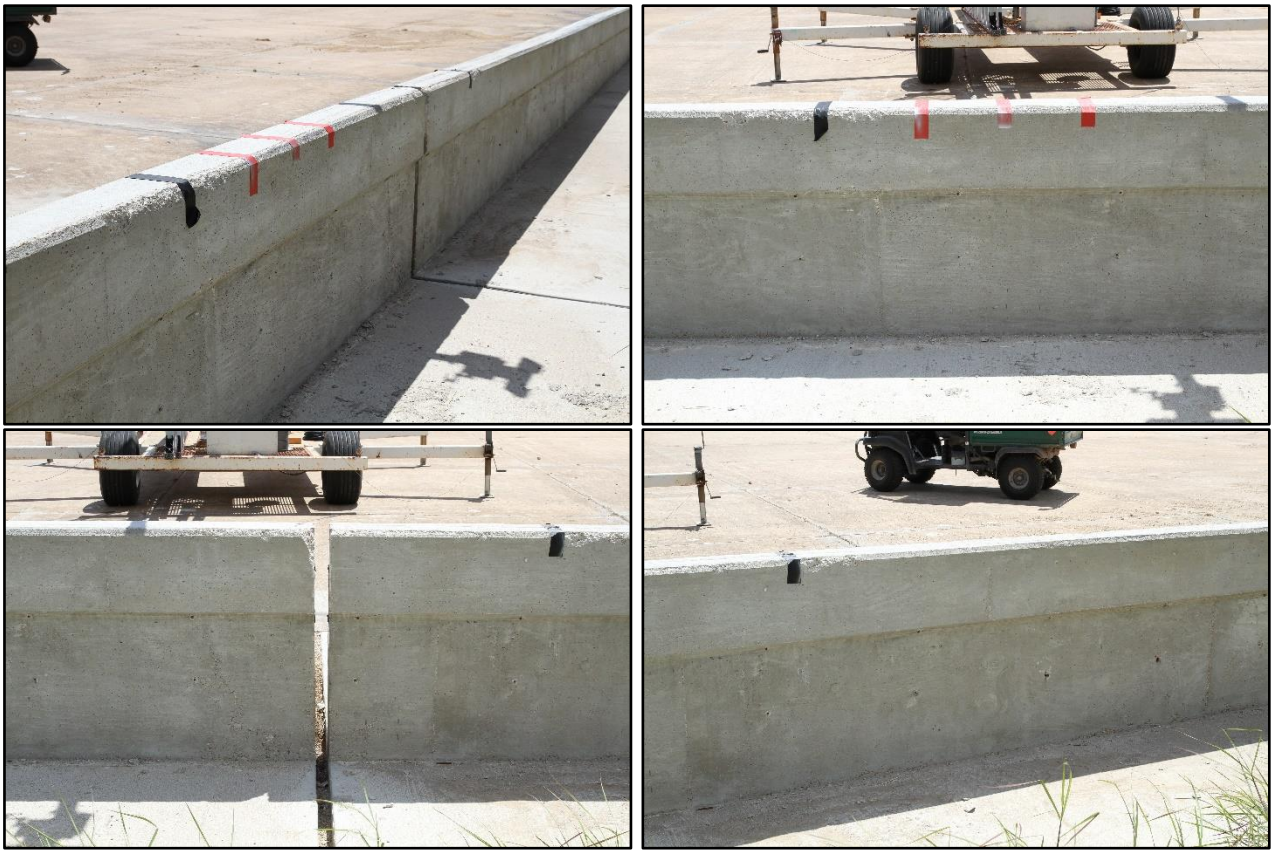
Figure 6.4. Field Side of SSTR without dowel bars after Test No. 469680-02-2.

Figure 6.3 and Figure 6.4 show the damage to the TxDOT shallow anchorage SSTR without dowel bars. No cracks were observed in the barrier or deck slab. No delaminations were detected at the interface between the two concrete slabs. Some gouging occurred on the traffic face of the barrier in the impact region, and contact and scuff marks were evident from the point of impact to the end of the barrier. Working width[*] was 60.6 inches, and height of working width was 150.9 inches. No dynamic deflection during the test nor permanent deformation after the test was observed.

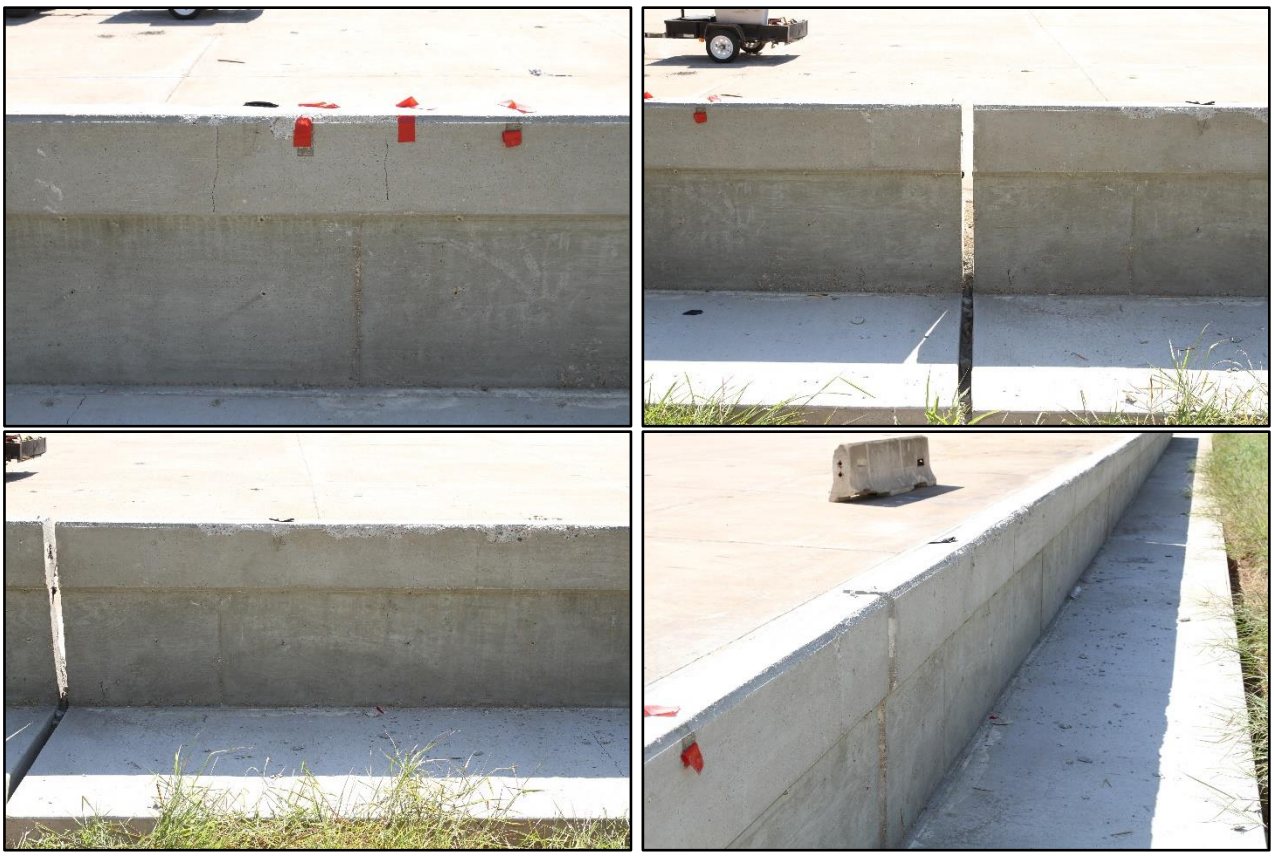
Figure 7.5. Field Side of SSTR without Dowel Bars and with Concrete Apron Extended Downstream of Barrier after Test No. 469680-02-3.

Figure 7.4 and Figure 7.5 show the damage to the TxDOT shallow anchorage SSTR without dowel bars. No cracks were observed in the barrier or deck slab. No delamination was detected at the interface between the two concrete slabs. There was some gouging on the face of the concrete barrier in the impact region and on Segment 2, with scuffing running along the length of the barrier. A section of rebar was exposed on the traffic side of Segment 1 at the joint between Segments 1 and 2. Working width[*] was 81.5 inches, and height of working width was 142.5 inches. No dynamic deflection during the test nor permanent deformation after the test was observed.
