# Prediction and Rehabilitation of Highway Embankment Slope Failures in Changing Climate

Project No. 17GTLSU04

Lead University: Louisiana State University

TECHNICAL DOCUMENTATION PAGE

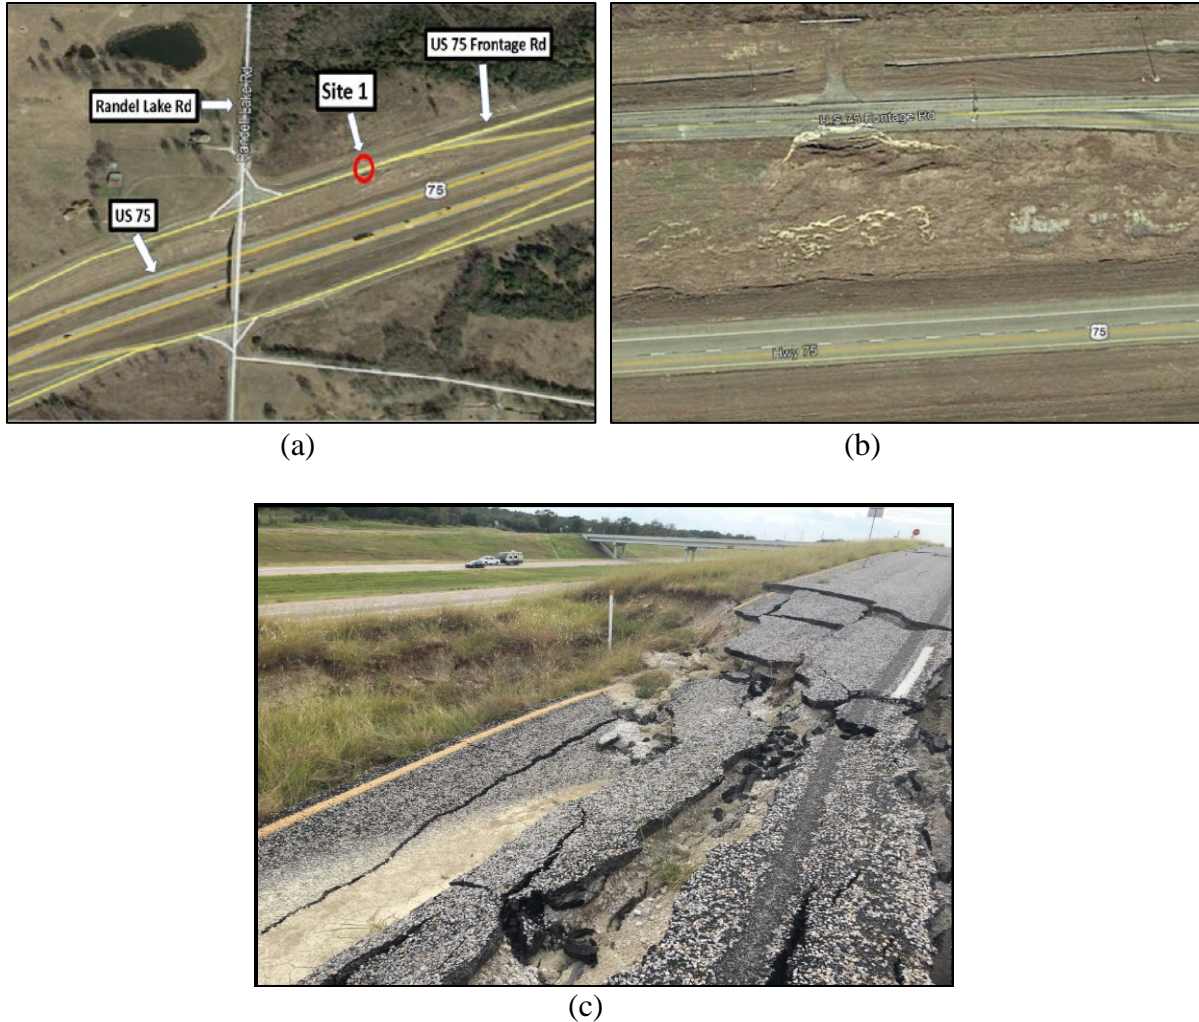
Texas Site 1 is located near Randell Lake, Denison, Texas along U.S 75 Frontage Road (Figure 1(a)). The embankment at this site has an approximate height of 30-35 feet. The site is overlain by the deposit of Fort Worth Limestone as per geological formation. This site experienced severe desiccation cracks starting in 2014, which resulted in a major slope failure in 2016 and caused extensive damage to the overlying pavement that lead to the closure of road. The soil sample was collected from the south side of the embankment where it had several failures and desiccation cracks from the failure scarp from a depth of approximately one foot below the surface, as the surface was covered by soil vegetation. Figures 1(b) and 1(c) show the major cracks in the upper side of the slope and there are significant number of desiccation cracks and several shallow slope failures along the embankment.

Figure 1. Overview of Site 1 and photos of slope failure at Grayson County, Denison, Texas: (a) and (b) Denison Site overview and (c) tension cracks in the upper side of the slope.

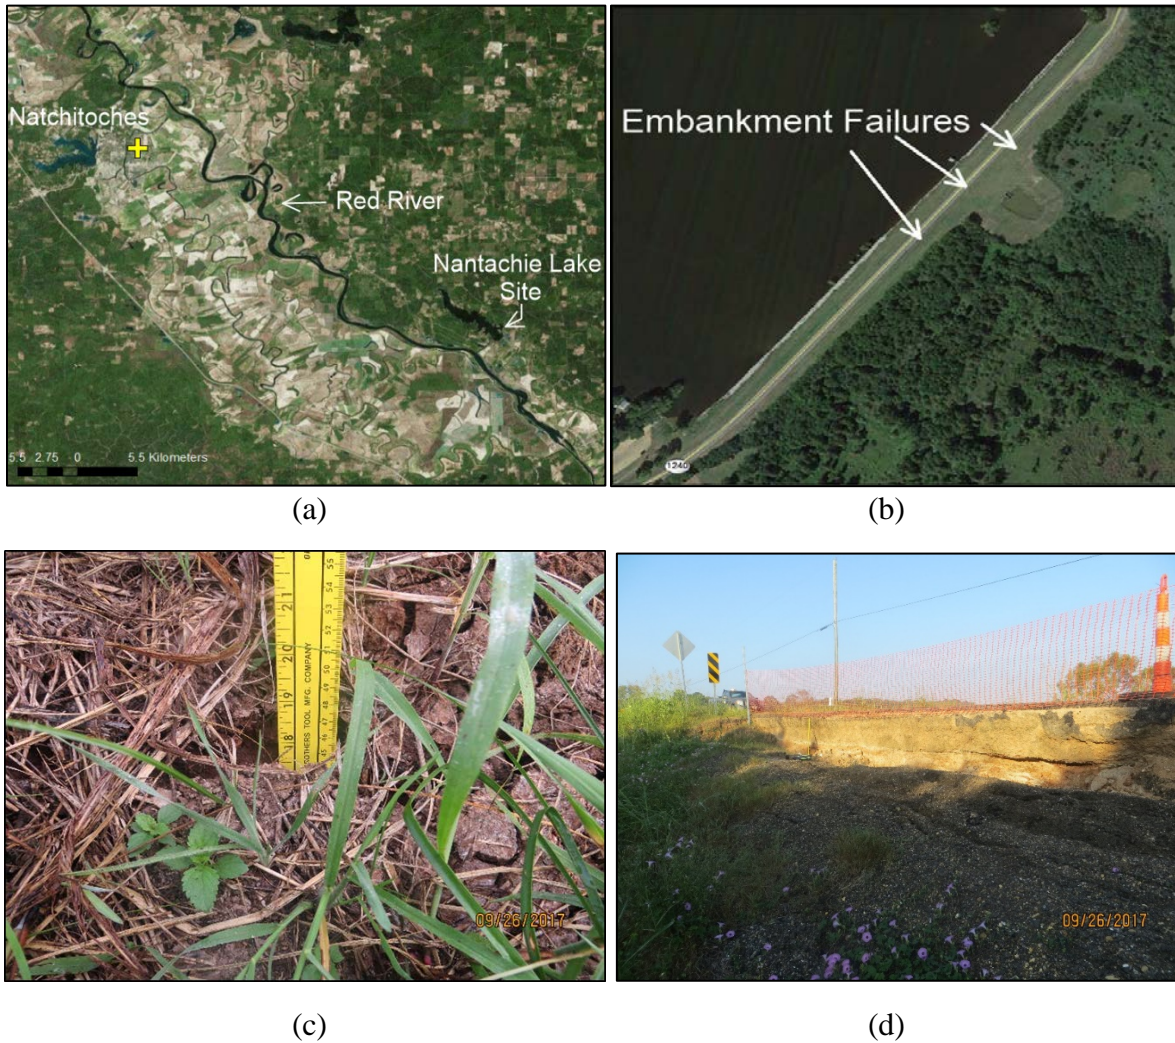
Site 2 is located approximately 30 km southwest of Natchitoches, Louisiana (Figure 4(a)) and is situated in close proximity to the Red River. The site features a roadway sitting on top of a levee separating local communities from Nantachie Lake (Figure 4(b)). The site experienced multiple failures which led to the roadway being closed by the LADOTD Dam Safety division (Figure 4(d)), though locals still drive around the barriers. Extensive desiccation cracking was

observed along the failure scarps as well as in the embankment sections which had not yet failed, measuring to an average of approximately 45 cm (Figure 4(c)).

Figure 4. (a) Aerial of Louisiana failure Site 2, (b) location of slope failures, (c) desiccation cracks, and (c) scarp along roadway.

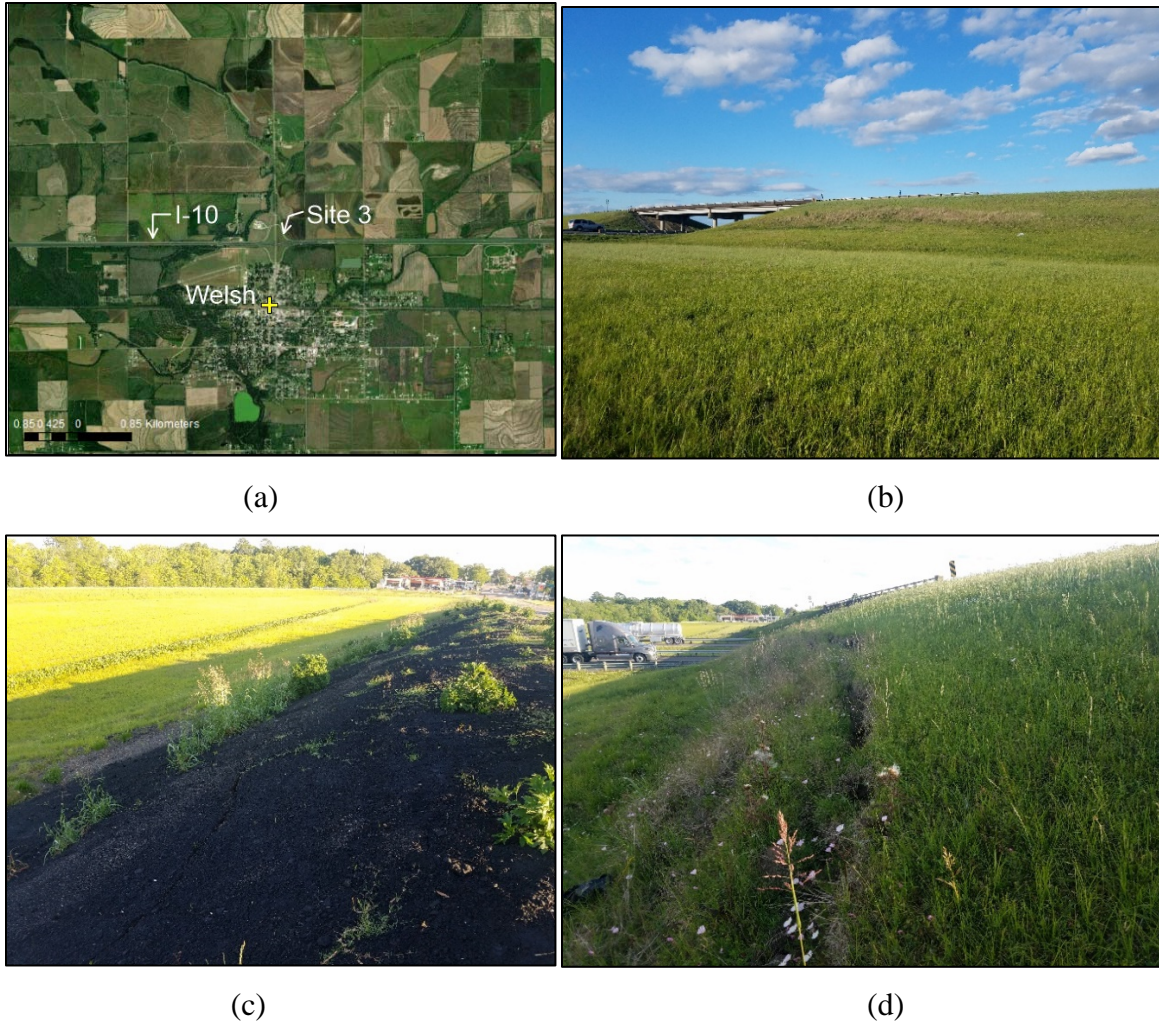
Site 3 is located along I-10 at Welsh, Louisiana (Figure 5(a)). The site is geologically characterized by the Pleistocene terrace deposits, in which Burns et al. *(2)* found significantly fewer failures. Failures in the adjacent embankments were likely excavated and filled with asphalt materials (Figure 5c). A longitudinal scarp was observed at the site. Soils taken from Site 3 were similar in characterization to the soils taken from Site 1.

Figure 5. (a) Location of Site 3 in Louisiana, (b) photo of failed embankment, (c) rehabilitated failure with asphalt, and (d) failure scarp.
