New Hampshire DOT

Reducing Cracking in New Bridge Curbs

Final Report

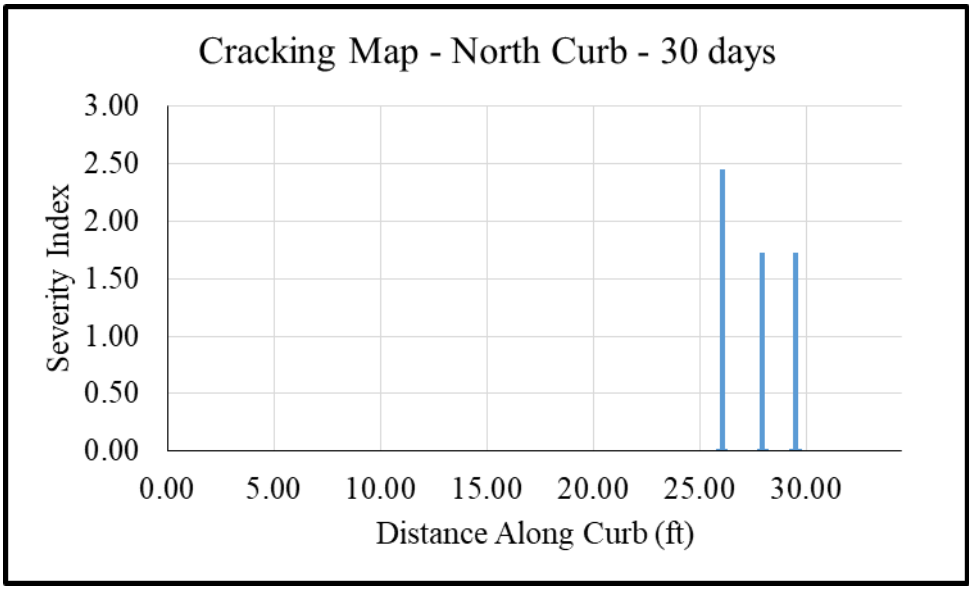
Figure 55: Alexandria north curb heat map at 30 days.

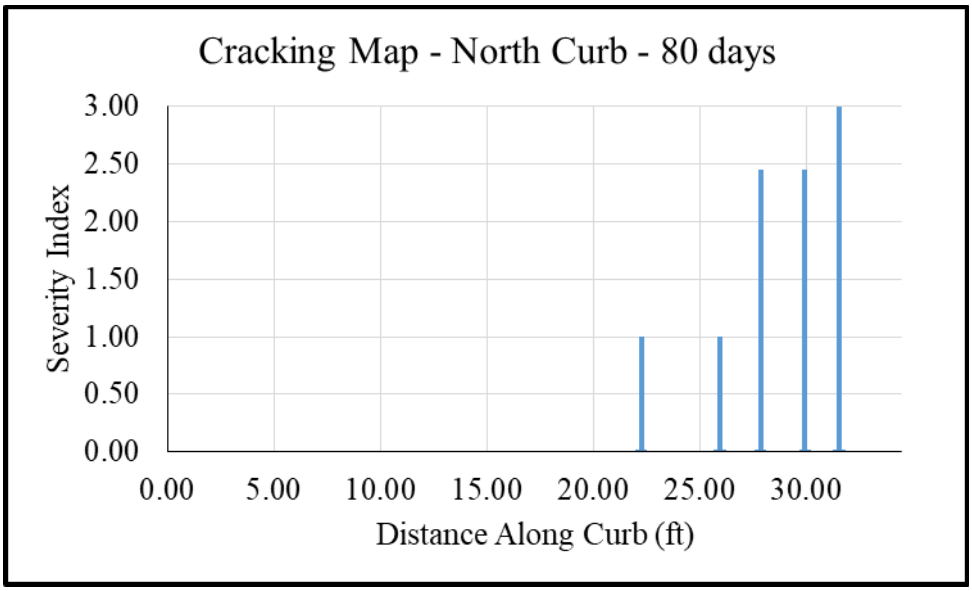
Figure 56: Alexandria north curb heat map at 80 days.

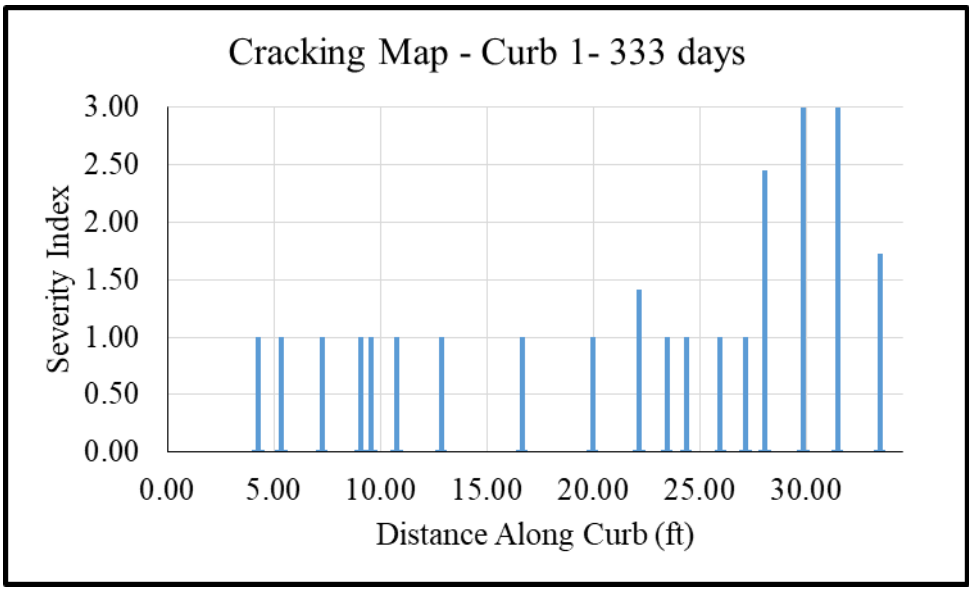
Figure 59: Alexandria north curb heat map at 333 days.

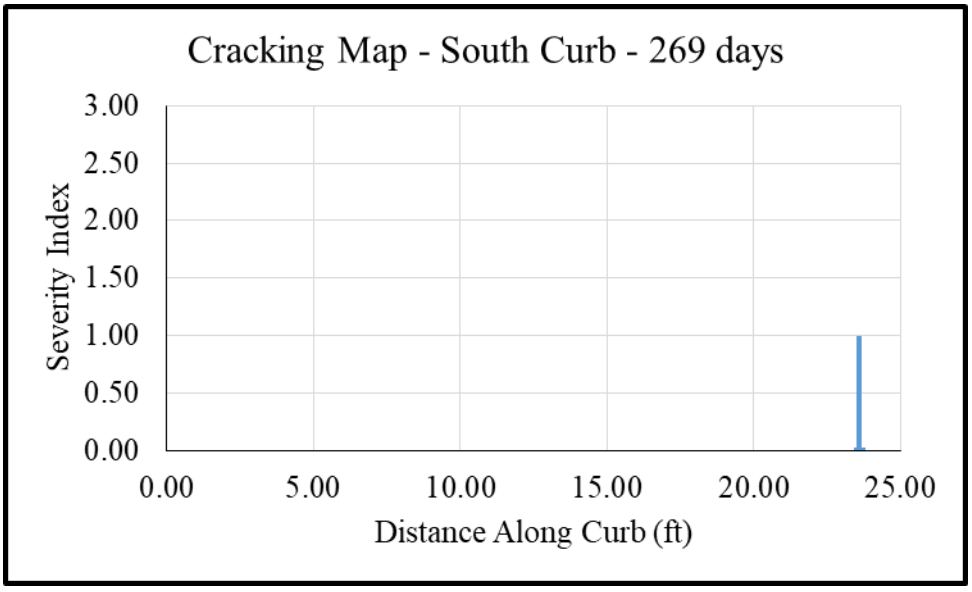
Figure 61: Alexandria south curb heat map at 269 days.

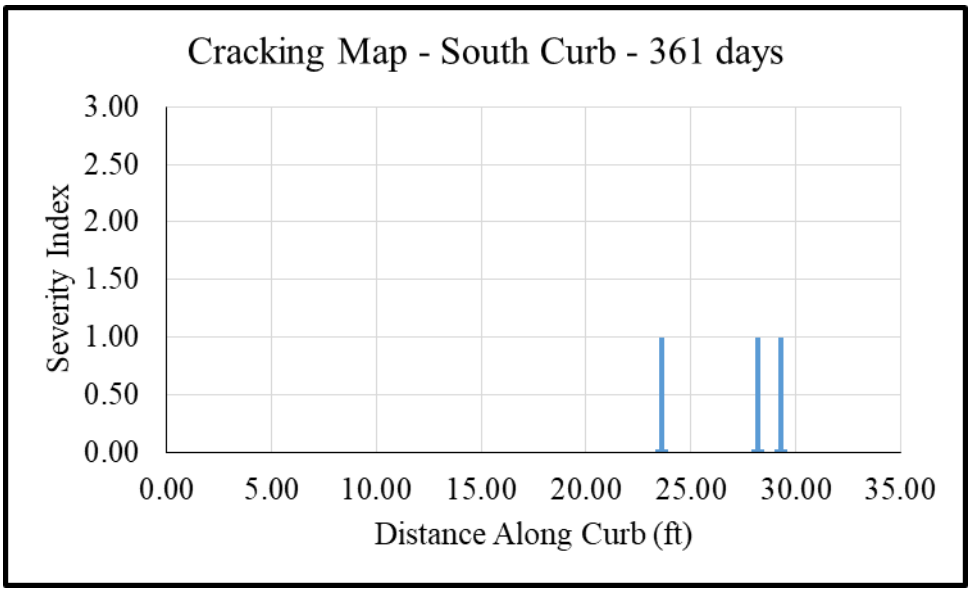
Figure 62: Alexandria south curb heat map at 361 days.

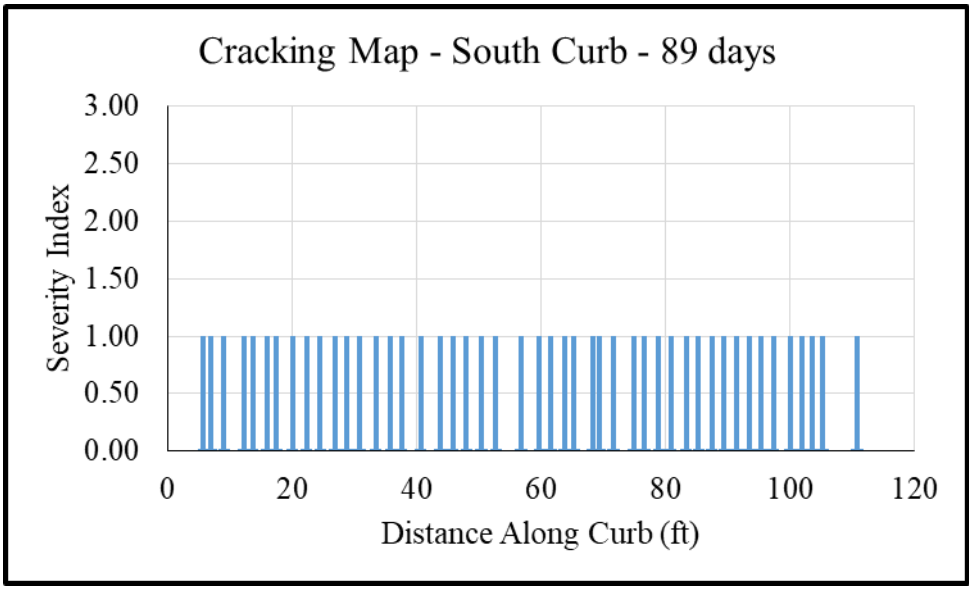
Figure 63: Hampton south curb heat map at 89 days.

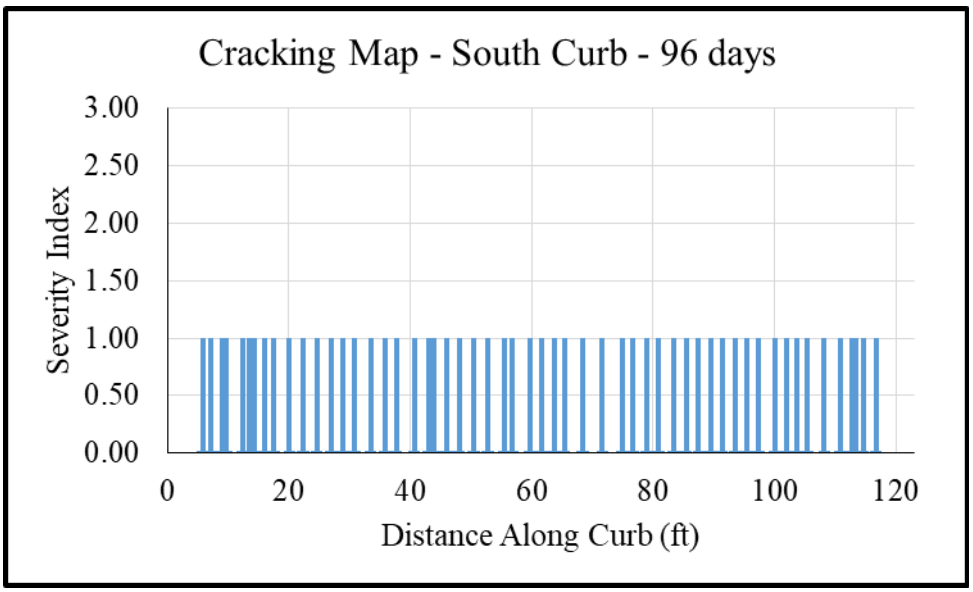
Figure 64: Hampton south curb heat map at 96 days.

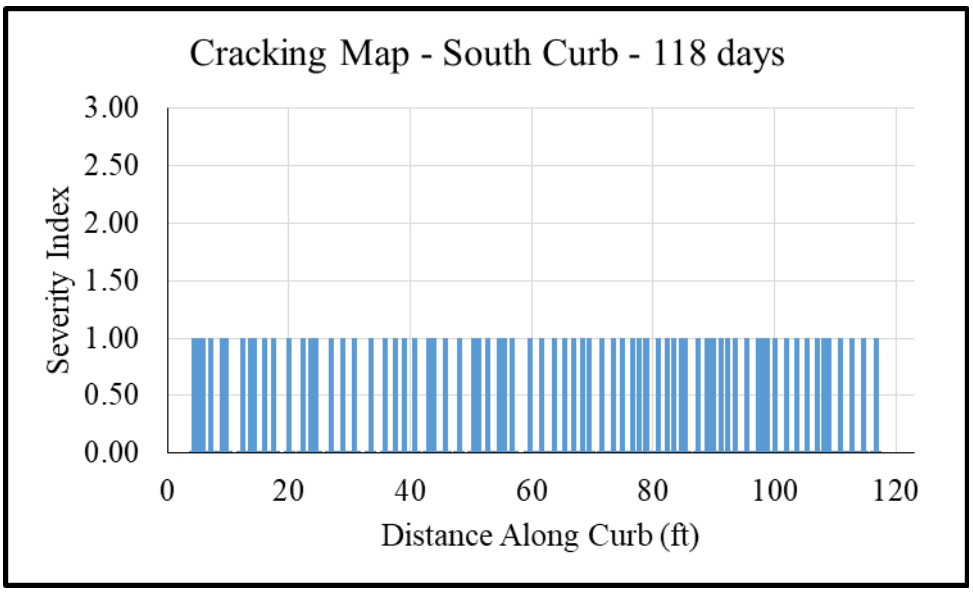
Figure 65: Hampton south curb heat map at 118 days.

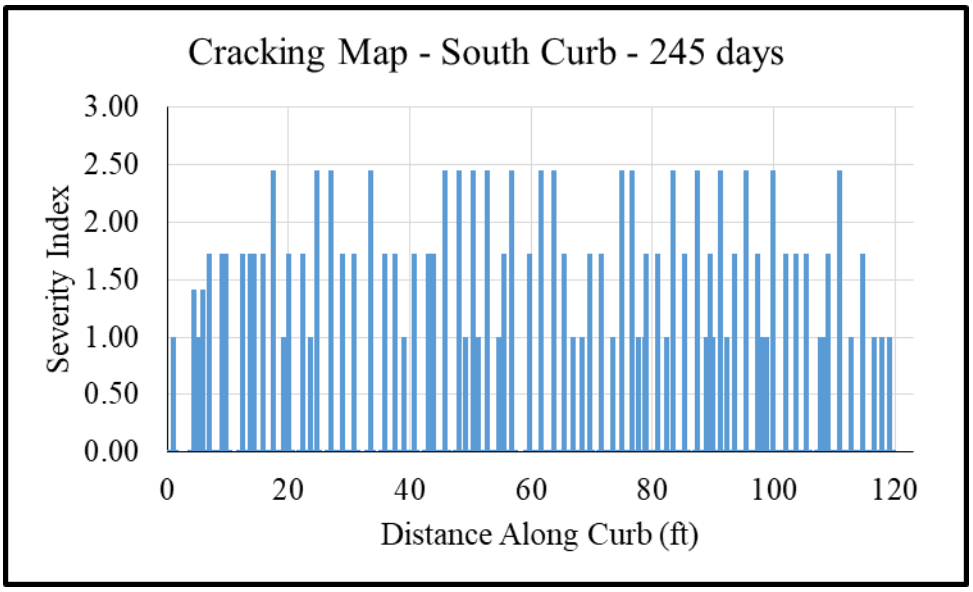
Figure 66: Hampton south curb heat map at 245 days.

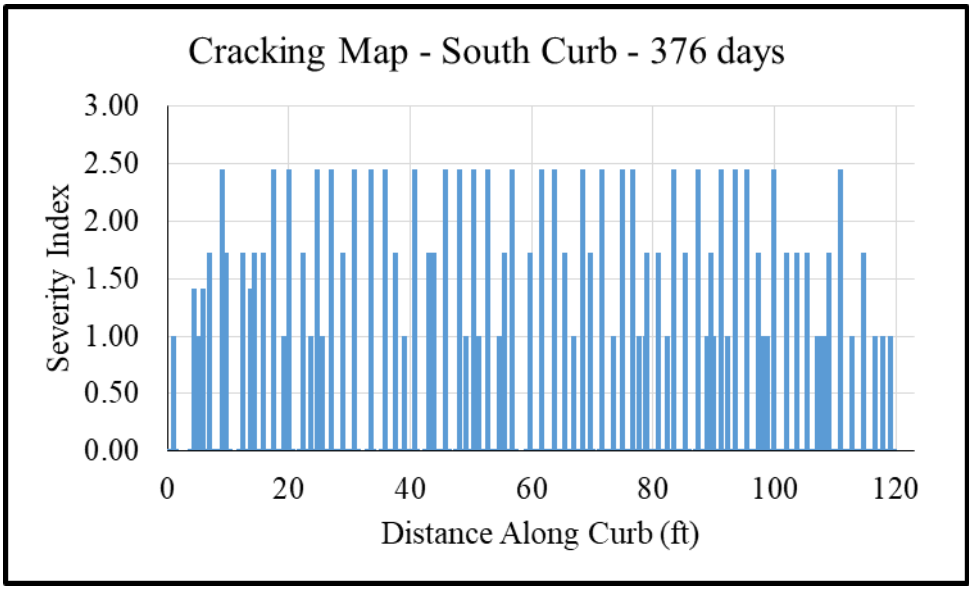
Figure 67: Hampton south curb heat map at 376 days.

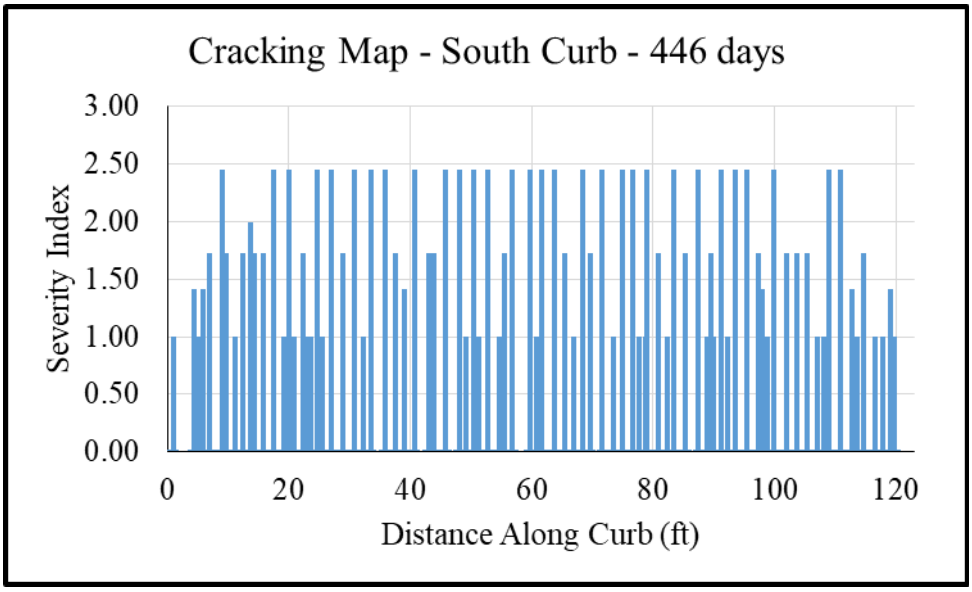
Figure 68: Hampton south curb heat map at 446 days.

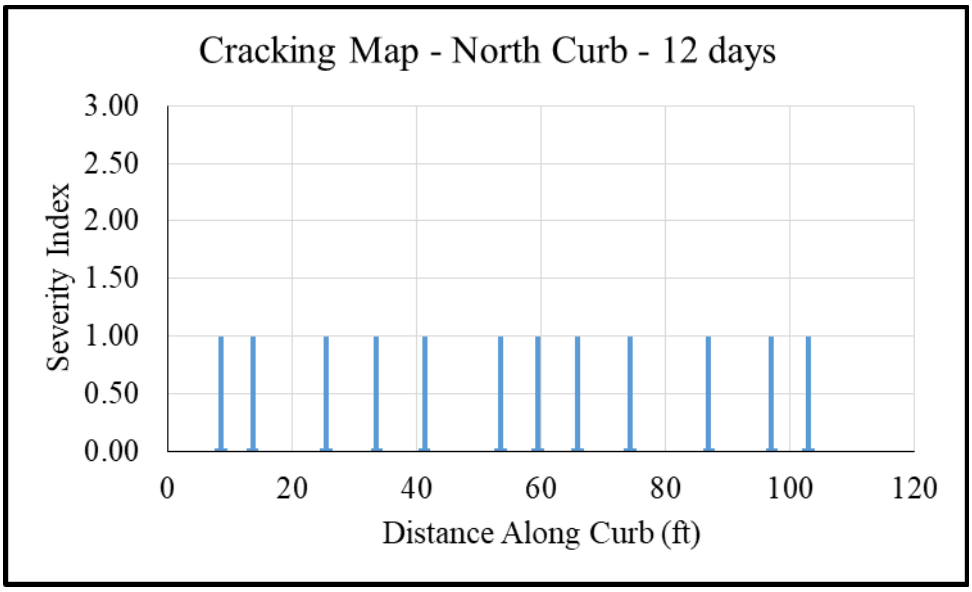
Figure 69: Hampton north curb heat map at 12 days.

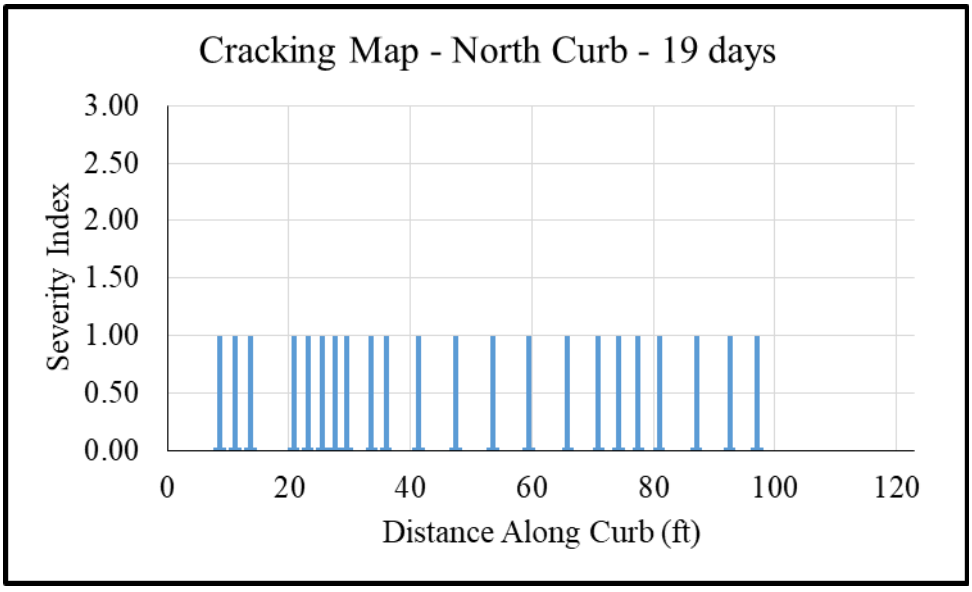
Figure 70: Hampton north curb heat map at 19 days.

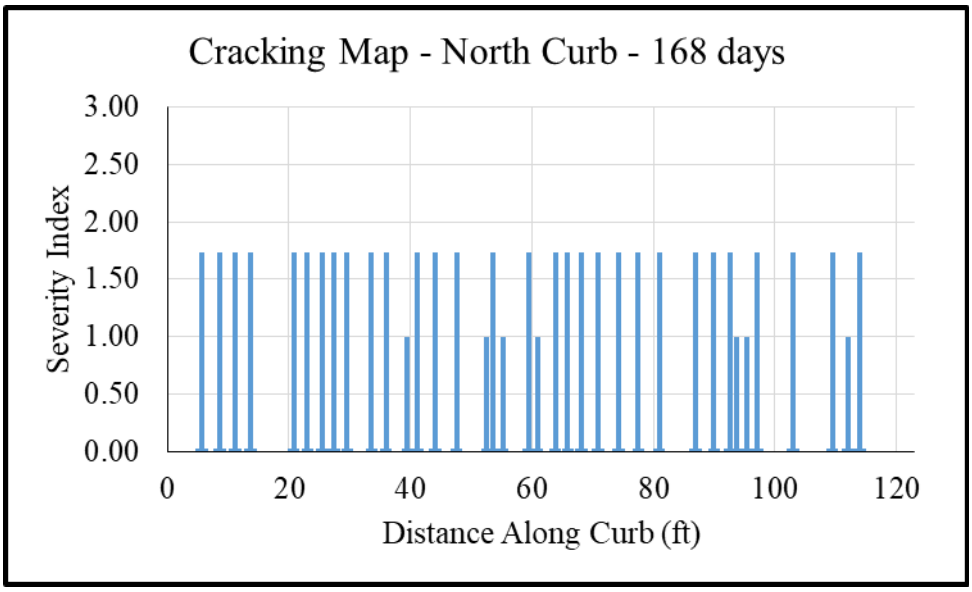
Figure 72: Hampton north curb heat map at 168 days.

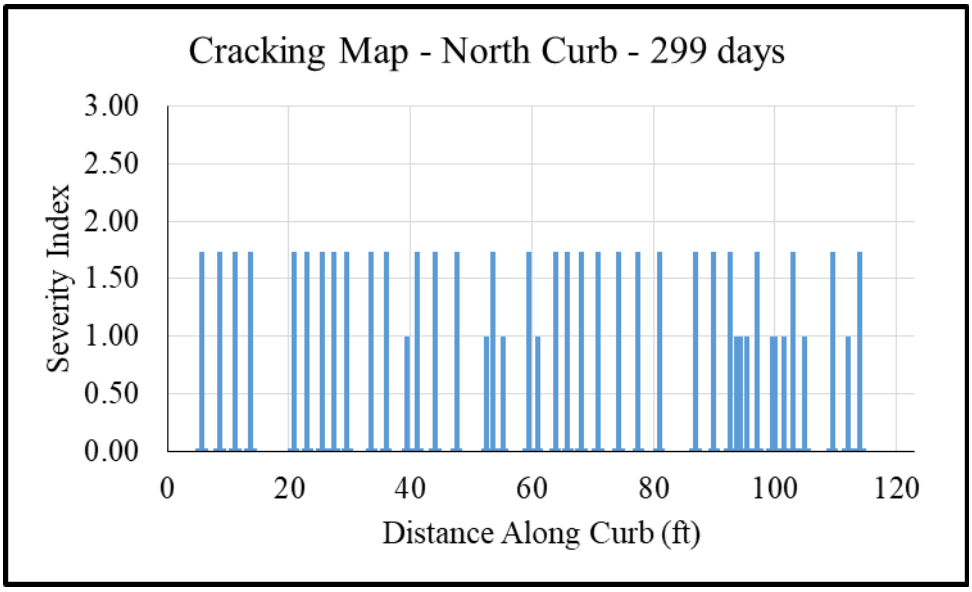
Figure 73: Hampton north curb heat map at 299 days.

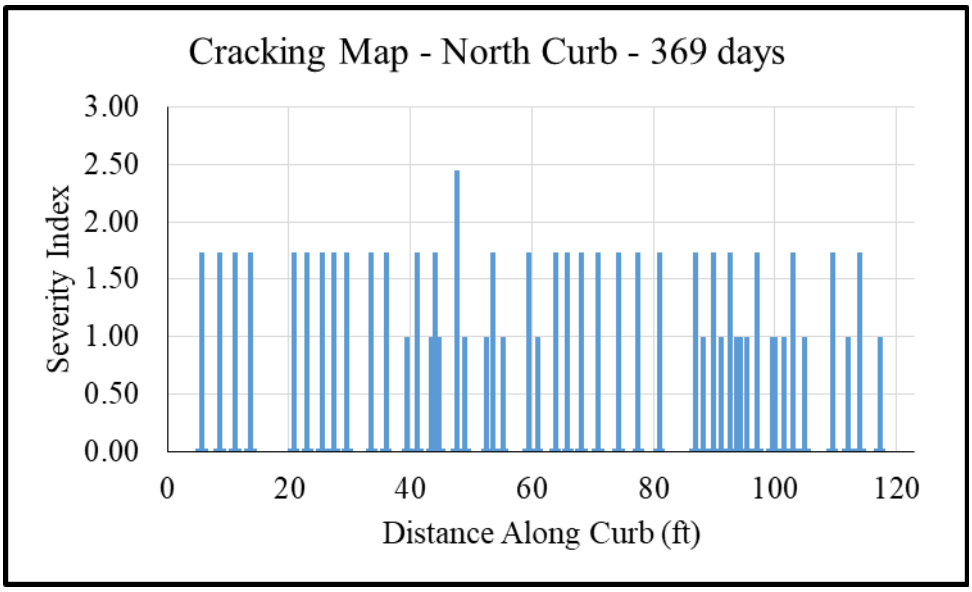
Figure 74: Hampton north curb heat map at 369 days.

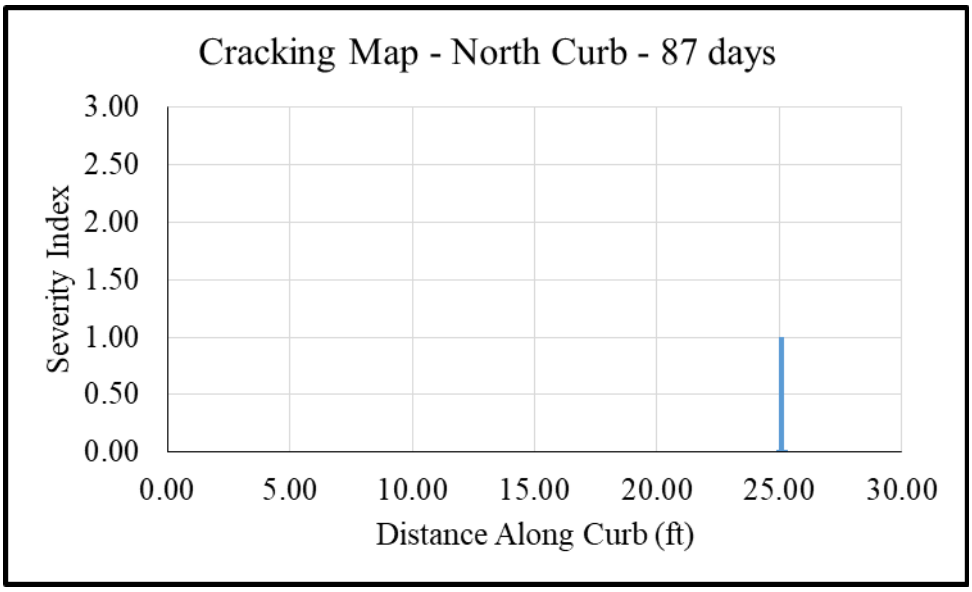
Figure 79: Grantham north curb heat map at 87 days.

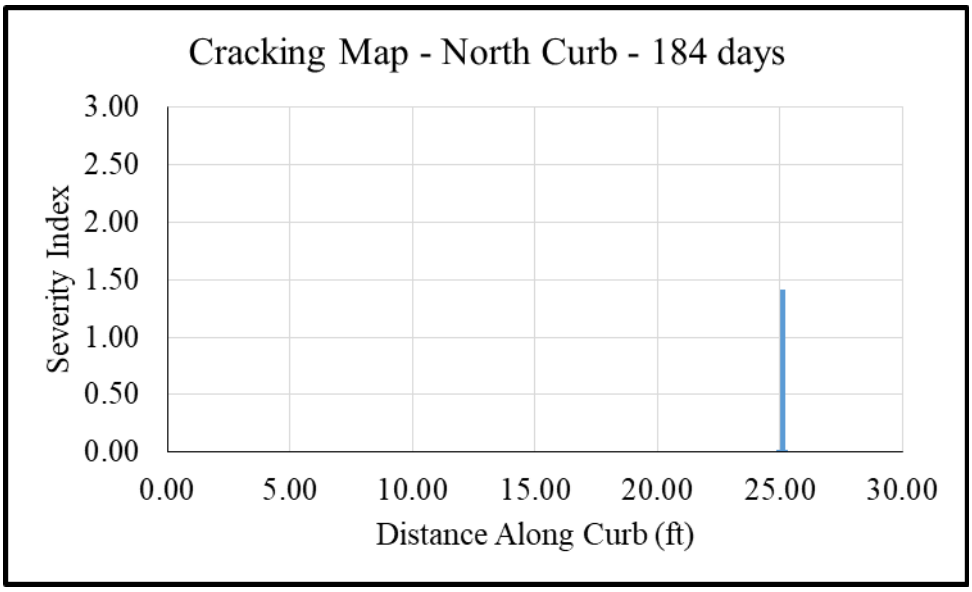
Figure 80: Grantham north curb heat map at 184 days.

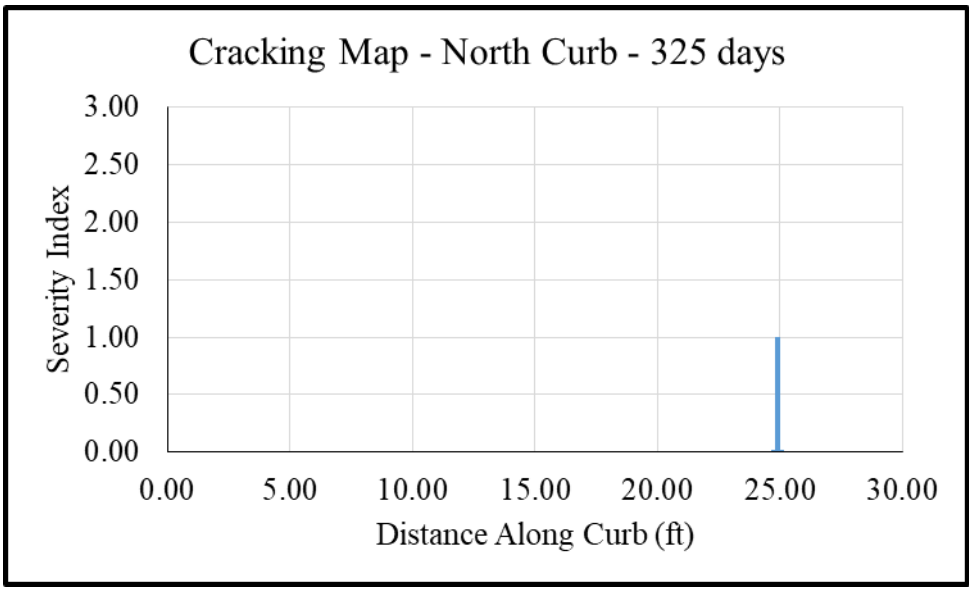
Figure 81: Grantham north curb heat map at 325 days.
