FRP Reinforcing Bars in Bridge Decks Field Instrumentation and Short-Term Monitoring

1. Report No. FHWA/TX-06/9-1520-4	2. Government Accession No.	3. Recipient's Catalog No.
4. Title and Subtitle FRP Reinforcing Bars in Bridge Decks Field Instrumentation and Short-Term Monitoring		5. Report Date August 2003

6. Performing Organization Code TechMRT
7. Author(s) R. Scott Phelan, W. Pennington Vann, Jacob Bice		8. Performing Organization Report 9-1520-4
9. Performing Organization Name and Address Texas Tech University Department of Civil Engineering Box 41023 Lubbock, Texas 79409-1023		10. Work Unit No. (TRAIS)

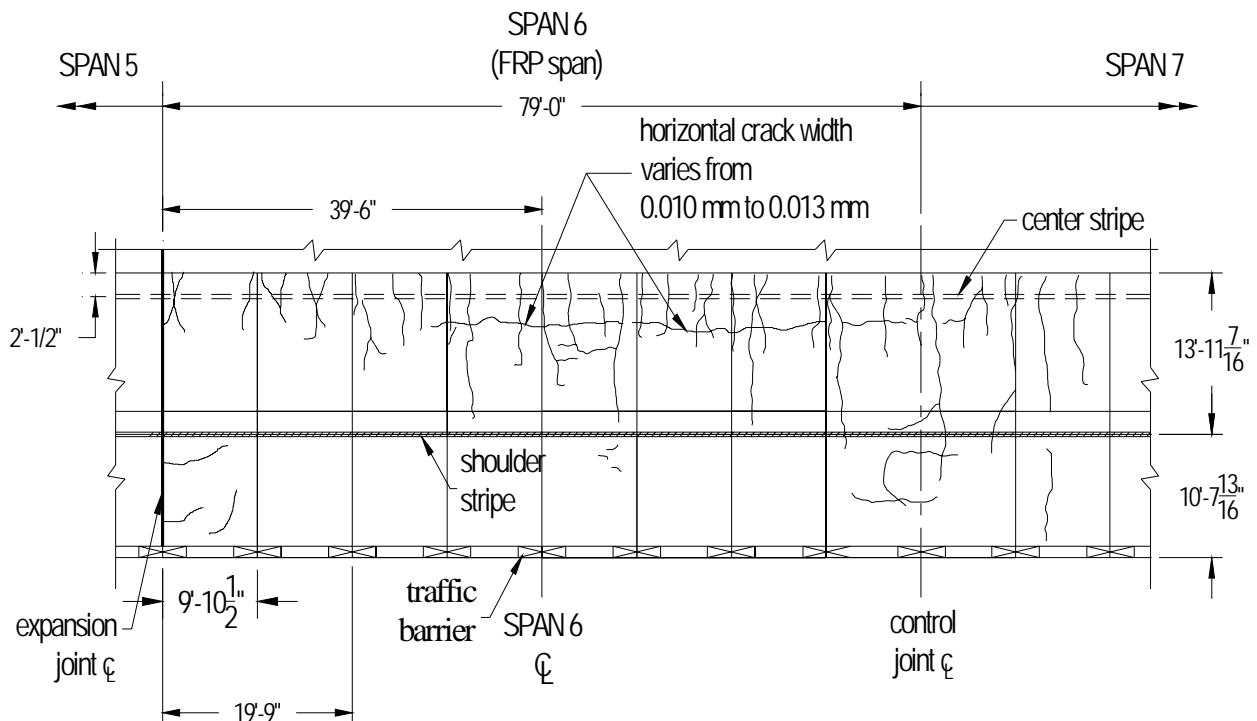
In considering all of these factors one should keep in mind that since the unique longitudinal crack failed to open further under the loads that were applied in December, 2001, it appeared that the crack was not load-induced but caused by shrinkage and/or temperature effects.

Unfortunately, the unique longitudinal crack in the FRP-reinforced slab (and the absence of a similar crack in the steel-reinforced slab) was not fully recognized until all data sheets were thoroughly analyzed upon completion of the live load tests of December, 2001. Researchers therefore returned to the bridge in September of 2002 and placed loads specifically intended to widen the longitudinal crack found in Span 6. Two trucks were positioned over the crack in order to cause a critical loading. The locations of these two trucks are shown in Figure 4.6. This loading also failed to propagate the crack. However, unloaded crack widths taken on that day ranged from 0.01 mm to 0.02 mm versus the 0.01-mm to 0.013-mm widths measured in December, 2001. While crack width measurement using a comparison card is somewhat subjective, these results may indicate some widening of the longitudinal crack over the nine months following the initial crack mapping. Therefore, long-term monitoring of this crack should be of interest.

Figure 4.4 Cracking After One Year of Service in Span 6, Reinforced with GFRP

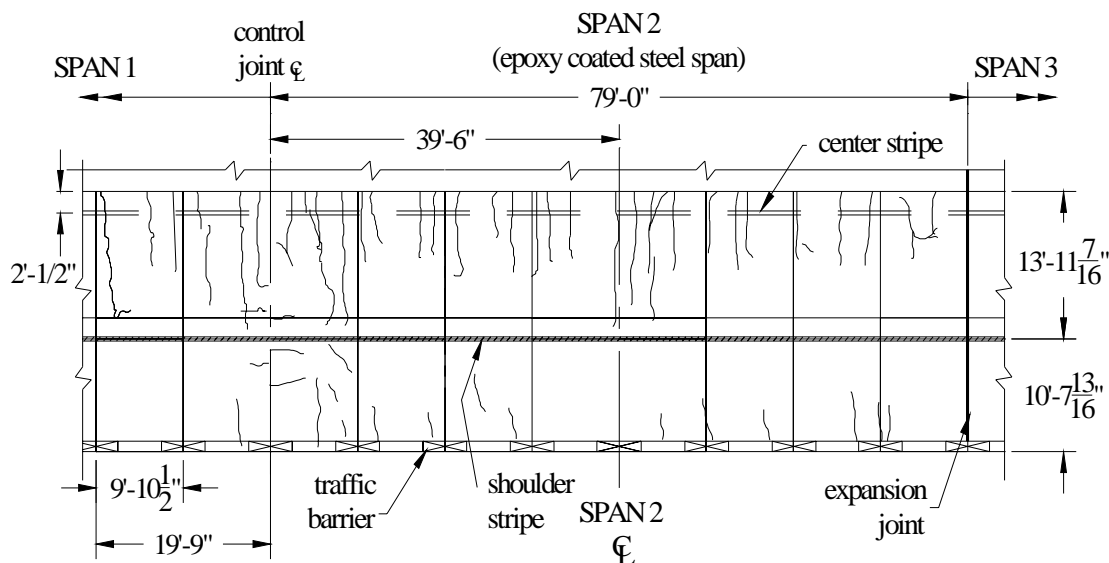
4.5 Cracking After One Year of Service in Span 2, Reinforced with ECS
