BRIDGE DECK CRACKING EVALUATION

FHWA/MT-21-005/9696-700

Final Report

prepared for
THE STATE OF MONTANA
DEPARTMENT OF TRANSPORTATION

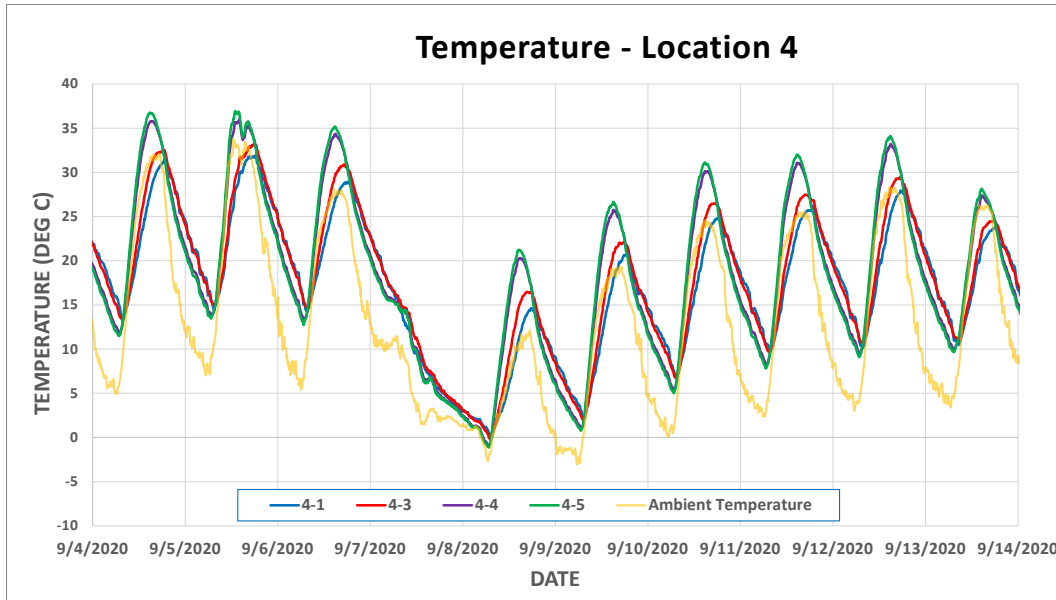
3. Large daily ambient temperature changes were observed with associated temperature gradients within the deck, with changes being most pronounced during the summer and early fall months. For example, in early September of 2020, daily ambient temperature increases and decreases of 55 to 60°F (30 to 33°C) were observed, see Figure 1. In this chart, the internal deck temperatures are graphed (as measured at five depths through the concrete deck at location No. 4, with 4-5 being at the top of the deck, 4-1 being at the bottom of the deck, and (4-4 and 4-3 are middle of the deck). These large ambient temperature changes create temperature gradients within the concrete deck, primarily during heating. This time period is an example of one of the extreme recorded events; however, daily ambient temperature variations during the summer and fall months are commonly 35 to 45°F (19 to 25°C). The implications of these large ambient temperature variations are further discussed and analyzed in the finite element modeling section and have an impact on alpine bridges in Montana.

Figure 1. Ambient and internal deck concrete temperatures measured at Location No. 4, early September of 2020.

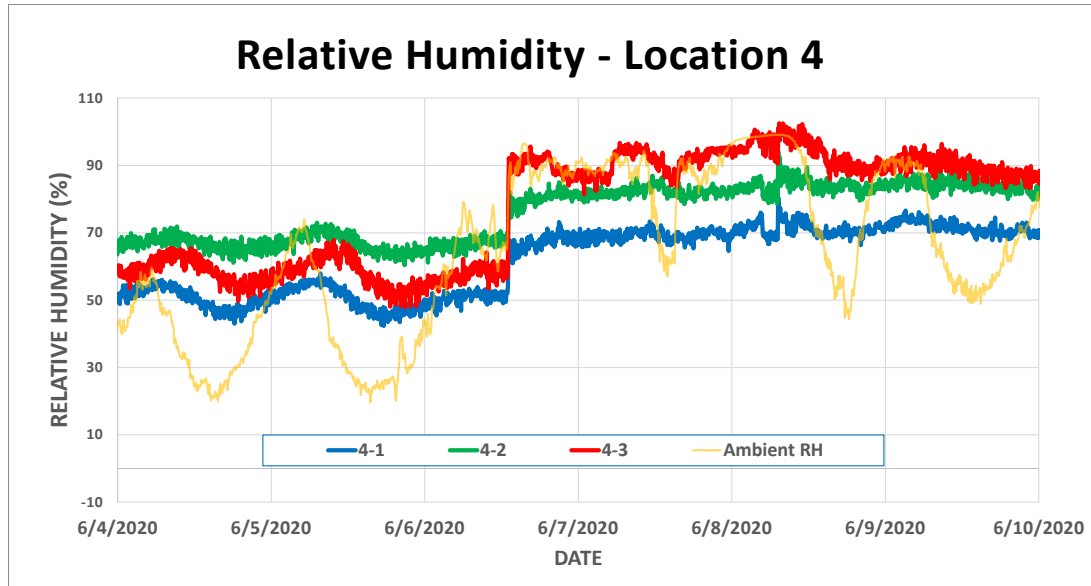
4. Large daily ambient relative humidity changes were observed, particularly in the spring and summer months, with associated large relative humidity changes and gradients within the deck concrete. For example, in early June 2020 (See Figure 2), the ambient relative humidity increased from approximately 20 to 100 percent within a 24 hour period, during a reported rain event. In this graph, the internal concrete deck relative humidity measurements are plotted at location No. 4. The measurement 4-3 represents the internal concrete relative humidity near the top of the deck; 4-2 mid-depth; and 4-1 near the bottom of the deck. This rain event created a relative humidity gradient, from top surface to bottom surface of the deck concrete, of approximately 25 to 30 percent. Prior to this rain event, the ambient relative humidity was generally low, and the concrete surface relative humidity dropped below the mid-depth relative humidity, and an approximate 5 to 10 percent relative humidity gradient was measured between the top and bottom of the deck. After the rain event, the surface of the deck went to 100 percent relative humidity and the bottom increased to 70 to 75 percent relative humidity.

This particular rain event was one of the more extreme examples of ambient relative humidity changes observed in the data; but daily ambient relative humidity changes of 40 to 50 percent during the spring and summer months were common. The implications of these high daily relative humidity changes are further analyzed in Item 4.5b (page 122) and are of significant importance for alpine bridges in Montana.

Figure 2. Graph shows the ambient and internal concrete relative humidity measurements at Location 4 during early June .RH probe 4-1 represents the bottom side of the deck and probe 4-3 represents the top side of the deck, with 4-2 in the middle.

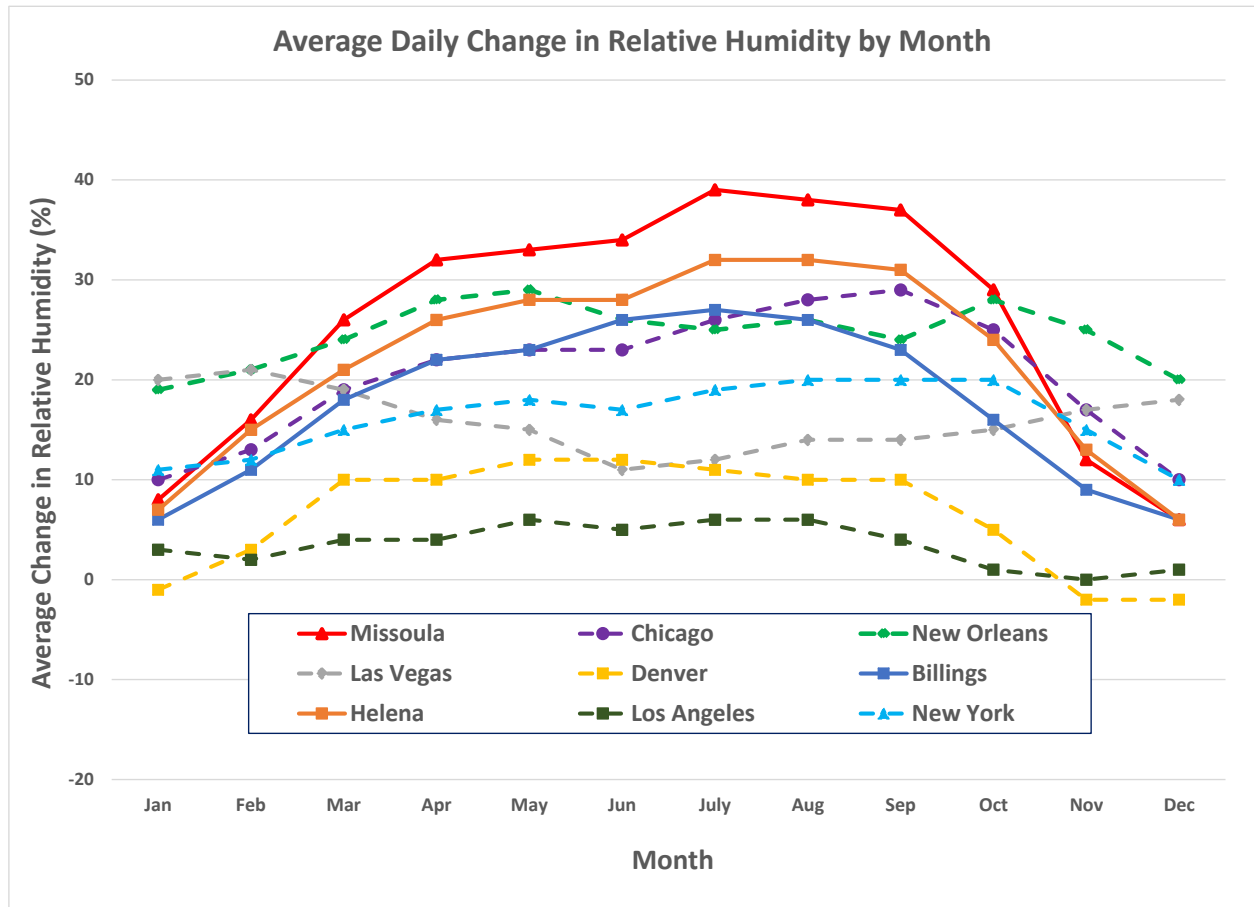
Based on research performed by WJE [9], the large ambient relative humidity changes and potential for significant moisture gradients within the deck may be somewhat unique to certain areas of Montana. In Figure 3, the average daily ambient relative humidity swings by month is presented for Montana as compared to other US cities. This chart shows the average absolute daily change for each month (i.e., the absolute daily ambient relative humidity changes, whether positive or negative, are averaged over the month and plotted). Missoula shows the highest average daily ambient relative humidity change during March through October as compared to any other US city. Helena and Billings show similar high ambient relative humidity changes compared to other US cities but not to the extent as Missoula.

Figure 3. Average daily changes in ambient relative humidity by month for Missoula, Helena, and Billings compared to other cities in the US.

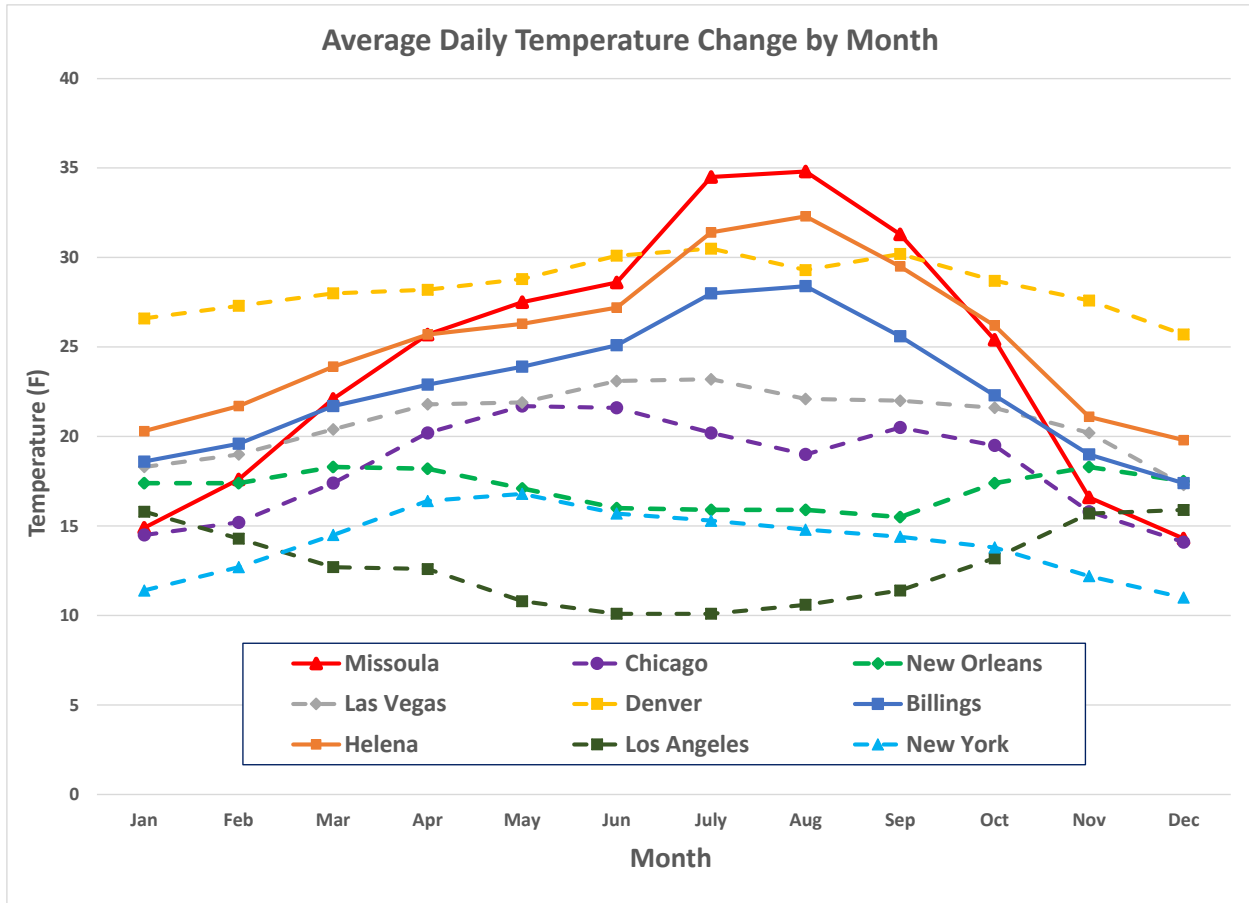
As previously researched and discussed by WJE in April 21, 2017, daily ambient temperature variations in Montana can regularly exceed 30°F (17°C) in summer months (Figure 4) with extremes reaching 55°F (30°C), giving rise to thermal gradients within placed bridge decks. These thermal gradients and associated stresses may be additive or subtractive to the stresses created by humidity gradients. In Figure 4, the average daily temperature changes per month is plotted for various cities in the US, including Missoula, Helena, and Billings. The ambient changes of parts of Montana are most extreme during the summer months. Other areas of the country, like Denver, have yearly fluctuations on average higher but do not reach these extremes.

Figure 4. Average daily temperature changes by month for various cities in the US.

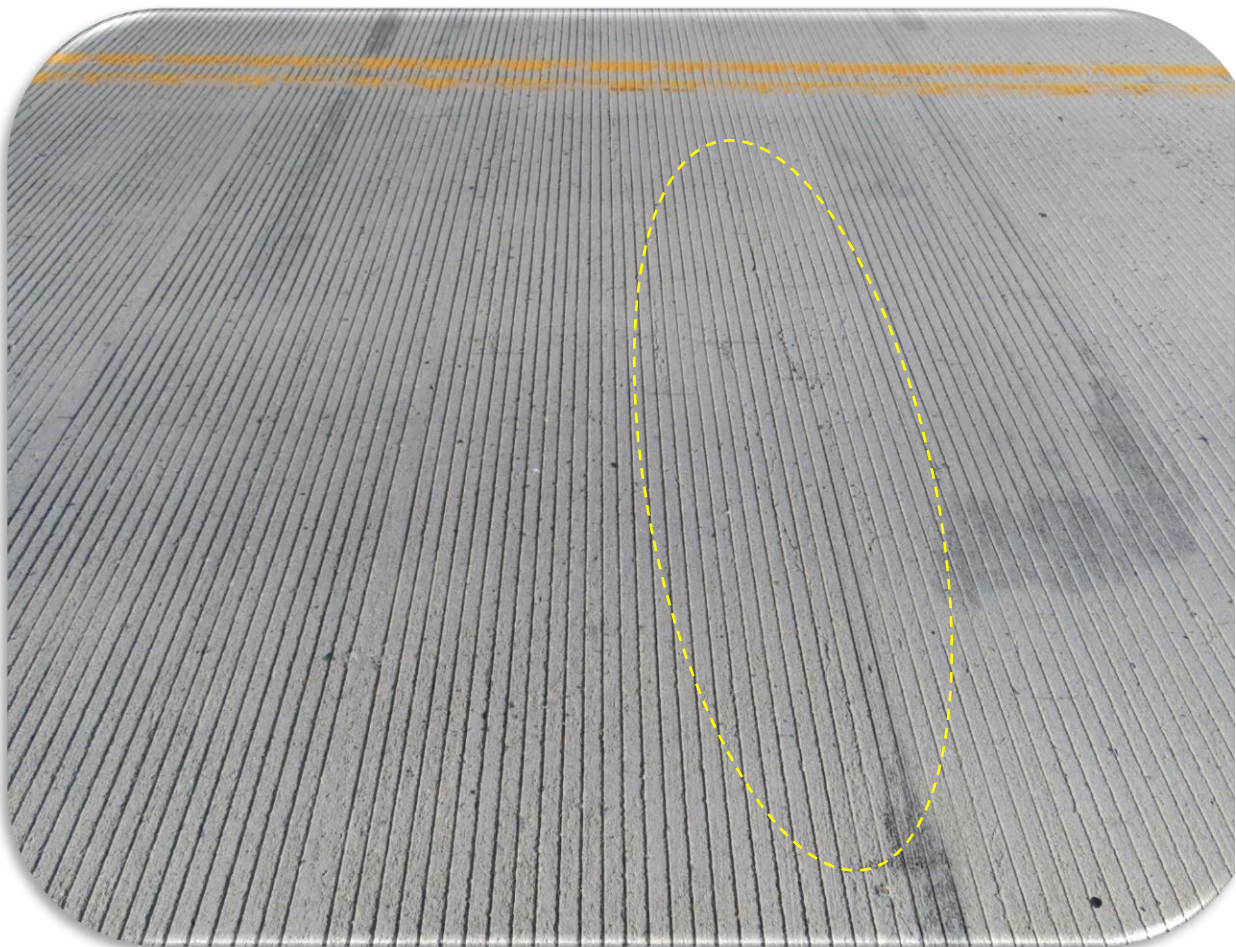
This bridge deck has the same overall rating of 1 as in the 2019 inspection.

Figure 16. Garrison Bridge - 2020 inspection - Deck topside showing a cluster of fine transverse cracks.

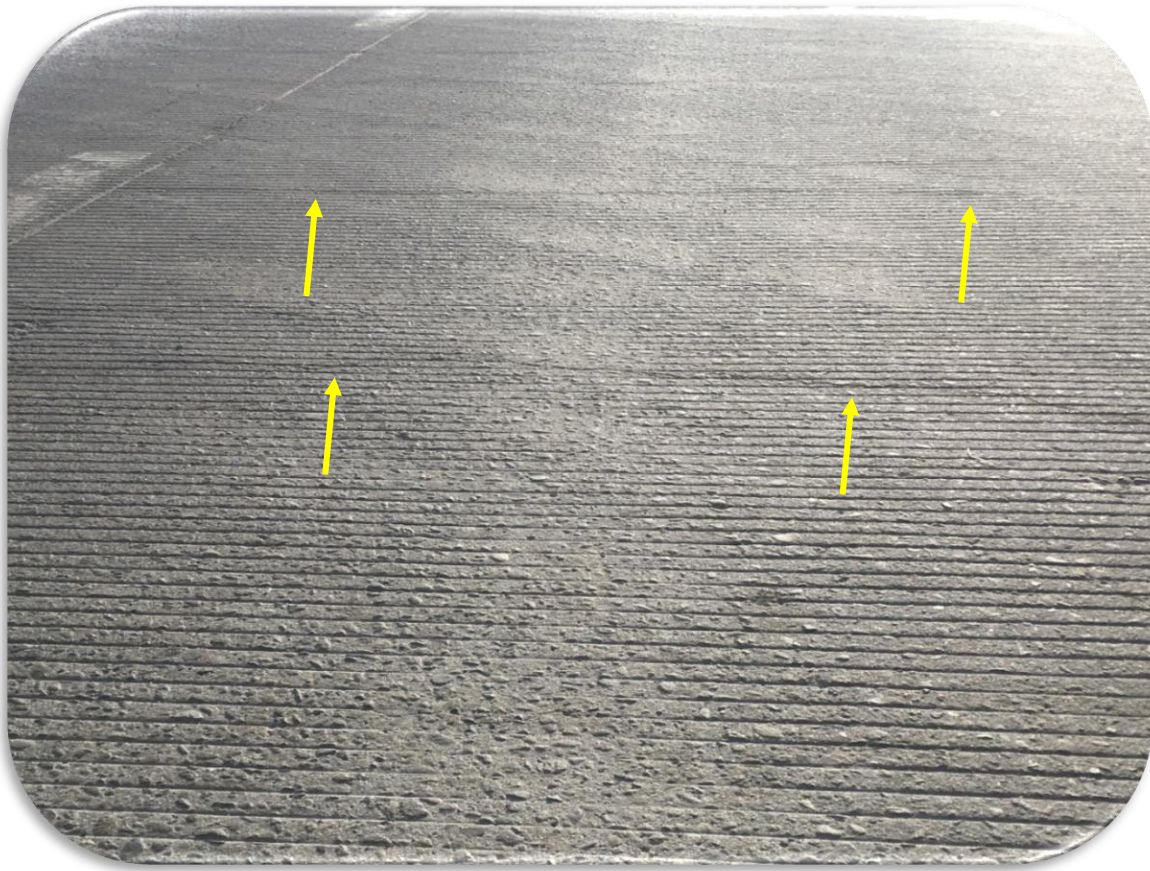
This bridge has an overall rating of 4.

Figure 21. Capitol-Cedar Bridge Phase I (NB)- Typical deck topside transverse cracks, Placement 3.

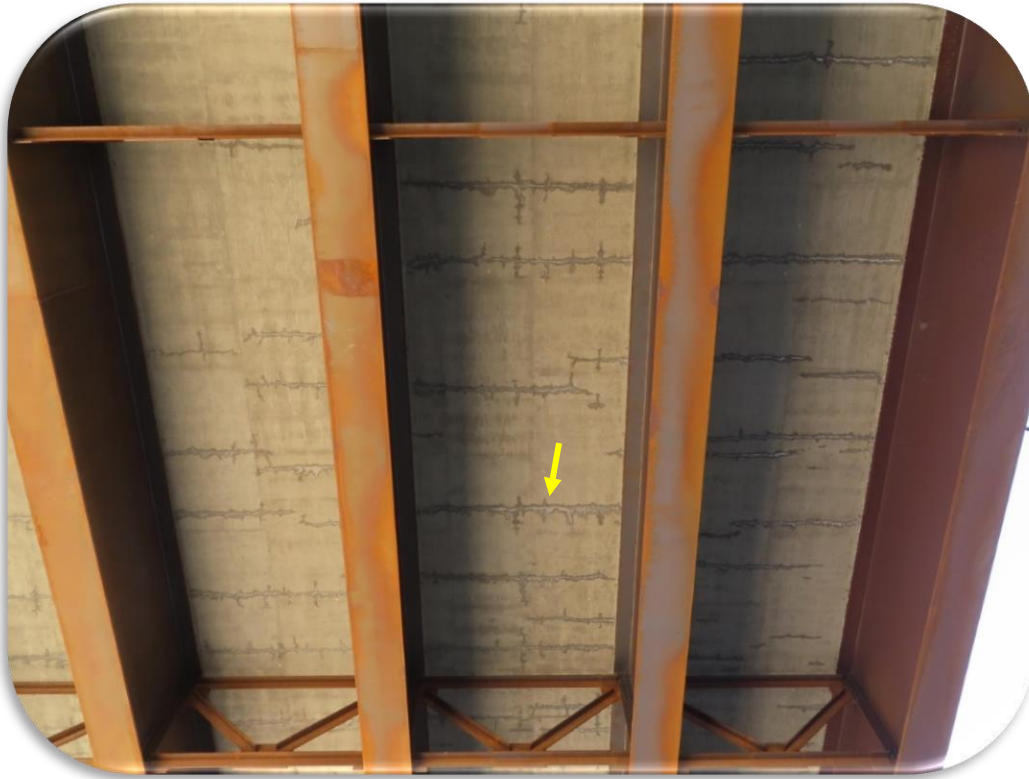
This bridge has the same overall rating of 4 as in the 2019 inspection.

Figure 25. Capitol-Cedar Bridge Phase I (NB) - 2020 inspection - Typical deck underside transverse cracks. The arrow points to the same transverse crack noted in Figure 22.

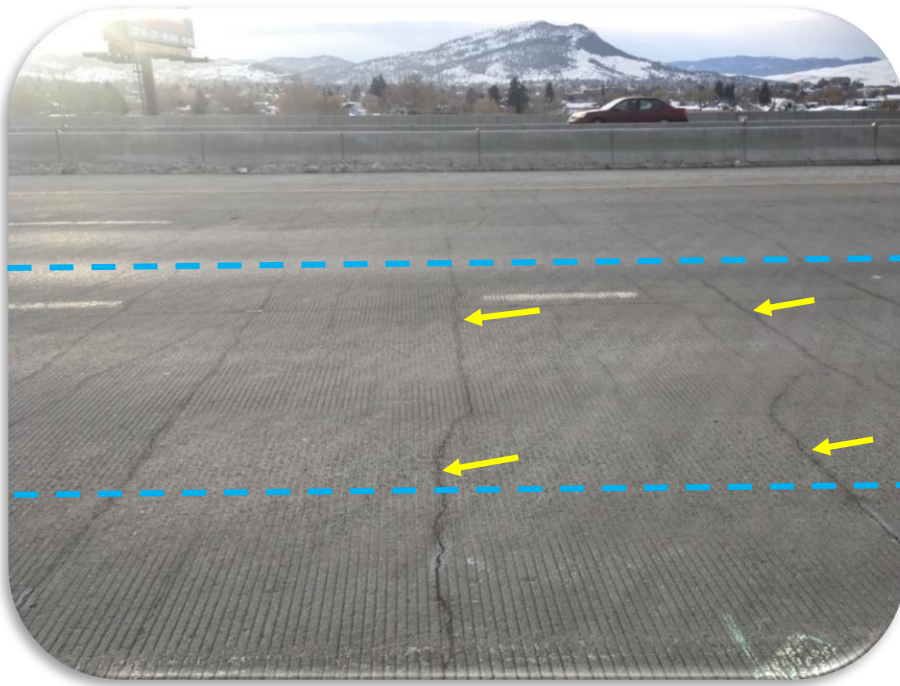
This bridge has an overall rating of 3.

Figure 26. Capitol-Cedar Bridge Phase II (SB) - 2019 inspection. Typical deck topside transverse cracks at arrows. Blue dotted lines indicate approximate locations of two adjacent steel girders.

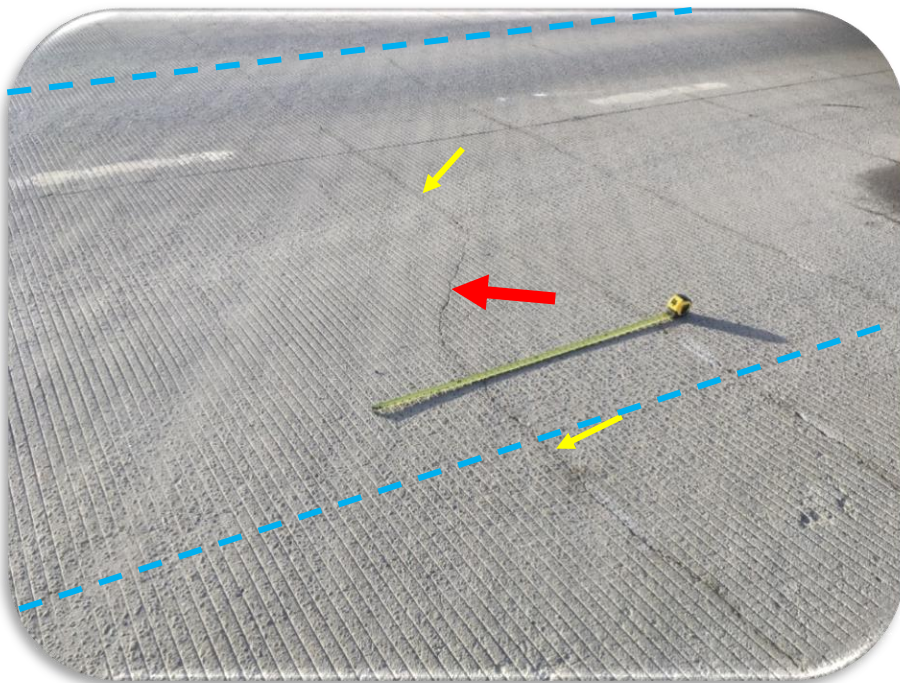
Figure 27. Capitol-Cedar Bridge Phase II (SB) - 2019 inspection. Jump (transverse) crack at arrows. Red arrow indicates the "jump" part. Blue dotted lines indicate approximate locations of two adjacent steel girders.

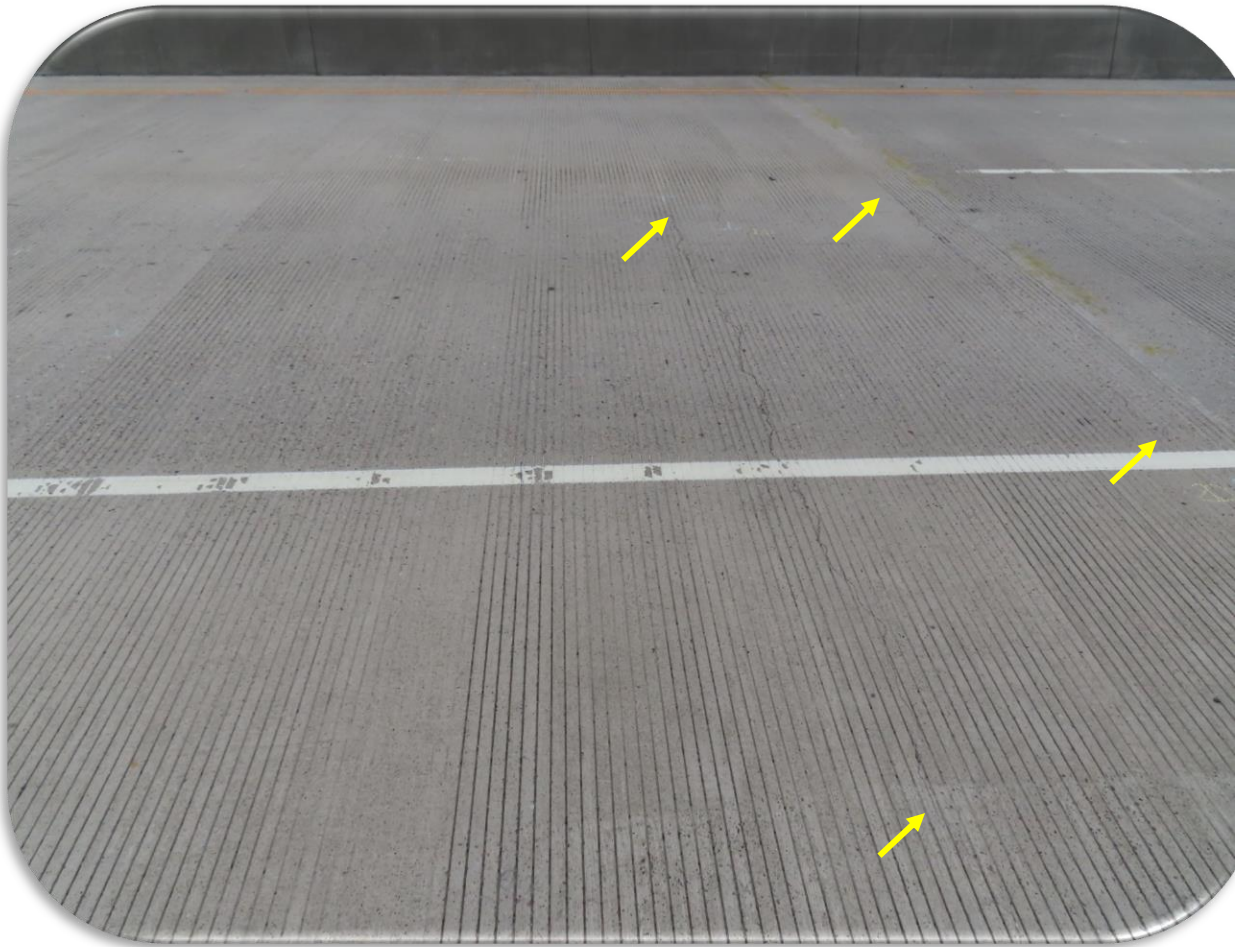
➢   Span 3: minimal cracking except just west of transition area from Placement 2 to Placement 5.

This bridge has the same overall rating of 1.5 as in the 2019 inspection.

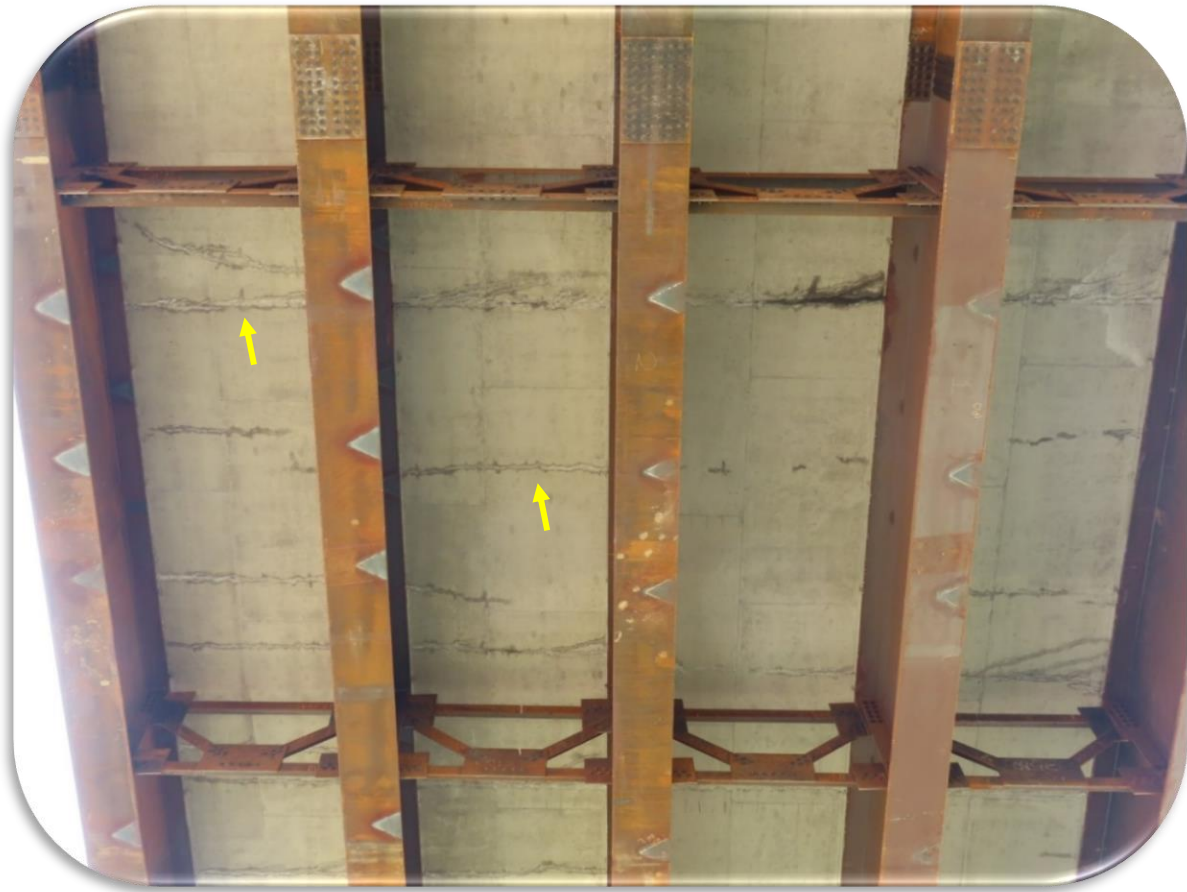
This bridge has an overall rating of 1.

Figure 40. Underside of Rarus/Silver Bow Creek Bridge B - 2020 inspection - Span 1, Typical transverse crack at arrows.

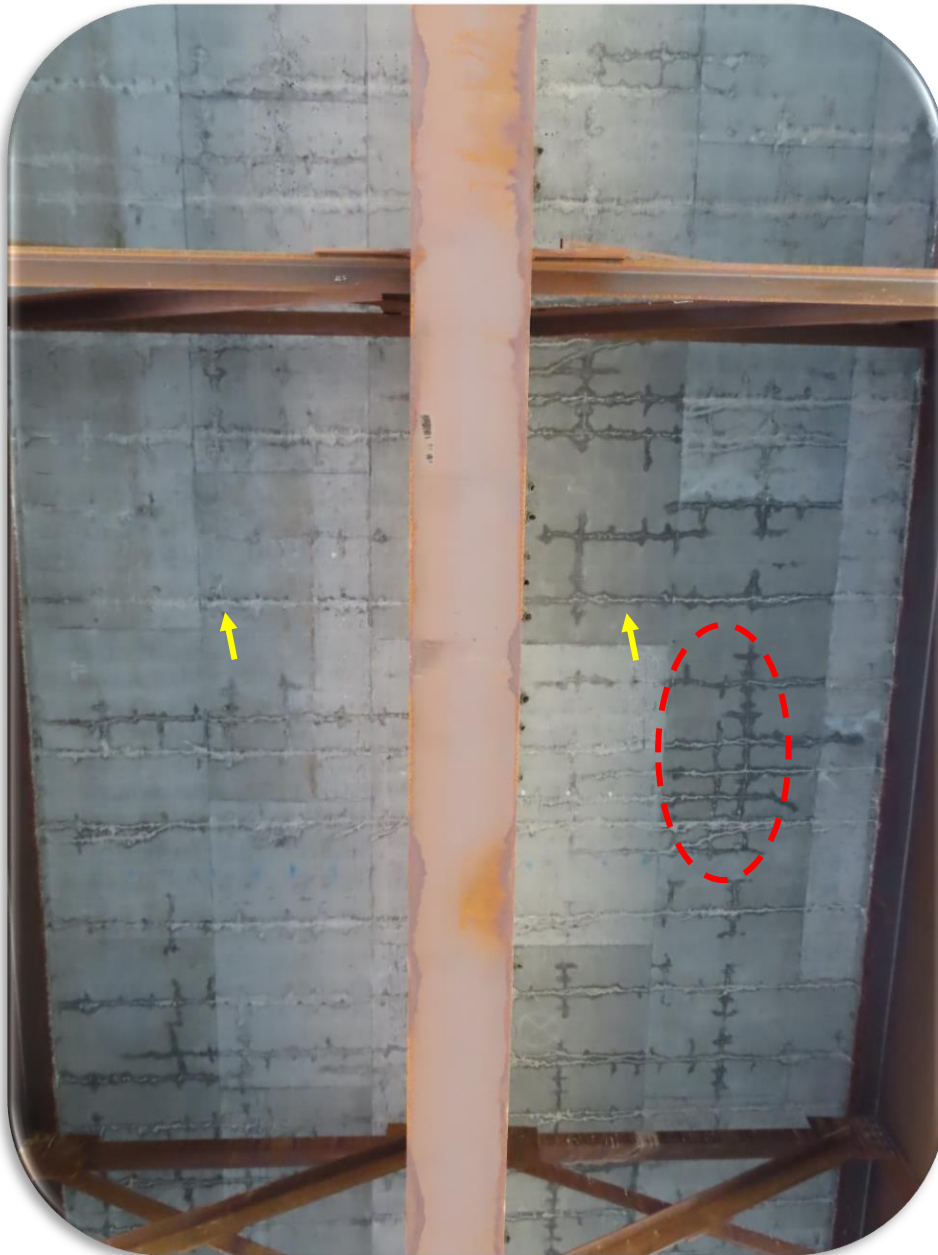
This bridge has the same overall rating of 3 as in 2019 inspection.

Figure 50. West Laurel Interchange - Phase II - 2020 inspection - Placement 1. Typical transverse crack at arrows.

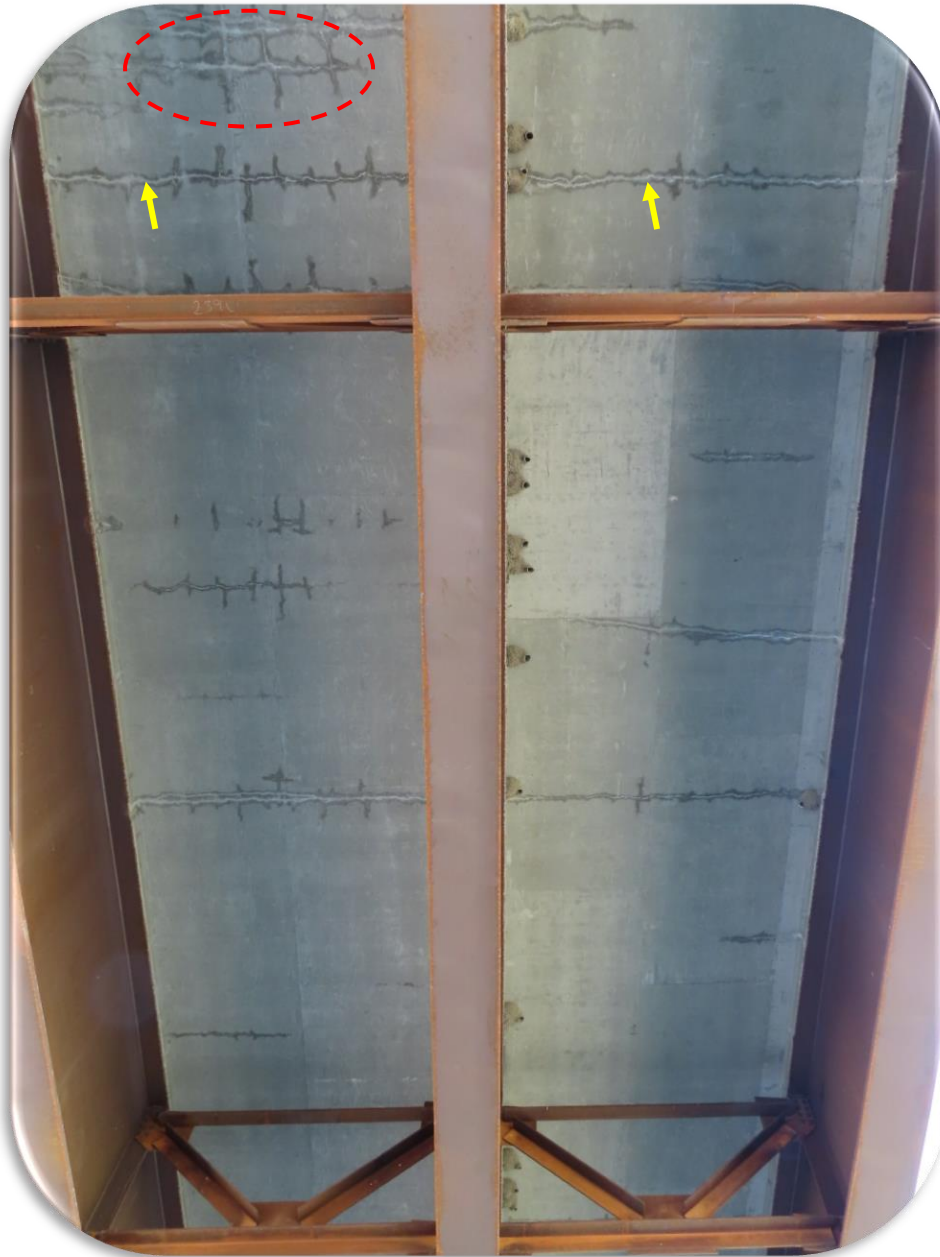
Figure 51. West Laurel Interchange - Phase II - 2020 inspection - Placement 2. Typical transverse crack at arrows. Red oval indicates an area with intersecting cracks.

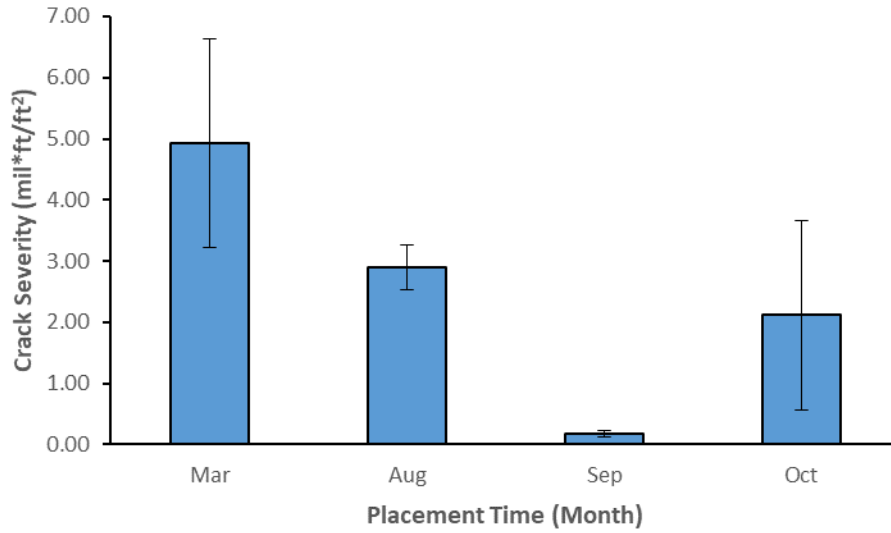
Crack density and crack severity data was summarized by placement time (month) in Table 16, and presented graphically in Figure 52 and Figure 53. Based on these table and figures, placement time appears to have an impact on deck cracking. Decks placed in colder weather (March) exhibited more severe cracking than those placed in warmer weather (June, August, and September). Possible causes for the more severe cracking at the March placements (all Russell Street bridges) include the low ambient temperatures, the use of heating hoses, heating from the top, removal of heating, or the combined effect. This is discussed in the next section.

Figure 52. Deck placement time vs crack density. Each error bar indicates ±one standard deviation.

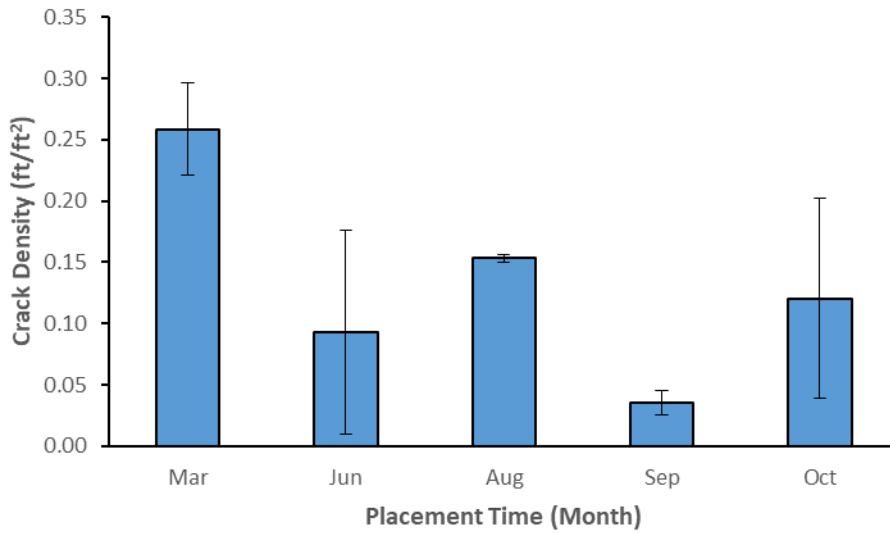
Figure 53. Deck placement time vs crack severity. Each error bar indicates ±one standard deviation.

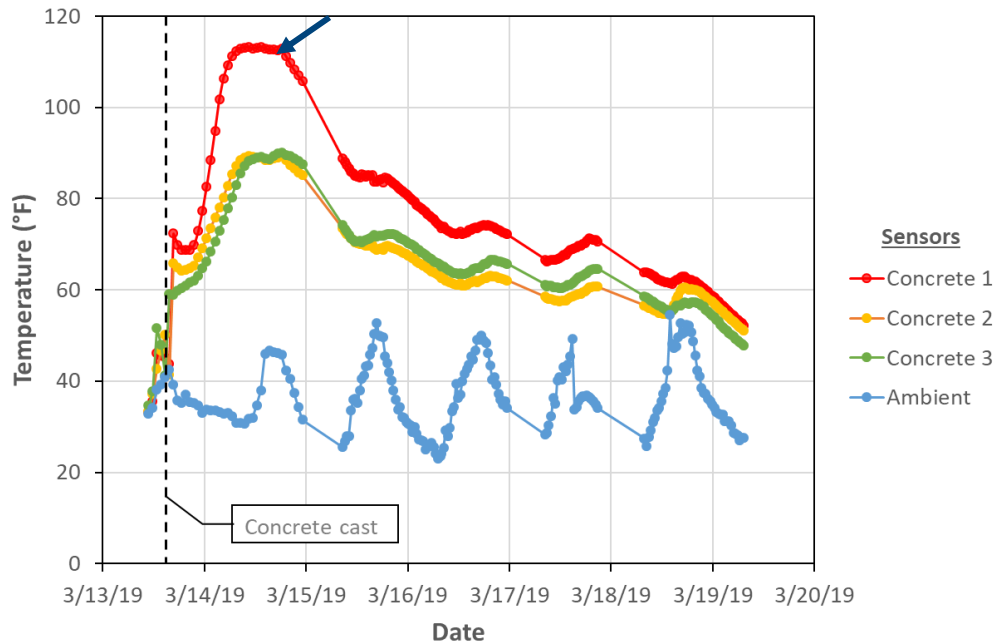
Based on these table and figures, more severe cracking appeared to occur in deck placements that had greater ΔT_{ca} and ΔT_{cc}. It is worth noting that the most severe cracking occurred at the Russel Street Bridge Phase I where the larger differences in concrete temperatures, particularly Placement 1, was possibly due to the early installation of heating hoses on top of the deck as discussed above. It is possible that the concrete temperature gradients over the deck thickness due to uneven heating during curing resulted in early-age cracks (see Field Inspections section for reported cracking after curing materials were removed), and those cracks have widened due to subsequent thermal and shrinkage movements.

Figure 55. Curing temperature data with heating hoses on top of concrete. Russell Street Bridge Phase I (NB), Placement 1, sensor location 3. Arrow indicates unusually high temperatures in one concrete sensor, possibly due to uneven heating.

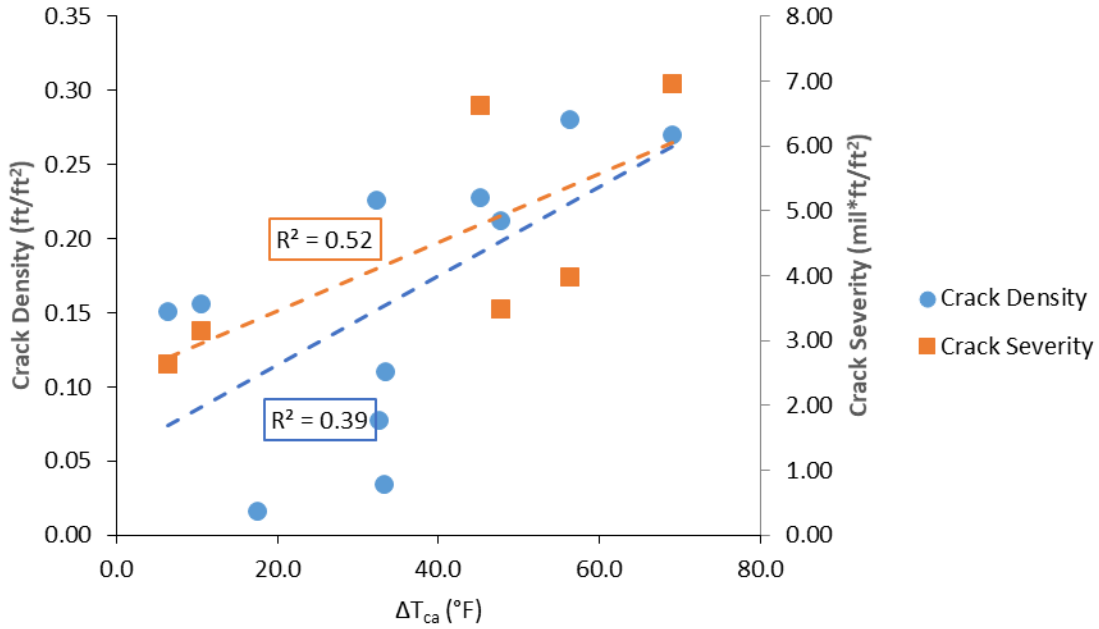
Figure 56. ΔT_{ca} vs Crack Density/Severity.

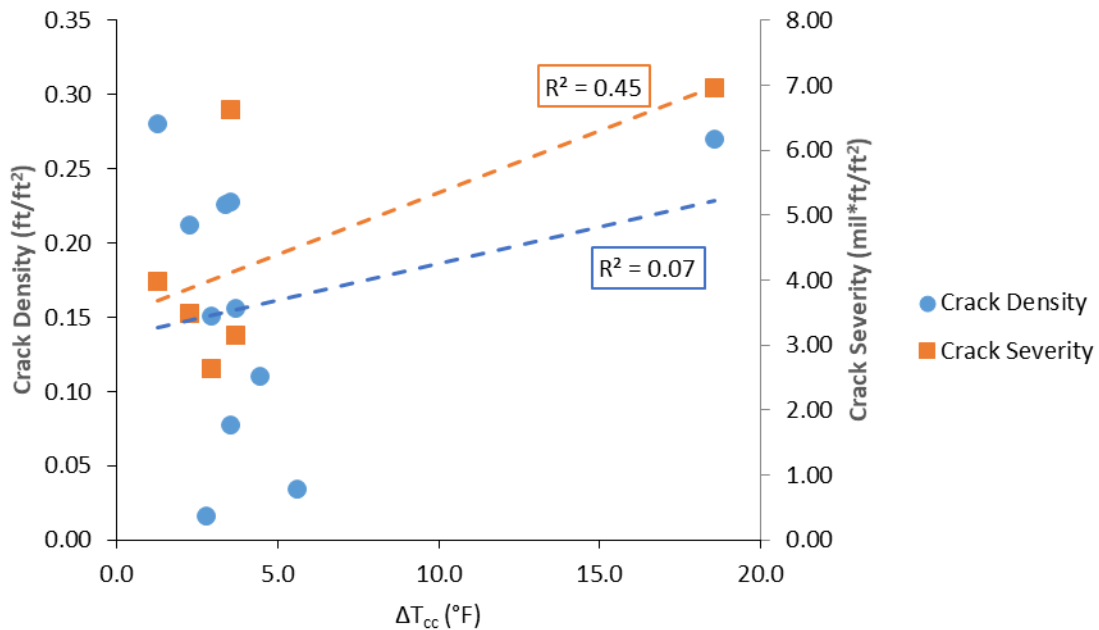
Figure 57. ΔT_{cc} vs Crack Density/Severity.

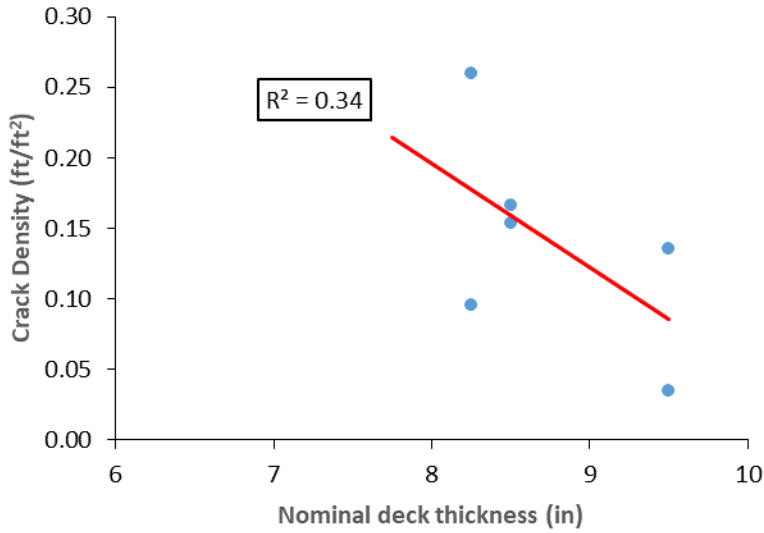
Plots of deck thickness versus crack density and crack severity are presented in Figure 58 and Figure 59. Based on these figures, thinner decks appear to exhibit more severe cracking.

Figure 58. Deck Thickness vs Crack Density. Each data point represents one bridge.

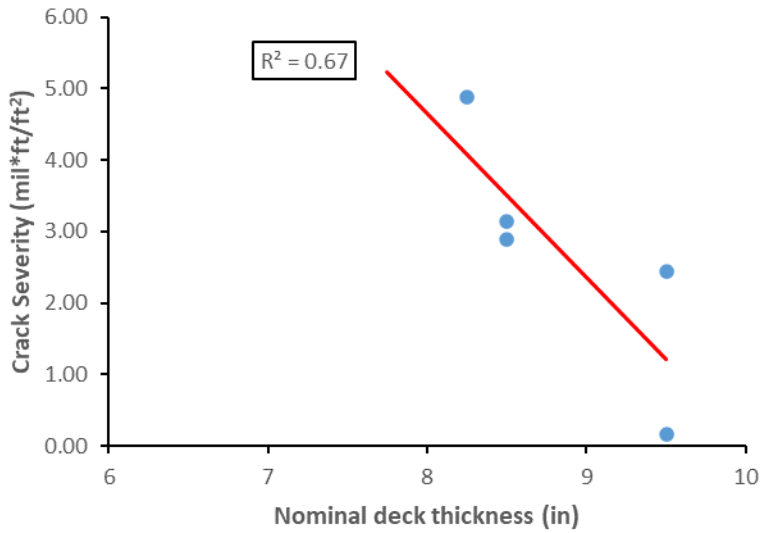
Figure 59. Deck Thickness vs Crack Severity. Each data point represents one bridge.

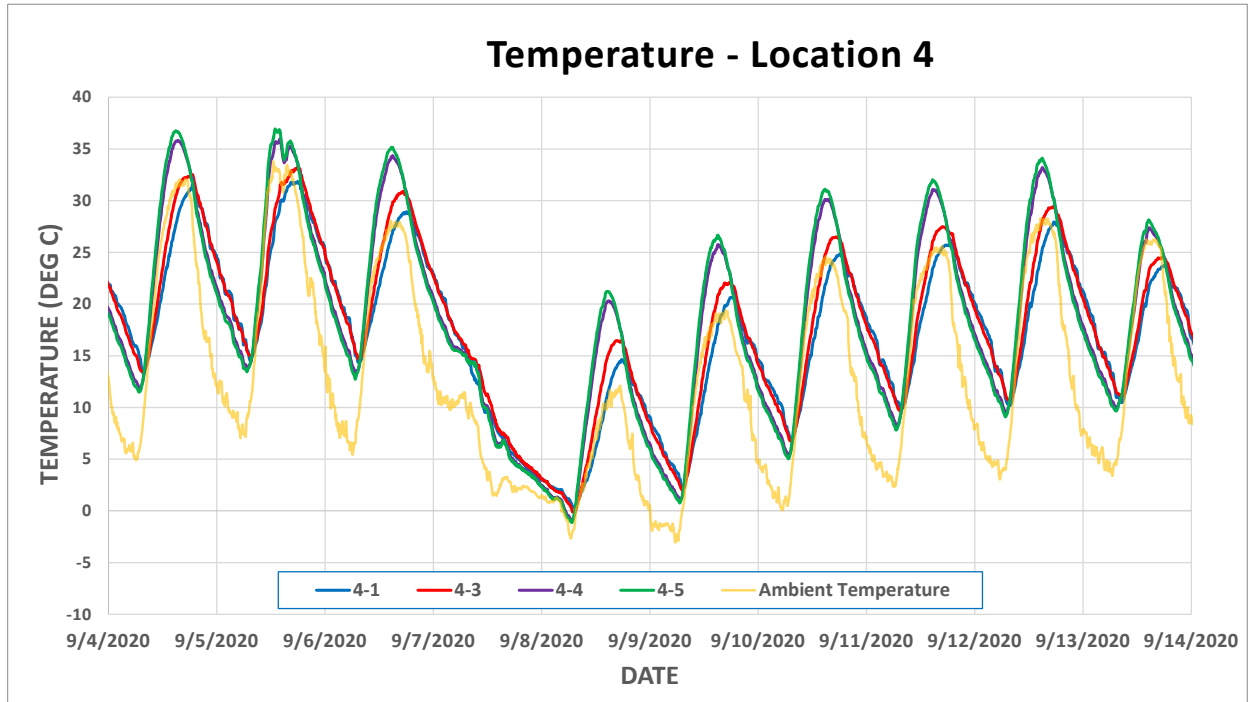
3. Large daily ambient temperature changes were observed with associated temperature gradients within the deck, with changes being most pronounced during the summer and early fall months. For example, in early September of 2020, ambient temperature increases and decreases of 55 to 60°F (30 to 33°C) were observed (see Figure 78). In this chart, the internal deck temperatures were measured at five depths through the concrete deck at location No. 4, with 4-5 being at the top of the deck and 4-1 being at the bottom of the deck (4-4 and 4-3 are middle of the deck). These large ambient temperature changes create temperature gradients within the concrete deck, primarily during the heating of the top side of the deck. This time period is an example of a relatively extreme event; however, ambient temperature variations during the summer and fall months are commonly 35 to 45°F (19 to 25°C). The implications of these large ambient temperature variations are further discussed and analyzed in the finite elemental modeling section.

Figure 78. Ambient and internal deck concrete temperatures measured at Location No. 4, early September of 2020.

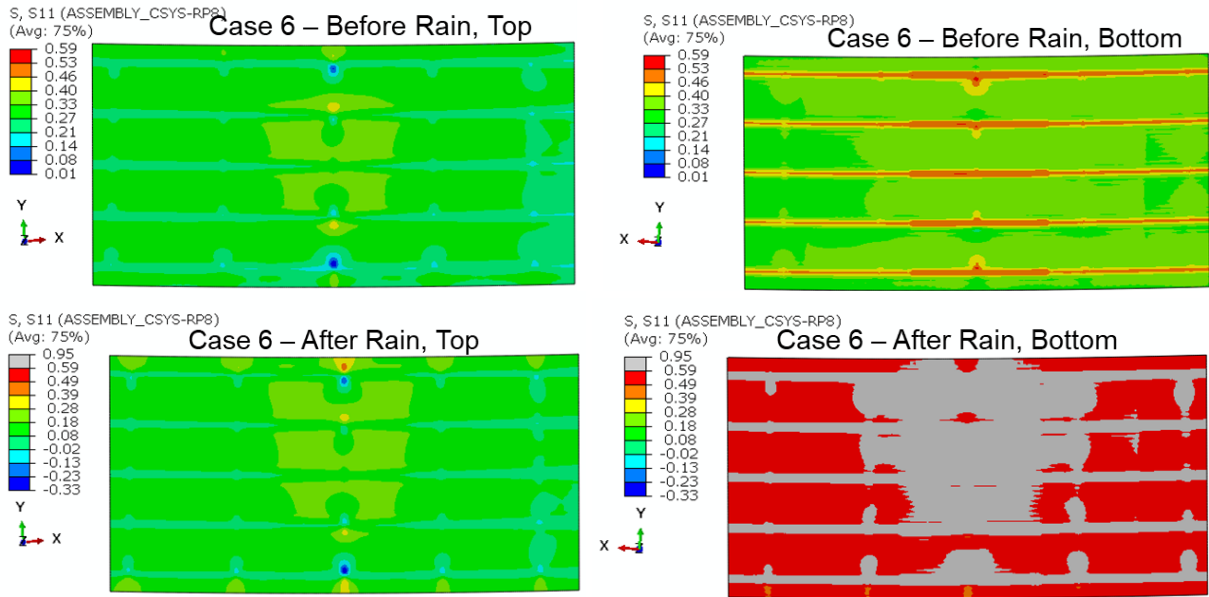
To translate the RH data to FE model input, the cross-sectional RH measurements from top to bottom were first converted to shrinkage strain forms using Equations (3) and (4) then to equivalent temperatures by dividing to the CTE of concrete. Figure 107 shows the longitudinal stress contours on the bridge deck top and bottom in Pour 7 due to nonuniform RH gradient before and after the rain event discussed above. Before the rain event, the concrete RH difference between the top and bottom was relatively small in the range of 10 to 13 percent. After the ambient RH rose to 100 percent due to rain, the top surface RH also rose to 100 percent (a 53 percent increase). The bottom surface on the other hand reached 74 percent RH level, leaving a significant 26 percent RH difference between the top and bottom of the deck. As a result, higher shrinkage strains were expected to occur at the bottom rather than the top, leading to a substantial increase in tensile stresses at the deck soffit as shown in Figure 107. This is analogous to bottom layers cooling down with a higher rate relative to top layers of the deck that would lead to a similar conclusion. It is noted that no thermal strains were included in this particular load case and only the effect of cross-sectional RH gradient was studied. The thermal strains effect can be additive or subtractive which is discussed next. The tensile stresses observed at the bottom of the deck tend to be higher than concrete tensile strength particularly near the pier center line and at the lateral bracing locations solely from the moisture gradient observed that could lead to crack initiations in these regions.

Figure 107. Longitudinal stress contours are shown for Pour 7 before and after a rain event. The stress unit is ksi with positive indicating tensile stress.

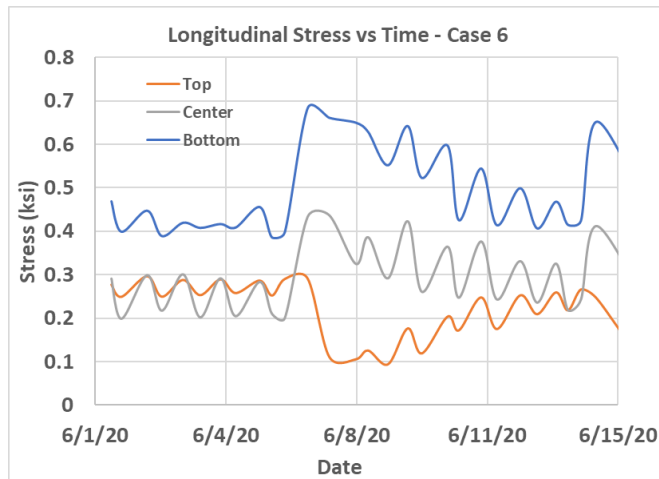
The longitudinal stresses were averaged across the pier centerline and compared in Figure 108 for top, center, and bottom of the deck cross-section. Several elements were selected near girders and between girders to capture the higher and lower stress regions in the averaging. The FE model prediction showed that right after the rain event (June 6th) the tensile stress as high as 700 psi can develop at the bottom layers reducing to 450 psi at the centroid. About 8 days after the rain, the ambient RH dropped back to the 20 percent range, causing the top deck to undergo more shrinkage relative to the centroid and bottom leading to $\Delta\sigma = +200$ psi in this time frame.

Figure 108. Predicted average longitudinal stress is shown for the nonuniform RH gradient load case (Case 6). The stress unit is ksi with positive indicating tensile stress.

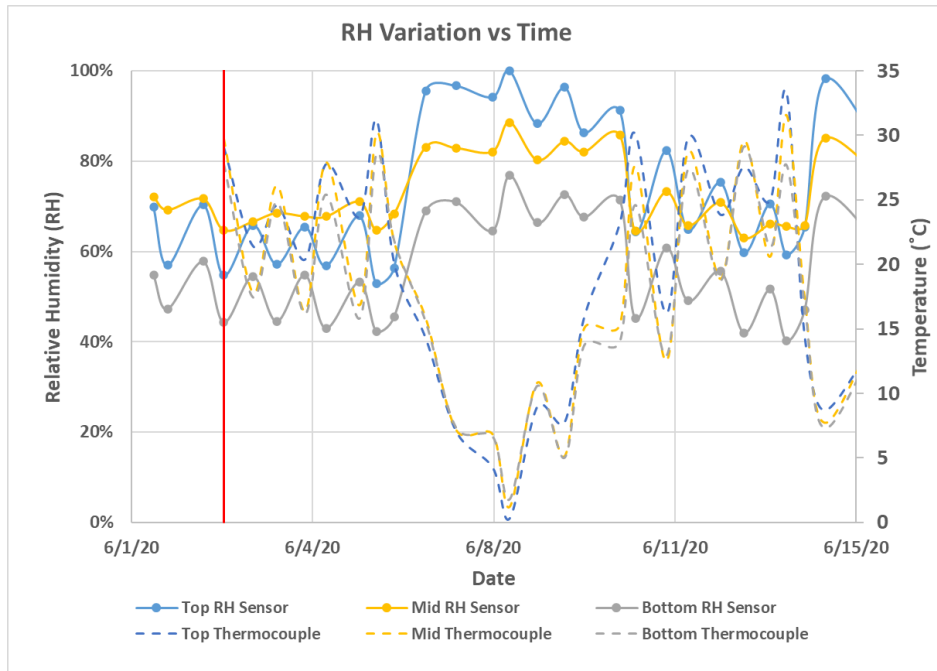
Figure 109. Deck cross-sectional RH and temperature variation recorded in early June 2020. The red line indicates the starting point of the analysis Case 7 where a zero stress state was assumed.

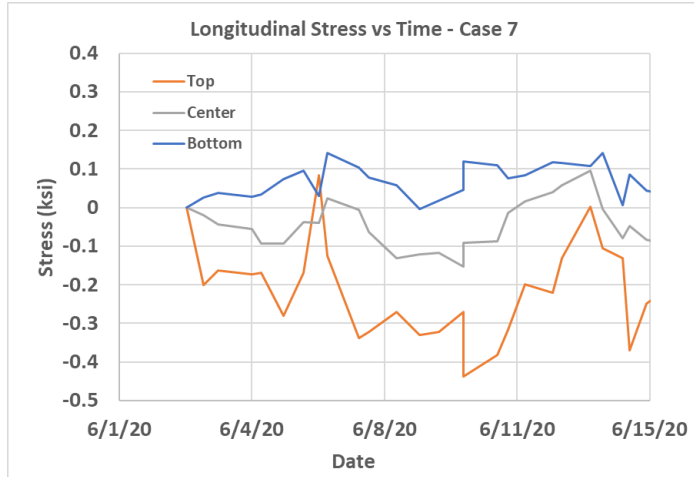
The longitudinal stresses were averaged across the pier centerline and compared in Figure 110 for top, center, and bottom of the deck cross-section. Several elements were selected near girders and between girders to capture the higher and lower stress regions in the averaging. The previously observed higher tensile stresses after the first rain event at the bottom and mid-section of the concrete deck have now been countered by compressive stresses that developed due to decreasing deck temperature. The FE model prediction also showed a spike in the top section tensile stress right after the rain event. This higher

tensile stress coincided with the time when concrete was cooling down from a previous peak temperature and the time when concrete RH was sharply increasing.

Figure 110. Predicted average longitudinal stress is shown for the combined nonuniform RH and temperature gradient load case (Case 7). The stress unit is ksi with positive indicating tensile stress.
