BRIDGE DECK CRACKING EVALUATION

FHWA/MT-21-005/9696-700

Final Report

prepared for
THE STATE OF MONTANA
DEPARTMENT OF TRANSPORTATION

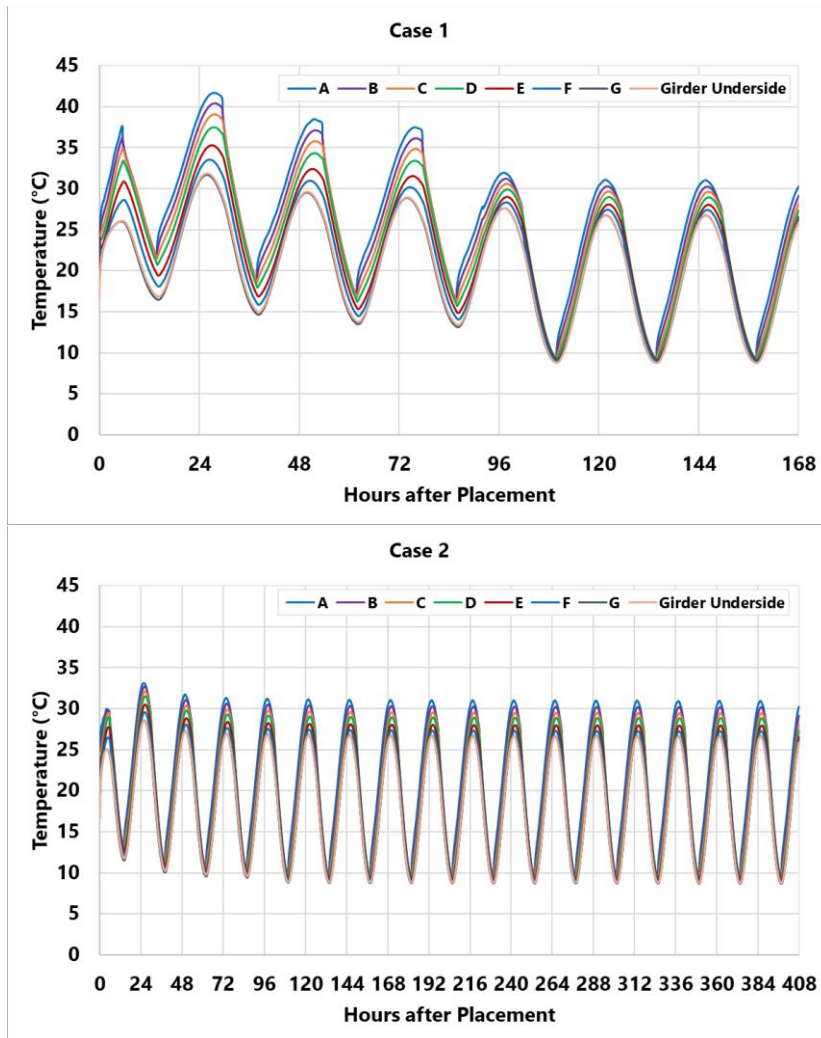
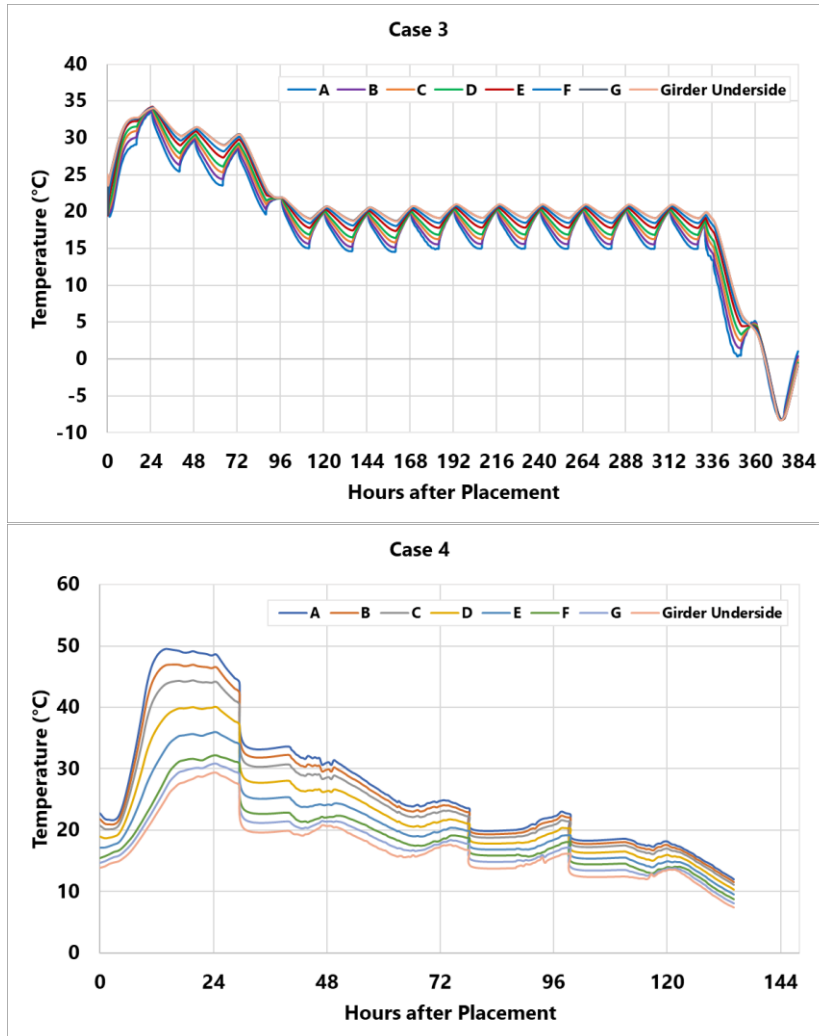
Figure 111 illustrates the cross-sectional temperature histories of the first two cases. The horizontal axis represents time in hours. Curves A to G correspond to deck top to bottom surfaces, respectively. The procedure to prepare the cross-sectional temperature inputs for the FE model was the same as previously discussed.

Figure 111. Case 1 and Case 2 concrete cross-sectional temperature cycles for summer placement scenarios. A to G represent deck top to bottom, respectively.

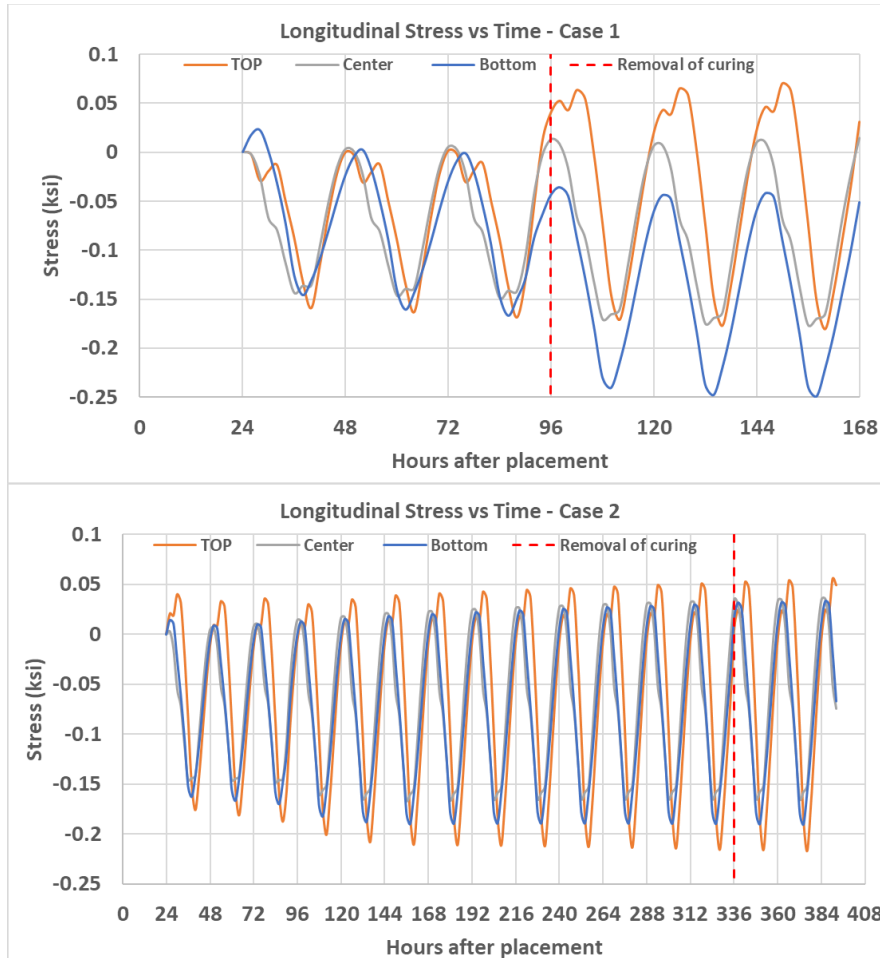
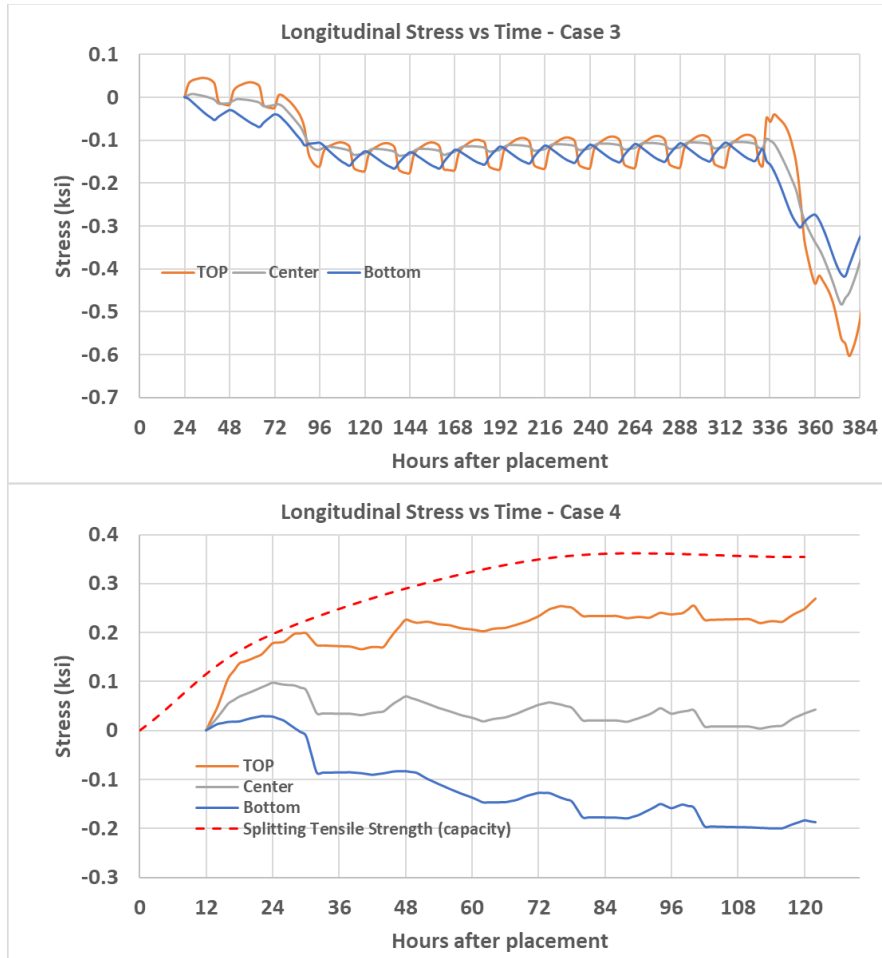
The longitudinal stresses were averaged across the pier centerline and compared in Figure 112 for the top, center, and bottom of the deck cross-section. Several elements were selected near girders and between girders to capture the higher and lower stress regions in the averaging. In the stress analysis of short-term cases, it was assumed that the first 24 hours was the zero-stress state in which no stresses could develop due to thermal straining. In Case 1, the FE model predicted little to no tensile stress within the 4-day curing period with insulation. The stress mode remained in the compression zone (negative stress) varying almost uniformly in this period with the peak to peak amplitude of about 150 psi ($\Delta\sigma_{max}$=150 psi). The average 5-day splitting tensile strength was 355 psi, so cracking would not be expected. Upon removal of insulation and exposure to ambient temperature at day 4, nonuniform stresses develop top to bottom with the top surface having a higher stress amplitude of 250 psi ($\Delta\sigma_{max}$=150 psi). The result of analysis Case 1 showed slight increase in tensile stresses after exposure to normal ambient temperatures. Analysis Case 2 on the other hand, showed a small tensile stress magnitude up to 40 psi from the first day of curing, however, the stress amplitude remained almost equal to the Case 1 result. The result of analysis Case 2 also showed no elevated tensile stresses after exposure to normal ambient temperatures.

Figure 112. Average cross-sectional longitudinal stress is shown for short-term analysis Case 1 and Case 2. The stress unit is ksi with positive indicating tensile stress.

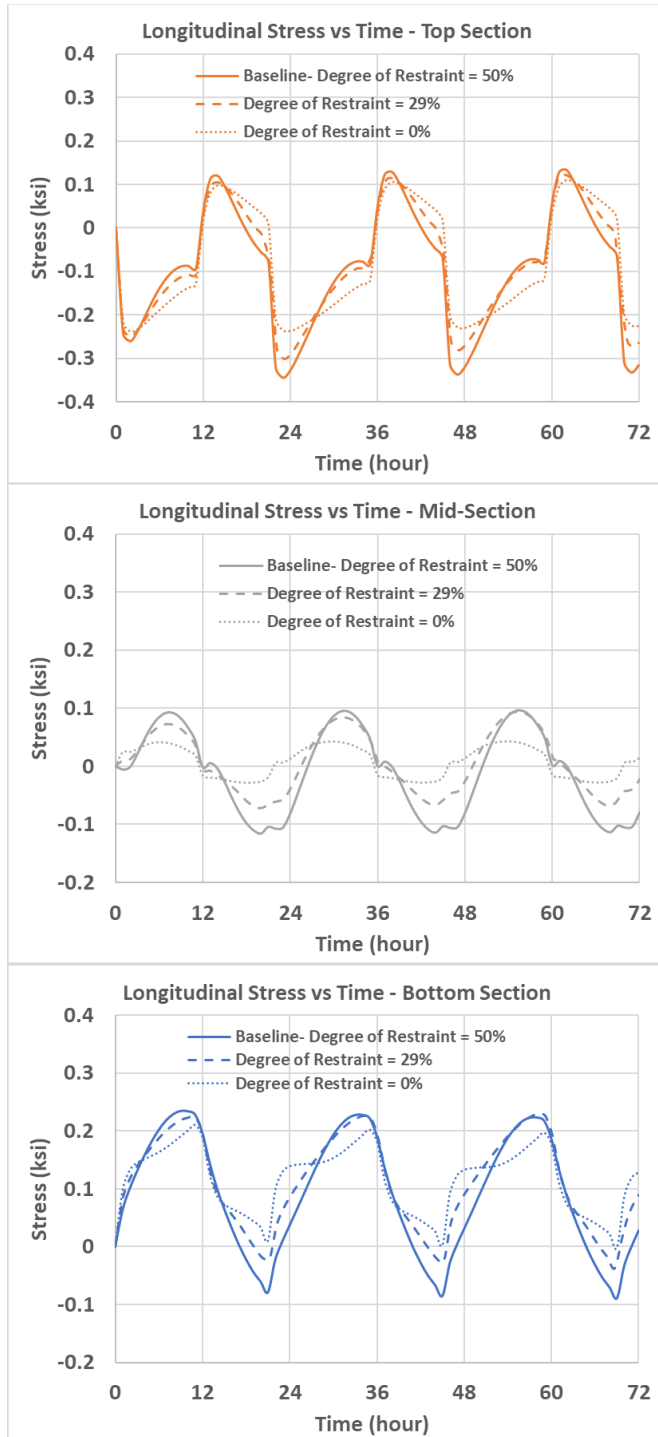
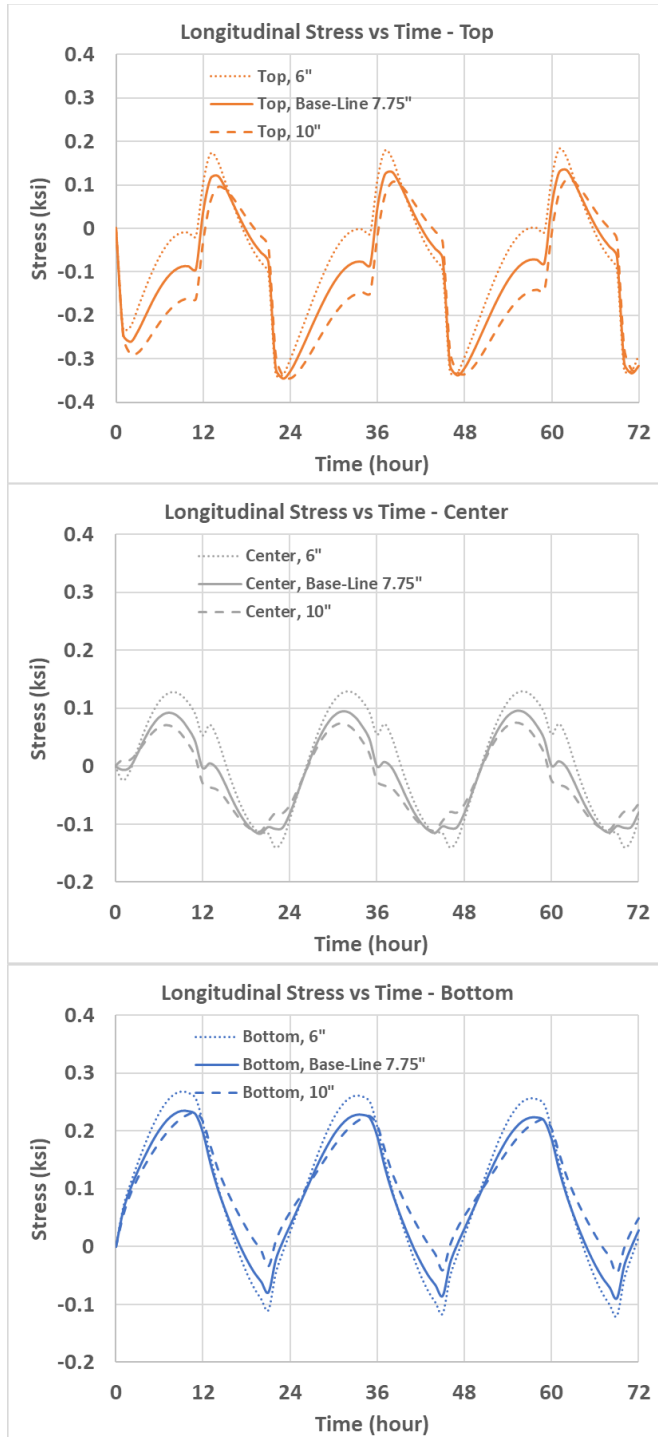
In each case, the longitudinal stresses were averaged across the pier centerline and compared in Figure 115 for top, center, and bottom of the deck cross-section. Several elements were selected near girders and between girders to capture the higher and lower stress regions in the averaging. This figure showed that with the same diurnal temperature changes, the stress amplitude (max stress - min stress) decreases with a decrease in the degree of constraint. The most reduction in stress amplitude was observed at the deck mid-section for the non-composite case. Previously, it was argued that the second jumps in the tensile stresses at the top surface (t=12, 36, 60 hours) was due to a nonuniform temperature gradient. It is shown here that the stress magnitudes after these jumps remained unchanged due to a change in the degree of restraint provided by girders. In other words, the main cause of the jumps, the internal restraint because of the temperature gradient, was unaffected. Table 34 summarizes the percent change in stress amplitude due to different degrees of constraint. It is noted that despite a reduction in stress amplitude in the non-composite deck section, it will be unfavorable to design a non-composite deck when subjected to vehicular live loads.

Figure 115. Average cross-sectional longitudinal stress is shown for different degree of restraints at the top, center, and bottom of deck cross section. The stress unit is ksi with positive indicating tensile stress.

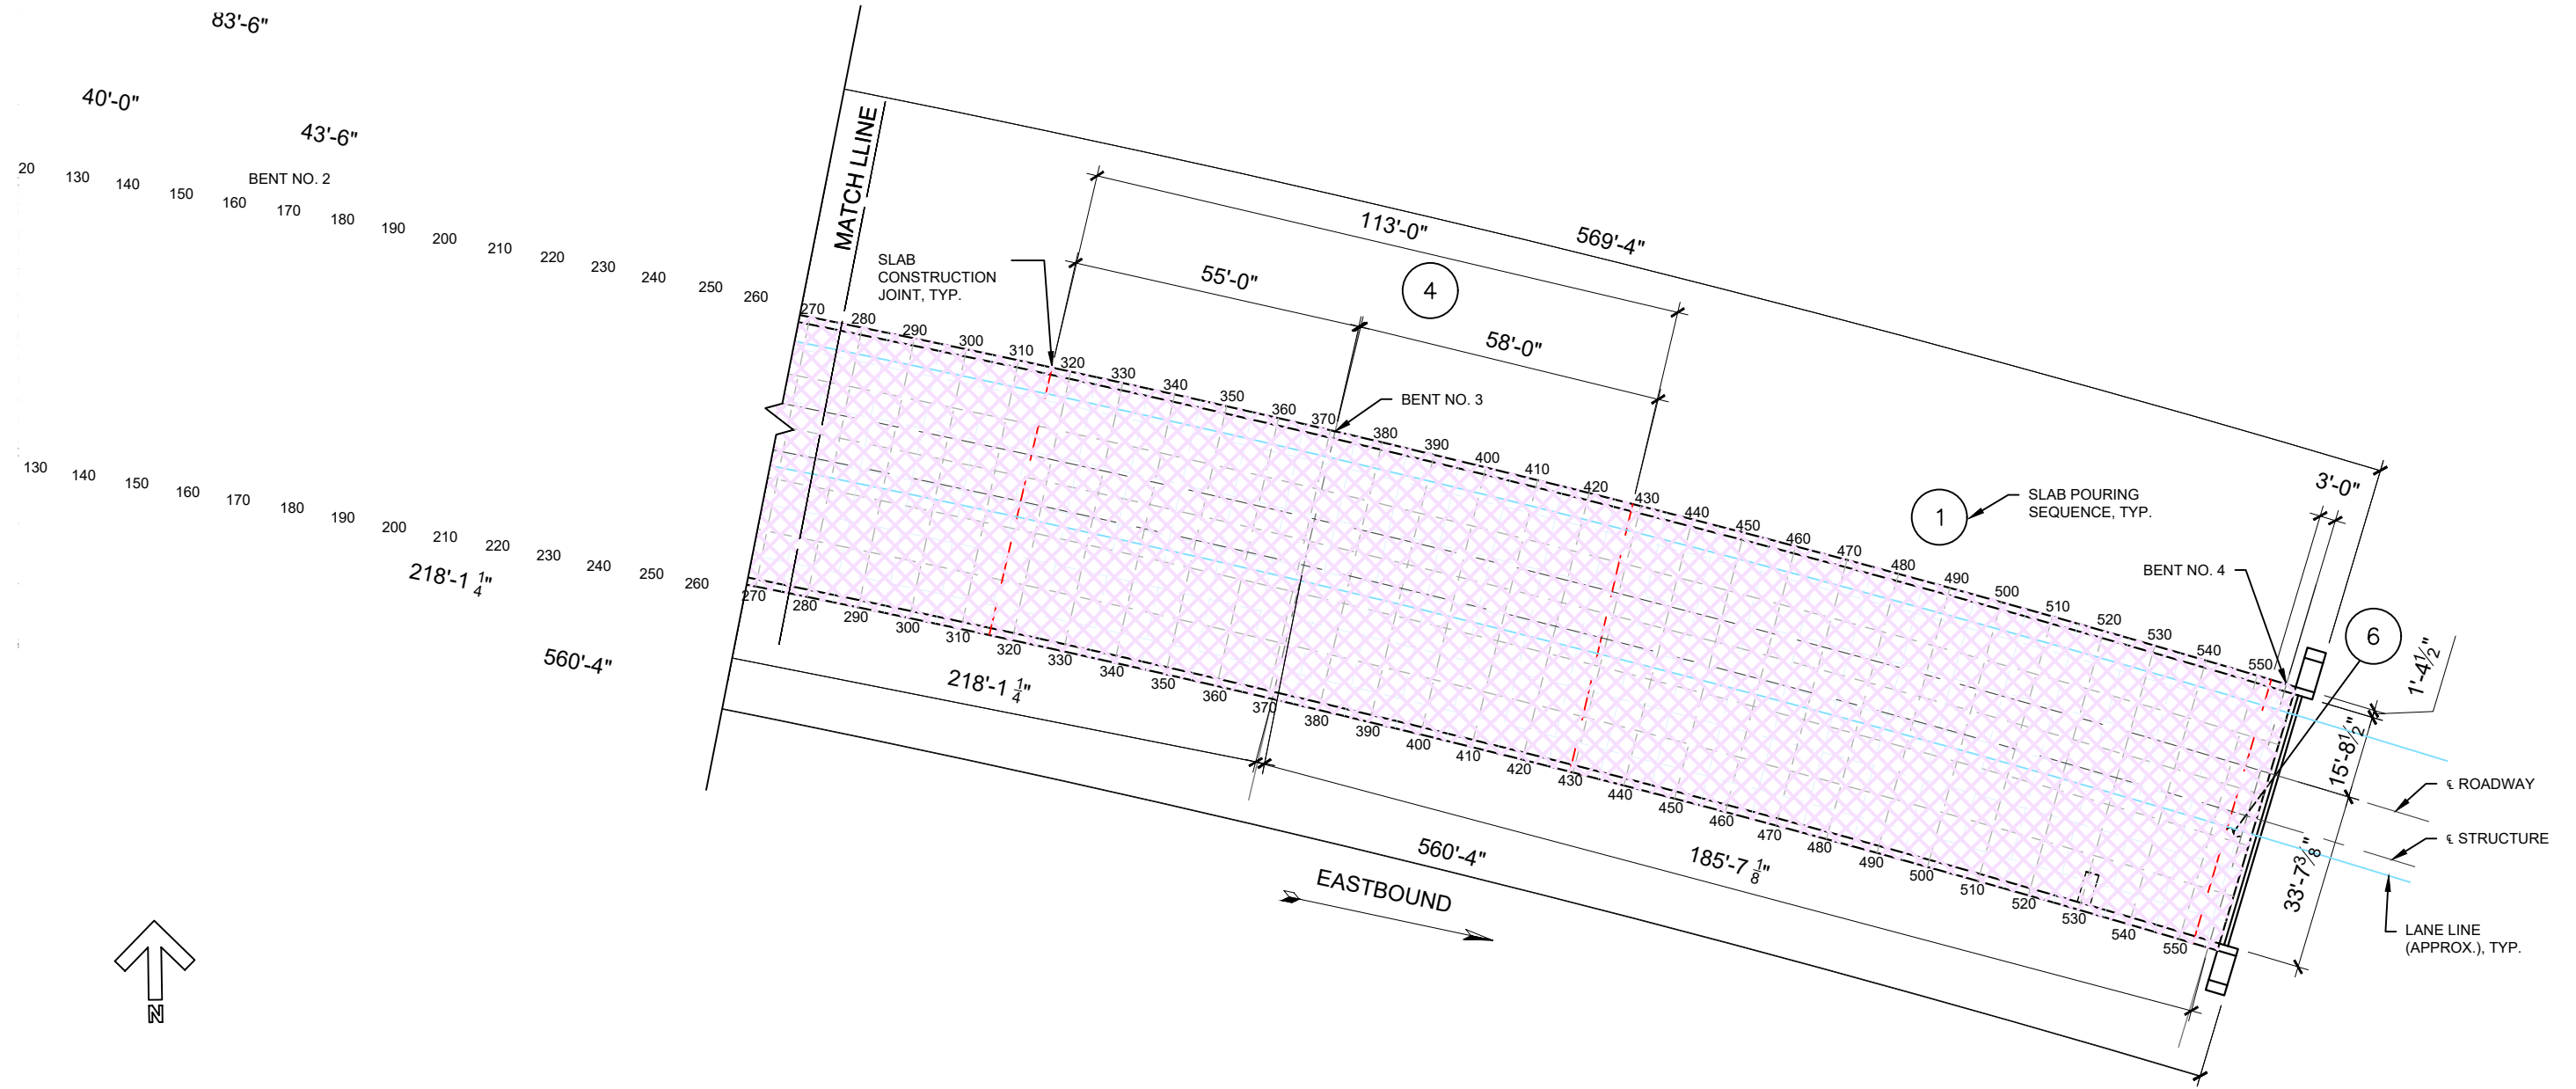
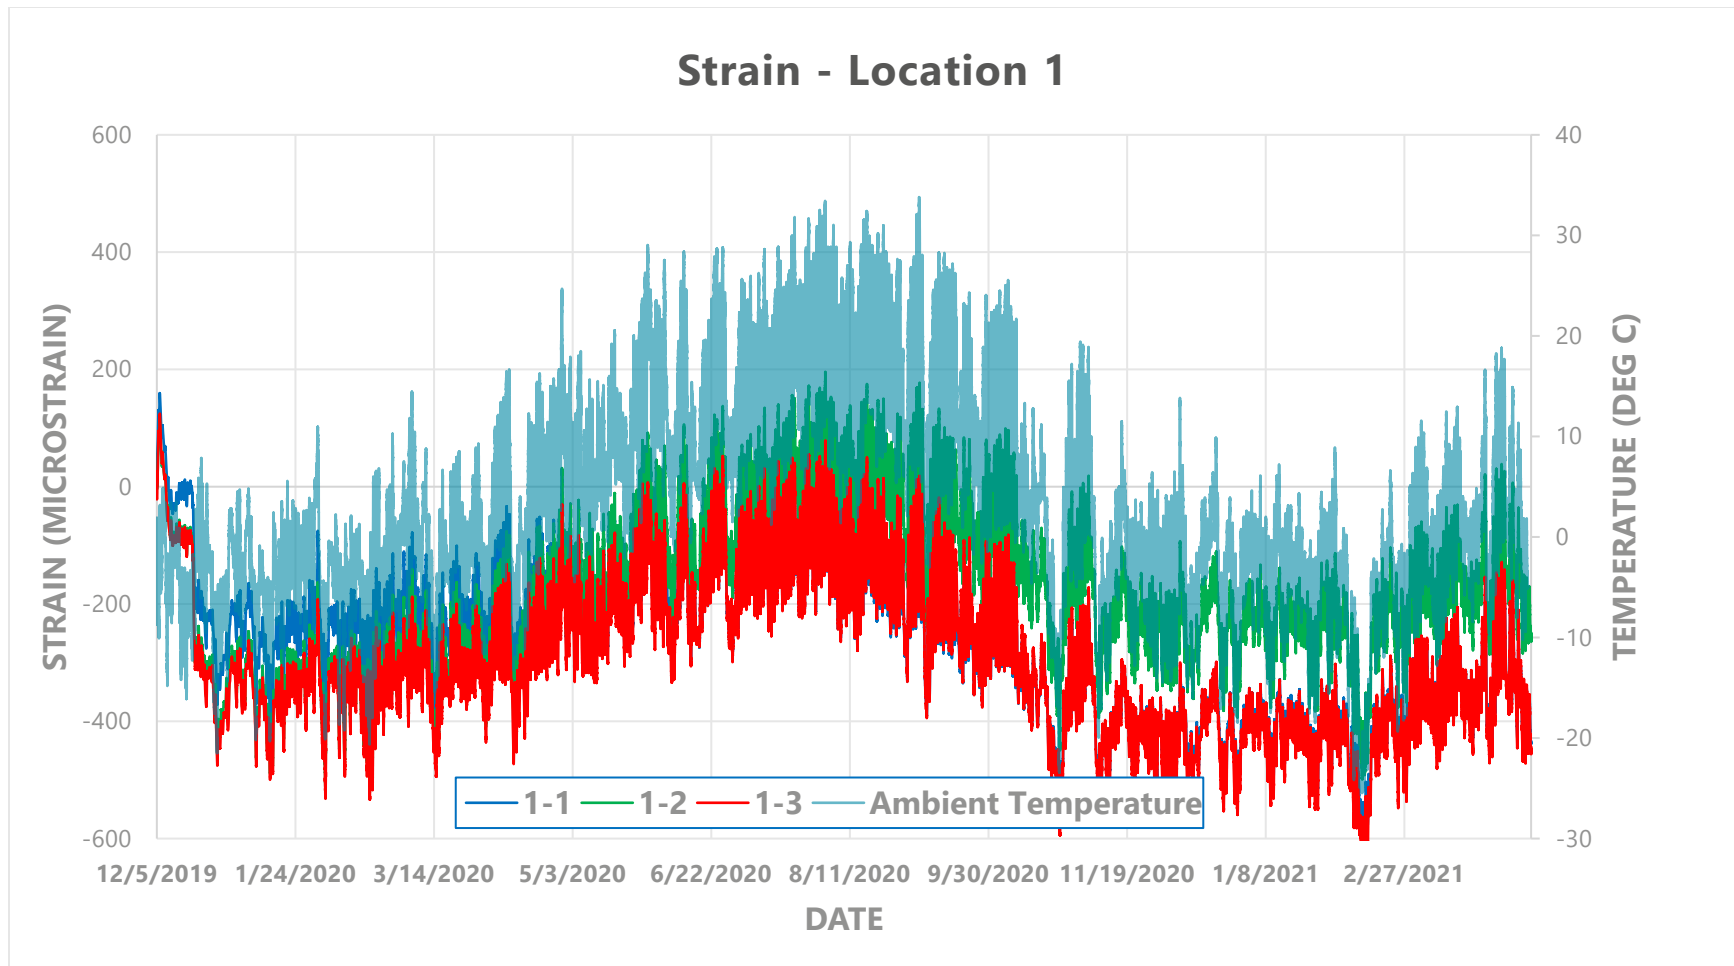
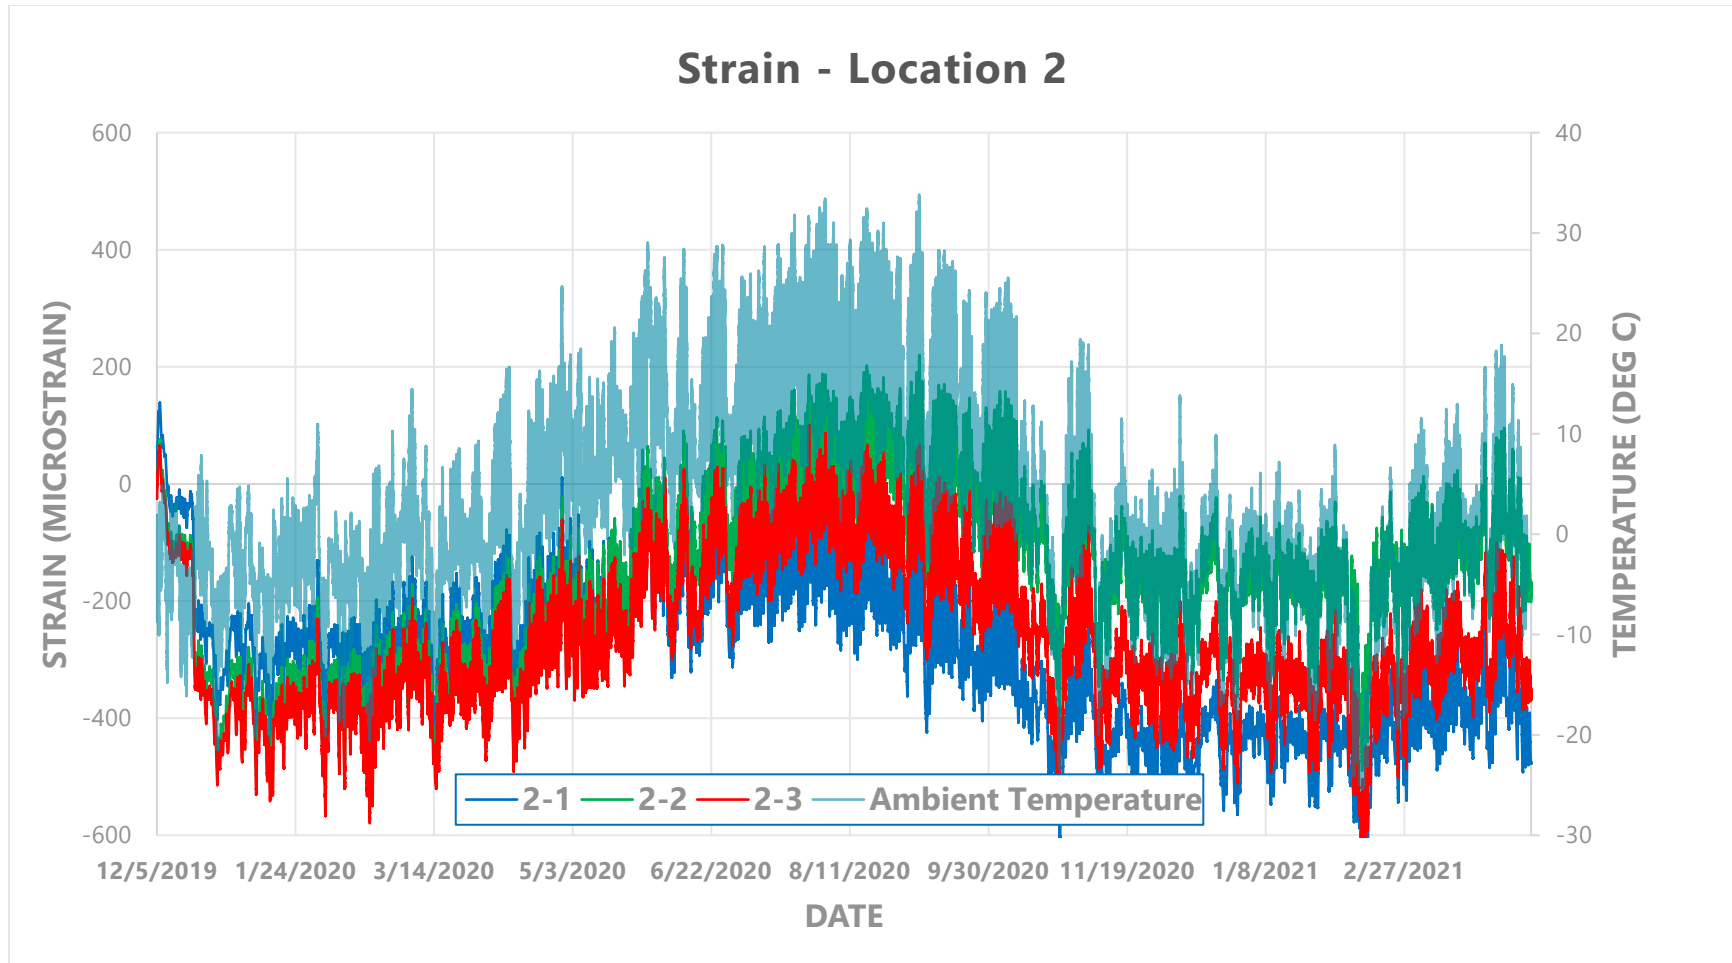
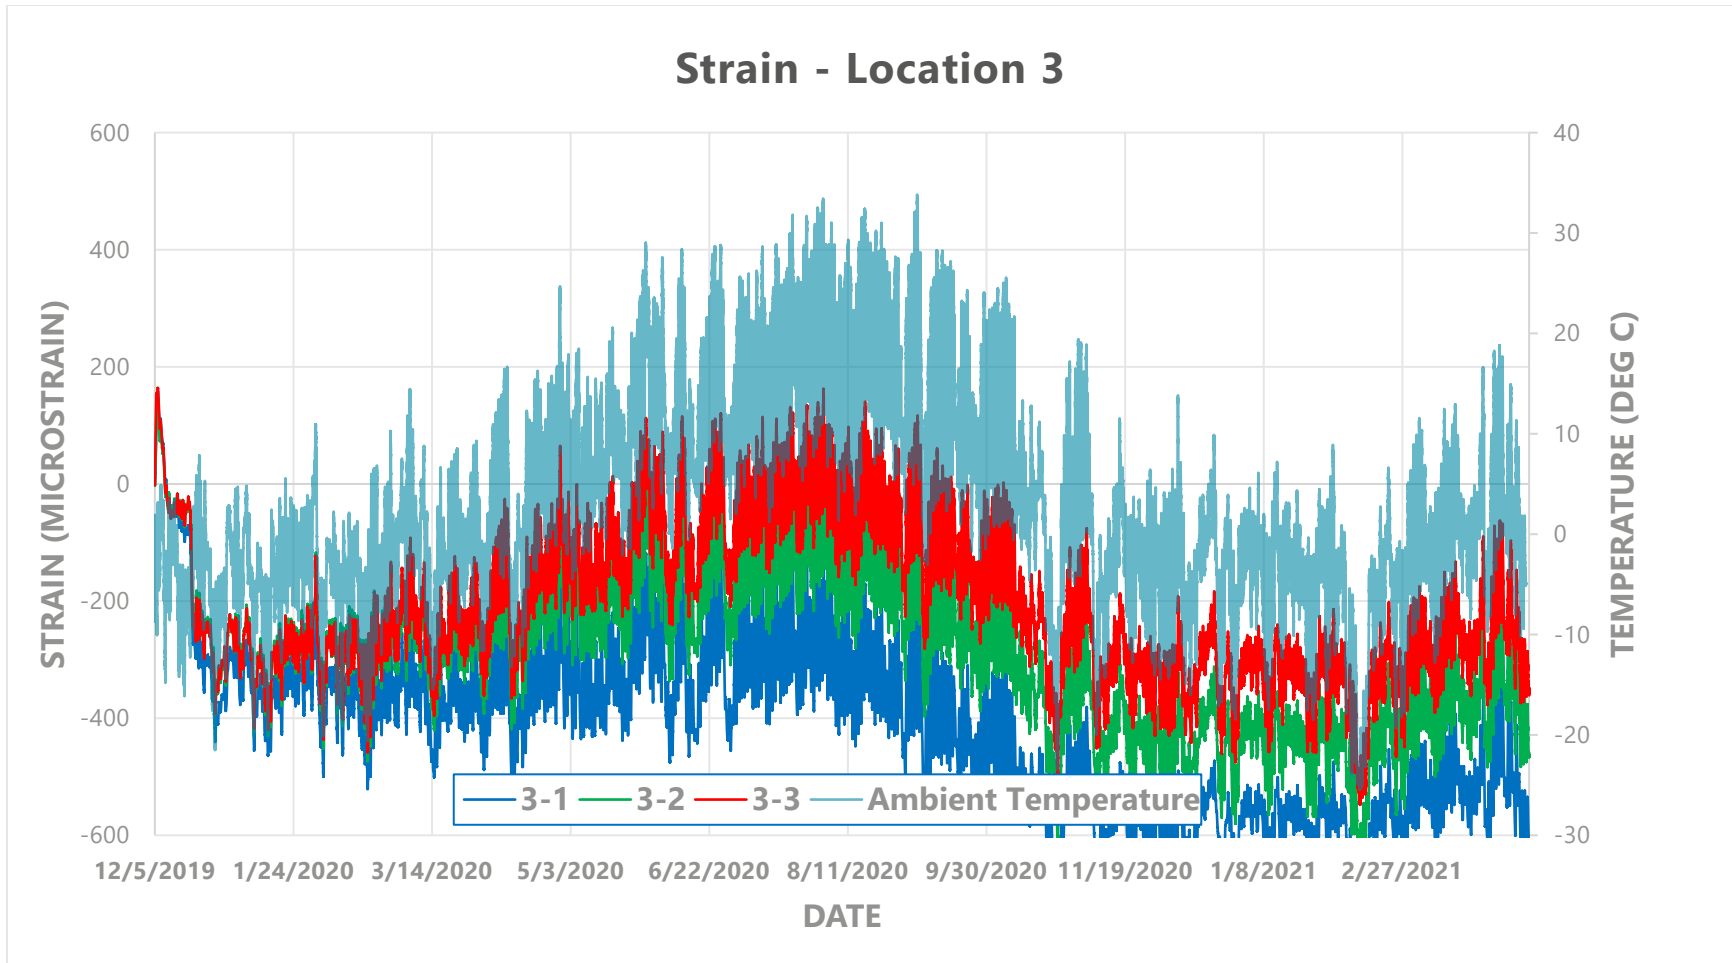
WEST LAUREL INTERCHANGE - EASTBOUND BRIDGE (PHASE I) - TOPSISDE - 2019 INSPECTION
1/32"= 1'-0"

CRACK MAPPING WAS BASED ON ORTHO MOSAIC PHOTOS PROVIDED BY MDT.
