FINAL REPORT ~ FHWA-OK-21-04

IN-STREAM STRUCTURES INTEGRITY AND CHANNEL STABILITY SURVEY AND EVALUATION

School of Civil Engineering and Environmental Science (CEES)
The University of Oklahoma
Norman, Oklahoma

September 2021

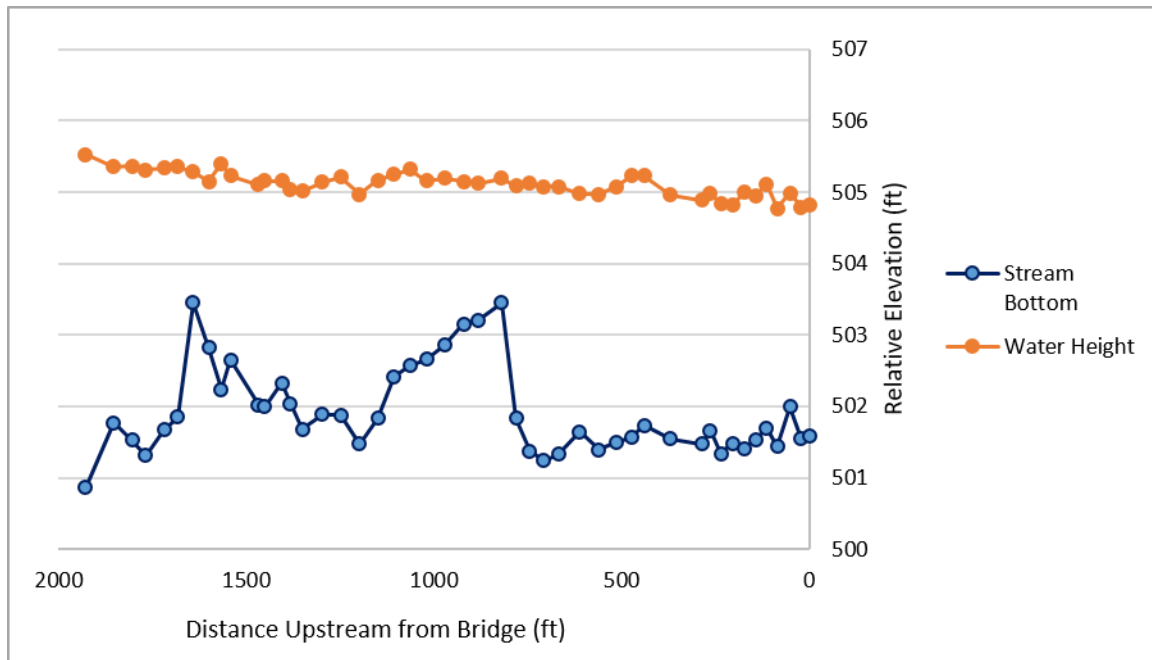
Figure 16: Site 18, Washita River and U.S 77 South of Davis in Murray county, longitudinal profile.

A riffle is located around 1000 feet upstream from the bridge with pools around 1250 and 500 feet upstream from the bridge. There is little variability in the stream slope but drastic changes in water depths along this reach of the river. The data points taken along the thalweg of the river can show where the thalweg is laterally in the stream. The lateral location of the thalweg at site 18 is shown in Figure 16.

The thalweg at site 18 moves laterally across the stream along the reach that was studied. Lateral movement of the thalweg is common in the Washita River, creating strong meanders and many high eroding banks. The average stream slope on the Washita River was 0.023%, with a minimum of 0.01% and a maximum of 0.04%. Overall, the Washita had very gentle stream slopes with little variability site-to-site.

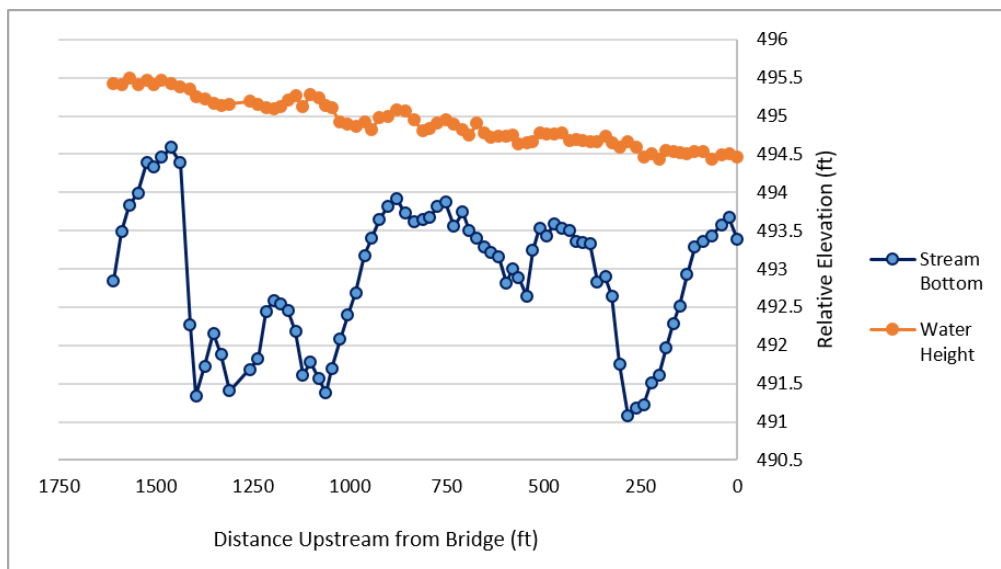
Figure 19: Site 27, North Canadian River and S.H. 99 south of Prague in Seminole county longitudinal profile.

Riffles are located around 1500 feet and 750 feet upstream from the bridge with pools around 1250 and 250 feet upstream from the bridge. There is little variability in the

stream slope but high variability in depth along this reach of the river. The location of the thalweg at site 27 is shown in Figure 20.

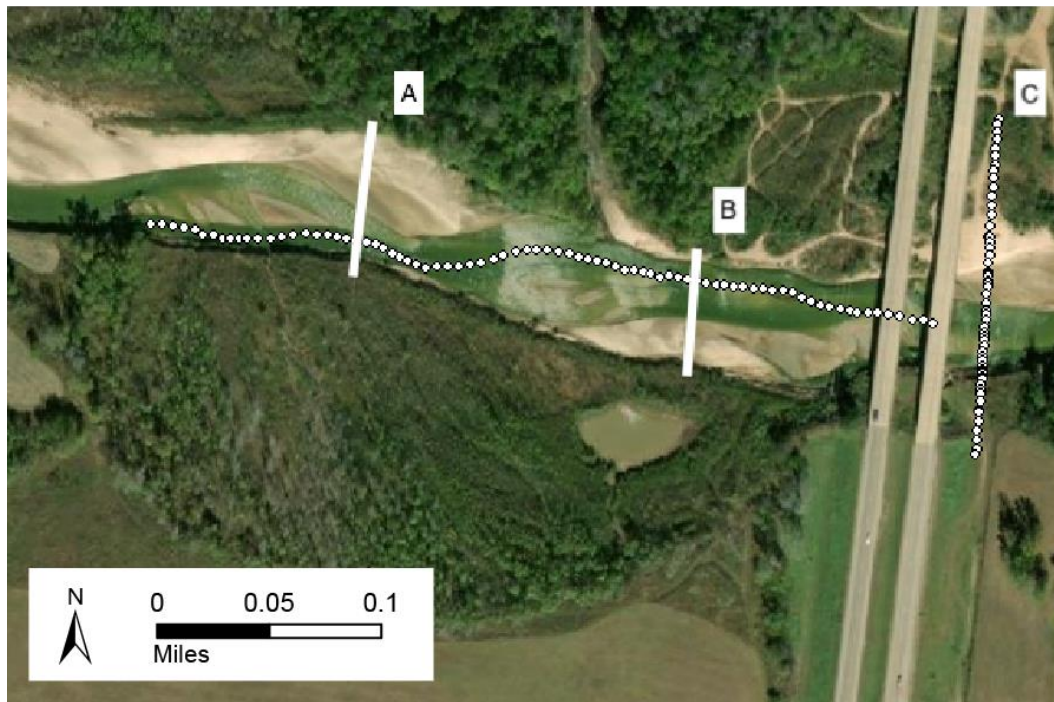
Figure 20: Site 27, North Canadian River and S.H. 99 south of Prague in Seminole county thalweg data points.

The thalweg moves laterally in the North Canadian River, but it moves more gently and creates fewer meanders than the Washita River. The average stream slope at sites on the North Canadian River is 0.040%, with a minimum of 0.026% and a maximum of 0.063%. These slopes are steeper than those in the Washita River, which may contribute to the lack of lateral movement in the thalweg.

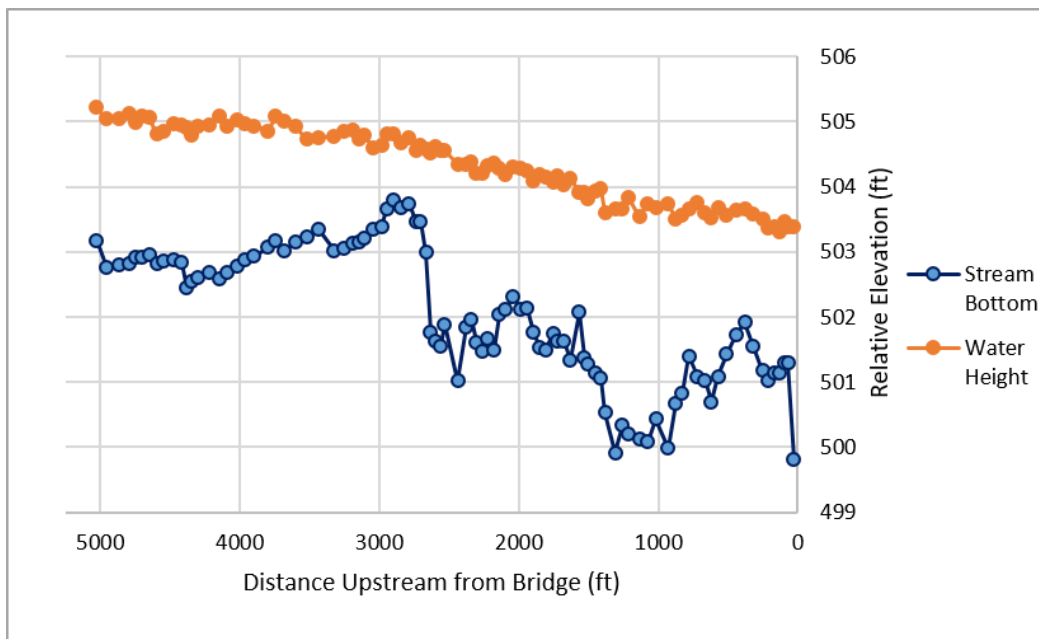
Figure 22: Site 13, Canadian River and S.H. 48 north of Atwood in Cotton county longitudinal profile.

A riffle was located around 3000 feet upstream of the bridge, with pools around 5000 and 1000 feet upstream of the bridge. The location of the thalweg at site 13 is shown in

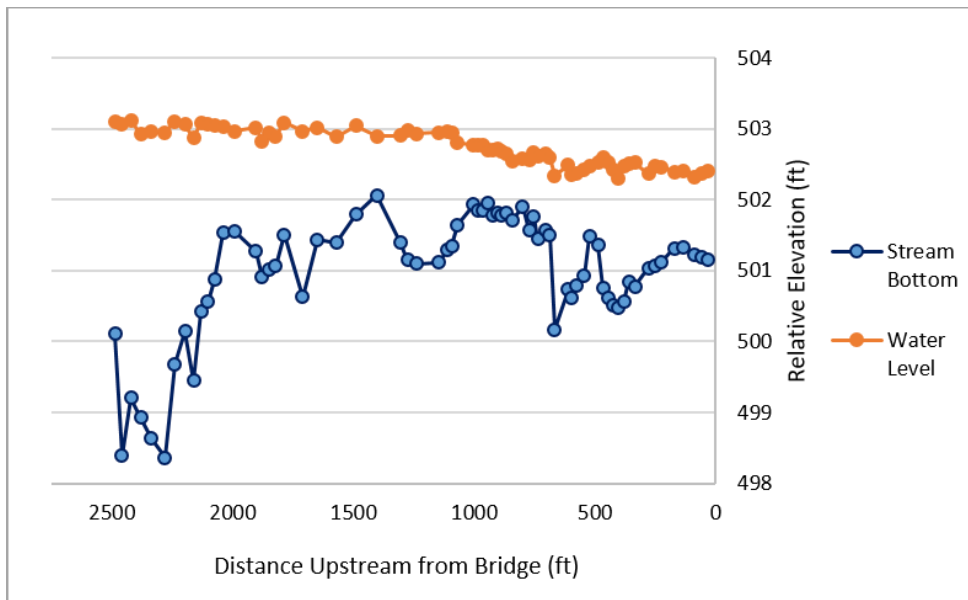
Figure 25: Site 17, Cimarron River and S.H. 74 south of Crescent in Logan county longitudinal profile.

Riffles are located at 1000 and 600 feet upstream of the bridge, and pools are located at 2500 and 1200 feet upstream. Figure 26 is a map of the data points taken along the thalweg at site 17. The thalweg moves gradually at this site, which is characteristic of the Cimarron River. It does not move from bank-to-bank as much as the thalweg in the Washita River, but there is slight lateral movement of the thalweg along this river.

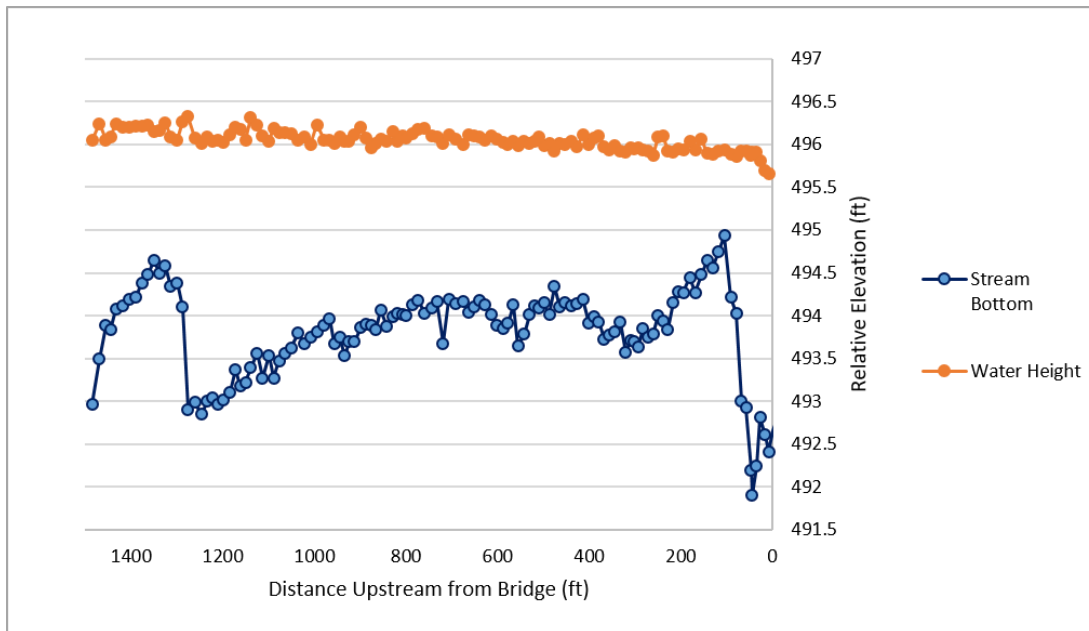
Figure 28: Site 21, Red River and S.H. 79 west of Waurika in Jefferson county longitudinal profile.

There is very little variability in the stream slope at this site, but there is a riffle 1400 feet upstream and a pool 1250 feet upstream from the bridge. Figure 29 shows the location

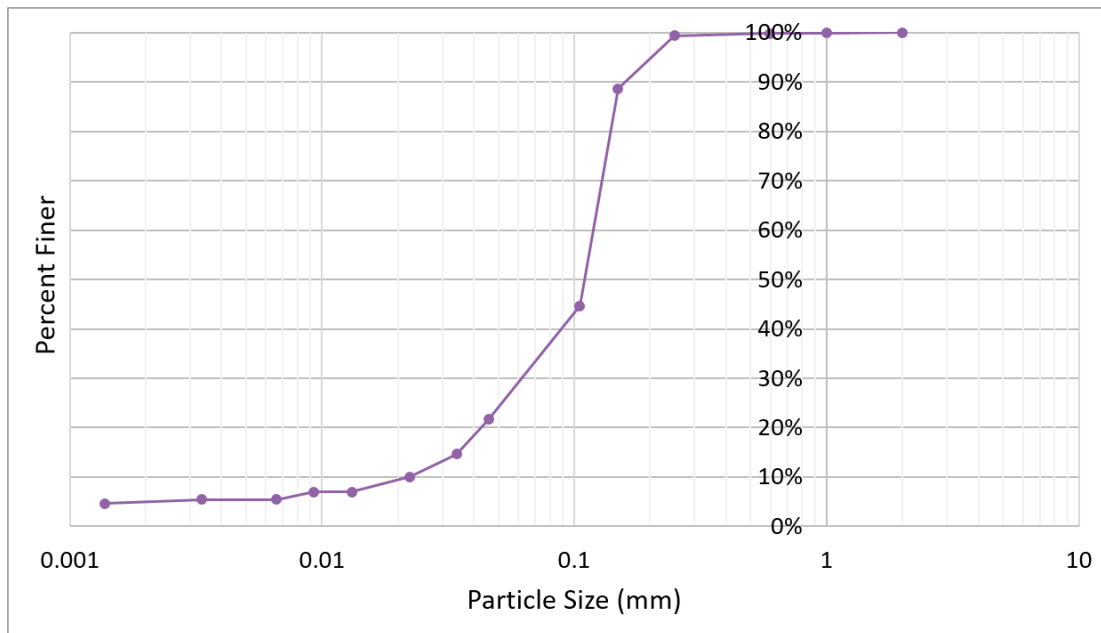
Figure 30: Site 11, Washita River and S.H. 74 north of Maysville in Garvin County, right bank particle size distribution.

Table 8 is a summary of the bank material particle size analyses on the eight Washita River sites. 50% of the samples on the Washita River were well graded, with high uniformity coefficients and coefficients of curvature between one and three. The other 50% had coefficients of curvature outside of the well-graded soil range.

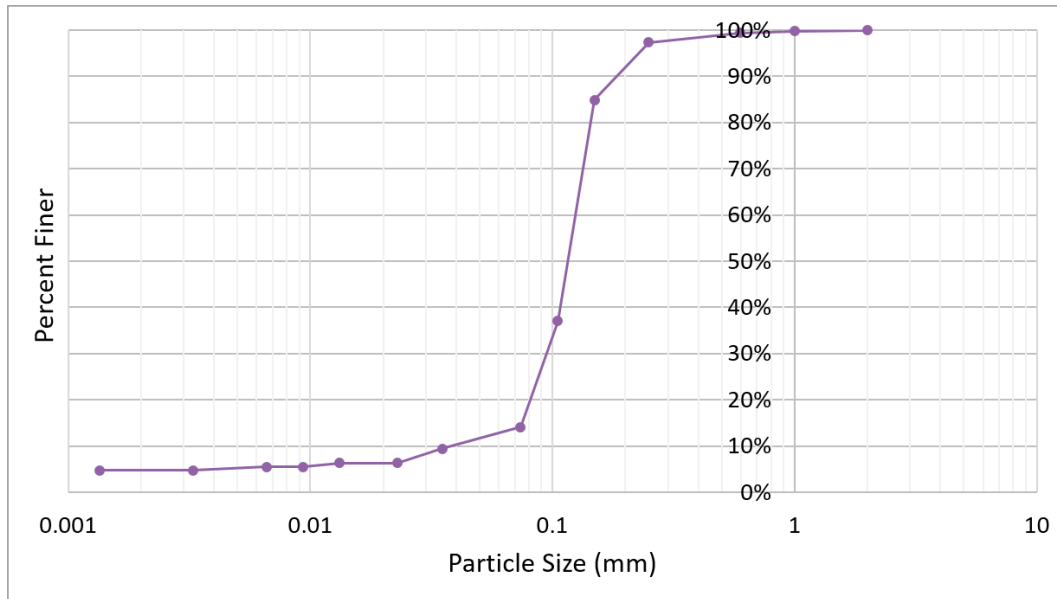
Figure 31: Site 25, North Canadian River and S.H. 48 north of Bearden in Okfuskee county left bank particle size distribution.

Table 9 is a summary of the bank material particle size analyses on the five North Canadian River sites. The samples on the North Canadian River had lower uniformity coefficients, meaning they were poorly graded, but the coefficients of curvature were mostly between one and three, meaning the samples were well graded. For sandy soils to be considered well graded, the uniformity coefficient must be above six, which was not the case for 80% of the samples. Thus, the soils in the North Canadian River were mostly poorly graded.

All of the bank samples taken on the North Canadian River are classified as sand. The minimum sand percentage of a bank sample on this river was 89%, with a maximum of 97%. There was little variability between the samples. Figure 32 is an example of a particle size distribution on the Canadian River.

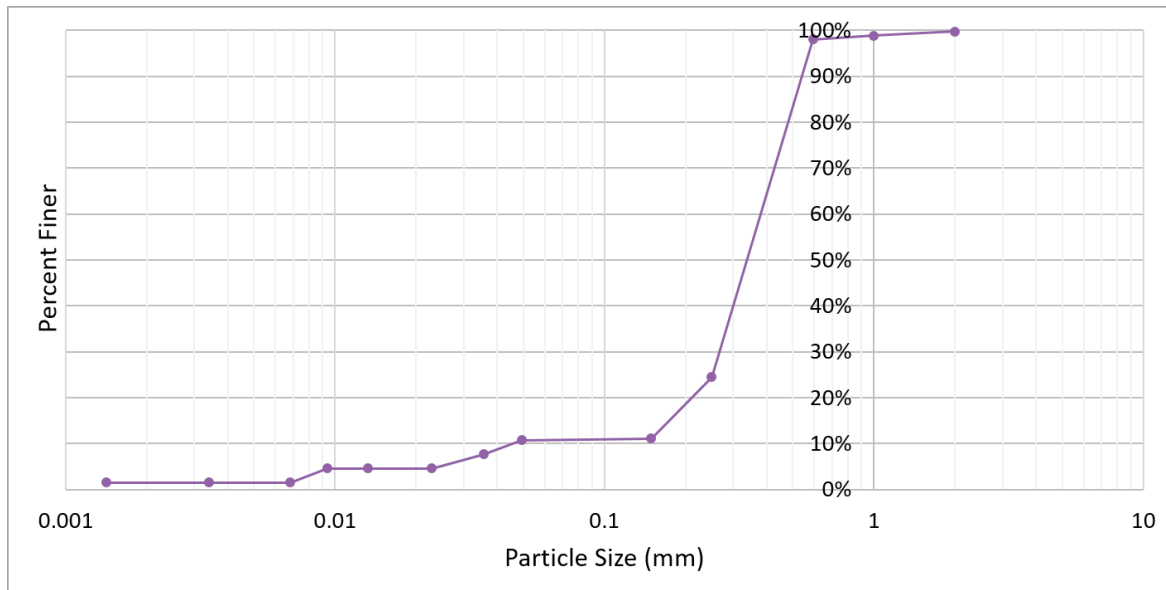
Figure 32: Site 7, Canadian River and U.S. 281 east of Bridgeport in Canadian county right bank particle size distribution.

Table 10 is a summary of the bank material particle size analyses on the two sites on the Canadian River. The samples taken at sites on the Canadian River both classified as sandy loam. There was little variability in the textures of the soils at these two sites, and neither was well graded, based on the uniformity coefficients and coefficients of curvature.

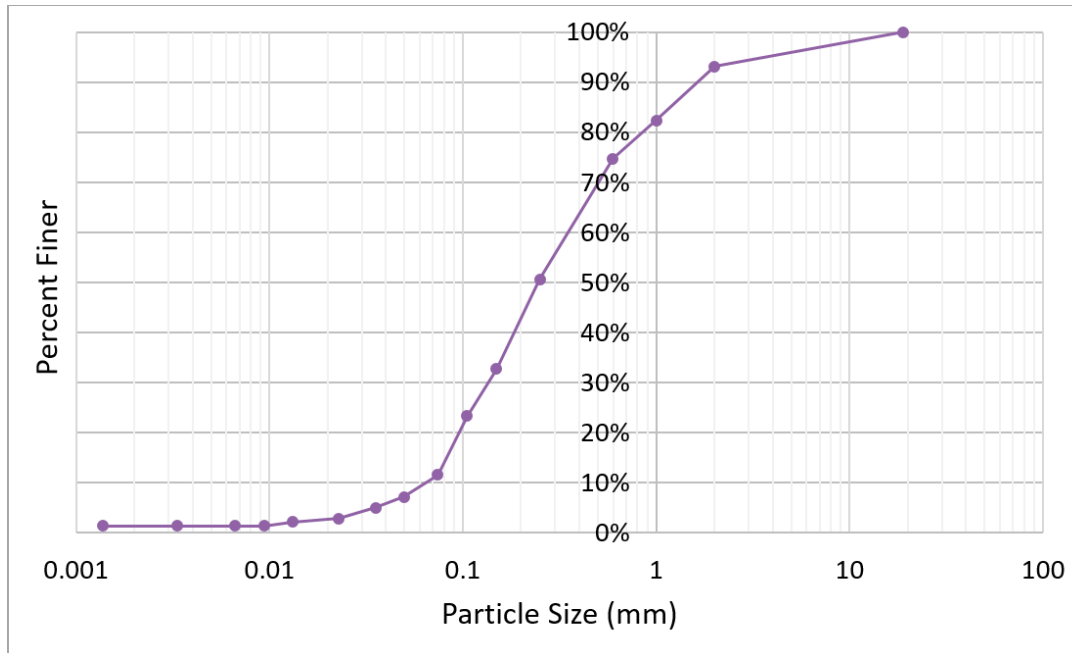
Figure 33: Site 12, Cimarron River and S.H. 33 north of Coyle in Logan county left bank particle size distribution.

The more gradual particle size distribution curve is characteristic of the bank samples collected at the Cimarron sites that were studied in this project. This corresponds to the higher uniformity coefficient (C_u) in Table 11, which means these sites had a higher variability in particle sizes with the sample than others. This is also represented by the coefficient of curvature (C_c), as none of the samples were in the range of well-graded soils.

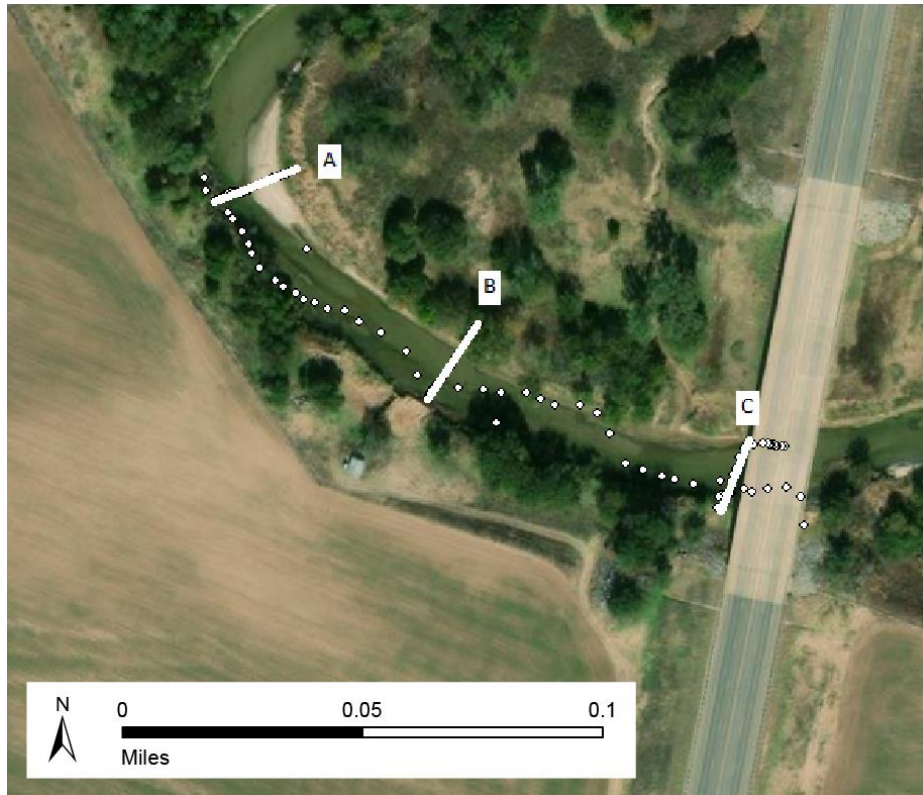
Figure 35: Site 6, North Canadian River and U.S. 281 near Watonga, cross section locations.

stream and banks upstream of the structures compared to at the structures and at the bridge. High and steep banks are at a higher risk of erosion, which represents the instability of the stream channel. The locations of the cross sections were carefully chosen to represent the variability in the bank along the stream reach. Site 6, on the North Canadian River, had Kellner jetties installed along the right (south) bank in 1927. The cross sections help show how the Kellner jetties have impacted the slope of the banks. The locations of the cross sections taken at site 6 are shown in white in Figure 35.

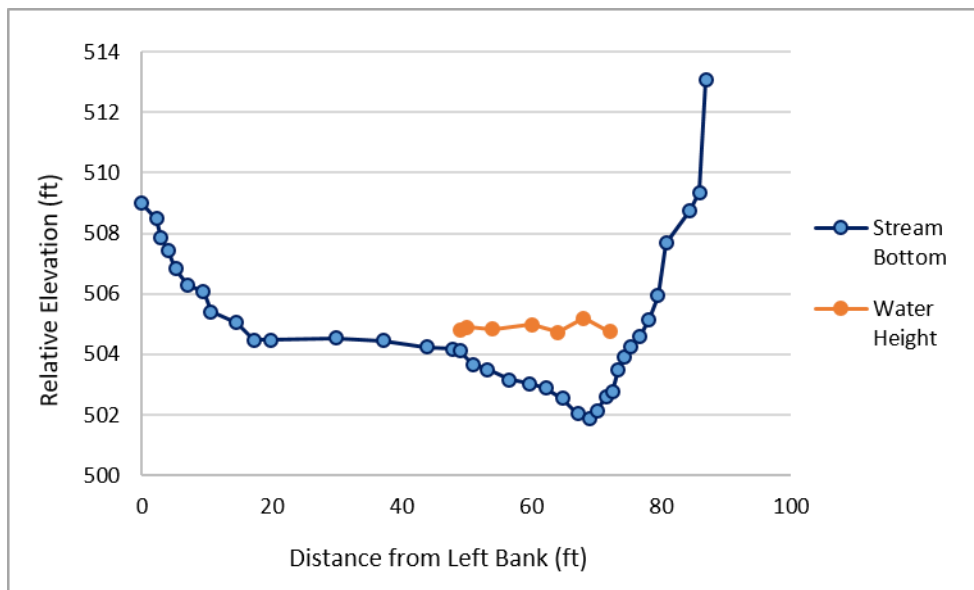
Figure 36: Site 6, North Canadian River and U.S. 281 near Watonga, cross section A upstream of structures facing downstream.

The slope of the right bank at cross section A was 0.47, and it was approximately 8 feet high.

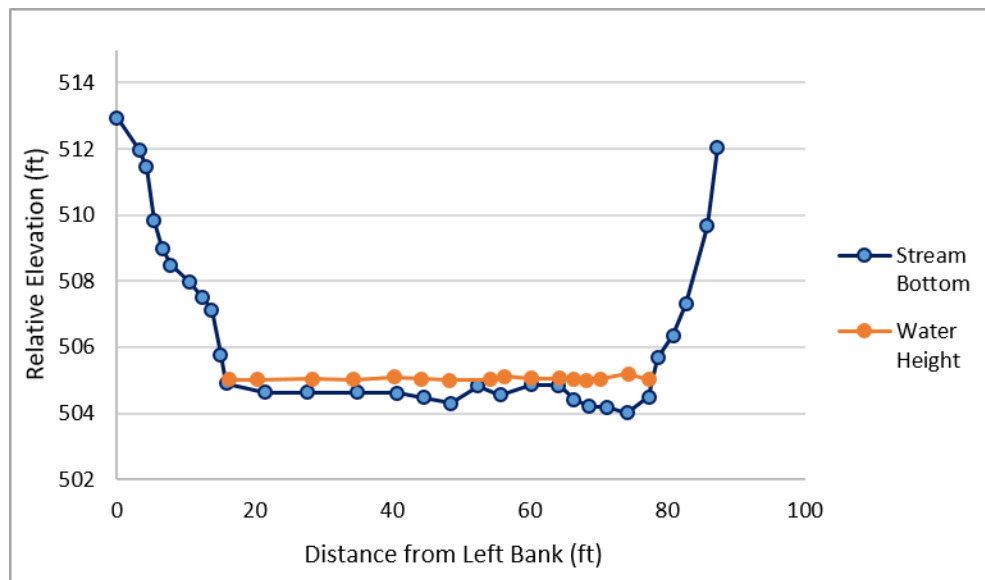
Figure 37: Site 6, North Canadian River and U.S. 281 near Watonga, cross section B at structures facing downstream.

The slope of the right bank at cross section B was 0.70, and it was 7 feet high, slightly steeper than upstream of the structures.

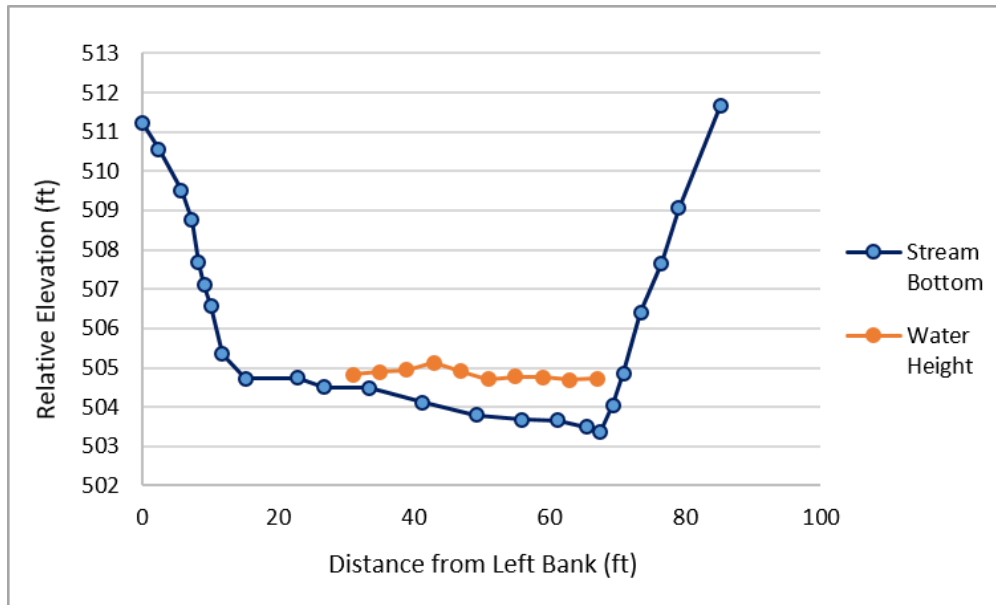
Figure 38: Site 6, North Canadian River and U.S. 281 near Watonga, cross section C downstream of bridge facing downstream.

The slope of the right bank at cross section C was 0.47, and it was 7 feet high. In addition to bank angle and bank height, the BEHI analysis also includes root depth, root density, and surface protection. Figure 39 shows a section of the bank of concern near cross section B and its condition for site 6 on the North Canadian River near Watonga, Oklahoma. The bank is about 60% vegetated with mostly grasses. Overall, this bank had a BEHI rating of 18, which puts it in the category of "moderate".

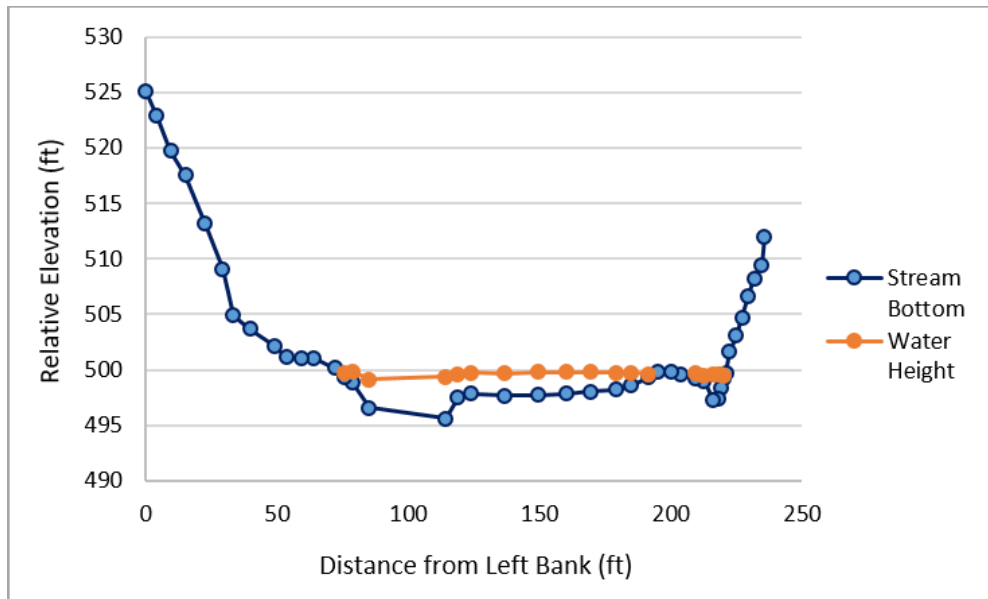
The lowest BEHI rating was in the category of "very low" with a rating of 5.5 at site 11, Washita River and S.H. 74 north of Maysville in Garvin county, near an installation of bendway weirs. The cross section at the bendway weirs is shown in Figure 40.

Figure 40: Site 11, Washita River and S.H. 74 north of Maysville in Garvin county, cross section at bendway weirs facing downstream.

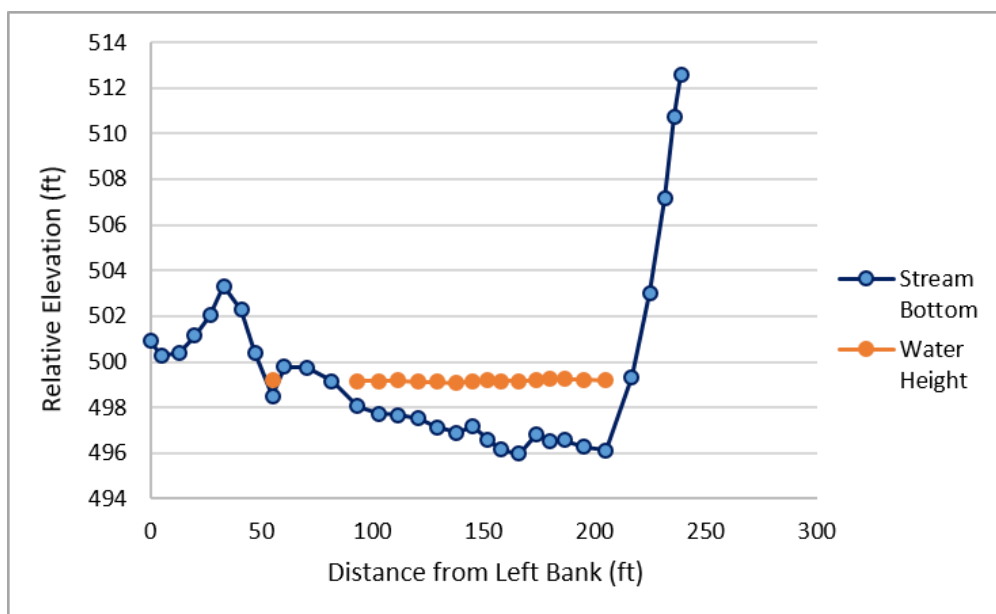
The highest BEHI rating on the sites studied was a rating of 32, in the category of "very high" at Site 32, Washita River and S.H. 7 west of Davis in Murray county. Site 32 has Kellner jetties installed along the left bank on a meander. These jetties have worked to slow the velocity down along the left bank and start building up a new bank. However, since they are a relatively new installment of Kellner jetties (2004), they need more time to fully build a new bank and encourage vegetation growth. The cross section at the Kellner jetties at site 32 is shown in Figure 42. The angle of the left bank was 2.1, with a height of about 14 feet. These measurements put the bank in the BEHI category of "high".

Figure 42: Site 32, Washita River and S.H. 7 west of Davis in Murray county, cross section at Kellner jetties facing downstream.

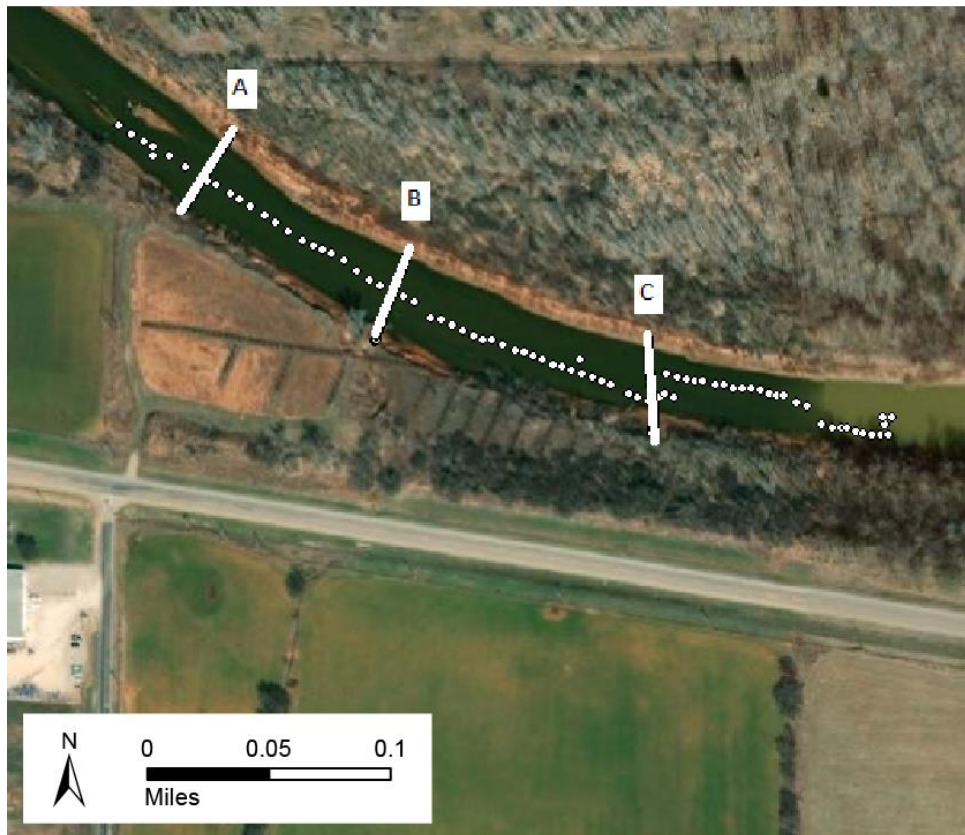
Figure 44: Locations of velocity profiles at site 29, Washita River at S.H. 19 South of Lindsay in Garvin county.

Velocity profiles are a two-dimensional representation of water velocity at a cross section. Higher velocities correspond to higher energy in the stream. High velocity located near a vulnerable bank can cause erosion. Velocity profiles from site 29 on the Washita River at S.H. 19 South of Lindsay in Garvin county are included below. This site had Kellner jetties installed along the right bank in 1999 to keep it from moving closer to S.H. 19. The locations of the velocity profiles taken at site 29 are shown in Figure 44. The upstream velocity profile shows the stream at a riffle in that reach,

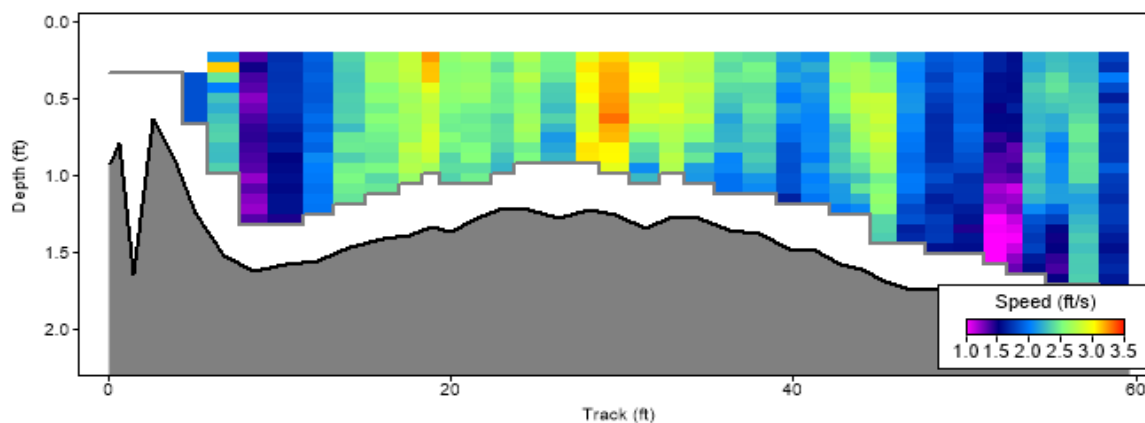
Figure 45: Site 29, Washita River at S.H. 19 South of Lindsay in Garvin county, velocity profile at cross section A, facing downstream. The near-bank stress rating at this cross section along the bank of concern (right bank) is low. The velocity profile ended 3 feet from either bank.

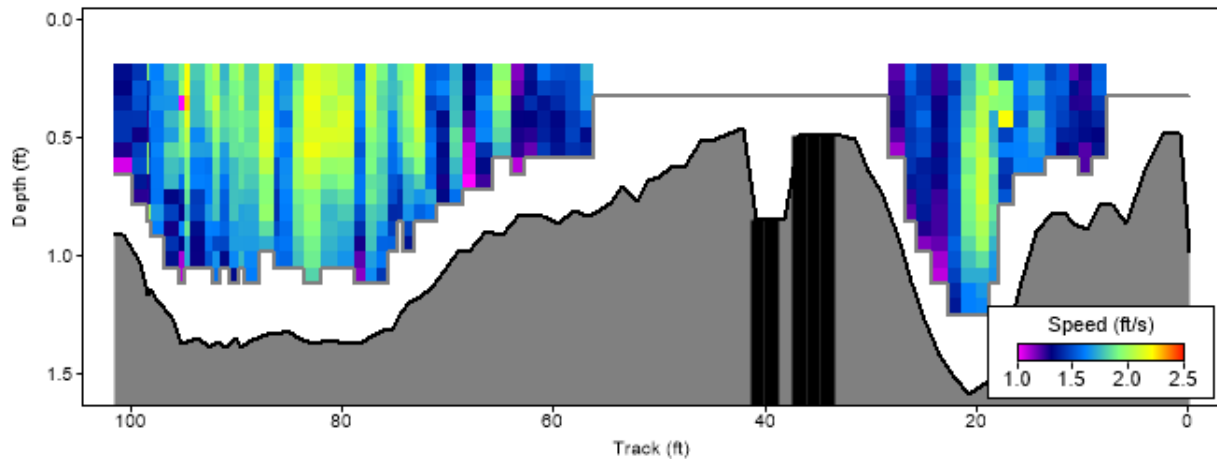
Figure 46: Site 29, Washita River at S.H. 19 South of Lindsay in Garvin county, velocity profile at cross section B, facing downstream. The near-bank stress rating at this cross section along the bank of concern (right bank) is very low. The velocity profile ended 2 feet from the left bank and 5 feet from the right bank.

The stream is split along the two sides of the stream at this location, but the energy is concentrated on the left bank, and the flow along the right bank is slow. The Kellner jetties seem to have slowed the flow of the stream along the right bank, which has allowed for sediment to settle out and extend the bank. The near bank stress along the right bank at the middle cross sections is categorized as "very low," as it is less than 0.5 ft/s/ft. Another velocity profile was taken downstream of the Kellner jetties, shown in Figure 47.

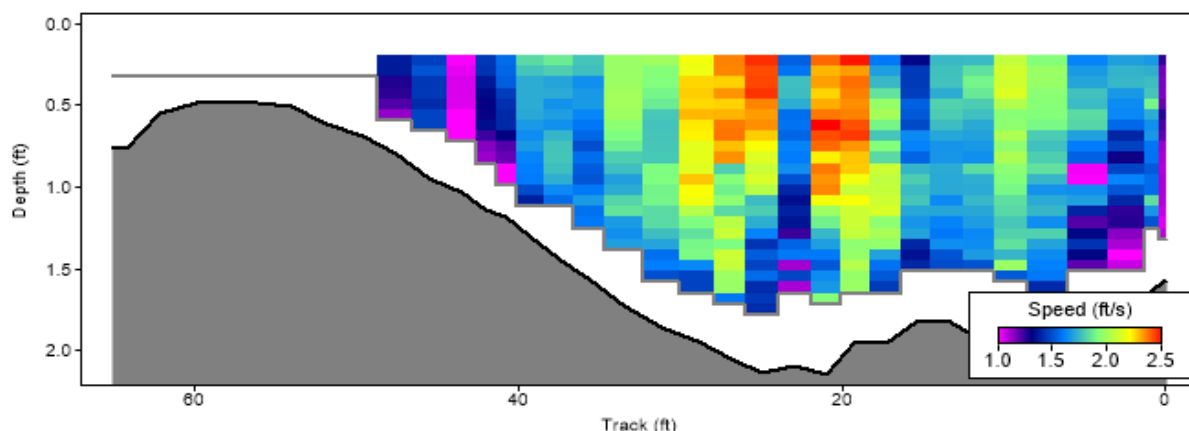
Figure 47: Site 29, Washita River at S.H. 19 South of Lindsay in Garvin county, velocity profile at cross section C, facing downstream. The near-bank stress rating at this cross section along the bank of concern (right bank) is very low. The velocity profile ended 10 feet from the left bank and 2 feet from the right bank.

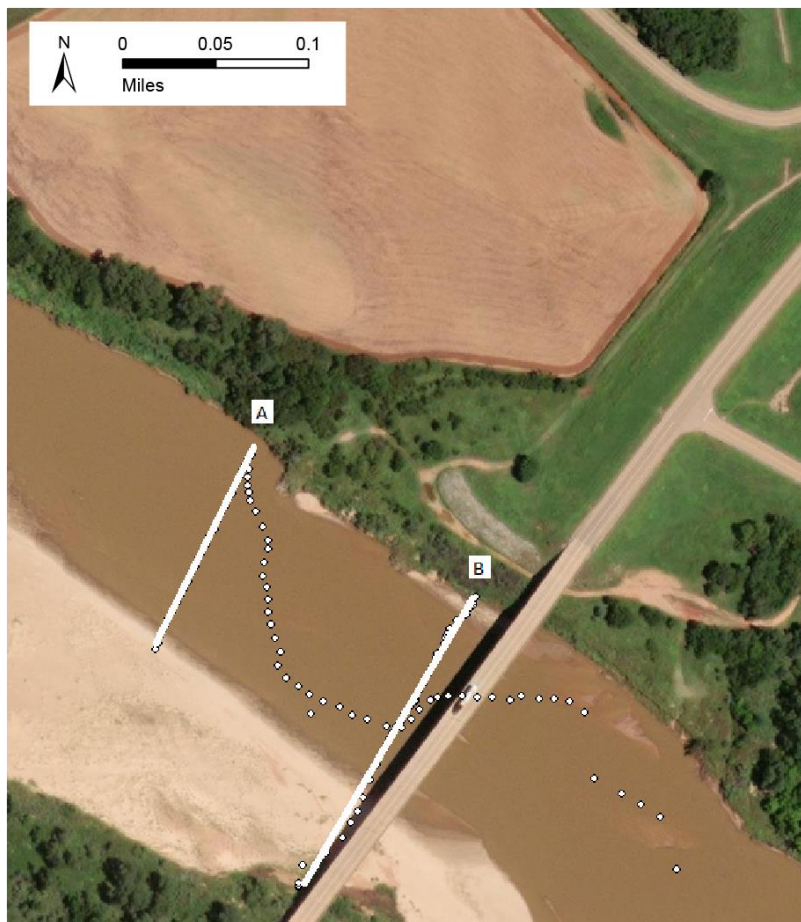
Figure 48: Site 12, Cimarron River and S.H. 33 north of Coyle in Logan county, velocity profile locations.

The velocity profiles can also show how the stream velocity has changed with the addition of bendway weirs. Site 12, Cimarron River and S.H. 33 north of Coyle in Logan county, is an example of a site where bendway weirs pushed the thalweg and energy of the stream away from the bank of concern and towards the center of the stream. Two bendway weirs were installed on the left bank at this site in 2003. They are a newer construction, so the site has not fully stabilized yet. This is an interesting point in time to see how the bendway weirs are impacting the stream while it is still changing in response to the installation. Velocity profiles were taken upstream of the bendway weirs as well as between the bendway weirs. If the bendway weirs are successful, the flow should stagnate between the weirs, and sediment should settle out to build up a bank. The locations of the velocity profiles taken at site 12 are shown in Figure 48.

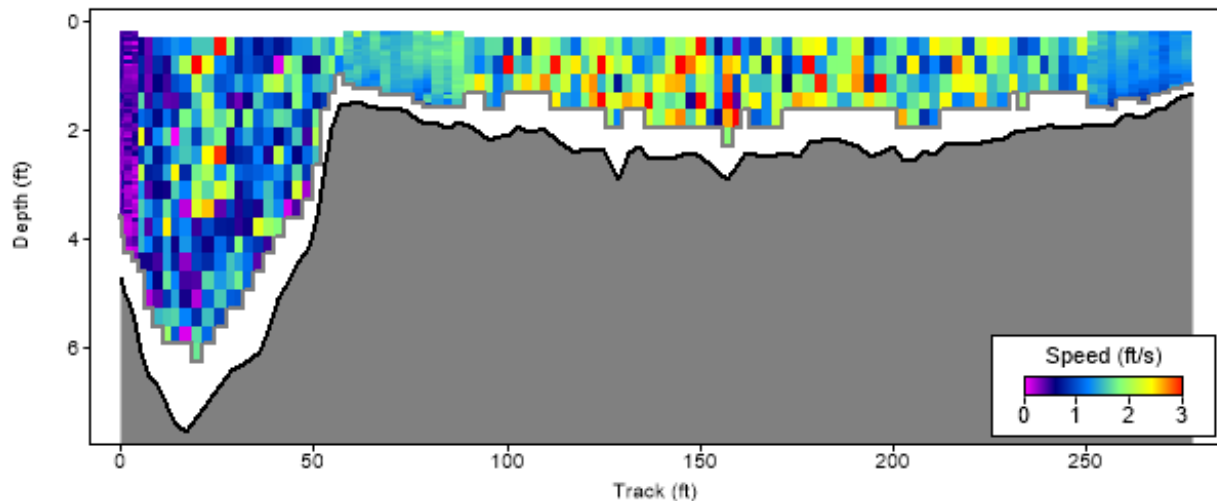
Figure 49: Site 12, Cimarron River and S.H. 33 north of Coyle in Logan county, velocity profile A upstream of bendway weirs, facing downstream. The near-bank stress rating at this cross section along the bank of concern (left bank) is low. The velocity profile ended 2 feet from either bank.

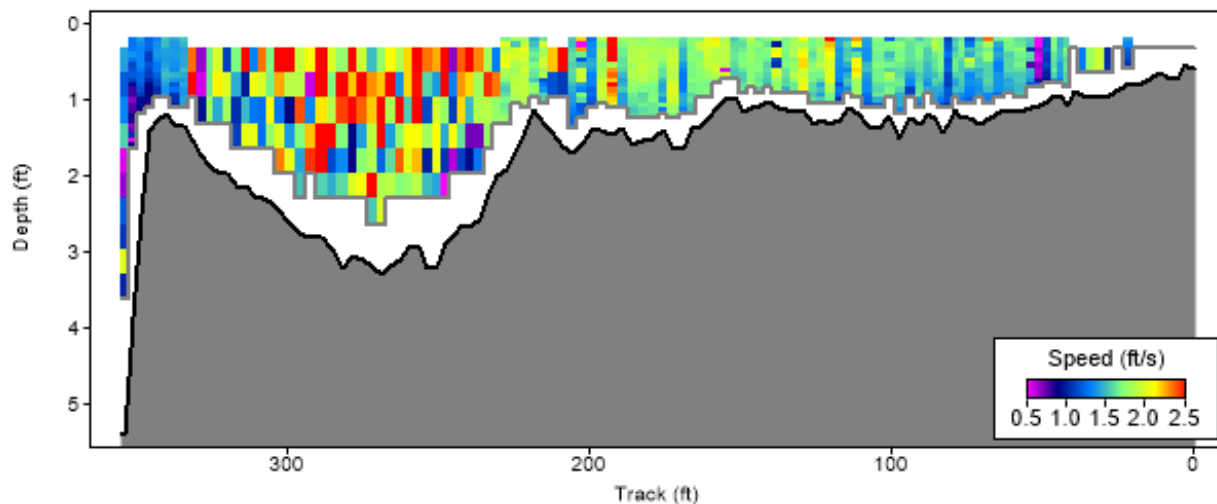
The bendway weirs have pushed the energy of the stream closer towards the center, as seen in velocity profile B taken between the weirs in Figure 50.

Figure 50: Site 12, Cimarron River and S.H. 33 north of Coyle in Logan county, velocity profile B between bendway weirs, facing downstream. The near-bank stress rating at this cross section along the bank of concern (left bank) is very low. The velocity profile ended 2 feet from either bank.

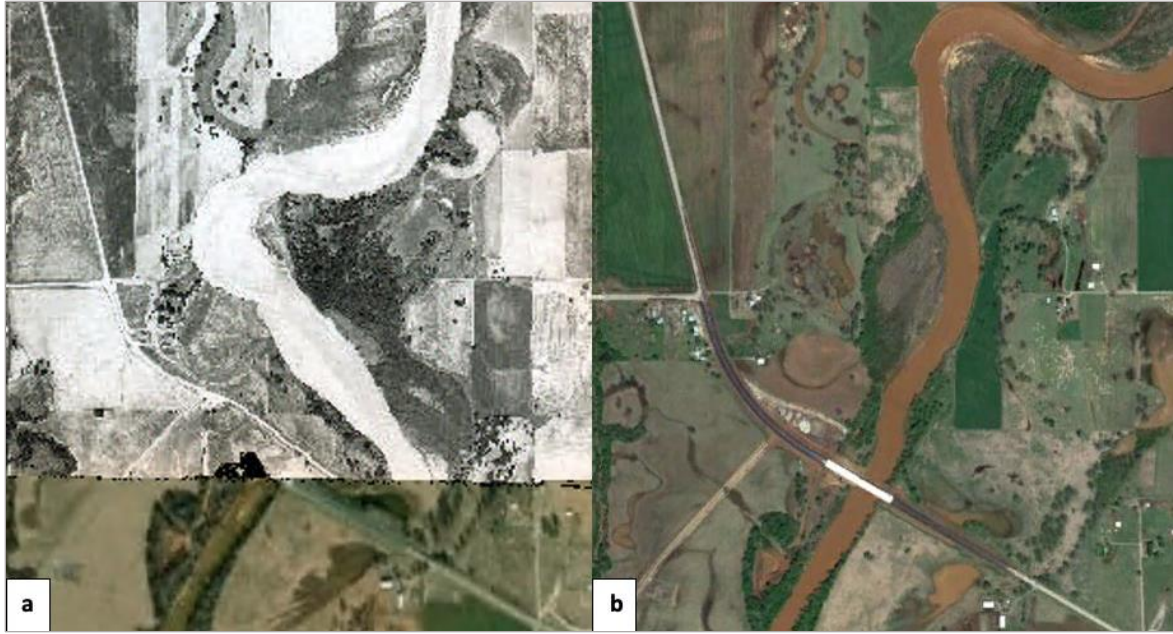
Figure 51: Site 1, Washita River and U.S. 77 north of Wynnewood in Garvin county, in 1956 and 2019.

The amount of movement varied between rivers, as well as within a river. Site 1 had the most thalweg movement of any site on the Washita River. The bridge at this site used to be located on a meander, but over time it straightened. Kellner jetties were installed on the right (west) bank in 1949, and pile diversions and spur dikes were installed on both banks in 1959. The difference in the stream between 1956 and 2019 is shown in Figure 51.

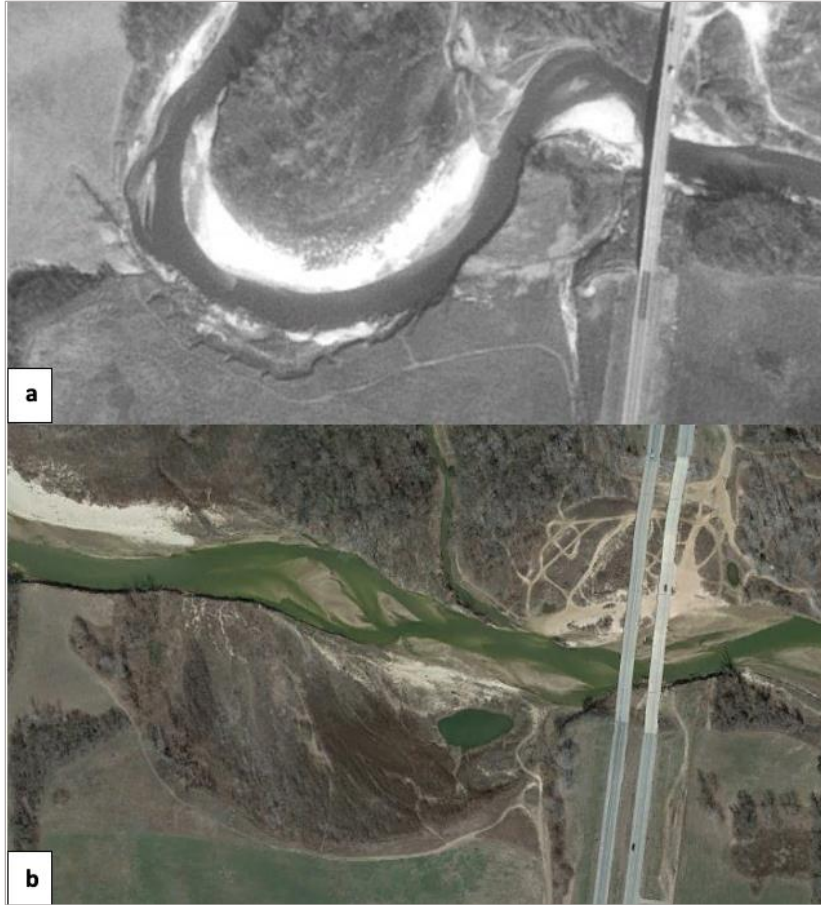
Figure 52: Site 27, North Canadian River and S.H. 99 south of Prague in Seminole county in a) 1995 and b) 2019.

Site 27, on the North Canadian River, also had a large thalweg movement over time. The bridge crossing was on a meander that was continuously eroding, so Kellner jetties were installed on the right (south) bank. The river continued eroding through these Kellner jetties, though, so bendway weirs were installed in the meander in 2001. These rapidly straightened out the river, making it nearly perpendicular to the bridge crossing. The change in this river between 1995 and 2019 is shown in Figure 52.

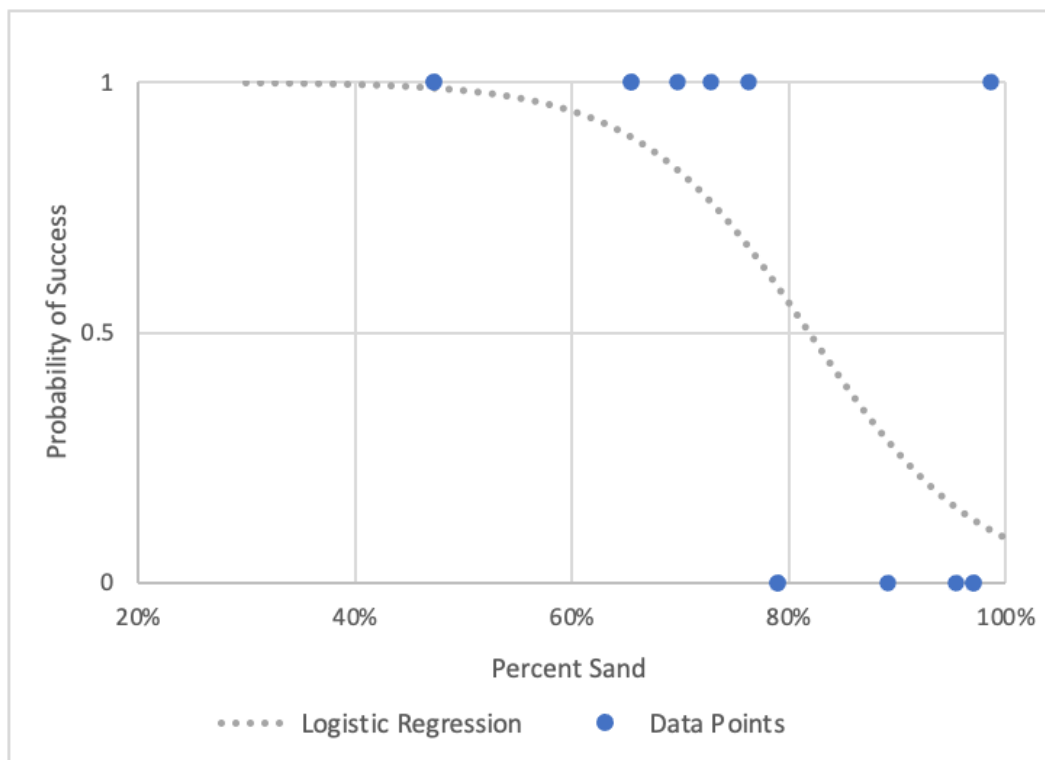
Figure 54: Pile diversion logistic regression with percent sand (p < 0.1).

The percent sand coefficient shows that pile diversions installed on banks with higher sand content are more likely to fail. This makes sense, since sandy streambeds are highly mobile, and pile diversions are an instable structure, compared to other structures studied (Harp and Thomas 1989). There is an exception to this pattern at site 4 on the Cimarron River near Waynoka, but the regression remains significant. More data is needed to confirm this regression.

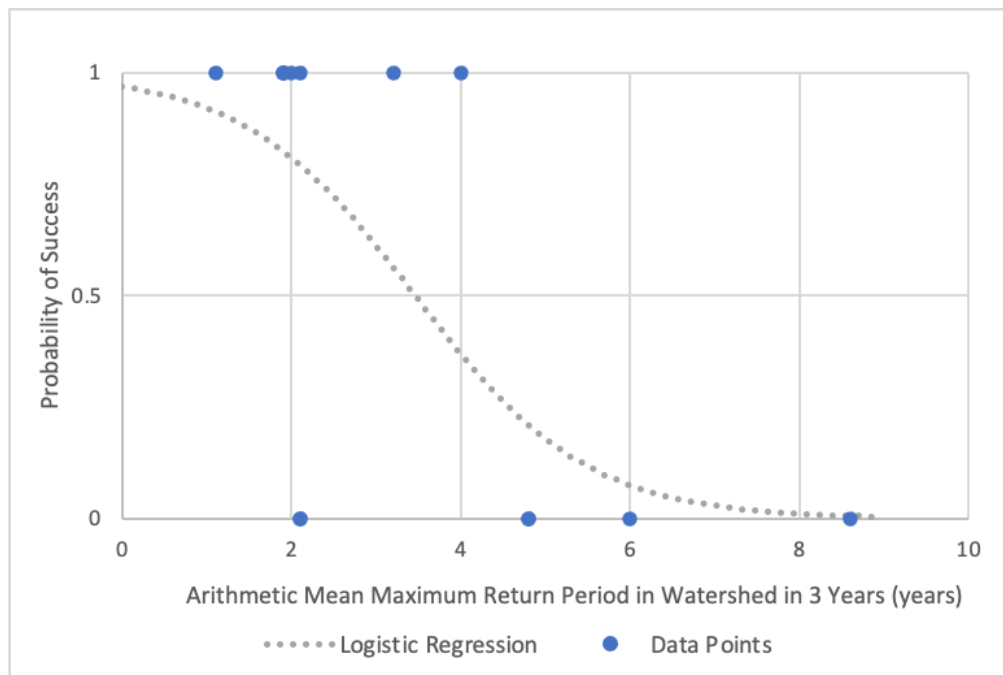
Figure 55: Pile diversion logistic regression with arithmetic mean maximum return period in the watershed within three years of installation (p < 0.1).

The return period coefficient shows that larger precipitation events within three years of installation makes the pile diversions more likely to fail. Harp and Thomas hypothesized that pile diversions failed because of the weakness of wood (1989). Additionally, unlike rock and steel, wood is weakened by the addition of moisture because of its porous nature, so it would be weakened more quickly in streams than other materials (Rammer and Winistorfer 1999). Large precipitation events could lead to the destruction of the pile diversions, and if this occurred before sediment has settled out and built up bank, the structure would be ineffective.

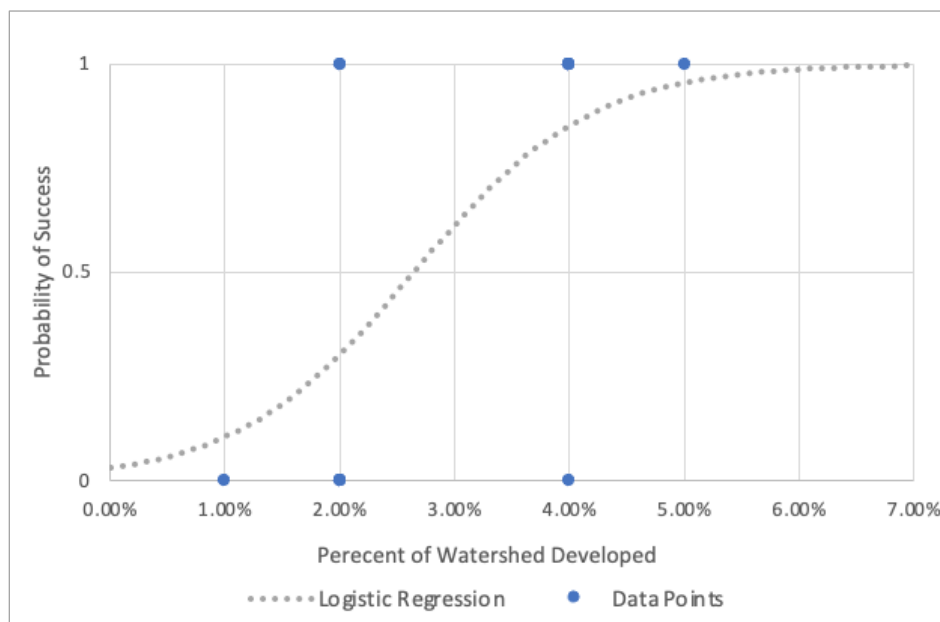
Figure 56: Pile diversion logistic regression with percent watershed developed (p < 0.1).

The percent watershed developed coefficient shows that pile diversions in a stream with a more developed watershed is more likely to succeed. A more developed watershed would have more runoff and higher flows during storm events, so a negative coefficient, such as the one seen with the return period variable, would be expected. It should be noted that the percent of the watersheds that were developed, based on the National Land Cover Database (2016) ranged from 1% to only 5%, so there was little variation. To fully understand the impact of development on the success of these structures, a different variable could be used, such as a binary urban or rural variable or a variable that takes into account agricultural land use, which also leads to increased runoff. Additionally, more data from urban watersheds is to confirm this regression because the sites were nearly all located in rural Oklahoma.
