FINAL REPORT ~ FHWA-OK-21-04

IN-STREAM STRUCTURES INTEGRITY AND CHANNEL STABILITY SURVEY AND EVALUATION

School of Civil Engineering and Environmental Science (CEES)
The University of Oklahoma
Norman, Oklahoma

September 2021

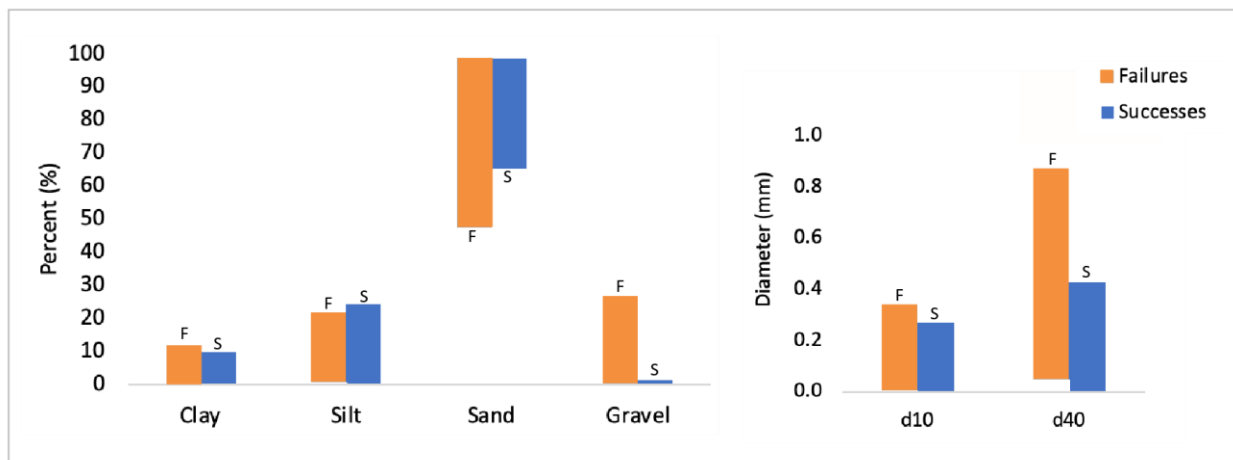
Figure 57: Ranges of sediment factors at sites with rip rap, separated by failures and successes.

Based on this data, the major difference between the bank material at sites where rip rap failed and where rip rap succeeded is the amount of gravel; however, the percent gravel is not a significant variable in a logistic regression. This lack of significance is likely due to the small number of data points (n=13).

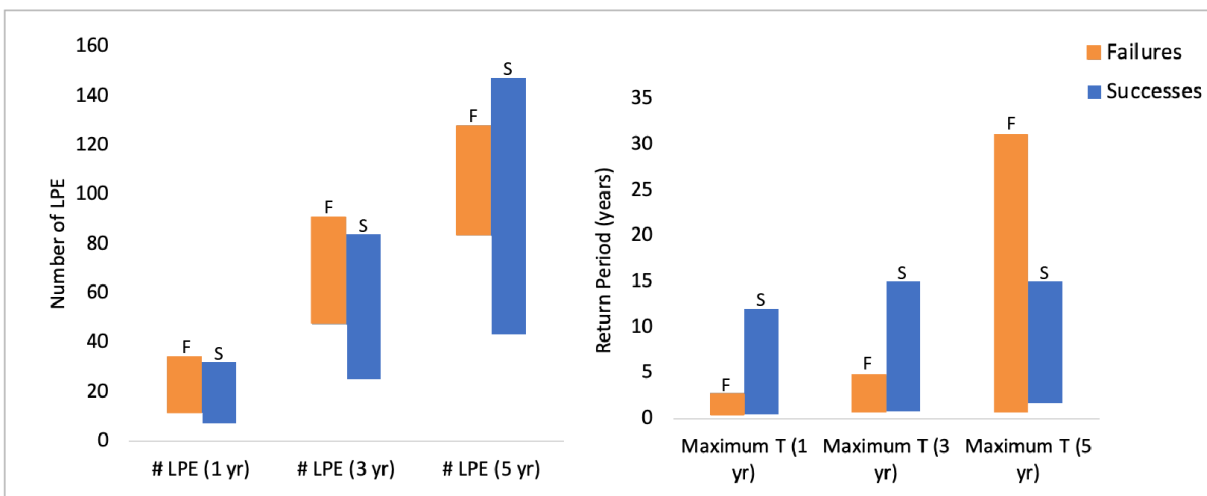
Figure 58: Ranges of precipitation data at sites with rip rap, separated by failures and successes (LPE = large precipitation events, T = return period).

The number of large precipitation events at the sites did not vary much between the failures and successes. The maximum return periods in one and three years were both higher at the successful sites, but the maximum return periods in five years were higher at the sites with failed rip rap.

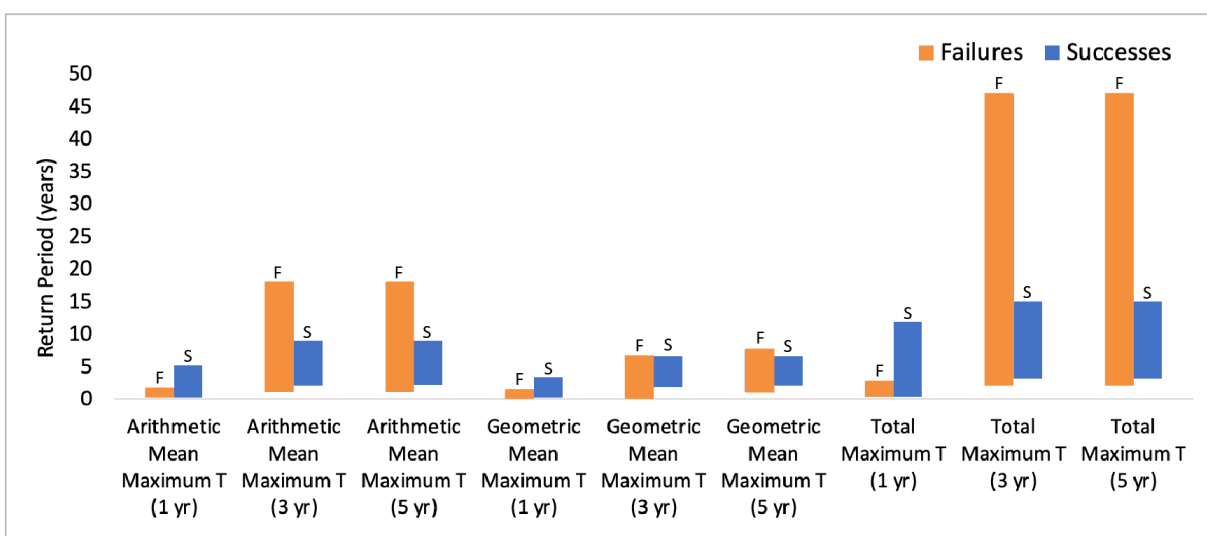
Figure 59: Ranges of arithmetic mean, geometric mean, and total maximum return periods (T) within the watersheds of sites with rip rap, separated by failures and successes

The arithmetic mean maximum return periods and the total maximum return periods in the watersheds in one year were higher at the successful sites, but the arithmetic mean maximum return periods in three and five years were higher at the sites with failed rip rap. The geometric means, however, did not vary much between the successes and failures. There is not enough data to draw a conclusion from the precipitation data. More sites with rip rap would need to be studied to understand how precipitation events impact the structure's success.

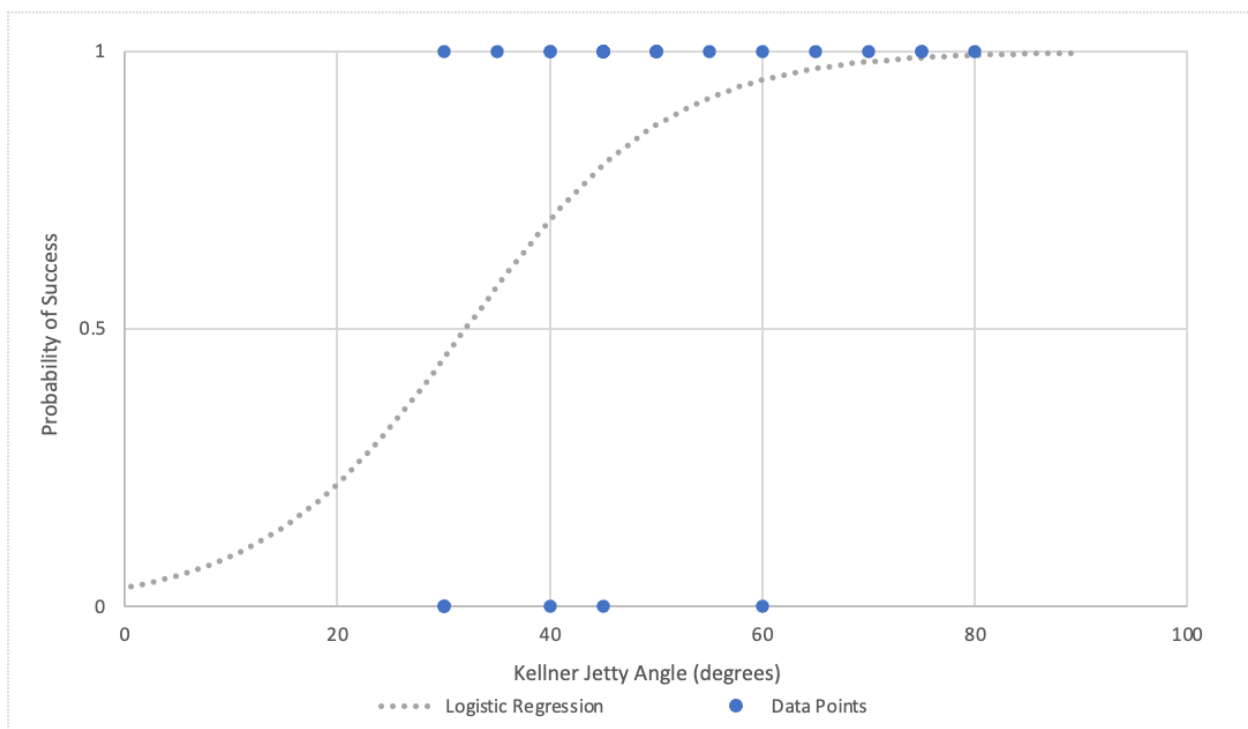
Figure 60: Kellner jetty logistic regression with oldest Kellner jetty angle (p < 0.1)

The Kellner jetty angles ranged from 30 to 80 degrees, and above 60 degrees, they were consistently successful. Only one failure occurred at 60 degrees (site 21) while the rest were all at 45 degrees or below. The results of this regression are summarized in Table 47.

The high p value on the intercept does not take away from the significance of the oldest Kellner jetty angle variable. The positive coefficient for the Kellner jetty angle shows that the larger the angle the jetties make with the thalweg, the more likely they are to succeed. This means the water hitting the jetties at an angle closer to perpendicular causes the water to slow down more and allow sediment to settle out.

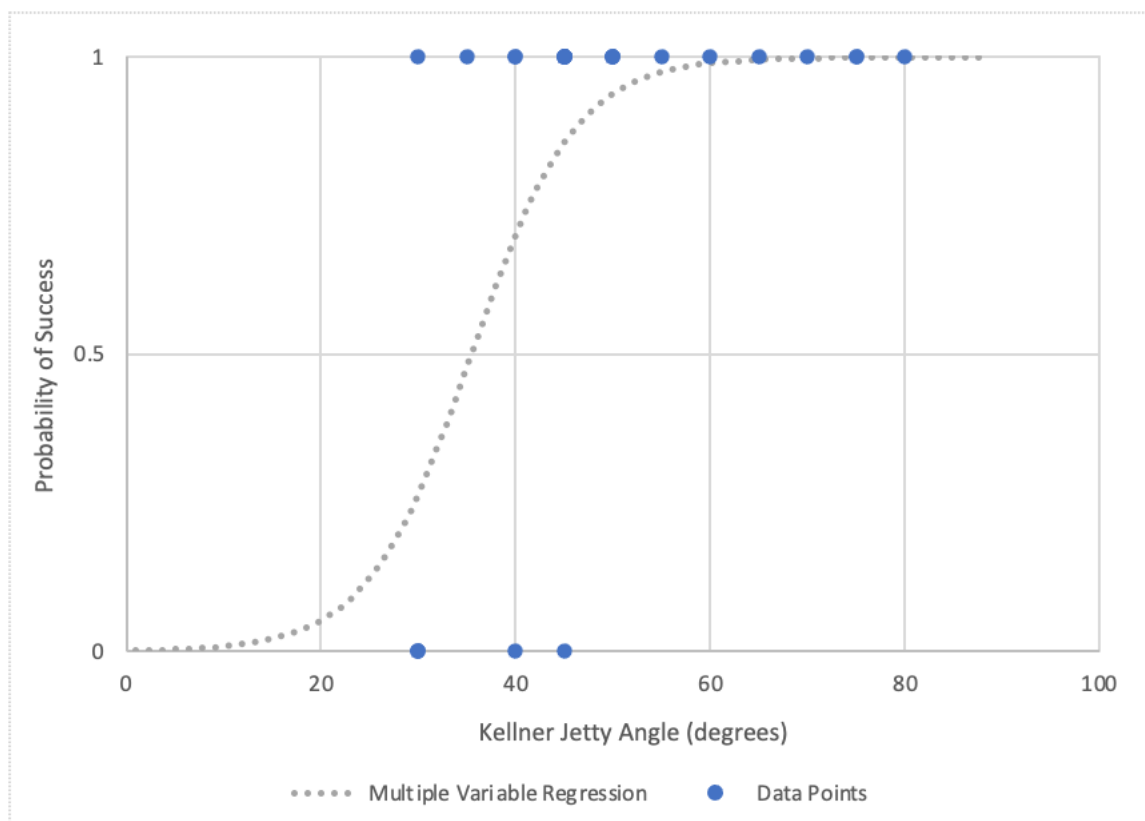
Figure 61: Kellner jetty multiple variable logistic regression in respect to Kellner jetty angle (p < 0.1)

The p values in this regression decreased with the addition of the thalweg movement variable when site 21 was included. To show the impact of each of the variables on the regression, the variables were isolated and shown in two separate models, where one was held constant while the other was changed. First, the thalweg movement was held constant at the average value of 55 feet, and the Kellner jetty angle was changed. The regression and data points in respect to Kellner jetty angles are shown in Figure 61. This regression is similar to the one without thalweg movement, as the steepest part of the curve is around 20 to 50 degrees.

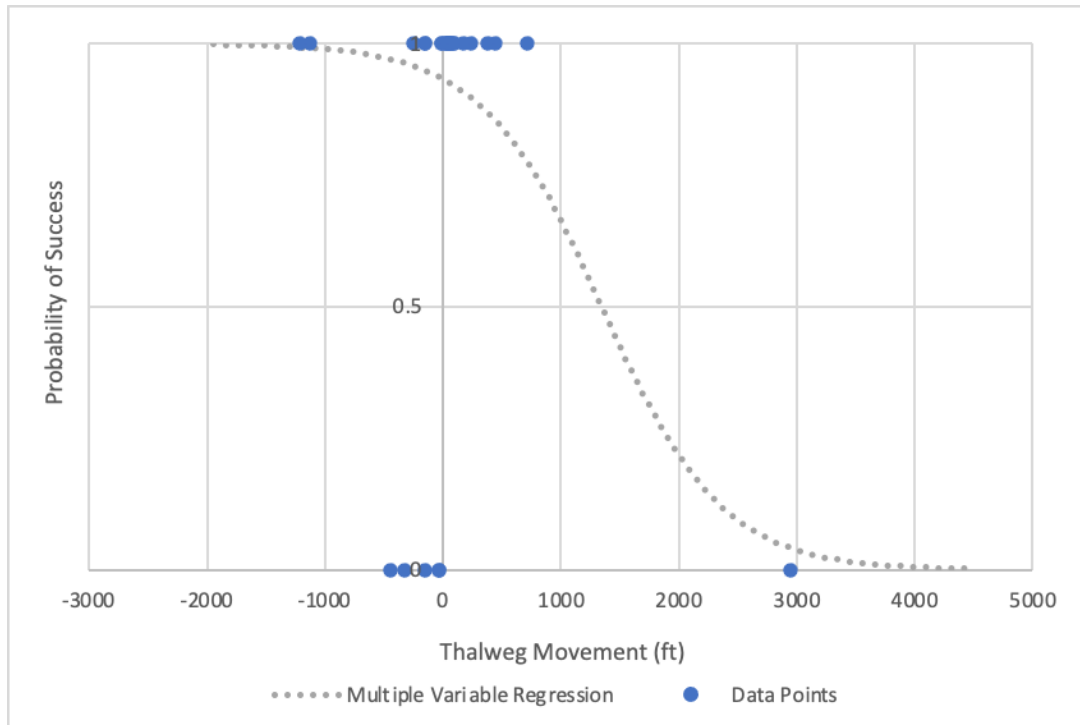
Figure 62: Kellner jetty multiple variable logistic regression in respect to thalweg movement (p < 0.1)

movement are shown in Figure 62. This regression shows that the further away from the bank of concern the thalweg moves, the more likely the structure is to fail. This is counterintuitive but may be due to the erroneous data point with a thalweg movement of 2950. This is site 21, which is the only failed structure with a positive thalweg movement. The impact of this data point on the regression is further analyzed after the presentation of these regressions.

The thalweg movement was negative when the thalweg moved towards the bank with structures and positive when it moved away. A negative coefficient means that thalweg movement towards the structures lead to successful structures. This is shown in Figure 62 when the Kellner jetty angle was held constant. When an individual logistic regression was completed with thalweg movement, the p value was 0.30, so it was not significant. It was only made significant by the addition of the Kellner jetty angle variable. The Kellner jetty angle and thalweg movement data for the failed Kellner jetty sites are shown in Table 49.

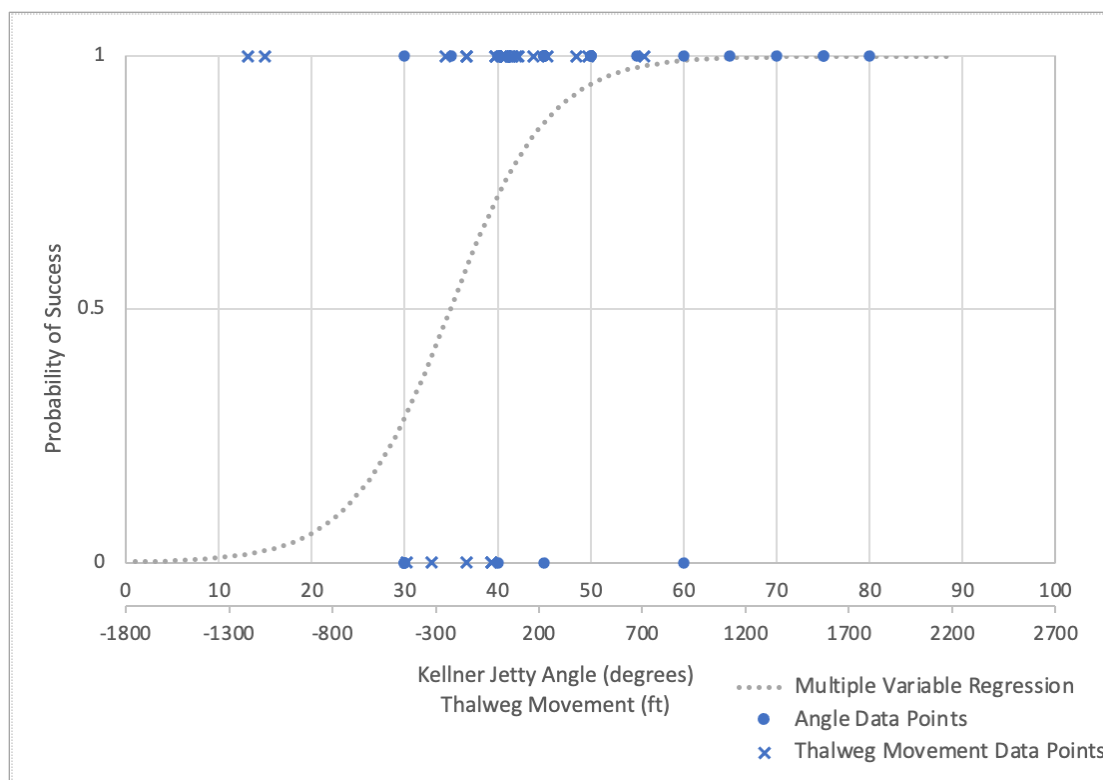
Figure 63: Kellner jetties multiple variable logistic regression in respect to oldest Kellner jetty angle and thalweg movement (p < 0.1)

To evaluate how the variables worked in the regression together, they were combined into one model. Figure 63 shows the logistic regression with the oldest available Kellner jetty angle and thalweg movement and the data points in respect to both variables for comparison. The regression is similar to the others in respect to the Kellner jetty angles, where Kellner jetties installed at angles greater than 60 degrees in respect to the thalweg are predicted to be consistently successful, but thalweg movement is also considered here. Based on this regression, sites with thalweg movement greater than about 400 feet away from the bank of concern and Kellner jetties angles of above 60 degrees will almost always succeed.
