Texas A&M Transportation Institute

Thermal Segregation Influence on Current Asphalt Mixtures

Technical Report 0-7075-R1

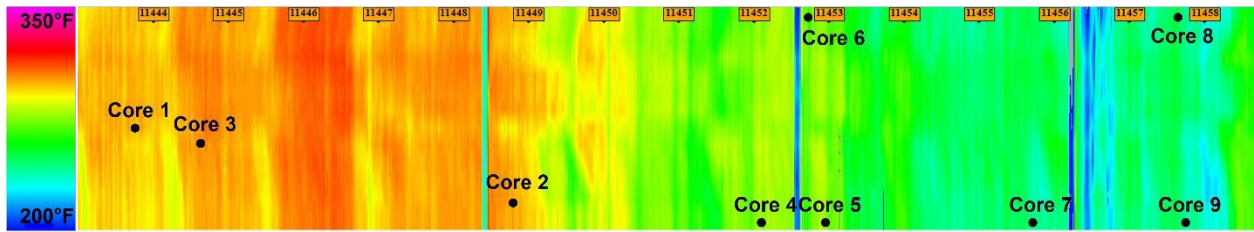
Figure 28. US 69 Thermal Plot with Core Locations.

Based on the results shown in Table 17, researchers identified and marked nine core locations that were representative of the observed temperature range. Figure 28 shows the thermal plot

In Table 18, Cores 7–9 showed much lower temperatures than Cores 4–6, yet the AV content of Cores 7–9 and 4–6 were similar. Researchers attribute this similarity to specific operations observed during the construction process. Within the area represented by Cores 7–9, the overall placement temperature dropped, prompting the contractor quality control staff to conduct extra spot tests with a non-nuclear density gauge. Furthermore, the breakdown roller was instructed to apply more passes in those areas. Thus, Cores 7–9 do not represent the identical operation as the other collected cores. The actions of extra quality control testing and the adjusted breakdown rolling likely contributed to mitigating the impact of the lower mix placement temperature on density.

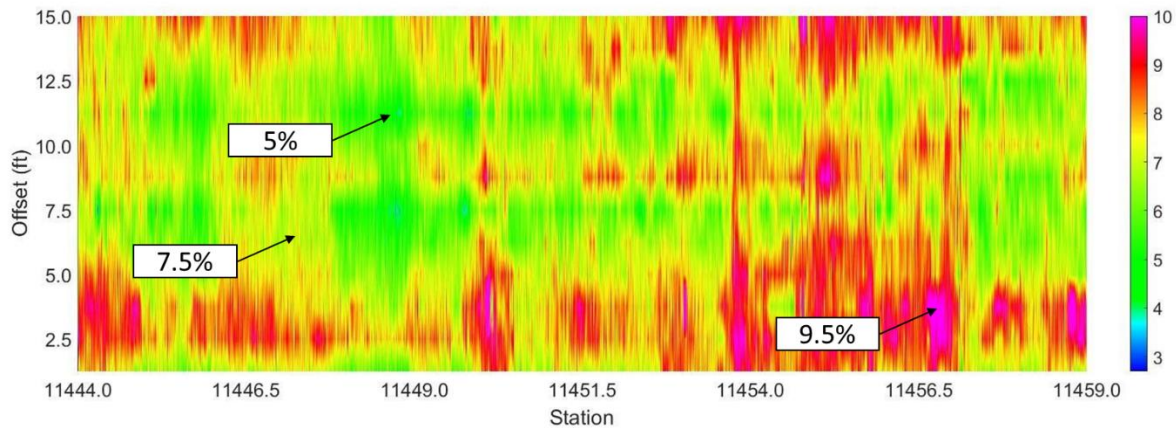
Figure 33. AV Map for US 69.

- Near STA 11459, Figure 33 shows a zone of expected high AVs that correspond with the location of thermal segregation observed in Figure 28.

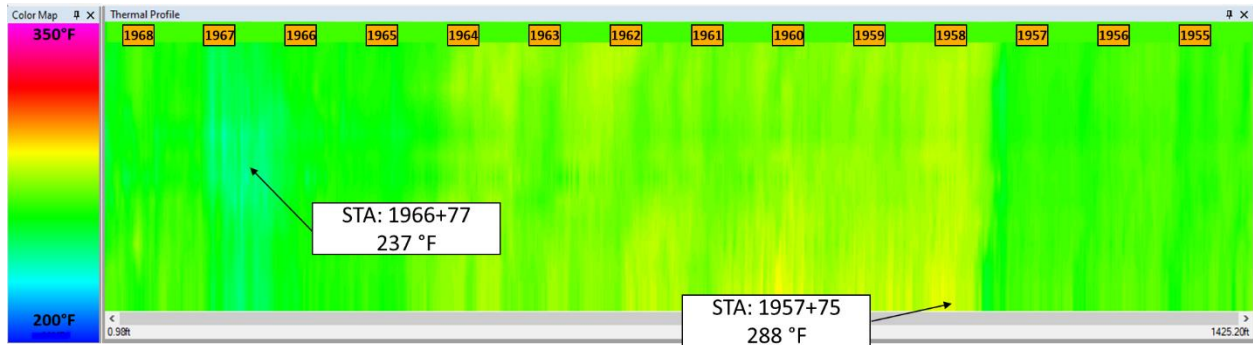
Figure 37. US 287 Thermal Profile.

Thermal profile data for this demonstration project were collected from STA 1968+25 to STA 1954+00. Figure 37 displays the thermal plot, demonstrating overall minimal thermal variations. The notable thermal irregularity is observed between STA 1967 and 1966, where measured placement temperatures were below 250°F.

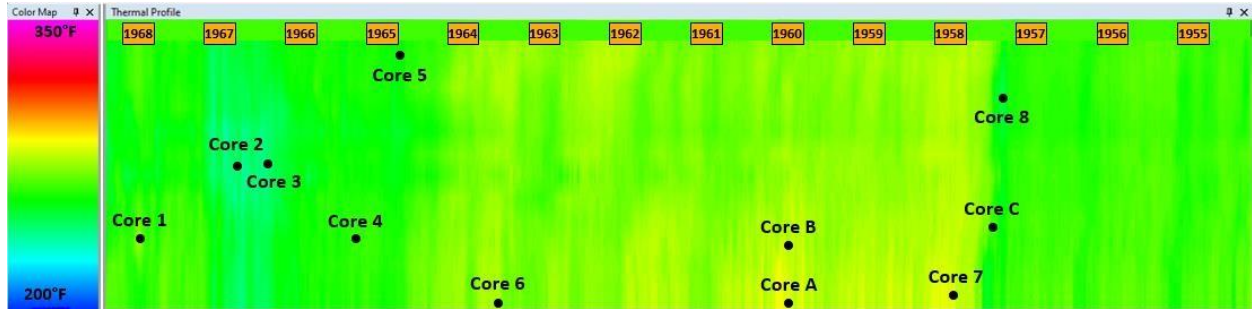
Figure 39. US 287 Thermal Plot with Core Locations.

Based on the results in Table 21, researchers field located 11 core locations to represent the temperature differentials observed in the thermal profiles. Figure 39 shows the thermal plot along with these selected locations. Researchers collected a GPR reading at each core location before extracting the core.

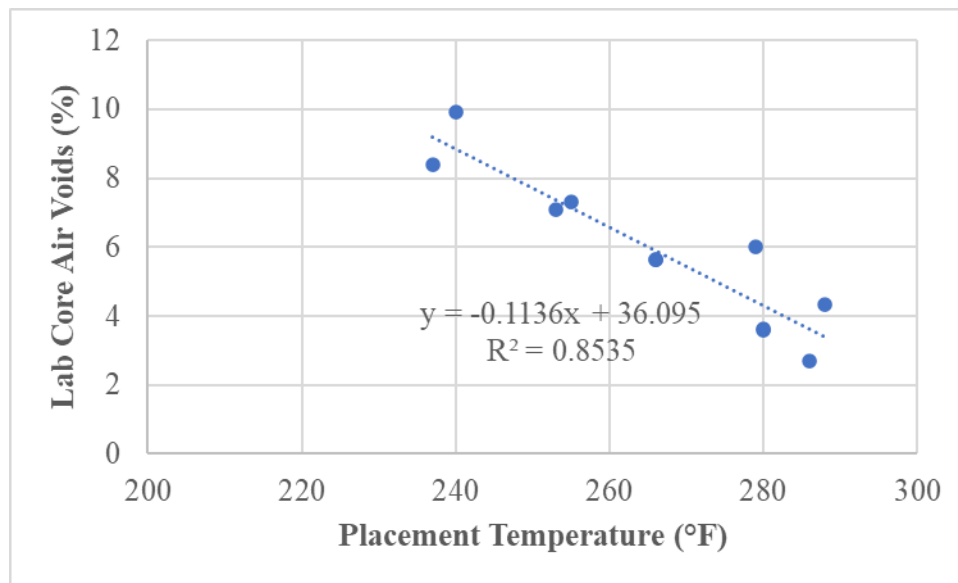
Figure 40. Results from US 287 AVs versus Temperature.

Figure 40 shows the lab-measured AVs versus the temperature measured at the time of placement. The results in Figure 40 illustrate the following:

- A good correlation was observed between the measured temperature at the time of placement and lab-measured AV contents. The data suggest that even if the thermal variation is relatively low in terms of temperature differentials within each 150-ft thermal profile segment, the level of compaction and final in-place AVs is still influenced by the absolute temperature of the mix at the time of placement.

- Although the amount and severity of thermal segregation measured in this demonstration project would be considered reasonably low, the measured AV content range was quite high.

- Based on the slope of the regression line, a temperature differential of 34°F corresponds to an expected density differential of 6 pcf, which aligns with the maximum allowable density range (highest–lowest) specified in TxDOT's density profile requirements for DG-D HMA. This finding is based on a 3.9 percentage point change in AV, which equates to a 6 pcf change in density considering the reported rice gravity of this mix.

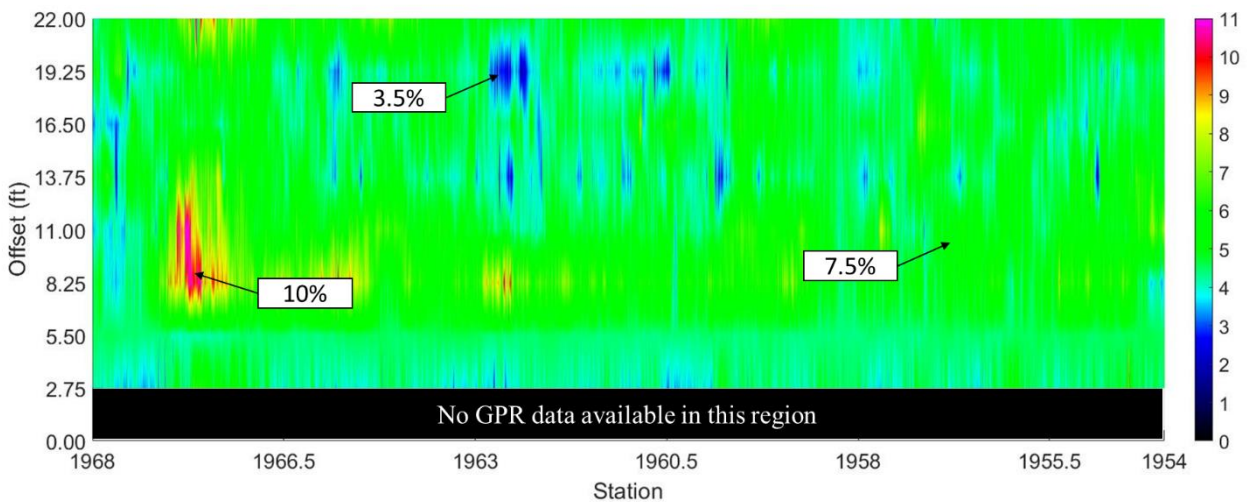
Figure 43. AV Map for US 287.

With multiple GPR runs available at different transverse offsets, the GPR data can also generate a geospatial plot of expected in-place mat density. Figure 43 presents this output for the demonstration area tested. Figure 43 illustrates:

- Most of the mat area exhibits AV content within the desired range of 3.8 to 8.5 percent.
- The cold spot in Figure 39 became the zone of the highest AVs in Figure 43.
- A small proportion of the mat is expected to have less than 3.8 percent AVs.

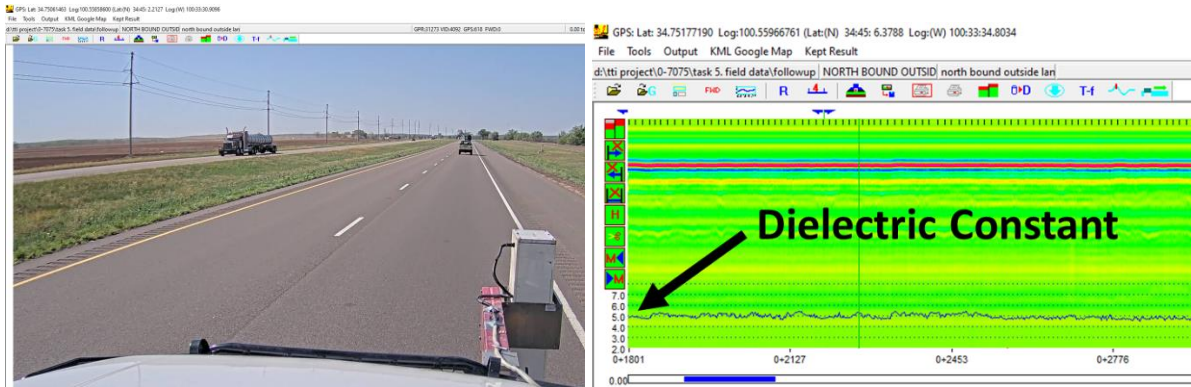
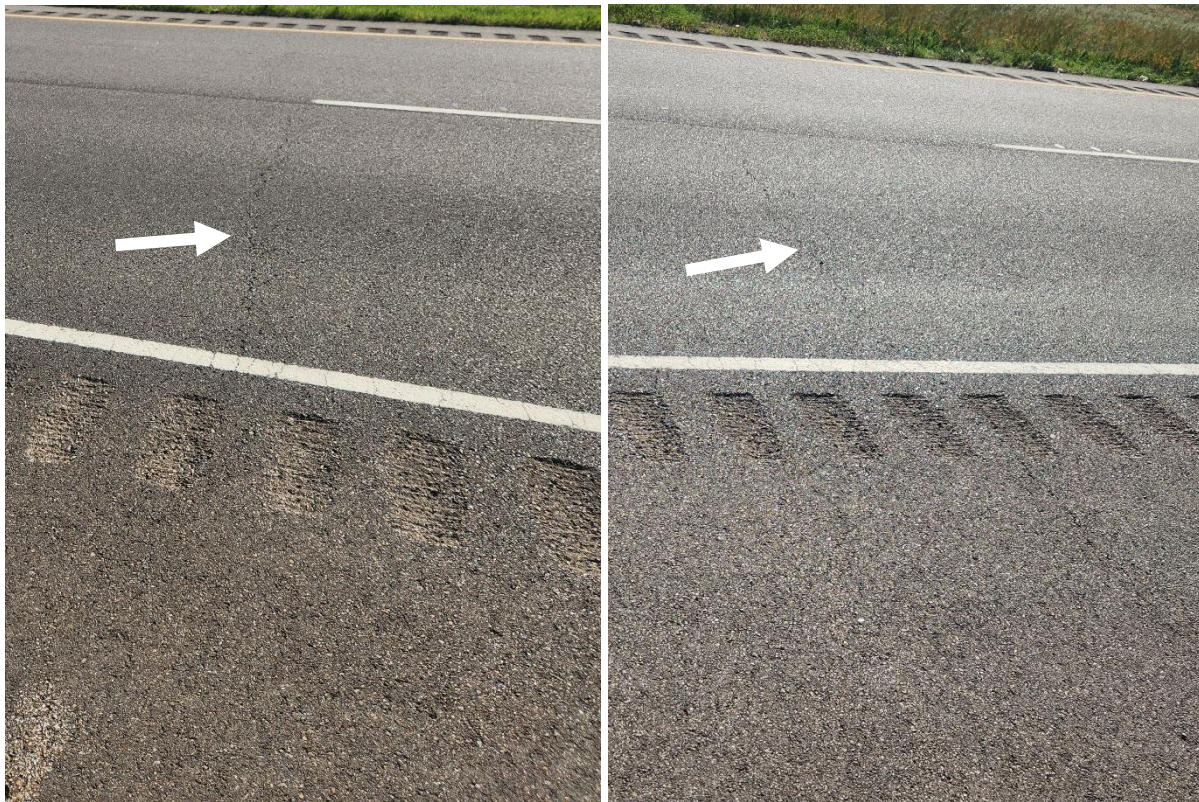
Figure 45. (a) GPR and (b) Post-Construction Condition on US 287.

During the construction of this project, 20 percent of the thermal profiles exhibited moderate thermal segregation. Figure 45a illustrates the follow-up GPR survey when the project was approximately 1.5 years old. The survey revealed the presence of transverse cracking, as shown in Figure 45b. However, no correlation was found between the temperature differential at the time of construction and the location of these transverse cracks.

Despite the presence of some transverse cracking distress approximately 1.5 years after construction, there was no correlation found between these distresses and thermal anomalies during the time of construction. Furthermore, no clear correlation was observed between the temperature differential or the absolute temperature at the time of construction and the measured DC value during the post-construction site visit.

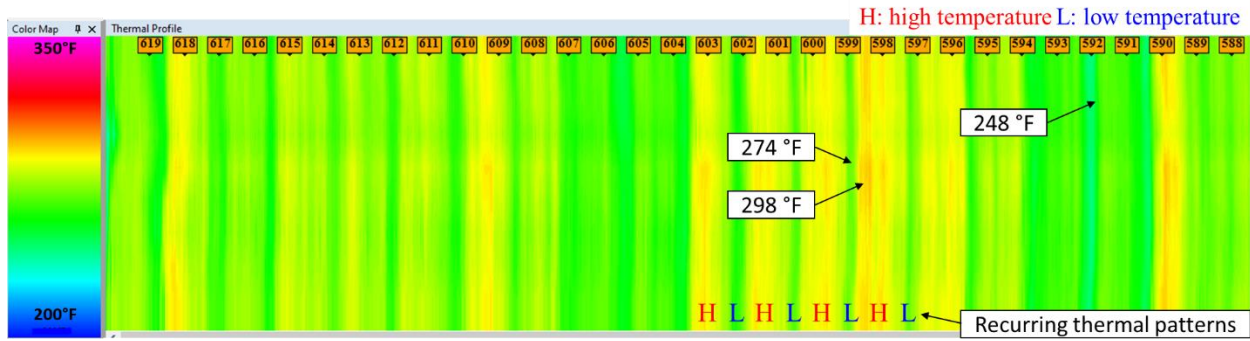
Figure 51. US 183 Thermal Profile.

Thermal profile data used in this demonstration were collected from approximately STA 620 to 587. Figure 51 shows the thermal plot and illustrates recurring thermal patterns.

Researchers evaluated the spacing between cycles of moderate thermal segregation in the thermal profile (Figure 51) and the spacing between high AV cycles in Figure 57. The spacings do not align. Researchers hypothesize the spacing of high AV cycles in Figure 57 corresponds with the breakdown rolling pattern. The breakdown roller struggled to keep up with the paving train until approaching STA 589 since the paving train stopped at that station.

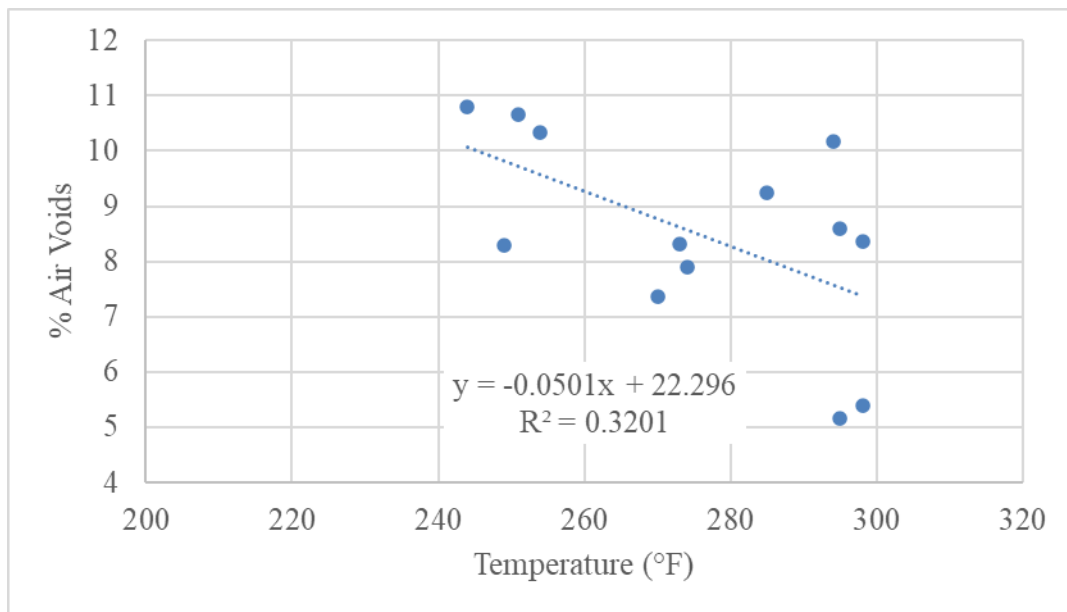
Figure 54. Results from US 183 AVs versus Temperature.

Figure 54 shows the lab-measured AVs versus the temperature measured at the time of placement. The results in Figure 54 show a poor correlation between the temperature measured during placement and the lab core AVs. This observation contradicts the prevailing understanding of how thermal segregation typically impacts the final in-place HMA density.

Researchers believe the poor correlation in Figure 54 is due, at least in part, to erratic breakdown rolling patterns on this project. While on site, researchers noted that the breakdown roller seldom

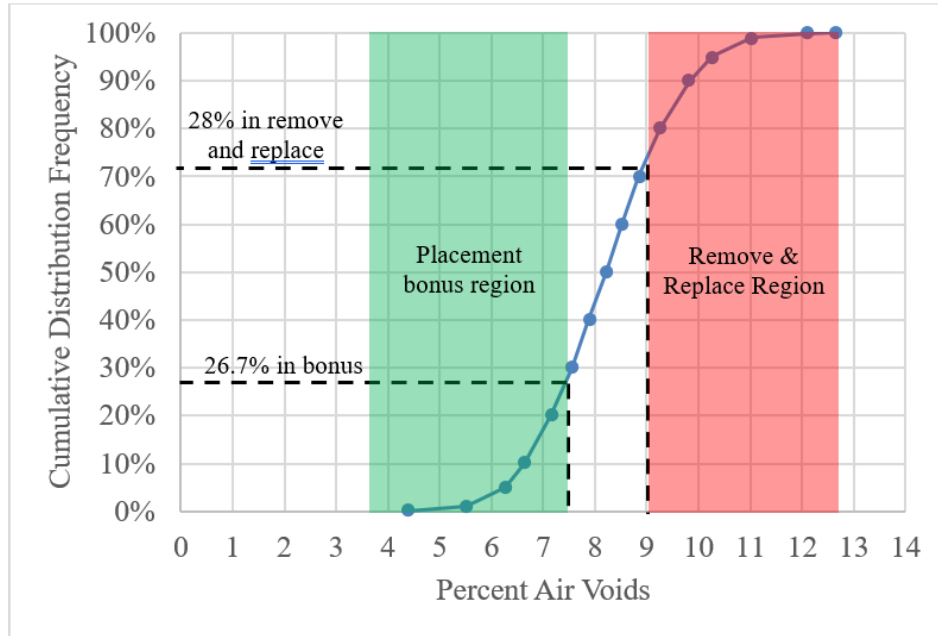
Figure 56. Expected Distribution of AVs on US 183.

Thus, the GPR data and Figure 56 show that for the area tested by GPR, about 27 percent of the mat area is within the placement bonus region. These data also show that about 45 percent of the tested area is in placement penalty and about 28 percent is expected to have AVs requiring removal and replacement.

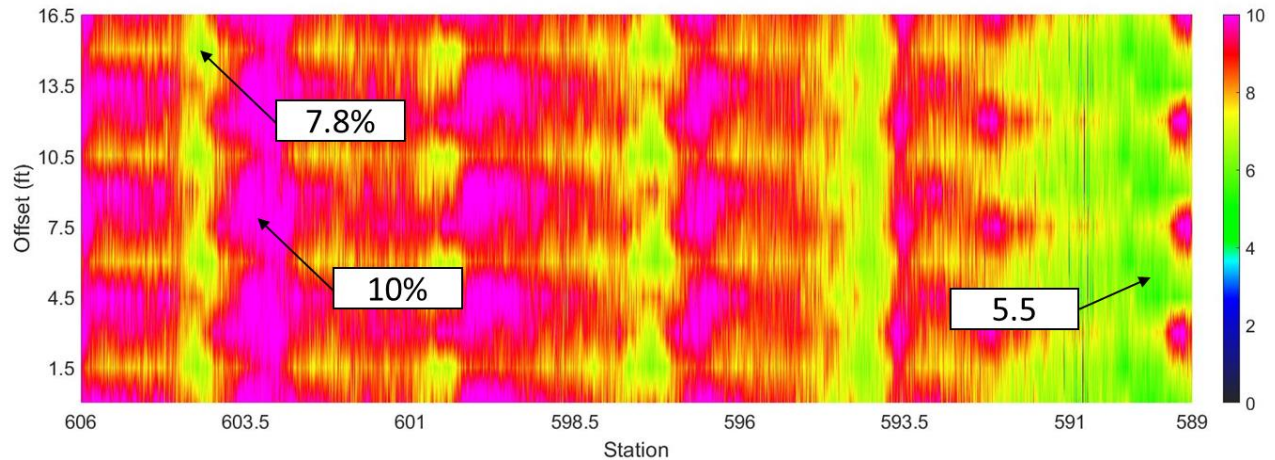
Figure 57. AV Map for US 183.

With multiple GPR runs available at different transverse offsets, the GPR data can also generate a geospatial plot of expected in-place mat density. Figure 57 presents this output for the demonstration area tested. Figure 57 illustrates:

- A significant percentage of the mat area exhibits high AVs.
- A cyclic pattern of low density seems to exist.
- Approaching STA 591, the severity of low density seems to lessen.

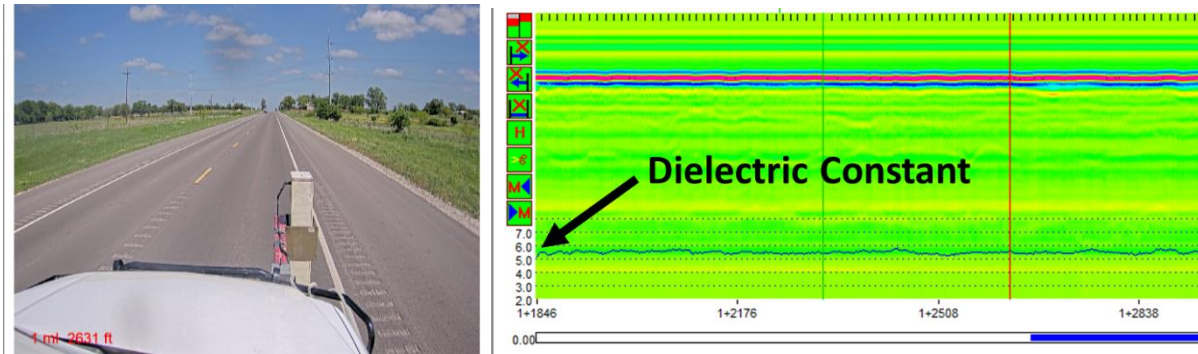
Figure 58(a) shows an excerpt from the 1-GHz air-coupled GPR survey. No significant distress was observed at the post-construction site, as shown in Figure 58(b).

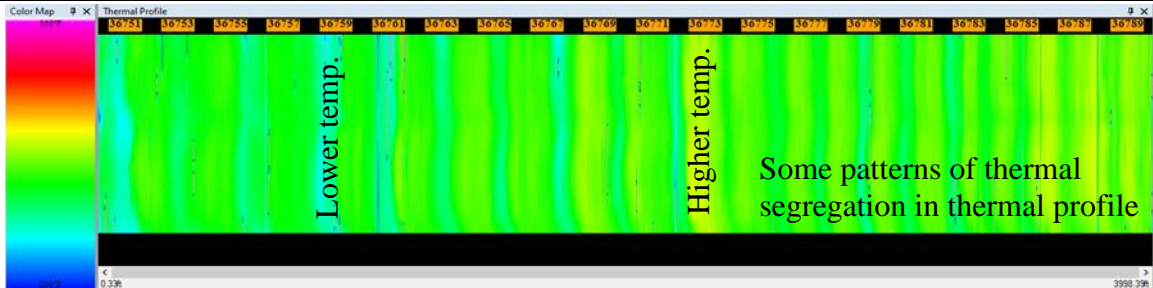
Example Thermal Plot

Section	SH 72 (CORPUS CHRISTI), CSJ 0270-09-027	
Limits	Live Oak, from US 259 to CR 344 (5.761 mi.)	
Letting Date	September 2013	
Overlay Type	1.5" Type D	PG 70-22
Date of condition survey	May 2022

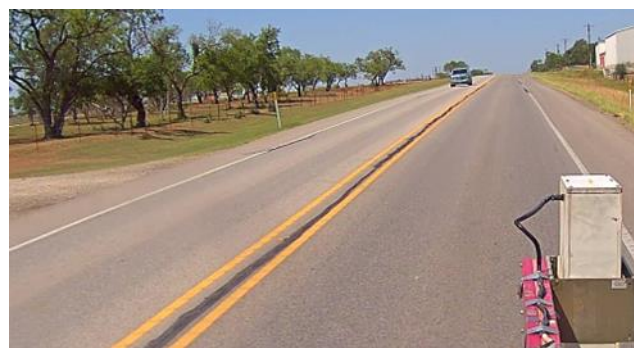
Example Current Condition Photo 1

In SH 97 in Wilson County, the correlation between the location of thermal segregation known at the time of construction and the distress of the pavement or the appearance of the surface could not be confirmed. No distress was observed for the 41 profiles over the project which classified as severe thermal segregation according to the TEX-244-F. The GPR survey did not correlate any trend between surface dielectric and thermal profile.

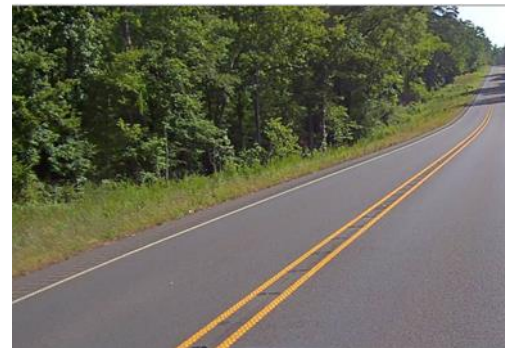
Example Current Condition Photo 1

In SH 43 in Harrison County, the correlation between the location of thermal segregation known at the time of construction and the distress of the pavement or the appearance of the surface could not be confirmed. No distress was observed for the 15 profiles which classified as severe thermal segregation according to the TEX-244-F. The GPR did not correlate any trend between surface dielectric and thermal profile

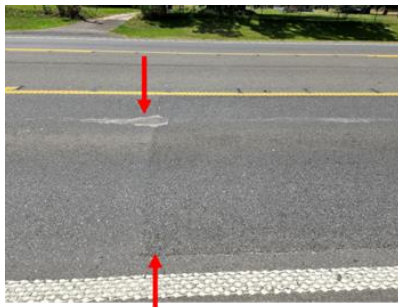
Discussion
In US 79 in Panola County, the correlation between the location of thermal segregation known at the time of construction and the distress of the pavement or the appearance of the surface could not be confirmed. No distress was observed for the 3 profiles which classified as severe thermal segregation according to the TEX-244-F. The GPR survey did not correlate any trend between surface dielectric and thermal profile. However, several distress types were observed including patching, pothole, and pumping at locations where temperatures below 250 °F were dominantly distributed.

Summary
No distress was observed for the 13 profiles which classified as severe thermal segregation according to the TEX-244-F. Distresses existed where mix placement temperatures were low, but uniform.

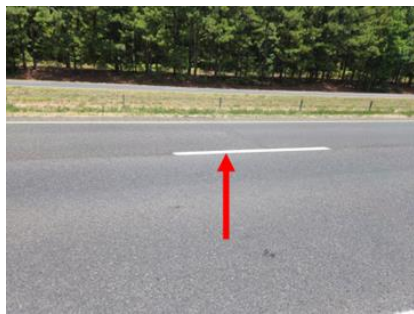
Example Current Condition Photo 1

In US 259 in Upshur County, the correlation between the location of thermal segregation known at the time of construction and the distress of the pavement or the appearance of the surface could not be confirmed. No distress was observed for the 3 profiles which classified as severe thermal segregation according to the TEX-244-F. The GPR survey did not correlate any trend between surface dielectric and thermal profile. However, evidence of pavement distress was observed in a profile where temperatures below 250 °F were dominantly distributed.
