Revised Load Rating Procedures for Deteriorated Prestressed Concrete Beams

Research and Technology Transfer Section
MassDOT Office of Transportation Planning

1. Report No. 23-047	2. Government Accession No. n/a	3. Recipient's Catalog No. n/a
4. Title and Subtitle Revised Load Rating Procedures for Deteriorated Prestressed Concrete Beams		5. Report Date August 2023

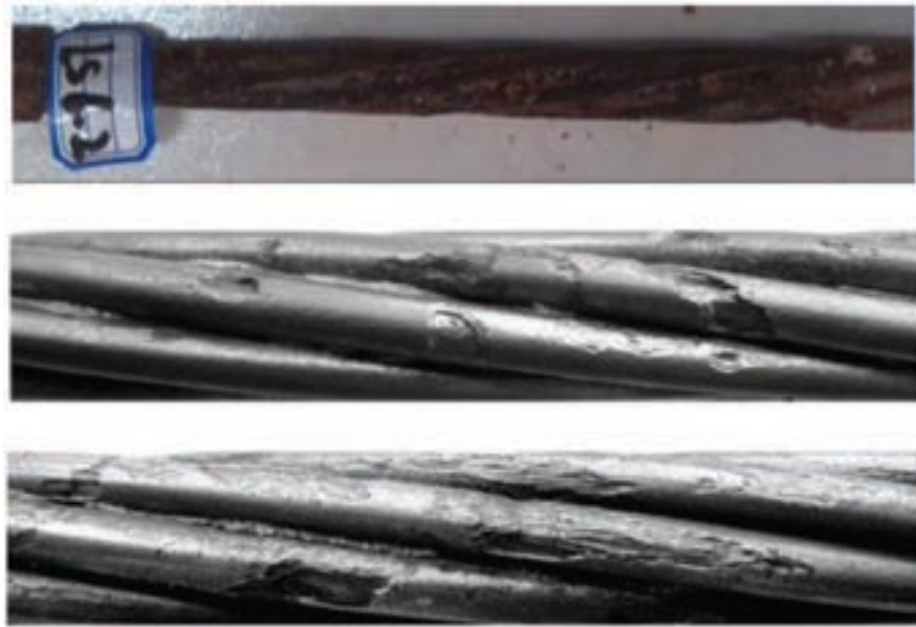
The stress-strain properties are likely to change with corrosion of strands. One of the primary corrosion mechanisms is pitting in the strands *(23)* (Figure 2.3). Lu et al. *(23)* proposed a procedure to account for the degradation of the stress-strain behavior for strands that have undergone corrosion. The proposed modification is related to the reduced area of the strand. The strand stress-strain proposed by Lu et al. consists of a bilinear model that can incorporate reduction factors. Deng *(24)* proposed a model for the reduced area that is based on experimental models and from FEM modeling.

Figure 2.3: Examples of pitting corrosion

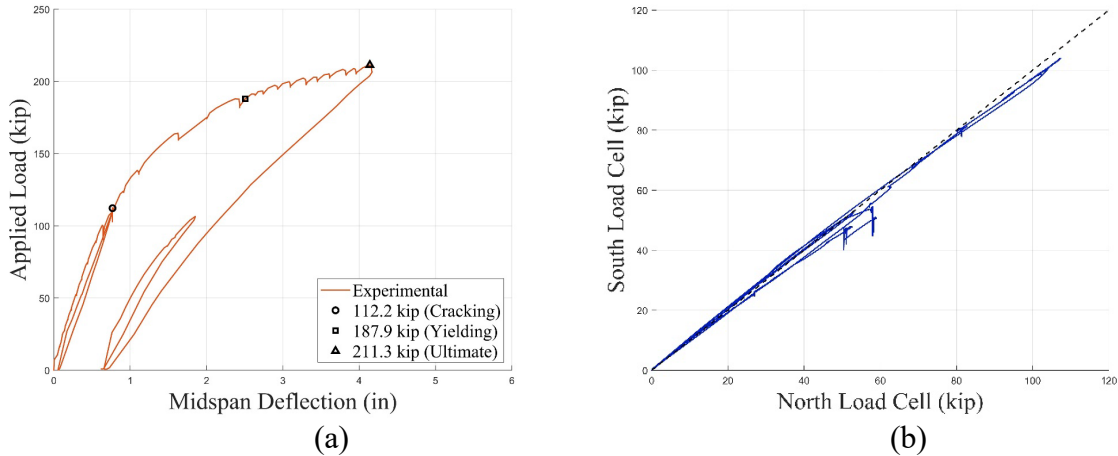
Figure 5.10 shows the load-displacement curve measured during the test and a comparison of the load measured by the two individual cells. It can be observed that despite the rod bending, the load cells measured approximately the same load throughout testing with a maximum difference of 8.1%.

Figure 5.10: Specimen R2: (a) load-deflection response; (b) north and south load cells

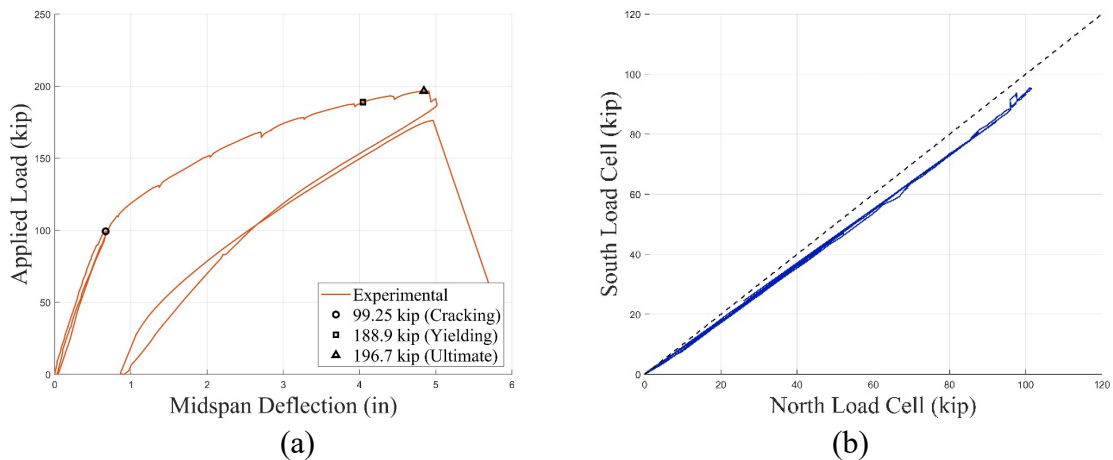
Figure 5.14 shows the load-deflection curve measured during the test and a comparison of the load cell values recorded throughout testing. The readings on the north load cell were higher than those in the south load cell. The slight differences in load cell reading could have been caused by beam twisting or slight loading beam misalignment, although differences did not exceed approximately 10%.

Figure 5.14: Specimen R3: (a) Load-deflection response; (b) north and south load cells

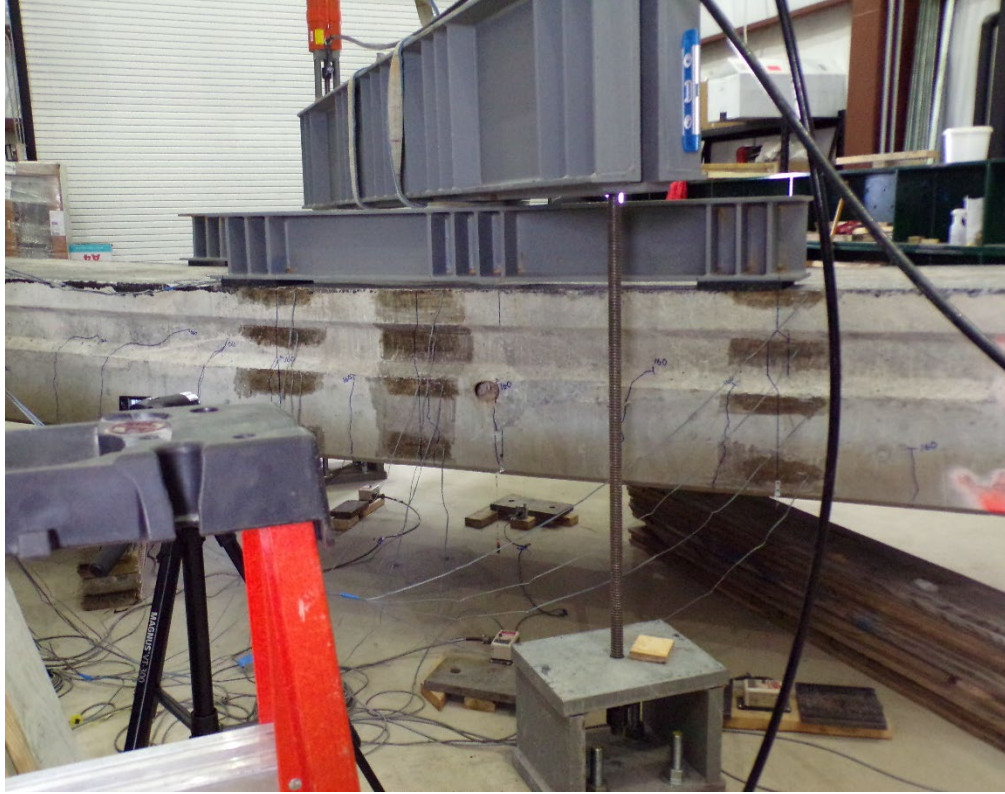
Figure 5.16: Cracking in Specimen R4 at 160 kip

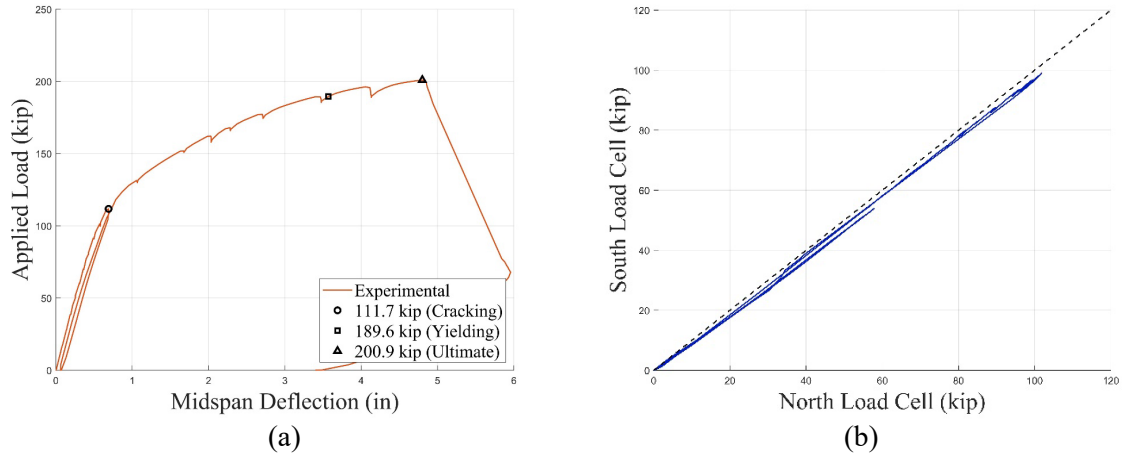
Figure 5.18 shows the load-displacement curve of Specimen R4 and a comparison of the load cell readings. The load cell reading comparison indicated less deviation than that recorded for Specimen R3. The north load cell registered slightly higher loads in comparison with the south load cell; the maximum difference was approximately 10%.

Figure 5.18: Specimen R4: (a) Load-deflection response; (b) north and south load cells

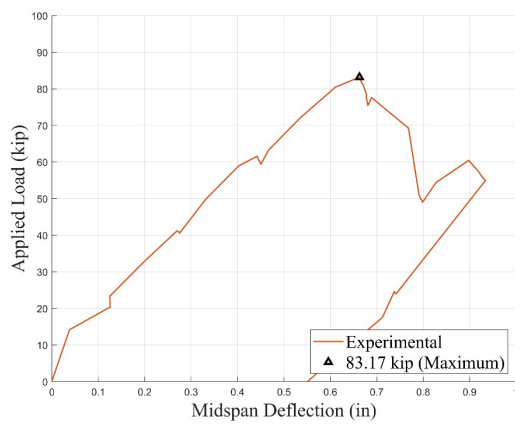
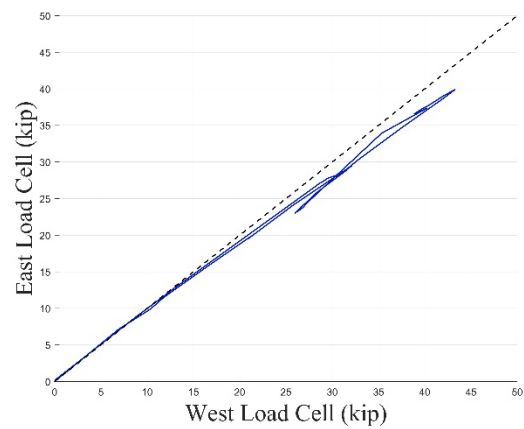
Figure 5.23: Specimen E4: (a) Load-deflection response; (b) east and west load cells

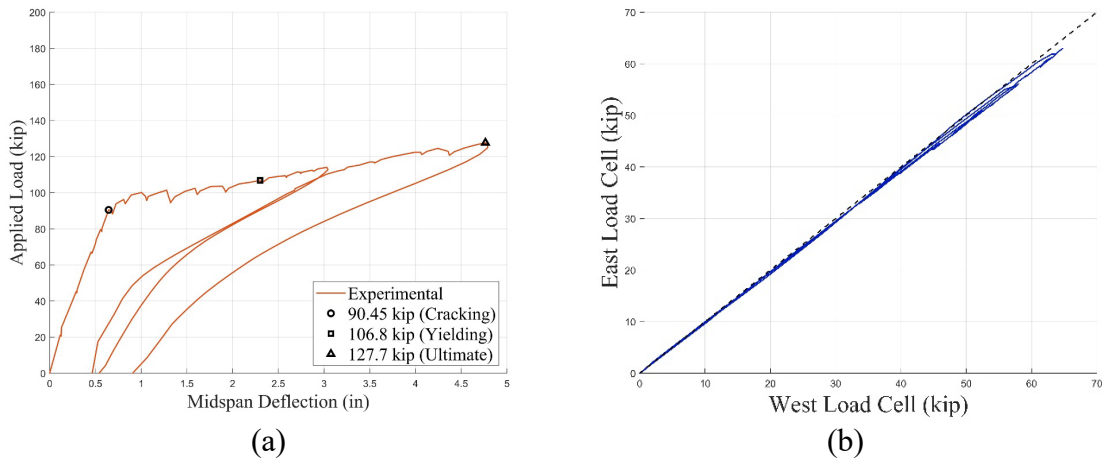
Figure 5.27: Specimen E3: (a) Load-deflection response; (b) east and west load cells

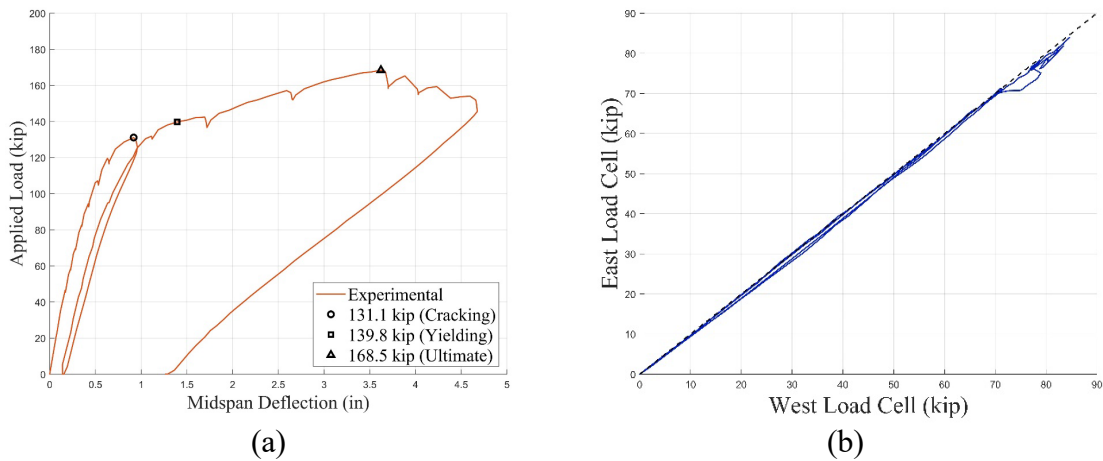
Figure 5.31: Specimen E9: (a) Load-deflection response; (b) east and west load cells

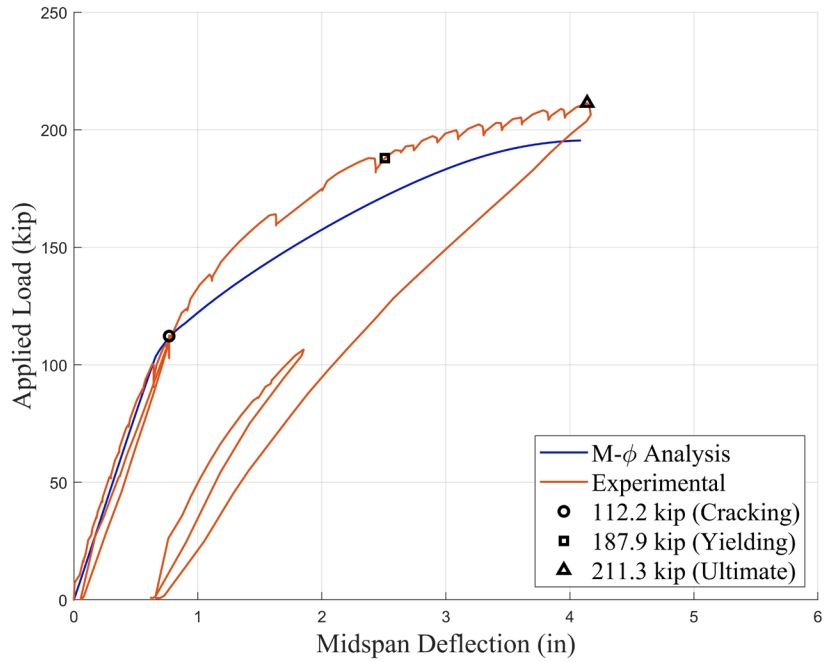
The three beams from the Rehoboth Bridge (Specimens R2, R3, and R4) exhibited similar load-deflection behavior (Figure 6.6 through Figure 6.8). Curves from analysis were constructed subtracting deflections caused by beam self-weight and the weight of the loading frame. Three key points in the curve obtained from the experiment results are identified in the figures: the cracking load, yield load, and ultimate load. The cracking load was identified when a visible loss in stiffness of the load-deflection curve was observed during testing and verified visually. The yield load was estimated from the results of the moment-curvature analysis (specifically the point at which the strands reached their yield stress of 243 ksi) and plotted in the experimentally determined load-deflection plots as shown in the figures. Since the test data were collected every 3 seconds, yield was identified as the closest load to what was predicted analytically. The values corresponded approximately to changes in slope of the load-deflection diagram of each of the specimens as shown Figure 6.6 through Figure 6.8. A peak load of 195.4 kip was predicted using the moment-curvature analysis, given the testing configuration. All the specimens exceeded the calculated peak load, confirming the ability of the analytical tools used for nondeteriorated beams. The maximum difference in measured to calculated peak load did not exceed 10%.

Figure 6.6: Specimen R2: measured and calculated load-deflection response

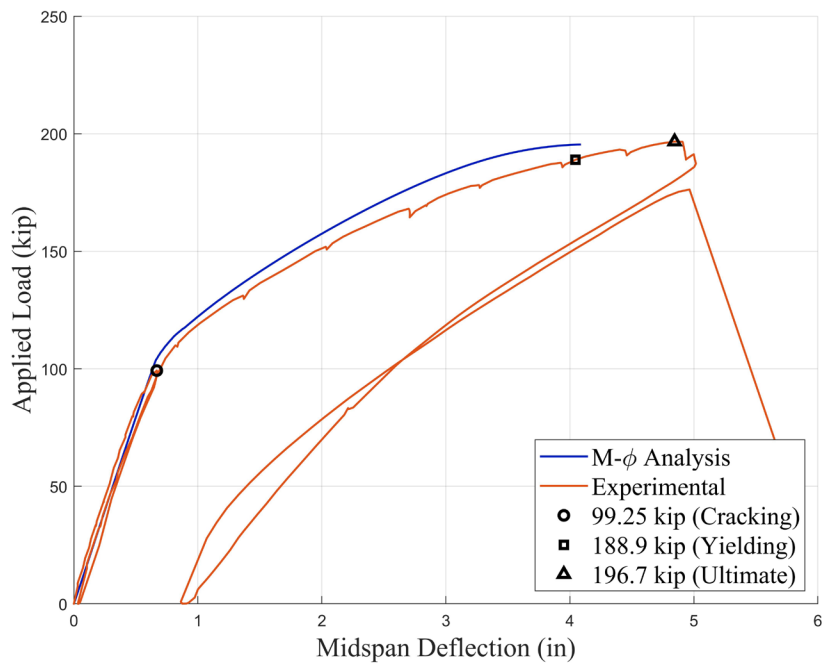
Although load was predicted accurately by the models used, deflections were not. The difficulty in accurate deflection calculation is not unique to this research. There is larger variability in modulus of elasticity of concrete than any other mechanical property involved in the calculations presented here. The modulus of concrete can be off by as much as 50%, so deflection calculations are hard to match with laboratory results. A reduction in modulus is also observed after concrete creep, so deflection calculations are often below measured values as experienced in Specimens R3 and R4 (Figure 6.7 and Figure 6.8).

Figure 6.7: Specimen R3: measured and calculated load-deflection response

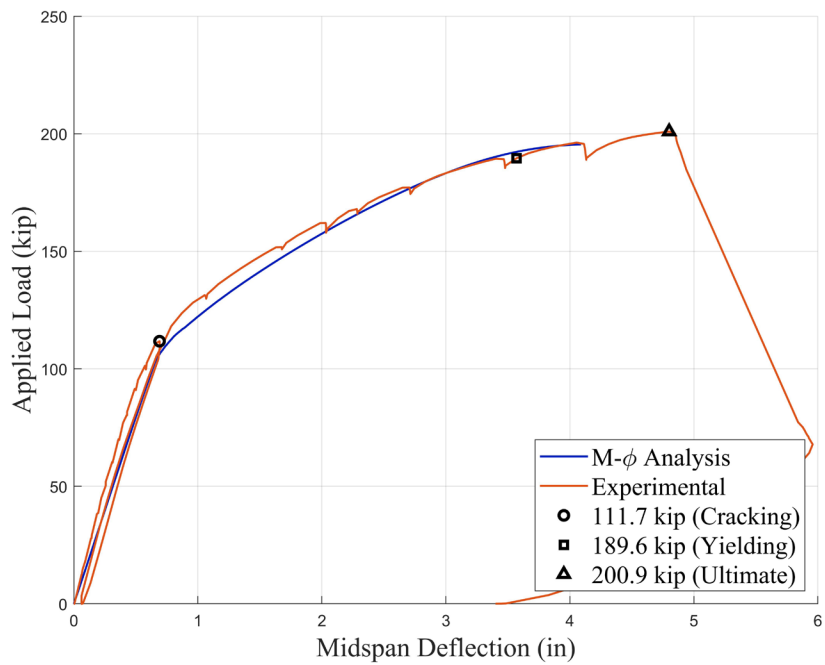
Figure 6.8: Specimen R4: measured and calculated load-deflection response

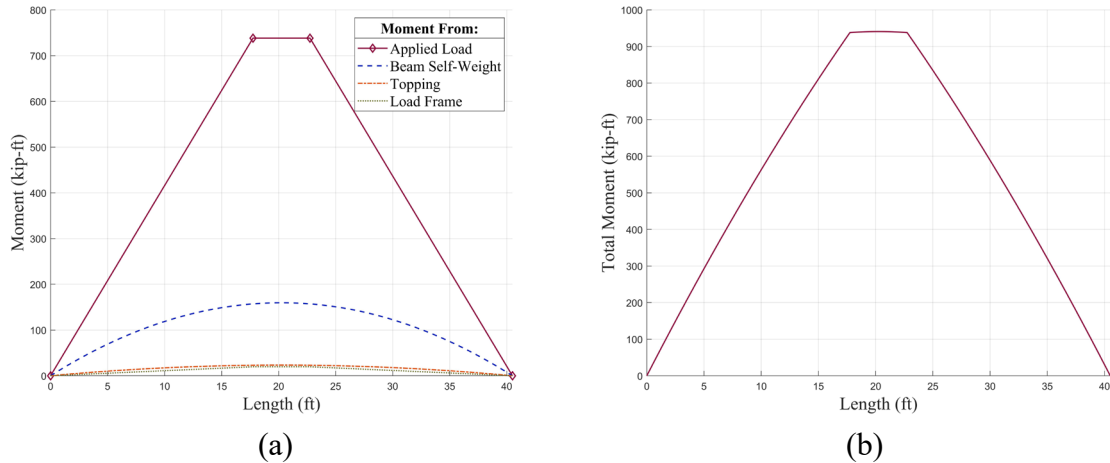
Figure 6.9: Specimen E4 moment diagrams: (a) individually applied/acting loads; (b) total moment

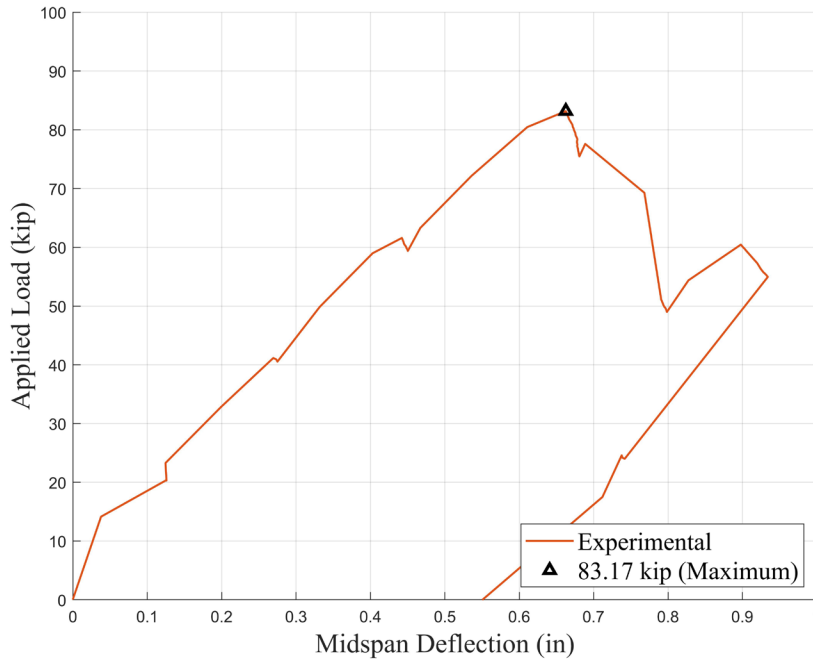
Specimen E4 achieved an applied load of 83.2 kip after failing in shear at the south end (Section 5.4.4; Figure 6.10). The maximum load, including the weight of the topping assumed uniformly distributed (2.5-in.-thick asphalt layer with a unit weight of 0.14 kip/ft^3), the weight of the spreader beams, and self-weight of the prestressed beam result in a maximum moment at midspan of 940.7 kip-ft. A summary of the contributors to the total midspan moment are listed in Table 6.5. Figure 6.9 shows the moment diagram for all loads in the test, corresponding to approximately 44.8% of the calculated moment capacity of a nondeteriorated beam. During the test, no flexural cracks were observed to form; only shear cracks formed primarily on the web near the south end of the beam. At this end, one of the webs was noticeably thinner because of shifting of the void-former used during construction, as previously discussed in Section 5 (Figure 5.20). Diagonal cracking occurred mostly in this web limiting the capacity for the beam to resist higher loads (Figure 5.22). Figure 6.10 shows the load-deflection curve, which shows the sudden drop in load experienced during the test as the cracks that formed in web and web-bottom flange connection widened.

Figure 6.10: Specimen E4 load-deflection curve with critical points

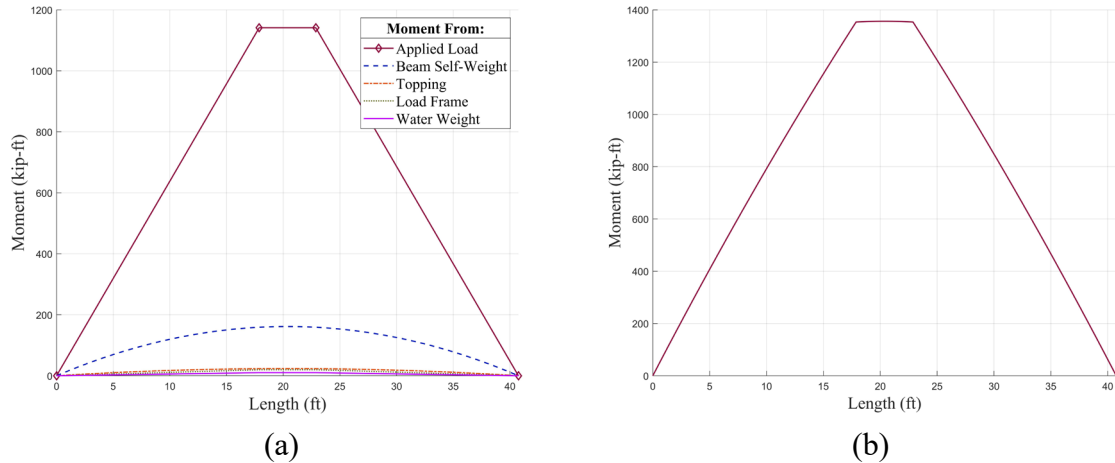
Note: Failure occurred at a section just north of the north load points.

Figure 6.11: Specimen E3 moment diagrams: (a) individually applied loads; (b) total moment

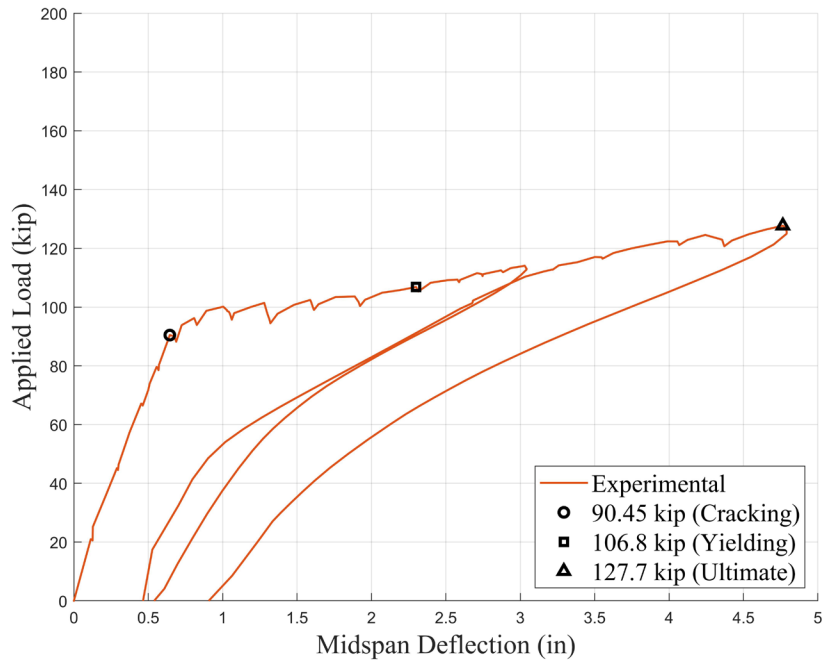
Specimen E3 reached an applied load of 127.7 kip, estimated from peak in the load-deflection plot (Figure 6.13). An ultimate moment of 1,356.3 kip-ft at midspan was calculated for the test configuration. The entrapped water weight in the middle cell of the beam was estimated by taking an assumed unit weight of water of 62.4 lb/ft³ and multiplying by the distance between the diaphragms, the width between the webs, and an assumed depth of water within the middle cell of 3 in. The moment diagrams from the individual loads and the total moment are shown in Figure 6.11, and the midspan moments are given in Table 6.7. The beam moment determined during the test was approximately equal to 64.6% of the calculated moment strength of nondeteriorated beam using specified material properties.

Figure 6.13: Specimen E3 applied load-deflection curve with critical points

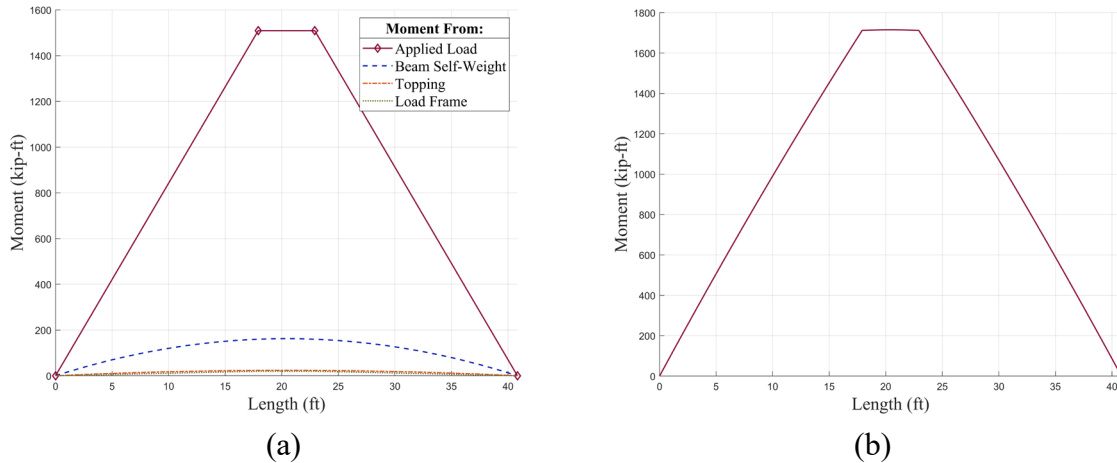
Note: Failure occurred at a section near the north load points within the shear span.

Figure 6.14: Specimen E9 moment diagrams: (a) individually applied loads; (b) total moment

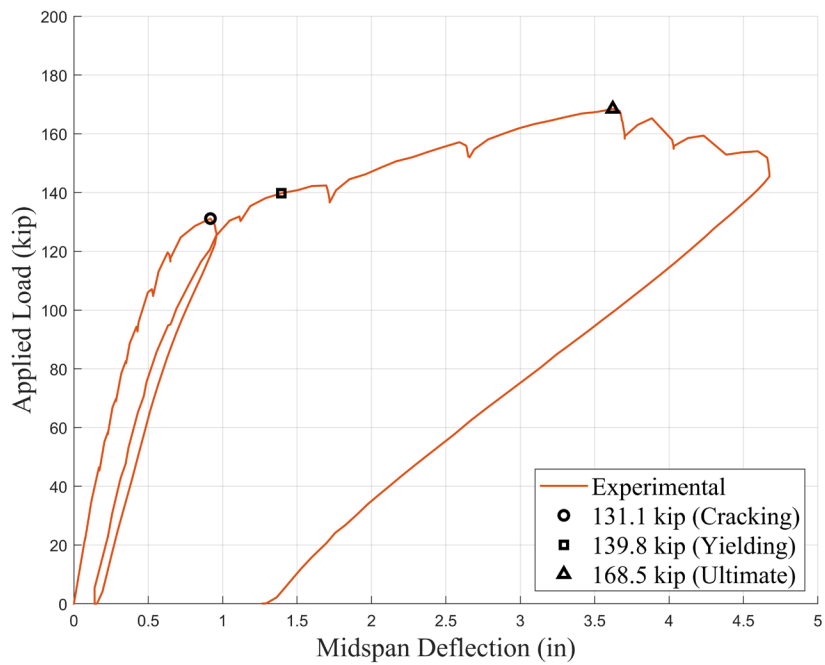
The maximum applied load to Specimen E9 was 168.5 kip, estimated from the peak in the load-deflection plot (Figure 6.16). An ultimate moment at midspan of 1,714.8 kip-ft was calculated using the testing configuration. This moment corresponds to 81.7% of the moment strength of the nondeteriorated beam. A summary of the maximum midspan moments induced by all loads acting at the time of testing are summarized in Table 6.8. The moment diagrams of the different loads (existing and applied loads) and the total moment diagram during the test are shown in Figure 6.14.

Figure 6.16: Specimen E9 applied load-deflection curve with critical points

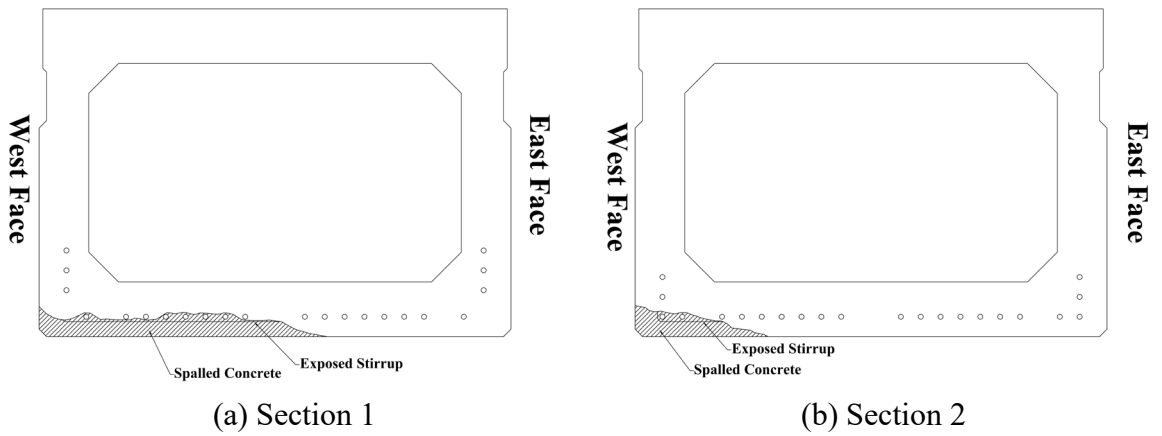
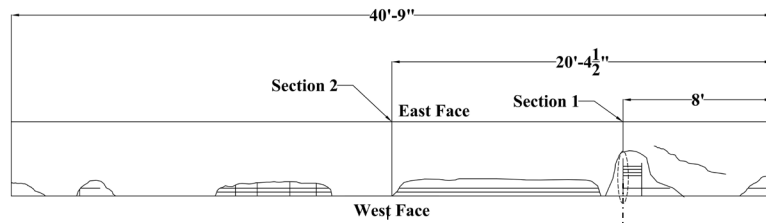
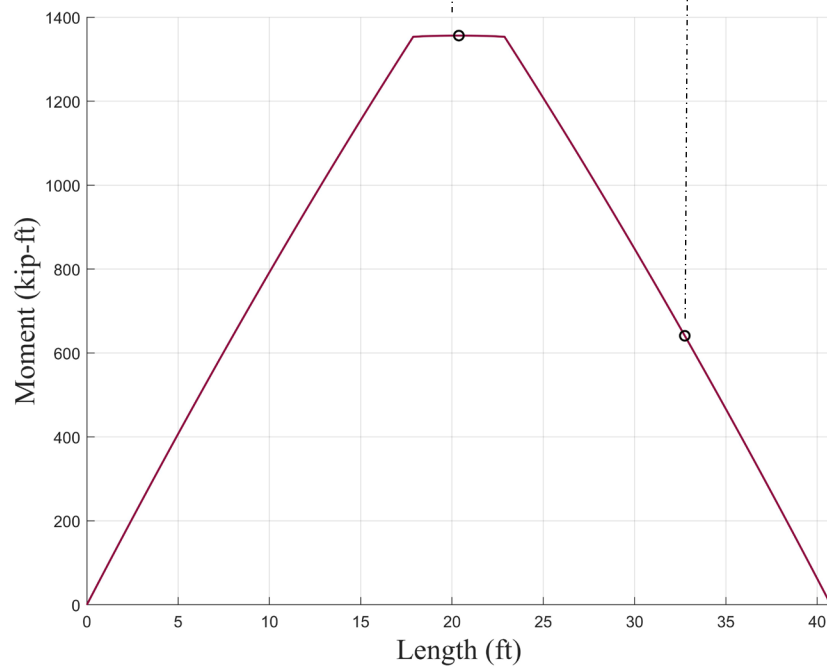
Figure 7.1: Deterioration condition of Specimen E3 at Section 1 and Section 2

The strength of each specimen was evaluated at the two sections indicated in Figure 7.1 and Figure 7.2. The sections corresponded to the section with the highest amount of deterioration and the section where the total moment was highest. Specimen E3 reached a total moment of 641.0 kip-ft at the section with the highest amount of deterioration and 1,356.3 kip-ft at the section with highest total moment. Specimen E9 reached total moments of 1,103.8 kip-ft and 1,714.8 kip-ft at the section with the highest amount of deterioration and the section with highest total moment, respectively.

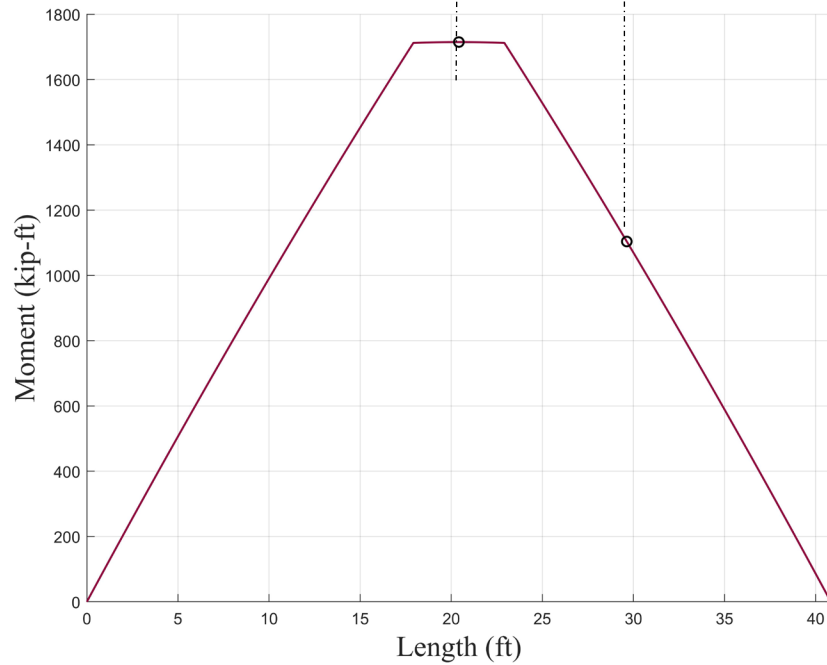
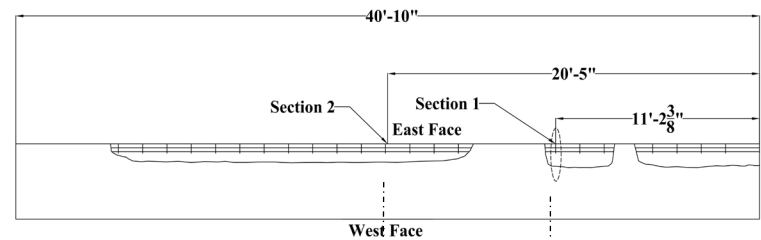
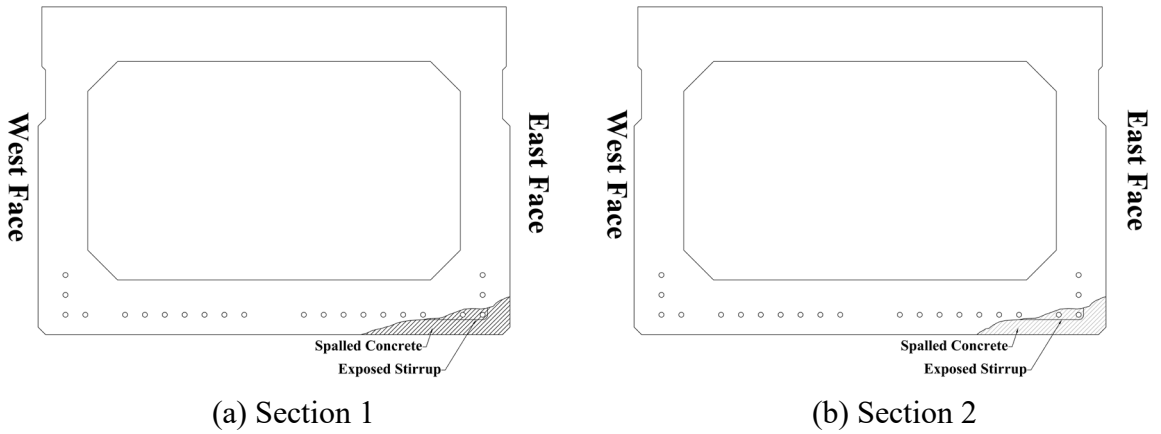
Figure 7.2: Deterioration condition of Specimen E9 at Section 1 and Section 2

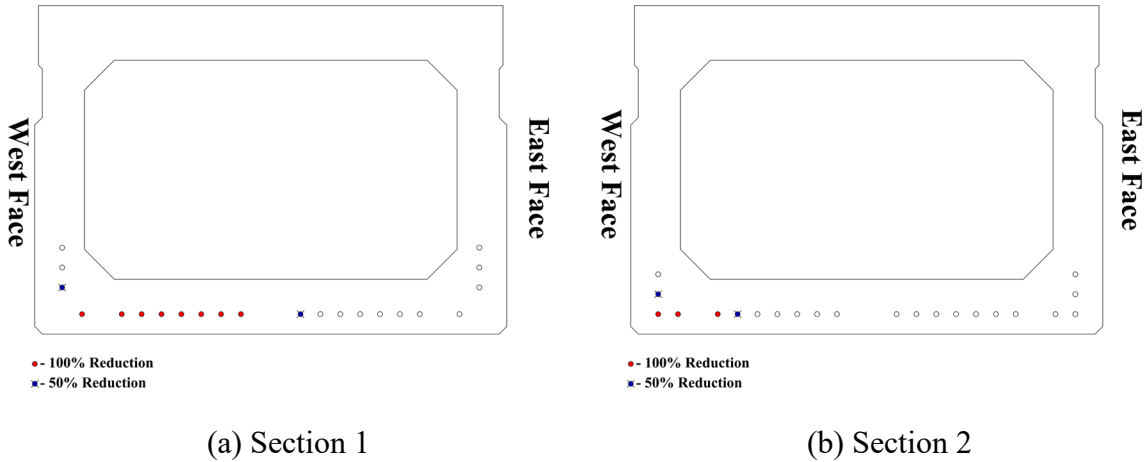
Figure 7.3: Specimen E3: Reduced areas of prestressing strand per MassDOT procedure

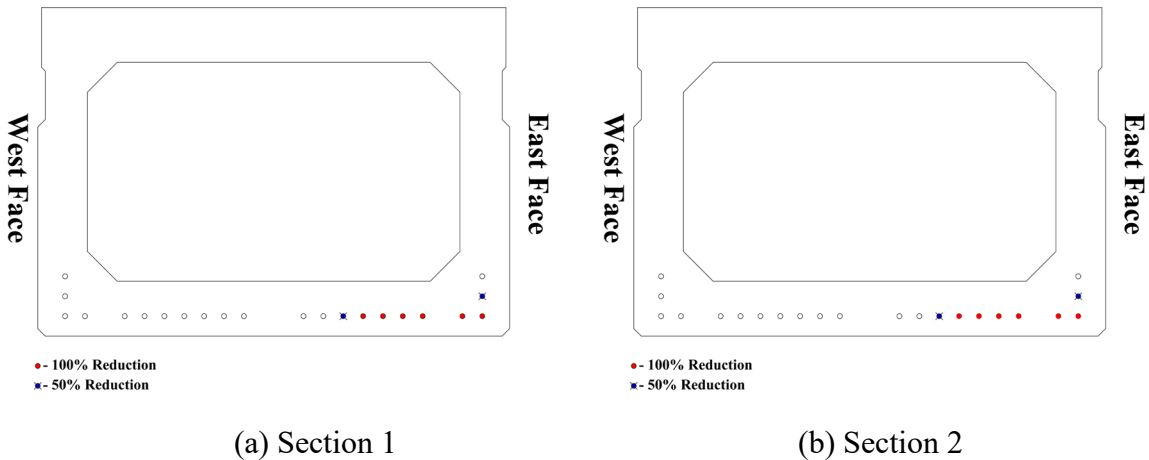
Figure 7.4: Specimen E9: Reduced areas of prestressing strand per MassDOT procedure

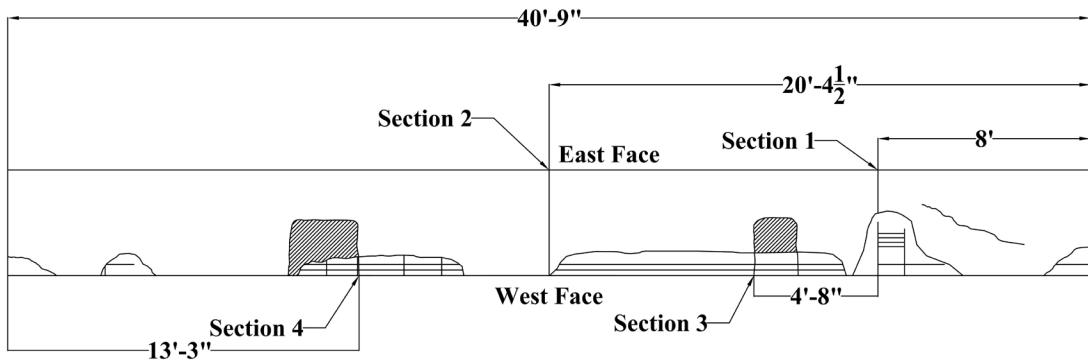
During testing of Specimen E3, areas of concrete spalled adjacent to previously identified deteriorated regions (Sections 3 and 4, see Figure 7.5). These two additional spalled regions are shown as dark hatched areas in Figure 7.5. Section 4 is close to the northwest load-point application. Sections 3 and 4 experienced very similar spalling patterns to Section 1 (Figure 7.6; only the first three corner strands were exposed prior to testing). Although these areas were adjacent to previously spalled areas, they did not show significant evidence of potential for strand corrosion; however, after concrete spalling during the tests, the exposed strand showed a significant amount of corrosion and, because of concrete spalling, experienced loss of bond to the surrounding concrete. These sections, therefore, could not develop the moment capacity estimated following the MassDOT bridge manual procedures. The proposed modifications to the MassDOT bridge manual particularly apply to areas adjacent to spalled regions of concrete or other areas where loose concrete may be present covering strands that might be severely deteriorated.

(a) Deterioration mapping on bottom surface (hatched area spalled after test)

(b) Section 3 after the test

(c) Section 4 before and after test
Figure 7.5: Deterioration of Specimen E3

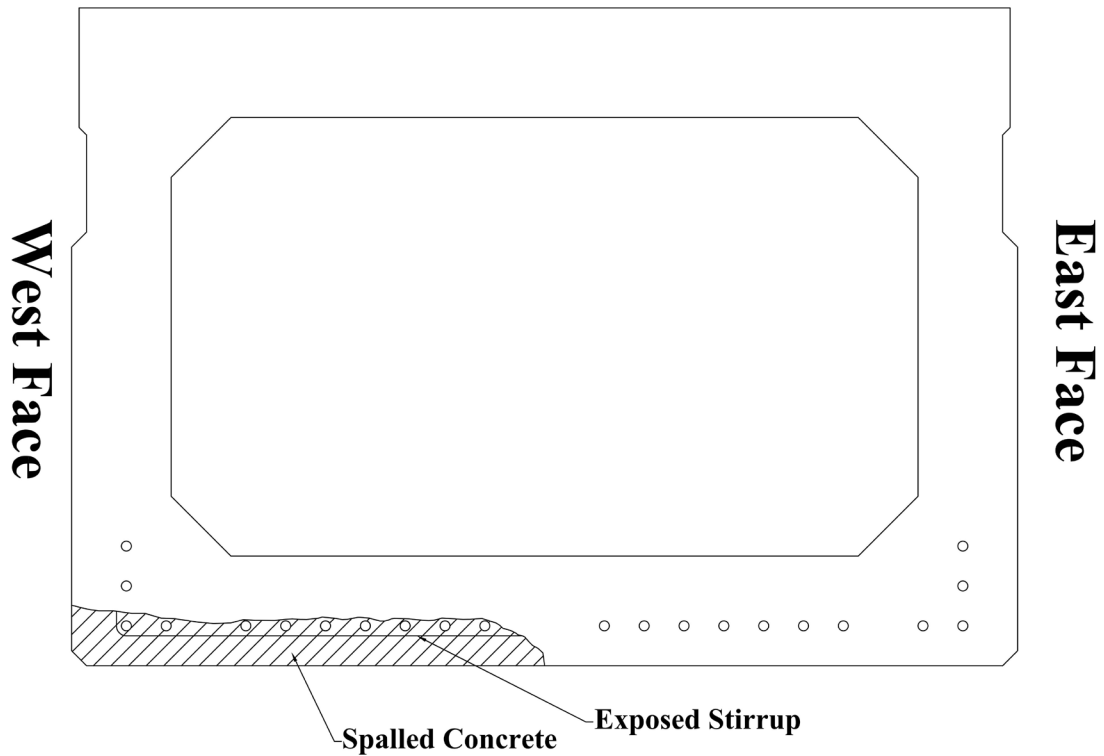
Figure 7.6: Cross section of Sections 3 and 4 of Specimen E3 after testing

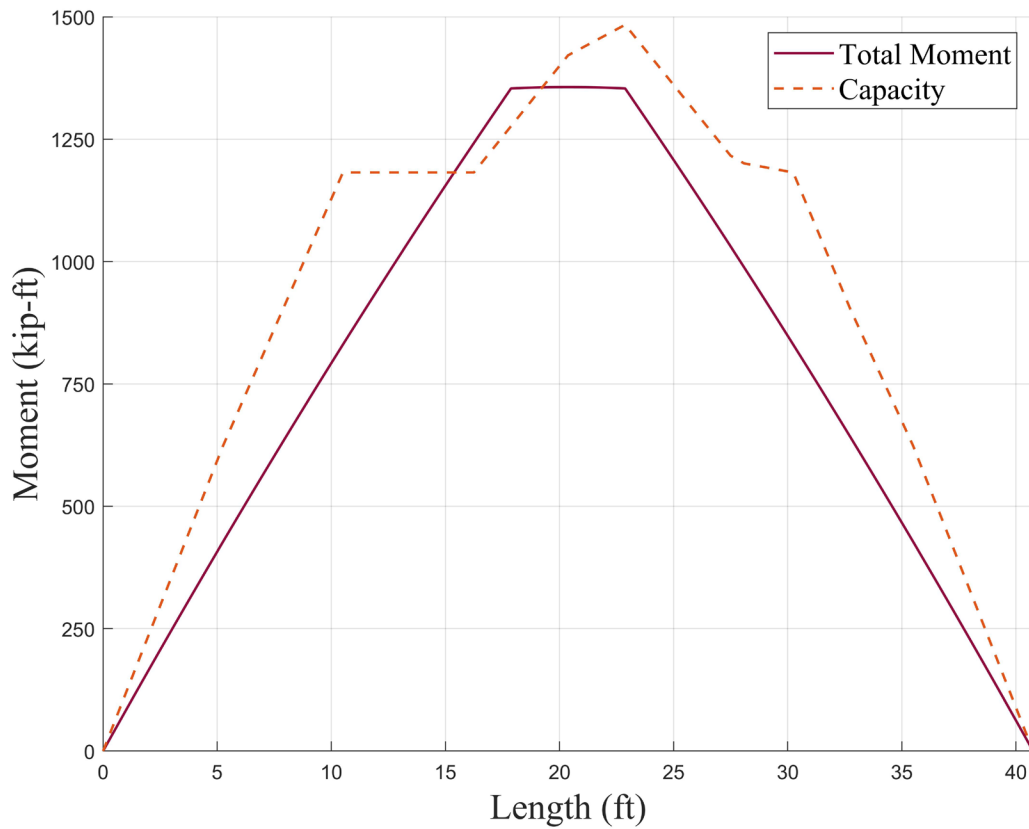
In Specimen E3, additional strands than those that were initially exposed were considered for reduction based on areas of spalled concrete. Furthermore, development of exposed strand was considered to initiate outside of the spalled region in sections that had sound concrete after testing (determined by light tapping). Concrete surrounding the spalled region near Section 3 (Figure 7.5) was identified as being sound, so development of strand was considered to initiate outside of the spalled region. For the spalled region in the proximity of Section 4, sound concrete was identified at a distance of 2 ft away from the spalled region toward the center of the beam (Figure 7.5c, for reference). A moment capacity diagram for Specimen E3 is shown in Figure 7.7, superimposed on the total moment diagram. Moment strength was determined at each section using the moment-curvature approach, accounting for partial development of strand based on deterioration including spalling. The values used for the analysis at different locations along the span are listed in Table 7.3. As shown, the calculated capacity diagram crosses the total moment diagram at a section approximately located at 15 ft from the north end of the beam. The calculations with the proposed modifications predict a slightly lower capacity than what the beam experienced during the test. However, a slight northward modification to the point where strands were considered to start developing (just to the left of 15 ft), would produce a moment strength diagram that ends up crossing the total moment diagram at almost the total load applied during the test. This example illustrates the sensitivity of moment strength (and eventual beam rating) on the section where strand starts developing adjacent to deteriorated beam regions with spalled concrete, so being conservative in this respect seems warranted.

Figure 7.7: Specimen E3: Total moment (solid line) and moment strength (dotted line)

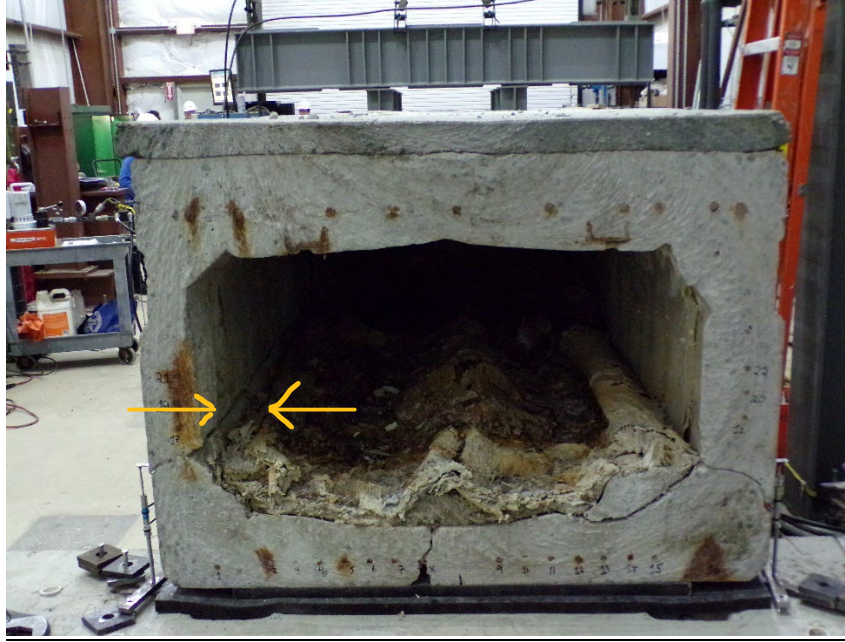
The tests conducted in this research also revealed the large variation of web thicknesses in box girders of the era that was studied (mid-1970s to mid-1980s decades). Variation in web thickness was apparently caused by movement of the void form that was used during construction (polystyrene or cardboard). As-built web thicknesses are nearly impossible to determine in adjacent box girder bridges because of lack of accessibility. Therefore, a conservative approach is proposed to alert engineers to also consider checking the capacity of the beams for shear in determining the load rating for these types of bridges, as follows:

Figure 7.2.10-3: Example of web thickness variation

7.2.10.7 The shear strength of adjacent box girders shall consider the possibility of shifting of the void form during construction. Unless an accurate estimate of web thickness can be determined, the shear strength of adjacent box beams shall be calculated using a web thickness equal to the design web thickness minus 1.5 in.
