FIELD PERFORMANCE EVALUATION OF HYDRATED, FLY-ASH BASES IN THE ATLANTA DISTRICT: YEAR 4

Report 2966-4
Project Number 7-2966
Research Project Title: Durability of Surface Treatments as the Wearing Course Placed on Crushed Fly Ash and Long-Term Performance of Crushed Fly Ash for Flexible Base

October 2000

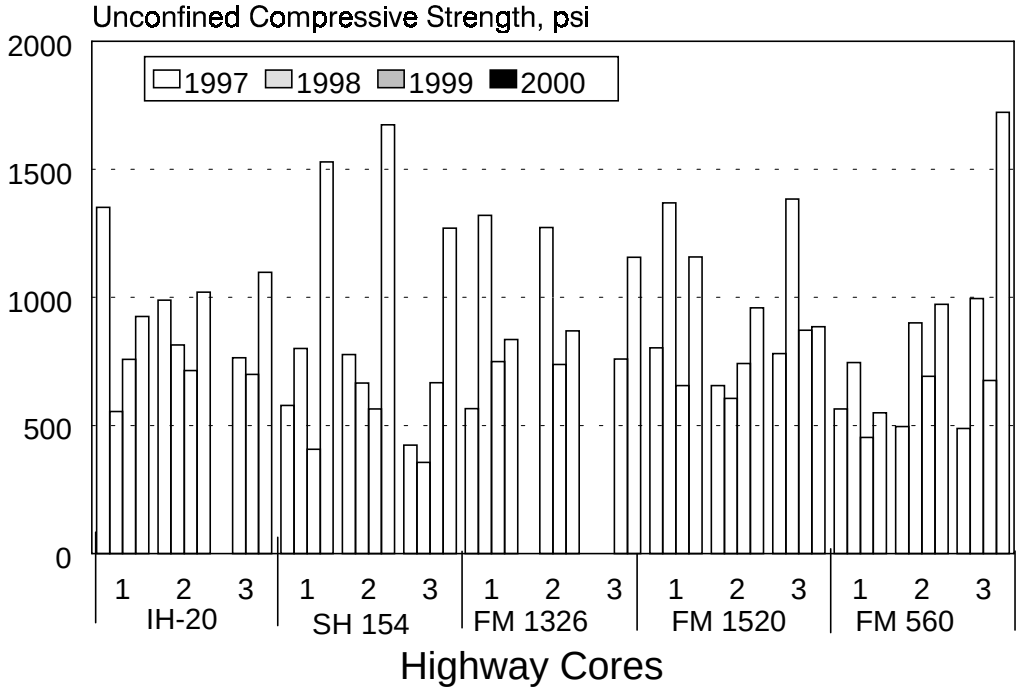
Figure 1. Unconfined Compressive Strength of Highway Cores.

TTI performed unconfined compressive-strength testing on the field cores. Plaster was used to cap the ends of the specimens prior to testing. For unconfined compressive strength, it is desirable to have a sample length (L) to diameter (D) ratio of at least 2. However, some of the cores were very short. Adjustment factors were used to facilitate comparing cores of different thickness as described in Tex 418-A . Table 8 shows results of the field core strength tests. Figure 1 compares results with previous years' results.

Three cores were obtained from this pavement as shown in Figure 1. The pavement core strengths are greater than the core strengths measured last year. There is very little change in the FWD data exhibited in Figure 3 since 1997. Note in Figure 3 that the last data point may coincide with the beginning of a different type of pavement section.

- Cores were taken on all of the test pavements except Loop 390. No intact core could be obtained from Loop 390. Compressive strengths for the cores from the other five test pavements were higher than the strengths observed in 1999.

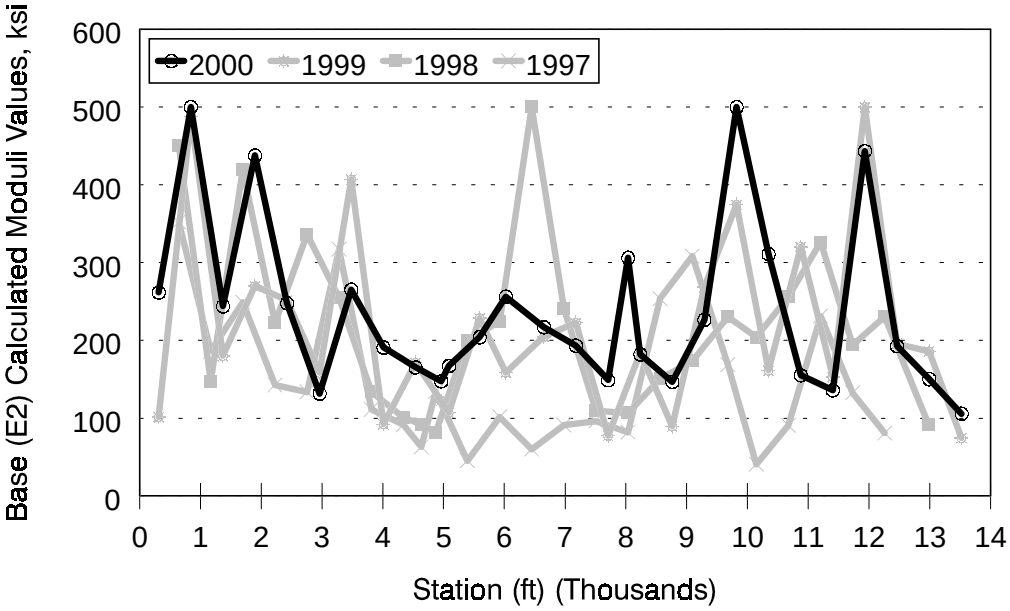
Figure 2. Base Moduli Values for Loop 390.

No cores were obtained from this pavement. Unsuccessful attempts were made in 1997, 1998, 1999, and again in 2000. As shown in Figure 2, there is some variation in the moduli values since 1997; however, it does not appear that the base is exhibiting a deteriorating strength overall. Some locations indicate an increase in stiffness while others show a decrease.

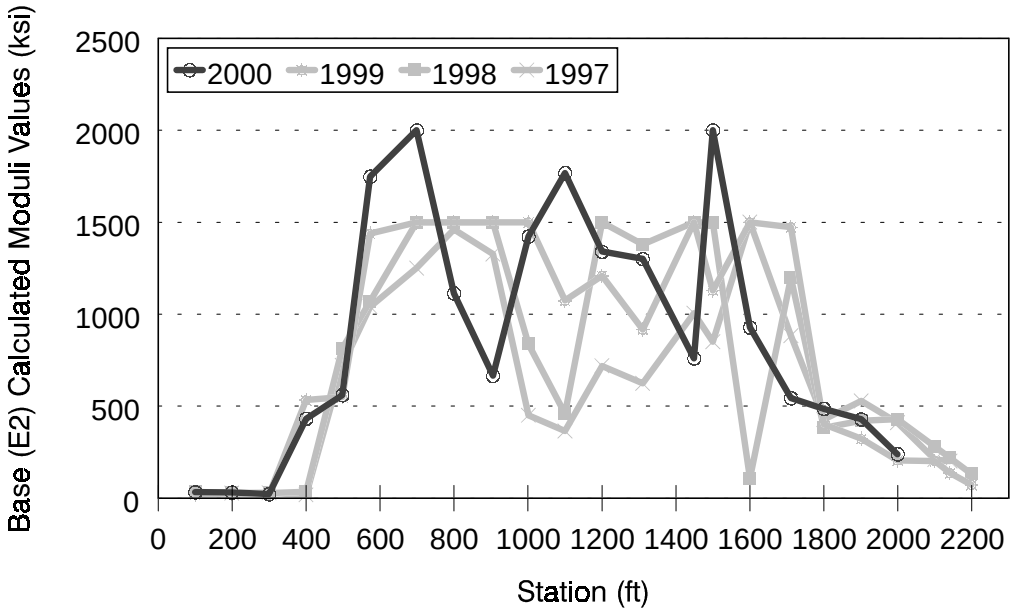
Figure 4. Base Moduli Values for SH 154.

From what has appeared to be shrinkage cracking, one would expect this pavement to be the stiffest of the six. This is true in terms of FWD data (Figure 4). Base moduli values along the pavement exceed 1,000,000 psi in some locations. Base moduli values in 2000 are similar to values observed in previous years. Compressive strengths of the cores taken in 2000 are much greater than strengths observed in previous years.

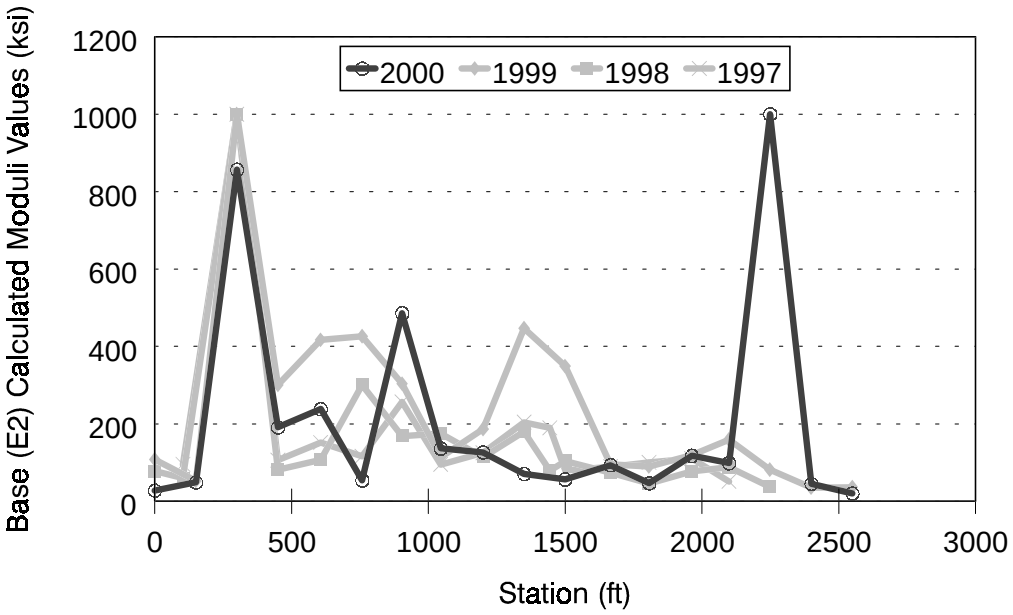
Figure 7. Base Moduli Values for FM 560.

All three cores obtained from FM 560 had higher compressive strengths than the cores obtained in 1999. The base on this pavement has two different thicknesses along its length: 9 inches and 16 inches. Because of the difference in thicknesses, two separate FWD analyses were performed as shown in Table 14. Results from both analyses, however, were combined for Figure 7. Moduli values for this pavement are generally lower in 2000 than in 1999 but comparable to values observed in previous years.
