# Commuter Rail Seat
# Testing and Analysis
# of Facing Seats

000347
10-18-00

| 7. PERFORMING ORGANIZATION NAME(S) AND ADDRESS(ES)<br>U.S. Department of Transportation<br>Research and Special Programs Administration<br>John A. Volpe National Transportation Systems Center<br>Cambridge, MA 02142 | 8. PERFORMING ORGANIZATION REPORT NUMBER<br><br>DOT-VNTSC-FRA-03-10 |

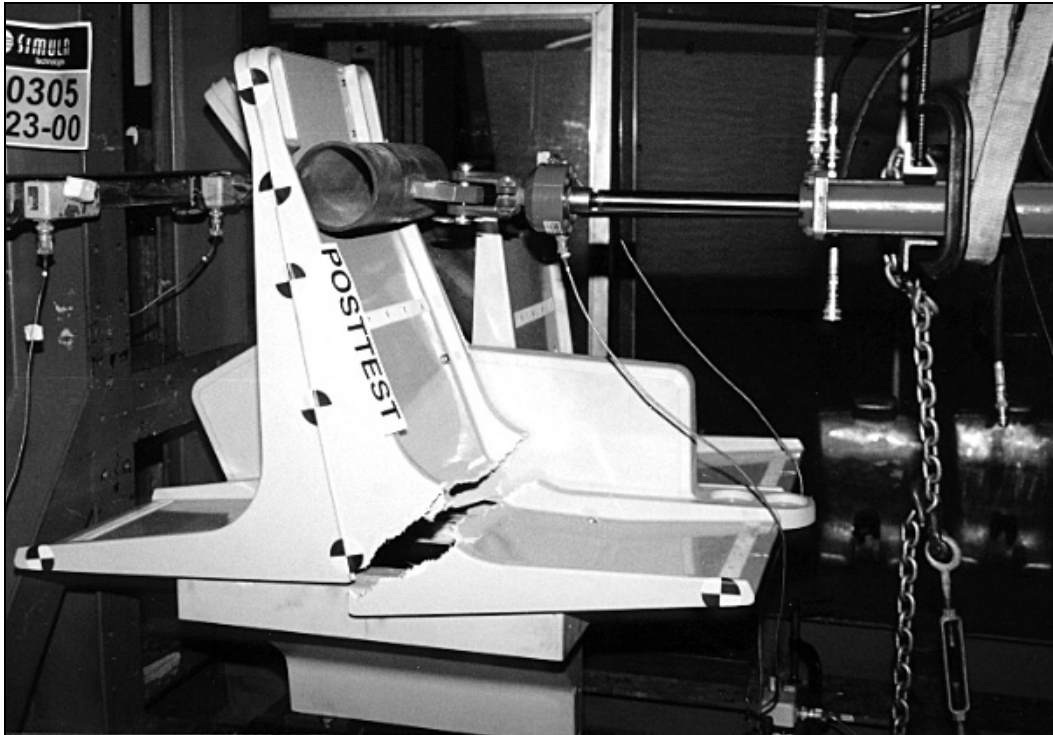
One static test was conducted on August 23, 2000. The load was applied independently at the top of each seat back at a rate of 2 inches/minute. The seat proved to be stiffer than anticipated. The seat stiffness was greater than that measured for the Long Island Railroad commuter seat (tested in October 1998), which is a cantilevered two-place passenger seat system comprised of a thermoplastic casing surrounding an extremely rugged tubular frame[2]. Failure of the thermoplastic casing of the seat occurred at the seat/pan junction. The primary failure on the aisle side of the seat was initiated at the point where the seat pan turns upward to the seat back. The failure propagated at a 45-degree angle toward the outer corner of the seat pan/seat back intersection. The window side of the seat also experienced a fracture at the same location, but the primary failure occurred across the top of the seat back. The load-deflection curve (Figure 6) shows that while the aisle- and window-side seats had different modes of failure, the stiffness characteristics were identical up to failure. Figures 7 and 8 show the window- and aisle-side seats and their failure modes.

**Figure 6. Static Test - Load-Deflection Curve**

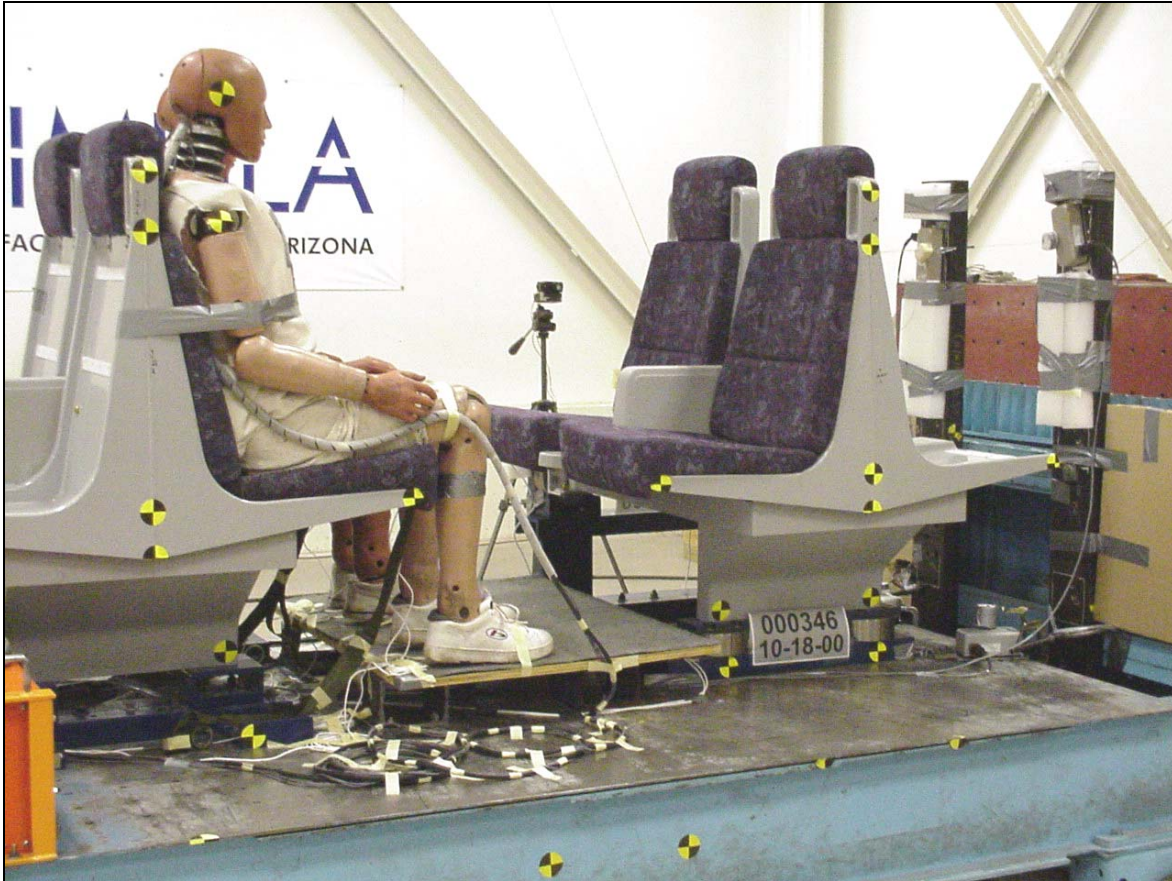
**Figure 16.  Pre-test Photo of Baseline Test No. 1**

**5.2.1.2  Post-test Description -** The seat components remained attached during this test.  While there was no damage to the aluminum base frame, the thermoplastic grab handles cracked.  The cracks did not propagate, however, so the entire headrest did not tear off of the seat back.  The seat cushions remained attached as well.  The window-side ATD remained compartmentalized, while the aisle-side ATD traveled over the seat back in front of it, landing on top of the headrest.

The head of the window-side ATD in this test impacted relatively low on the seat back in front of it, while the head of the aisle-side ATD hit higher up on the seat back, near the top of the headrest, causing it to crack almost to complete failure.  The reason for the difference in head impact location is due in part to the translational differences of the ATD's feet.  While both ATDs wore shoes that complied with the standard (J211), the shoes' soles were not made of the same material, and they reacted differently across the floor; specifically, the shoes on the aisle-side ATD had "bumpier" soles, which caused greater friction, and this caused the ATD to rotate forward nearly about the tip of its feet.  For the window-side ATD, the shoes allowed the ATD's feet to slide along the floor, carrying the entire body of the ATD across to the seat in front.  The

ATD's knees impacted the lip of the seat pan, causing the ATD to rotate at that time about the knees, with the head impacting the top of the seat back below the headrest. This ATD rebounded back toward the launch seat. The feet on the aisle-side ATD, however, stuck to the floor near their initial position, so the body of the ATD pivoted more about the feet than the knees, which then impacted the seat cushion (not the front lip of the seat pan) keeping the ATD more upright, allowing its head to impact the uppermost portion of the seat back, at the top of the headrest. This aisle-side ATD then traveled over the top of the seat back and did not remain compartmentalized. Figure 17 provides a three-frame sequence of the occupant kinematics for the Baseline Test No. 1, and Figure 18 provides the post-test view.

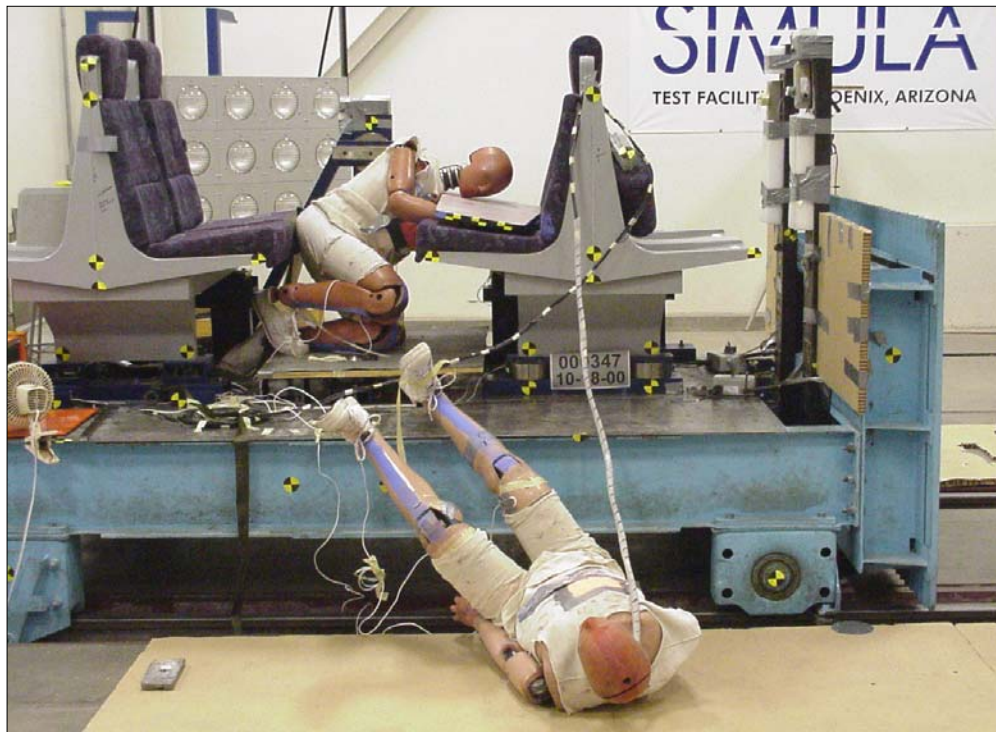
**Figure 22. Post-test Photo of Test No. 2, Baseline with Table**

**5.2.2.2 Post-test Description -** While there was no damage to the aluminum base frame, there was significant damage to the window-side grab handles on the headrest, and complete failure of the headrest on the aisle side. The table attachments sheared at the wall connection; specifically, the vertical attachment pulled the screws out of the table and failed the weld at the table's base. The table detached completely from the wall and landed on the seat in front of it.

The head of the aisle-side ATD hit the higher portion of the headrest, causing the headrest to completely fail across the seat back. This ATD again wore the shoes with the "bumpier" soles that prevented the feet from sliding across the floor, again introducing an occupant response repeatable from the last test. The higher-friction shoes caused the ATD to pivot more about the feet (instead of the knees), allowing the ATD's head to impact the top of the headrest, which completely failed. While the table prevented the aisle-side ATD from launching over the seat

back, it instead caused the ATD to pivot about the end of the table, to face toward the window, and then fall out into the aisle. Therefore, this aisle-side ATD did not remain compartmentalized. All seat cushions remained attached. Figure 21 provides a 3-frame sequence of the occupant kinematics, and Figure 22 is a post-test view of the test.

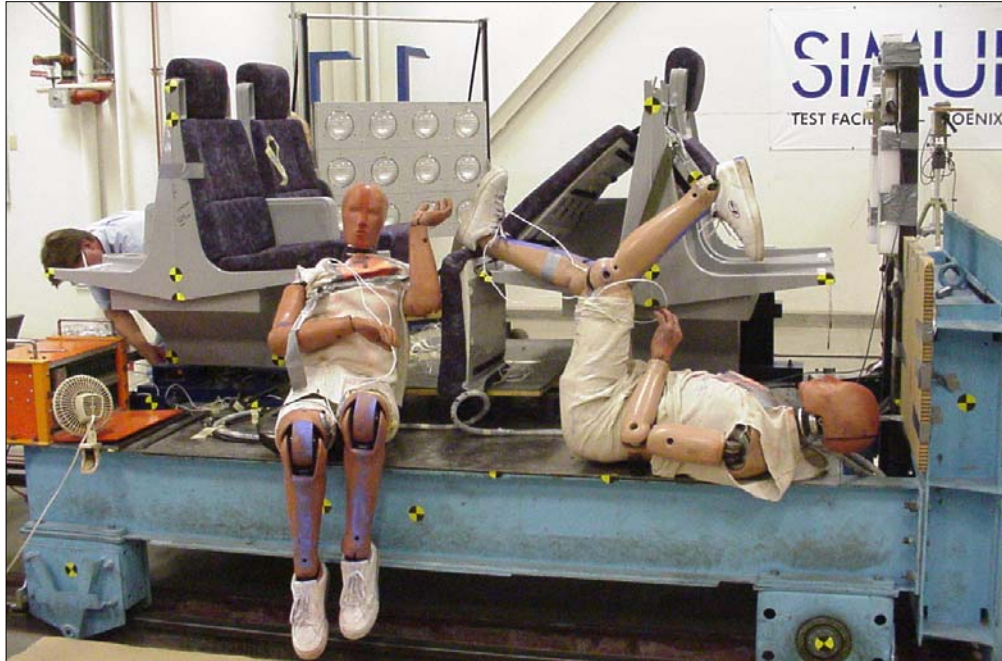
**5.2.3.2  Post-test Description -** The seat/occupant system in this test experienced a higher peak deceleration.  While there was no damage to the aluminum base frame, there was significant damage to the grab handles on the aisle side, causing complete failure of the headrest on that side.  The seat cushions detached from the aisle-side seat pan and seat back.

Due to the higher deceleration forces, the window-side ATD impacted the seat back in front of it (below the headrest) and rebounded into the back of the launch seat. The window-side ATD remained compartmentalized. The knees of the aisle-side ATD impacted the seat pan cushion rather than the lip of the seat pan, causing the ATD to translate forward more than in previous tests. The head impacted the seat back and then the torso followed. The aisle-side ATD then landed the top of its head on the seat pan of the forward-facing front-row seat. The aisle-side ATD fell outside of the compartmentalized area. Figure 24 provides a three-frame sequence of the occupant kinematics, and Figure 25 is a post-test view.

**Figure 25. Post-test Photo of Test No. 3, Baseline with 9 G Peak Acceleration (Note: The occupant shown seated on the sled was manually positioned there after the test to prevent it from falling from its precarious post-test position.)**

The window-side ATD neck forces and moments exceeded the injury criteria, and the neck-compression forces were exceeded in the aisle side ATD. This seat did not pass the structural portion of the APTA Standard, nor did it pass the human test components of the APTA Standard. See Table 12 for the results of the test.

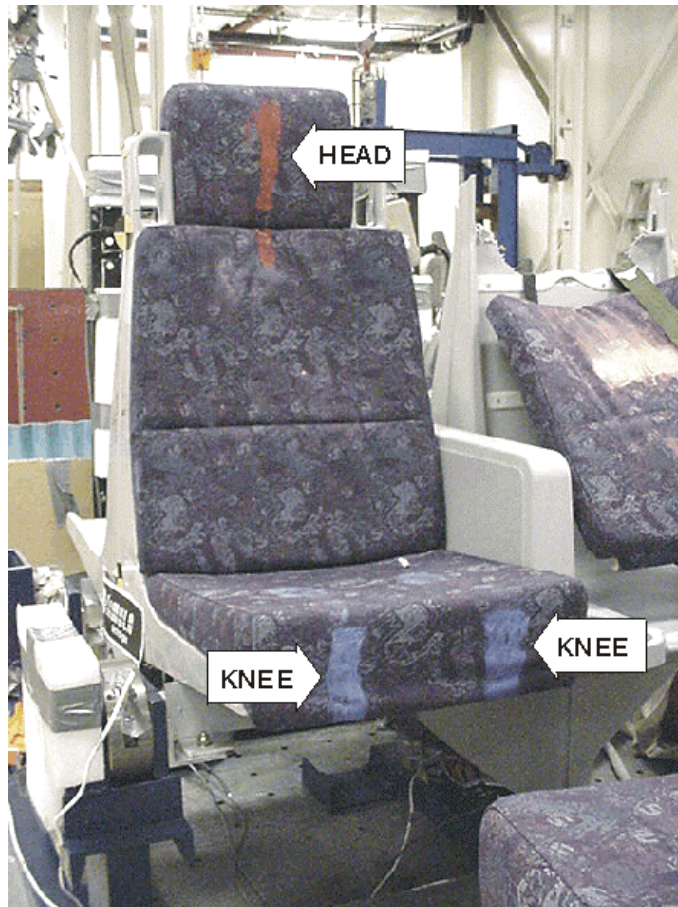
**Figure 31. Chalk Markings Left on Opposite Seat by Forward-Traveling ATD**

There were several seat failures that were repeated in all four tests. The headrest portion of the seat back sheared completely from the remaining part of the seat back, leaving a jagged, fiber-pronged edge (see Figure 29). The headrest failure occurred after the grab handles cracked (see Figure 30). Figure 31 shows the markings of a typical collision between the launched ATD and

the seat in front of it.  The knees impacted the cushion, causing it to translate forward.  The head of the ATD squarely impacted the center of the headrest, in many cases causing its failure.  The window-side headrest predominantly stayed intact.
