Final Report O.R.A. 157-622

EFFECTIVENESS OF RIVERBANK PROTECTION AND RIVER CONTROL IN OKLAHOMA

By
Jimmy F. Harp, PhD
Professor
and
Mathew Thomas
Research Assistant

August 15, 1989

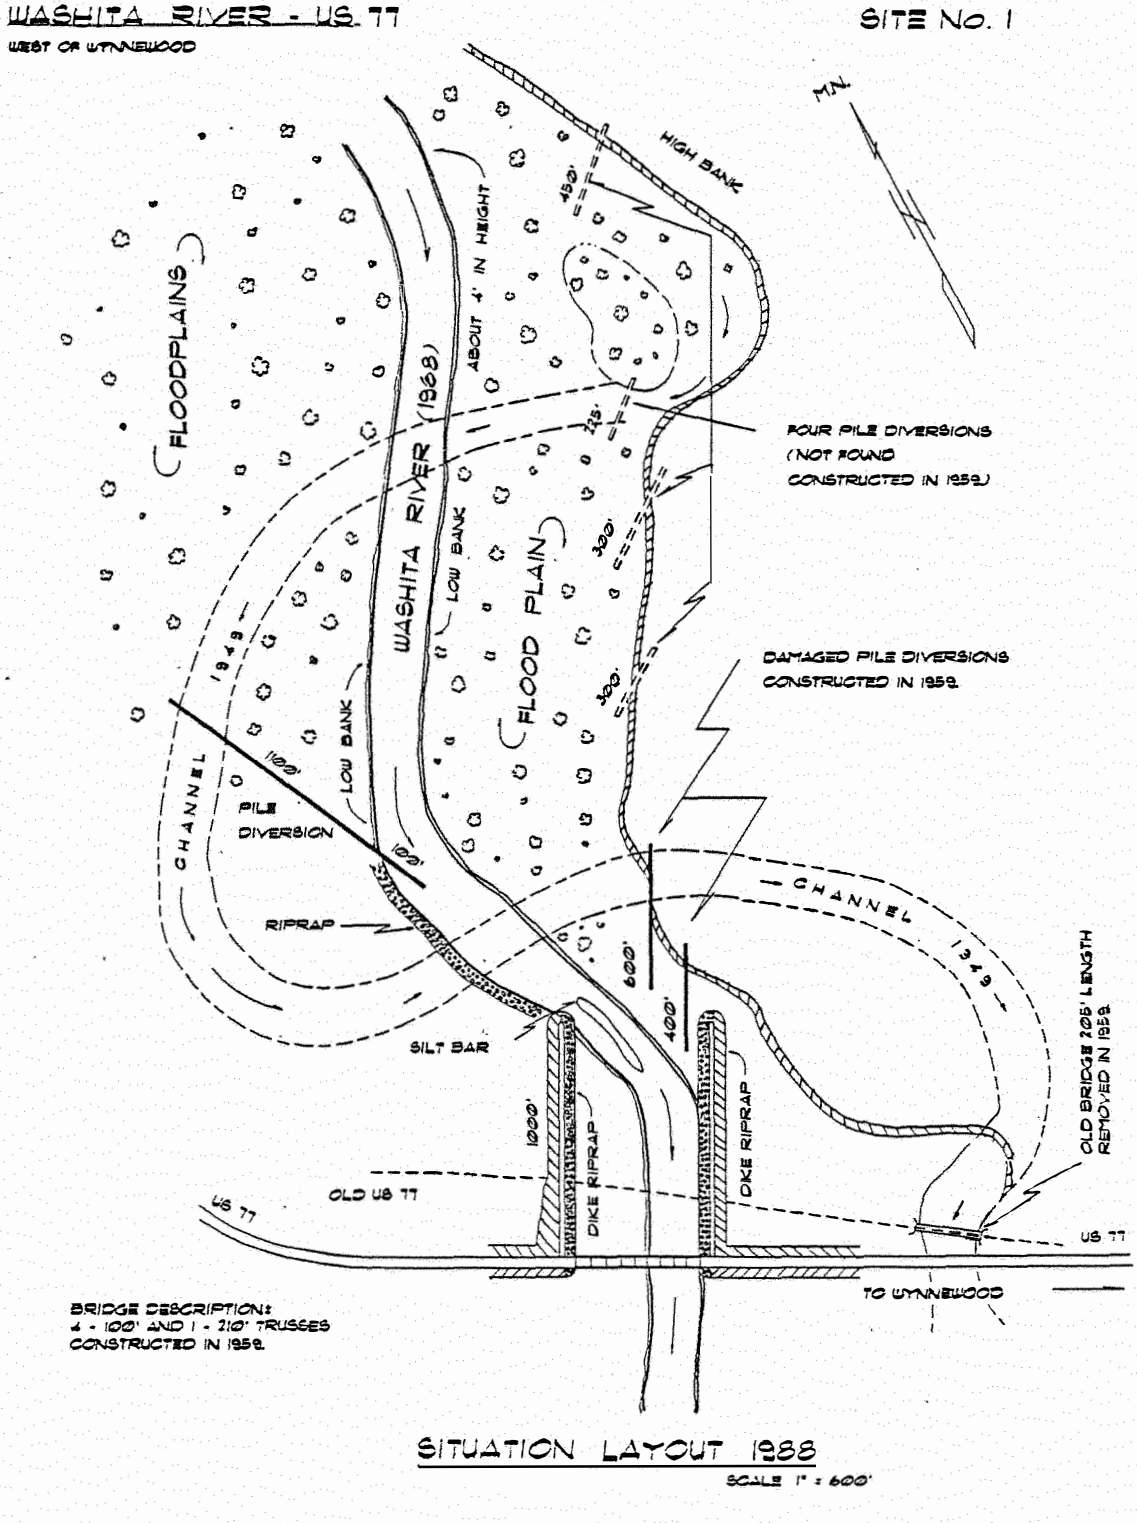
FIGURE 30

nature, the Washita river is highly erratic and has a constantly changing channel alignment. The 6 pile diversions constructed on the eastern bank are at present in a deteriorated condition. However they have lasted for over 30 years and have been absolutely effective. In the event of a major flood event the river might cut back into its original channel. With the loss of these pile diversions the river may cut behind the spur dikes at the bridge and render them ineffective. These pile diversions definitely need repair, or new diversionary structures should be installed. The extolling virtue at this site is that the floodplain in between the diversionary structures is quite extensive and has a mature vegetal cover that will likely prevent the river from changing course.

Only a small part of the first pile diversion (situated on the western bank) can be seen in the river and it is in very bad condition. This may not need immediate attention due to the heavily riprapped banks downstream to the structure all the way to the western spur dike. The old river channel on the western bank seems to be heavily silted and overgrown and it is unlikely that the river will flow there again.

The river is constantly attacking the eastern spur dike at the bridge and a loss of the face riprap is in evidence. The river is also attacking the toe of the dike which may cause some slope failure. Although this is not a cause for immediate concern some maintenance work is needed to keep the whole system effective.

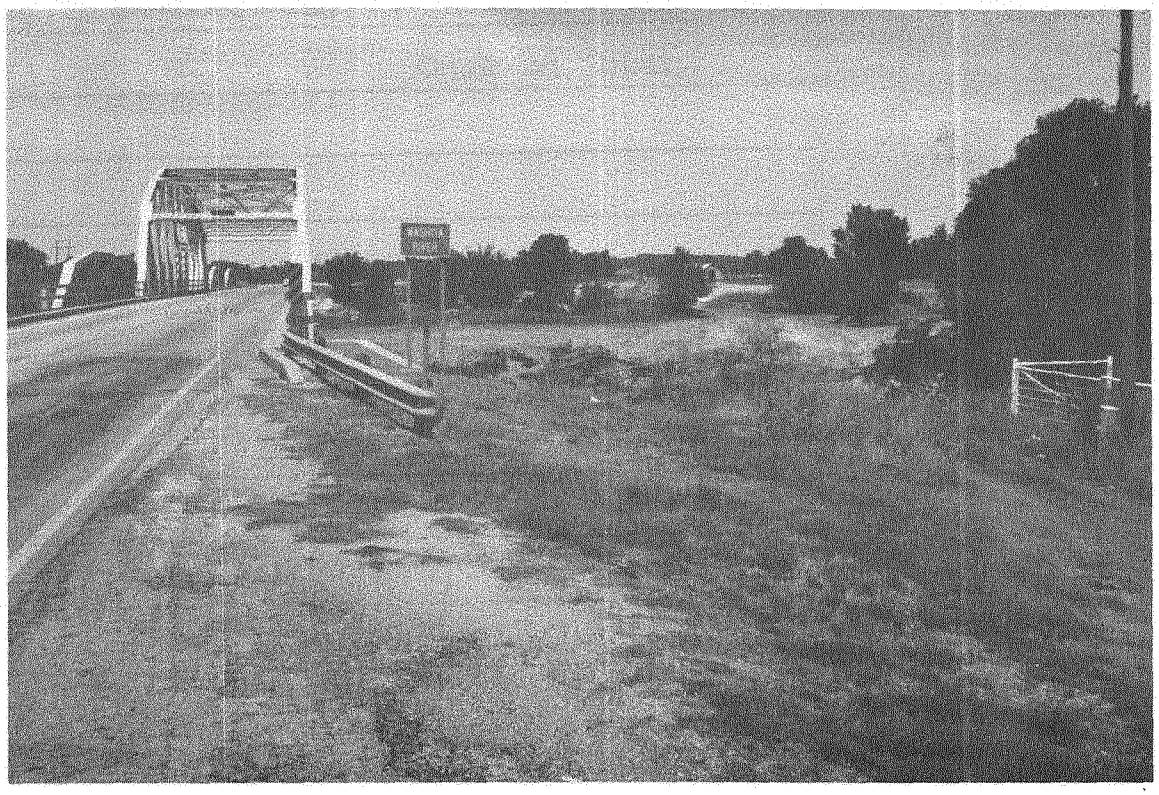
TYPE: RIPRAP (ON WESTERN BANK)

a) Description: HEAVY RIPRAP ON THE WESTERN BANK TO PREVENT MEANDER OF THE RIVER.

b) Present Condition: FOUND IN FAIRLY GOOD CONDITION.

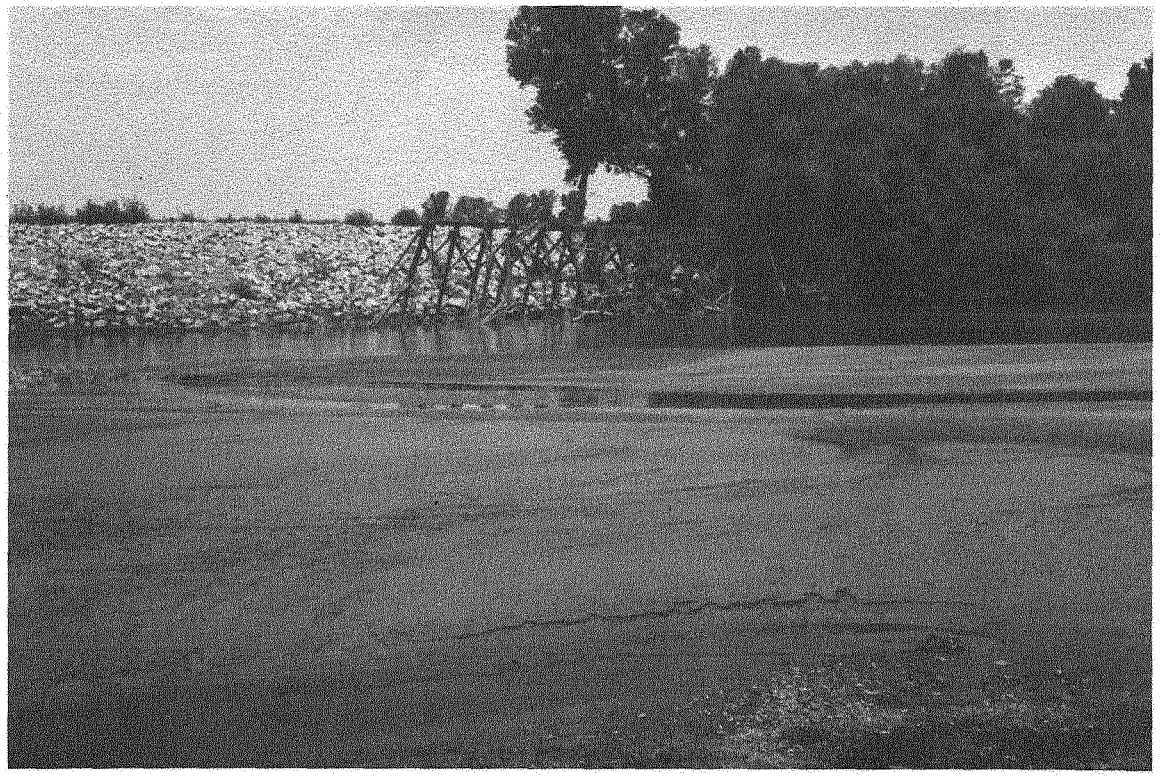
VIEW OF DAMAGED PILE DIVERSION
FIGURE 31c

RIPRAP AND PILE DIVERSION ON WESTERN BANK

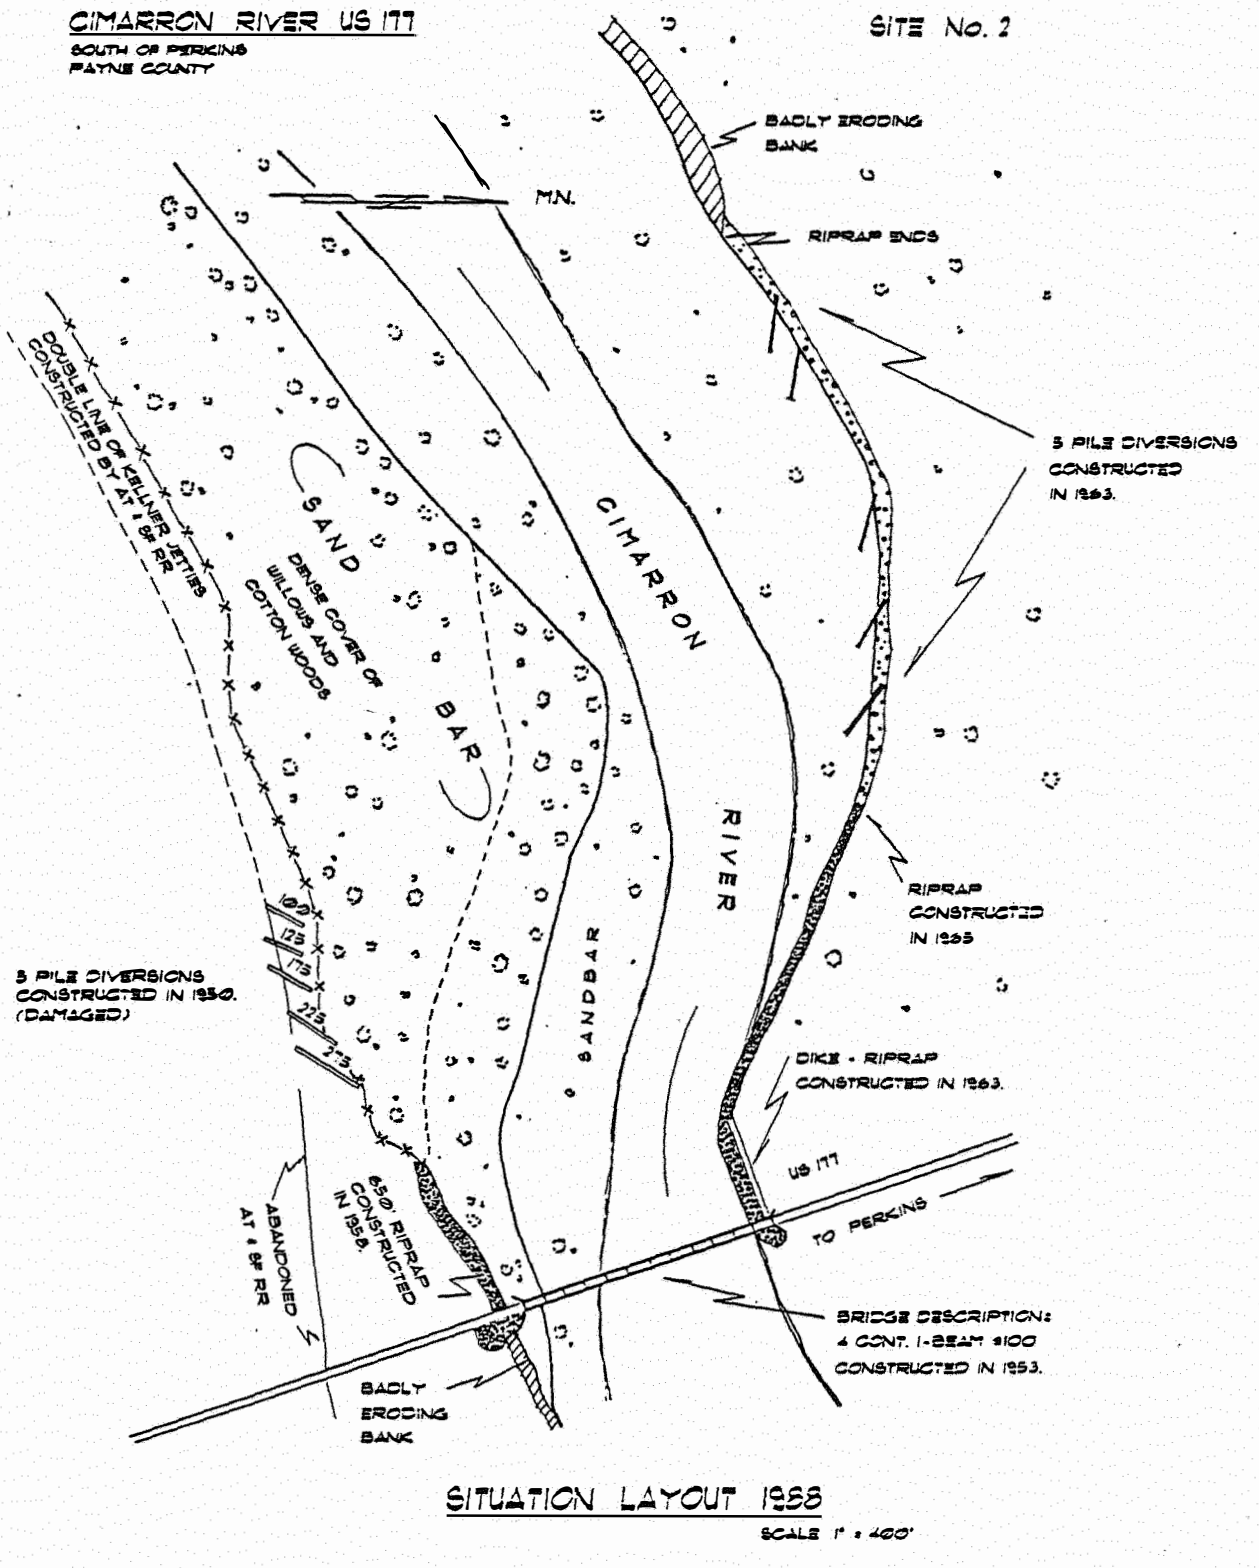
FIGURE 32

As stated earlier there are pile diversions on both the northern and the southern river banks which are meant to divert the river flow inward. The situation in 1989 shows that neither set of the diversions are in contact with the river. This is because of the low flow condition of the river at present. These diversionary structures will be active in the event of a large flood. The present northern bank in contact with the river is riprapped and appears to be in good condition. There is an extensive sandbar deposition in the river and the major part of the river seems to be confined on a braid to the northern bank.

Comparision of the 1969 and 1989 aerial photographs show a well behaved river condition at present. The pile diversions on the southern bank seems to be in perfect condition and are densely overgrown. The riprapped dike on the southern bank also seems to be in perfect condition and does not show signs of distress.

Most of the Kellner jetties constructed by the Railroad company seem to be covered up and none of them could be located during the field visit. The southern bank has a dense cover of willows and cottonwoods. At the bridge location the river now seems to be attacking the southern bank. There is, however, no cause for immediate alarm.

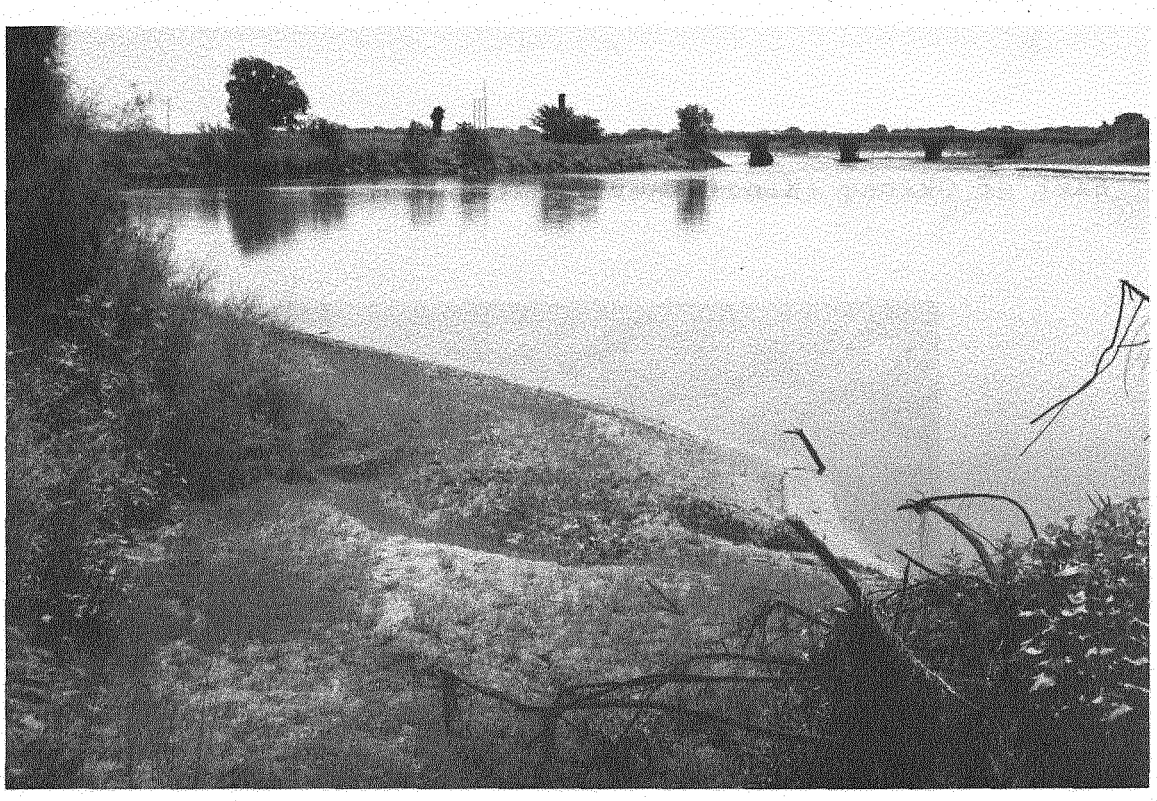
FIGURE 34b

River Cutting into North Bank

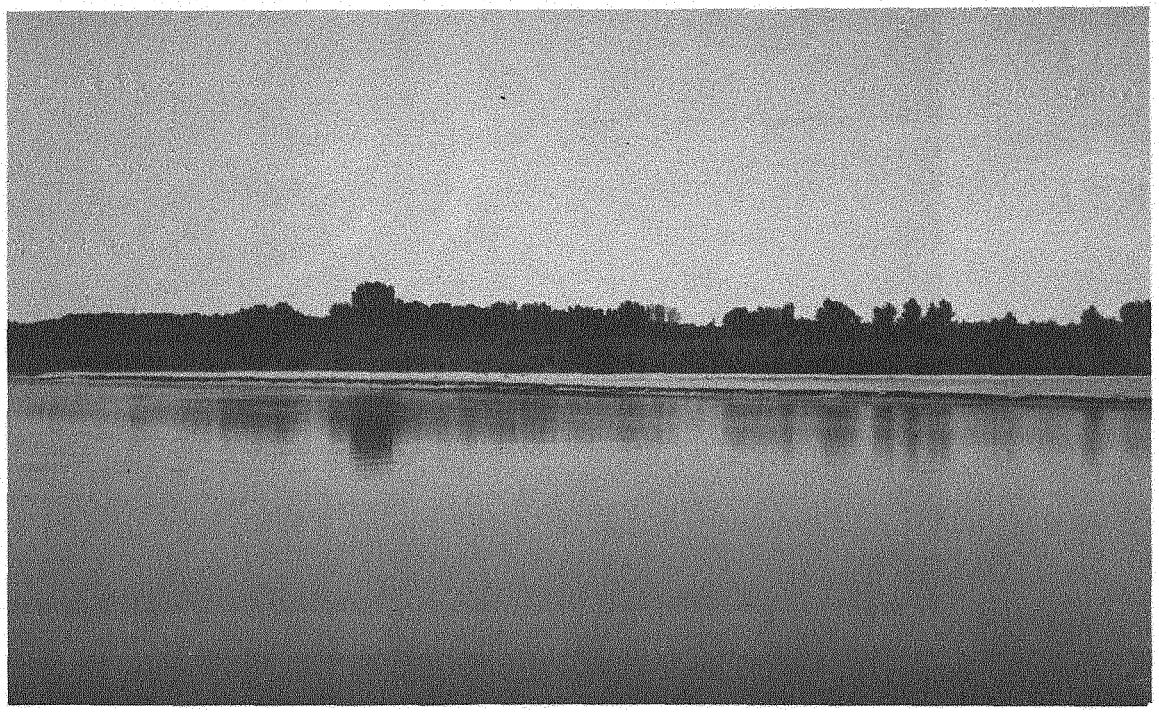
FIGURE 34c

Sandbar in Midstream

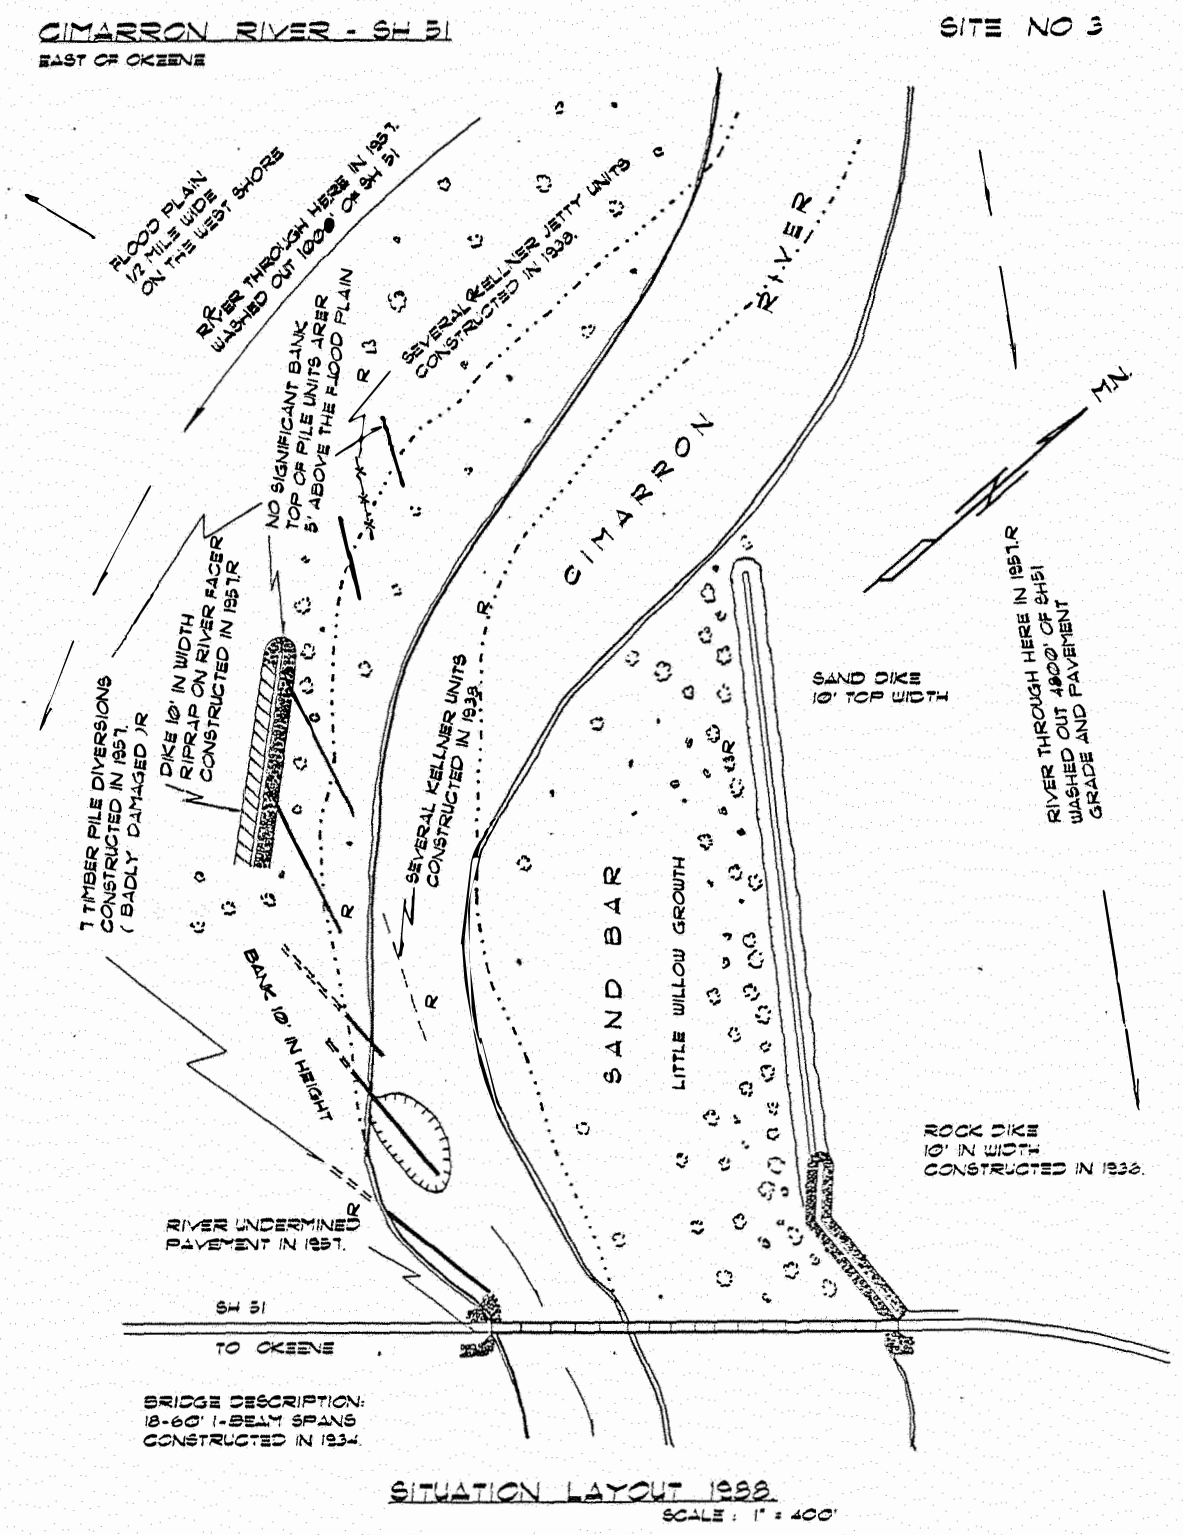
FIGURE 36

The present bridge structure on the site was built in 1934 and consisted of 18, 60 ft I-Beam spans. The bridge floor elevation is at 1010.5 ft and the High Water Elevation for the design of the bridge was estimated at 1002.0 ft. The river has an extensive but well-defined floodplain, about one mile wide, and during periods of low flows extensive sandbar deposition has been observed. The southern bank under attack of the river is on an average of about 10 ft in height.

The northern abutment and dike seems to be in perfect condition. The inward movement of the river has put the upstream end of the dike in contact with the river. This seems to be no cause of concern, mainly due to the

For now, increased attention should be focused on the river action at the southern bank. In the event of a major flood, the river may erode the southern bank extensively, given the present conditions. The pile diversions should be repaired or an alternative river training technique should be looked into. As an observation, the present bridge structure is likely scheduled for replacement in the next decade or so. Consideration should be given to moving the bridge site downstream. This would also correct the highway alignment.

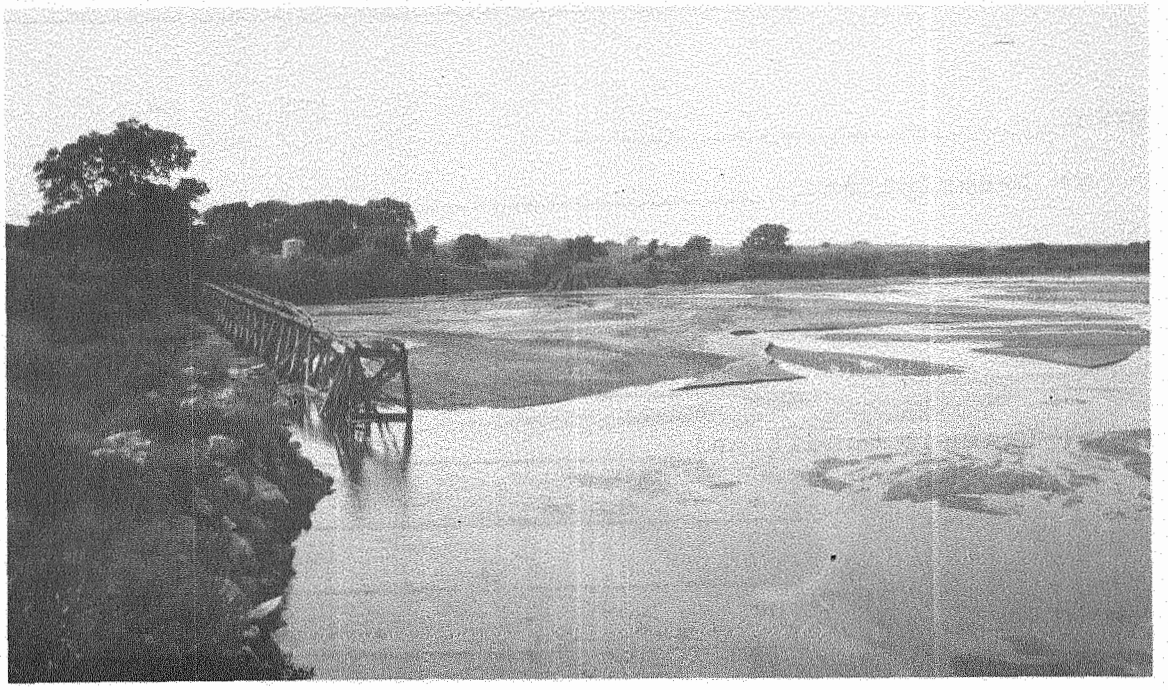
FIGURE 37a

View of Bridge Abutment with Riprap

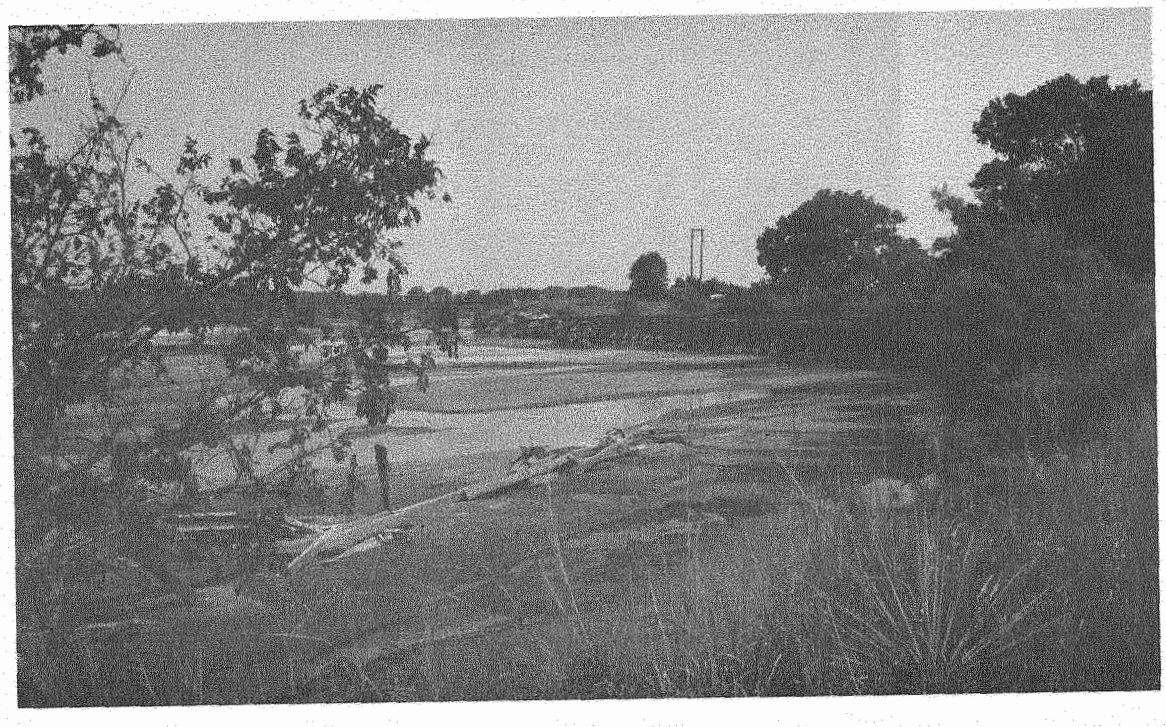
FIGURE 37c

Pile Diversion with Missing Face Planks

Another View of Damaged Pile Diversions

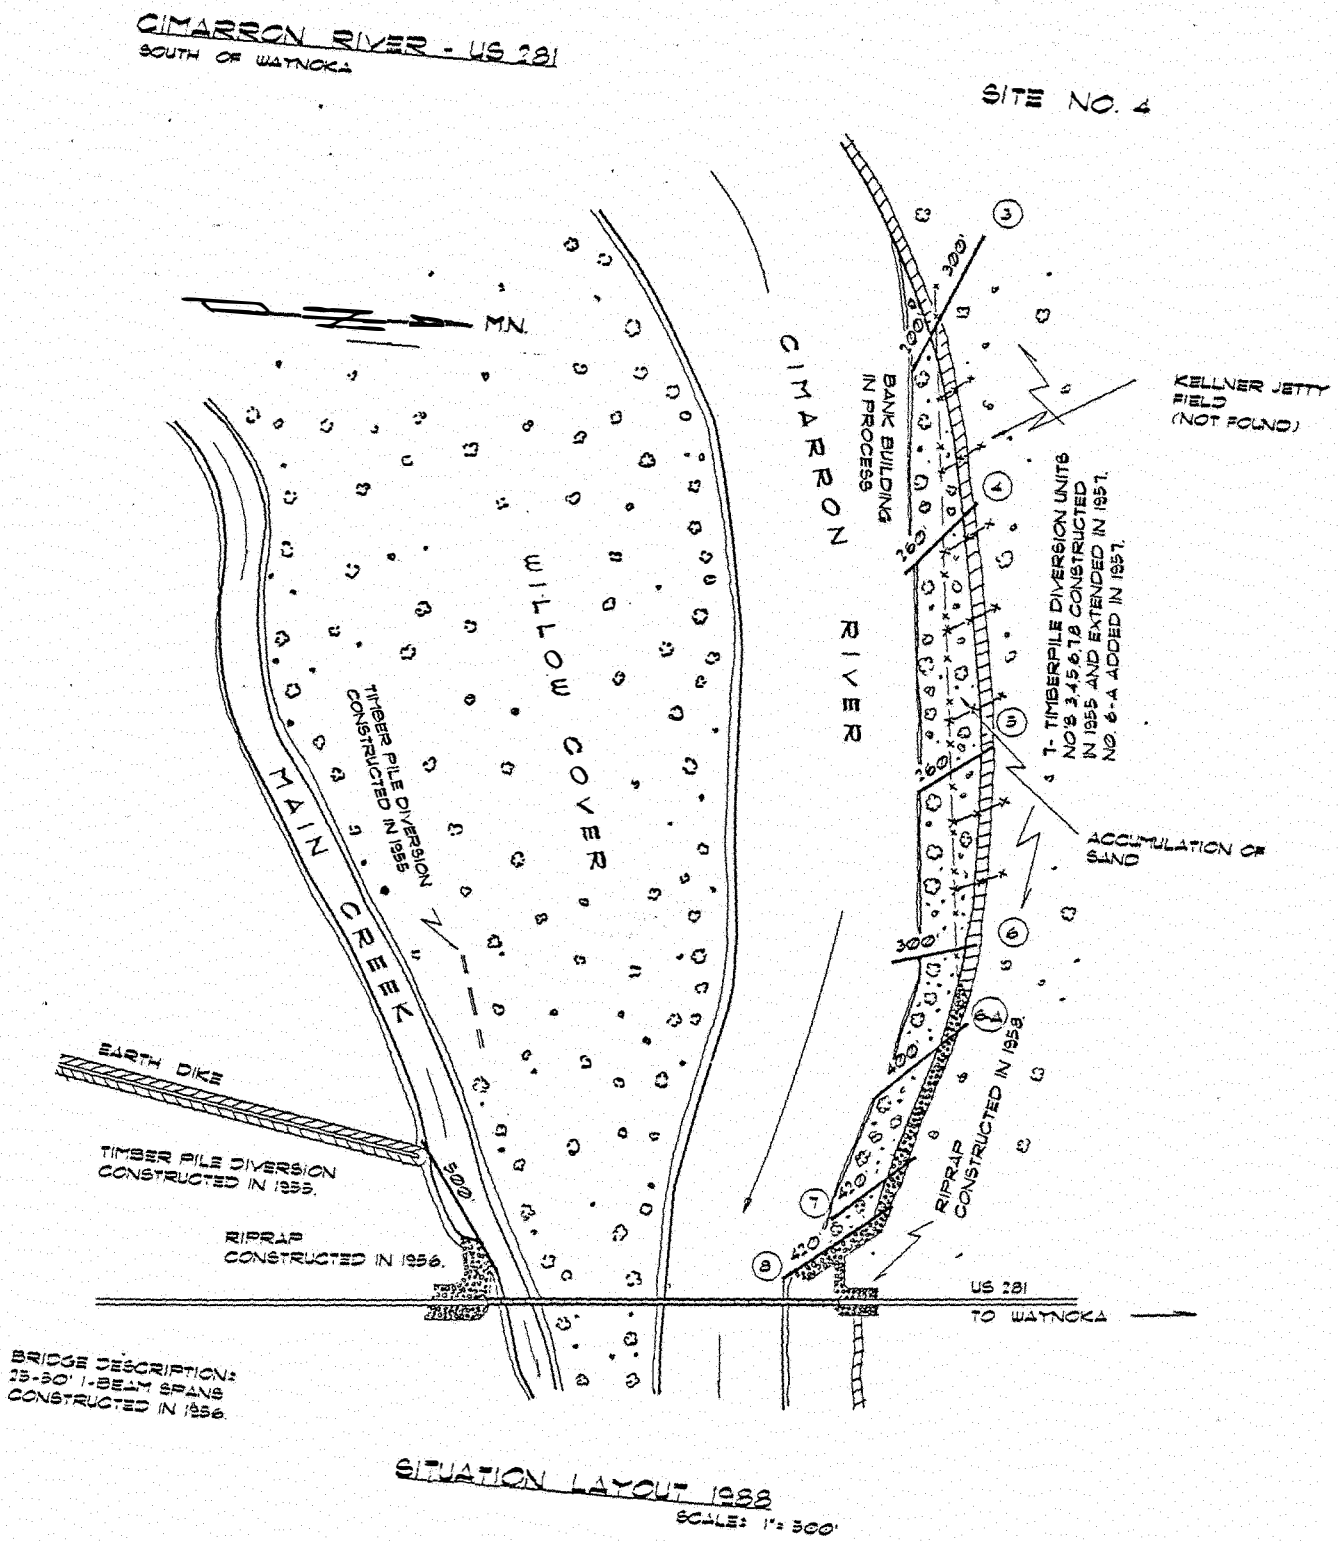
FIGURE 39

About 1950, before the new bridge was constructed, Kellner jetties were constructed to protect the northern banks of the river from riverine attack. In 1955, the present bridge structure was constructed and along with it two pile diversions were erected on the southern bank, and six pile diversions were constructed on the northern bank. The 1957 flood created the need to repair the diversions on the northern bank, and also a new diversion structure was added. In 1958, riprap was added along the damaged sections of the northern banks. Extensive riprap can be found on both the northern and the southern bridge abutments. An earth dike can be located near the pile diversion adjoining the southern bridge abutment.

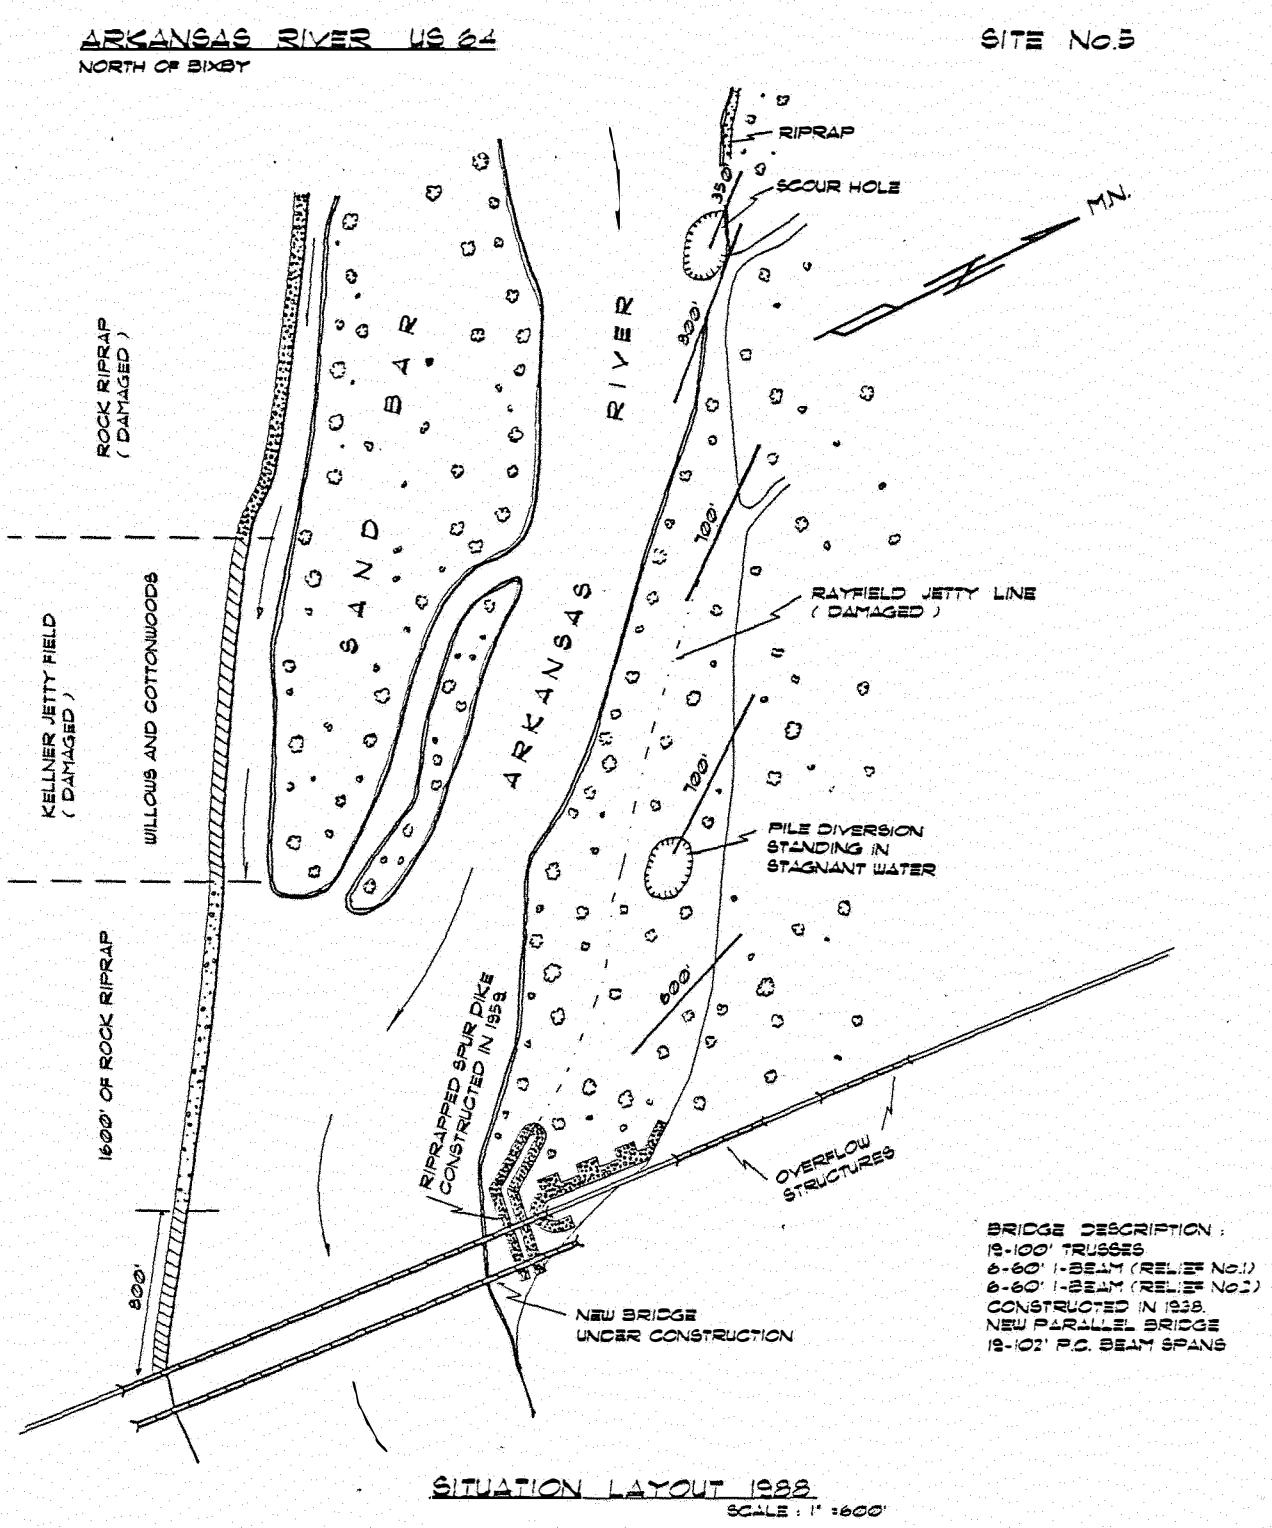
FIGURE 42

Along with the construction of the bridge in 1938, a Kellner jetty field was constructed on the northeast bank. Another jetty field was constructed in 1948 on the southeast bank. Rock riprap can be seen on the north bank in broken segmented sections. The major stabilizing structures were constructed in 1959. This included replacement of the fill of the northern abutment with broken stone, and construction of a rock spur upstream of the north abutment. Five pile diversions were constructed on the north bank and they were anchored to the bank formed by the 1959 floods. North of the bridge are overflow structures, built along the path of the river in 1959.

The five pile diversions that have been constructed on the upstream northern banks seem to have been highly successful. Damage to a pile diversion can be an evidence of the effectiveness of the structure. This can be demonstrated by the fact that the three pile diversions that are immediately upstream of the bridge structure are in a bad state of deterioration. Most of the face planks are missing and there is noticeable structural failure. These three structures are also seen to be resting on high banks. This phenomenon can possibly be explained by the fact that they were erected right across the river channel of 1959, and a later flood acted on them in an effort to cut back into the channel. This action was effectively thwarted due to the proper location of the pile diversions. The other two pile diversions further upstream are in near perfect condition although they are in direct contact with the water line. This may be because they may have not been in the direct line of attack of the water. The sandbar that is present on the northern bank is about 10 ft high and

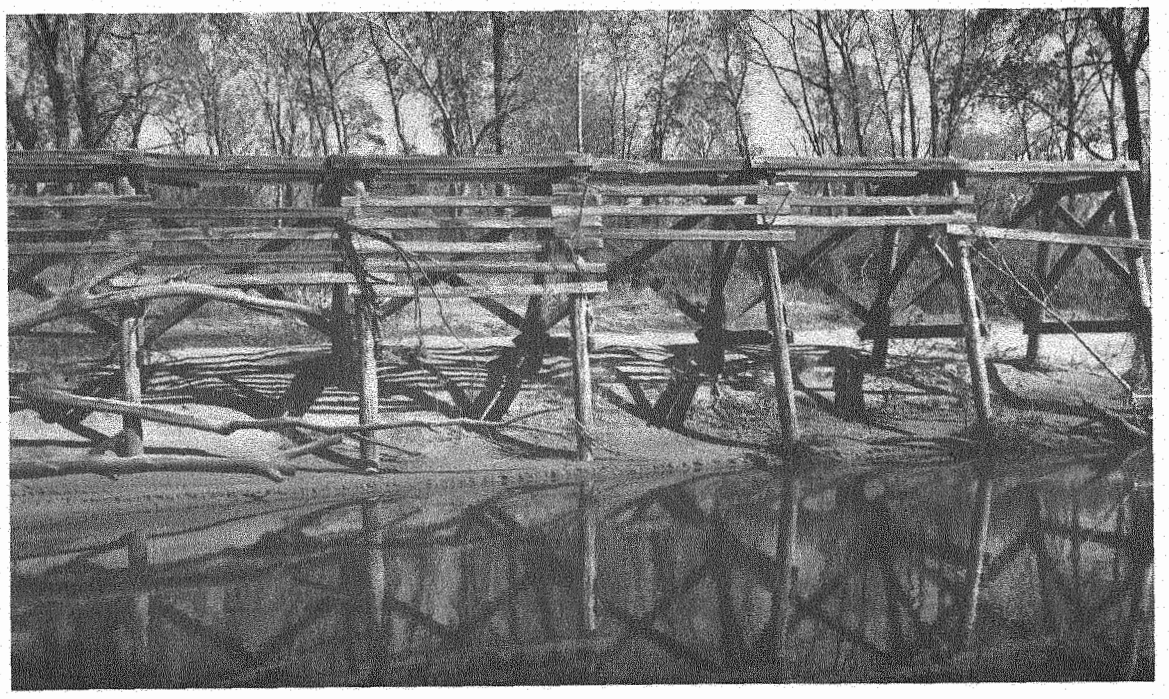
FIGURE 43a

Pile Diversion standing in a Scour Pool

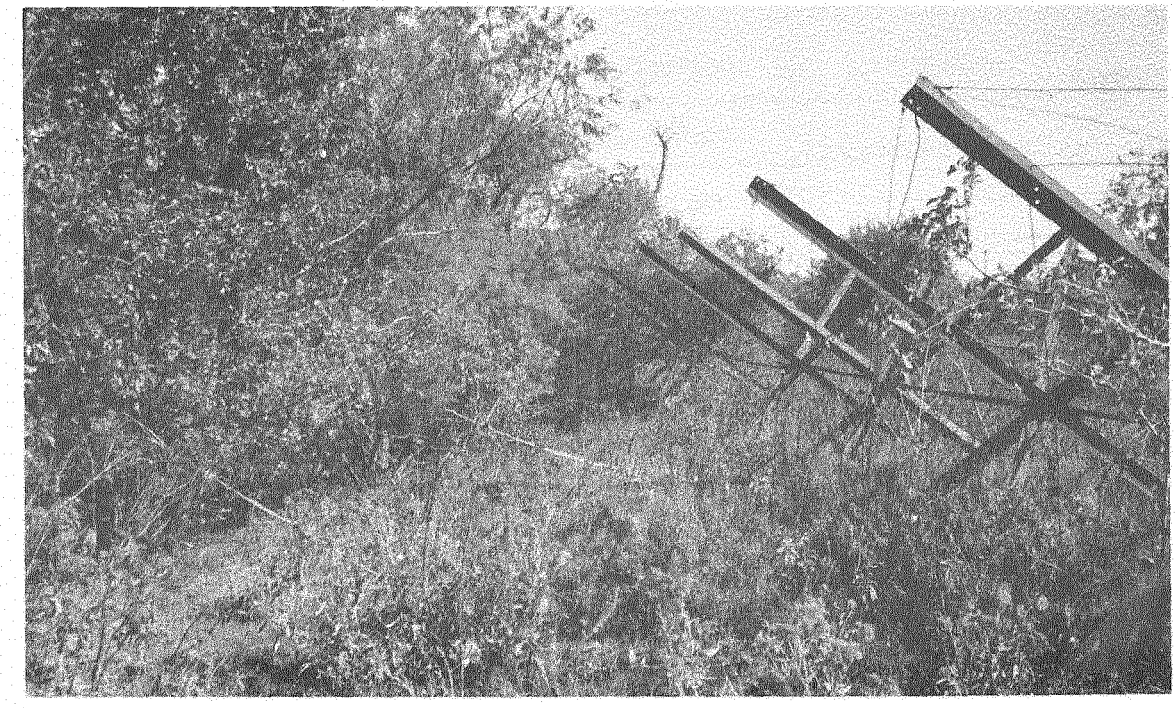
FIGURE 49a

View of Kellner Jetties on South Bank

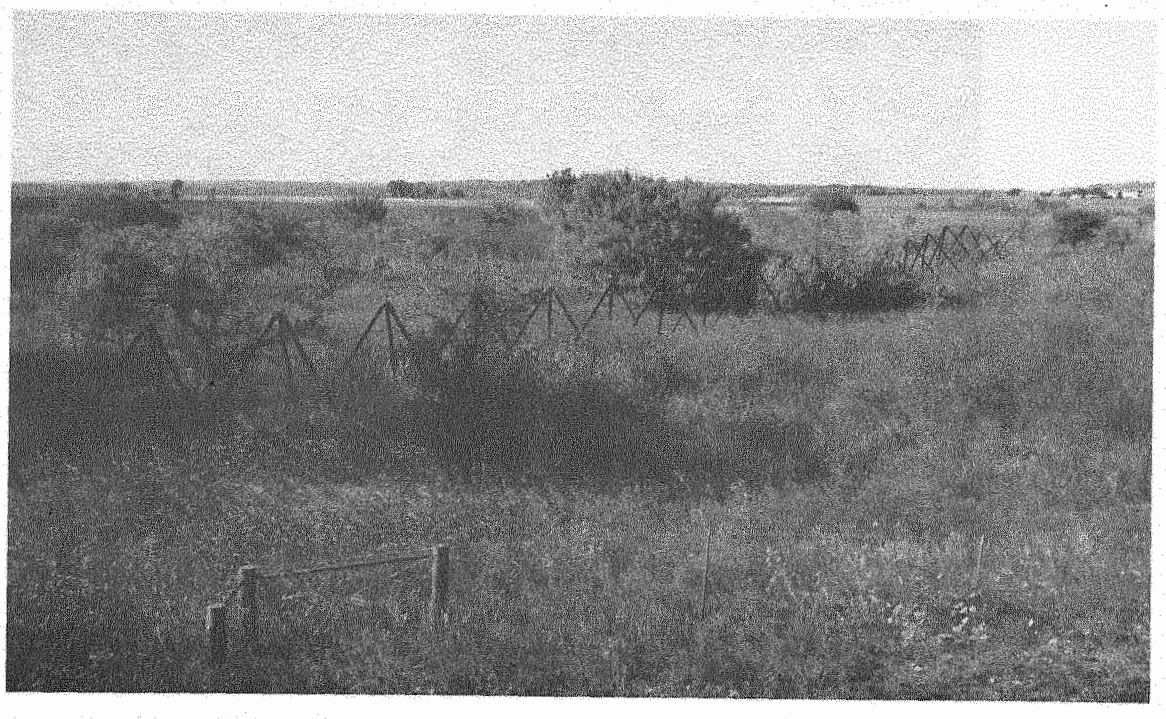
FIGURE 49c

View of Eroding South Bank (Upstream)

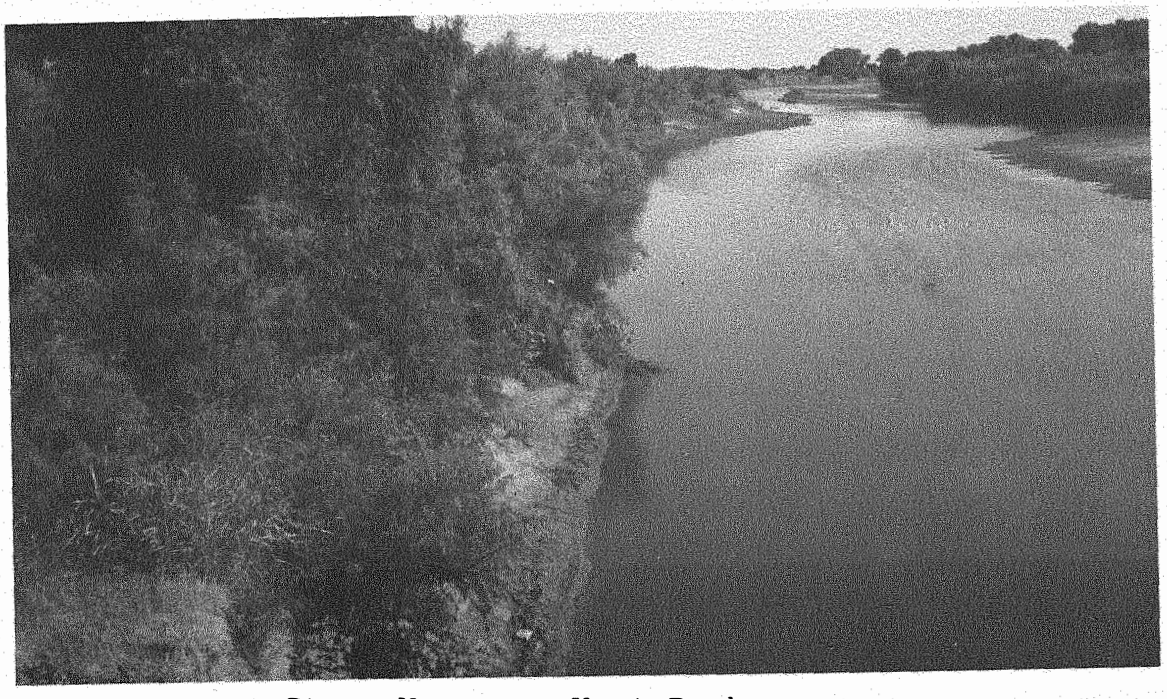
FIGURE 55a

View of the Bridge Site

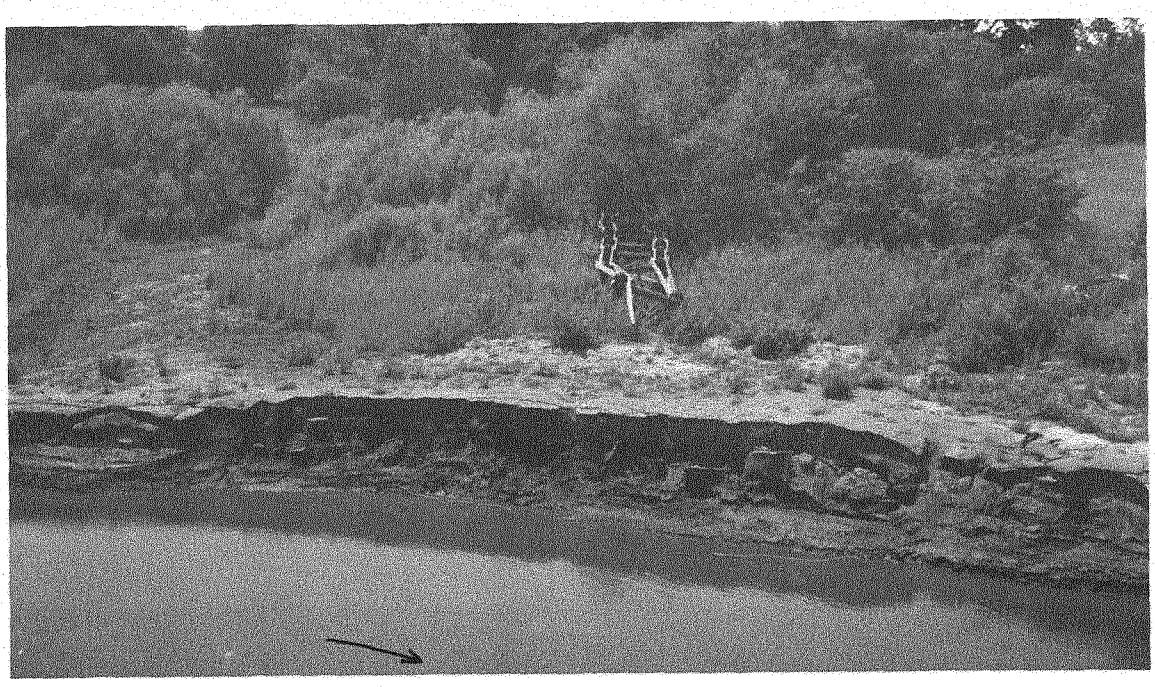
Bridge and Eroding Concave Bank

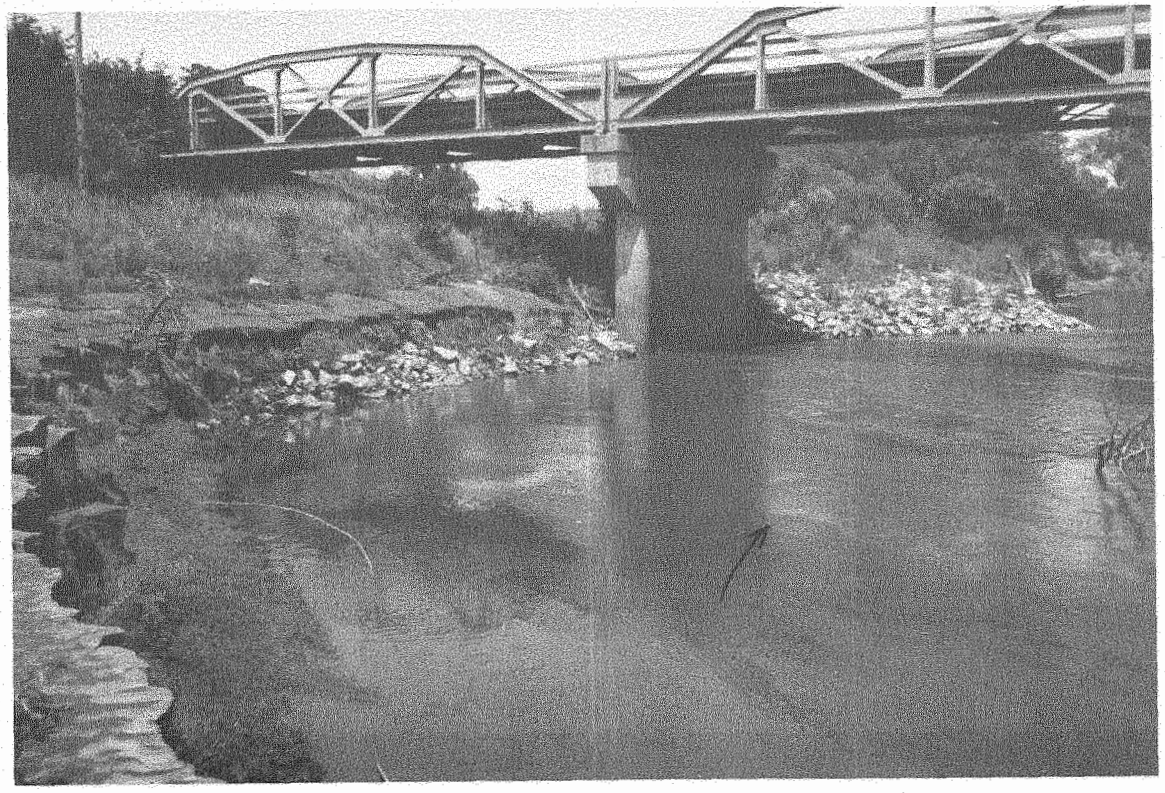
FIGURE 58b

View of Damaged Pile Diversion from Bridge

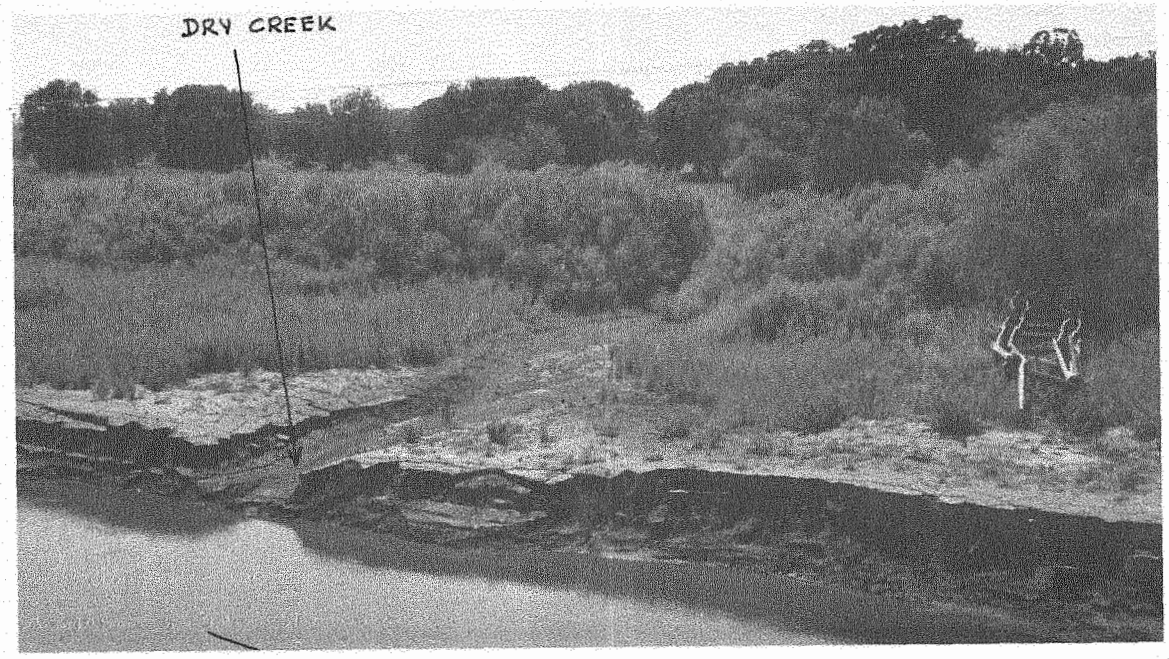
FIGURE 58c

Damaged Riprap on North Bank
