Final Report O.R.A. 157-622

EFFECTIVENESS OF RIVERBANK PROTECTION AND RIVER CONTROL IN OKLAHOMA

By
Jimmy F. Harp, PhD
Professor
and
Mathew Thomas
Research Assistant

August 15, 1989

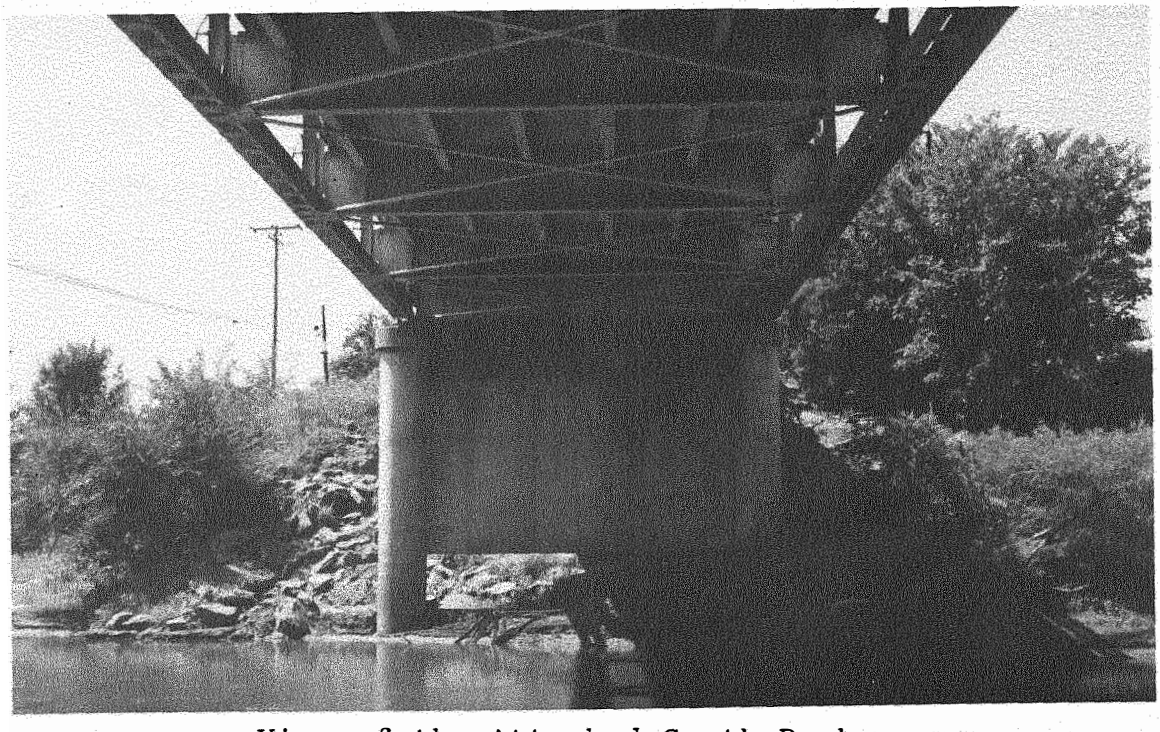
FIGURE 61a

View of the Bridge Pier

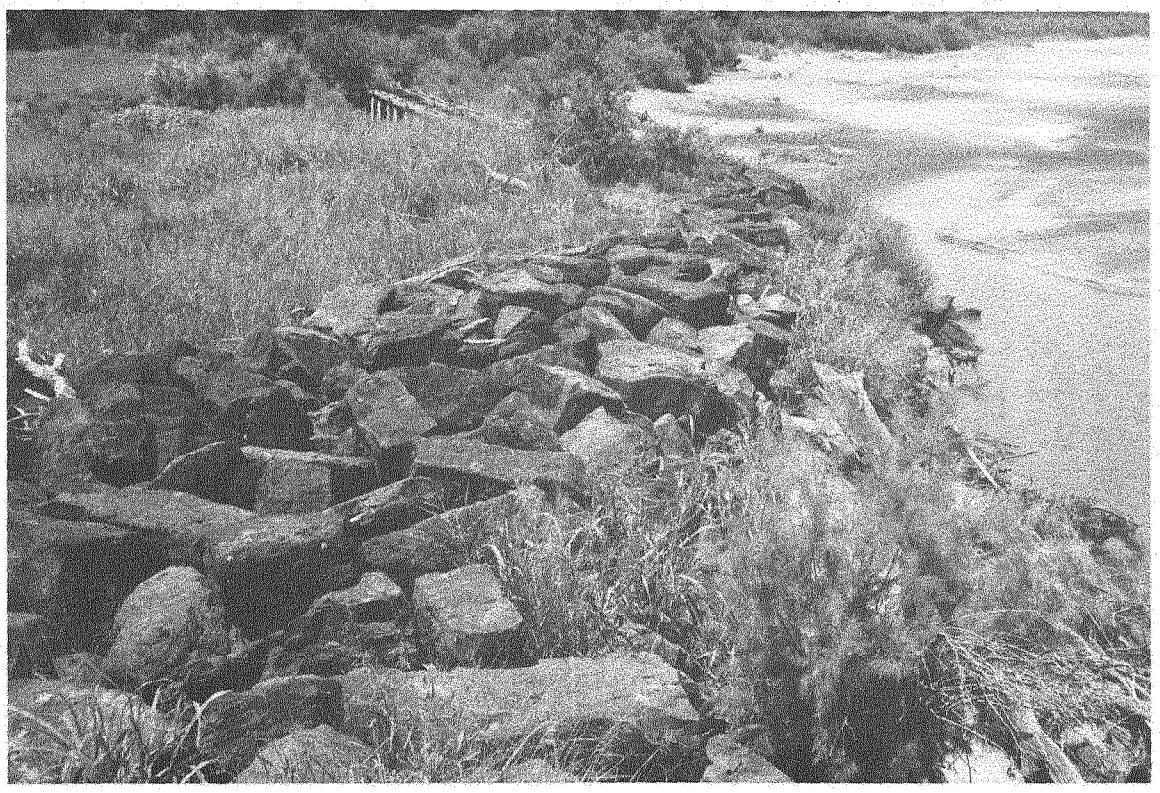
FIGURE 64b

Sandbar in the River

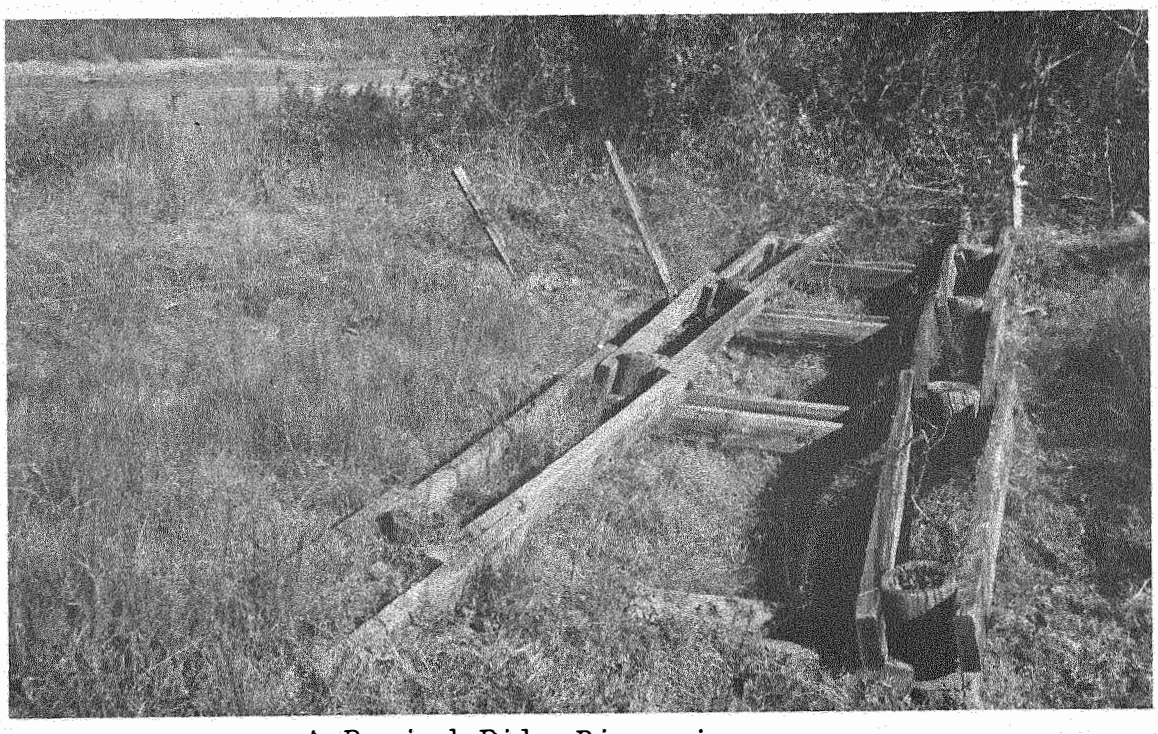
FIGURE 70c

Damaged Jetty Field

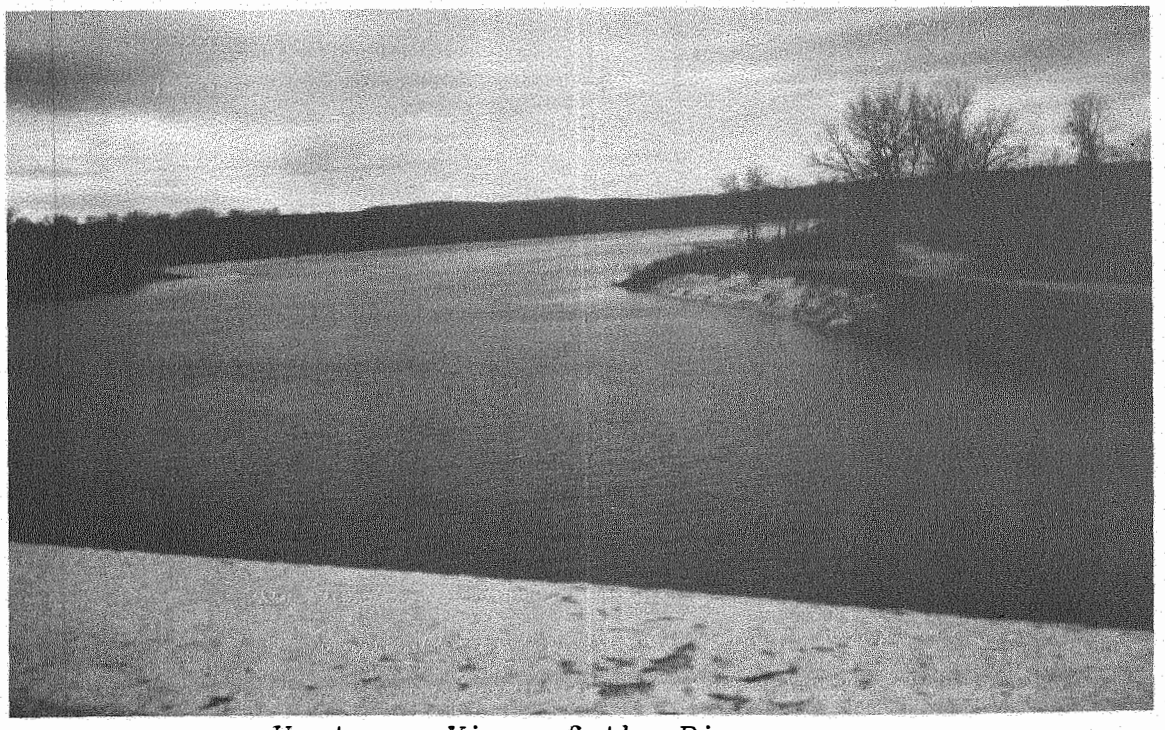
FIGURE 73c

Upstream View of the River

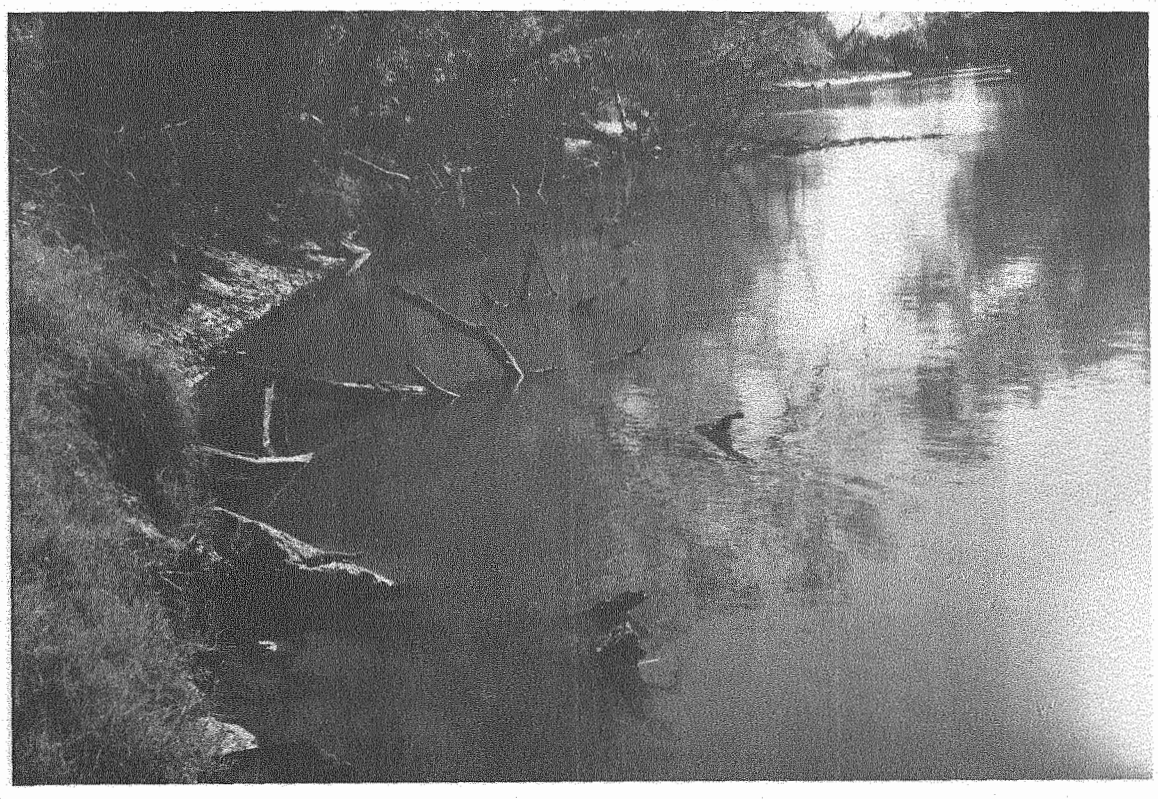
FIGURE 76b

b) Present Condition: MOST JETTIES IN CONTACT WITH THE RIVER ARE IN A BAD CONDITION, WHILE THOSE ON THE HIGH BANK ARE IN NEAR GOOD CONDITION. VERY LITTLE BANK BUILDING ACTIVITY.

Damaged Kellner Jetty Field

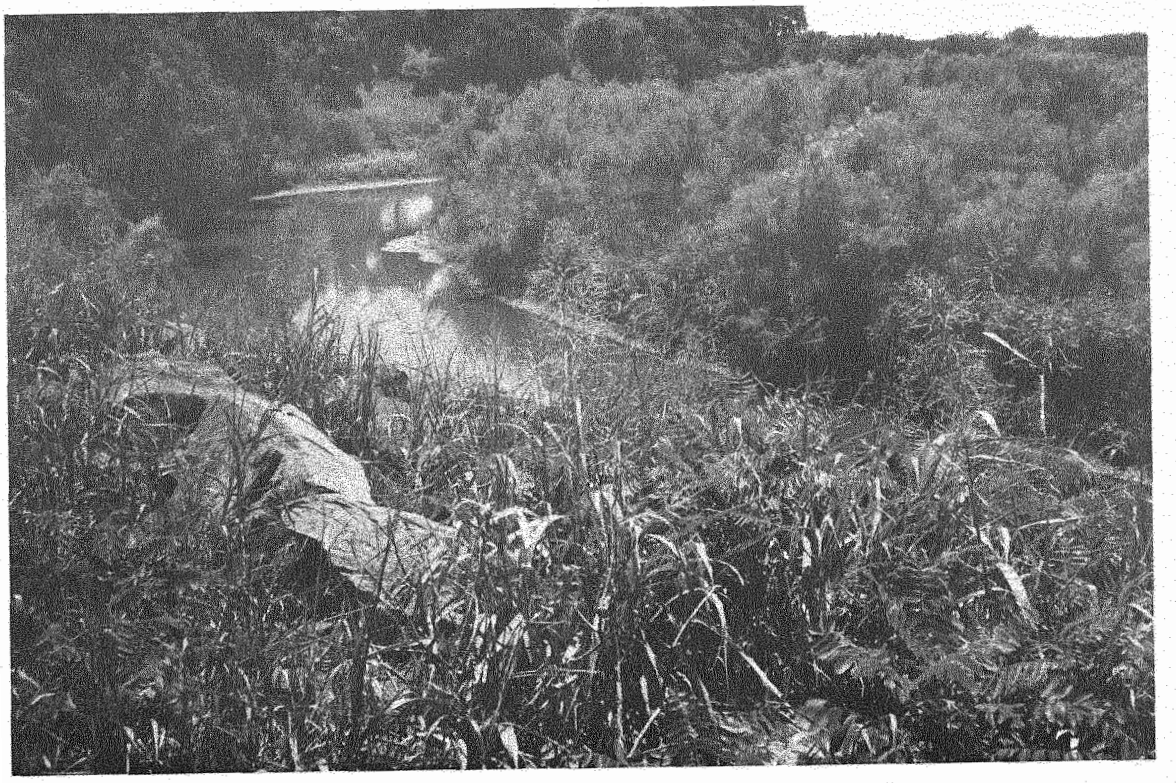
FIGURE 79b

Creek Flowing into the River

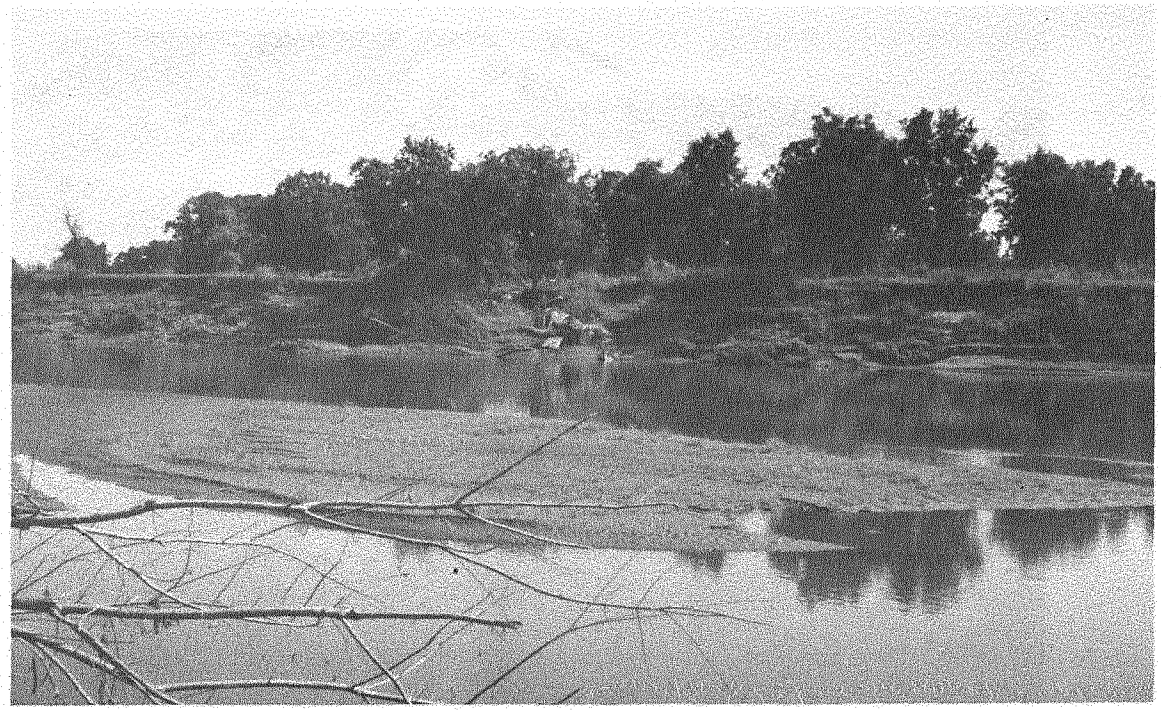
FIGURE 82c

Car Bodies Used to Prevent Erosion

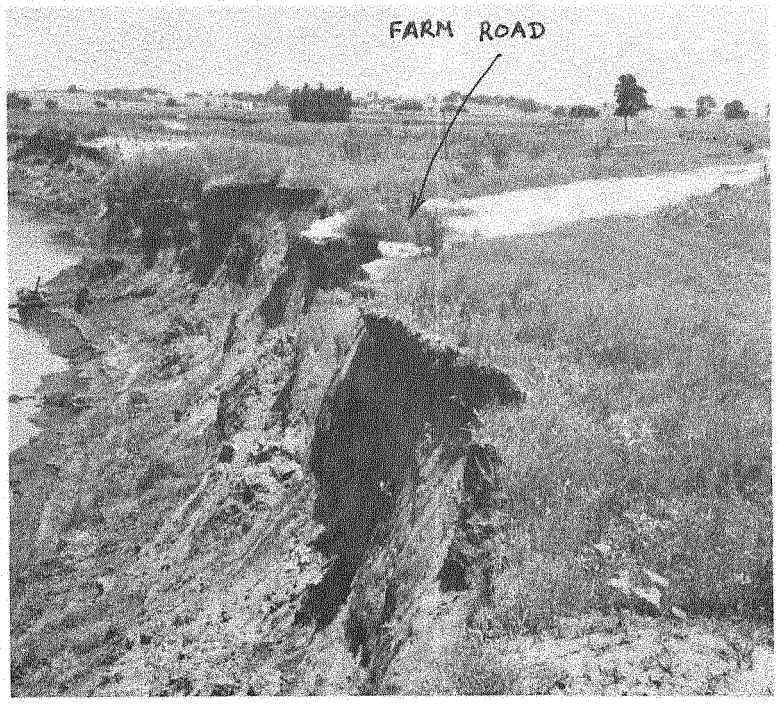
FIGURE 88c

Badly Eroding High Bank

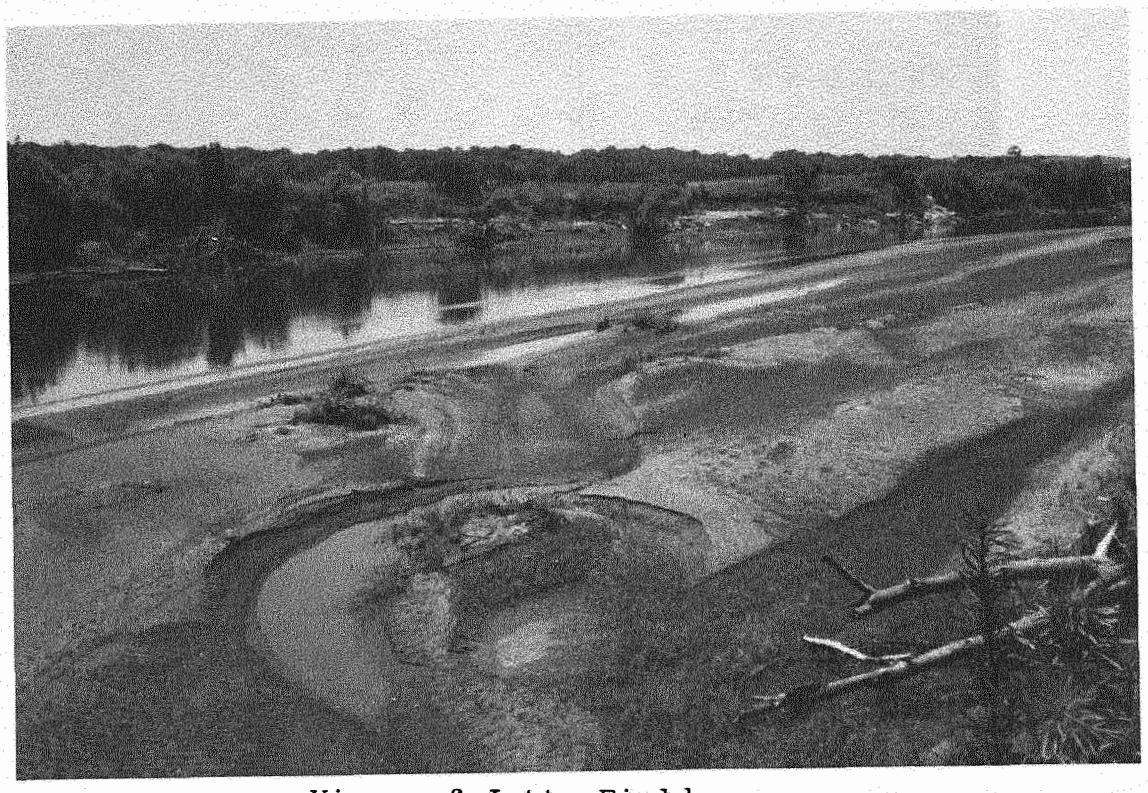
FIGURE 88d

Views of Jetty Field

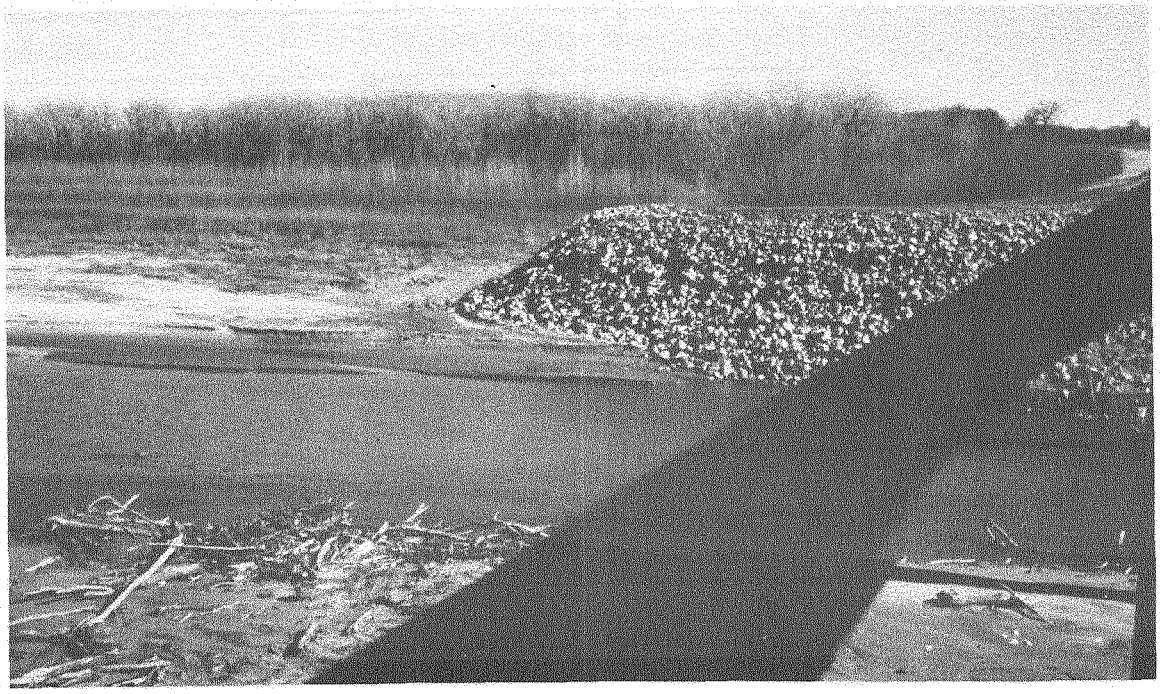
FIGURE 94a

Upstream View of the Washita

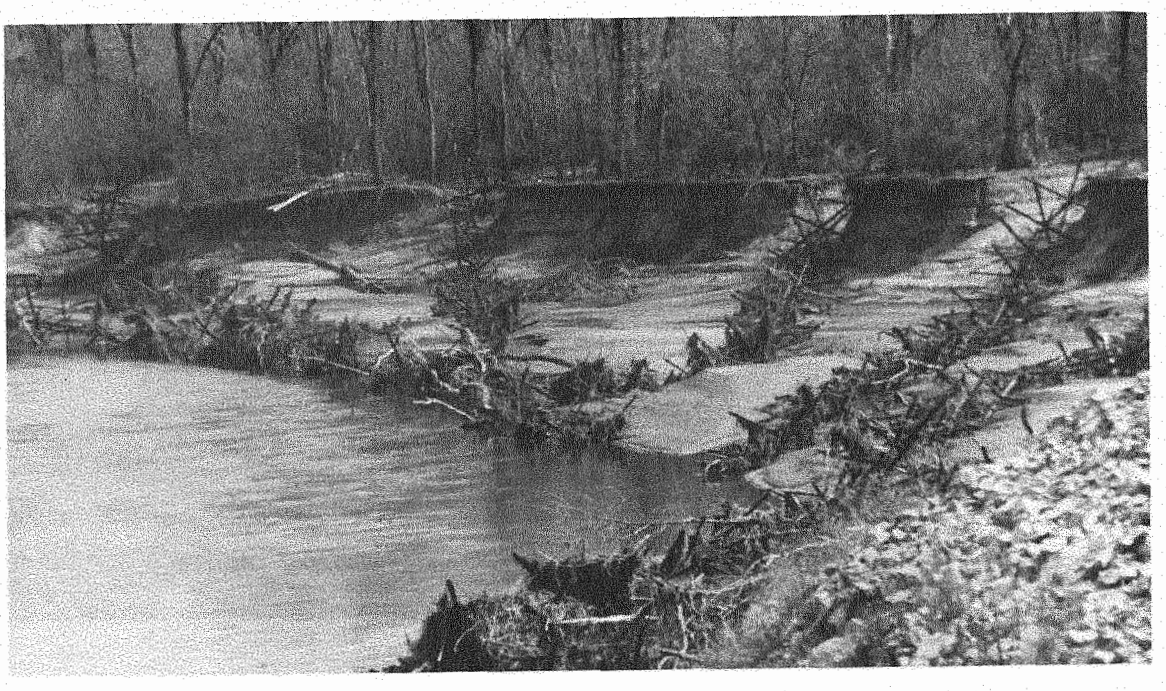
FIGURE 94b

Riprap faced Spur Dike

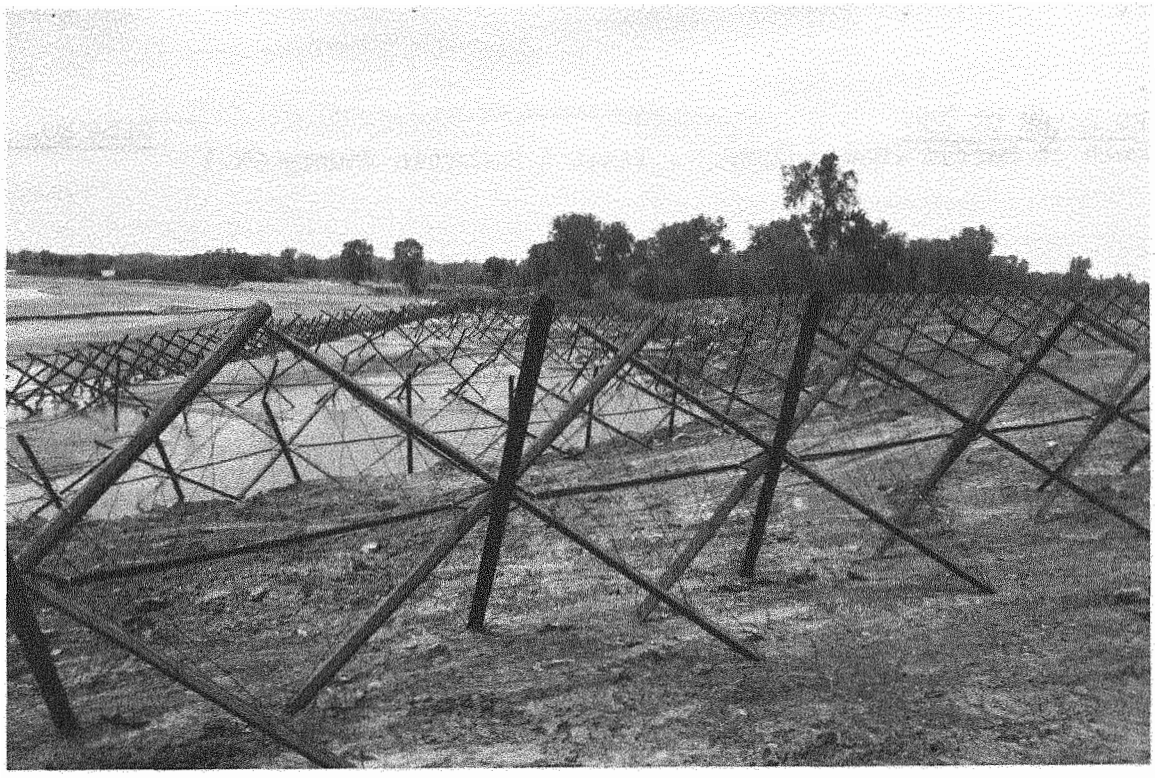
FIGURE 97b

View of Kellner Jetty Field

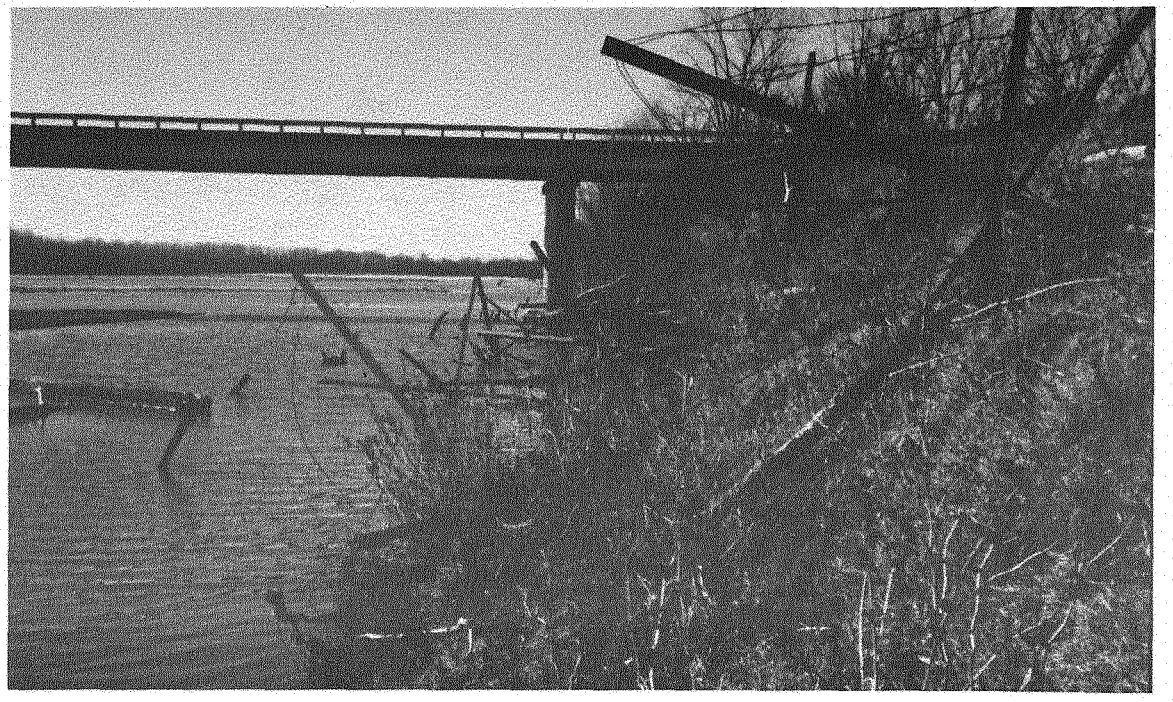
FIGURE 100a

Jetty Field Upstream of Bridge

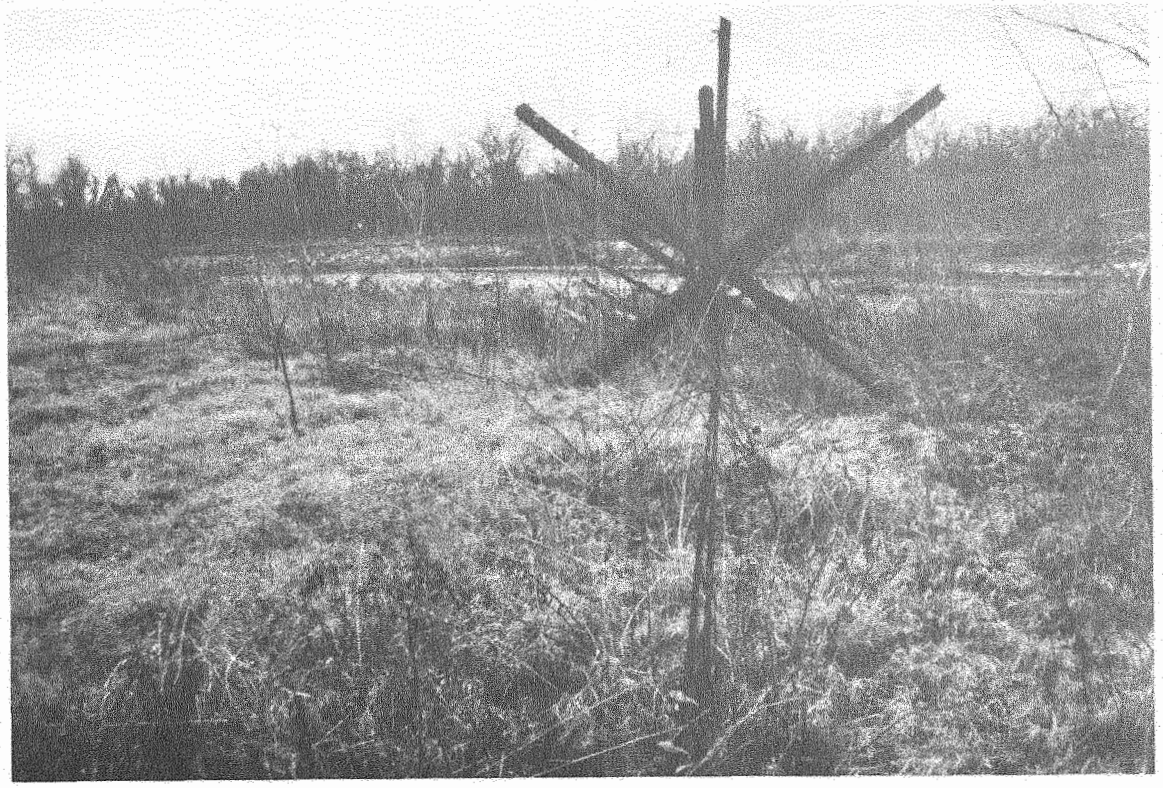
FIGURE 103b

Views of the Jetty Field
