DOT/FAA/CT-94/119

Evaluation of Alternative Pavement Marking Materials

January 1995

Final Report

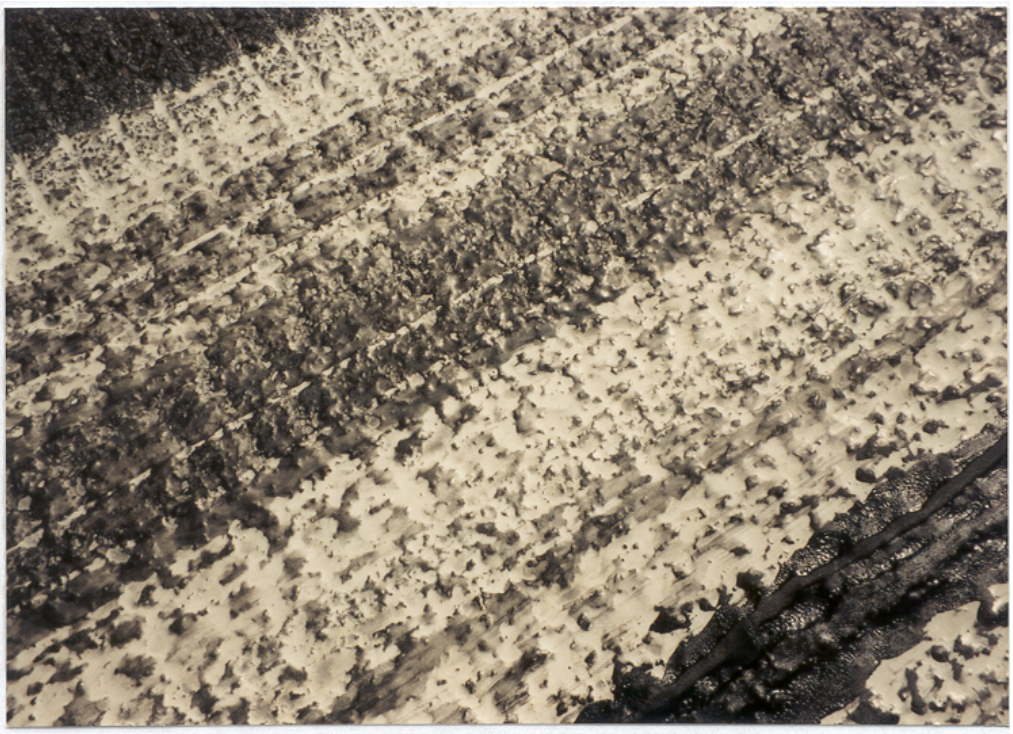
Resistance to rubber buildup is an important factor on those materials which have been installed in an area subjected to the impact of aircraft landing gear. At the Atlantic City location, the water-borne material no. 1 was almost totally covered with rubber within a short time after application. Each of the other materials had significantly less rubber coverage at this site. Certain materials offered greater rubber resistance than others. Resistance to rubber buildup was better when silica and/or bead additives were applied to the material, as opposed to the heavier buildup noted with similar materials not having silica or beads applied.

FIGURE A-19. RUBBER BUILDUP ON RUNWAY TEST STRIPE

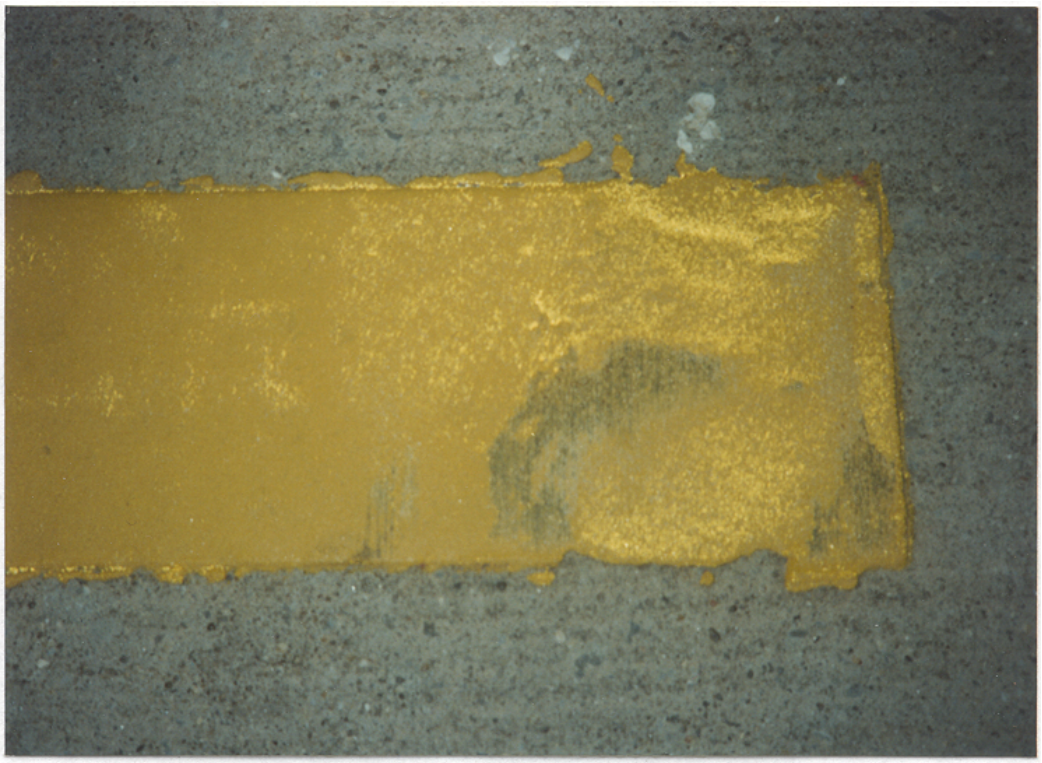
FIGURE A-20. SNOWPLOW STRIKE ON METHACRYLIC RESIN

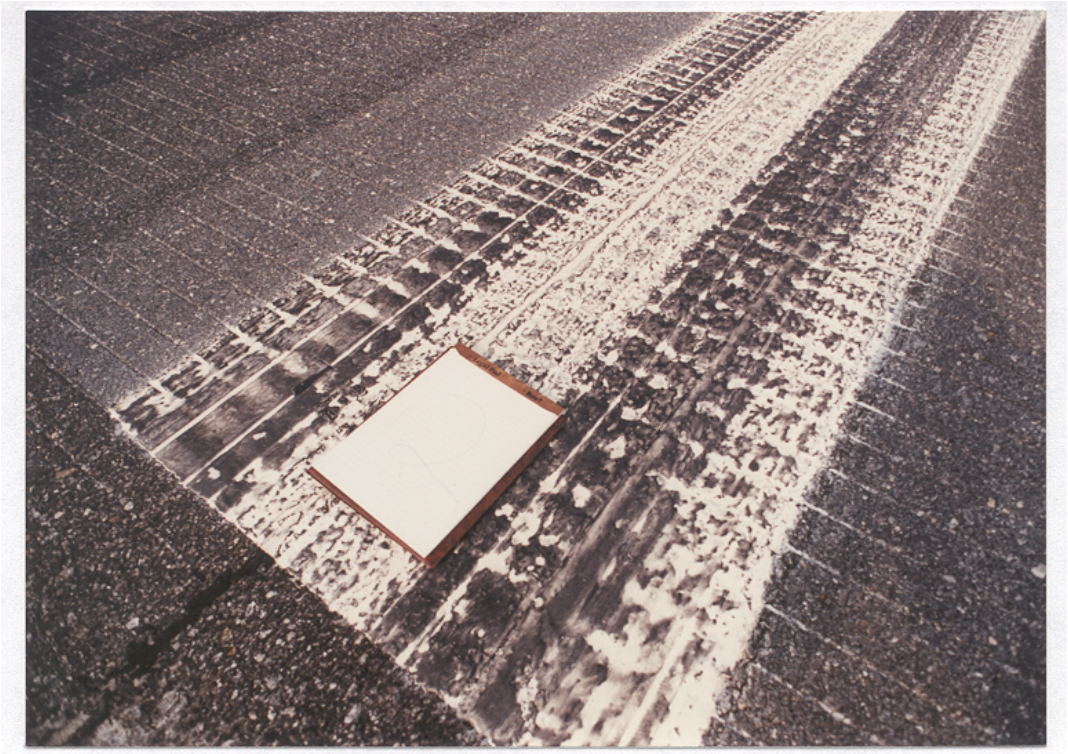
FIGURE A-22. RUBBER ACCUMULATION ON RUNWAY TEST STRIPE

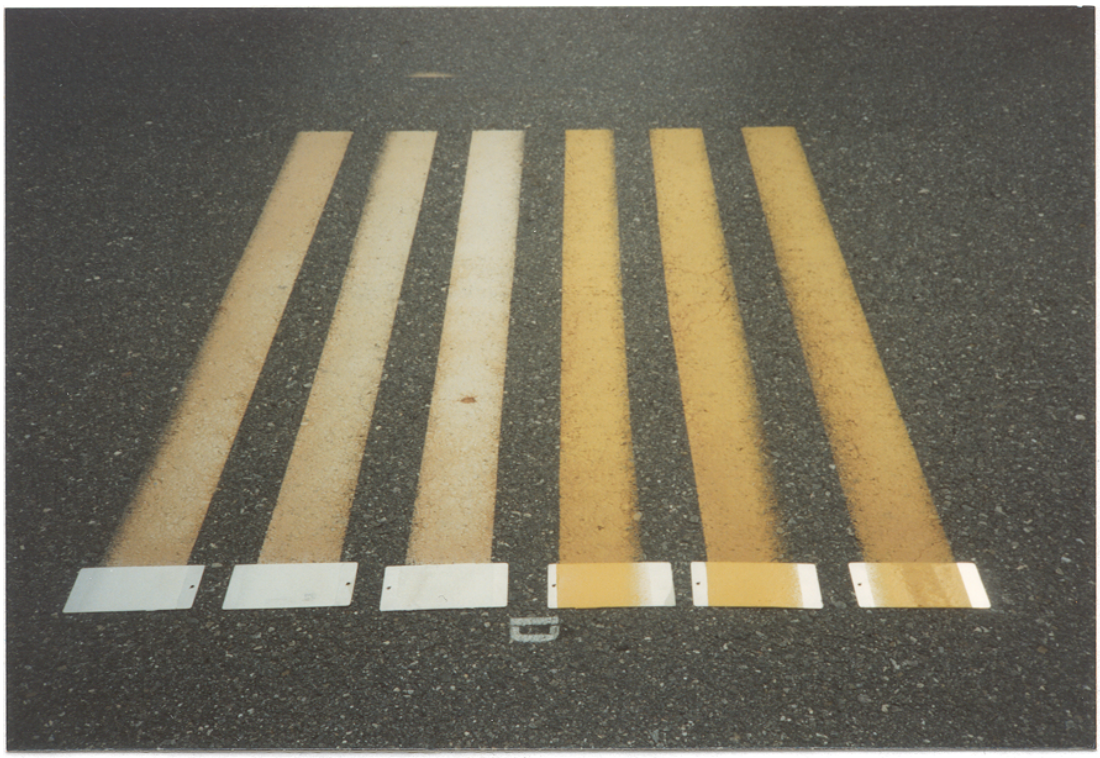
At Atlantic City airport the water-borne material no. 2 was found to have developed a rust-colored cast on the runway threshold stripes and on the asphalt taxiway stripes. Since this occurred only on the asphalt pavement surfaces, it was believed that a component in the asphalt mix was interacting with the materials. Use of drawdowns and comparative photographs illustrated the color transformations that occurred. Refer to the appendix for individual comparisons. Overall, the test materials displayed a constancy in color characteristics with the exceptions already noted.

FIGURE A-24. WATER-BORNE DISCOLORATION - ASPHALT SURFACE

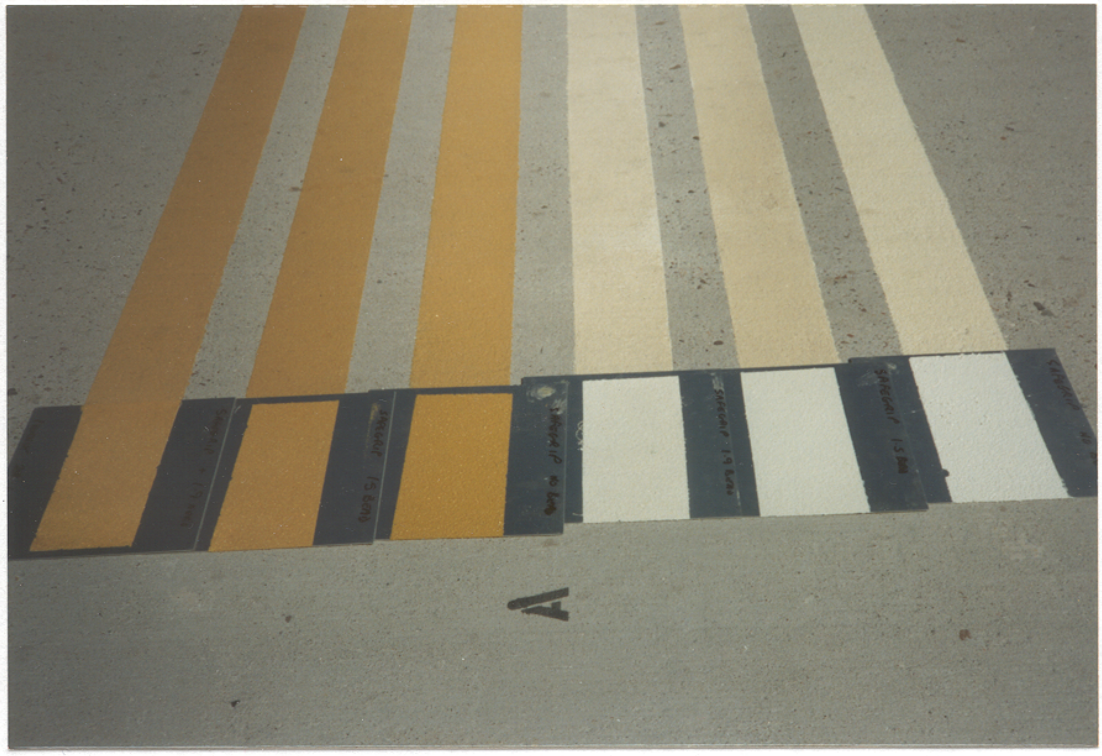
FIGURE A-25. EPOXY NO. 1 DISCOLORATION - CONCRETE SURFACE

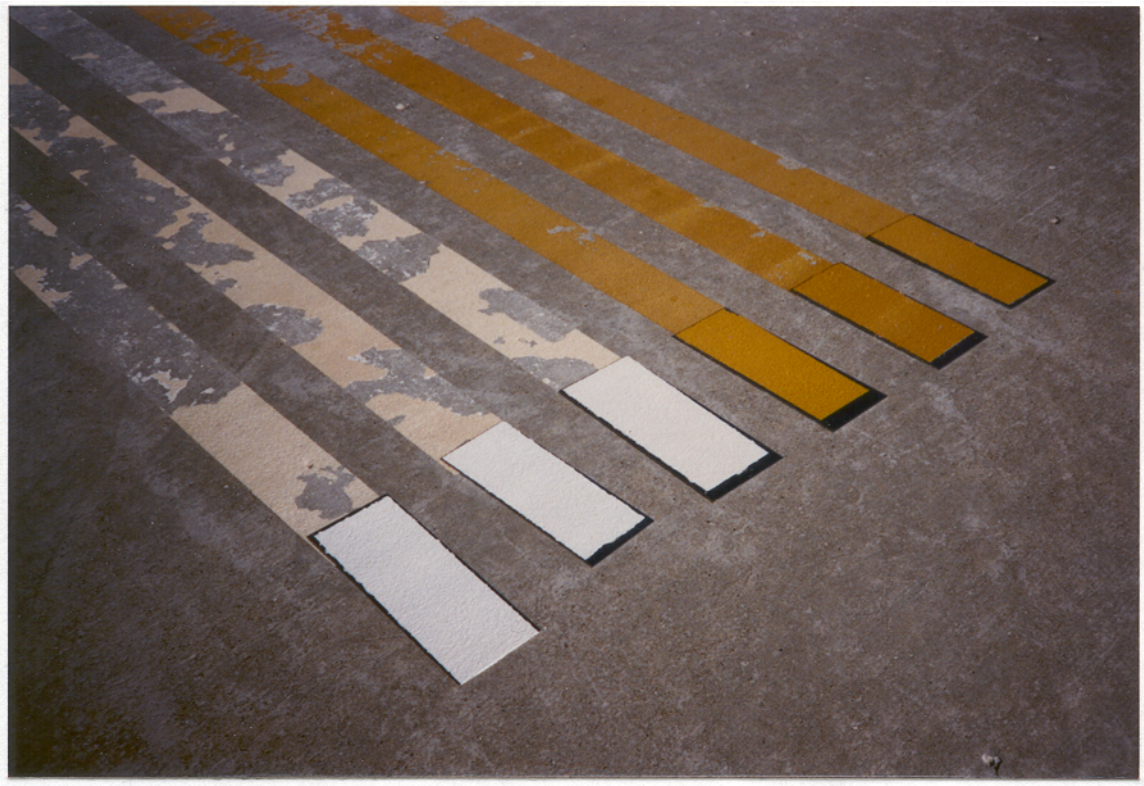
FIGURE A-28. EPOXY NO. 1 TAXIWAY TEST STRIPE AFTER 1 YEAR - PITTSBURGH

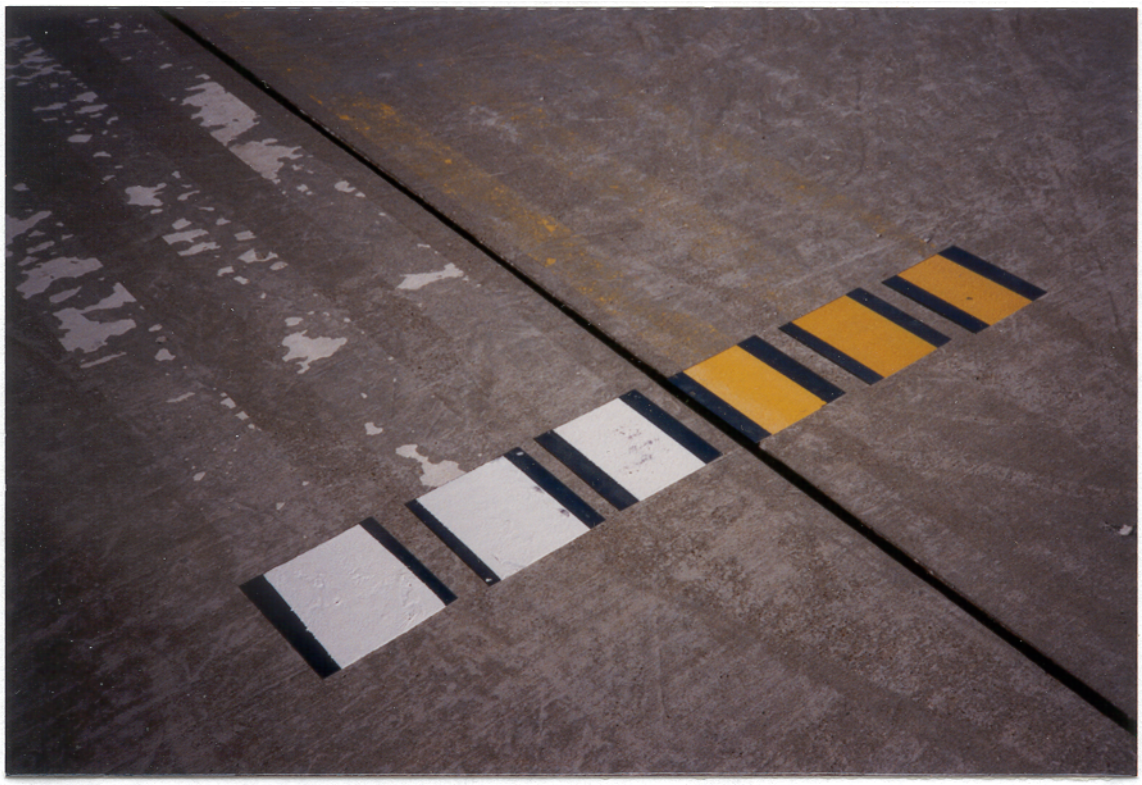
FIGURE A-31. WATER-BORNE NO. 2 TAXIWAY TEST STRIPE AFTER 1 YEAR - PITTSBURGH
