Report No. CDOT-DTD-R-93-19

I-70, SILVERTHORNE TO COPPER MOUNTAIN: A CASE HISTORY OF THE USE OF EUROPEAN TESTING EQUIPMENT

Colorado Department of Transportation

Final Report

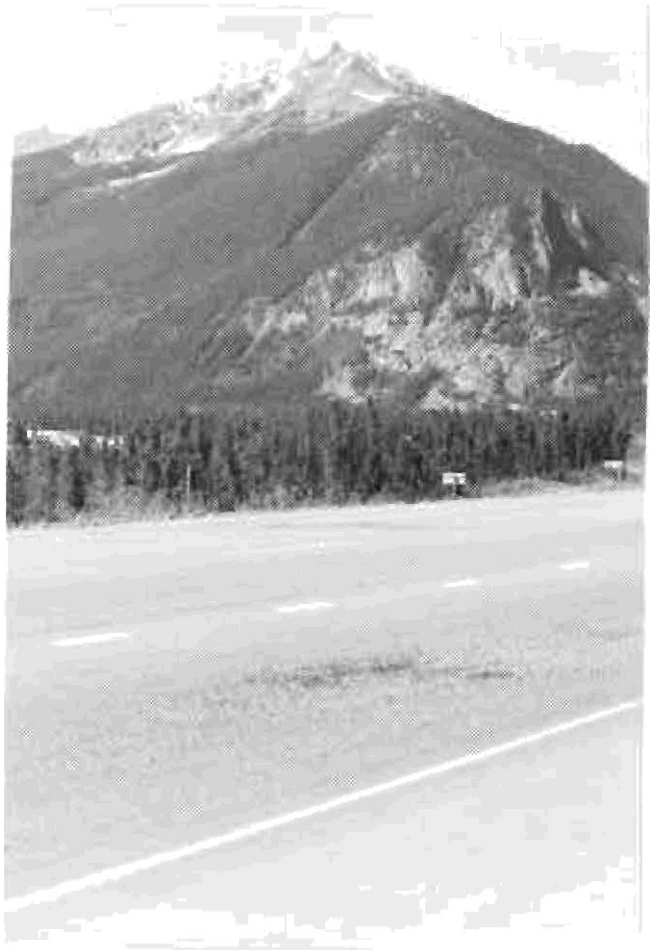
Paving was suspended for the winter after 70,000 tons of HMA were produced. During a very harsh winter, the new HMA overlay began exhibiting signs of distress. The distress was related to moisture damage and was primarily ravelling (Fig. 1). The distress occurred most frequently at the transverse and longitudinal joints. Additionally there were approximately a dozen potholes. Although the distress was not a dramatic failure, the presence of the distress after such a short

period of time was indicative of a reduced pavement life. It was estimated that the overlay would likely need rehabilitation in 3 to 5 years despite a structural design of 10 to 20 years.

Fig. 1. Example of Pavement Distress on I-70, Silverthorne to Copper Mountain.

Based on the testing with the French rutting tester, it is recommended to increase the optimum asphalt cement content from 5.2% to 5.8%. The increase of 0.6% asphalt cement should provide an HMA pavement that has better durability against moisture and provide an HMA pavement that is still resistant to rutting. Field verification should be performed on the HMA to monitor the void properties during construction.

In order to resist moisture damage, it is recommended to add a liquid anti-stripping additive in addition to lime. Pave Bond Special is recommended because of the slightly improved results obtained with the Hamburg wheel-tracking device and the boiling water test. PBS can be added easily at the refinery.

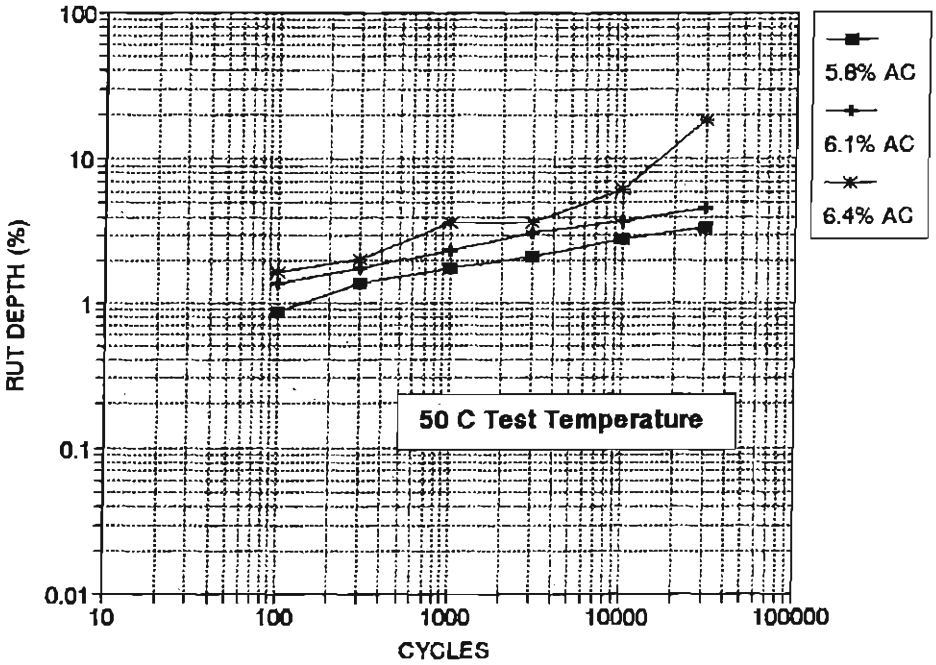
The asphalt mixture with lime was tested at increasing asphalt cement contents until it failed in the French rutting tester. The test results are shown in Fig. 2. HMA likely to resist rutting will

have less than 10% rutting depths after 30,000 cycles of loading. The highest allowable asphalt content for the mix is approximately 6.3% as shown by Fig. 3.

Fig. 2. Results from the French Rutting Tester.

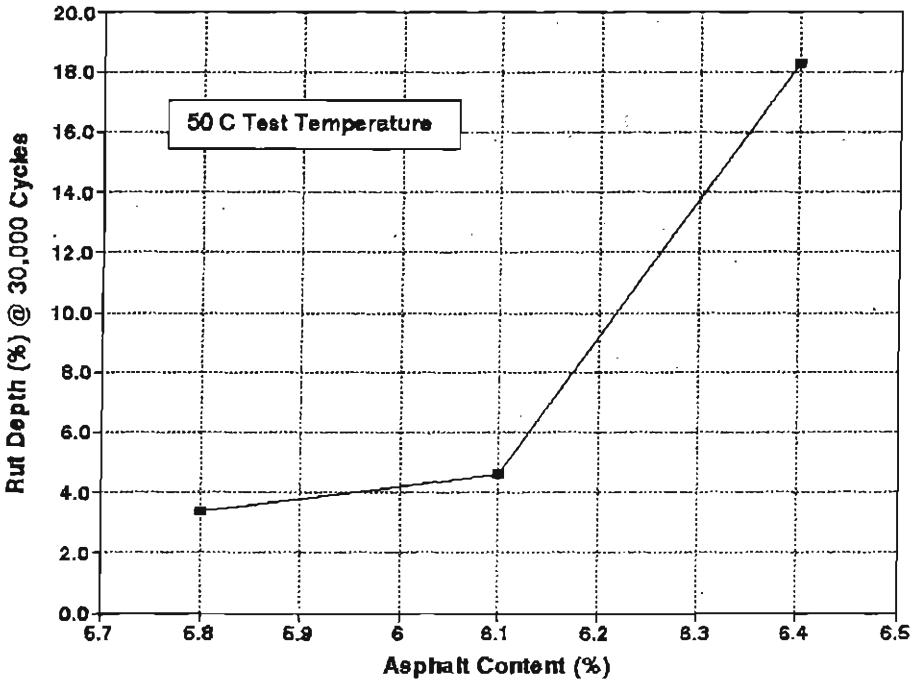
Fig. 3. Summary of Results from the French Rutting Tester.

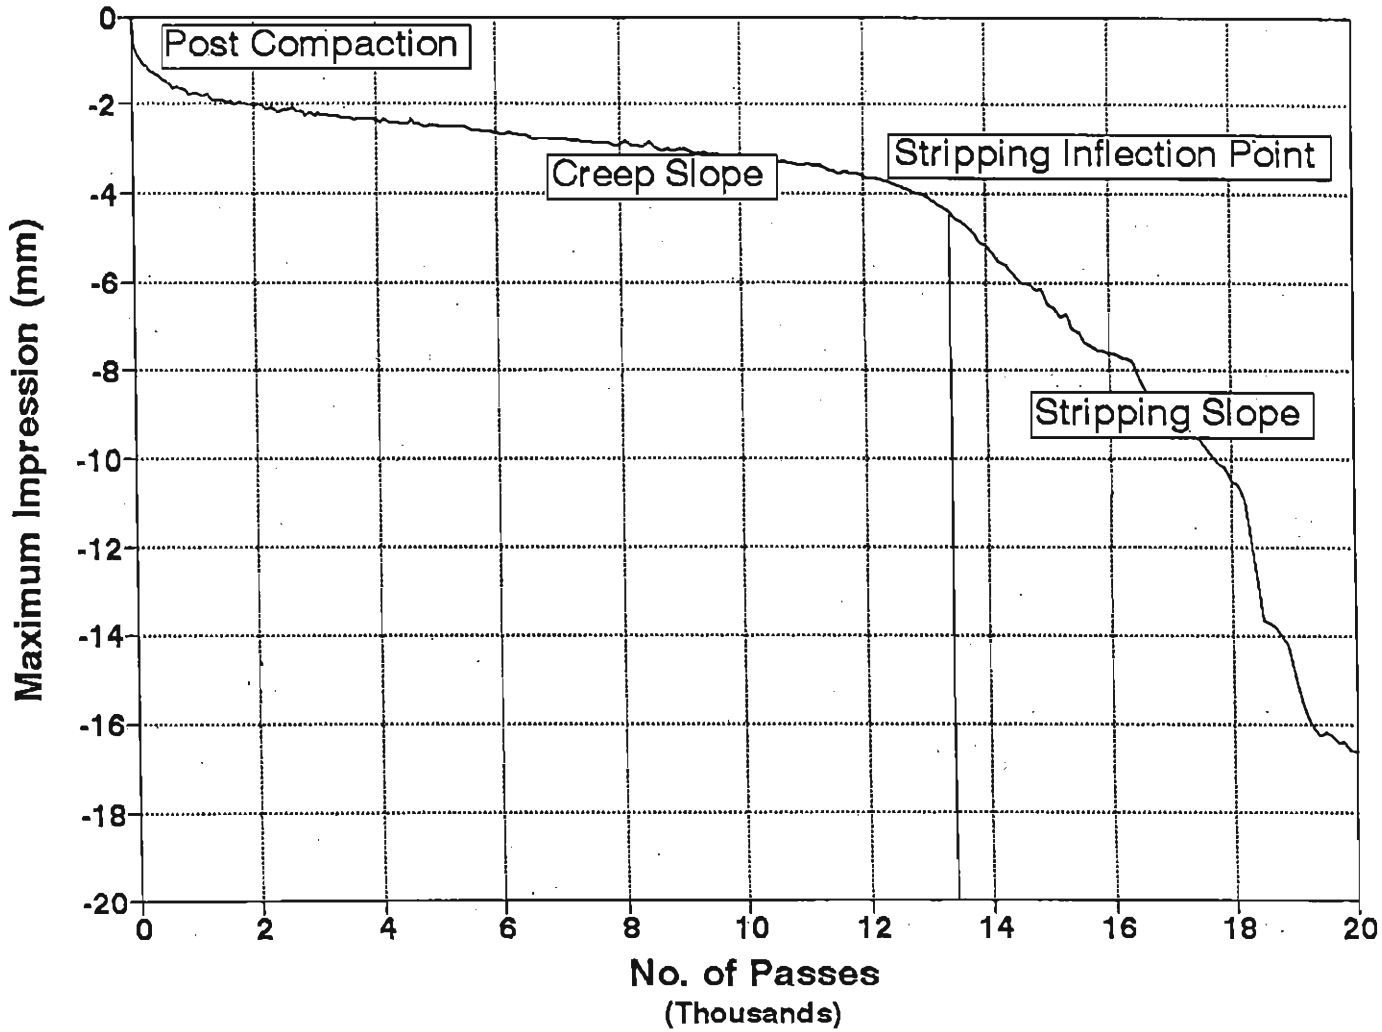
Although the asphalt cement from the Conoco refinery in Colorado did not pass the Hamburg wheel-tracking device, it is believed that the refinery in Colorado can produce asphalt cement that passes the Hamburg wheel-tracking device. Unfortunately, the short time frame allocated to improve the HMA did not allow for testing of all the crude oil sources and chemicals used in the refining process in Colorado. A study will be undertaken in the winter to investigate these variables.

Fig. 4. Summary of Results Obtained from the Hamburg Wheel-Tracking Device.

Additionally, the use of asphalt cement from the Conoco refinery in Ponca City, Oklahoma is recommended. Although the asphalt cement from Frontier and the polymerized asphalt cement from Koch Materials both had acceptable results on the Hamburg wheel-tracking device, the asphalt cement from Oklahoma is more cost effective. It is believed the asphalt cement from Conoco's Colorado refinery could pass the Hamburg wheel-tracking device, but insufficient time was available to test the many variables. A research project will be performed this winter.
