Report No. CDOT-DTD-R-93-8

# Rehabilitation of Rutted Asphalt Pavements Project IR-25-3(96)

Final Report
June 1993

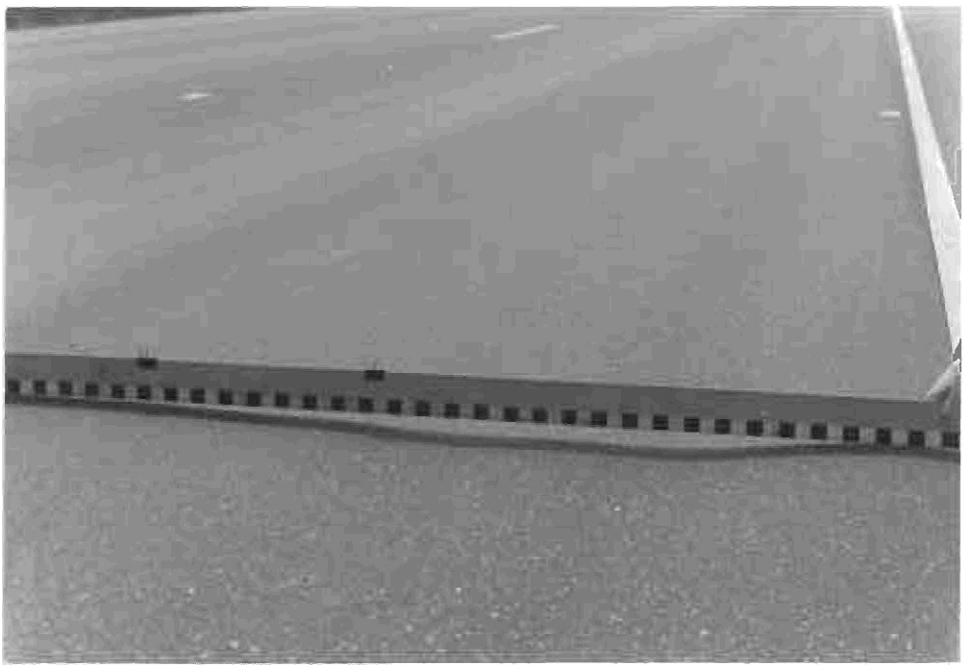
Photo 1 & 2: I-25 Southbound with dual-wheel trace ruts approaching one inch.

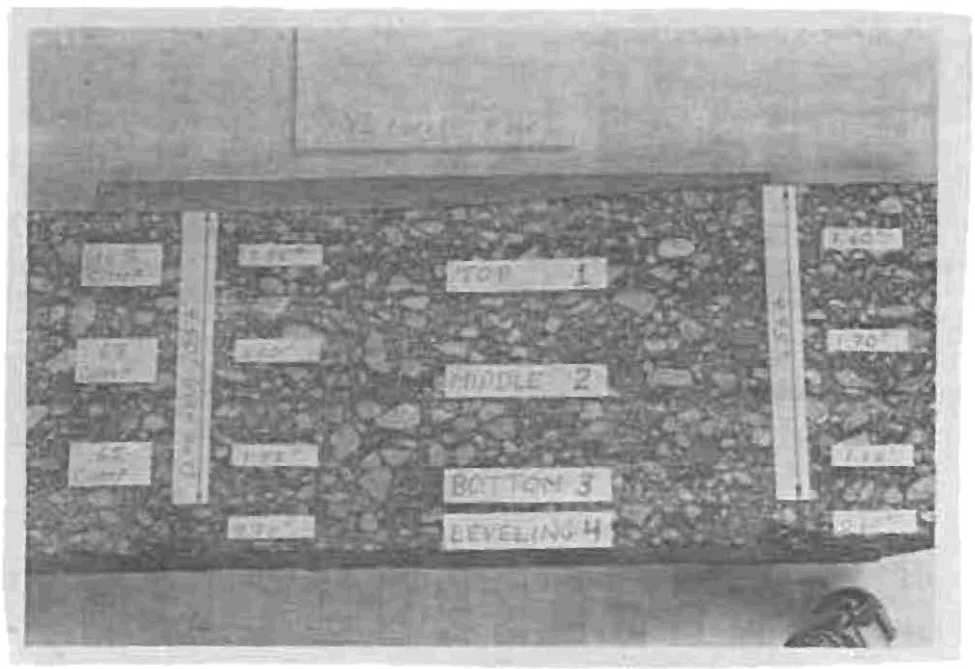
Photo 4: Measurements showed that the largest part of the rut developed in the top mat of the pavement.

As shown in the above table, the top layer exhibited the greatest rutting (16 percent), while the middle and the lower layers had been consolidated only about 6 percent. This suggests that rutting is indeed a surface phenomenon.

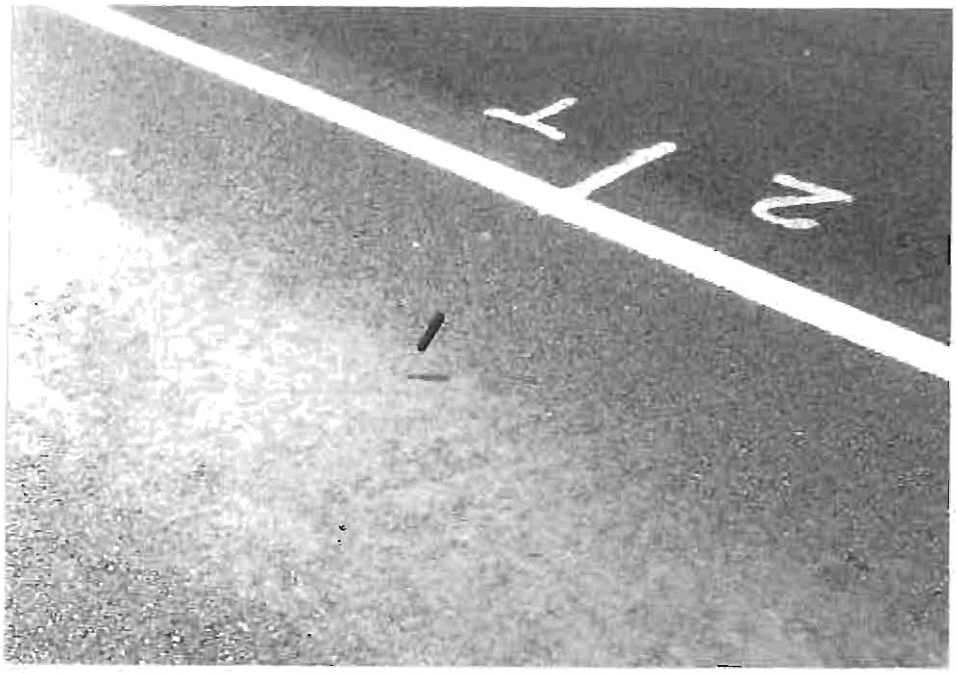
One of the major problems encountered was with the AC content of the PMSC. The AC content of the PMSC used exceeded the amount design called for; as a result the entire length of the driving and the passing lanes started to flush (Photographs 7 and 8). The PMSC was rejected and the contractor was directed to mill out the defected material and replac it with a PMSC that contained the proper amount of asphalt cement.

Photo 7: Flushing of the PMSC at MP 236.6, note the difference in texture between the shoulder and the driving lane.
