Report No.CDOT-DTD-R-92-8

UNBONDED PCCP OVERLAY PROJECT IR-25-3(77)

4. Title and Subtitle	5. Report Date
Evaluation of Unbonded Concrete Overlay Project IR-25-3(77)	September 1992
	6. Performing Organization Code File 20.19 1571P
7. Author(s) Ahmad Ardani	8. Performing Organization Report No. CDOT-DTD-R-92-8
9. Performing Organization Name and Address Research Branch Colorado Department of Transportation 4201 E. Arkansas Avenue Denver, CO 80222	10. Work Unit No. (TRAIS) 11. Contract or Grant No.
12. Sponsoring Agency Name and Address Colorado Department of Transportation 4201 E. Arkansas Avenue Denver, CO 80222	13. Type of Report and Period Covered Final Report 14. Sponsoring Agency Code

Evaluation of Unbonded Concrete Overlay
Project IR-25-3(77)

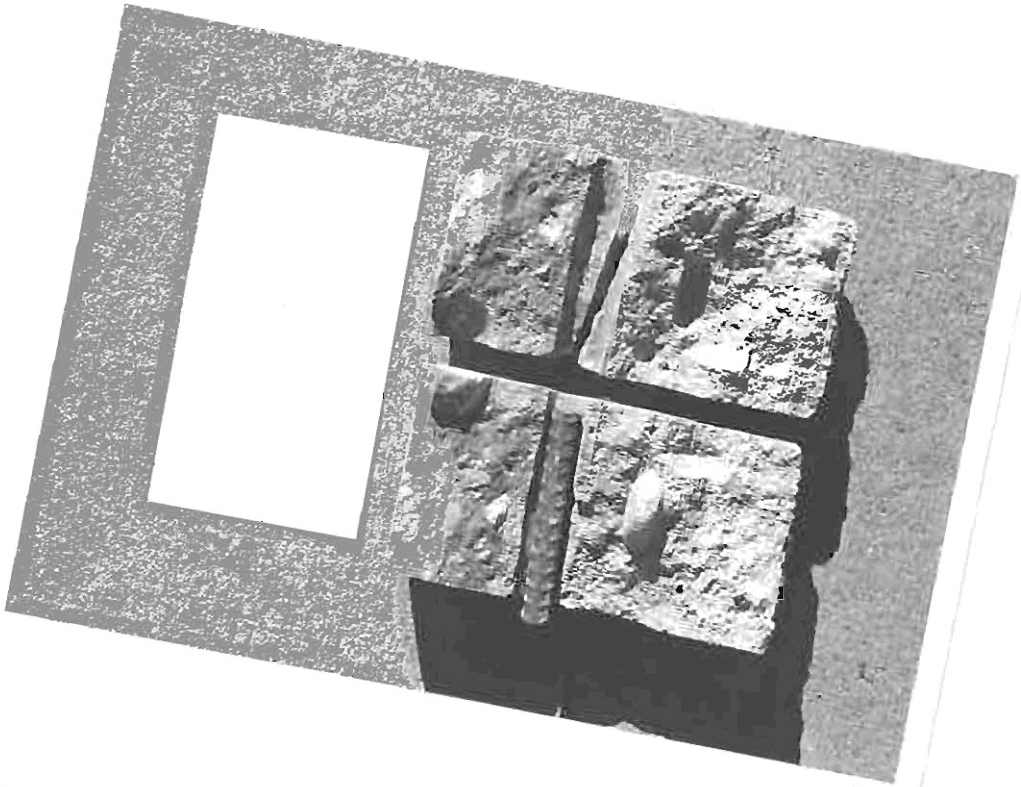
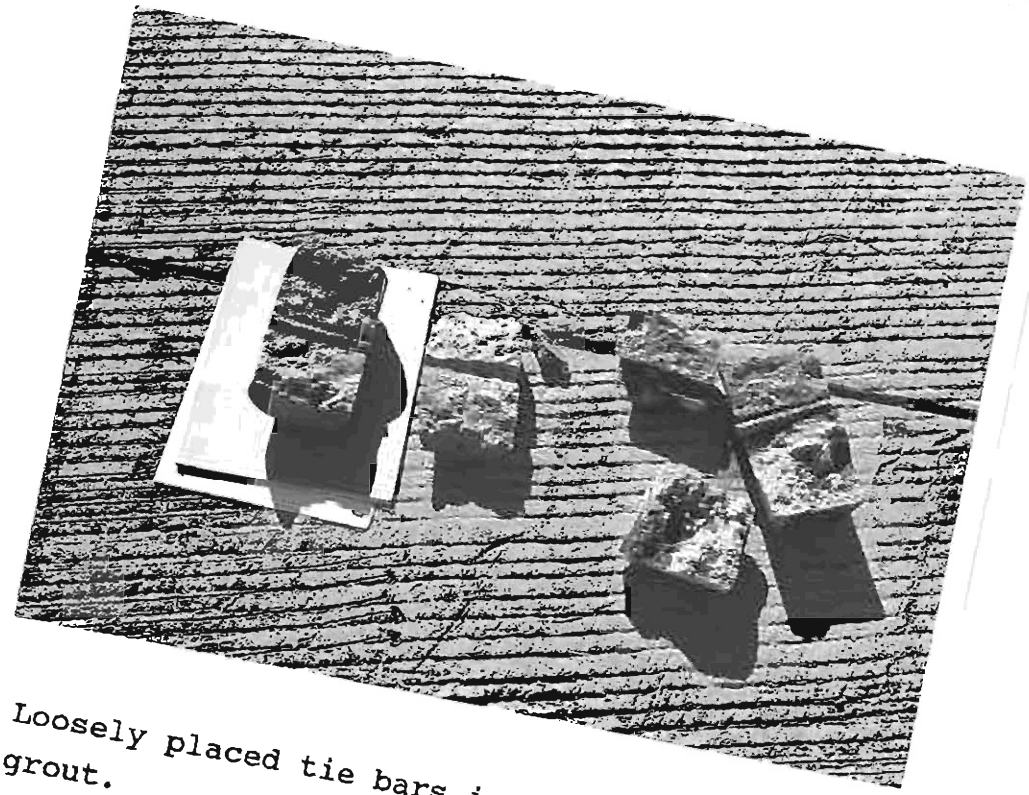
* Note site # 1 (thin section) was omitted from the study. The reason for the omission was that the cores taken from the thin slab section showed that the tie bars were not embedded in the slab but were placed loosely in a drilled hole. This was due to an uncorrected construction error. As a result, the deflection data taken from the thin section showed a much higher deflection (over 100 percent higher) than that of control section.

Failure of the paving equipment combined with improper inspection during shoulder placement resulted in drilled holes for tie bars that were not grouted before shoulder

Photo 3 & 4: Loosely placed tie bars in drilled holes without grout.

placement. As a result, the data from the thin slab section is considered invalid. Photograph 3 and 4 show the extracted cores from this section of pavement.

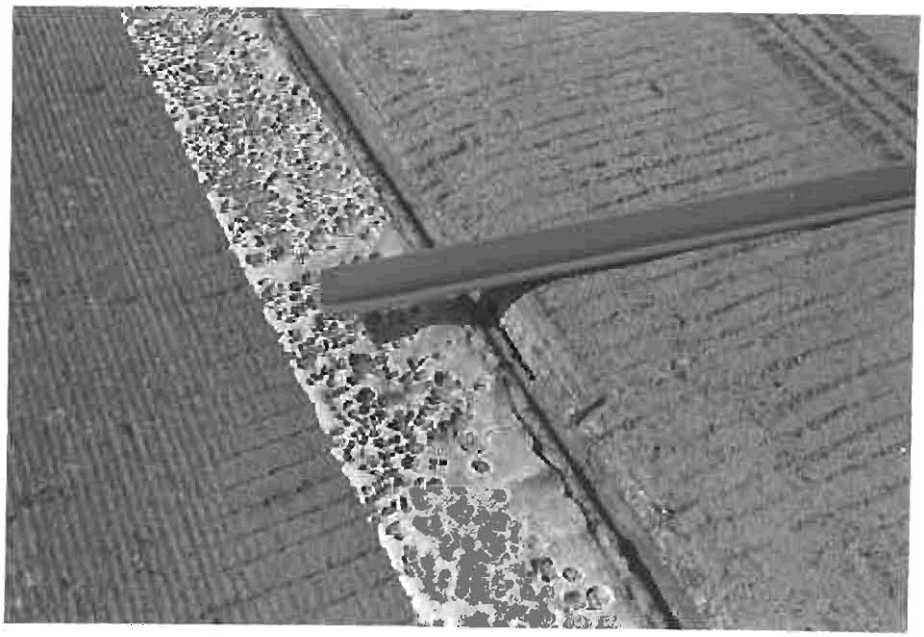
Photo 6: Elevation differential between the driving lane and the shoulder in the un-tied shoulder section.

driving lane was in excess of one inch for the un-tied shoulder section. Photograph 6 clearly demonstrate this elevation differential.

Elevation differences between the shoulder and the driving lane were quite evident (in excess of 1 inch in some instances) in the un-tied shoulder section.

The use of unbonded overlays, where suitable, is recommended, along with close attention being paid to design and construction details. Furthermore, we recommend the use of tied shoulders over the un-tied shoulders for unbonded overlays.

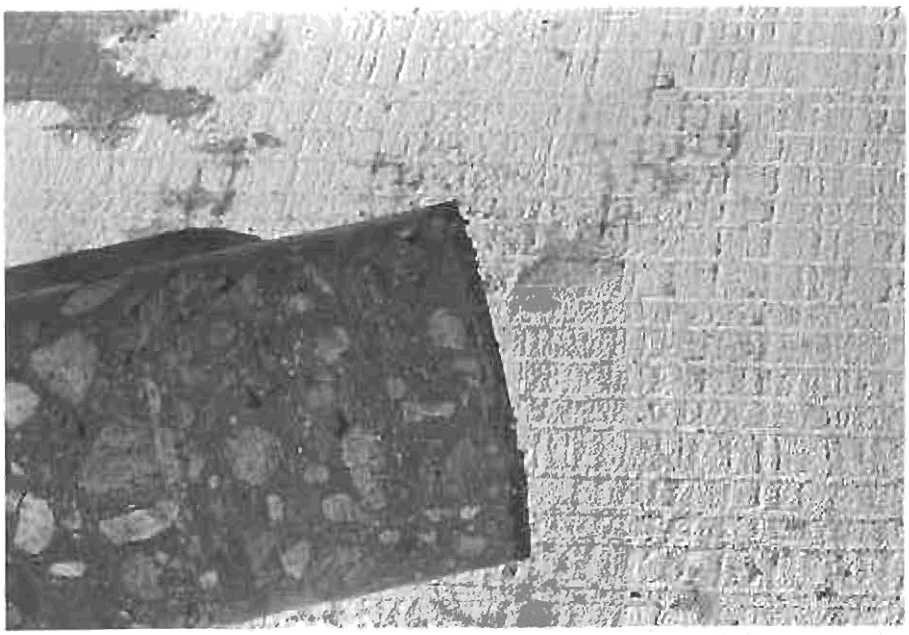
This core has the chip seal bond breaker attached.
