Report No. CDOT-DTD-R-92-5

# SPECIAL POLYMER MODIFIED ASPHALT CEMENT

Interim Report
March 1992

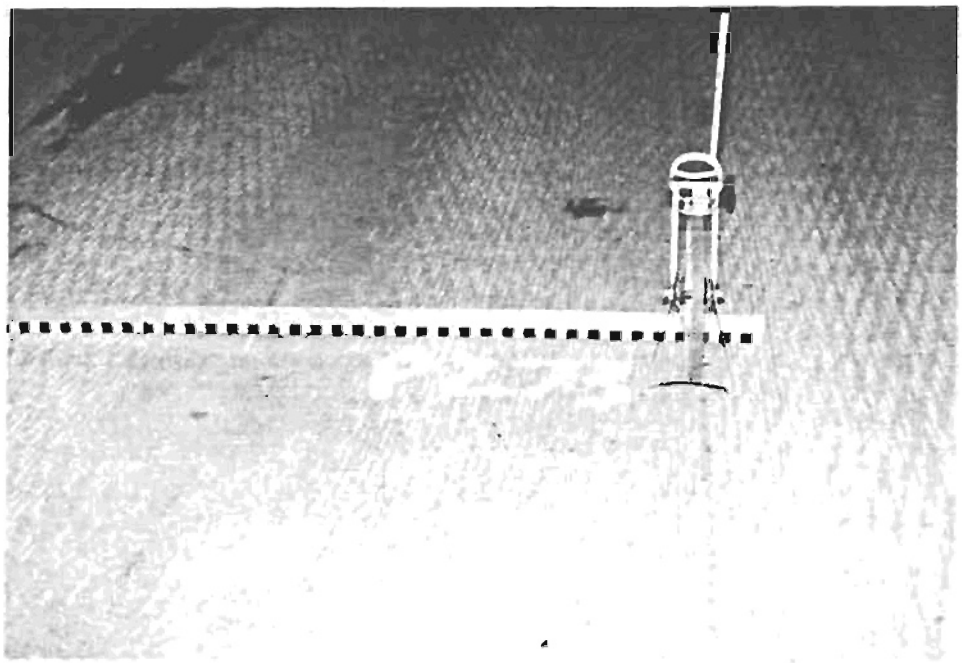
Rutting could still be seen in wheel path following milling.

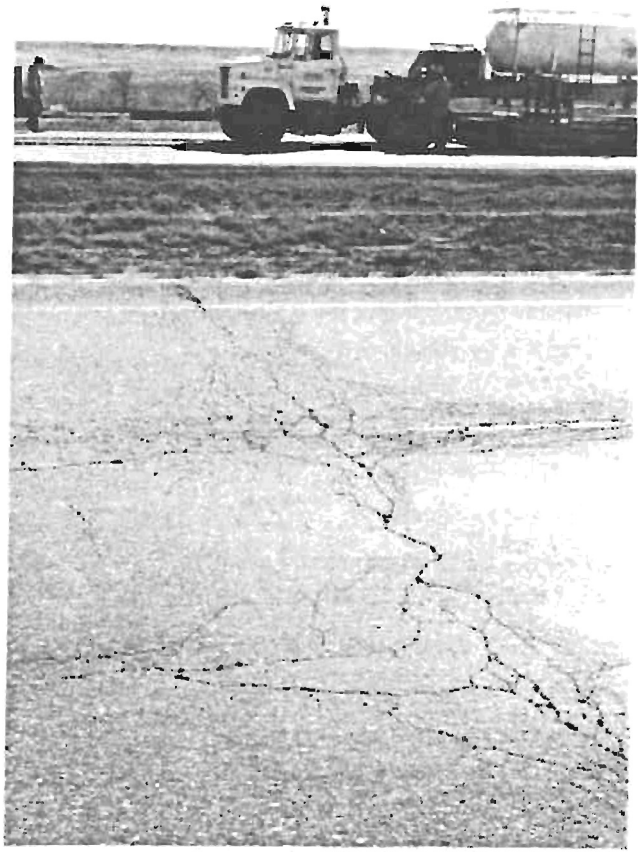
Prior to construction the majority of the transverse cracks were badly deteriorated.

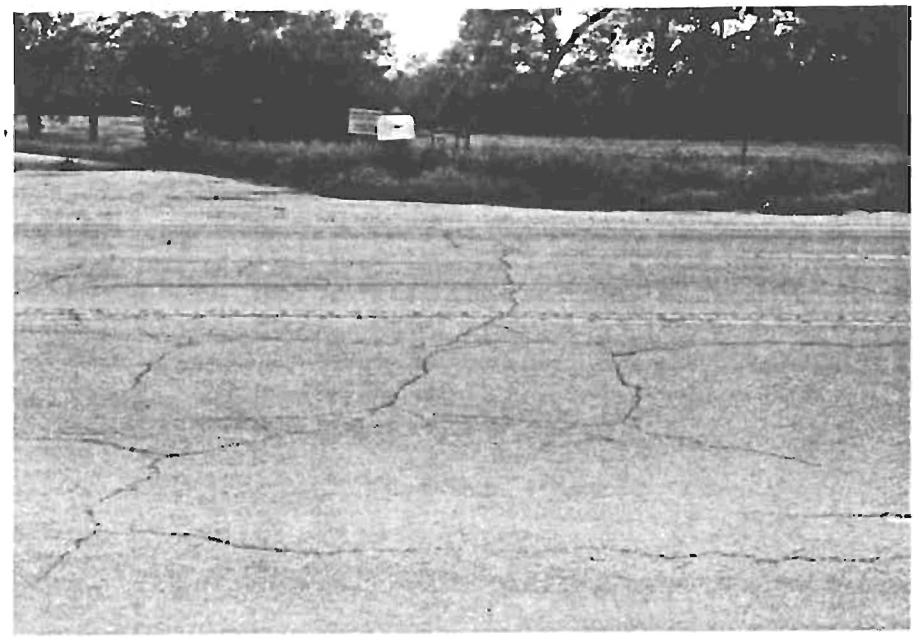
Condition of pavement prior to construction.

Pre-paving rutting

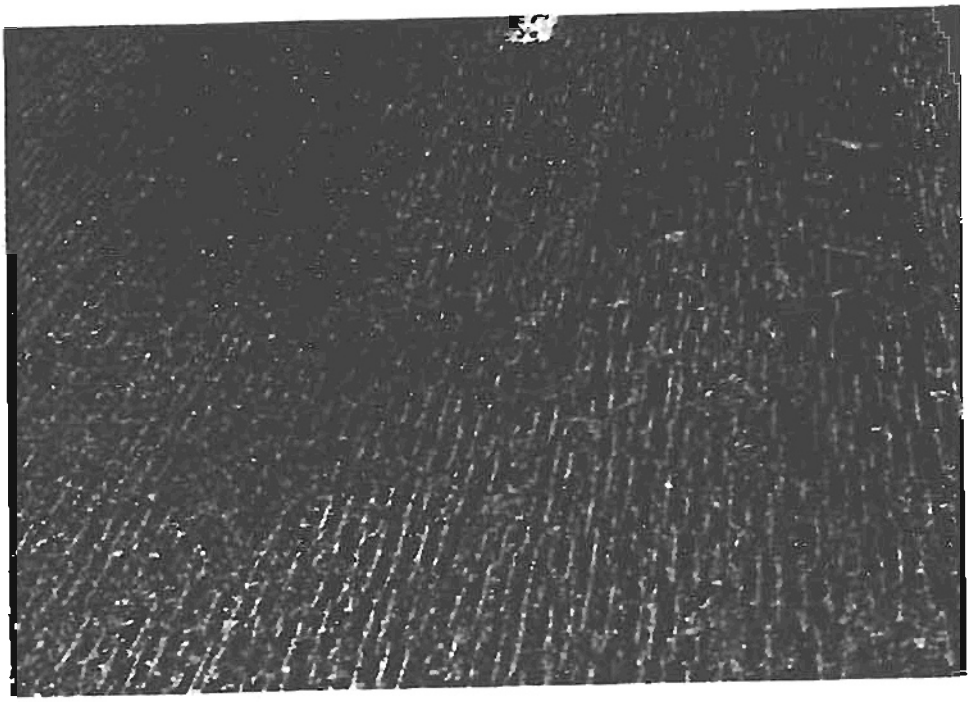
Following milling cracks could still be seen in the pavement.

Some rutting could still be seen in wheel path following milling.

Segregated areas could be found throughout the project during the first evaluation following construction.

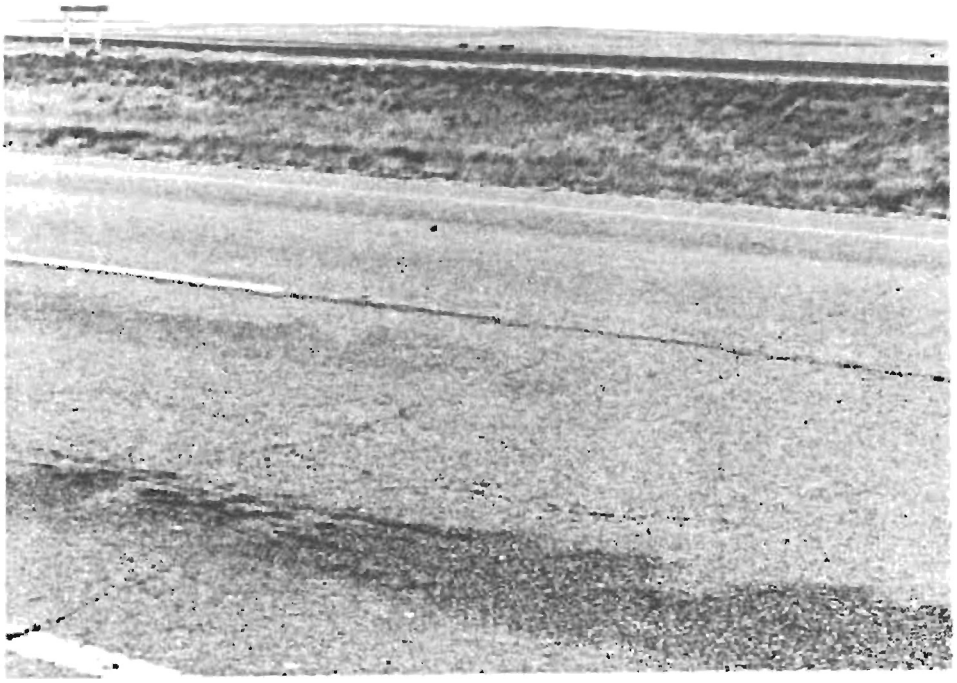
Longitudinal cracking and flushing in the wheel paths could be found in the pavement prior to paving.
