Report No. CDOT-SM-AI-92-15

Investigation of Premature Distress in Asphalt Overlays on IH-70 in Colorado

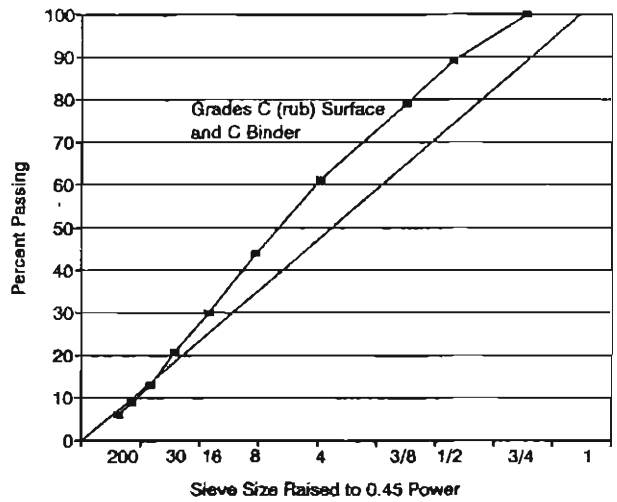
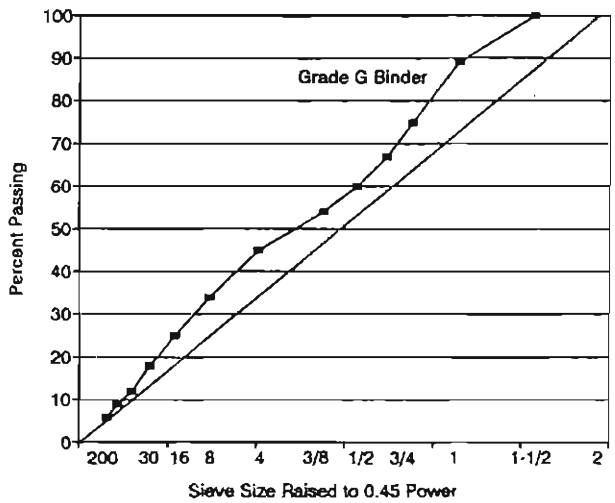
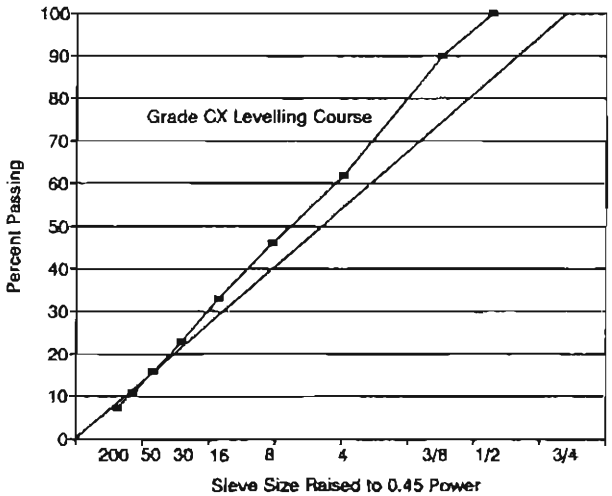
Figure 1. Job-Mix Formula Gradations for Overlay Materials, IH-70

The gradation of the combined aggregate for the C mixtures appears acceptable when compared with the maximum density gradation (Fig 1). The mixture was well graded, primarily on the fine side of the maximum density gradation, with no gaps. With 44 percent passing the No. 8 sieve, the mixture might be considered slightly fine, although not overly so.

The binder course consisting of Grade G (Fig 1) is slightly gap graded. Practically

the entire gradation exists on the fine side of the maximum density gradation. Of the fine fraction between about the No. 4 and No. 200 sieve, the gradation is slightly deficient in the material between the No. 4 and No. 30 sieve.

The Grade CX rut filling course (Fig 1) is very dense. Its gradation plots in a straight line on the fine side of the maximum density gradation. Because this mixture was expected to be placed in very thin lifts, mostly less than 1-inch, it was designed to be entirely finer than 1/2-inch. If covered immediately by a binder or wearing course, it would likely serve its only intended function: rut filling and levelling.

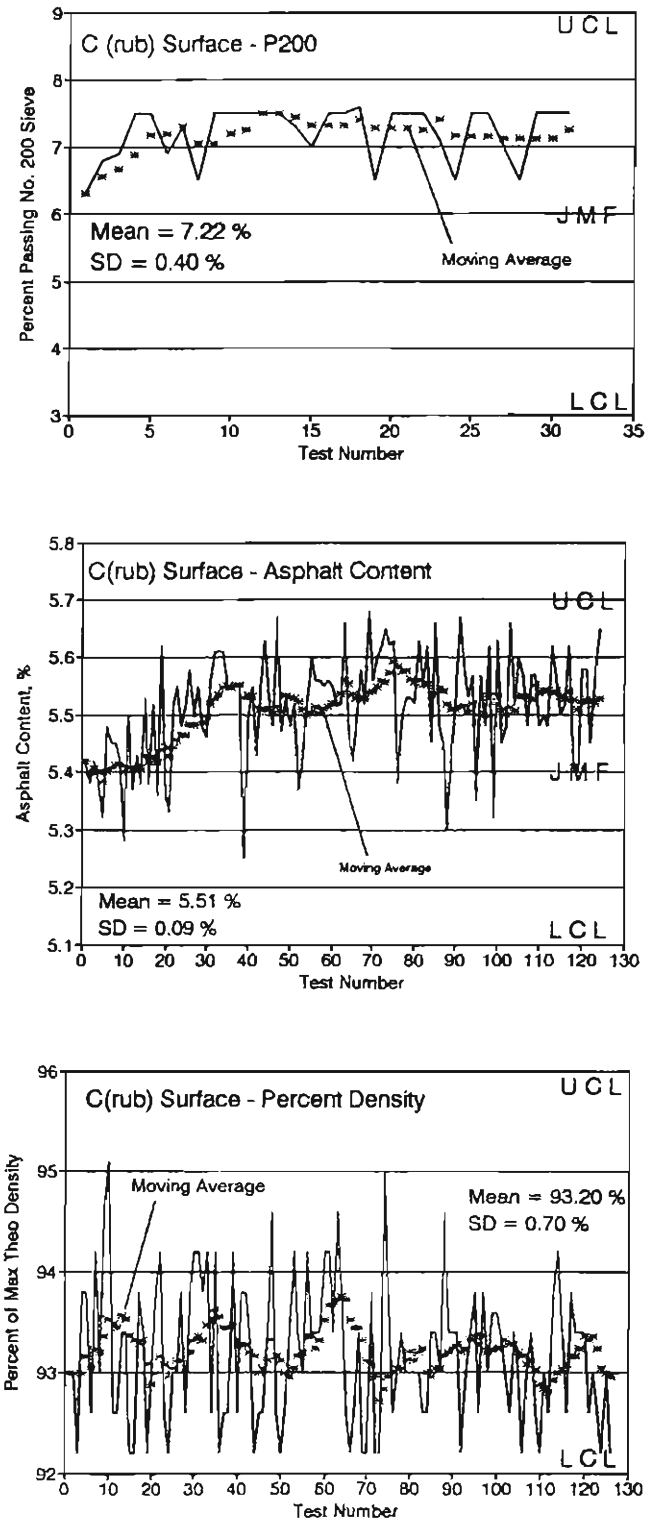
Figure 4. Quality Control Test Results for C (rub) Surface Course, IH-70

C (rubberized) Surface. Figure 4 illustrates contractor quality control test results for the C (rubberized) surface. The percent passing the No. 200 sieve (P200) averaged 7.2 percent, which is 1.2 percent higher than the design value of 6.0 percent. For over 120 test results, the asphalt content averaged 5.5 percent, about 0.1 percent higher than the design value of 5.4 percent. Figure 4 indicates that there was a high degree of control on asphalt content of the as-produced asphalt mixture. The in-place density of the C (rubberized) surface averaged over 93 percent of maximum theoretical density. No test result was below 92 percent, a typical industry standard.

Comments on Contractor Quality Control Test Results. There are two notable observations concerning the quality control data presented in Figs 4 through 6. First, no values exceeded the upper or lower control limits (UCL or LCL). In almost 500 quality control tests, no parameter (asphalt content, P200, or in-place density) was out of specifications. Based only on these test results, the contractor exercised considerable control of asphalt mixture production. CDOT engineers indicated they were impressed with the quality control of the contractor.

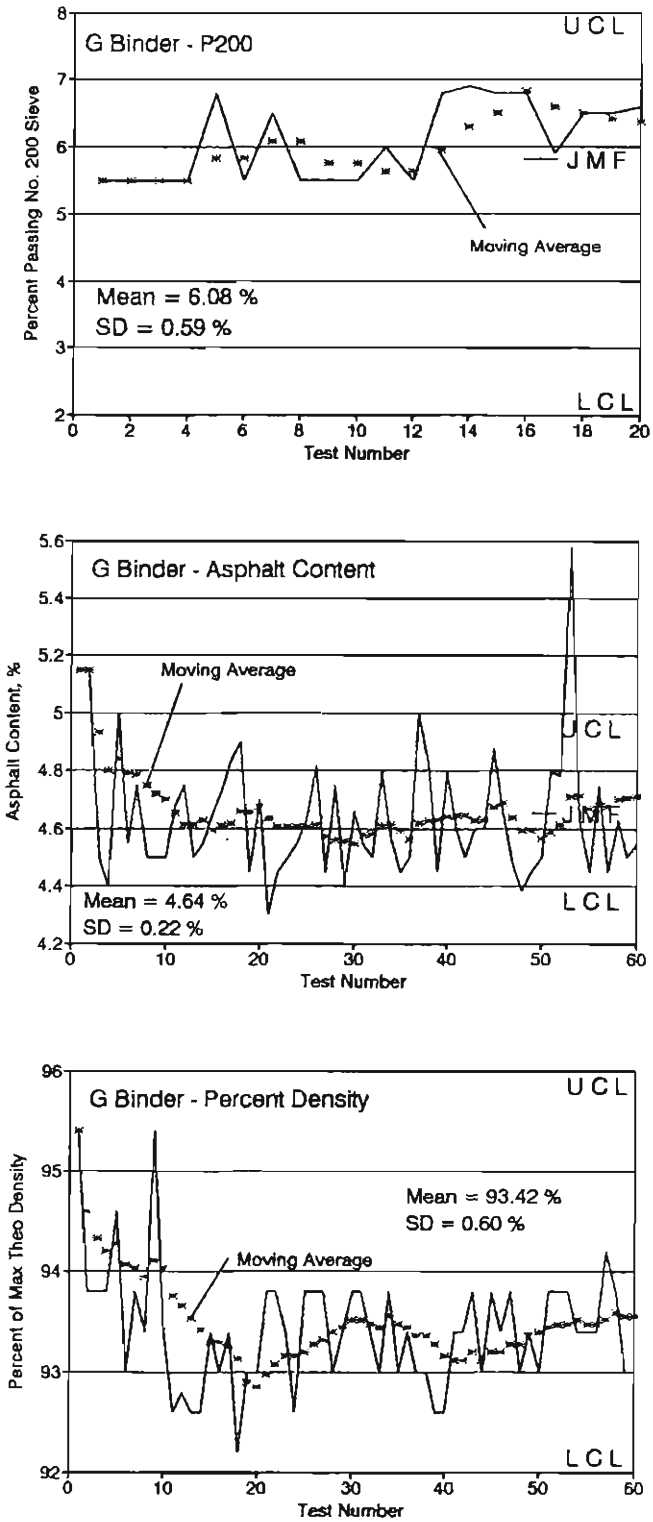
G Binder. Figure 5 illustrates contractor quality control test results for the G binder course. As produced, this asphalt mixture did not possess significantly more P200 than the design value. Twenty test results showed the P200 to average about 6.1 percent as compared to the design value of 5.8 percent. The average asphalt content shown by the test results in Fig 5, 4.64 percent, was practically the same as the design value, 4.65

Figure 5. Quality Control Test Results for G Binder Course, IH-70

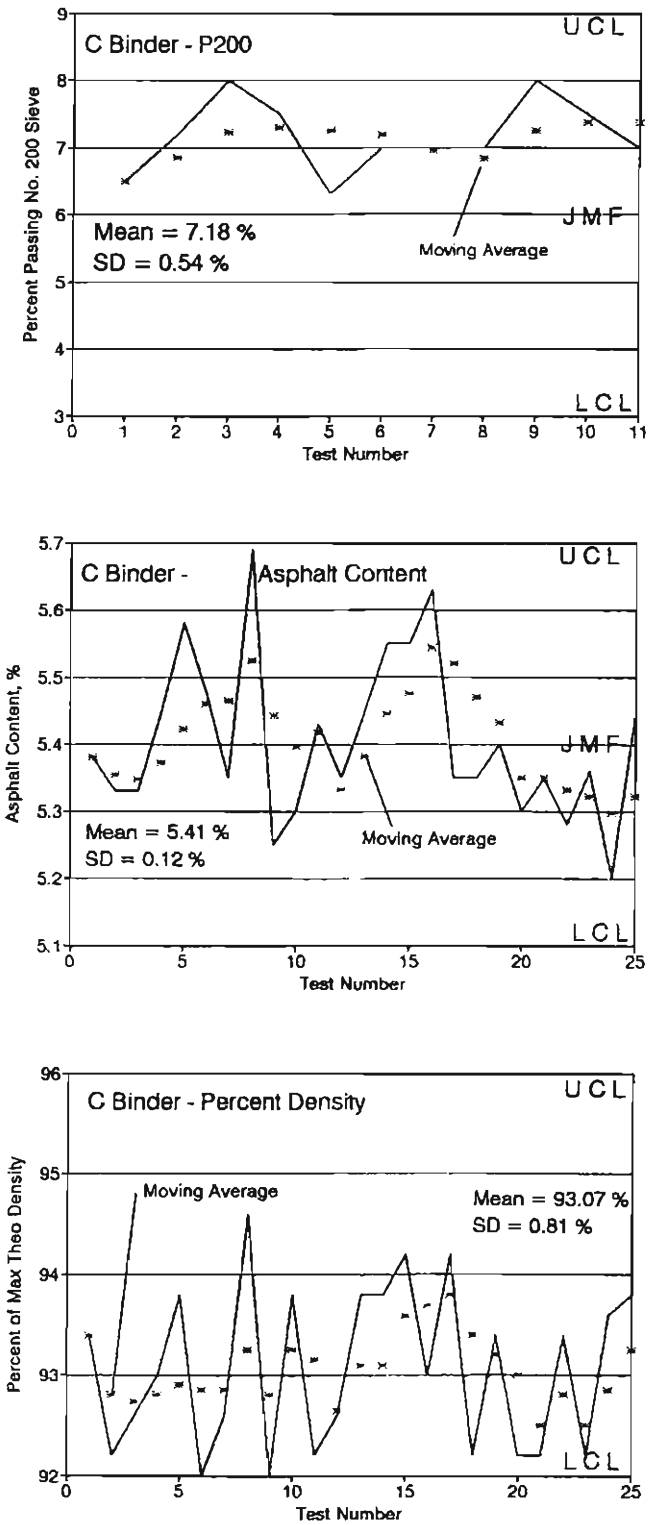
Figure 6. Quality Control Test Results for C Binder Course, IH-70

C Binder. Contractor quality control test results are shown in Fig 6. Test results on the C binder course exhibited similar trends to the C (rubberized) surface. The P200 averaged about 7.2 percent which is 1.2 percent higher than the design value, 6.0 percent. The measured asphalt content was identical to the design value, both at 5.4 percent. In-place density averaged over 93 percent.

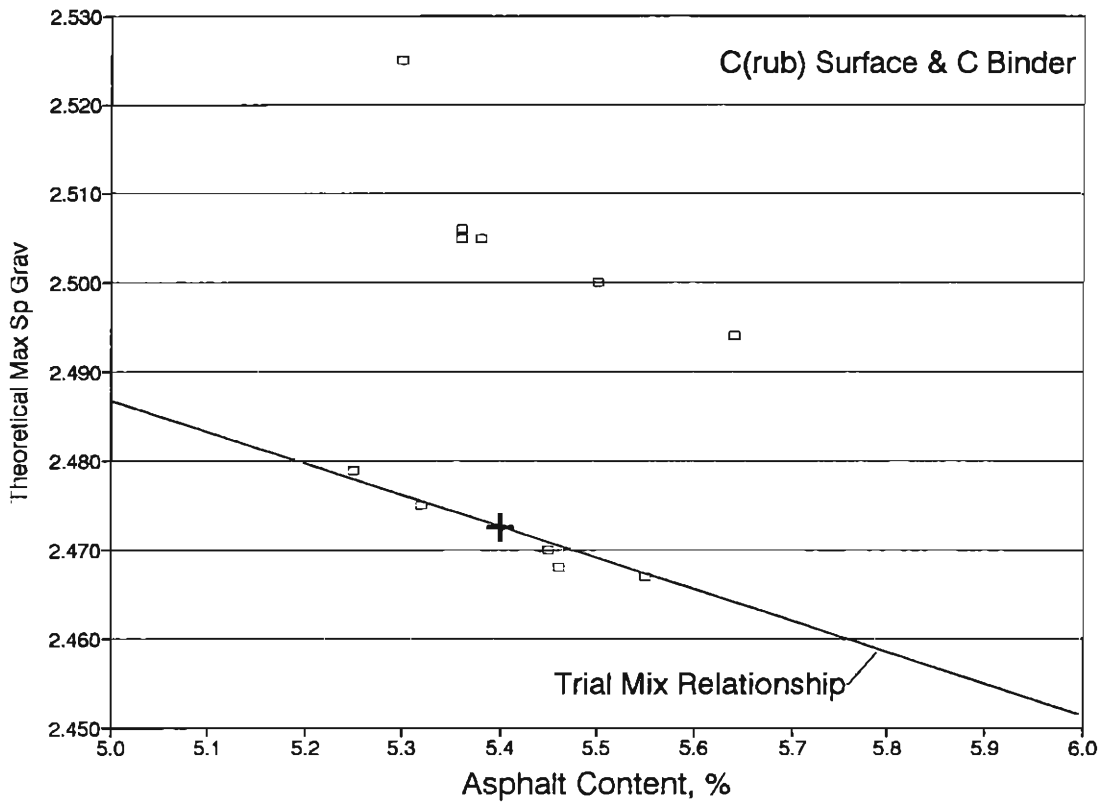
Figure 7. TMSG Independent Assurance Test Results for C Mixtures, IH-70

Because of this anomaly, an analysis was performed to test the veracity of the air void data presented in Table 6. Figure 7 illustrates a plot of theoretical maximum specific gravity (TMSG) versus asphalt content for the C (rubberized) and C mixtures. The solid line represents the design relationship evident from trial mix specimens and the "+" symbol represents the job-mix formula. Five of the independent assurance test results plot exactly on the design line. This is the expected relationship. Five other points plot in an exact parallel straight line, approximately 0.031 above the design line. One point does not plot in either group of data.

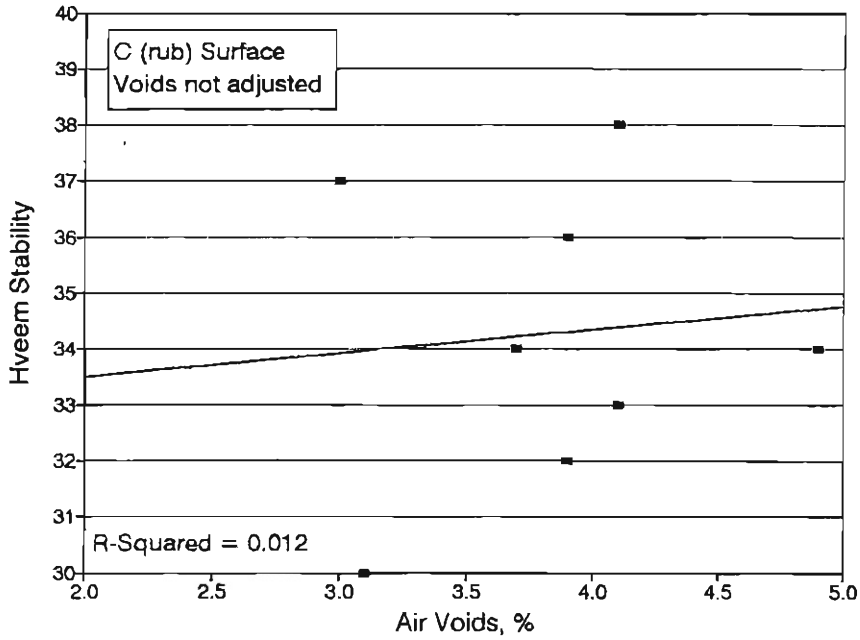
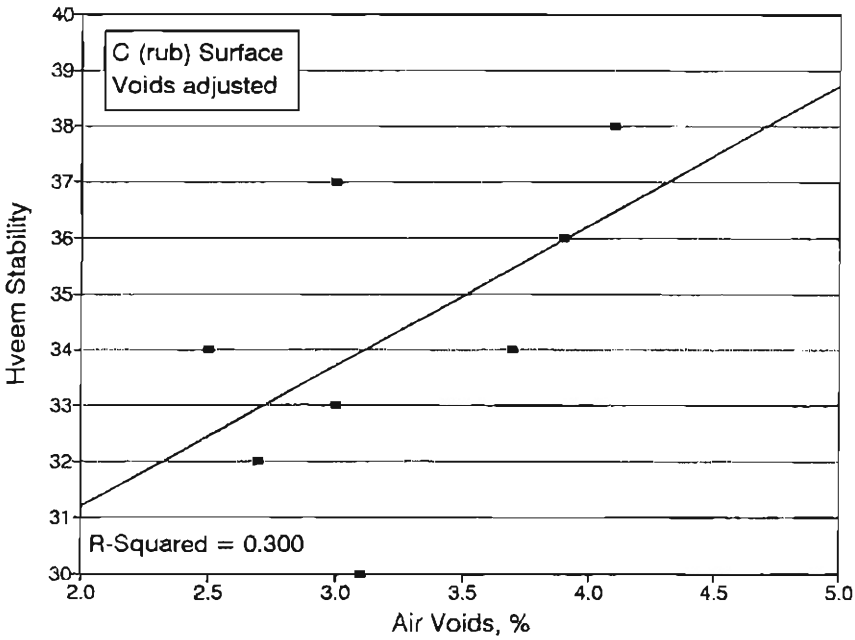
Support for this theory is provided by Figure 8 which shows plots of Hveem stability versus air void content for the original and adjusted air void contents. The plot of stability versus original air void content exhibits no correlation (R-squared = 0.01). None of the variation in stability is explained by the air void content and stability appears to be insensitive to air voids. The plot of stability versus adjusted air void content indicates a

Figure 8. Hveem Stability versus Non-Adjusted and Adjusted Air Void Content, IH-70

better correlation (R-squared = 0.30). At least some of the variation in stability is explained by air void content. In addition, the shown trend is logical; that is, stability is proportional to air void content.

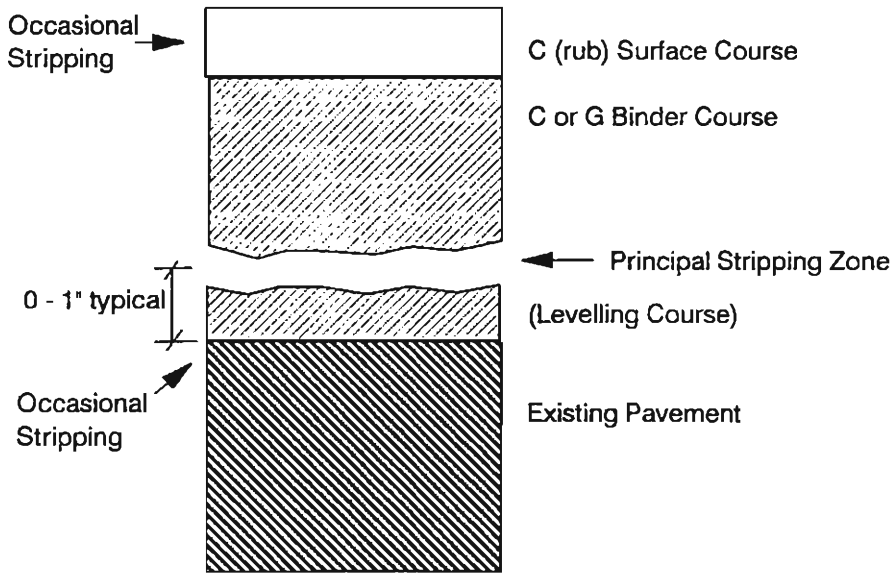
This visual examination showed that most of the moisture damage was occurring in Grades C and G binder or Grade CX rut filling courses. Because of the varying thickness of these layers, it was very difficult to establish which of these materials was undergoing the most distress. In fact, all of these layers exhibited varying degrees of stripping. Figure 10 illustrates a schematic of a typical damaged core from sites 1, 2, and 3. In some cases, moisture damage occurred at the interface between the old and new asphalt materials. In other cases, it occurred above this interface, completely in the new binder or rut filling course. A serious problem in the visual examination was evaluating whether a rut filling course was present. In fact, in some cases, stripping was even visible

Figure 10. Schematic of Moisture Damage in Cores, IH-70

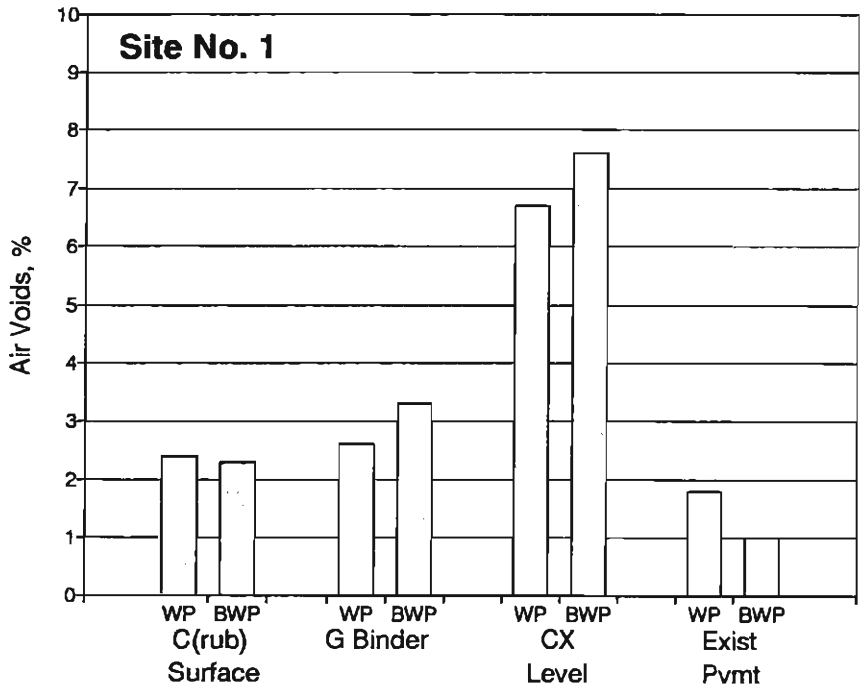
The CX levelling course at sites 1 and 2 exhibited the highest air void contents, between about seven and nine percent. Air void contents in this range and higher are considered by most asphalt technologists to be permeable to moisture.

Figure 11. Core Air Void Contents, Site 1, IH-70

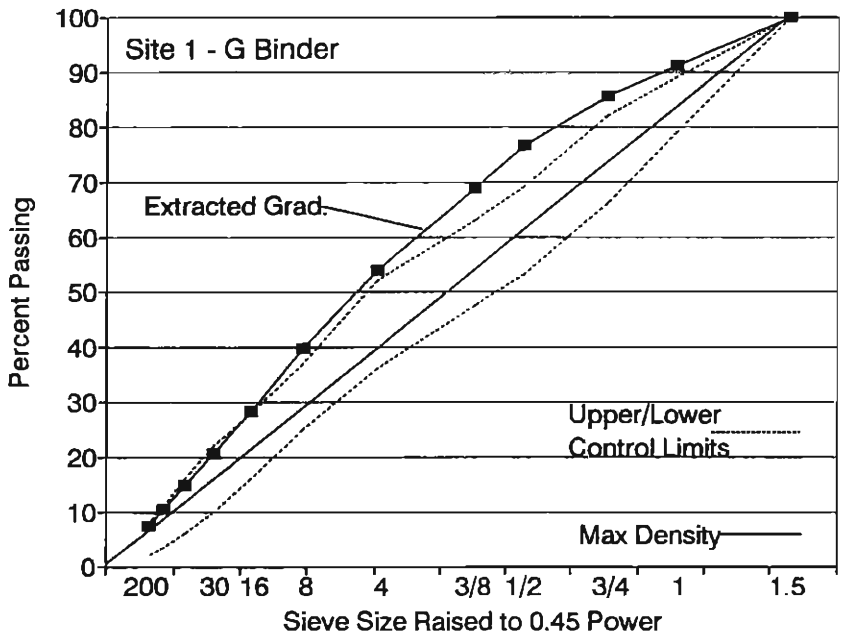
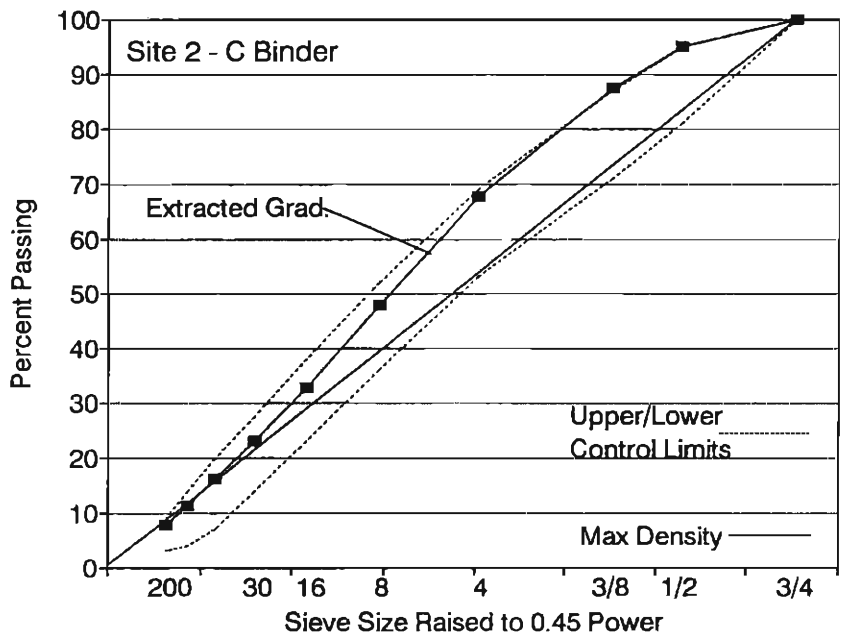
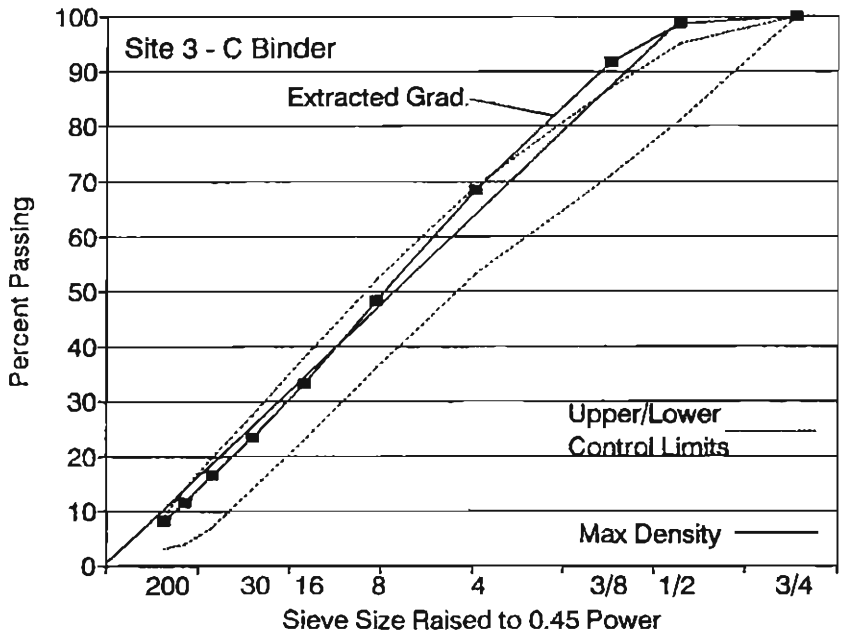
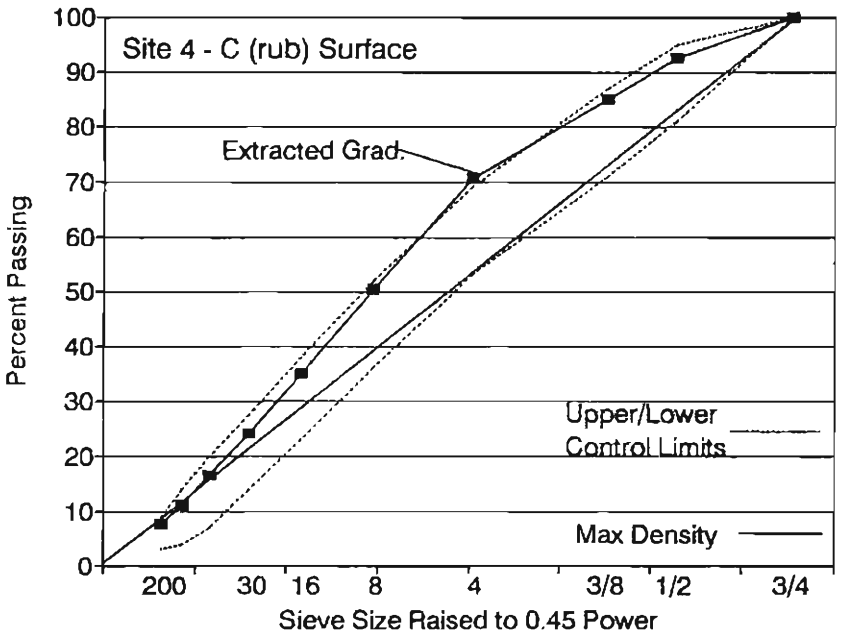
Figures 15 through 18 show extracted gradations for the various mix types at sites 1, 2, 3, and 4, respectively. In all cases, the extracted gradation was finer than the job-mix formula. Asphalt contents (by weight of mix) for the samples were as follows:

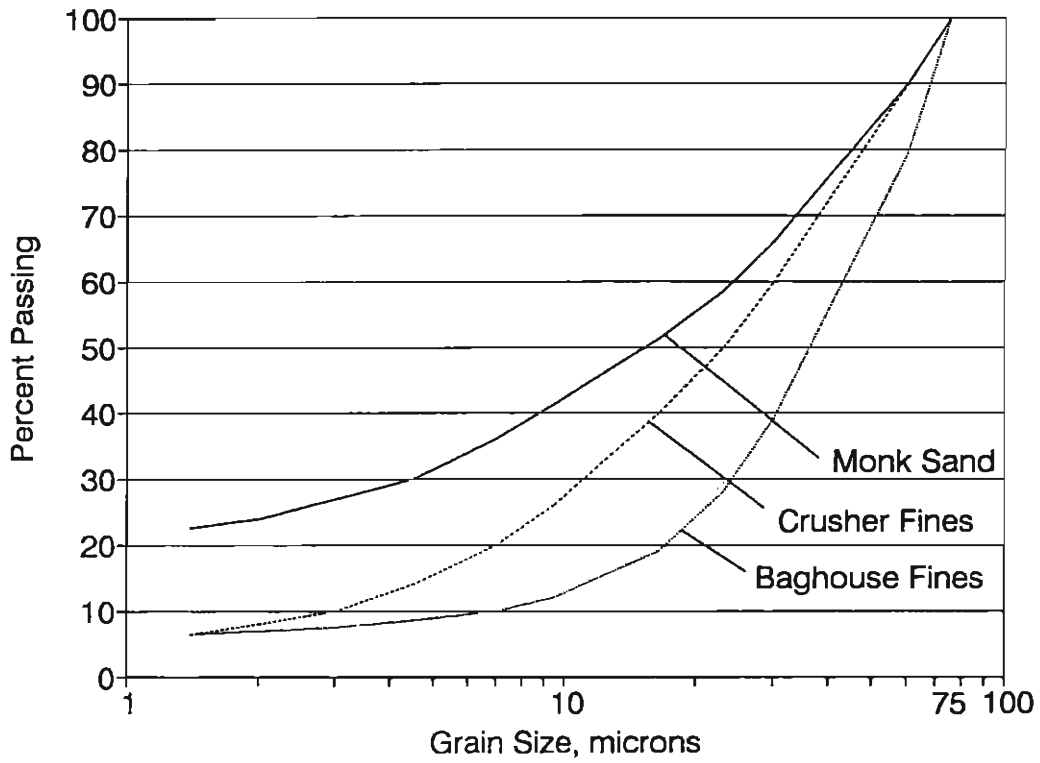
A simple calculation for the C mixtures indicates an asphalt film thickness of about 8 microns at the design asphalt content. Thus, a significant portion of the P200 in the mixture was in the same size range as the asphalt film coating. According to the sand equivalent tests, much of these fines tended toward silty, clayey, or dusty material.

Figure 19. Particle Size Distribution of P200 Materials, IH-70

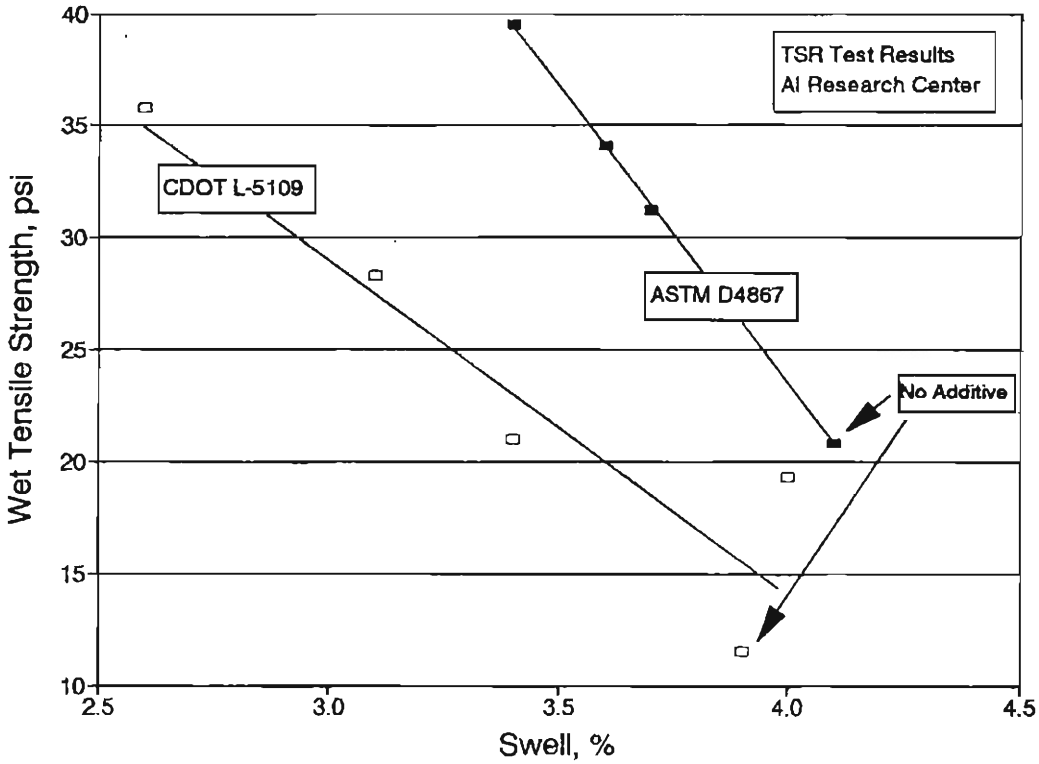
Figure 20. Wet Tensile Strength Versus Swell for AI Moisture Susceptible Tests, IH-70

Thus, all mixtures exhibited stripping; yet antistripping additives seemed to improve TSR, but not enough to achieve a passing value. Figure 20 illustrates a possible explanation for this phenomenon. This is a plot between wet tensile strength and swell; the data points are sorted according to test method. For both groupings of data, there is a strong, expected relationship between swell and wet tensile strength; that is, higher swell indicates lower wet tensile strength. Because mixtures with additives always swell less, they tend to have a higher wet tensile strength and thus, a higher TSR. However, their resistance to stripping, that is, asphalt cement debonding from aggregate, does not seem to be improved.
