Report No. CDOT-DTD-R-91-3

SYNTHETIC VS WOODEN SNOW FENCE

Final Report
July, 1991

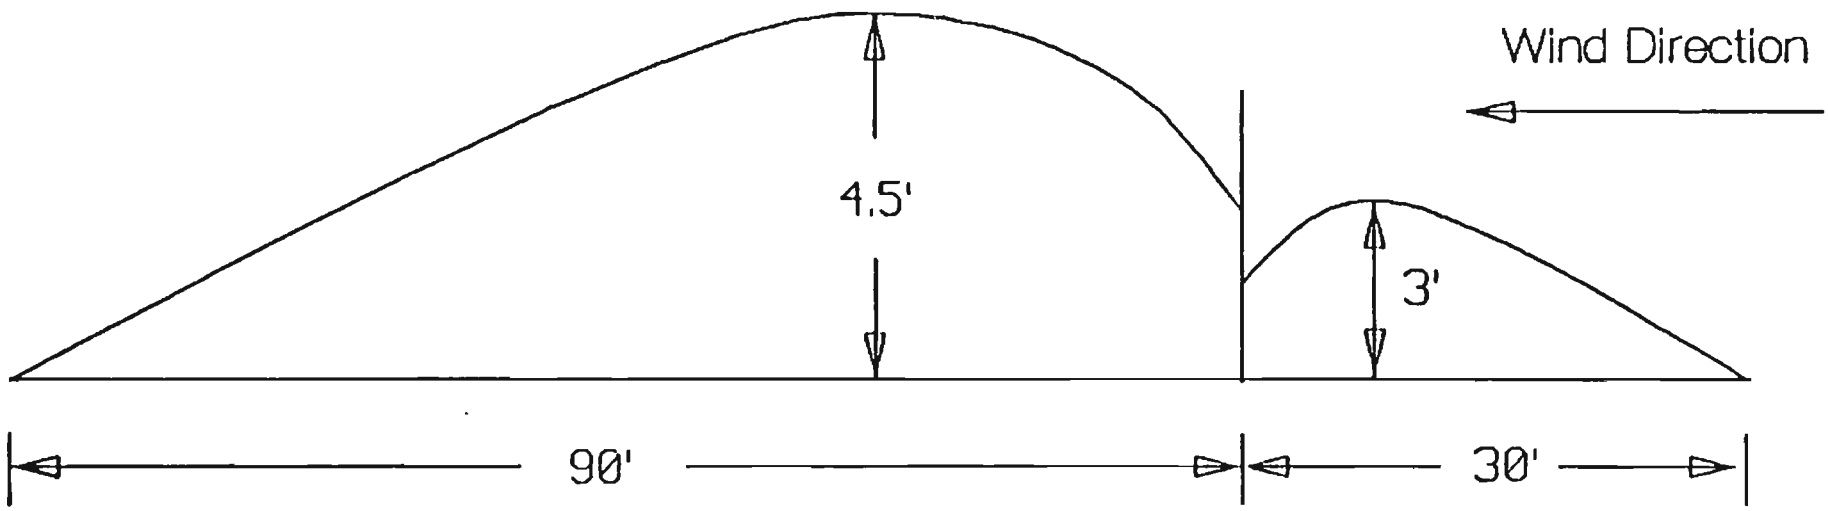
Figure 2: Drift Geometry For All The Fences.

- The snow trapping efficiency of the synthetic snow fences were comparable to wooden fences. The amount and the geometry of the snowdrifts formed behind all the fences were approximately the same, ranging from 3.5 to 4.5 feet in height and 90 feet in length downstream of the fence.

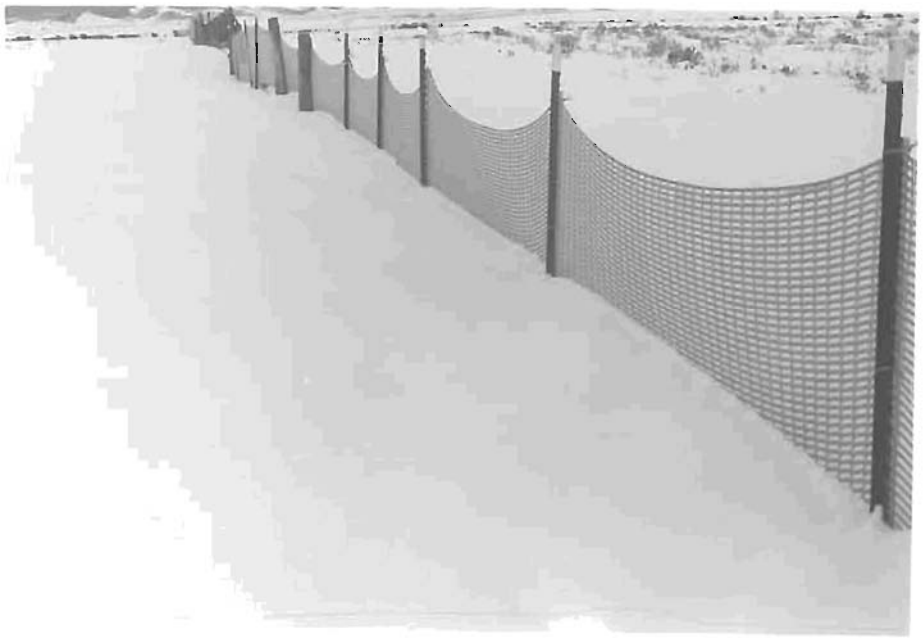
All four types of snow fences (Tenex, Tensar, Fence-It-plus, and the wooden fence) were visually inspected and photograph showing their appearances were taken. The height and length of the drifts behind individual fences were measured using a steel rod. The amount and the geometry of snowdrifts formed behind all the fences measured to be approximately the same, ranging from 3.5 to 4.5 feet in height and 90 feet in length (Figure 2). The bases of all the fences were nearly clear with the exception of the Fence-It-Plus, which was buried about one foot into the snow and was badly sagged.

Photograph 7: Fence-It-Plus was buried one foot into the snow and was badly sagged.

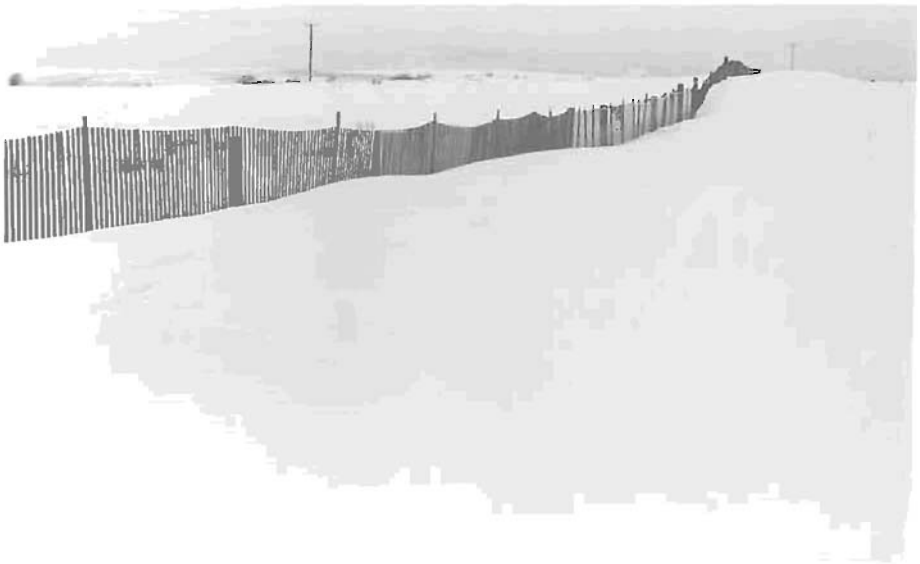
The wooden fence showed a small amount of lateral sagging,

Photograph 8: The wooden fence showed a small amount of lateral sagging.

however, it was still performing well. Tensar and Tenex were among the best, retaining their original tension with no apparant distress. Photograph 5 through 8 show the drift formation behind all these fences, and illustrate their appearances.

The wooden fence appeared to be in good condition. However, the 6-inch bottom gap that was established for the fence was no longer there. This was caused by the weight of the wooden fence. The wooden fence is approximately four times heavier than the synthetic snow fences. The bottom gap is quite essential in creating long drift (as much as 35 times the height of the fence), and increasing the storage capacity of a fence.

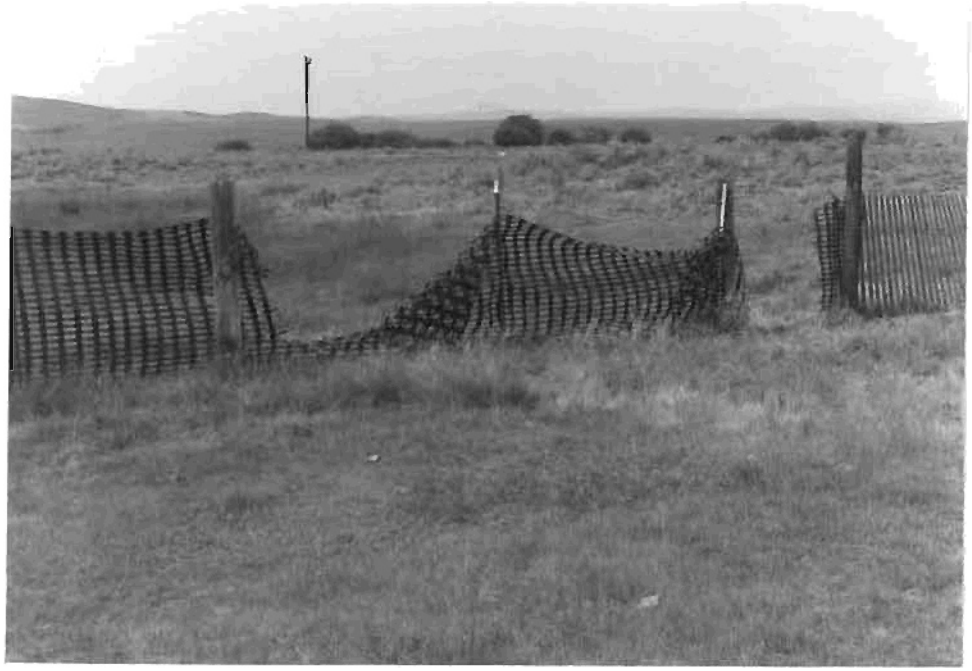
Even though Tensar, and Tenex were quite effective in controlling snow during the winter, they were susceptable to damage by the grazing bulls in the summer. Photograph 9 through 11 demonstrate sections of these fences that have been chewed or disturb by the bulls in the area. on occasion, bulls fur were found on the wooden slat indicating that maybe the bulls were scratching

Photograph 9: Badly torn Tenax fence

- The use of synthetic snow fences for controlling snow drifts looks promising; however, close attention must be paid in selecting a proper site. Sites with close proximity to a ranch with grazing bulls may not be suitable for synthetic snow fences. Bulls have tendencies to either lean against the synthetic snow fences or to chew on them.

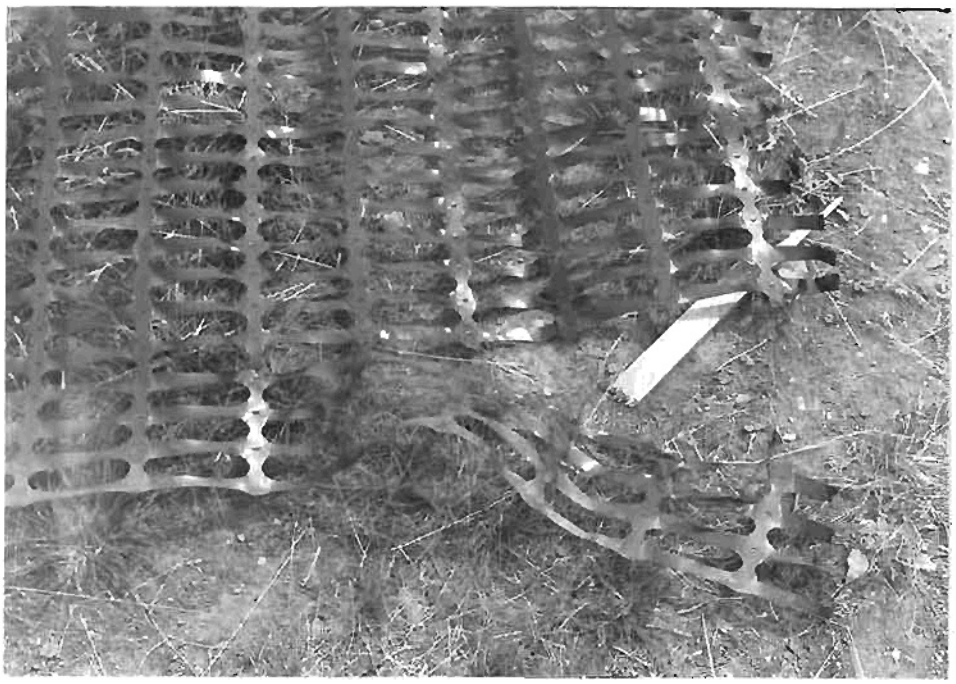
Photograph 10: Torn Tensar fence.

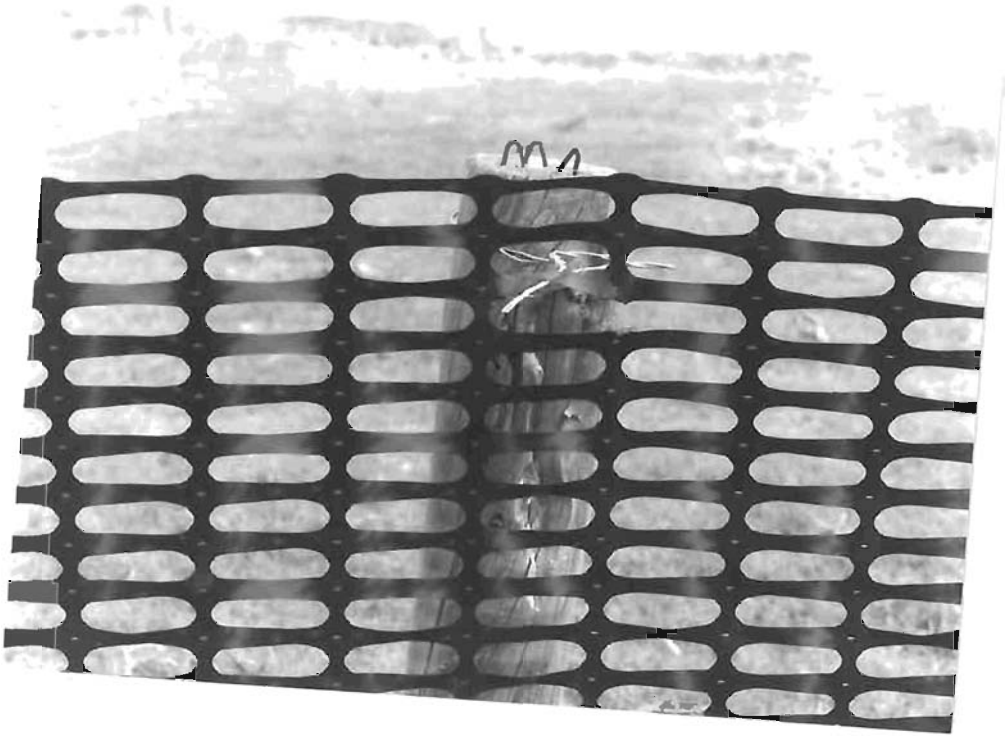
Photograph 11: Abrasion caused by the tie wire due to absence of the wooden slat.

In one case, the fence was abraded by the wire that was used to tie the fence to the pole. However, it is believed that the abrasion could have been prevented if a wooden slat was used to sandwich the fence against the pole.

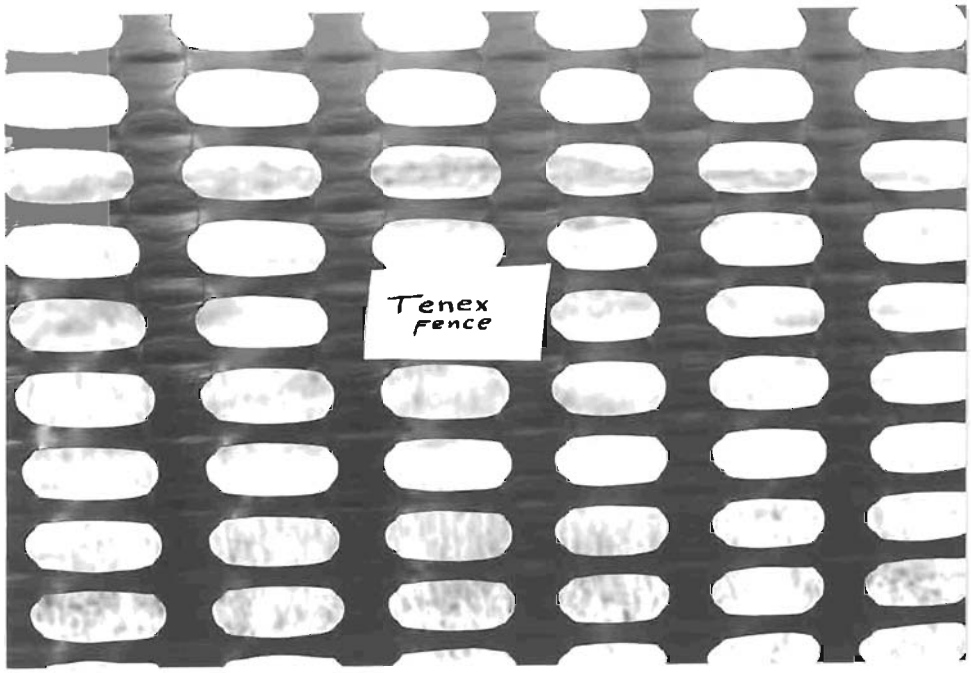
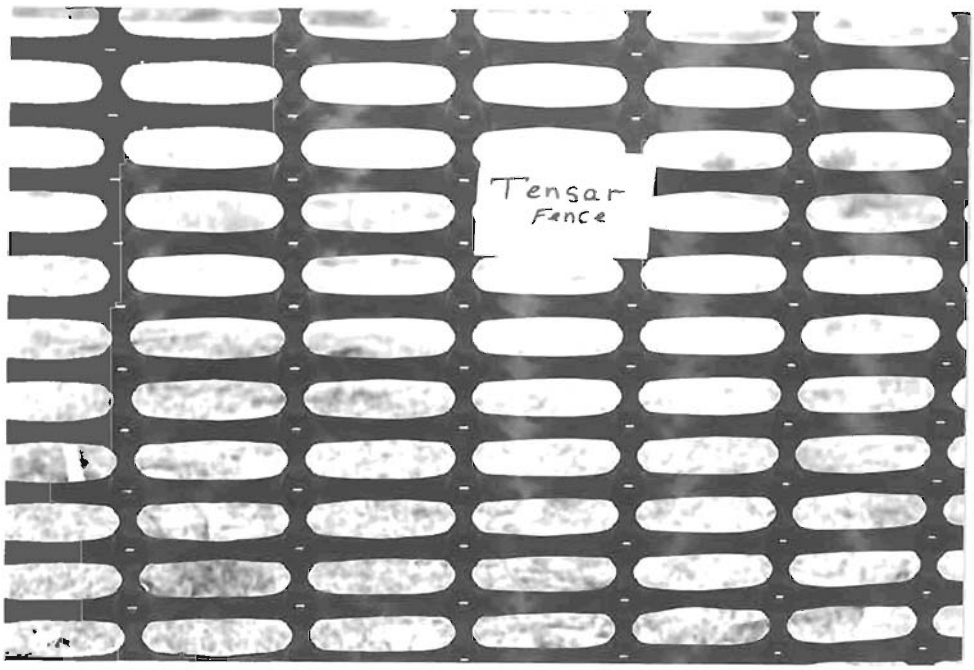
Photographs 3 and 4: Tensor and Tenex fences. Their prosity is the same (50%), but their designs are different.

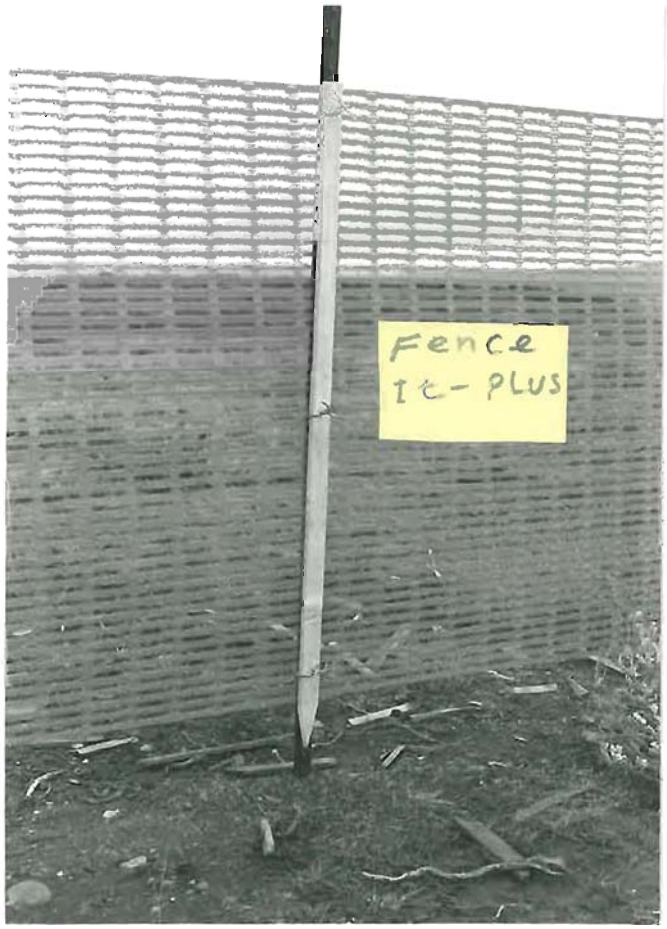
Photographs 5 and 6: Wooden fence and Fence It-Plus

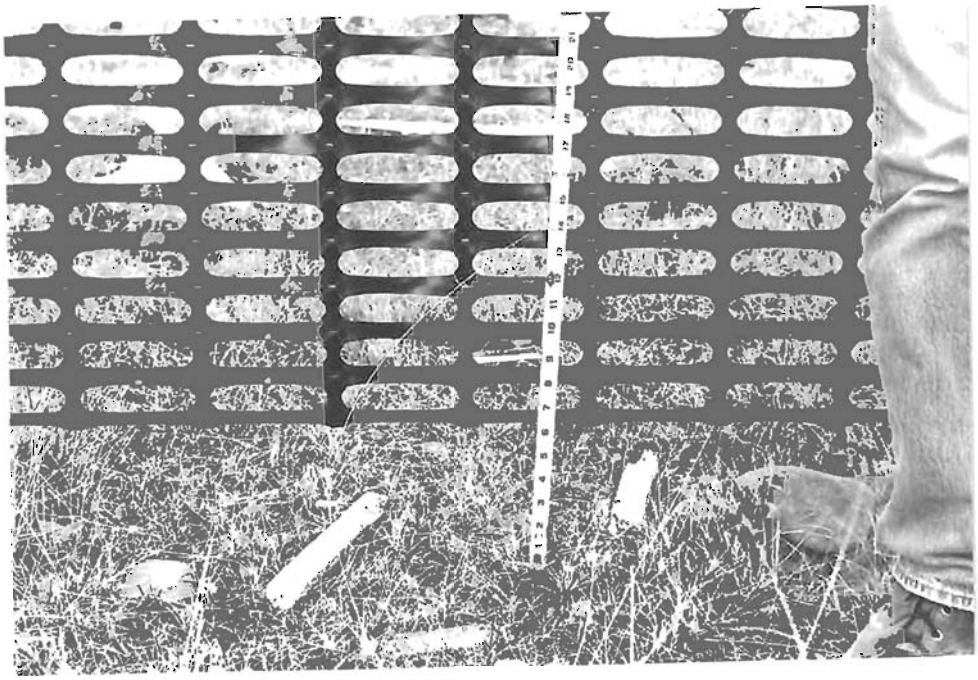
Photograph 9:

A bottom gap of six inches was established for all the fences.

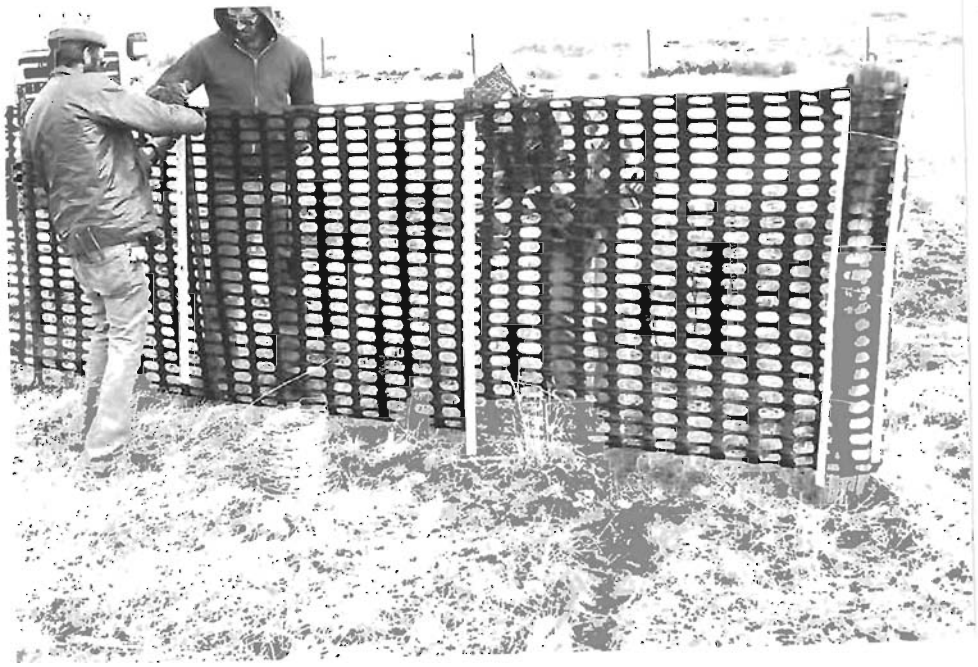
Photograph 10:

After stretching, the fence was sandwiched between a wooden slat and the flat side of a post. The wooden slat was used to prevent abrasion of the fence by the wire.

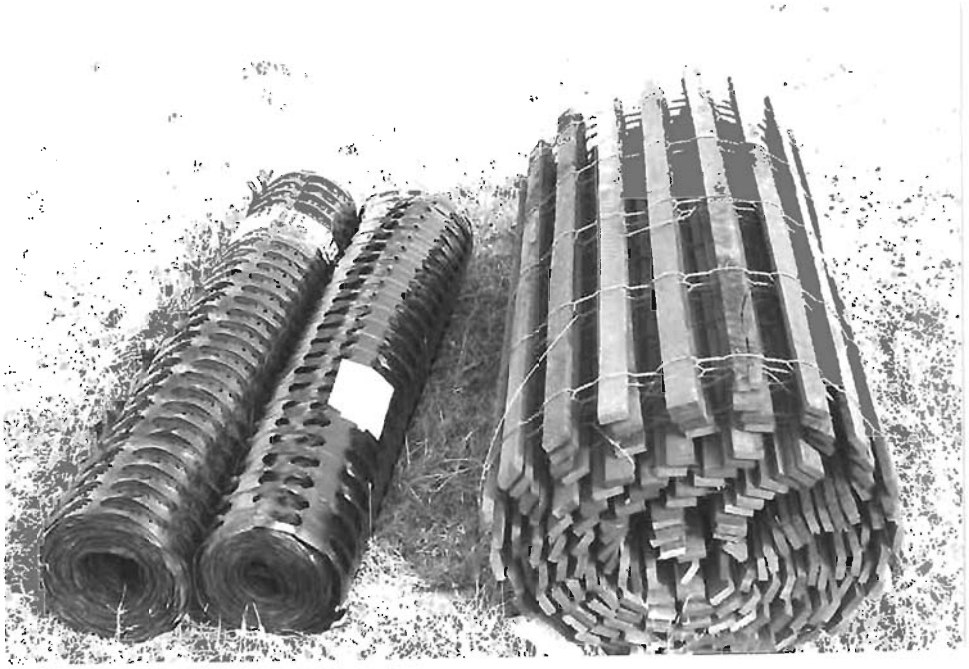
Photograph 11: coparison of the 50'roll of wooden fence against 2 -100'rolls of industrial fences.
