REPORT NO. FAA-RD-81-43

ASDE-3 ANTENNA DEVELOPMENT AND TEST

U.S. DEPARTMENT OF TRANSPORTATION
Research and Special Programs Administration
Transportation Systems Center
Cambridge MA 02142

JANUARY 1981
FINAL REPORT

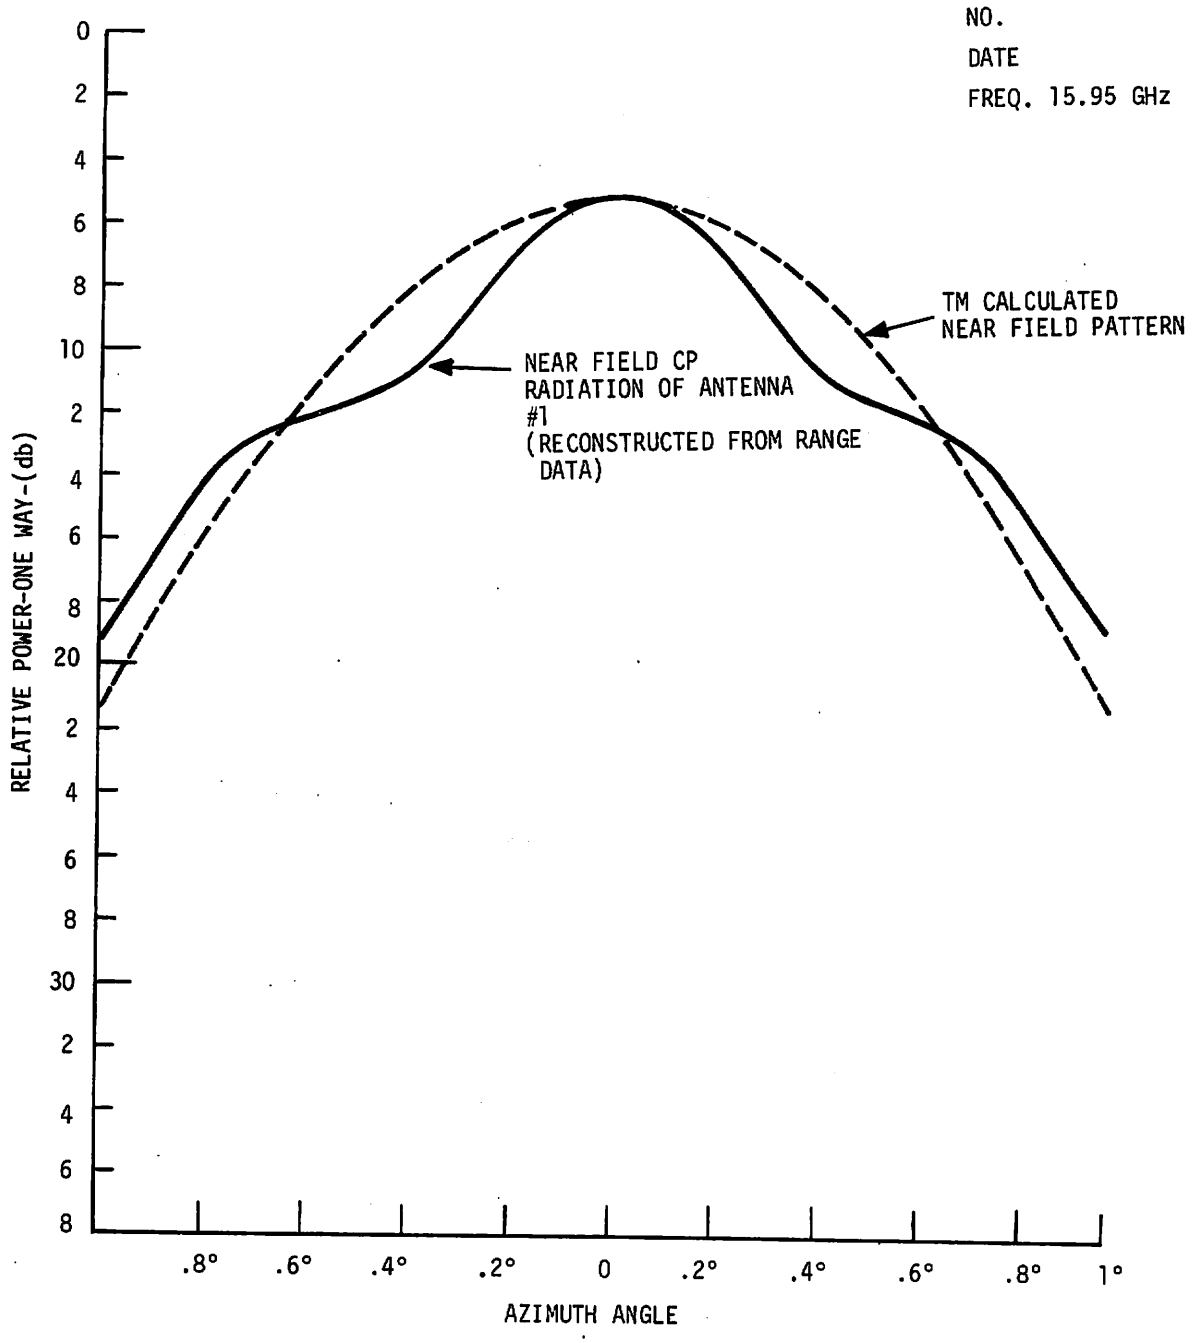
FIGURE 6. NEAR FIELD AZIMUTH DEFOCUSSING AT PEAK OF ELEVATION BEAM

gain points. Similar results were observed in the TM analysis. In addition their analysis included a near field azimuth pattern computed for the peak of the elevation beam. Figure 6 shows the severe defocussing effects that occur in the near-field, as computed by T.M.

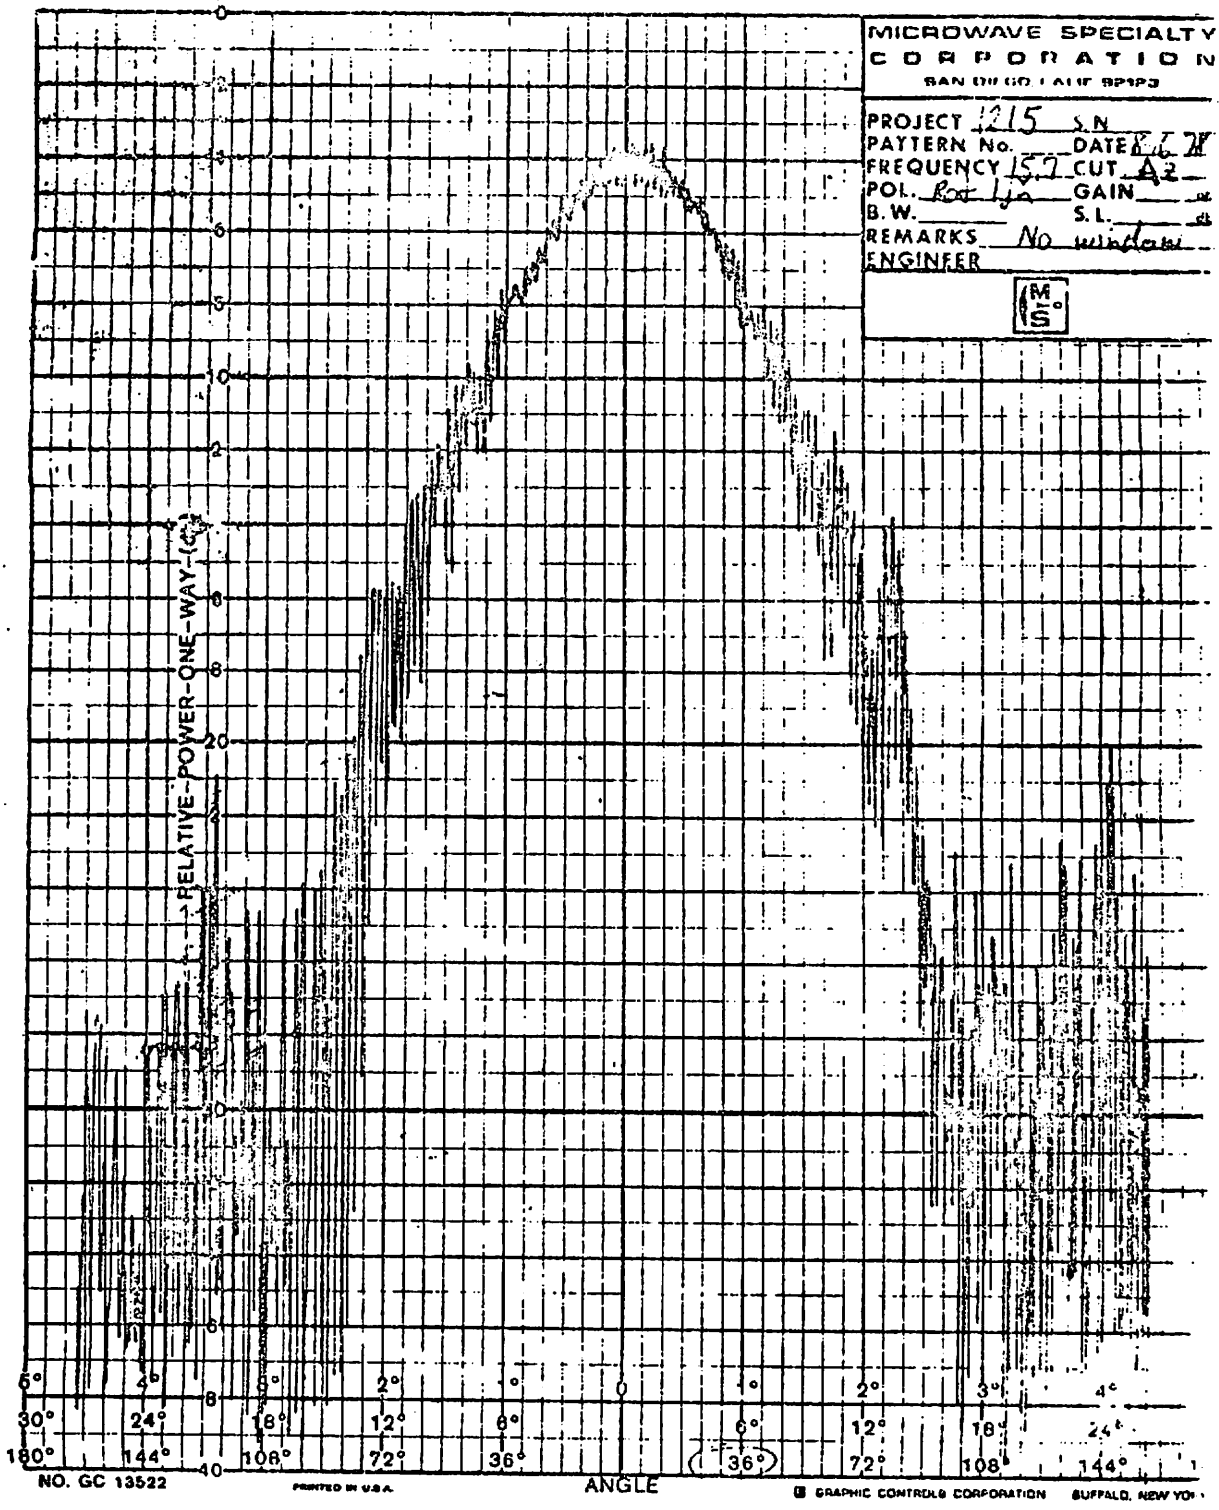
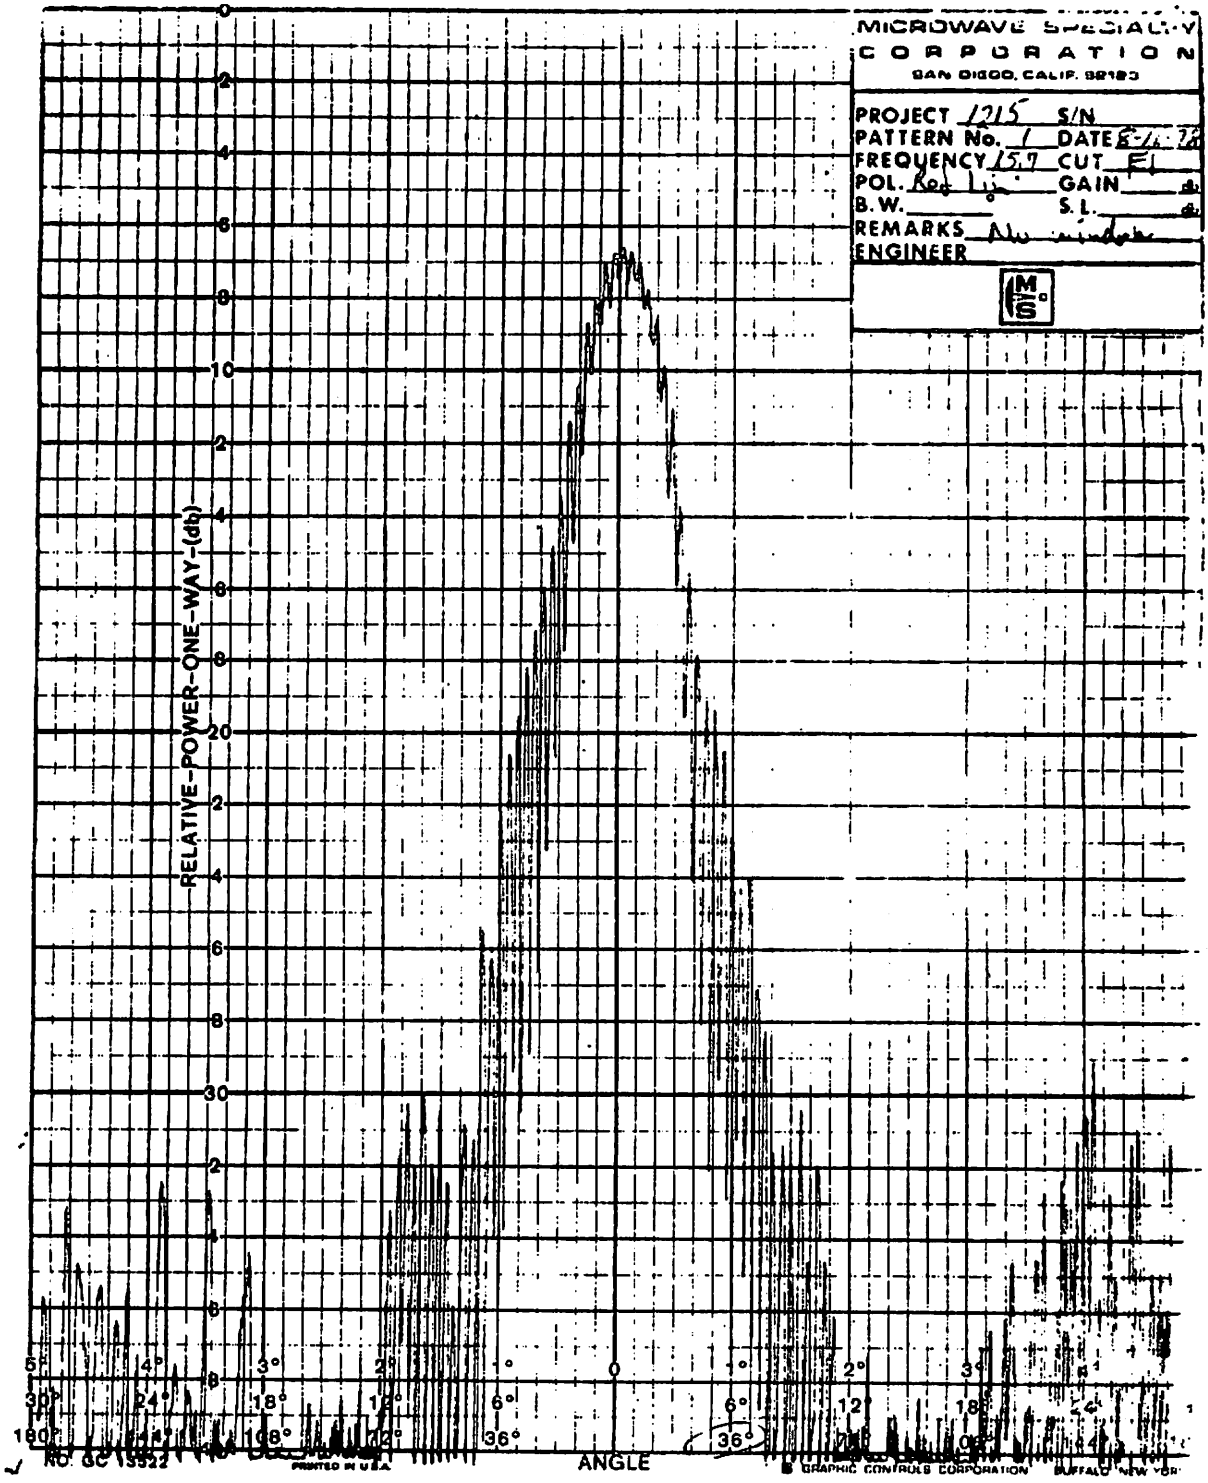
Both analyses used the primary feed horn patterns which are shown in Figures 7 and 8 in their computations. In a more detailed analysis T.I. concluded that the poor axial ratios of the feed horn patterns were due to a lack of coincidence of the phase centers of the two linearly polarized orthogonal components. This condition results in a cumulative phase error across the aperture and consequent poor axial ratios in the far field radiation patterns. In addition, as a consequence of calculating the radiation patterns, they found that the feed horn did not produce equal amplitude orthogonal components but rather the horizontal component was about 1.3 dB below the vertical component, and that the two components were not orthogonal. These factors tended to degrade the axial ratio, and hence the feed horn design is an area for improvement.

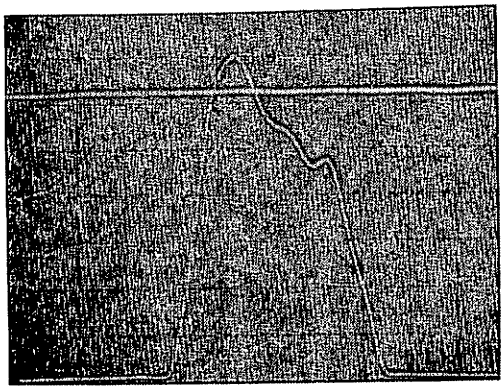
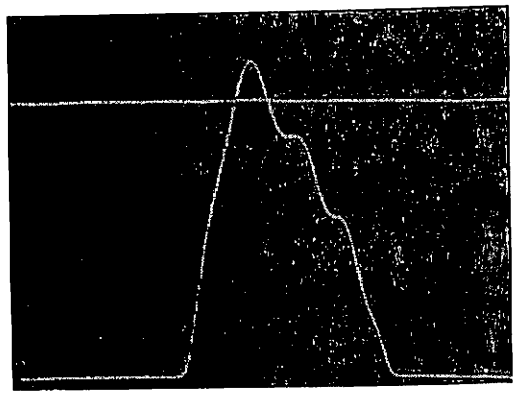
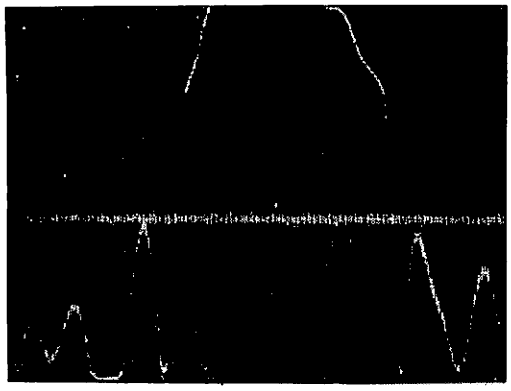
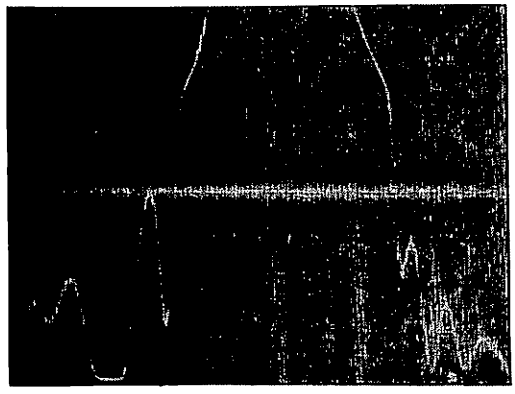
FIGURE 35. ASDE-3 ROTODOME RADIATION PATTERNS TAKEN FROM PAD #1

this technique. The pattern data taken when transmitting from Pad #1 are shown in Figure 35. This pattern corresponds to a depression angle of about 11.3° and is within the near-field. The -3 dB BW measured about 0.9°. This figure is approximately 3 times the -3 dB BW measured by TM on their antenna range and tabulated in Table 2. The most disturbing fact about this pattern was the severe distortion of the azimuth beam. Radiation azimuth patterns were also taken from Pads #2 and #3. These are shown in Figures 36 and 37. The -3 dB beamwidths were 0.50° and 0.44° respectively. Slight distortion persisted in the Pad #2 pattern and to a lesser degree in the Pad #3 pattern.

VERT. POL. BW = 1.0°
VERT. POL. GAIN =26 dBi
VERT. POL. SLL = -16.2dB

HORIZ. POL. BW = 0.8°
HORIZ. POL. GAIN = 26 dBi
HORIZ POL. SLL = -15.2 dB

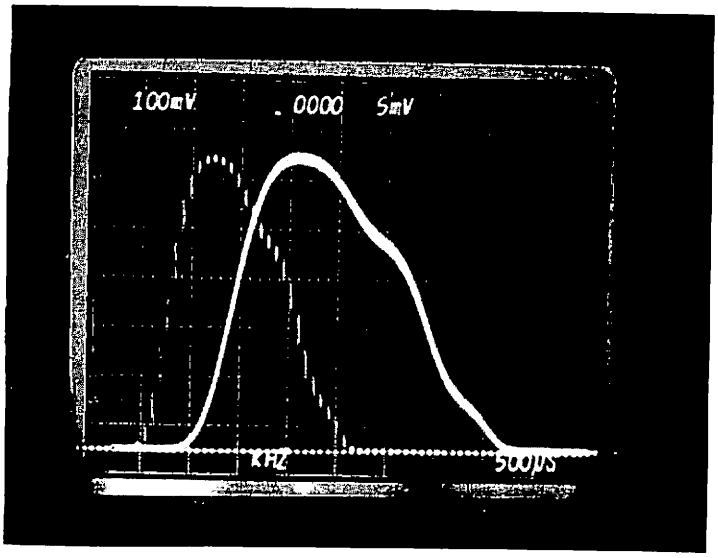
FIGURE 38. ASDE-3 ROTODOME RADIATION PATTERNS TAKEN FROM PAD #1

It was suspected that the distortion was in some way caused by the centrifugal forces associated with the 60 rpm rotation. In order to verify this, a Cardion circuit designed for use by TM in their dynamic tests was used to allow radiation patterns to be taken at slow rotation. This circuit integrates the Azimuth Change Pulses (ACPs) from the pedestal and provides a voltage to the X-axis of the oscilloscope that is proportional to azimuth angle. Figure 38 shows the azimuth patterns from Pad #1 taken by this technique as well as the sweep technique at 62 rpm. The beamwidths measured by both techniques agree fairly well. As the antenna slowed down, the "integrated ACP technique" showed a narrowing of the beamwidth and the virtual disappearance of distortion. Figures 39 and 40 show additional patterns taken from Pads #2 and #3.

VERTICAL POL BW
62RPM
ACP TRACE BW= 0.64°
TIME TRACE BW= 0.63°

0 RPM
ACP TRACE BW= 0.40°

AZIMUTH @ 0 RPM	BEAMWIDTH @ 62 RPM
PAD #1	Reflector Not Restrained	----	0.9°
	Reflector Restrained	0.4°	0.64°
PAD #2	Reflector Not Restrained	----	0.50°
	Reflector Restrained	0.25°	0.25°
PAD #3	Reflector Not Restrained	----	0.25°
	Reflector Restrained	0.25°	0.25°

In an attempt to fix this problem, temporary restraining brackets were installed in the rotodome to limit the deflection of the reflector tips. Patterns were retaken and the results are summarized in Table 3. The brackets narrowed the Pad #1 pattern but some distortion still remained.

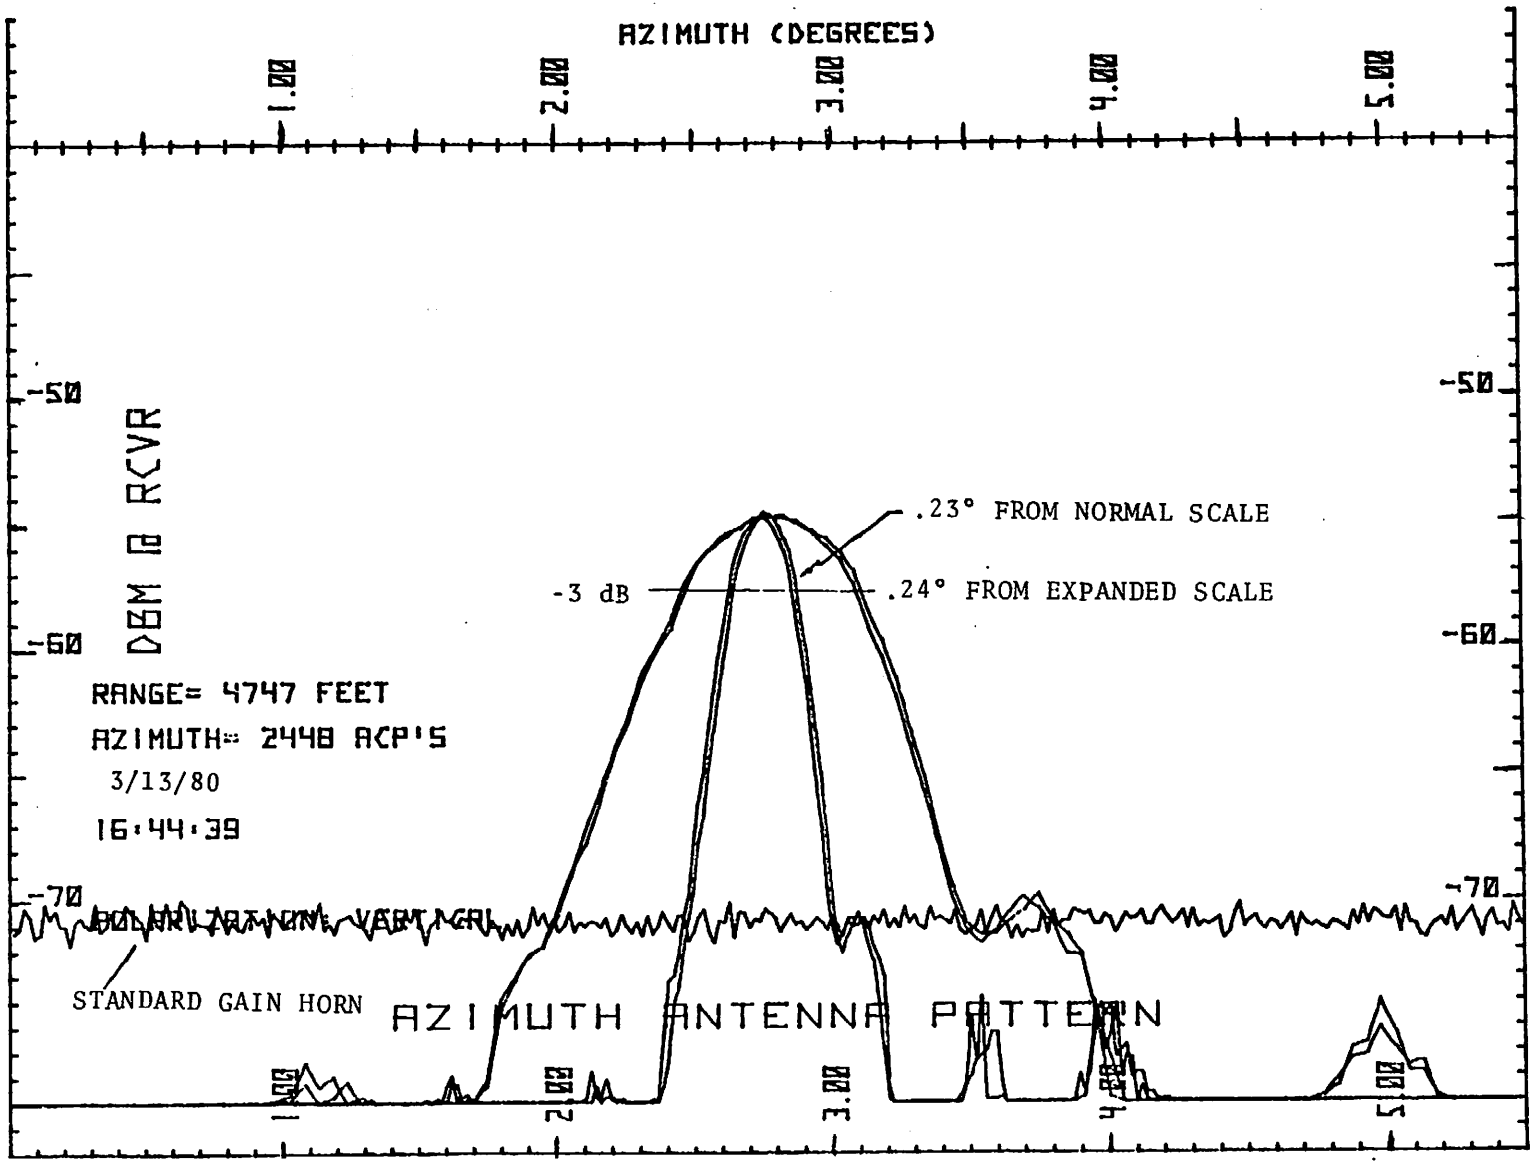
FIGURE 43. RADIATION PATTERN FROM PAD #2 (SHOWING REPEATABILITY)

When the DAS became available, attempts were made to repeat the dynamic antenna pattern tests performed with the oscilloscope technique. Considerable difficulties were encountered in performing these tests; the DAS antenna program was not optimum and required modification; heavy rains occurred during the scheduled week; and the source antenna transmitter exhibited stability problems. Consequently, a limited amount of valid data was taken, and due to schedule constraints additional test time was not available. Some data was taken from Pads #1 and #2. Typical DAS processed radiation patterns are shown in Figures 41 and 42. These radiation patterns showed the asymmetry previously observed on the dynamic patterns taken with the oscilloscope techniques. The patterns are plotted in dB's so that direct comparison with the previous dynamic pattern data is difficult. The DAS technique permits examination of the side lobe levels and provide a permanent record of the test. Repeatability of the technique can be seen in Figure 43 for both the expanded scale as well as the normal scale. The repeatability is shown in Figure 44 which shows successive radiation pattern plots taken over a period of 10 minutes and averaging the readings of 2 scans for each plot.

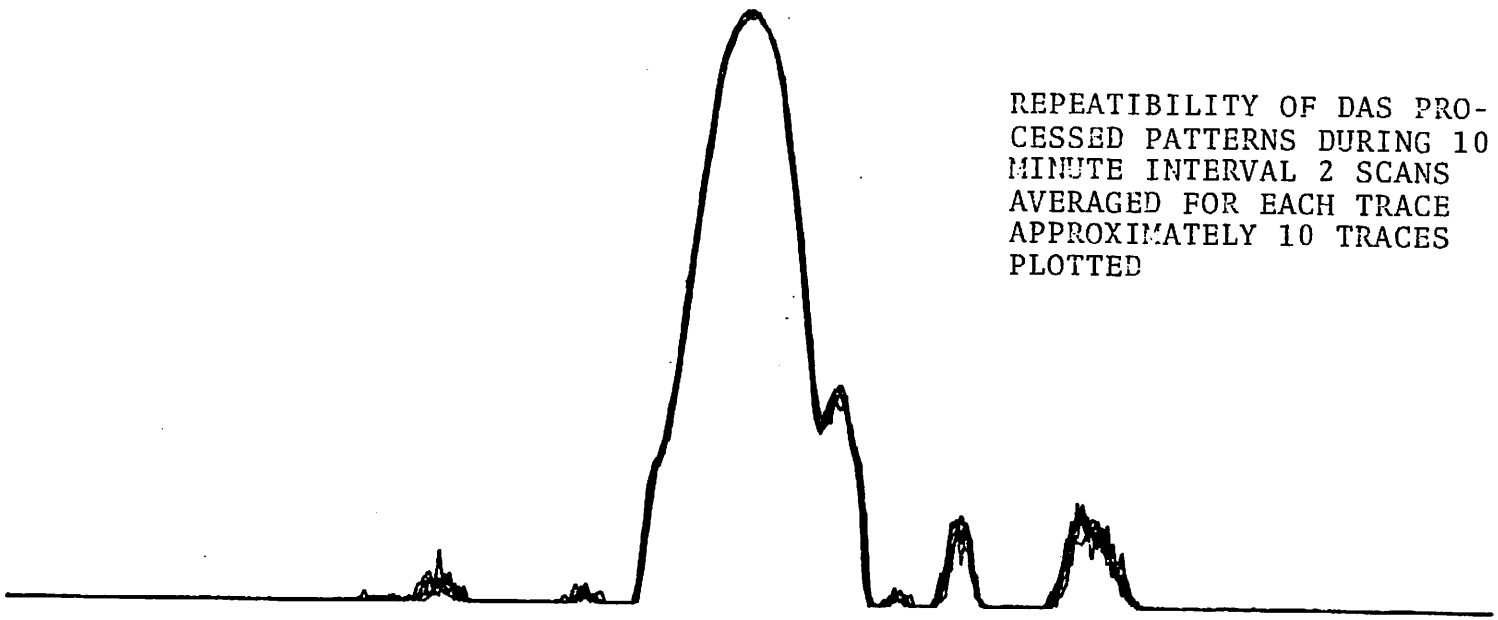
FIGURE 44. RADIATION PATTERN FROM PAD #2
(SHOWING LONGER TERM STABILITY

Although, the DAS is a very convenient and powerful technique for measuring antenna characteristics "in situ", its full potential could not be adequately exploited. Some changes on the program were required to allow operator flexibility, and although the program was later modified, a second iteration of the testing could not be performed due to schedule.
