DOT/FAA/AR-01/118

Aircraft Age-Related Degradation Study on Single- and Three-Phase Circuit Breakers

November 2002

Final Report

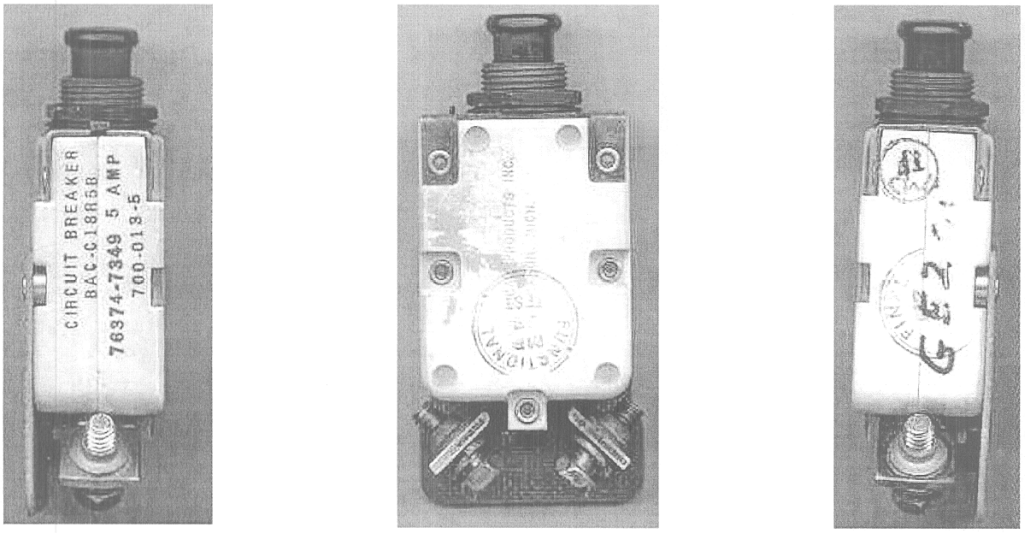
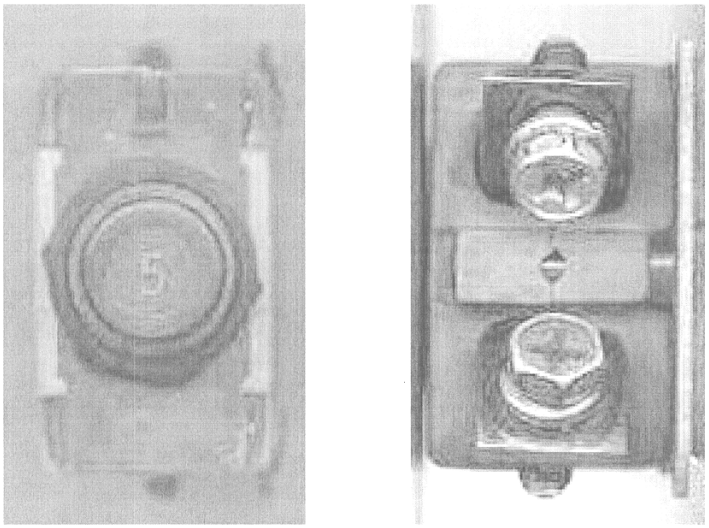
Figure 1.
Exterior of circuit breaker "GE200".

The breaker was externally examined. There was both terminal and mounting hardware attached to the breaker, presumably the hardware that was used in the aircraft application. Mechanical Products' Final Inspection and Functional Test department stamps were visible on the breaker case. These stamps, as well as the original part number stamping, Mechanical Products name, and the felt pen ID applied prior to receipt by MP are shown in the photographs of Figure 1.

It was noted that the external surfaces of the breaker were very clean (as compared to others field units of similar age which have been examined by MP). However, the ampere rating on the button ("5") was covered with grime and barely visible. This grime layer also appeared on the top side of the button (with respect to the rating stamp) but did not appear on the trip indicator. The terminals were thinly coated with a black substance, primarily on the screw head side. There was some dust and grime on the terminal screws and a thin layer of gray grime on parts of the case (which could be easily removed). The mounting bushing was a dark metallic gray color (rather than black).

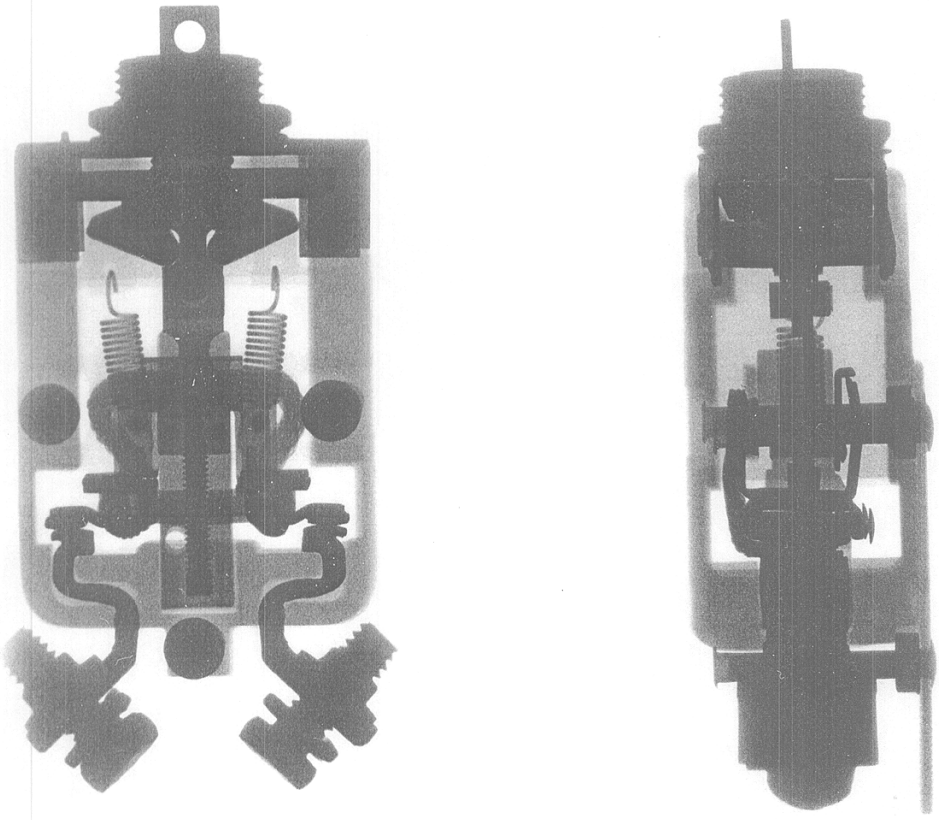
Figure 2.
Radiograph of breaker "GE200" in the open (unlatched) position as received.

Figure 3.
Radiograph of breaker "GE200" in the closed (latched) position.

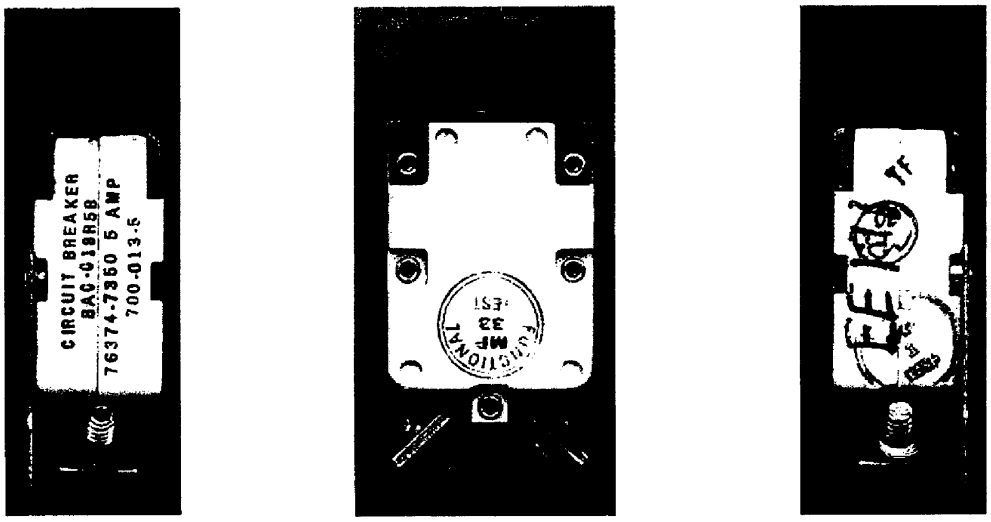
Figure 1.
Exterior of circuit breaker "EE191".

The breaker was externally examined. There was both terminal and mounting hardware attached to the breaker, presumably the hardware that was used in the aircraft application. Mechanical Products' Final Inspection and Functional Test department stamps were visible on the breaker case. These stamps, as well as the original part number stamping, Mechanical Products name, and the felt pen ID applied prior to receipt by MP are shown in the photographs of Figure 1.

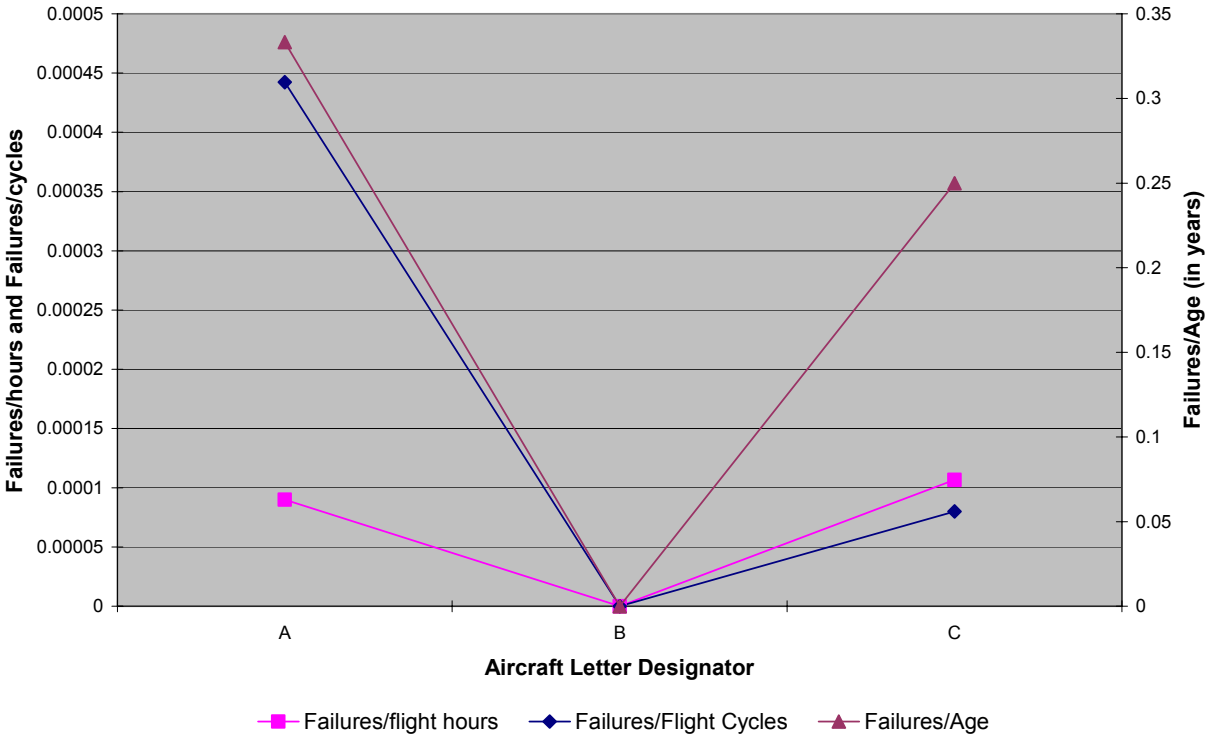
FIGURE J-7. FAA AANC CIRCUIT BREAKER FAILURES PER AIRCRAFT HOURS, CYCLES, AND AGE

g. Figure J-7 compares the circuit breaker failures per flight hours, failures per flight cycle, and failures per service life (years) of the aging aircraft.
