New Town Walkability Assessment - 2026

Final Report

October 2026

Prepared for:
Mandan Hidatsa Arikara Nation

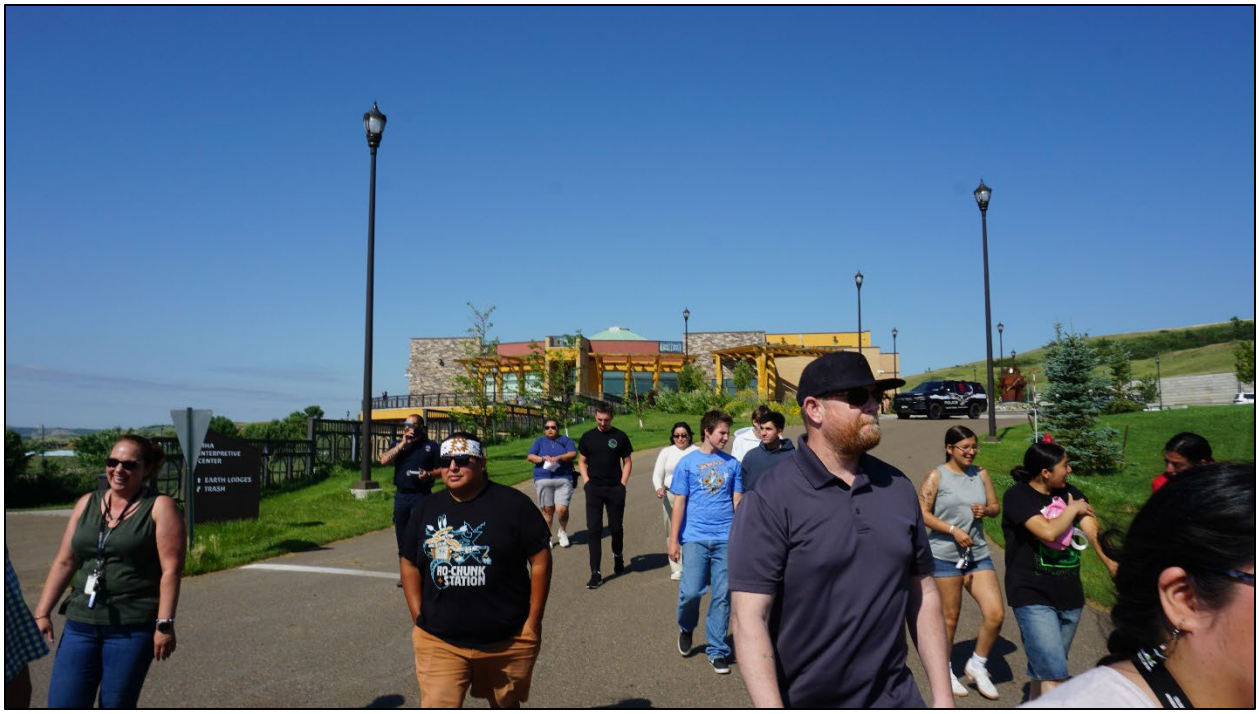
As the group began the field assessment, participants immediately encountered a significant challenge related to the absence of dedicated pedestrian facilities or marked shoulder along the start of the selected path. The lack of dedicated pedestrian infrastructure created uncertainty about where people should walk and resulted in participants dispersing across the roadway environment rather than following a clearly designated route. With no designated sidewalk or clearly defined pedestrian pathway available, individuals naturally began walking along different parts of the paved area as can be seen in Figure 5.

Figure 5. Participants starting the walk to assess walkability

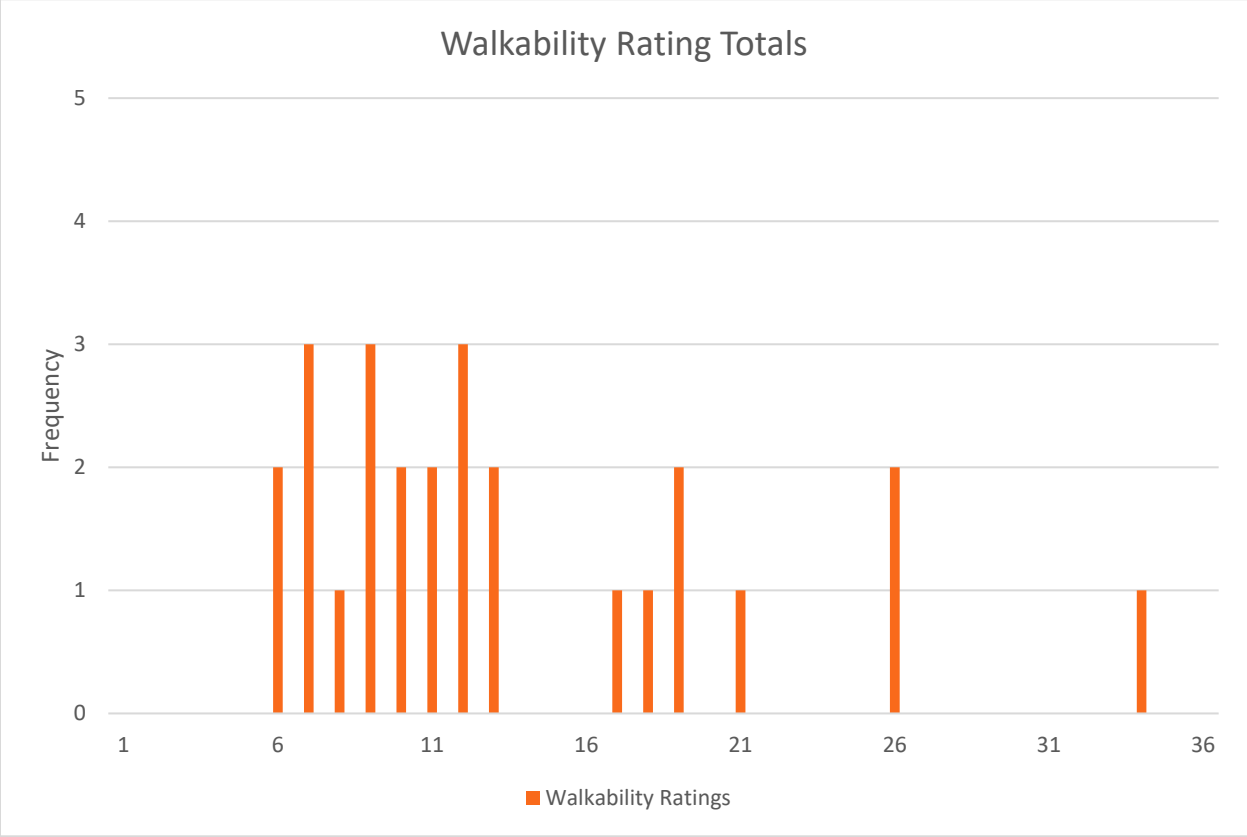
Based on the compiled checklist responses, participants assigned an overall walkability score averaging approximately 13 points, as shown in Figure 13. This rating indicates that participants generally viewed the corridor as having substantial opportunities for improvement. Observations made during the field assessment support this conclusion, as participants encountered several challenges, including the absence of sidewalks in key locations, limited crossing opportunities, heavy truck traffic, and a lack of separation between pedestrians and vehicles. Throughout the assessment, the group frequently discussed how these

Figure 13. Walkability ratings totals chart

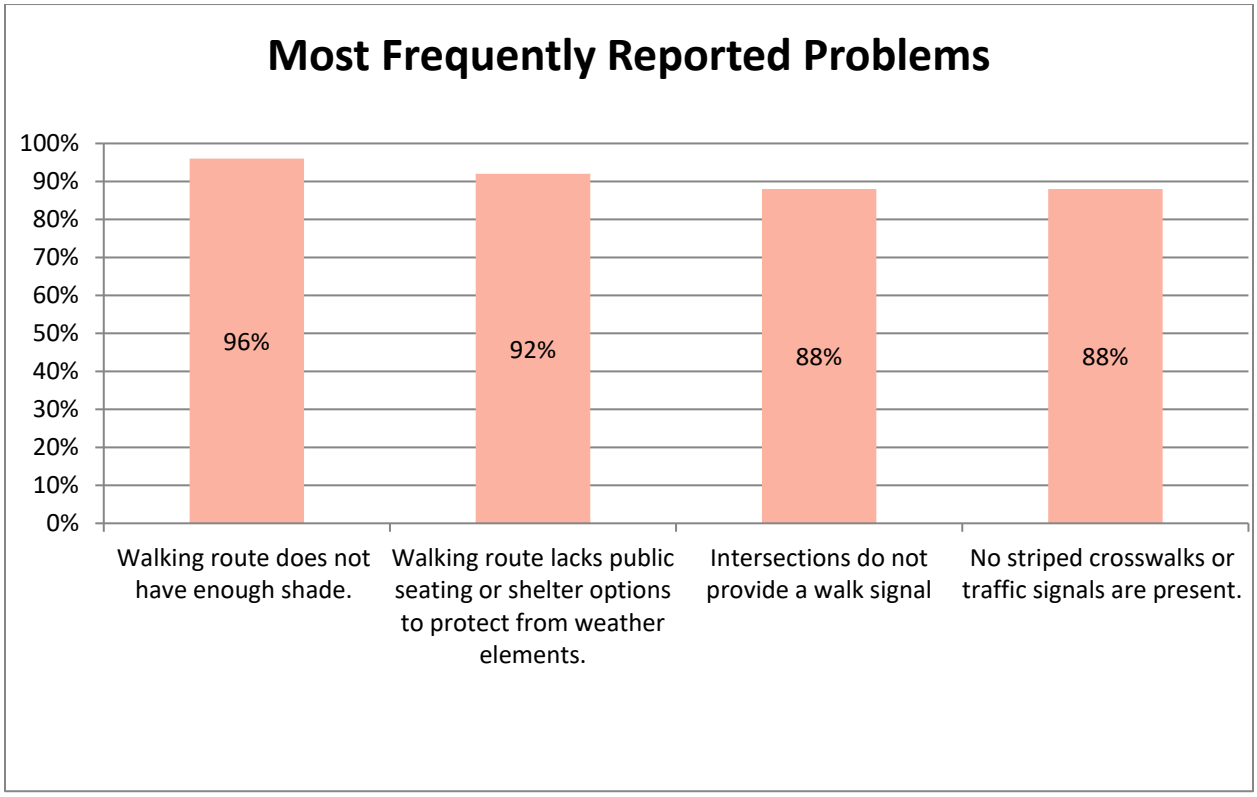
The assessment results identified several recurring issues affecting the walking experience. As shown in Figure 14, the two most frequently reported problems were:

1. The walking route does not have enough shade.
2. The walking route lacks public seating or shelter options to protect pedestrians from weather conditions.

Figure 14. Most frequently reported problems
