Publication No. FHWA-RD-93-114
July 1994

Testing of Small and Large Sign Support Systems FOIL Test Number: 92F026

U.S. Department of Transportation
Federal Highway Administration

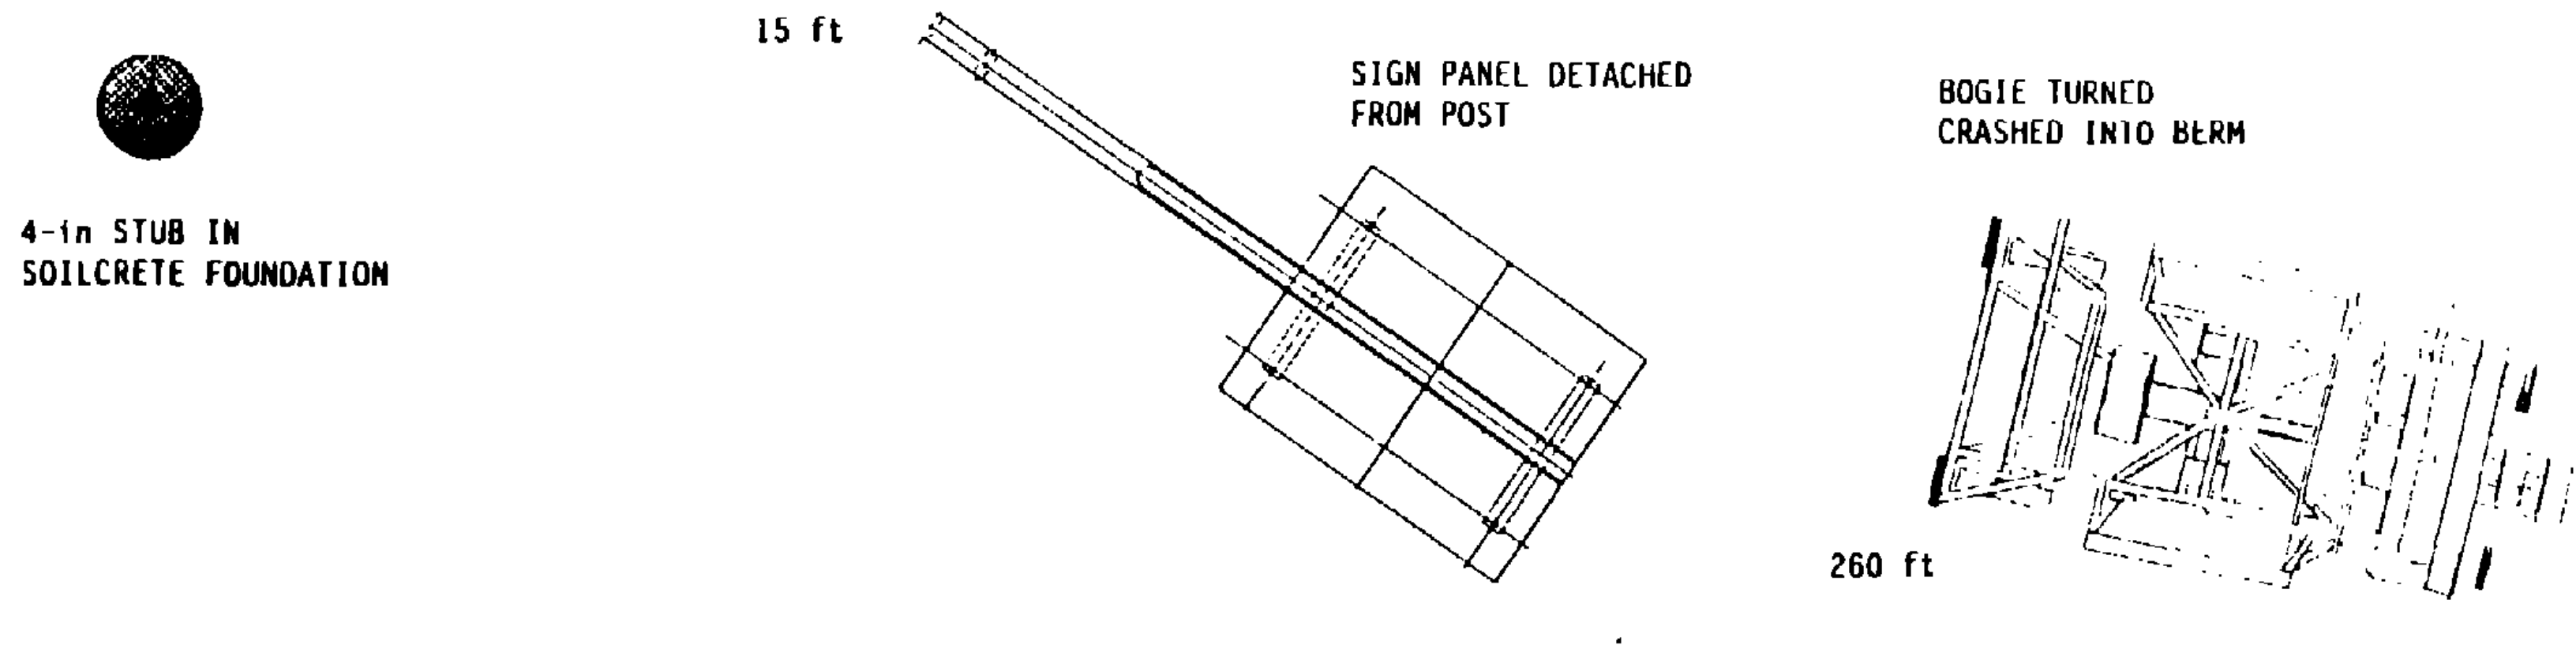
Figure 4. Summary of test 92F026.

Damage to the bogie vehicle consisted of crushed honeycomb. The damage was to expendable material and not to structural members of the bogie. The measured honeycomb crush after the test was recorded to be 16.1 in (408.9 mm). None of the sign components would have impaled an actual automobile's occupant compartment.

Damage to the sign consisted of a fractured wooden sign post. The soilcrete foundation did not move during the crash test. The sign panel was in good condition after the test.
