# FRA/Volpe Center Task Force Observation of Operations at TVE Transrapid Test Facility October 15 to December 17, 1992

DOT-VNTSC-RR393-PM-93-1  
April 1993

Prepared by the Federal Railroad Administration/Volpe National Transportation  
Systems Center High Speed Guided Ground Transportation Safety Task Force

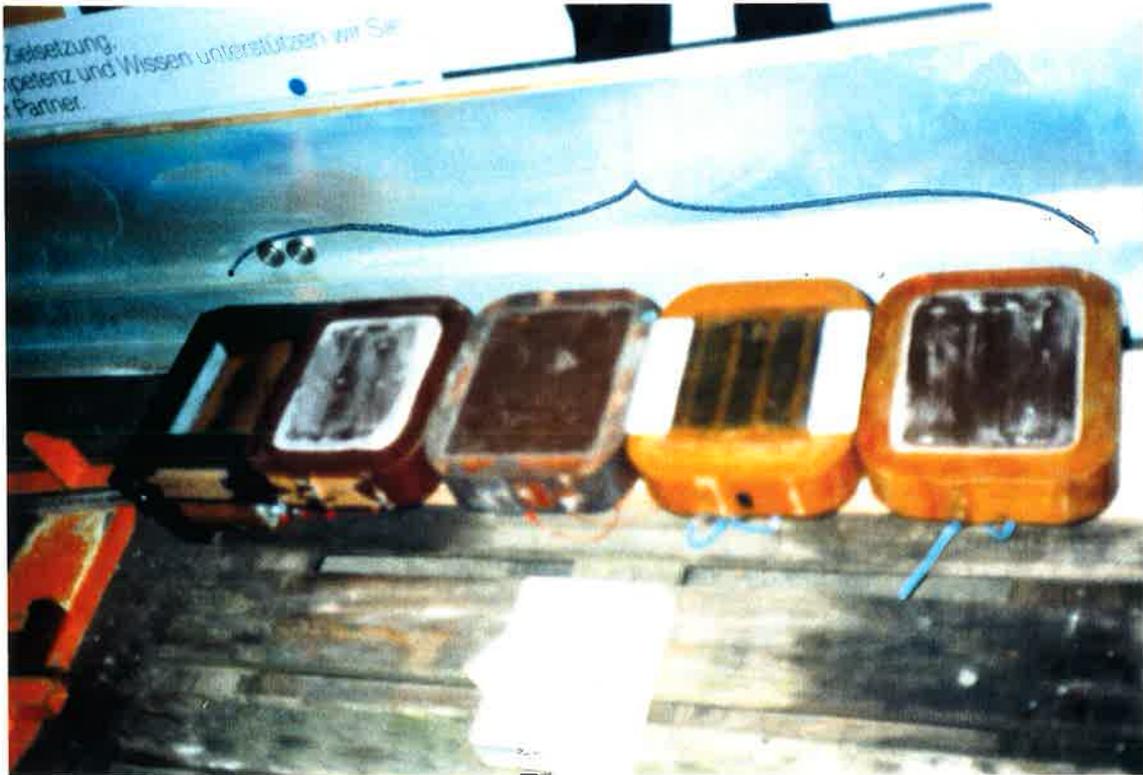
Figure 7. One-Half Existing TR07 Levitation Magnet Configuration

The present gap control system is designed to share sensors between adjacent magnet packs to permit continuous operation over the "infinite gap" discontinuities that are present between each of the guideway sections. Each half magnet pack has a single sensor located at the open end. Figure 7 shows a half magnet pack removed from a vehicle section with the single sensor housing located on the left side. The sensor housing has been sloped to allow lifting of a dropped stator pack, if encountered. Figure 8 shows a side view of the sensor housing as mounted in the vehicle section. The new gap control system will incorporate dual sensors at each end of each magnet set to allow each magnet set to react more independently of adjacent units. The location for one set of these dual sensors is shown in Figure 9. This new gap control system, along with reduced vertical and longitudinal stiffness, is expected to improve the vehicle's ride response at lower speeds.

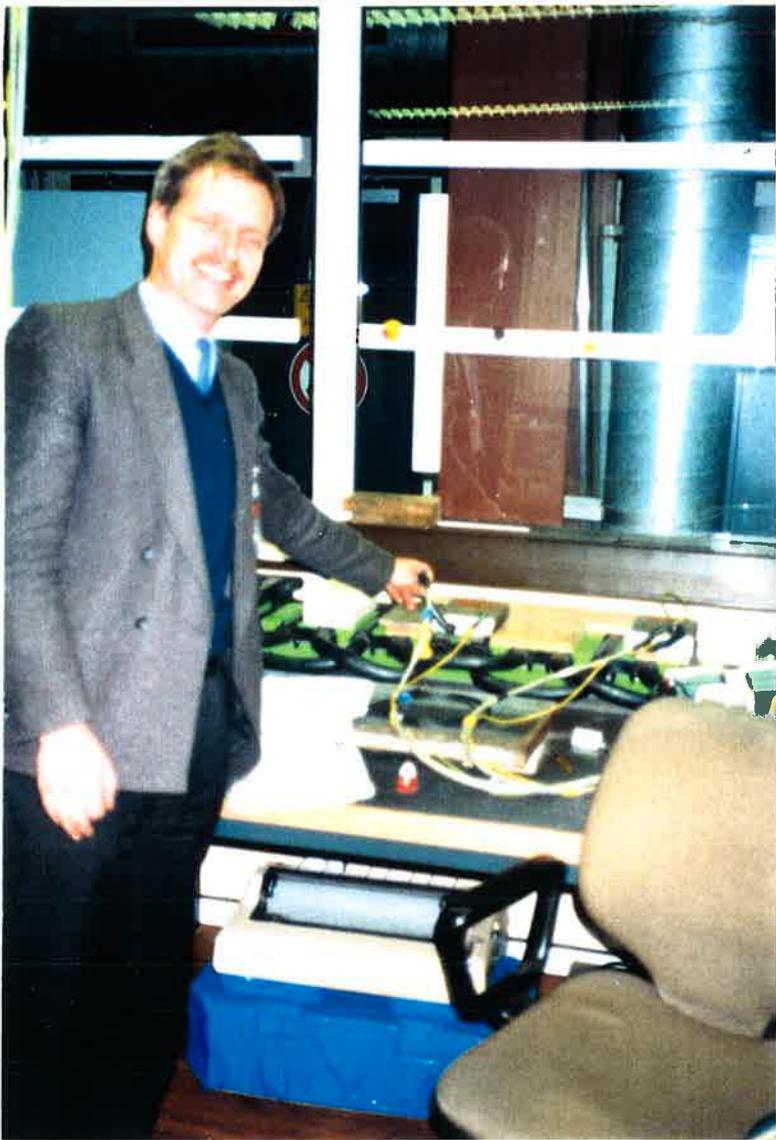
Figure 11.  
Calibration Arrangement  
for Gap Sensors

The MREs, which include the power supplies and logic control electronics for both the levitation and lateral control magnets, were examined and discussed. The control boards for these units are also being modified for the new magnets and gap control system. Dr. Konigorski conducted a brief tour of the area where periodic functional testing of both the MREs and the gap control electronics is performed. Figure 10 shows the MRE functional testing equipment, and Figure 11 shows the testing fixture for calibrating the gap sensor system.

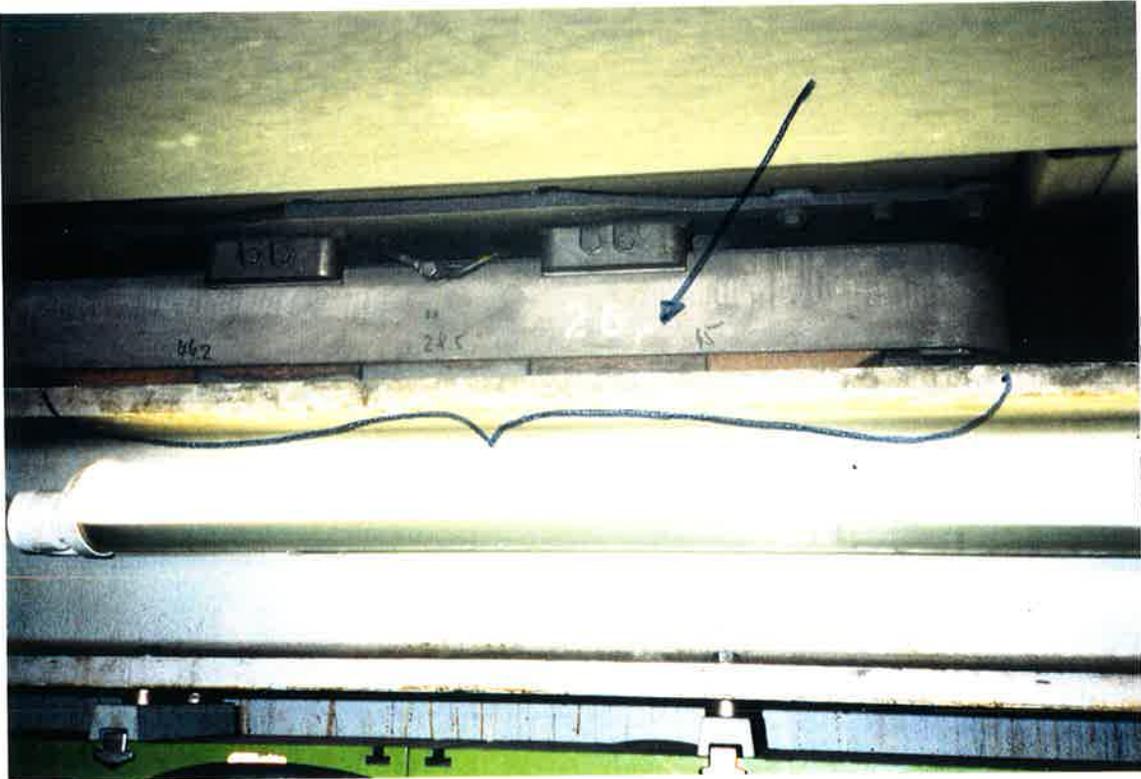
Figure 14. TR07 Skid Assembly

The day's runs with the TR07 vehicle included a final series of tests of the programmed braking. During one of the runs at low speed, propulsion was lost, and the vehicle had to be set down on the skids. Although not a safety concern, the recurring loss of propulsion could become an operational problem during normal revenue service. Figure 14 is a photograph of one of the skids, taken after the vehicle returned to the Halle.

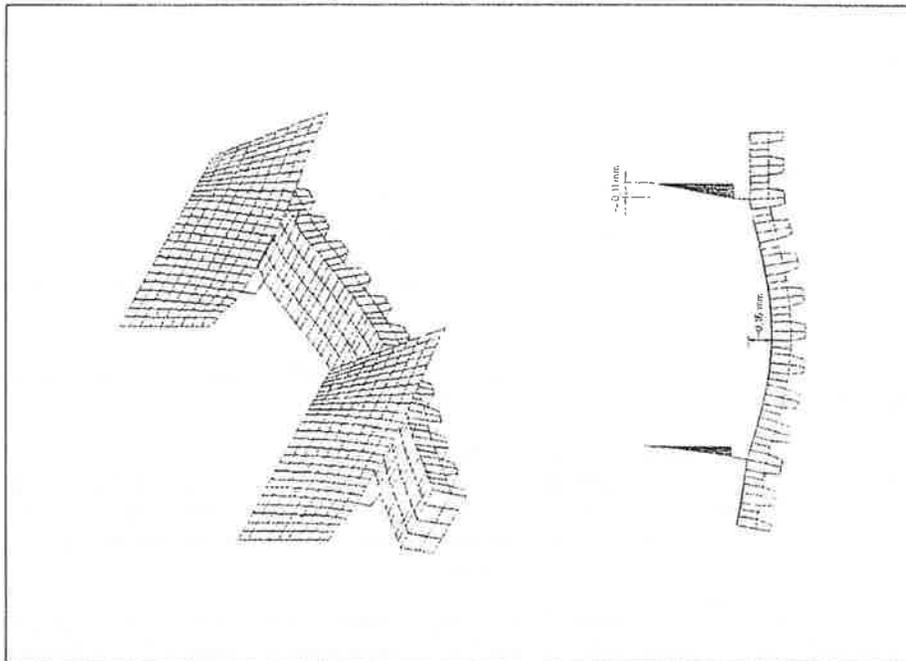
**FIG.2 FINITE ELEMENT MODEL OF THE STATORPACK INCLUDING THE ATTACHMENTS. DEFORMED SHAPE UNDER LOADING.**

The statorpack is a beam clamped on both ends. The resulting compulsive forces due to external loading is dependent on the stiffness of the attachments including parts of the guideway.

To get the cutting power necessary for the optimization of the bolt connection and the shape of the slots in the stack of sheets, a finite element model was used (see fig.2).

For this model, the orthotropic material properties of the stack of sheets were considered. Since it is difficult to derive the material properties easily, experimental measuring of the essential stiffness values for the complete statorpack has been carried out. Using a bending and a torsion test with the original statorpack, the stiffnesses were evaluated and applied to the finite element model.

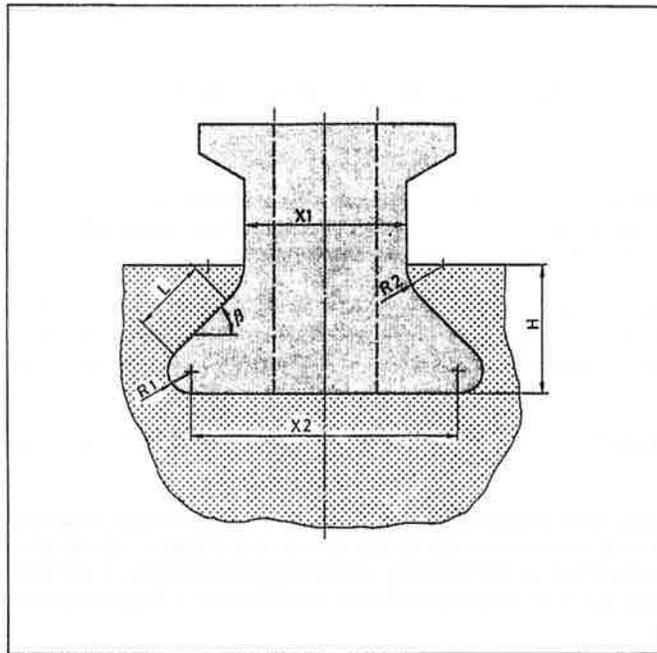
FIG.4 SHAPE OF THE SLOT IN THE STATORPACK INCLUDING THE BONDED BAR FOR THE ATTACHMENT AT THE GUIDEWAY BEAM

The shape of the slot should be dovetailed with rounded corners and ending (see fig.4).

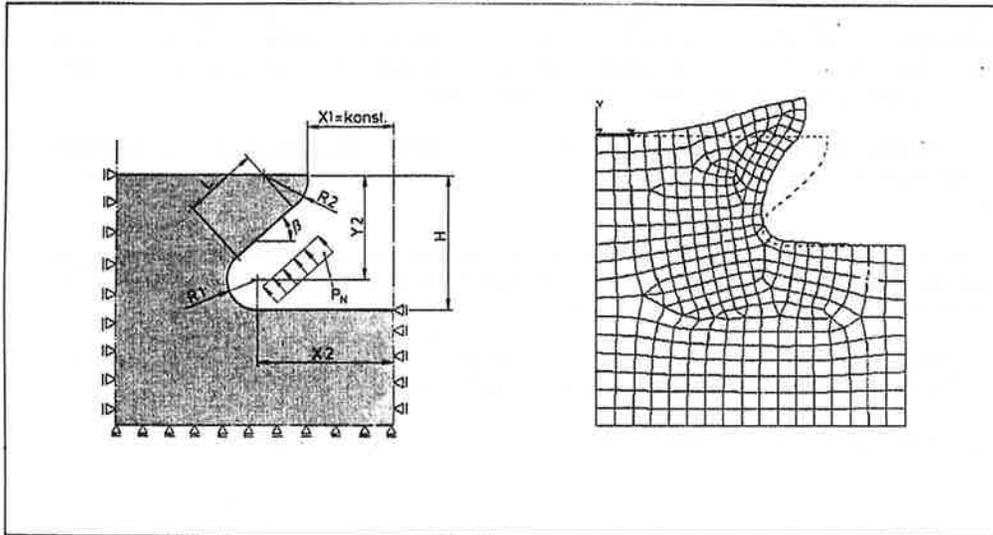
**FIG.5 FINITE ELEMENT STRUCTURE AND DEFORMED SHAPE OF THE SLOT UNDER LOADING**

For optimization a two dimensional model with solid elements under plane stress conditions was used (see fig.5). For the layered type of construction of the statorpack this idealization is accurate enough.

The shape of the slot had to be optimized in order to minimize equivalent stresses, stress gradients, displacements and contact pressure and mainly the depth of the slot. A design should be developed which fulfills in an optimal manner the needs of the bar bonded into the statorpack.

Only 14 iterations had to be made to reach the goal. The result can be seen as a displacement plot in fig. 5. For the optimum design the outlet radius was maximized and the inner radius was minimized. The slope angle  $\beta$  is calculated at the lower edge of this state variable. The variation of the two radians versus the iteration number is shown on fig. 6. as an example.
