**Federal Railroad  
Administration**

## **Alternative Occupied Volume Integrity (OVI) Tests and Analyses**

| 4. TITLE AND SUBTITLE<br>Alternative Occupied Volume Integrity (OVI) Testing and Analyses | | | 5. FUNDING NUMBERS<br>RR28A1/JG343<br>RR28A2/JL649<br>RR28A2/KL649 | |
| 9. SPONSORING/MONITORING AGENCY NAME(S) AND ADDRESS(ES)<br>U.S. Department of Transportation<br>Federal Railroad Administration<br>Office of Research and Development<br>1200 New Jersey Avenue, SE<br>Washington, DC 20590 | | | 10. SPONSORING/MONITORING<br>AGENCY REPORT NUMBER<br>DOT/FRA/ORD – 13/46 | |

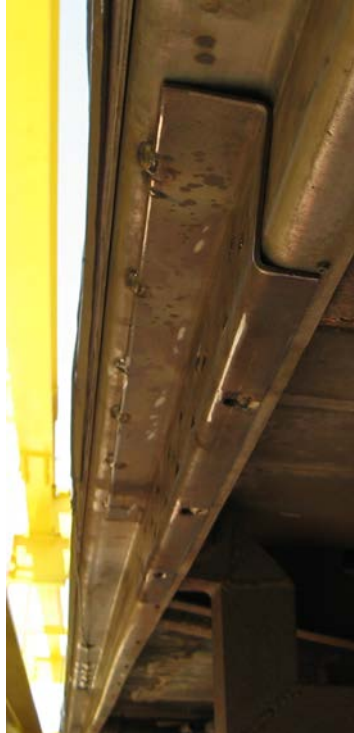
**Figure 6. Patch Installed on Car 244 Side Sill**

The 800-kip elastic verification test was performed on January 19, 2011, at Transportation Technology Center (TTC) in Pueblo, CO. A previous 800-kip elastic verification test had been performed on this car on January 10, 2010 [11]; however, during review of the test results, several anomalies were discovered. These anomalies included indication of a lateral shift of the test frame that was not captured by any instrumentation. This behavior caused difficulty in comparing the test results and the results of the corresponding FE analysis. Additionally, post-test examination of the car revealed several small cracks in one side sill. The decision was made to perform a second buff test on the car. A doubler plate was installed over the side sill cracks, with a second patch placed on the other side sill to maintain symmetry. Figure 6 shows a photograph of one of the crack patches that was added to the side sill of Car 244. Following the addition, the test frame was better restrained against unintended lateral motion. Finally, additional string potentiometers were installed on the underframe of the car so that motion in the vertical, lateral, and longitudinal directions could be resolved into its components.

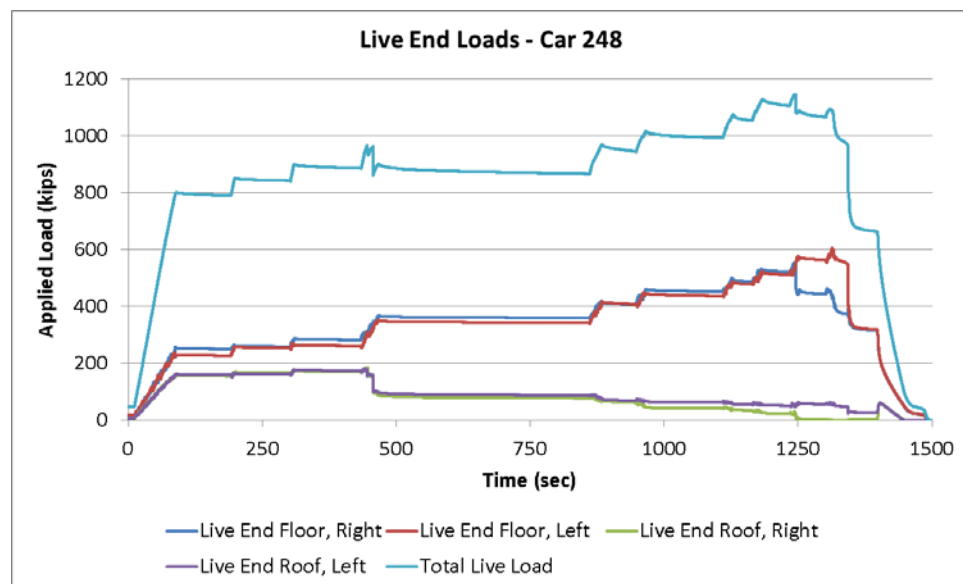
**Figure 42. Live End Loads versus Time, Car 248 Crippling Test**

The limited-instrumentation shakedown test of car 248 was performed at TTC on June 15, 2011. An initial longitudinal load was used to settle the car within the test frame. The car was then loaded in 200-kip increments, with a return to a nominal load of approximately 20 kips between increments. Once a load of 800 kips was reached, the load was not actively removed between loading increments. The load was paused at 800 kips to permit the data recorded up to that point to be reviewed. Loading increased beyond 800 kips until the roof buckled, at which point the test was paused to permit inspection of the data collected and photographs of the car to be taken. Loading then resumed until crippling was reached. The load versus time data from the four live end load cells are plotted in Figure 42 for the final load increment, from the nominal load to 800 kips, and then up to crippling. This figure also includes the sum of the four load cell measurements plotted against time.

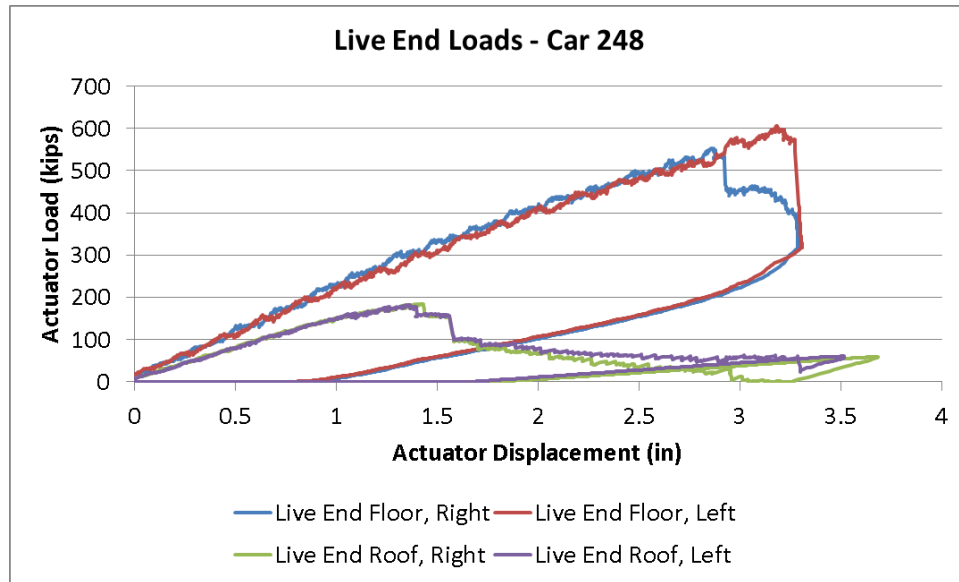
**Figure 43. Live End Loads and Displacements, Car 248**

The load from each individual load cell is plotted against the corresponding actuator displacement in Figure 43 for the load cells at the live end of the car. As seen in this figure, the two load cells at the roof recorded very similar load-displacement characteristics. The roof's stiffness was approximately the same for both the left and right sides, and both sides reached nearly identical peak loads. The right load cell recorded a peak load of 185 kips, and the left load cell recorded a peak load of 183 kips.

At the floor-level, both load cells recorded similar load-displacement characteristics. There is a larger variance in peak load between the floor-level load cells than was seen at the roof-level. The right load cell recorded a peak load of 554 kips, and the left recorded a peak load of 607 kips. The left side load begins to decrease at a smaller displacement than the load on the right side. This behavior may be an indication of the left side sill crippling before the right side sill. Because of the limited instrumentation employed in the test of Car 248, additional information on the progression of damage to the carbody is not available.

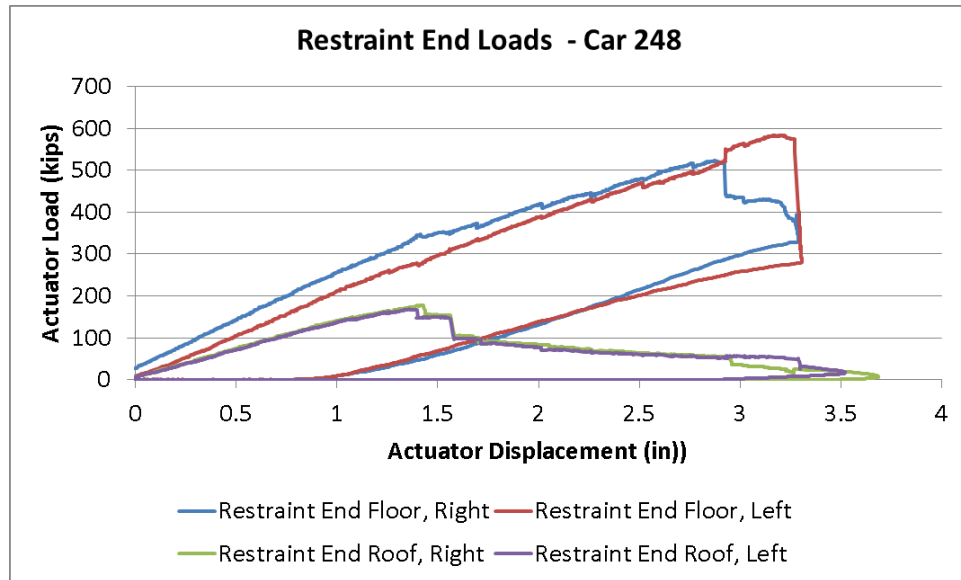
**Figure 44. Restraint End Loads and Displacements, Car 248**

The loads in the individual load cells at the restraint end of the car are plotted in Figure 44 against the displacement of the corresponding actuator on the live end. The roof-level data are nearly identical for the left- and right-side load cells, as it was at the front end of the car. At the floor-level, the left and right side data have more variance than at the front end. The left-side load cell records a higher load at zero displacement than the load cell at the right. However, even with this offset taken into account, the right side load does not reach the same level as the left side load at the floor.

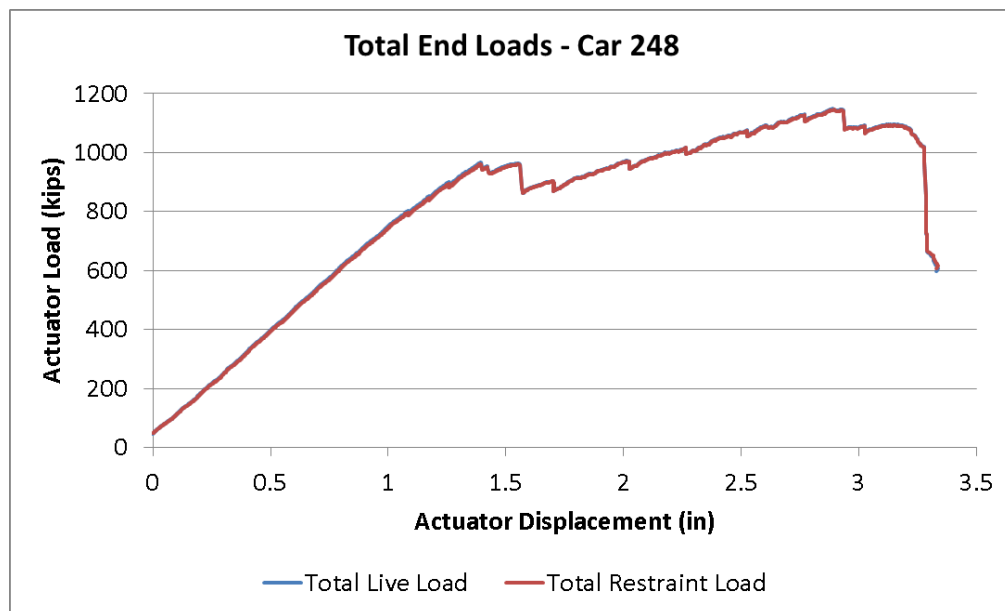
**Figure 45. Total End Loads for Car 248 Shakedown Test**

The total applied load and total restraining load are obtained by summing the four load cell measurements at each respective end of the car. The total applied load and total restraint load are plotted against the average live end actuator displacement in Figure 45. These two values are in excellent agreement with each other. This indicates that the test is being conducted in a quasi-static manner, free from dynamic effects, and that the full load applied to the front end of the car is exiting the structure through the rear restraints. The load does not appear to be exiting the car through any uninstrumented locations or “short-circuits” in the load path.

The load-displacement response is approximately linear to above 800 kips. At a total load of approximately 950 kips, the roof structure begins to buckle and the total load decreases. Because

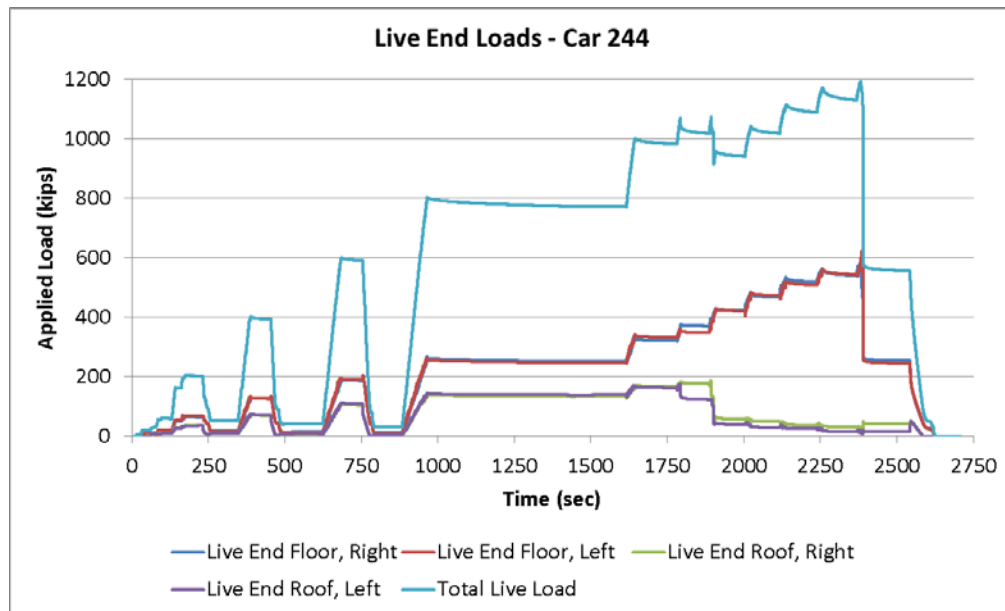
**Figure 54. Live End Loads, Car 244 Crippling Test**

The loading procedures used in the test of Car 244 were similar to the procedures used on Car 248. In both tests, the car was secured within the frame by a small longitudinal load. The car was then loaded in 200-kip increments, with a return to a nominal load of approximately 20 kips between increments. Once a load of 800 kips was reached, the load was not actively reduced between increments. The actuators were pushed forward in 0.25-inch increments and then paused to allow the structure to settle. This approach was followed until crippling occurred. The individual live end loads and the total live end load are plotted against time in Figure 54 for the full sequence of loads.

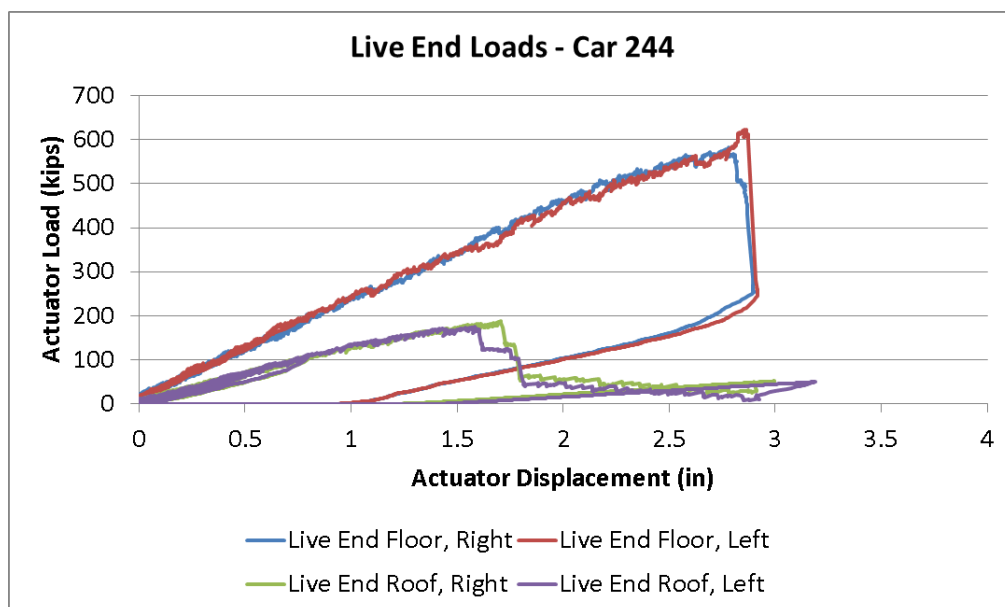
**Figure 55. Live End Loads and Displacements (Car 244 Crippling Test)**

The loads measured by each of the four live end load cells are plotted against the displacement of each hydraulic actuator in Figure 55. The load cell names and locations for the test of Car 244 are the same as were used for Car 248, as shown in Table 7. Both of the floor-level load cells recorded approximately the same load-displacement characteristic, with the left-side load cell measuring a slightly higher peak load than the right-side. The two roof load cells also recorded very similar load levels. The right load cell measured a slightly higher peak load than the left.

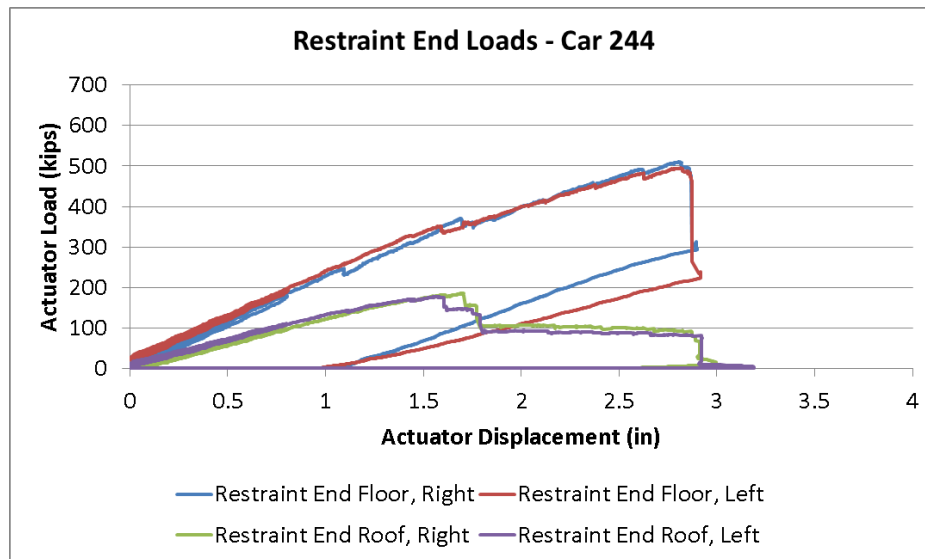
**Figure 56. Restraint End Loads and Displacements (Car 244 Crippling Test)**

The load at each restraint location is plotted against actuator displacement for the corresponding location on the live end for the four restraint end load cells in Figure 56. At both the floor and roof restraint locations, the left and right side loads are roughly equal. Comparing the loads at a

given displacement between the restraint end (Figure 56) and the live end (Figure 55), it is apparent that some portion of the load that is introduced to the car through the floor at the live end is being reacted through the roof at the restraint end of the car. The peak load in each floor location on the live end is approximately 600 kips, while the peak load in each floor location on the restraint end is slightly greater than 500 kips.

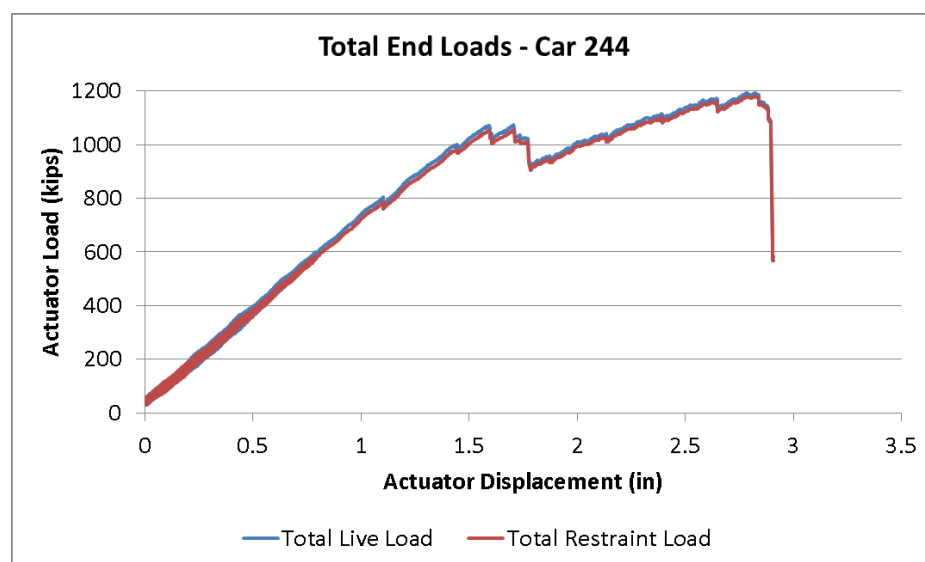
**Figure 57. Total End Loads for Car 244 Crippling Test**

In Figure 57, the total applied load on the live end of the car and the total reaction load from the restraint end of the car are plotted against the average displacement of the actuators on the live end. The live end and restraint end loads are approximately equal throughout the entire test. This verifies that the test is being run in a quasi-static manner, free from dynamic effects. Additionally, this result indicates that the longitudinal load is entering and exiting the car through the load cells without experiencing losses through any noninstrumented load paths.

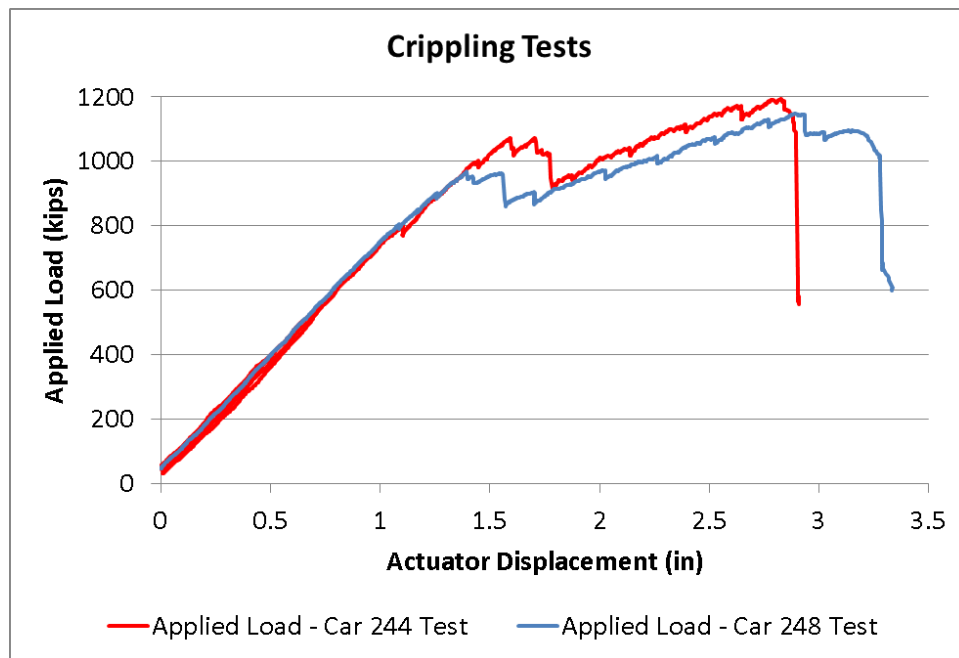
**Figure 58. Load-Displacement Behavior for Car 248 and Car 244**

The results from the crippling test of Car 244 are similar to the results from Car 248. The live end load versus actuator displacement from each car is plotted in Figure 58. In both cars, the roof structure buckles at a load of approximately 1 million pounds. In Car 248, the actual buckling load is slightly below 1 million pounds and in Car 244 this load is slightly above 1 million pounds. Because the underframe structure has not been compromised at the roof buckling load in either car, as the displacement continues to increase, the load is able to increase as well. Car 248 had a crippling load of 1.15 million pounds and Car 244 had a crippling load of more than 1.19 million pounds.

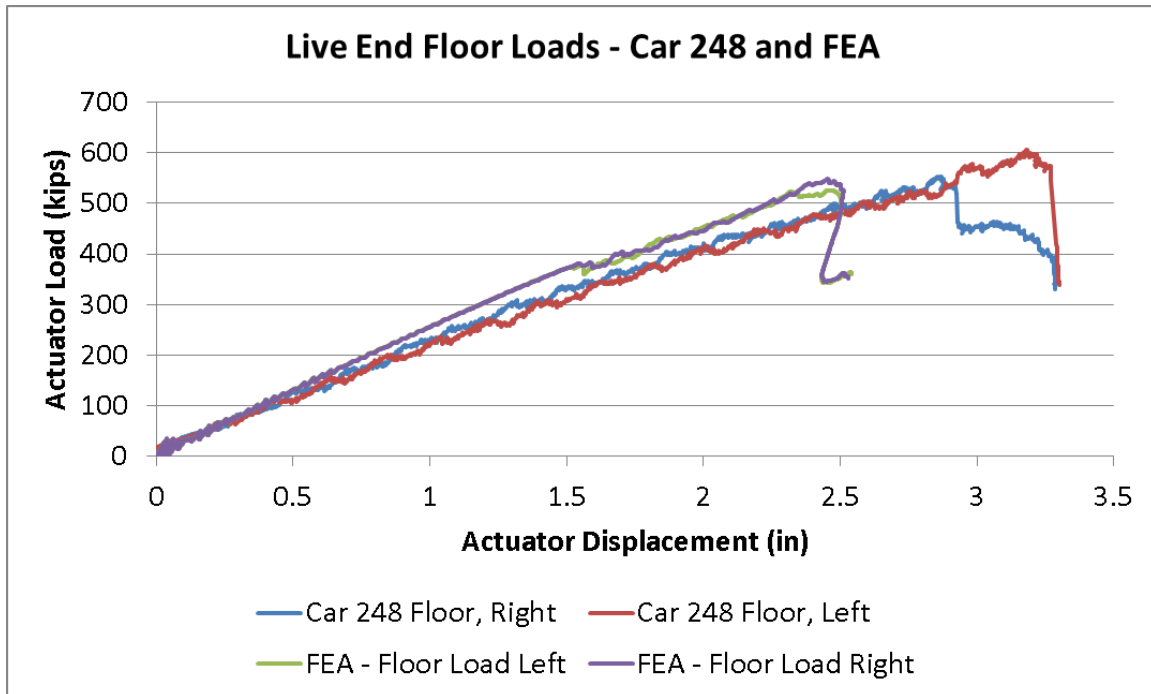
**Figure 71. Live Load at Floor for Test of Car 248 and FE Model**

Figure 71 plots the load in the floor-level energy absorber supports in the test and the loads in the corresponding energy absorber supports in the FE model. There is generally good agreement between the floor-level load data from the test and the floor-level response of the FE model. The FE model is slightly stiffer than Car 248. The load through the left floor energy absorber support in the model reaches a maximum load of 525 kips, and the load on the right floor energy absorber reaches a maximum load of 550 kips.

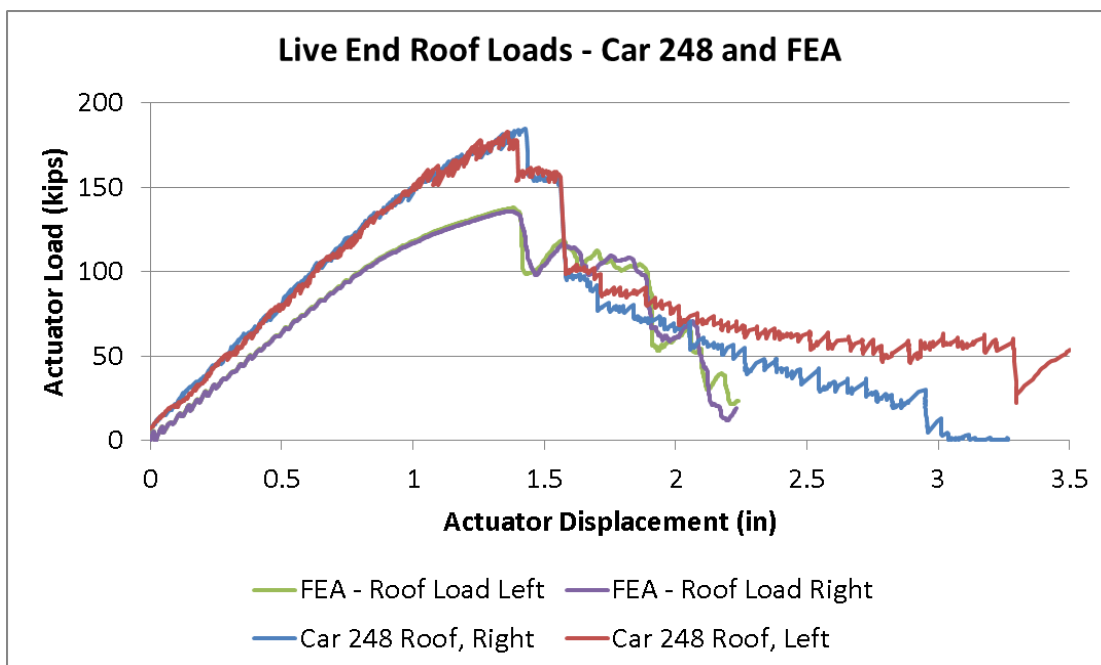
**Figure 72. Live Load at Roof for Test of Car 248 and FE Model**

The live end load-displacement responses of the roof-level energy absorber supports are plotted in Figure 72 for both the test of Car 248 and the analysis. In both the test and the analysis, the roof reaches its maximum load at an actuator displacement of approximately 1.5 inches. The roof in the model exhibits a softer response than the roof of the test car. Additionally, the model has a lower maximum load of approximately 135 kips at each roof load point, compared with approximately 180 kips at each roof load point in the test.

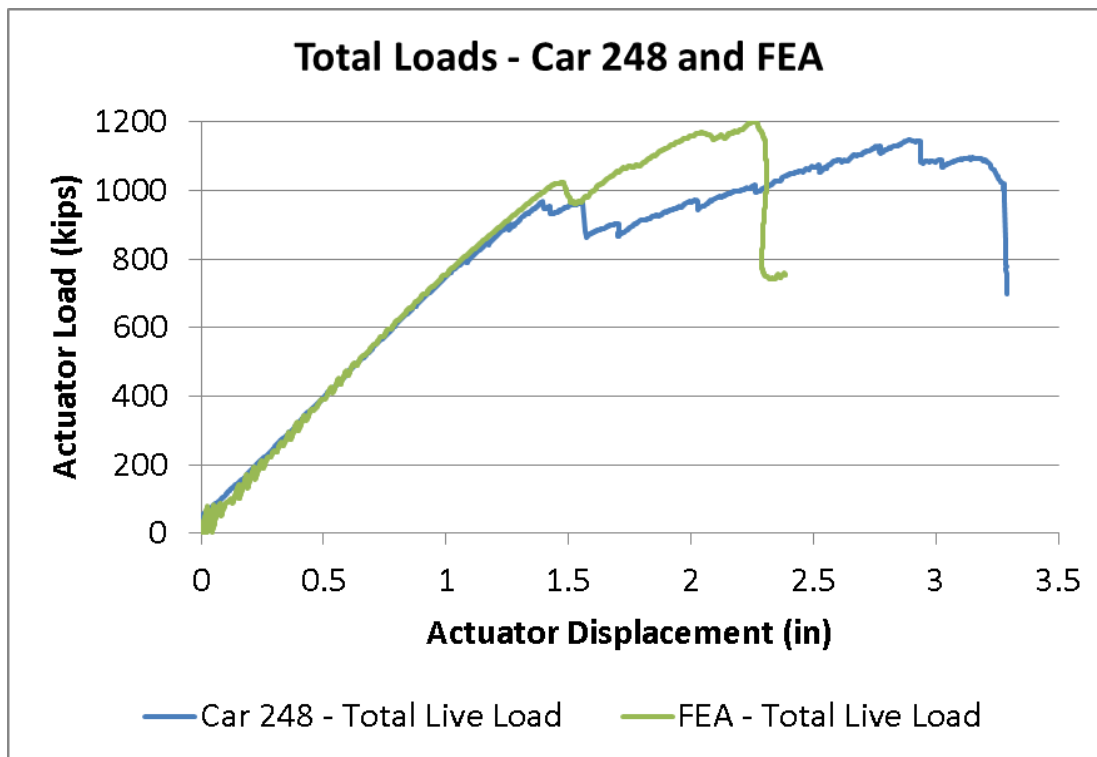
**Figure 73. Total Live Loads for Test of Car 248 and FE Model**

The four live end load cell data channels are added together to obtain the total live end load for Car 248. Similarly, the four applied loads on the live end of the FE model are added together to obtain the total applied load. The total end load from the test of Car 248 and the FE model are plotted in Figure 73 against the actuator displacements.

There is good agreement between the FE results and test data up to the point where the roof buckles at a total load of approximately 1 million pounds. At this point, the load reported in the test and calculated in the FE model both drop. Because the underframe structure has not yet crippled in either case, the total applied load begins to increase as the actuator displacement continues to increase. Following buckling of the roof structure, the FE results are greater than the test results. The FE results reach a global maximum load of approximately 1.2 million pounds and Car 248 reaches a global maximum load of approximately 1.15 million pounds. These maxima occur at different actuator displacements, owing to the model being stiffer than Car 248 actually was following buckling of the roof. Additionally, because the stiffness of the load frame was estimated and added to the displacement results for the FE model, the apparent difference in displacement at the time of crippling may be partially due to this approximation.

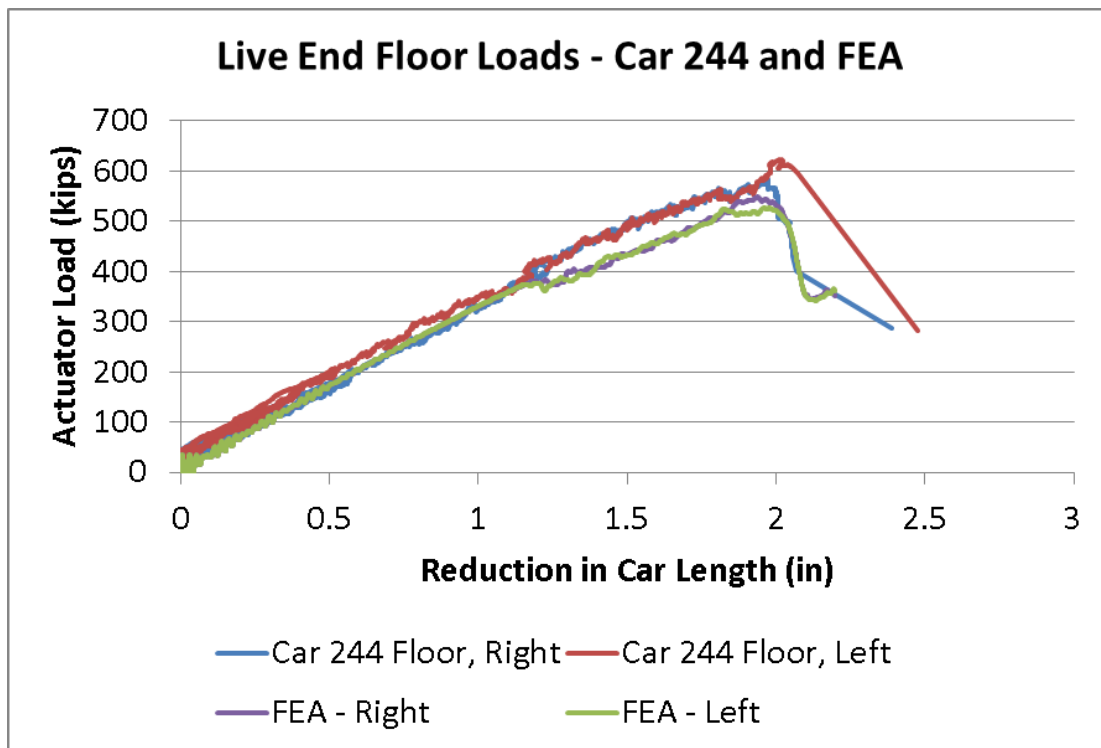
**Figure 74. Live Load at Floor for Test of Car 244 and FEA**

The floor-level loads from the test of Car 244 and the FE model are compared with one another in Figure 74. All four measurements follow approximately the same initial slope. At both the left and right FE locations the maximum sustained load is below the maximum load recorded during the test.

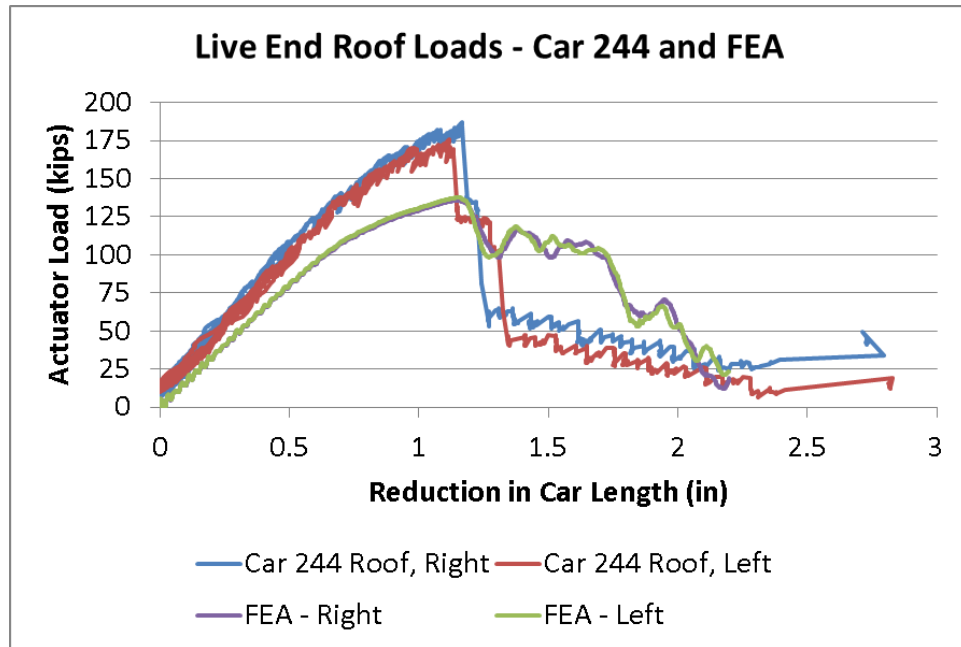
**Figure 75. Live Load at Roof for Test of Car 244 and FEA**

The live end load-displacement responses of the roof-level energy absorber supports are plotted in Figure 75 for both the test of car 244 and the FE analysis. Both the test results and the FE analysis results have the same shape. The model has an apparent lower stiffness in its roof than the test car did. The model reaches a lower peak load than the test on both the left and right sides. In both the test and the analysis, the roof reaches its peak load at approximately the same displacement.

The post-crippling behavior of the roof is different between the test and analysis. In the test, both the left and right side channels record a sudden drop in load, followed by a more gradual decrease in load. In the FE analysis results, the peak is followed by a gradual drop in load.

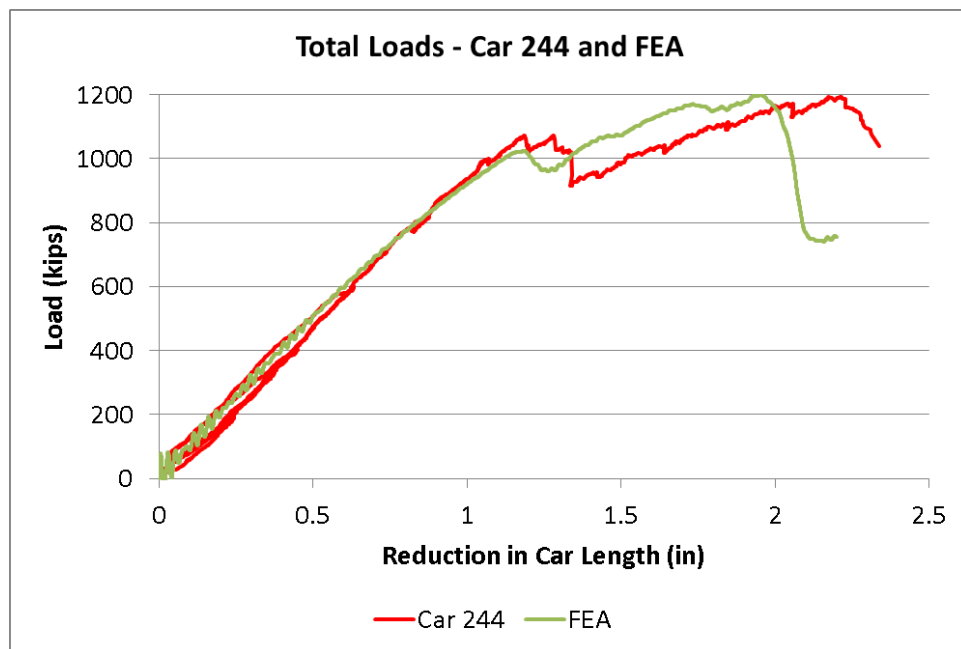
**Figure 76. Total Live Loads for Test of Car 244 and FE Model**

The four live end load cell data channels are added together to obtain the total live end load placed on Car 244. Similarly, the four loads on the live end of the FE model are added together to obtain the total simulated applied load. The total end load from the test of Car 244 and the FE model are plotted against the reduction in car length in Figure 76.

There is good agreement between the FE model and Car 244's test data prior to the point where the roof buckles. Both the test and the analysis experience a drop in load when the roof has begun to cripple at a load of approximately 1 million pounds. Since the floor structure has not yet crippled, the total load can begin to rise again. In both the test and the model, the second rise in load is along approximately the same slope. Both Car 244 and the model have a global crippling load of nearly 1.2 million pounds. The FE model reached its crippling load after a reduction in length of approximately 1.9 inches and Car 244 reached its crippling load after a reduction in length of approximately 2.2 inches.

The FEA displacement results appear to correlate better in Figure 76 than in Figure 77. In Figure 76, the horizontal axis represents the reduction in car length. This quantity is derived entirely from the results of the FEA and from test data for Car 244. In Figure 77, the horizontal axis represents the displacement of the actuators at the live end of the test cars. The FE results in this figure must be adjusted to account for the stretching of the test frame. These two figures indicate that this approximation represents the behavior of the car well, up to the point of roof buckling. Beyond this point, the frame stiffness approximation results in an overestimate, resulting in an underestimation of the actuator displacement at a given amount of load.

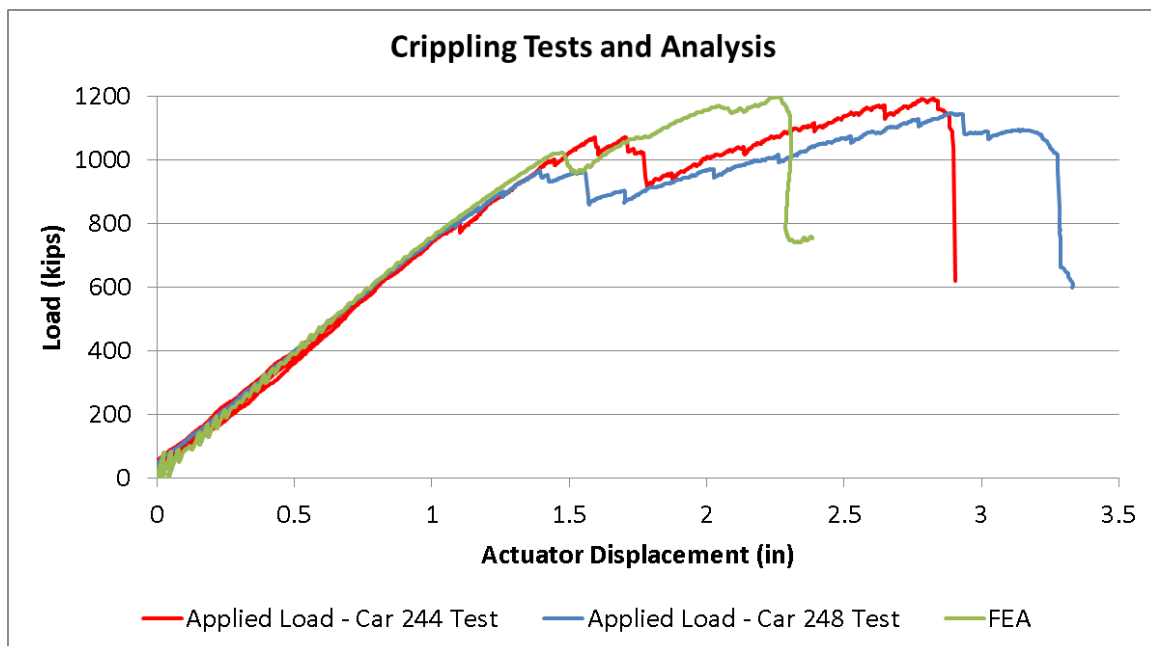
**Figure 77. Load-Displacement Behavior for Both Tests and Analyses**

The results of the crippling test of Car 244 and the FE analysis are both qualitatively and quantitatively similar to the results from the crippling test of Car 248. The three force-displacement results (two tests, one analysis) are plotted together in Figure 77. In this figure, the horizontal axis represents the live end (actuator) displacement for all three results. Because Car 244 and Car 248 were both tested within the same test frame, the actuator displacements may be directly compared. The FE results in this figure have been adjusted to include the estimated expansion of the test frame. The FE model reached its crippling load after an actuator displacement of approximately 2.2 inches. Car 244 reached its crippling load after an actuator displacement of approximately 2.8 inches, and Car 248 reached its crippling load after an actuator displacement of approximately 2.9 inches.

There are slight variations in each of the results plotted in Figure 77. The analysis result exhibits slightly higher roof buckling and crippling loads than the test of Car 248, but a slightly lower roof buckling load than Car 244. Car 248's roof buckled at a load slightly below 1 million pounds, while Car 244's roof buckled at a load slightly above 1 million pounds. Car 244's crippling load of nearly 1.2 million pounds is slightly larger than the 1.15 million pound crippling load reached by Car 248. This is likely due to the damage known to preexist in Car 248. The two crippling load magnitudes measured in the tests vary by approximately 50 kips, which is approximately 4 percent of 1200 kips.

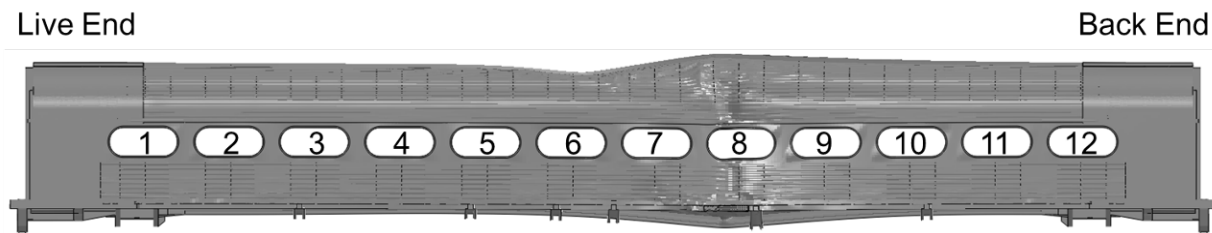
**Figure 78. Deformed Shape of Crippled Car in FEA**

In the FEA results the car first experiences buckling of the roof and sidewall structures. As seen in Figure 78, the roof buckle is a fairly long wavelength buckle, spanning from the sixth window to the eighth window. While buckling initiated at the roof and sidewalls, the underframe continued to carry load until the center sill reached its crippling load. In the FEA, the center sill buckled beneath the eighth window. The center sill also experienced a fairly gradual buckling, as can be seen in Figure 78.

In the FE model, buckling occurred at both side sills and on the center sill at approximately the same distance from the live end. In the model, each side sill experienced an inward buckling mode of its lower web and flange. The center sill buckled at its upper flange and web. The buckled center sill and one of the two buckled side sills are shown in Figure 79. The center sill has been given a different color from the other members to allow it to stand out in this figure.

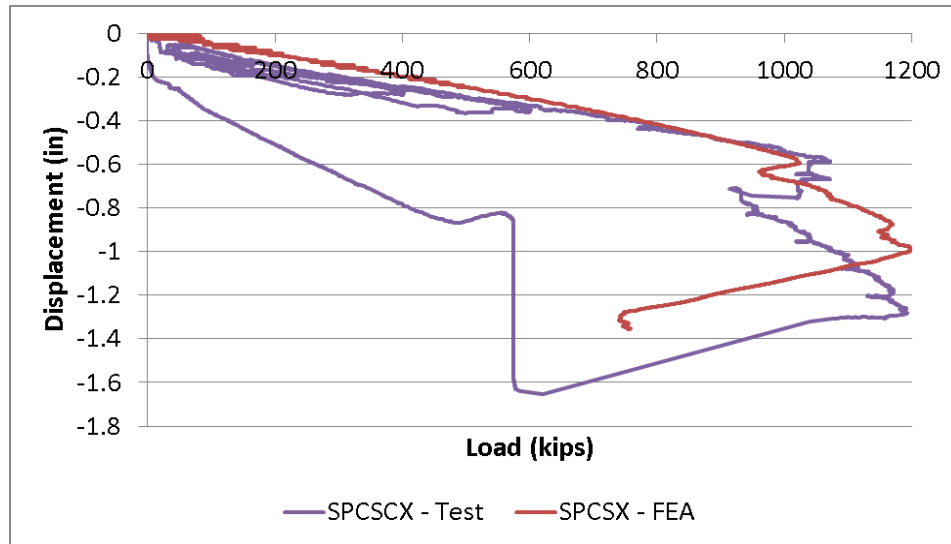
**Figure 81. Longitudinal Displacement at Center Point of Car, Car 244 Test and FEA**

The predominant deflections occurred parallel to the applied load, in the longitudinal direction. There is good agreement between the FE analysis and the test of car 244. An exemplar comparison between test and analysis is presented in Figure 81, which shows the longitudinal displacement measured at the center sill at the centerline of the car. The negative displacement indicates motion in the direction of the applied load in both the test and the model.

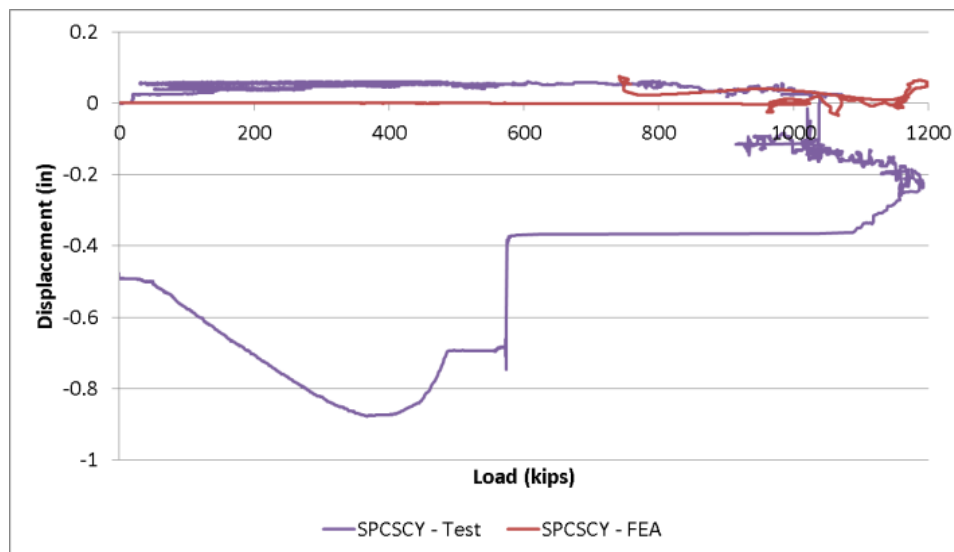
**Figure 82. Lateral Displacement at Center Point of Car, Car 244 Test and FEA**

Lateral displacement data were also collected during both the test and analysis. The lateral displacements were small compared to the longitudinal displacements for both the test of Car 244 and the analysis. The car exhibited very little lateral motion prior to the buckling of the roof. Lateral motion is observed from the onset of roof buckling through unloading of the car. The largest magnitude of lateral deflection in the test was measured at the center sill at the centerline of the car. This result is plotted in Figure 82 alongside the FE results for the same location. Although the FE model was not constrained against lateral motion, it does not exhibit very much lateral motion. A small amount of lateral motion occurs once buckling begins to occur, as was the case with the car in the test.

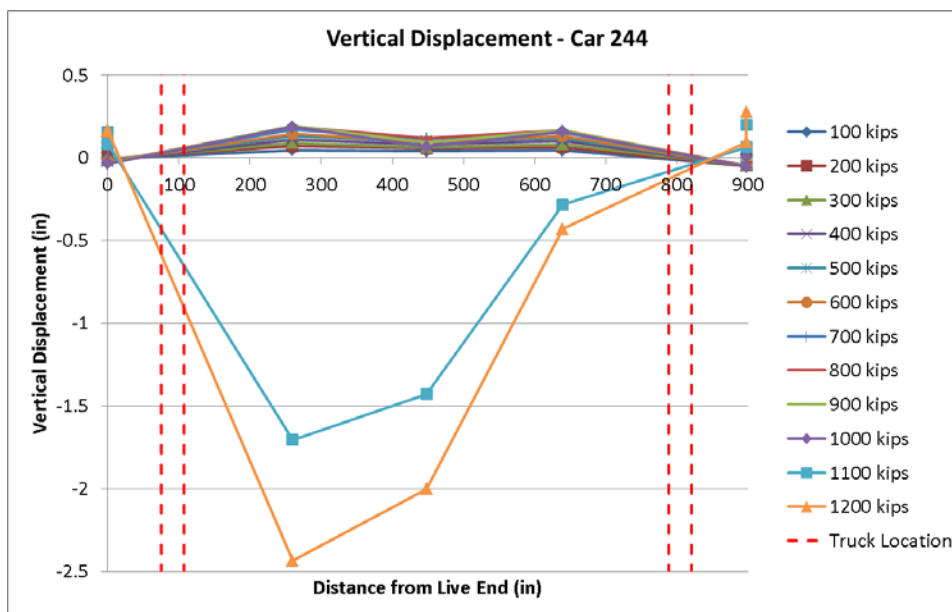
**Figure 83. Vertical Displacement along Length of Car 244 in Crippling Test**

The vertical displacement measured at each instrumented location on Car 244 is plotted against the distance of that instrumented location from the end of the side sill on the live end of the car in Figure 83. Each data series in this figure represents a “snapshot” of the mode of deformation at a particular load level. With a total applied load of 1 million pounds (1,000 kips) and less, the car experiences very little vertical deflection. Above 1 million pounds, buckling has started to occur within the body of the car. The largest deformations are measured near the live end of the car where the center sill crippled.

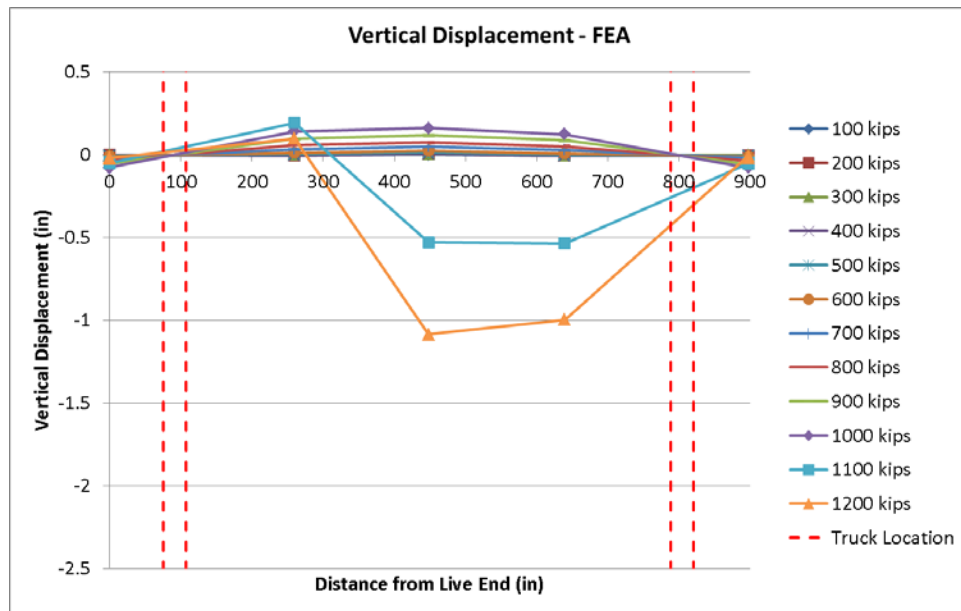
**Figure 84. Vertical Displacement along Length of FE Model in Crippling Simulation**

An analogous plot was created for the FE results and is shown in Figure 84. As with the tested car, the FE model initially experiences very little vertical deflection. The test and the analysis both experienced different initial modes of deformation. Where Car 244 exhibited an “M” shaped bending mode with 2 inflection points, the FEA results indicate a shallow inverted “U” shaped mode. This may indicate that the FE model is underweight compared to Car 244, as the center of the model experiences greater vertical uplift under small bending moments.

As the load increased beyond 1 million pounds, both the model and Car 244 began to exhibit fairly large vertical deflections. Because Car 244 and the FE model experienced center sill crippling at different locations along their lengths, the vertical bending modes are somewhat different as crippling occurs. Buckling occurs further away from the live end of the car in the model than was observed in the test. The model also indicates smaller downward deflections than were recorded during the test of Car 244.

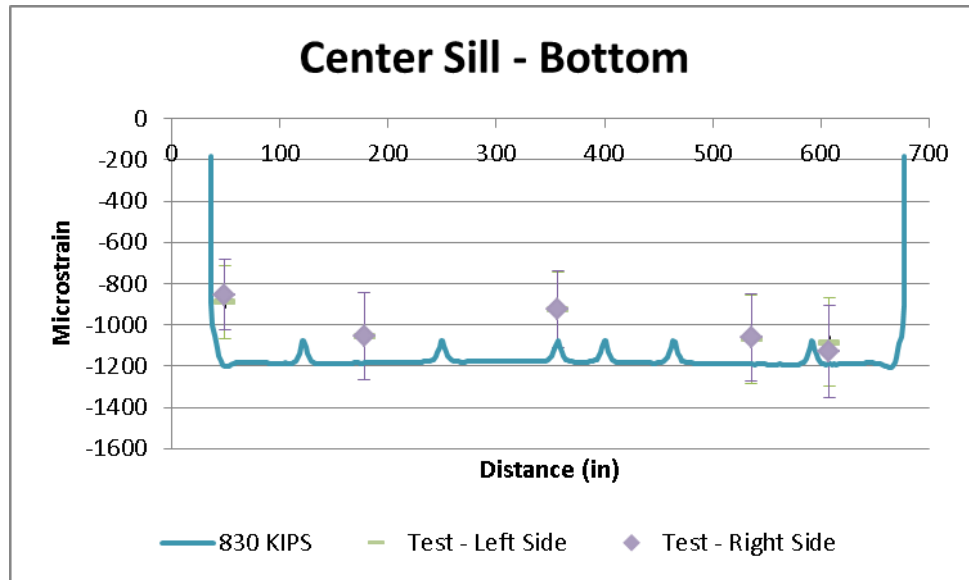
**Figure 85. Longitudinal Strain in Center Sill at 830 kips, Crippling Test**

Strain data were collected on the center sill at five cross-sections. At each cross-section one gage was placed on each quadrant of the center sill's webs (upper left, upper right, lower left, lower right). Figure 85 is a plot of the longitudinal strain in the center sill as measured in the gages on the bottom half of the member. The horizontal axis indicates the undeformed distance between the datum of the car (the center of the restraint end body bolster) and each strain gage. The strains in this figure are the result of an 830-kip total load applied to the car. The error bars on the test data indicate a  $\pm 20$  percent tolerance on the measured test data. The strains calculated along the length of the center sill in the FEA result are plotted as a continuous line in this figure.

The strain data measured in the test indicate a relatively constant level of strain in the center sill at this load. At each cross-section, the strain measured on the left and right sides of the center sill of the tested car are nearly equal. The FE results also indicate a constant level of strain along the length of the center sill. The peaks that occur along the plot of the FE result coincide with locations of the six cross members that connect the center sill with the side sills. At the ends of the center sill, the model indicates a steep strain gradient where the center sill ends at the body bolster. If this high gradient is present in the physical car as well as the model, it emphasizes the need to place strain gages with extreme care. A small difference in placement can result in a large difference in the strain measurement. Although the FE results are not within  $\pm 20$  percent of the FE results at the left-most cross-section in this figure, the test and analysis results would overlay one another if the strain gage were placed a few inches closer to the restraint end.

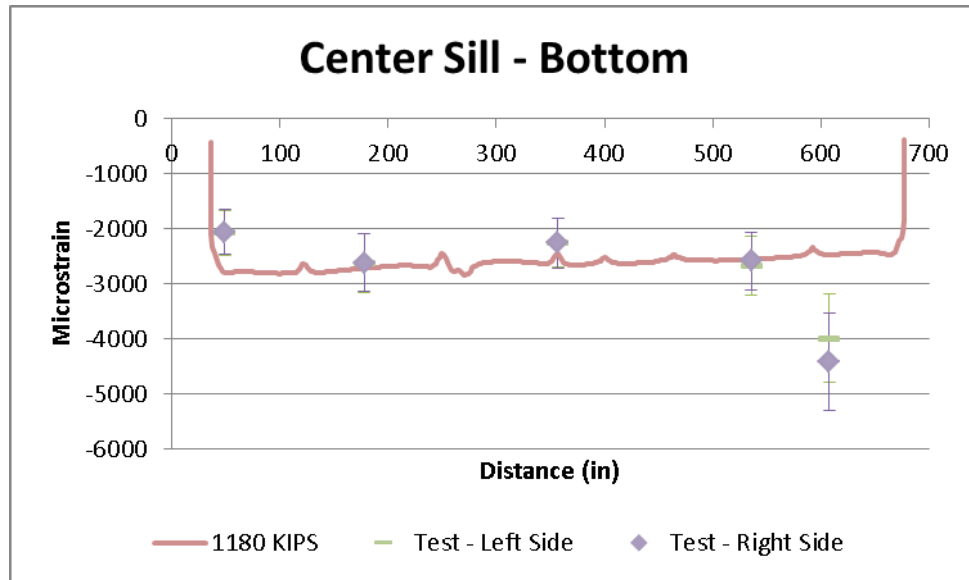
**Figure 86. Longitudinal Strain in Center Sill at 1180 kips, Crippling Test**

A second plot of longitudinal strain versus distance along the center sill for the strain measurements in the bottom half of the web is shown in Figure 85. In this figure the strain measurements are taken at a total applied load of approximately 1.18 million pounds. This load is just prior to crippling in both the test and the model. The test data at 1.18 million pounds are similar in appearance to the test data at a load of 830 kips (Figure 84) with the exception of the measurement location at approximately 600 inches. Because the datum point on this car is at the restraint end, this cross-section is the closest to the live end of the tested car. This set of center sill strain gages happened to be adjacent to an area of the center sill that buckled during the test (Figure 59).

The strain gages adjacent to the buckle indicate a very high level of strain in the center sill at a load just prior to crippling. However, even though the crippling load is a global measurement for the entire car, the strain data in the previous figure indicate that the center sill's buckling is a localized behavior. The center sill remains elastic at the cross-section away from this local buckle even at a load just below the crippling load of 1.2 million pounds.

Figure 86 also contains the strain-distance results calculated from the FE model along the entire length of the center sill for elements in the lower half of the web. Except at the crippling cross-section, the FE results compare favorably with the test data. Because the FE model experienced crippling at a different location than Car 244, there is not a steep change in strain data at the same location as the test car. The FE model's center sill buckled at a location adjacent to a cross-bearer on the restraint end of the car (Figure 78). A small inflection between 200 and 300 inches can be observed in the FE results in Figure 86; this is the location where the incipient buckle will cripple the model.

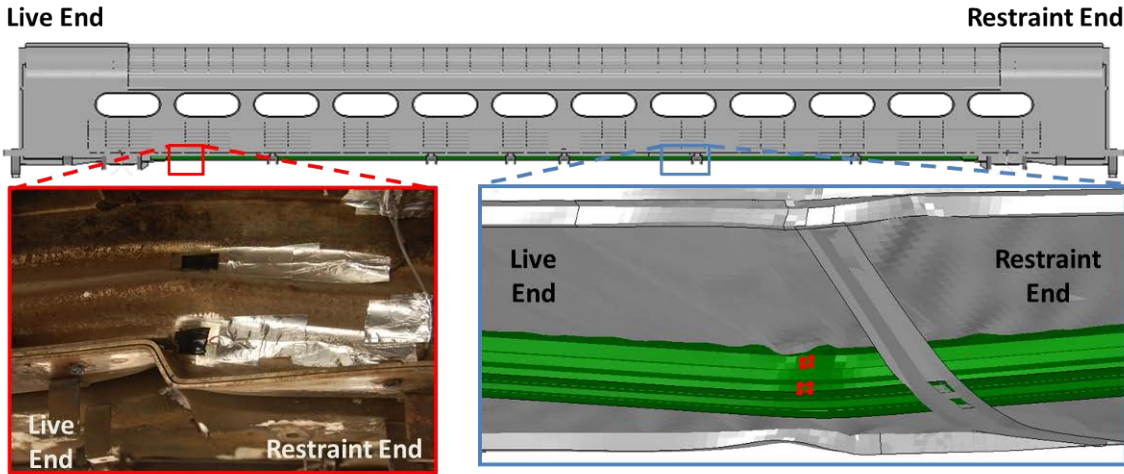
**Figure 87. Crippling Locations for Strain Comparison, FEA (right) and Car 244 (left)**

While the FE model and the tested cars each experienced crippling at different locations, the overall crippling behaviors were very similar. Specifically, the global force-displacement characteristics and the sequences of structural failures were similar for all three results. In order to assess the strain behaviors of Car 244 and the FE model at the location where center sill buckling occurred, data from one location in the test but a different location in the model must be compared. Figure 87 shows an image of the crippled center sill from the FE model and a photograph of one buckled location on the center sill of Car 244. The approximate location of each of these areas of damage is indicated on a profile view of the undeformed car in this figure. Two elements are highlighted in the image of the center sill taken from the FE model, shown at the right in this figure. These two elements correspond to the approximate placement of strain gages on the web of the center sill of Car 244. Two such strain gages can be seen in the left hand side of this figure.
