**Federal Railroad  
Administration**

## **Alternative Occupied Volume Integrity (OVI) Tests and Analyses**

| 4. TITLE AND SUBTITLE<br>Alternative Occupied Volume Integrity (OVI) Testing and Analyses | | | 5. FUNDING NUMBERS<br>RR28A1/JG343<br>RR28A2/JL649<br>RR28A2/KL649 | |
| 9. SPONSORING/MONITORING AGENCY NAME(S) AND ADDRESS(ES)<br>U.S. Department of Transportation<br>Federal Railroad Administration<br>Office of Research and Development<br>1200 New Jersey Avenue, SE<br>Washington, DC 20590 | | | 10. SPONSORING/MONITORING<br>AGENCY REPORT NUMBER<br>DOT/FRA/ORD – 13/46 | |

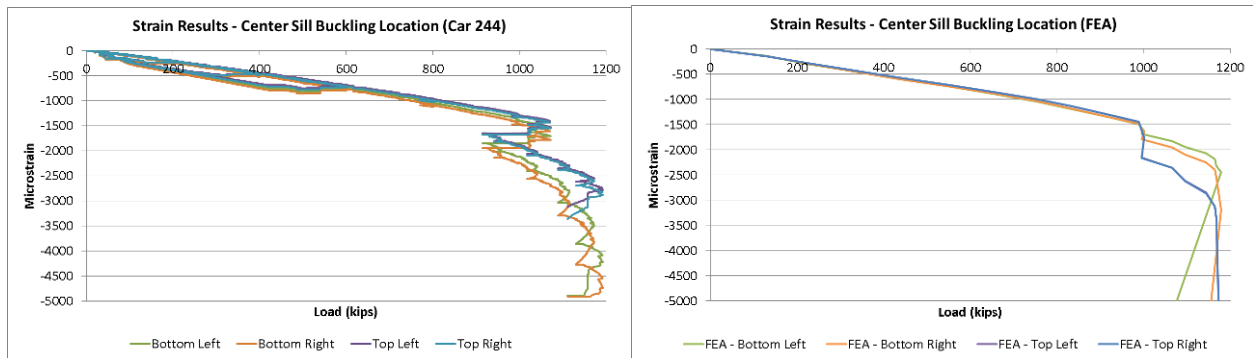
**Figure 88. Strain vs. Load Behavior at Center Sill Buckling Locations, Test (left) and FEA (right)**

The strain versus applied load results from the crippled location on the center sill of Car 244 and the FEA result are plotted in Figure 88. This figure shows the measurements from the four test strain gages on the left; the right shows the calculated strains in the FEA from four elements at the corresponding locations on the center sill at the buckle.

In both the test and the analysis, the strain behaviors are very similar. In both cases, the four strain results overlay one another up to a load of approximately 1 million pounds. The inflection point at approximately 1 million pounds corresponds with buckling of the roof structure. Beyond this load the four strain results begin to diverge in both the test and the FEA. In the test, the two gages at the bottom of the center sill indicate a more rapid change in strain with additional load than do the two at the top. In the FE results, the two locations at the top of the center sill experience greater changes than the two locations at the bottom. Figure 87 shows that the FE results experienced a buckling in the top of the center sill while Car 244's center sill buckled at its bottom. The strain gauges installed on the car during this test had a maximum capacity of  $\pm 3,000$  microstrain. Although the gage reports values up to  $-5,000$  microstrain, these results have greatly exceeded the intended range of the strain gage.

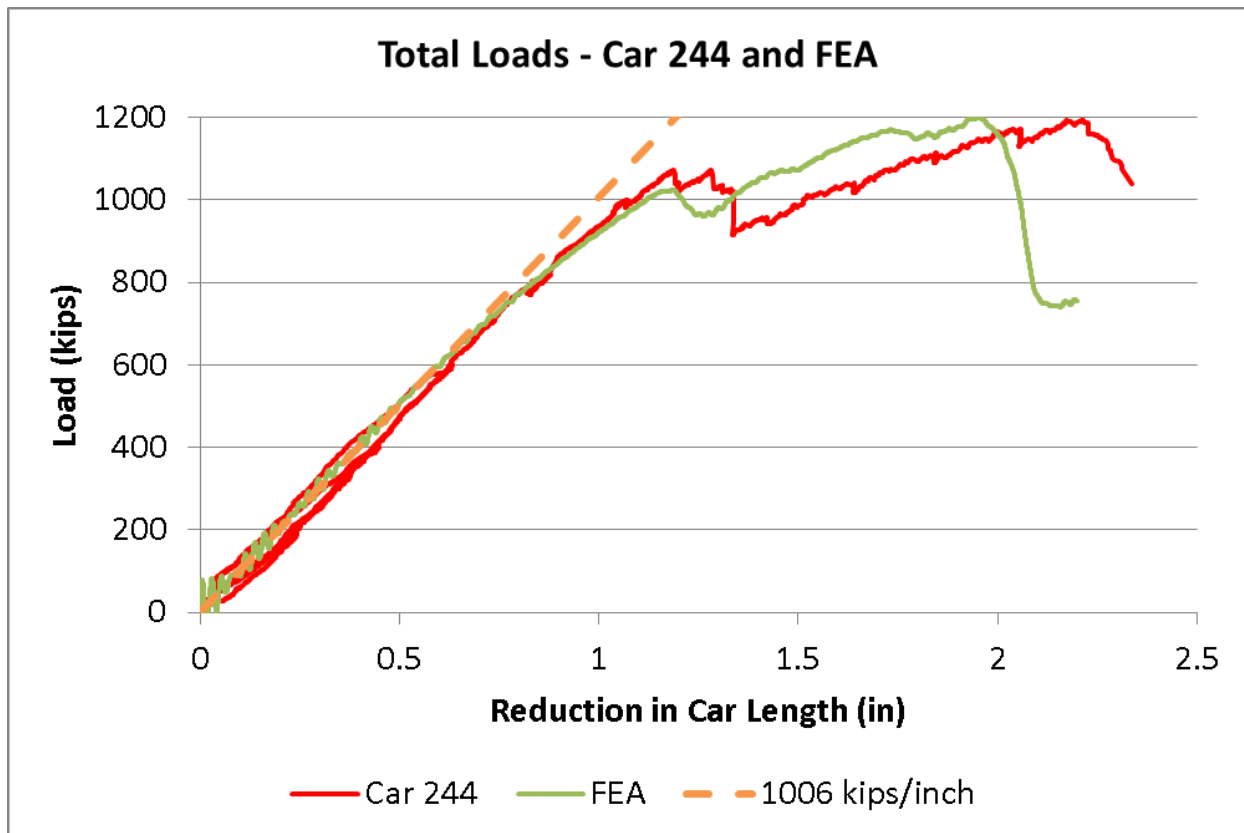
Figure A 1. Estimated Car Stiffness and Reduction in Car Length Results

The Budd Company calculated the Pioneer car to have an effective cross-sectional area of 30.8 in<sup>2</sup>. The length from the energy absorber supports on the live end to the energy absorber supports on the back end measures approximately 871.75 inches. The carbody is made of stainless steel, with a Young's modulus of  $3 \times 10^7$  psi. Substituting these values in Equation 2 gives the estimated stiffness of the car as:

The estimated stiffness of the car is plotted against the applied load versus change-in-car-length data from Car 244 and the crippling FE analysis in Figure A 1.

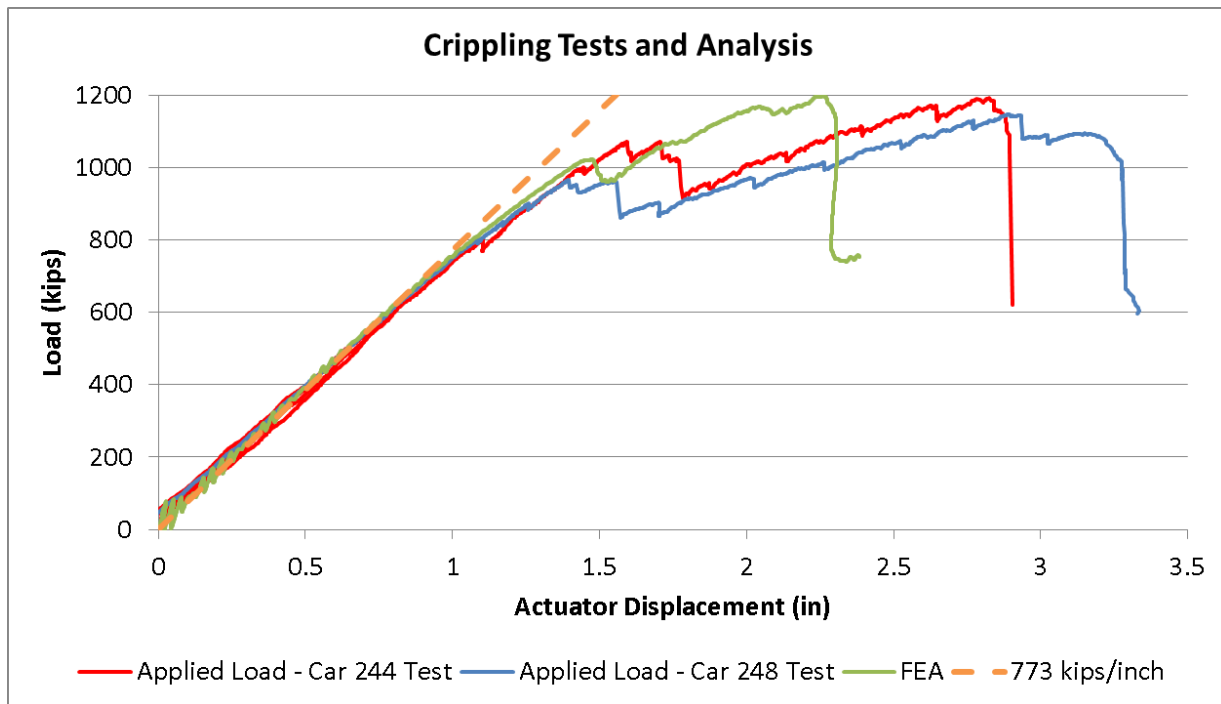
**Figure A 2. Estimated System Stiffness and Load-Actuator Displacement Results**

The estimated system stiffness is plotted against the load-actuator displacement results from the two crippling tests and the crippling FEA in Figure A 2.
