MA 82-18

Air Conditioning Modifications for the GMC RTSII Series 01 Coach (Model TH-8201)

October 1982
Final Report

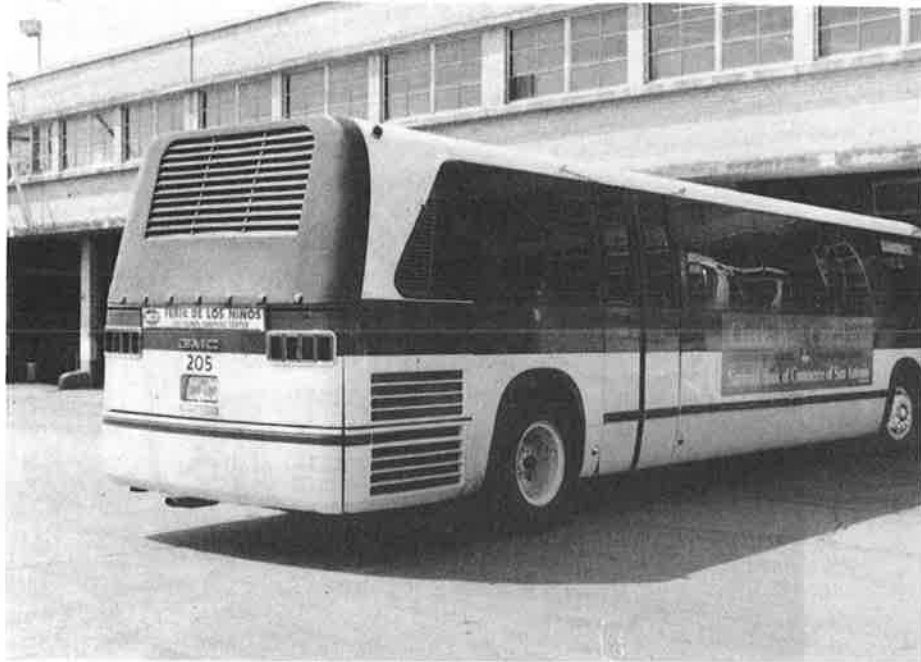
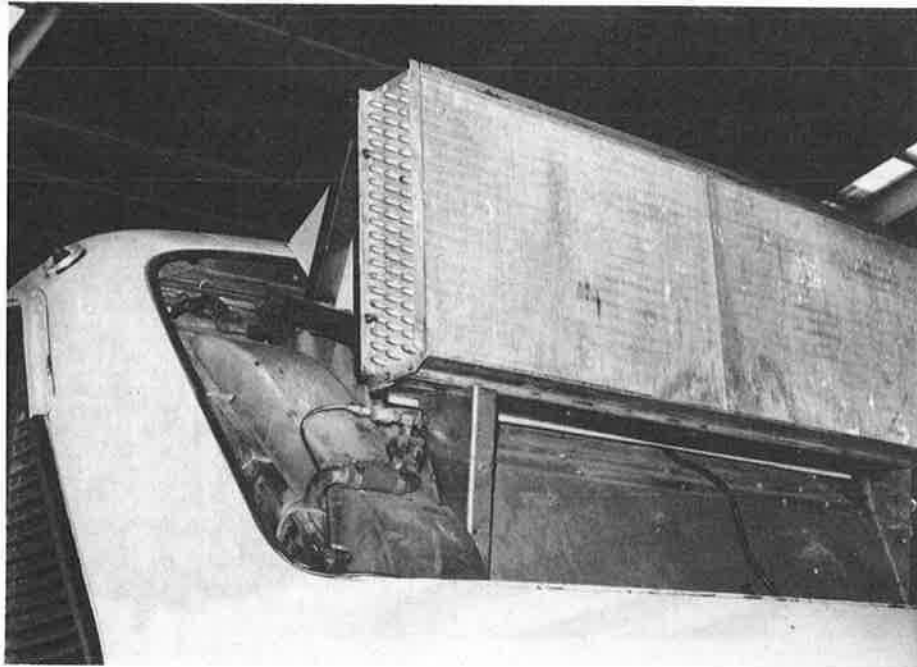
FIGURE 2
Modified RTS II Series 01 Coach

In an effort to alleviate these problems, San Antonio VIA Metropolitan Transit maintenance personnel have developed and implemented modifications to some of the RTS II subsystems. The major air conditioning modification involved replacing the refrigerant condenser with a smaller unit and relocating it outside the engine compartment. The new condenser was mounted along with 2 electric-motor-driven cooling fans just below roof level at the rear of the bus. This modification is illustrated in Figures 1 and 2, which show both the unmodified and modified versions of the RTS II Series 01 coach.
