REPORT NOS. DOT-TSC-NHTSA-79-51

# CORRELATION BETWEEN ULTRASONIC NONDESTRUCTIVE INSPECTION AND WHEEL TEST OF 34 RETREADED TIRES

NOVEMBER 1979

FINAL REPORT

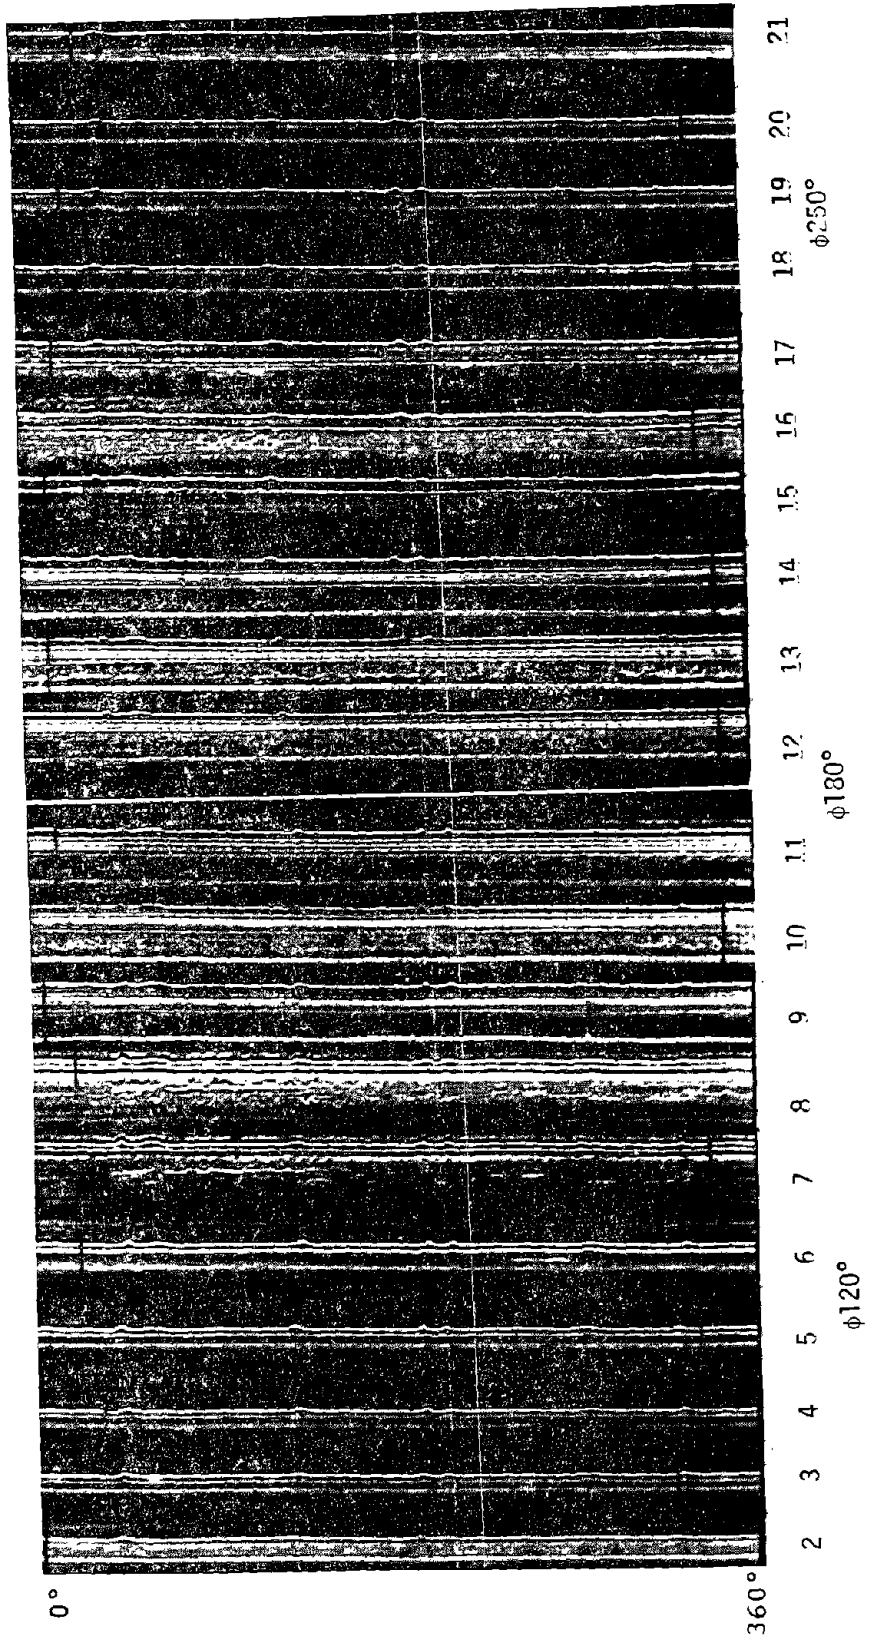
FIGURE 3-1. TIRE TSX 1717

Figure 3-1 is an ultrasonic trace of a good tire. Additional descriptive data concerning ultrasonic inspection may be found in Reference 1 and 4, but a summary is given here to assist in understanding the means by which anomalies are identified. The tire is displayed as if cut at the serial number, opened up and laid out flat. Each channel numbered from 2 to 21 represents a cross-section cut through the tire casing from outside to liner. In each channel, outside is to the left and the liner is to the right. The channels progress from channel 2 which is near the serial side bead to channel 5 near the turnup to channels 8, 11, 16, 18 and 21 which are, respectively, the blackwall or serial shoulder, tread center, the white sidewall shoulder, the white sidewall turnup area and close to the white sidewall bead. In vertical orientation, each channel represents one complete tire rotation, beginning at
