REPORT NO. FRA-OR&D-76-03

# LOCOMOTIVE TO AUTOMOBILE BASELINE CRASH TESTS

R. L. Anderson

AUGUST 1975  
FINAL REPORT

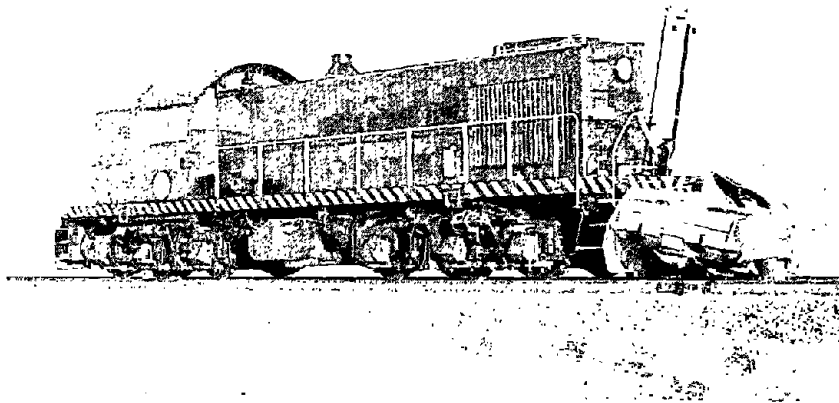
Figure 13. Post-test Orientation of Automobile (Test TGB-1).

Upon impact, the coupler penetrated the automobile just behind the front door. Penetration was almost complete before any significant movement of the rest of the automobile occurred. After 84 msec the coupler was at maximum penetration and the occupant compartment was moving at the approximate velocity of the locomotive. The post-test speed of the locomotive and automobile combination, assuming conservation of linear momentum, is 51.1 mph for a locomotive speed reduction of about 0.8 mph. The front section of the automobile from the firewall forward broke loose and rotated into the side of the locomotive, held only by the sheet metal of the left front fender.

Fuel tank was ruptured

Skid marks showed rear wheels had slid straight sideways but front wheels had rotated immediately with engine dragging before it left the grade crossing

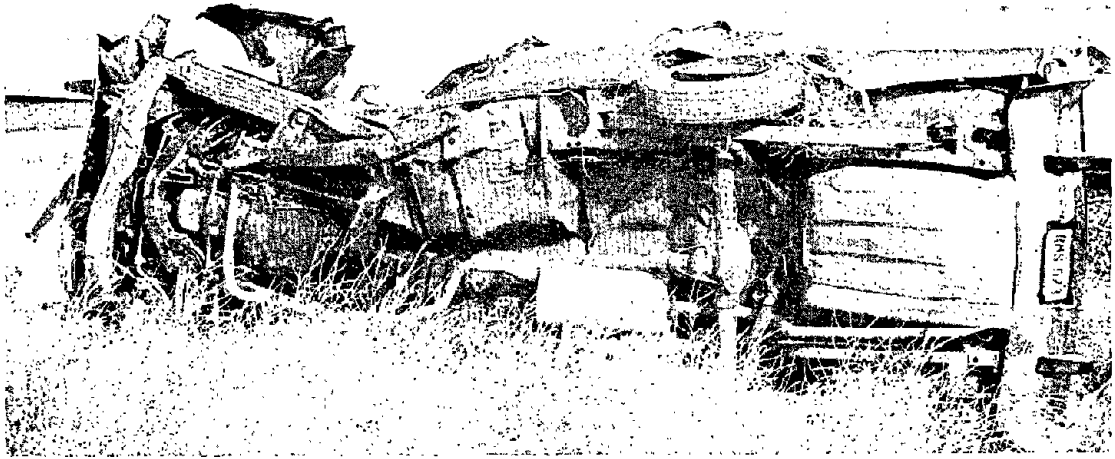
Figure 25. Post-test Orientation of Automobile (Test TGB-2).

The locomotive coupler contacted the left front fender of the automobile above the front wheel. The fender was crushed and the coupler contacted the top part of the engine, crushing the valve cover, cracking the head, and breaking off the carburetor.

Figures 23 and 24 are overall and overhead views of the pre-test impact orientation. Figures 25 through 29 show the post-test deformation of various sections of the automobile.

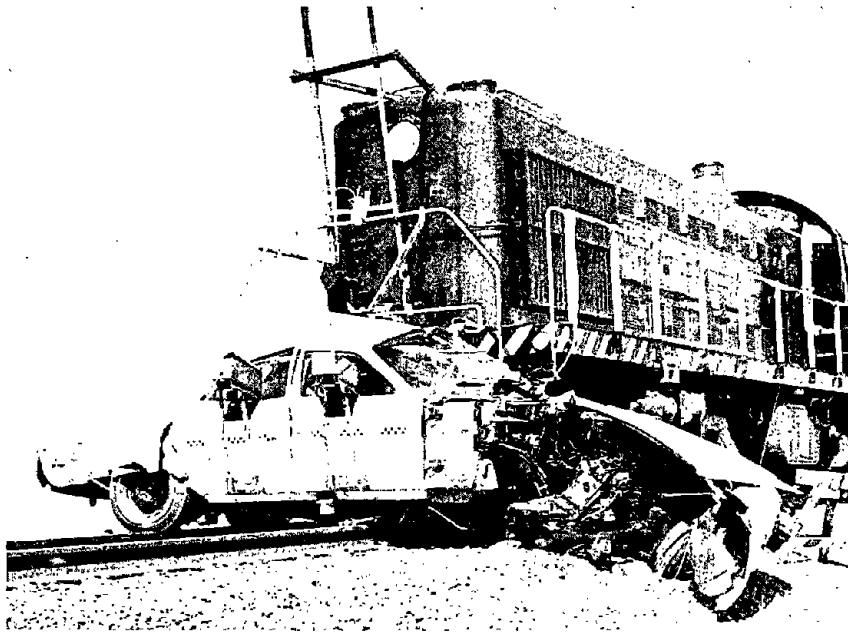
Figure 35. Post-test View of Locomotive and Automobile (Test TGB-3).

Figures 33 and 34 are overall and close-up views of the pre-test impact orientation of Test TGB-3. Figure 35 is an overall post-test view of the automobile and locomotive which shows the broken front section of the automobile as well as the torn right rear fender and overall condition of the automobile. Figures 36,

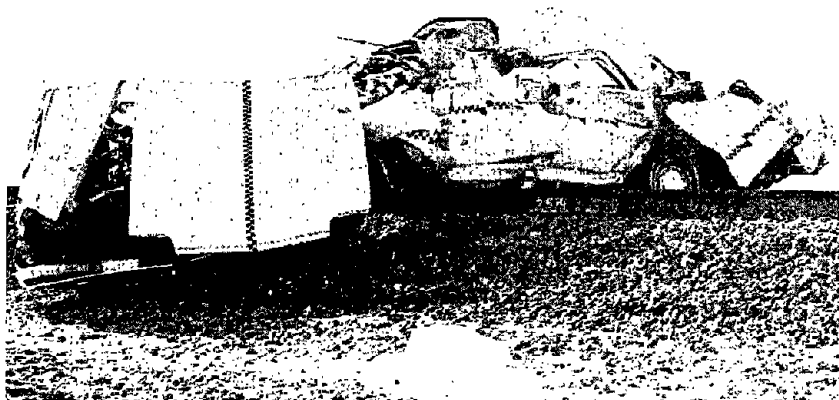
Figure 41. Post-test View of Automobile Showing Imprint of Locomotive Front (Test TGB-3).

Figure 39 is a view of the coupler through the right rear door, showing the intrusion into the occupant space of the automobile. Figure 40 is a post-test view of the dummy in the driver area. The dummy retained its structural integrity with no apparent permanent damage, even though the loads experienced during the impact would have been fatal for a human, as will be discussed later. After the front section of the automobile was pulled back, the locomotive was simply backed away from the automobile leaving an imprint as shown in Figure 41.

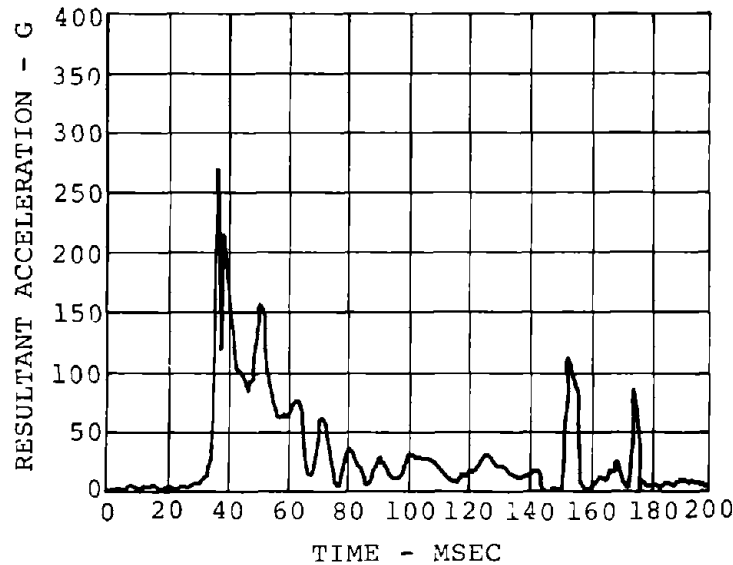
Figure 48. Resultant Dummy Head Acceleration (Test TGB-3).

The occupant of the automobile is of utmost concern in a grade crossing accident. The dummy in the driver location simulates a human occupant. Figure 48 is the time history of the resultant dummy head acceleration. The maximum resultant acceleration was 277G at 36 msec. The two most common measures of impact severity based upon head acceleration are the Gadd Severity Index (SI) and the Head Injury Criterion (HIC). These criteria are based upon studies that attempt to correlate human trauma and injury to accelerations of the head. The severity index is defined as follows:

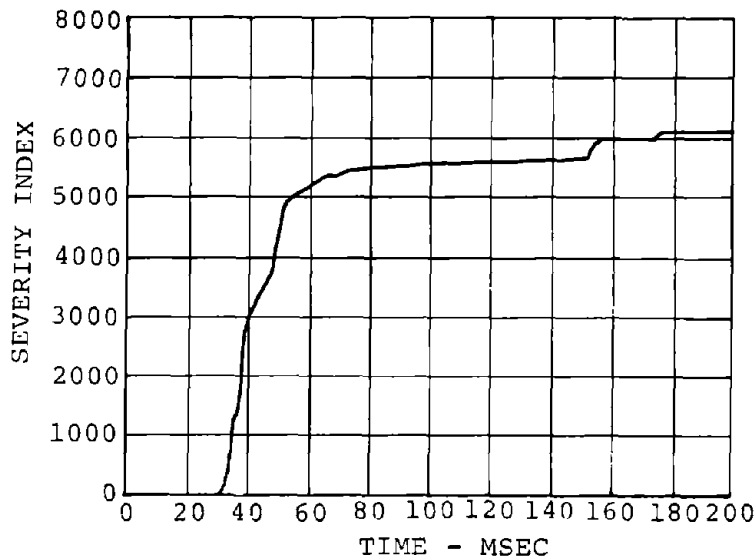
Figure 49. Severity Index for Dummy Head During Test TGB-3.

A plot of the severity index is shown in Figure 49. When SI exceeds a value of 1000 the excessive acceleration is considered to have been fatal if a human had been in place of the dummy. For Test TGB-3 the SI exceeded 1000 at 36 msec. At the end of the computation interval of 200 msec the value of SI had risen to 6062.

If the value of HIC exceeds 1000 for any interval  $t_2 - t_1$  the impact is considered fatal. The HIC for TGB-3 was 3821.

These measures, along with the overall observation of the extent of damage to the automobile, confirm that the impact was not survivable.

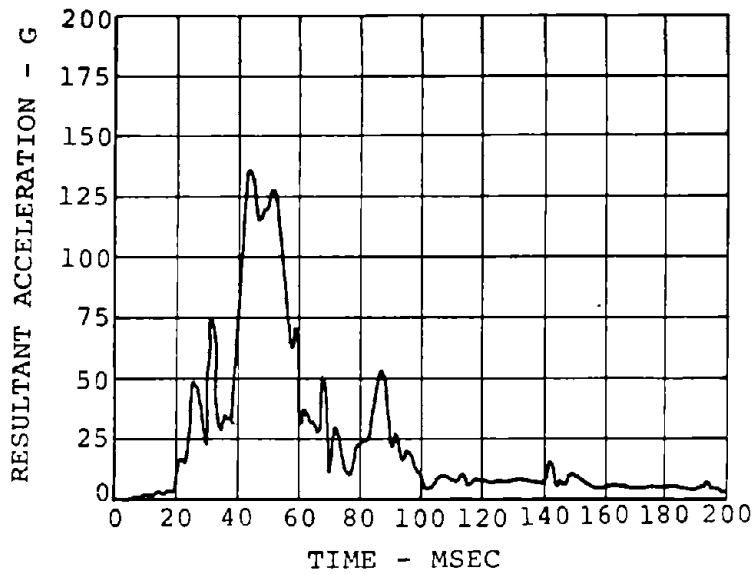
Figure 50. Thorax Acceleration During Test TGB-3.

The dummy thorax resultant acceleration is shown in Figure 50. The maximum thorax resultant acceleration was 136G at 44 msec. The two injury criteria for the thorax acceleration involve the SI and the length of time the acceleration exceeds 60G. Figure 51 shows the thorax SI versus time. When the SI exceeds 1000, the impact is considered fatal. This condition occurred at 45 msec for the dummy thorax during test TGB-3 which is just prior to the dummy head striking the window header.

If the resultant acceleration exceeds 60G for more than 3 msec, the impact is fatal. For Test TGB-3, the resultant dummy thorax acceleration exceeded 60G for 22 msec.

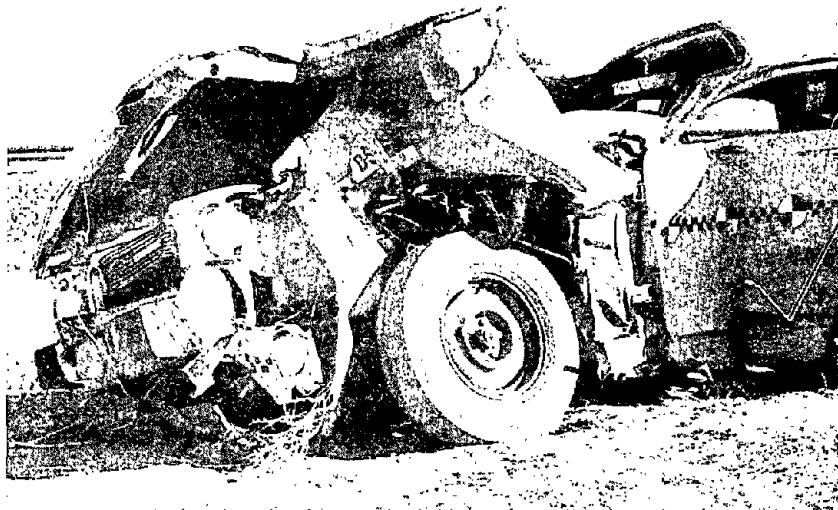
Figure 56. Post-test View of Impact Area (Test TGB-4).

Figure 56 shows the post-test impact point. The coupler contacted the engine head, resulting in a crack in the head.

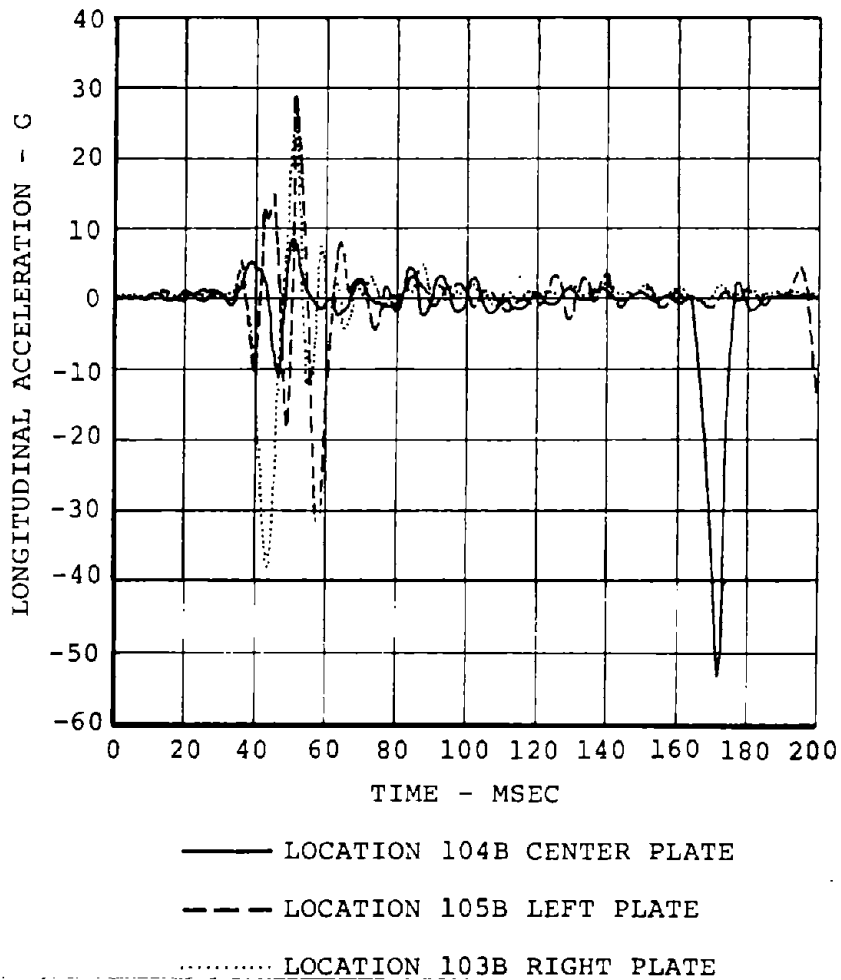
Figure 64. Comparison of Longitudinal Accelerations on Front Plate of Locomotive (Test TGB-4).

Figure 64 shows the longitudinal accelerations of the accelerometers superimposed on the front plate of the locomotive during Test TGB-4. The acceleration at Location 104B had a lower peak than the accelerations at Locations 103B and 105B since the accelerometer was attached to the massive support structure of the coupler.

The high amplitude vibration (between 40 and 60 msec) of the front plate occurs when the automobile structure is in contact with the locomotive. The automobile also experiences a high acceleration during this time. Since the locomotive did not sustain any significant deformation and did not experience any significant change in velocity, the majority of the acceleration seen on the front plate is simply a vibration, which explains both a positive and negative acceleration. The large negative spike in Location 104 near 170 msec coincides in time with the automobile pulling free of the locomotive coupler and probably represents the force required to detach the automobile from the locomotive.

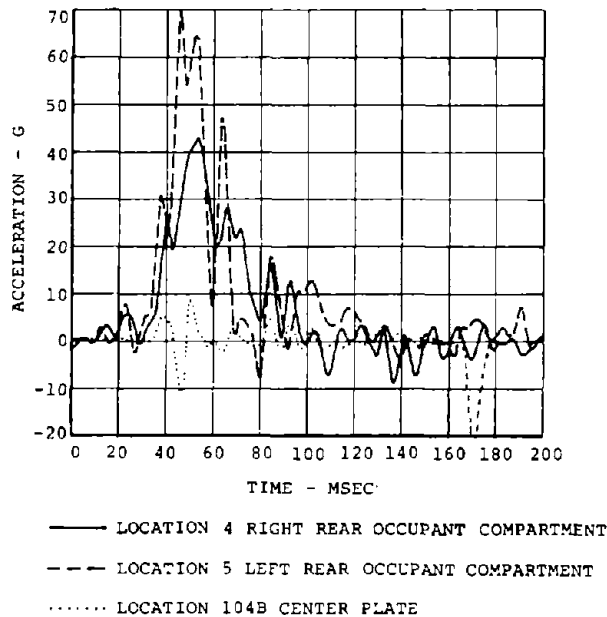
Figure 65. Comparison of Occupant Compartment Accelerations With Locomotive Center Front Plate Acceleration (Test TGB-4).

Figure 65 compares the acceleration at Location 104 (on the center of the locomotive front plate) with the accelerations of the occupant compartment. As anticipated, maximum peaks in both the locomotive and automobile curves occur close to the same time.

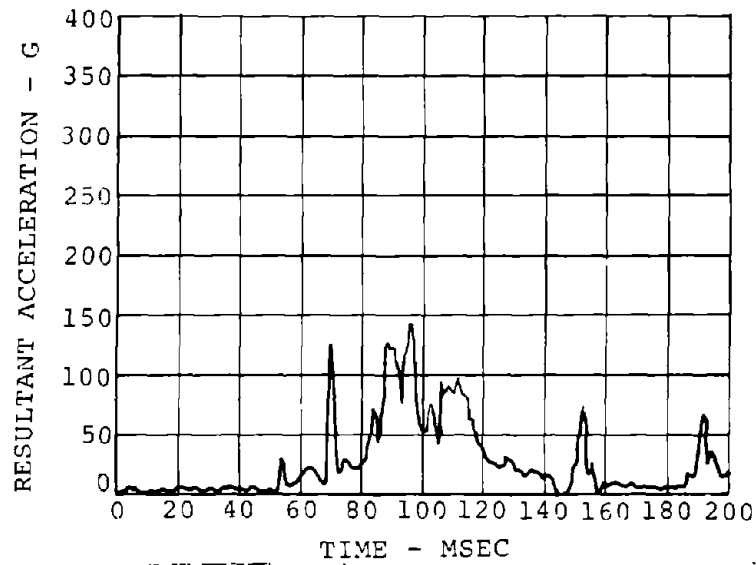
Figure 66. Resultant Head Acceleration (Test TGB-4).

The occupant accelerations are of utmost concern since they are the most direct indication of impact severity. The anthropomorphic dummy in the driver location represents a human occupant. Figure 66 is the time history of the dummy head resultant acceleration. The maximum acceleration of 141.2G occurred 96 msec after initial impact. The SI and HIC injury criteria were defined in Section 5.3. For Test TGB-4, the head SI exceeded 1000 at 90 msec and reached 3121 by the end of the event (200 msec). A plot of the head SI versus time for this test is shown in Figure 67.

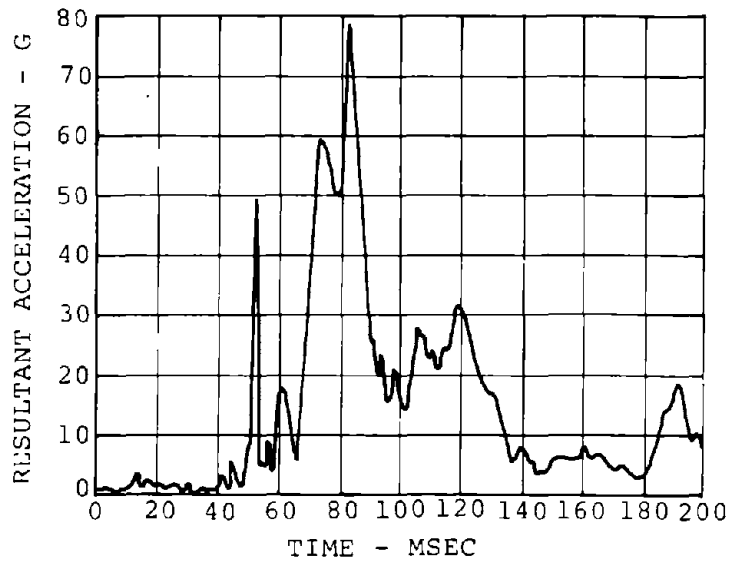
Figure 68. Resultant Thorax Acceleration (Test TGB-4).

The resultant thorax acceleration is presented in Figure 68. The injury criterion for the thorax is also summarized in Section

5.3. The thorax had a maximum resultant acceleration of 79.4G 80 msec after impact. The thorax acceleration exceeded 60G for a total of 6 msec. Figure 69 is a plot of thorax severity index versus time. For this test, the thorax severity index was only 640.

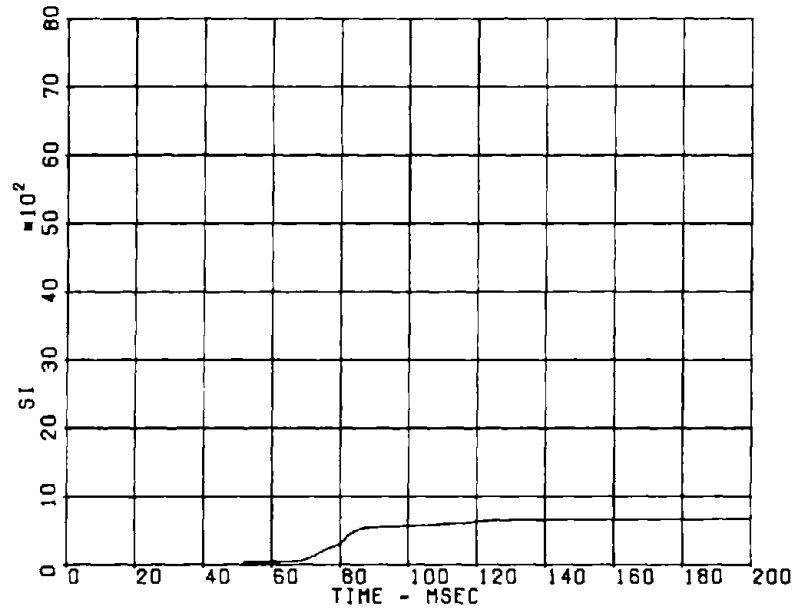
Figure 69. Thorax Severity Index Versus Time.

Observation of the damage to the automobile along with the high values of the injury criteria substantiate that the impact of Test TGB-4 would have been lethal for a human occupant.

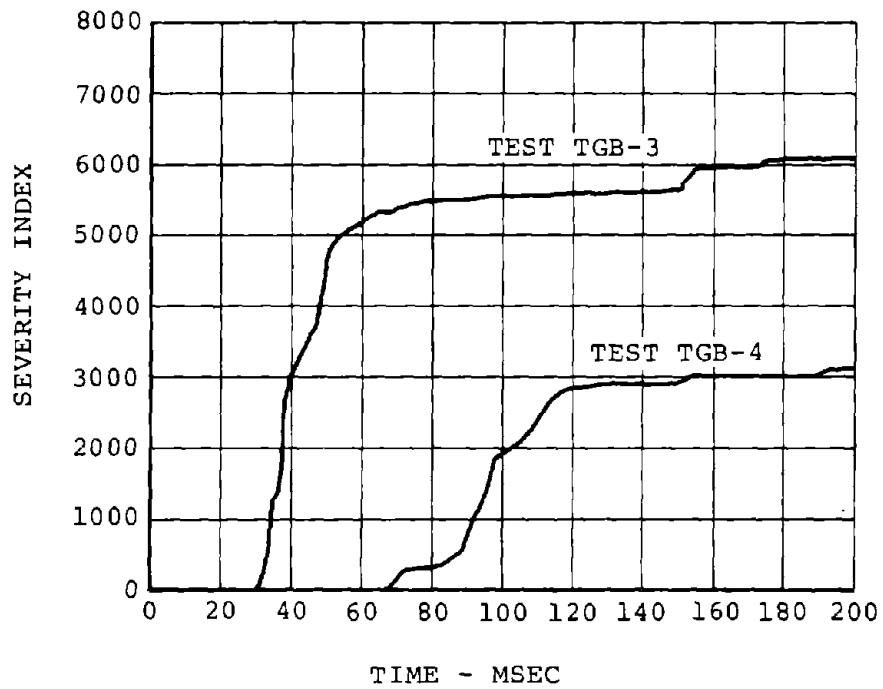
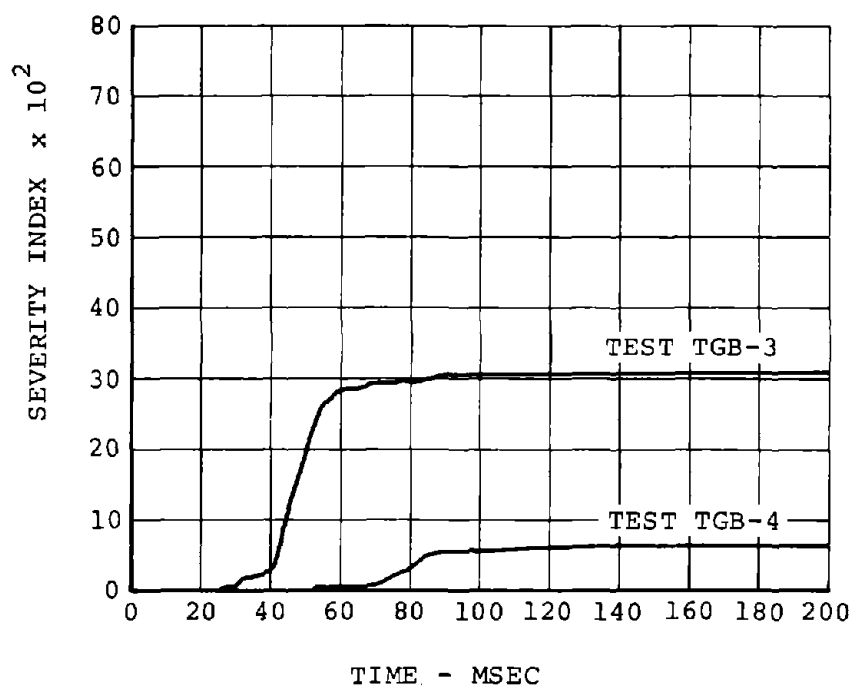
Figure 70 compares the Severity Index for the dummy head between Tests TGB-3 and TGB-4. Figure 71 provides a comparison of the severity index for the thorax between Tests TGB-3 and TGB-4.

TABLE 28. SUMMARY OF IMPACT SEVERITY FOR ANTHROPOMORPHIC DUMMIES DURING TESTS TGB-3 AND TGB-4		
	Test TGB-3	Test TGB-4
Head SI after 200 msec	6062	3121
Time at which head SI >1000	36 msec	90 msec
HIC	3821	2142
Thorax SI after 230 msec	3005	640
Time at which thorax SI >1000	45 msec	-
Time resultant thorax acceleration > 60G	22 msec	6 msec
