Water Intrusion Problems in Transit Tunnels

P. Parks
J. Francis
A. Gorlov
E. Gorlova
J. D. Guertin, Jr.

Paul Parks and Associates, Inc.
Engineering & Management Consultants
100 Boylston Street
Boston MA 02116

September 1986
Final Report

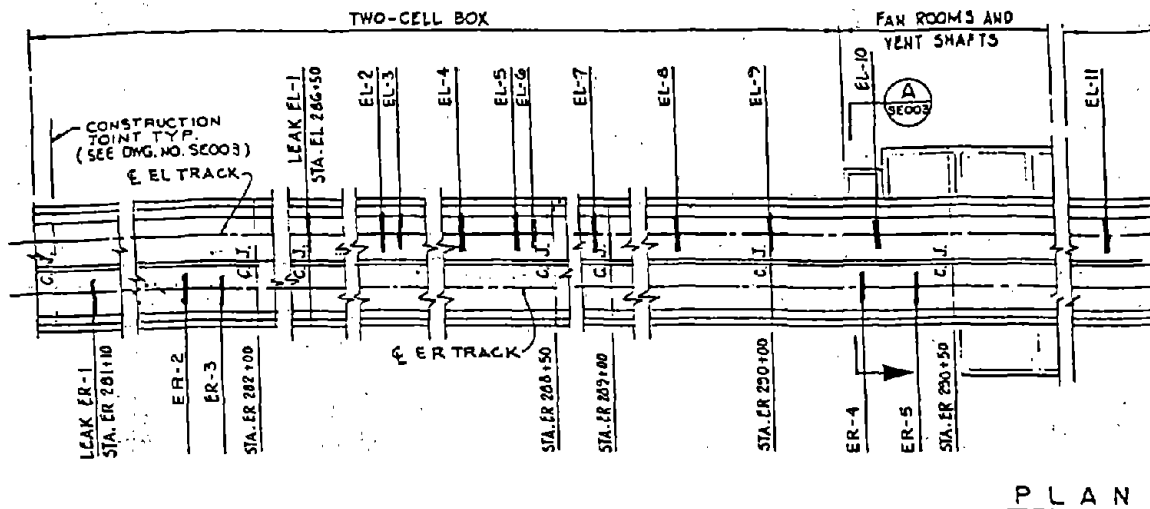
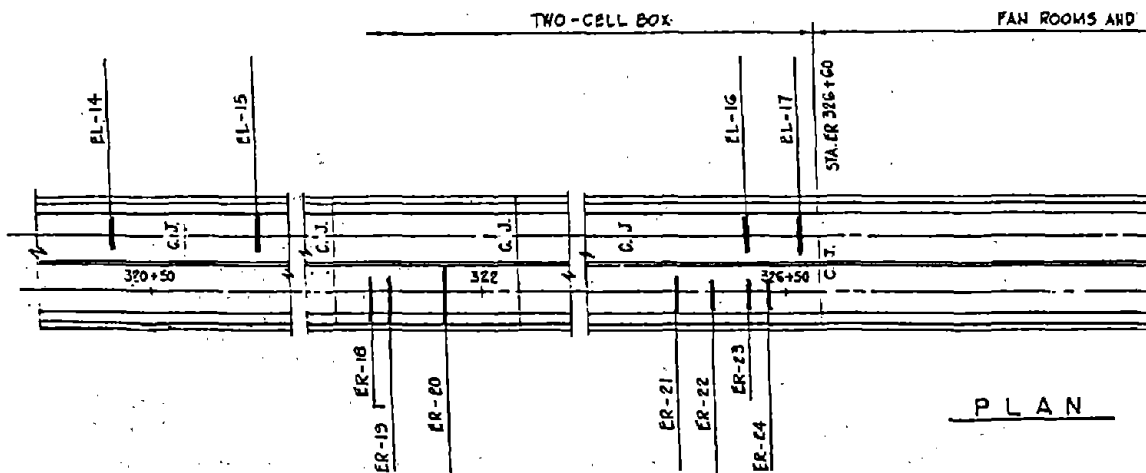
FIGURE 6.2 EAST LINE SUBWAY STRUCTURE - LEAK LOCATIONS

Figures 6.2 and 6.3 show the number of leak locations. As can be seen, the frequency of leaks at some tunnel segments reaches a magnitude of 15-20 leaks per 100 ft.

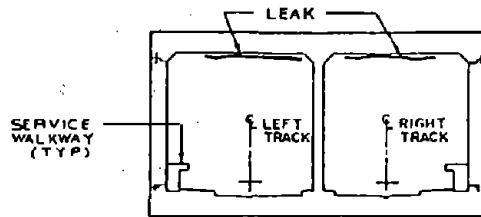
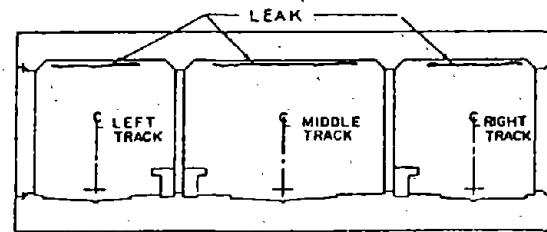
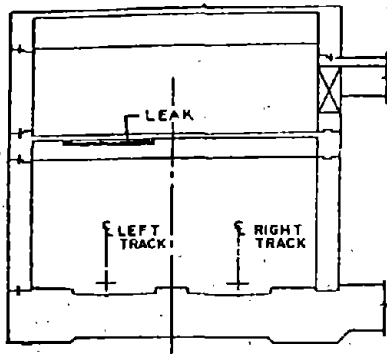
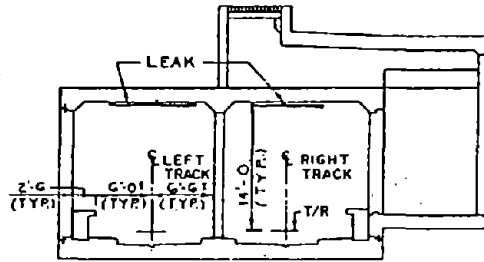
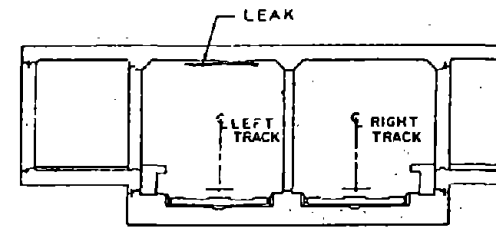
FIGURE 6.8 LEAKS AT SUBWAY STRUCTURES IN WEST LINE

Figures 6.7 and 6.8 demonstrate various types of leaks and their locations in the MARTA Subway System. Figure 6.7 shows numerous leaks through the concrete ceiling of "Five Point" Station. Figure 6.8 shows numerous leaks in West Line tunnels where locations of leaks were mainly through the concrete walls and ceilings in different cross-sections of tunnels.

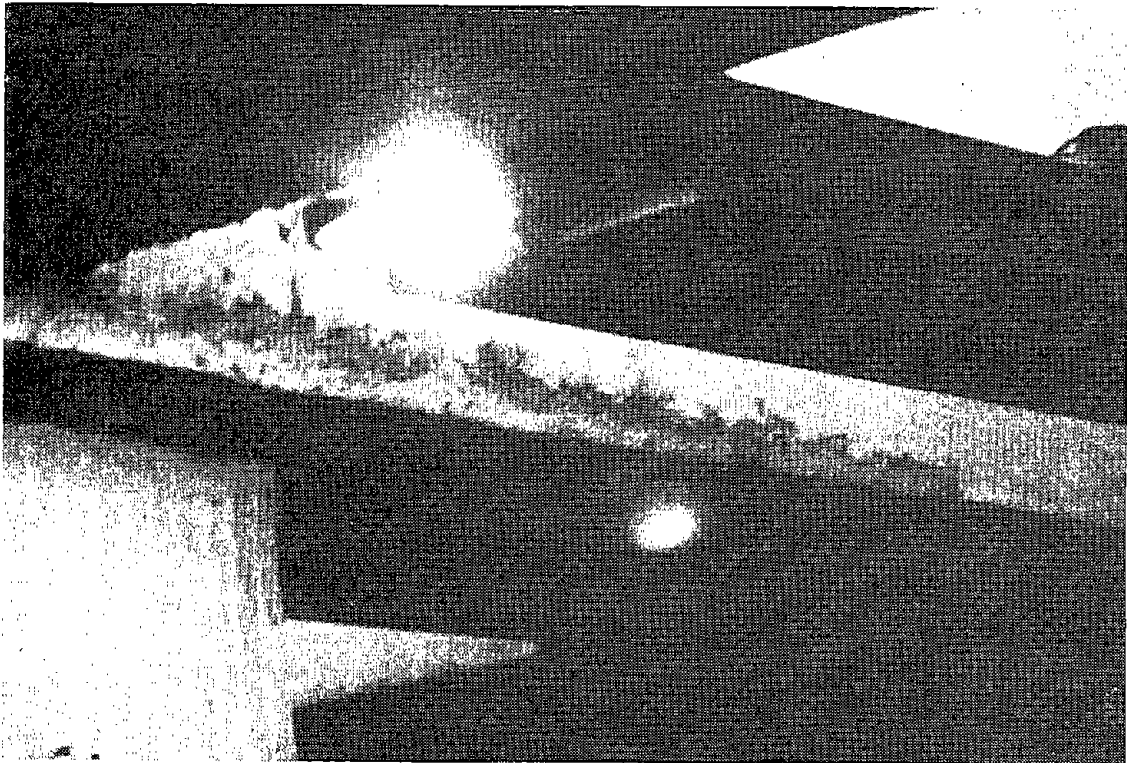
The surface of some structural concrete elements such as ceiling beams remains permanently wet due to hidden water leaks behind the finish of walls and ceilings, as shown in Figure 7.8.

FIGURE 7.8 WET CEILING BEAMS (BLUE LINE, AQUARIUM STATION)

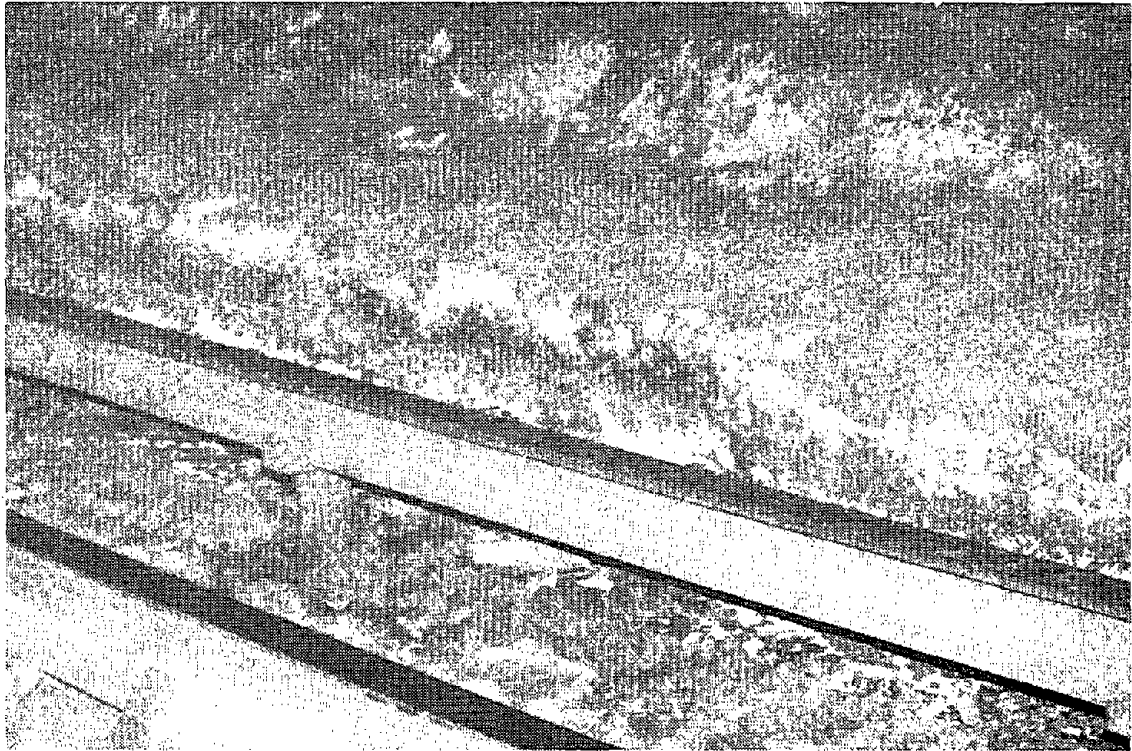
Figures 7.17 and 7.18 demonstrate the conditions of the station tracks. In Figure 7.17 one can see a heavy precipitation in the area of the third rail. Figure 7.18 shows part of the track bed where the ballast was washed out almost

FIGURE 7.17 CALCIFICATION IN AREA OF THIRD RAIL (ORANGE LINE, ESSEX STATION)

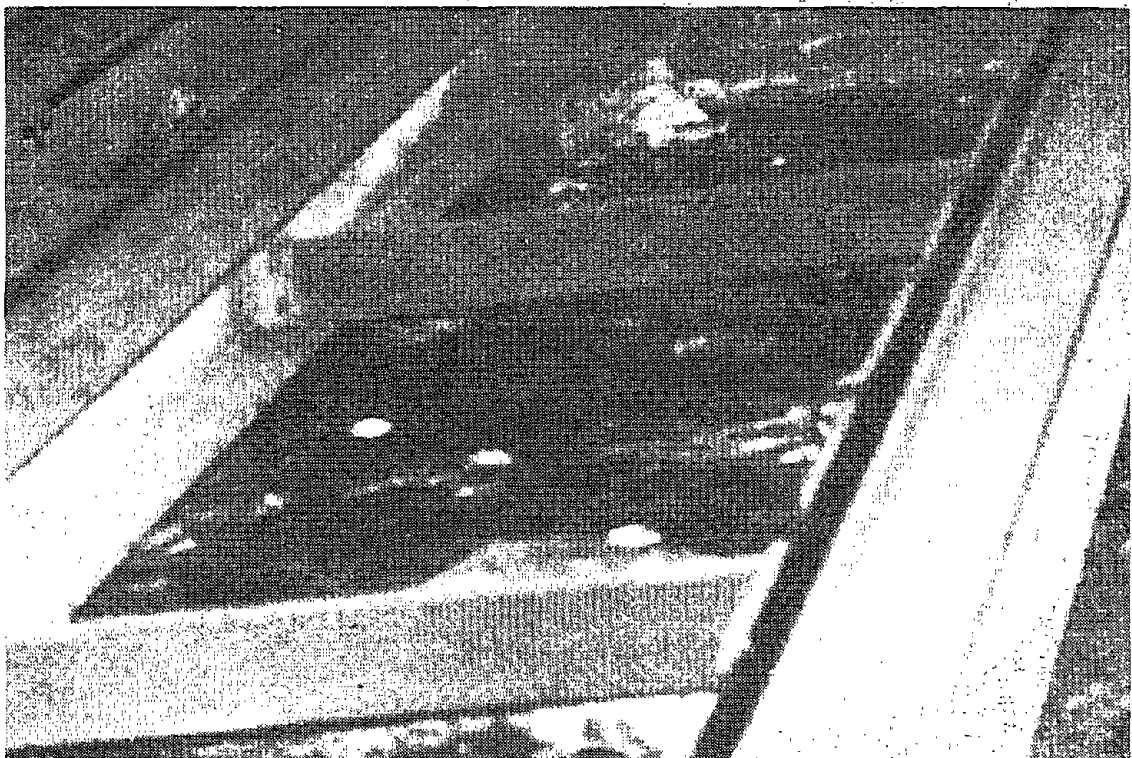
FIGURE 7.18 AREA WHERE BALLAST IS WASHED OUT COMPLETELY (ORANGE LINE, ESSEX STATION)

entirely. To prevent disintegration of the rail track due to the absence of ballast, both rails were bolted together with the transverse beam (see Figure 7.18).

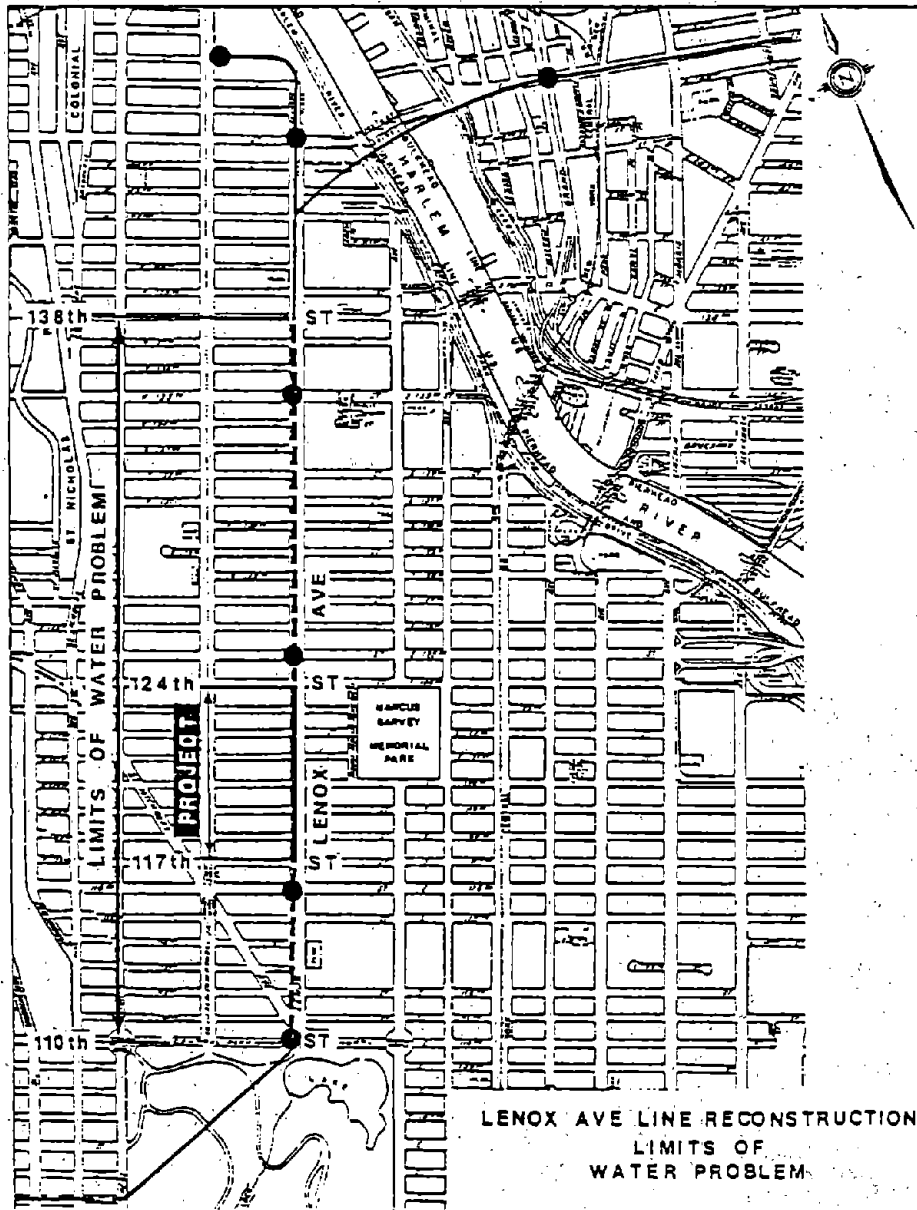
FIGURE 9.14 LENOX AVENUE LINE - PROPOSED RECONSTRUCTION

Over the years of operation the tunnel structures have seriously deteriorated (see Figure 9.6), allowing a tremendous water inflow. Due to this problem, NYCTA proposes to rebuild the invert and to repair tunnel structures on the Lenox Line between 117th Street and 124th Street. The proposed Lenox Line reconstruction is shown on Figure 9.14.
