PROOF PRESSURE EVALUATION OF WORN PASSENGER CAR TIRE CARCASSES

S. K. Clark
R. N. Dodge
D. W. Lee
J. R. Luchini

The Regents of the University of Michigan
Ann Arbor MI 48109

NOVEMBER 1976
FINAL REPORT

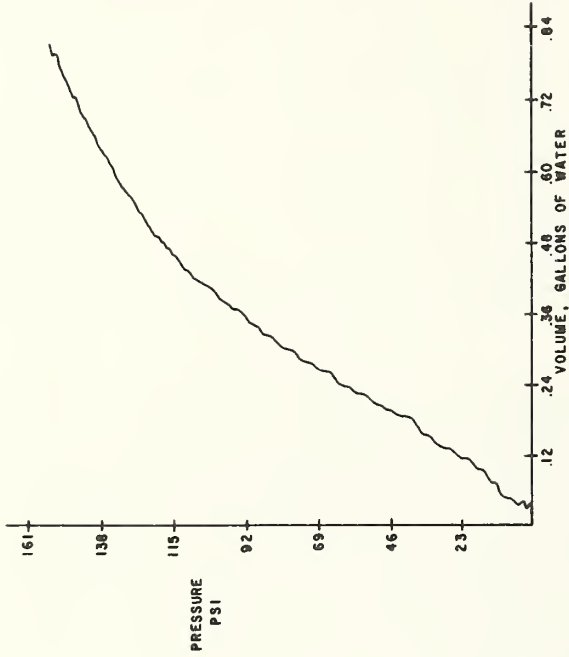
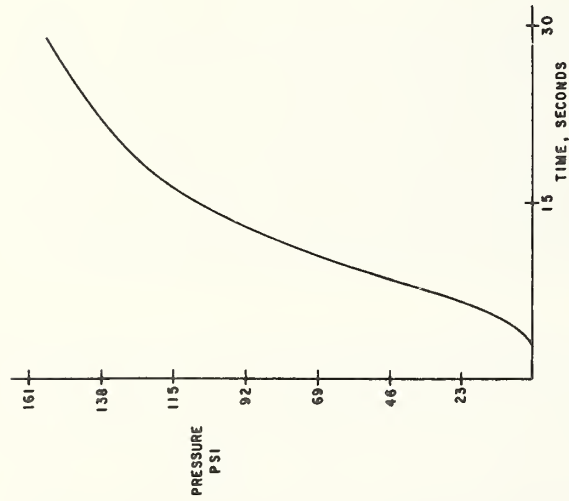
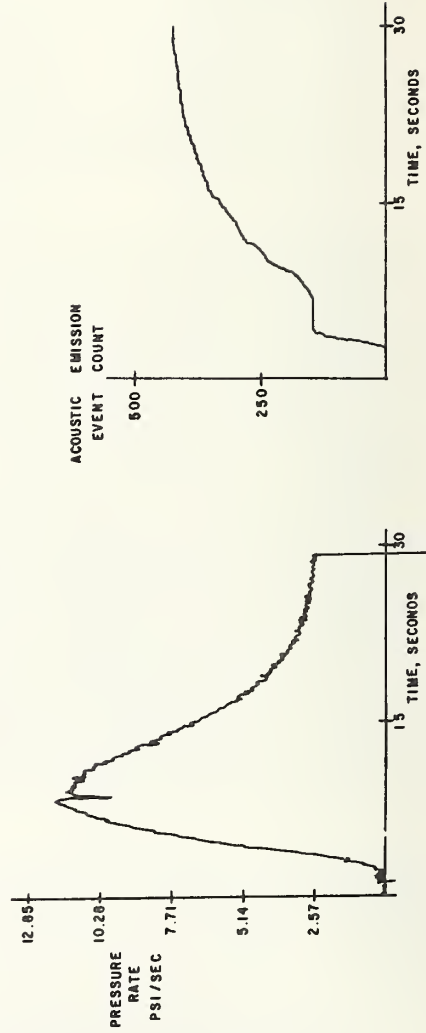
FIGURE 1. DATA FOR 165-SR 14 RADIAL-PAIRED EXPERIMENTS

During the pressurization process internal pressure, contained volume, pressure rate, and acoustic emission output were recorded as functions of time. This data is described more fully in the present report. However, consideration of the data showed that only limited correlation can be made between this data and tire carcass characteristics. There is only minimal benefit to the use of the pressurization process as a screening device prior to recapping. For example, Figure 1 gives data taken from a typical radial tire which could be considered in good condition, suitable for retreading. Forcing water at nearly a constant volume rate into the tire results in pressure and acoustic emission output which probably is to be normally expected for a composite structure such as this. There is no clear way that departures from linearity can be used as an indication of impending structural failure such as is common in pressure vessel testing. Later results showed that probably the most significant flaw which could be located by means of the pressurization process was a small hole or leak not evident upon visual inspection. This type of flaw is difficult to detect in normal retreading practice and yet appears quite clearly in the pressurization process, where leakage of fluid can be sensed.

- (a) The pressurization process applied to a sound tire carcass has no effect, either detrimental or beneficial, on the subsequent tire durability after recapping.
- (b) The proof pressure process appears to have limited benefit in the selection or screening of worn tire carcasses for the retreading

industry. It cannot be used as a substitute for good visual and tactile inspection technique, although it is capable of detecting pinhole leaks in used carcasses.

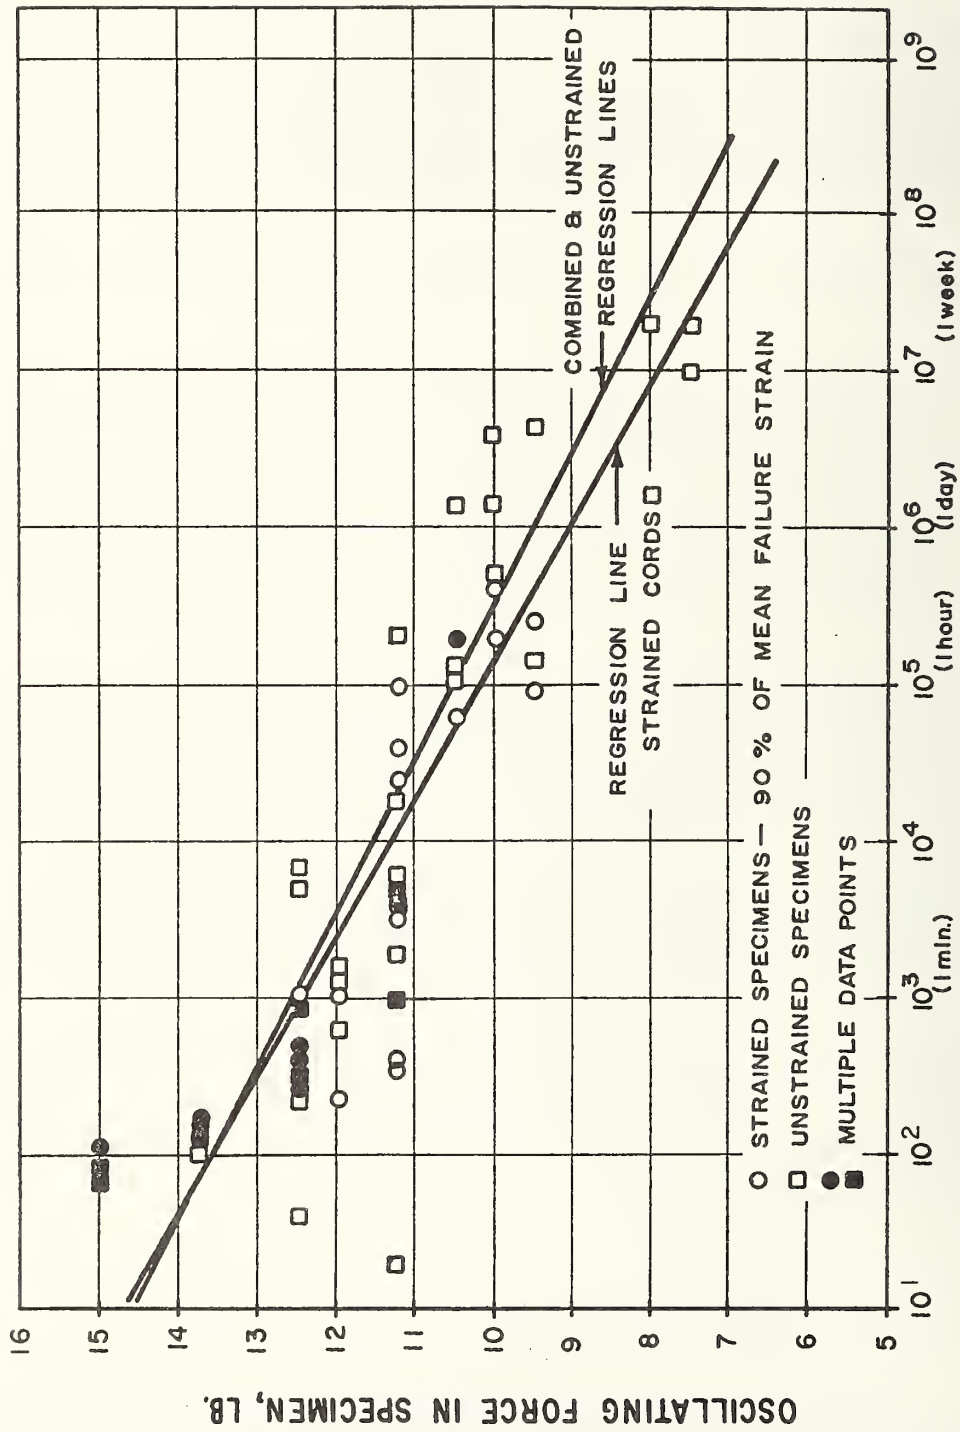
FIGURE 2. CYCLES TO FAILURE VS. OSCILLATING FORCE LEVEL FOR DIPPED NYLON CORD

The data obtained is shown in Figure 2.

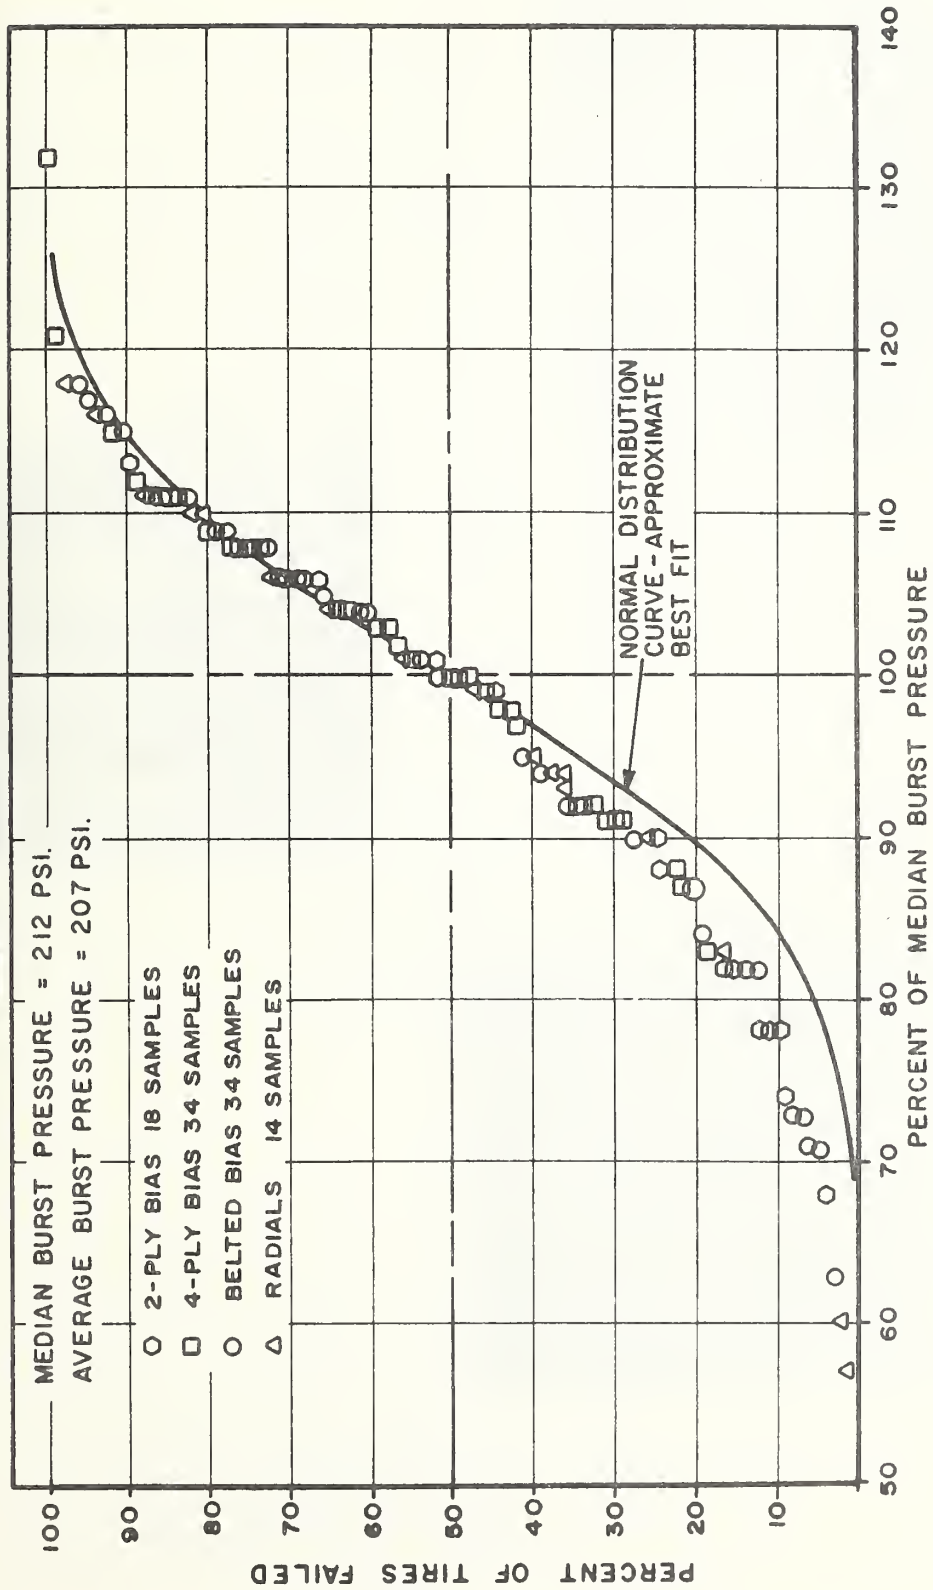
FIGURE 3. PERCENTAGE FAILURE RATE AFTER 100 TESTS

After nearly fifty tires had been burst, an analysis of the completed test data showed results significantly less disperse than originally anticipated. The plot of percent of tires failed versus percent of mean burst pressure showed a curve of a continuous nature, but with some gaps in it. It was felt that this curve could be made more useful if more data points were included, so all extra tires at the laboratory not scheduled for later experiments were designated E tests and were burst, and this data was added to the plot. Most of the gaps existing in the fifty-tire data plot were filled in with this new data. In total, approximately fifty additional tires were burst. The complete data set is shown in Figure 3. For the second fifty tires, no randomized sequence was explicitly developed, since after the first half of the testing program it was apparent that the burst test results were independent of test order. It should be noted that this doubling of the sample size affected the median burst pressure by only three psi and the mean burst pressure by only 2 psi, or about 1%. This tends to support the view that the original population of fifty tires gave a good statistical measure of 15-in. tire burst pressure.

The data of Figure 3 may be compared with a normal distribution curve centered about the 100% of median burst pressure and arbitrarily adjusted to pass through the data point (132% mean burst pressure, 100% failed). This is the uppermost data point shown in Figure 3. It is seen that the data points follow the normal distribution quite well, and if we delete the very low burst pressure data, points probably could be adjusted to fit even better. The low burst pressure points are suspect since the tires causing them may have been damaged in service.

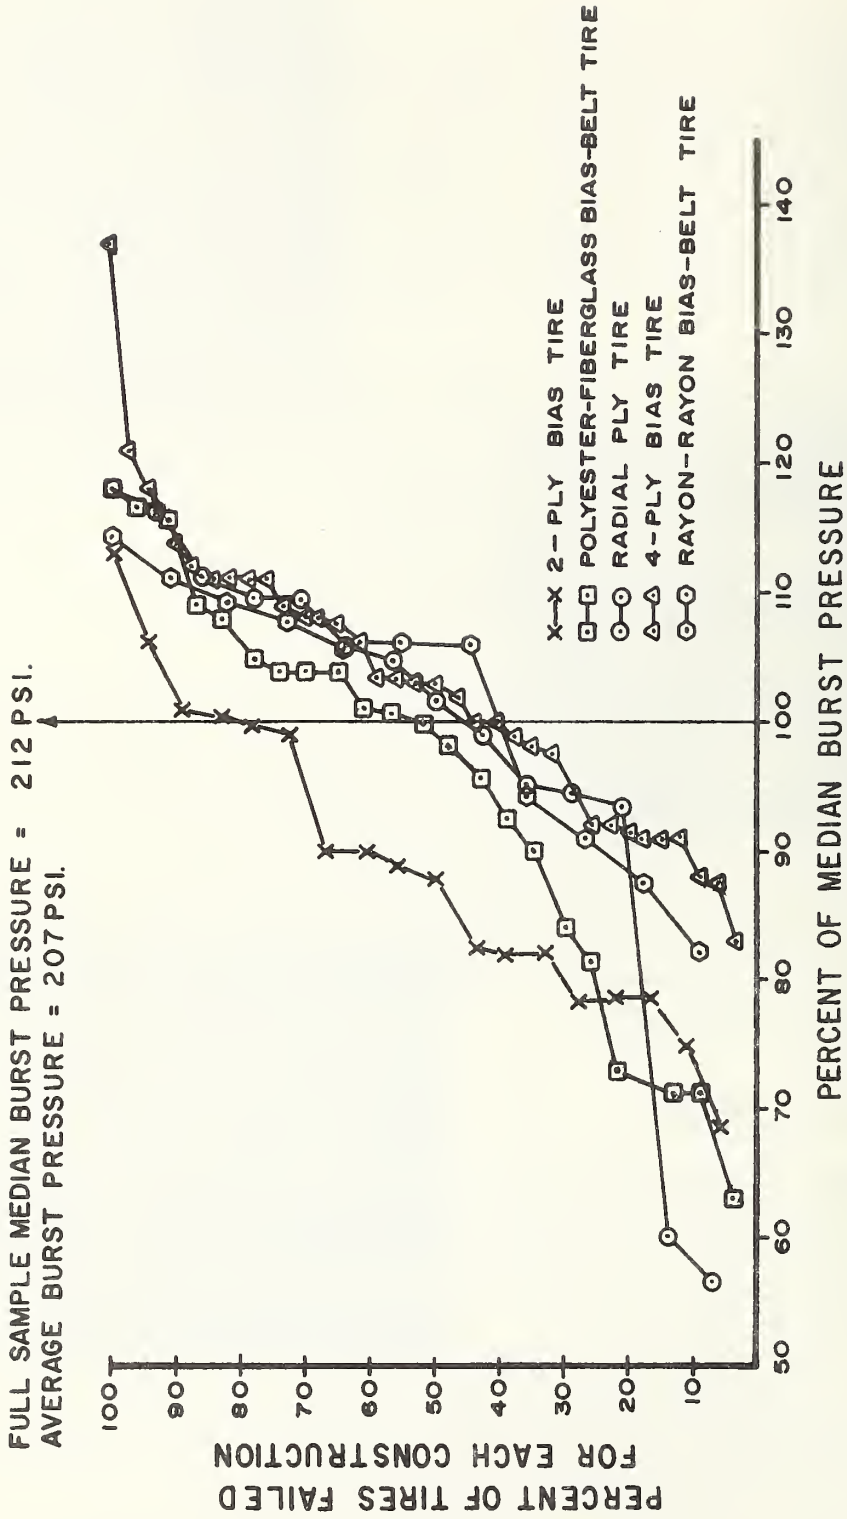
FIGURE 5. PERCENTAGE FAILURE RATE FOR EACH CONSTRUCTION RELATED TO THE FULL SAMPLE MEDIAN

Of final note is the cumulative distribution of failure pressure for each of the construction groups, which are plotted with respect to the full sample median in Figure 5. This graph is of particular importance in the selection of the pressure at which the carcasses are to be proof tested. This graph shows that the selection of a single pressure for all constructions may be prejudicial against certain constructions due to their lower burst pressure. Although there is not adequate data for statistically accurate conclusions, it appears likely that the two-ply bias tires and the polyester-fiberglas bias-belted tires will be penalized by a single pressure value, provided that the proof pressure is chosen high enough to cull out a significant portion of them by burst.
