FTA-MA-26-0031-94-1
DOT-VNTSC-FTA-94-9

Detectable Warnings: Testing and Performance Evaluation at Transit Systems

Final Report
November 1994

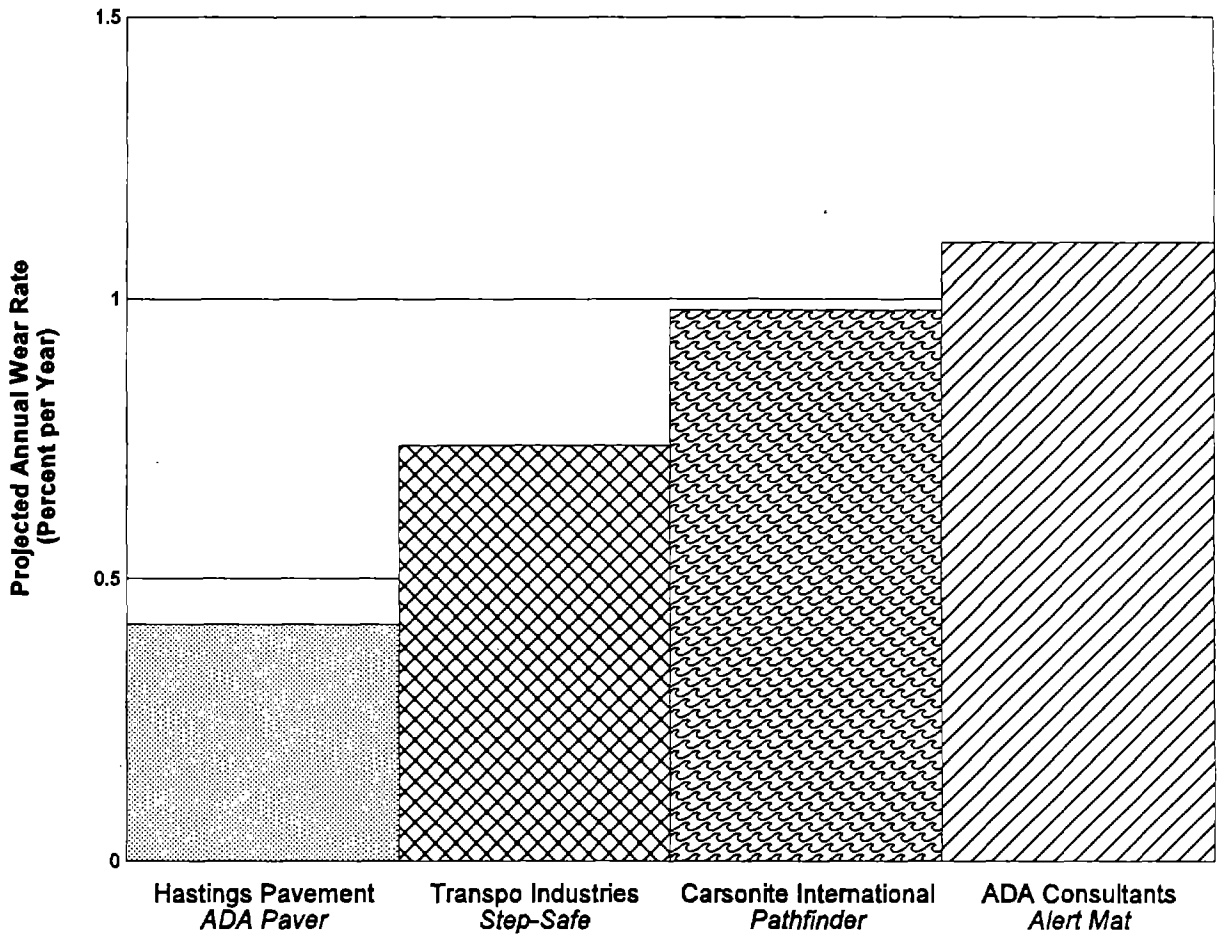
Figure 3-9 presents the projected annual wear rate for the materials installed at GCRTA's Brookpark station. This is a relatively low passenger volume station (estimated by GCRTA at 650 riders per day). The annual wear rates range from approximately 0.4 percent to 1.1 percent. This indicates that the wear resistance of all of these materials is satisfactory. If the indicated wear rate is consistent over a long term, such as 10 years, the average dome height would only be reduced by 4 to 11 percent.

Figure 3-9
Projected Annual Wear Rate of Detectable Warning Materials at Platform Edge for
Low Passenger Volume Station at GCRTA (Brookpark)

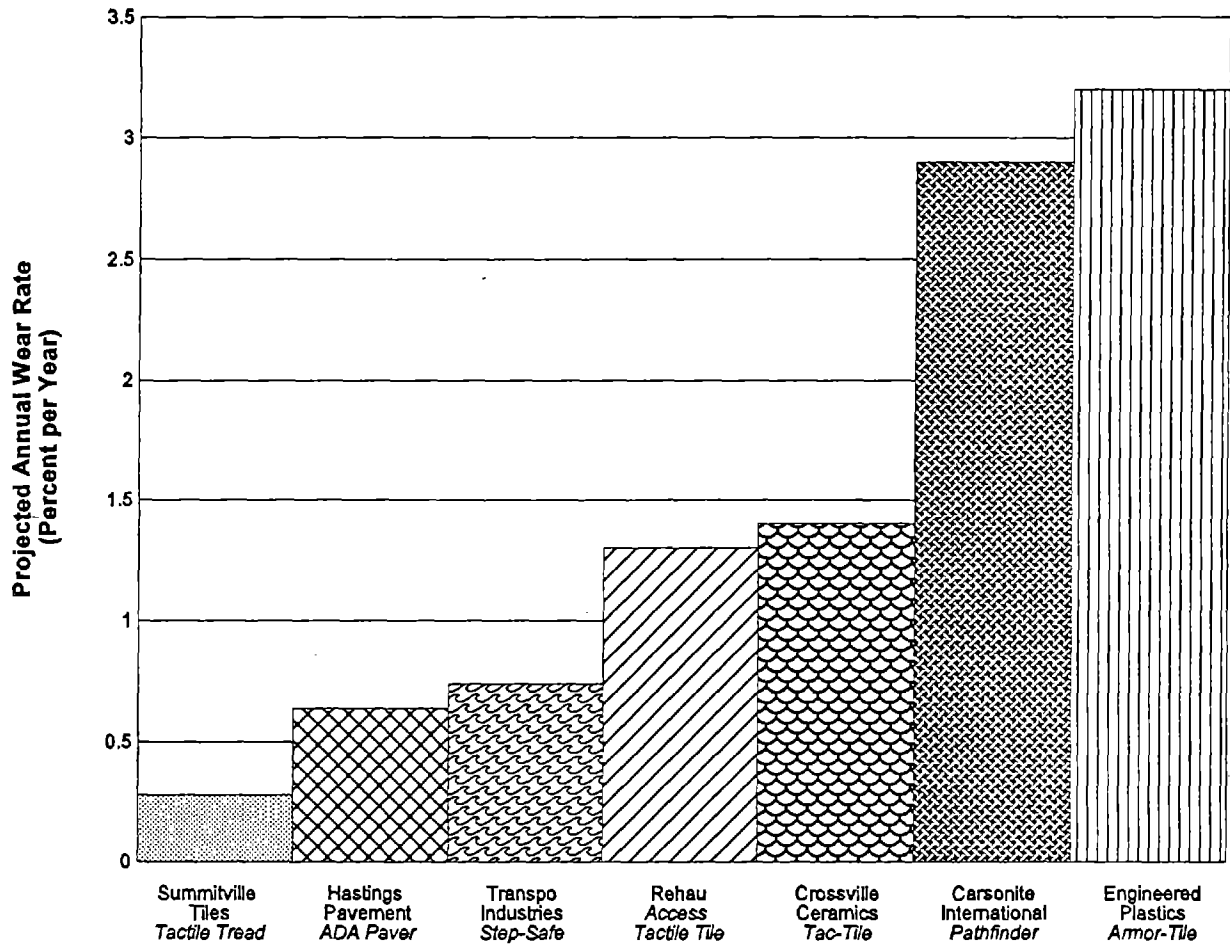
Figure 3-10 presents similar information on projected annual wear rates for the seven detectable warning materials installed at the MBTA South Station site. This station is a high passenger volume station with an estimated 16,275 passengers per day, approximately 25 times greater than that of the Brookpark station. In this case, the projected annual percentage wear rate ranges from a low of 0.28 percent to a high of 3.2 percent. The highest wear rate would result in a 32% average reduction in dome height over a period of 10 years, assuming that the rate remained constant over that period.

Figure 3-10
Projected Annual Wear Rate of Detectable Warning Materials at Platform Edge for High Passenger Volume Station at MBTA (South Station)
