HOLOGRAPHIC TECHNIQUES FOR NONDESTRUCTIVE TESTING OF TIRES

Contract No. DOT-TSC-NHTSA-72-4
April 1972
Interim Report

U.S. DEPARTMENT OF TRANSPORTATION
NATIONAL HIGHWAY TRAFFIC SAFETY ADMINISTRATION
WASHINGTON, D.C. 20590

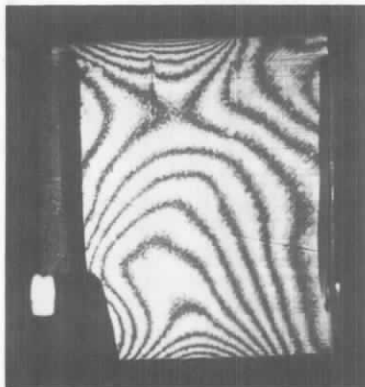
Figure 2. Holograph Interferogram of Rubber/Cord Specimen with No Defect

Figure 2 shows an interferogram of a specimen with no defects. Only gross fringes from creeping rubber are visible. Figure 3 is a specimen with a separation in the central area. Concentric rings show the location and size of a separation. The fringe density is an indication of the severity of the separation.

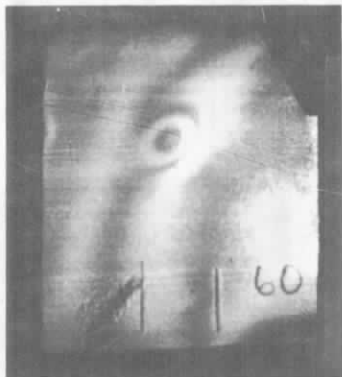
a. 1 inch separation, 2 ply specimen, 0.55 thick, $\Delta P=15$ torr

b. 1 inch separation, 2 ply specimen, 0.32" thick, $\Delta P=15$ torr

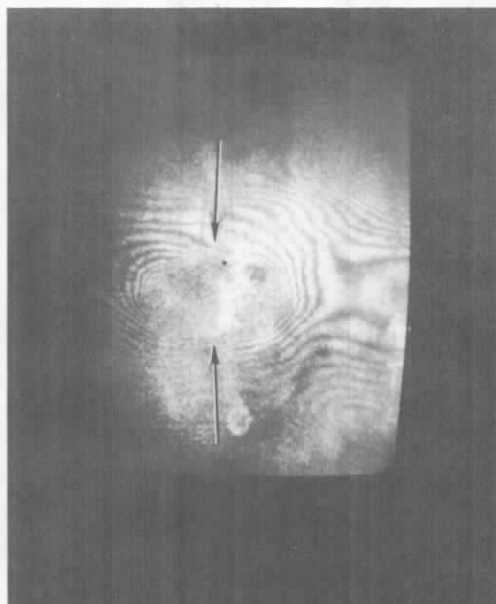
Figure 23. Holographic Interferogram of Tire (# ϕ 1T6061)

Figure 22 is a photograph of a section of a tire which has a separation between the plies of the carcass. Figure 23 is an interferogram of that portion of the tire. The arrows show the location of the separation. Notice that the fringe density of this type of separation is very high. This is typical for separations between the inner plies which are near the inner exposed surface of the tire.

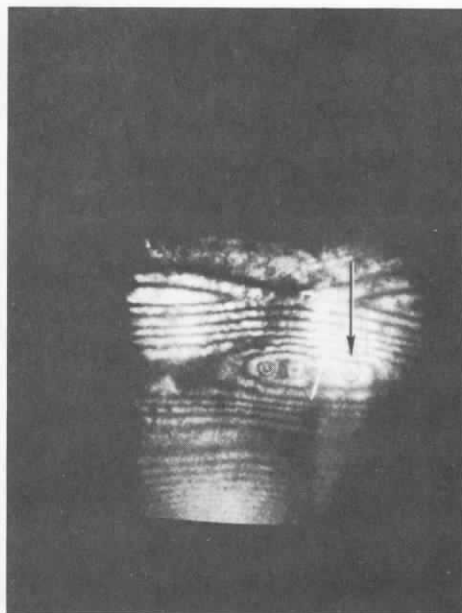
Figure 25. Holographic Interferogram of Tire (#ϕ1T6142)

Figure 24 shows a photograph of a section of a retreaded tire which has a separation at the junction of the new tread rubber and the old carcass rubber. This is a defect commonly found in failed retread tires. Figure 25 is an interferogram of that same portion of the tire. The arrow locates the position of the separation. Notice that the fringe signature of the separation contains only a few fringes. This is usually an indication that the separation is not near the surface exposed to holographic exposure.

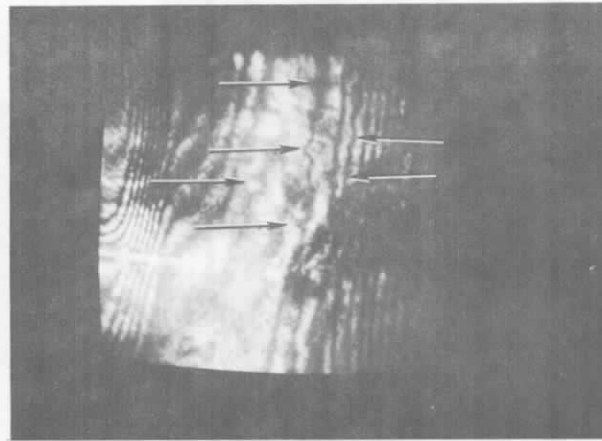
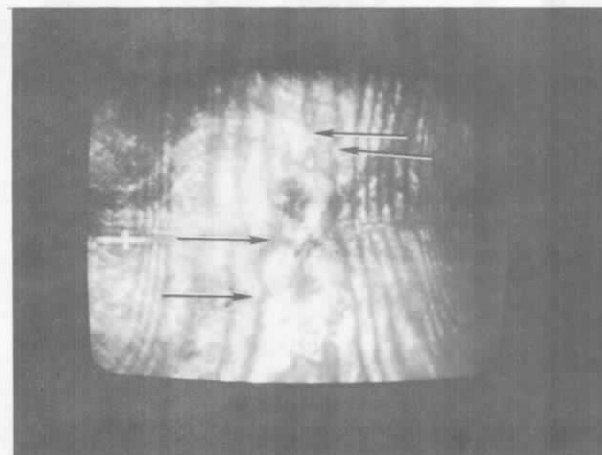
Figure 26. Irregularities in Gross Fringe Pattern

The interferograms in Figure 26 show irregularities in the gross fringe pattern. Tires exhibiting this type of signature have failed during wheel tests. Studies are currently underway to identify the anomaly.

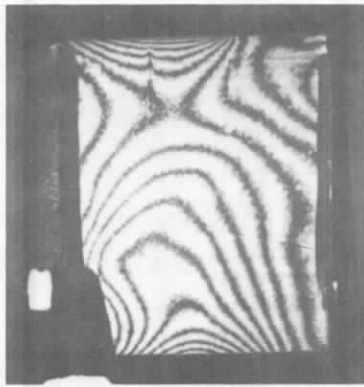
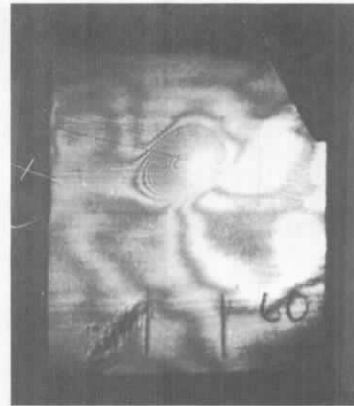
Figure B-5. Holograms of Rubber/Cord Specimens

(a) Rubber/Cord Specimen with No Defects

(b) Rubber/Cord Specimen with a 1 Inch Separation

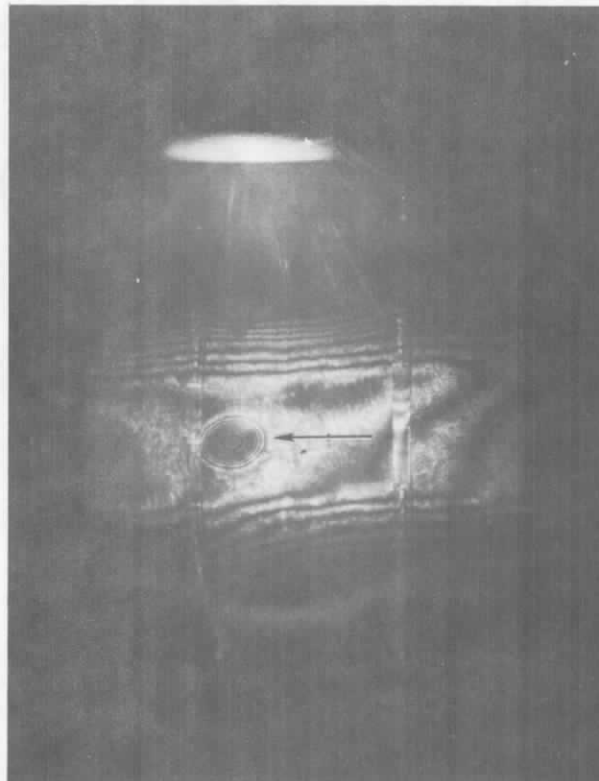
Figure C-7. Holographic Interferogram of a Tire with a Separation Between the Tread and Top Belt

The separation is indicated by the arrow. The fringe signature shows the separation to be circular in shape and approximately 1 inch in diameter. The low fringe density (6 fringes) can be an indication that the separation is not near the inner surface. This is true for this particular tire since the separation is between the belt and the tread.

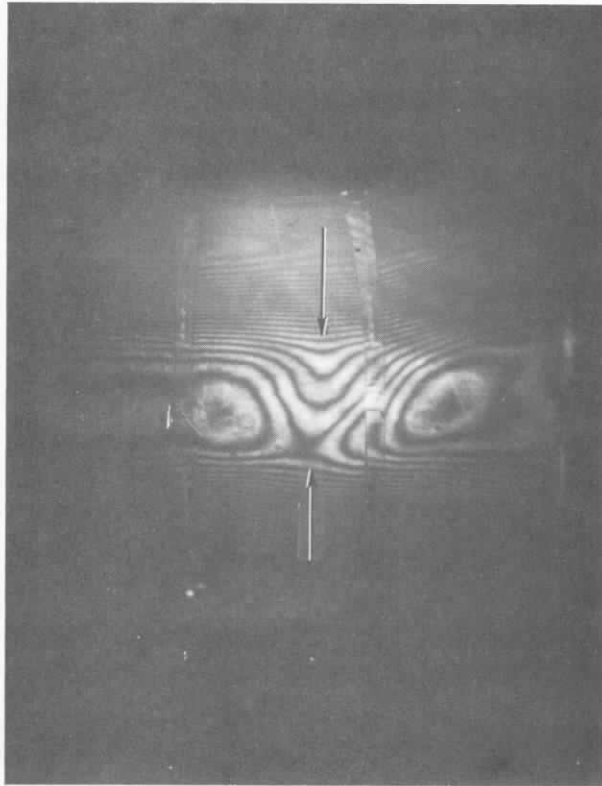
Figure C-8. Holographic Interferogram of a Tire with a Ply Overlap

This type of defect can be identified by irregularities in gross fringe pattern.

This interferogram shows a fringe signature of a ply overlap, the arrow indicating the area of the defect. This type of defect can be identified by an irregular gross fringe pattern.
