Magneto-Optic Imaging Inspection of Selected Corrosion Specimens

July 1992

DOT/FAA/CT-TN92/20

1. Report No. DOT/FAA/CT-TN/92/20		2. Government Accession No.		3. Recipient's Catalog No.	
4. Title and Subtitle MAGNETO-OPTIC IMAGING OF SELECTED CORROSION SPECIMENS				5. Report Date July 1992

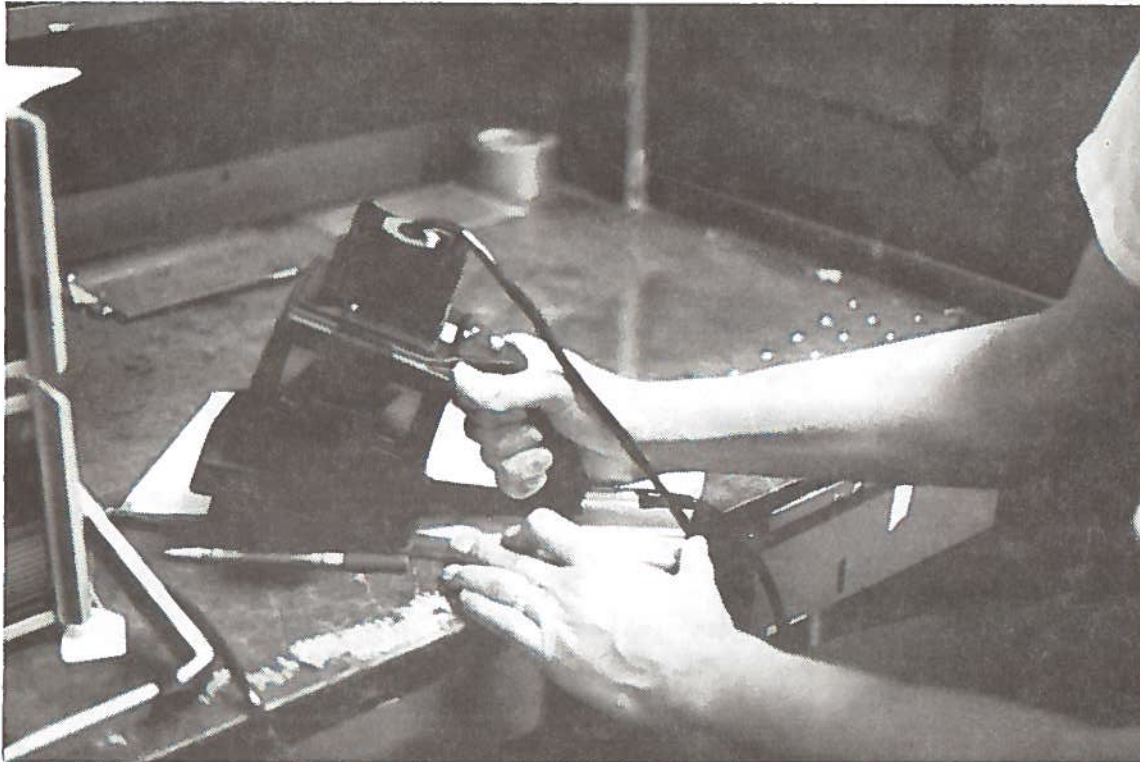
The Model 301-1 MOI instrument in operation on a test panel is shown in Figure 2.

Figure 2 Model 301-1 in operation on a test panel.

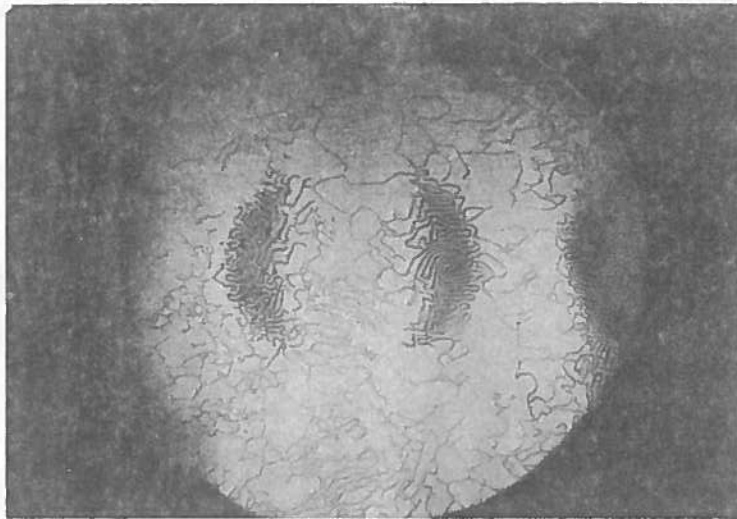
Figure 1. Image of Boeing Reference Standard 127-XXX. Note how the flat-bottomed hole gives a sharper "edge" type image, while a real corroded image gives a diffuse "area" type image.
