NATIONAL TRANSPORTATION SAFETY BOARD

AIRCRAFT ACCIDENT REPORT

GROUND SPOILER ACTIVATION IN FLIGHT/HARD LANDING
VALUJET AIRLINES FLIGHT 558
DOUGLAS DC-9-32, N922VV
NASHVILLE, TENNESSEE
JANUARY 7, 1996

Abstract: This report explains the ground spoiler activation in flight and subsequent hard landing of ValuJet Airlines flight 558, N922VV, a Douglas DC-9-32 at Nashville International Airport, Nashville, Tennessee. The safety issues discussed in the report include the adequacy of ValuJet's operations and maintenance manuals, specifically winter operations nose gear shock strut servicing procedures; the adequacy of ValuJet's pilot training/crew resource management training programs; flightcrew actions/decisionmaking; the role of communications (flightcrew/flight attendants/operations/dispatch/air traffic control); ValuJet's flightcrew pay schedule; Federal Aviation Administration (FAA) oversight of ValuJet; and the adequacy of cockpit voice recorder (CVR) duration and procedures. Safety recommendations concerning these issues were made to the FAA and ValuJet Airlines.

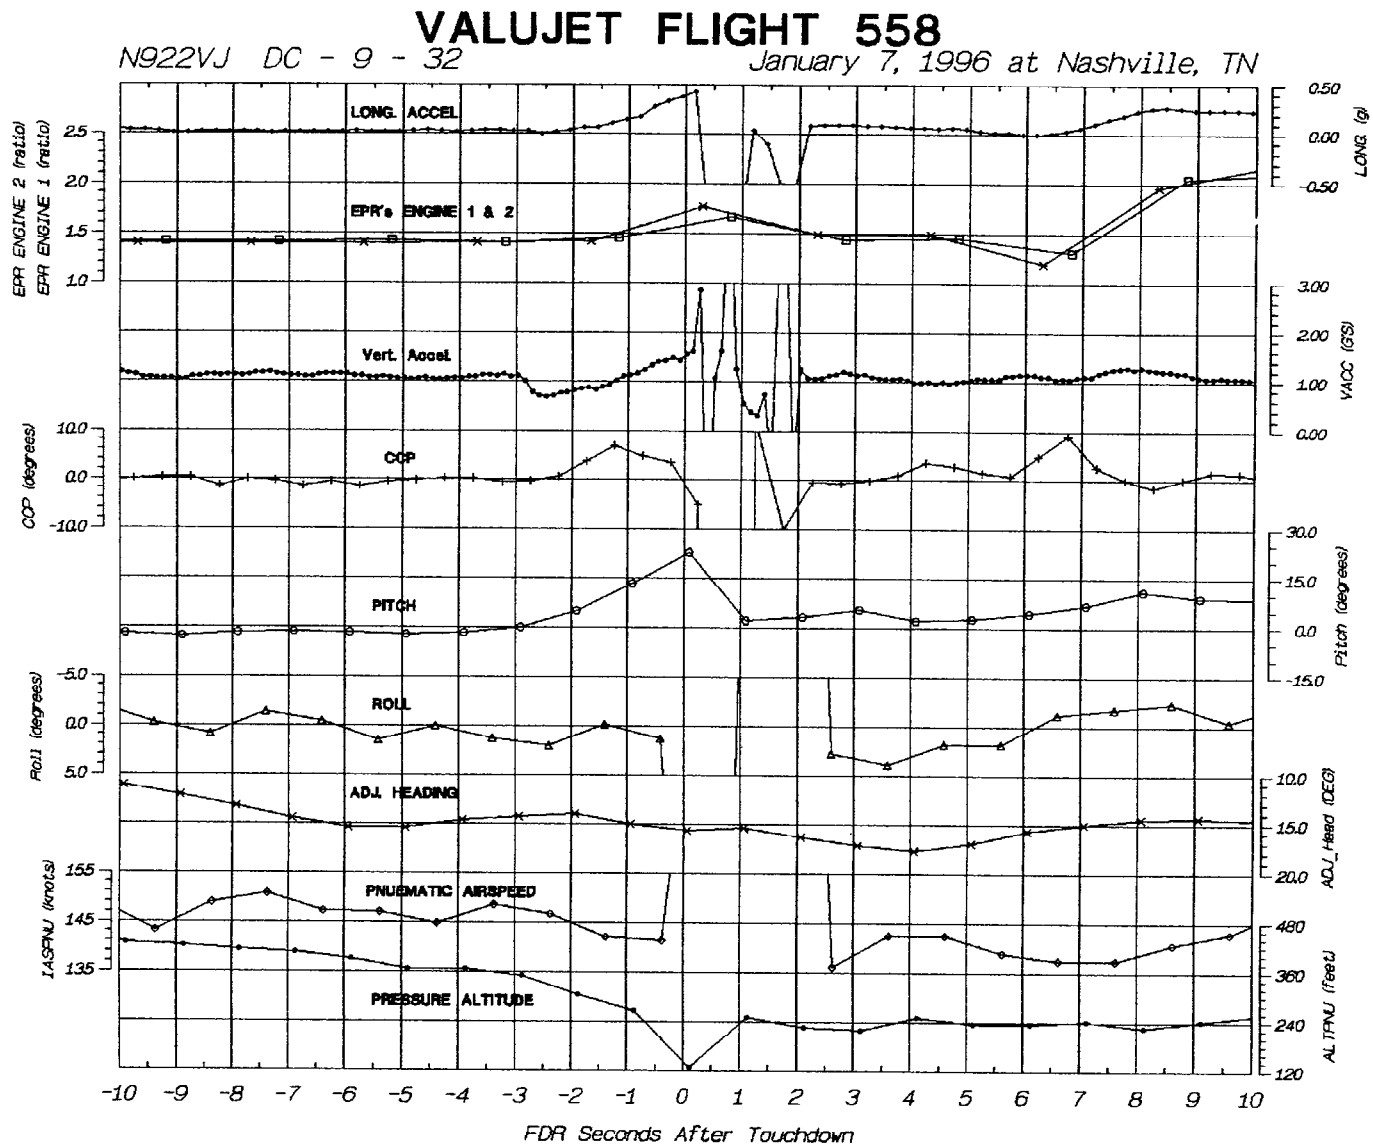
Initial Touchdown Plot
 Revised: December 11, 1996

At approximately 1620, the DC-9 struck the runway approach light area tail first, followed by main landing gear and nosegear, with engine thrust increasing. The nosewheel tires and rims separated after ground impact,¹⁵ and then the airplane became airborne again. The captain assumed control of the airplane as it became airborne and established a climb on runway heading. The first officer raised the flaps to 15°, which positioned the flaps for the climb. Because of possible impact damage, the flightcrew decided not to retract the flaps/slats any further and to leave the landing gear extended during the go-around.
